Elk Creek Coldwater Conservation Plan

Prepared by

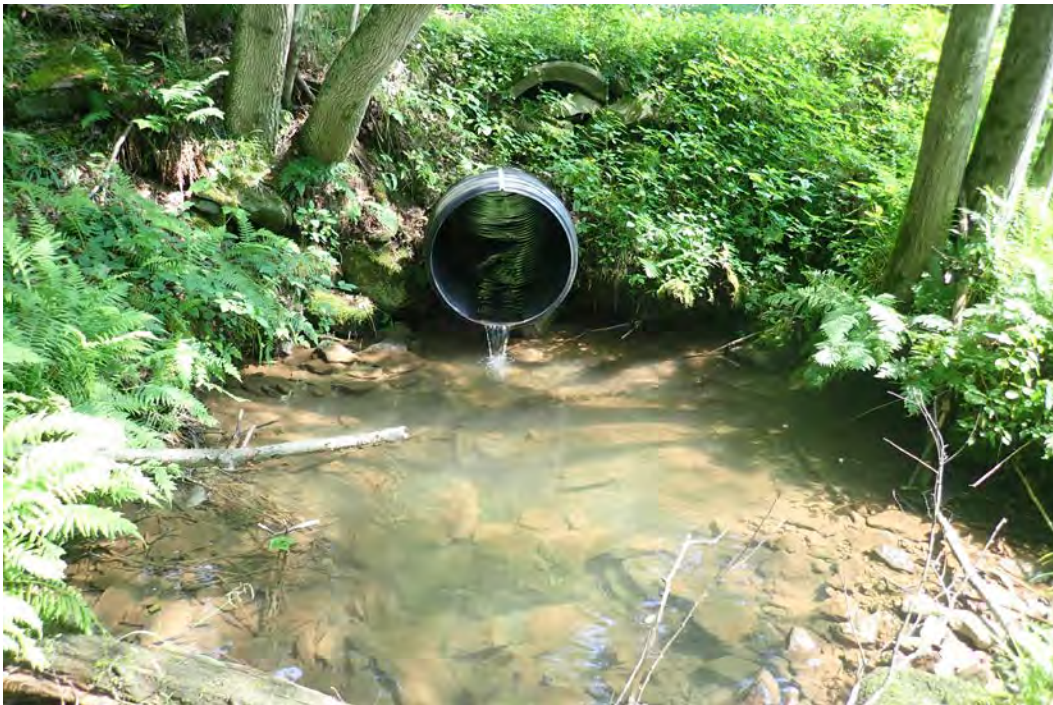
Photo 2. Culvert outlet under an ATV trail in EC04. Wild Brook Trout were observed in the tail pool. At normal and low flows, this culvert presents challenges for aquatic organism passage.

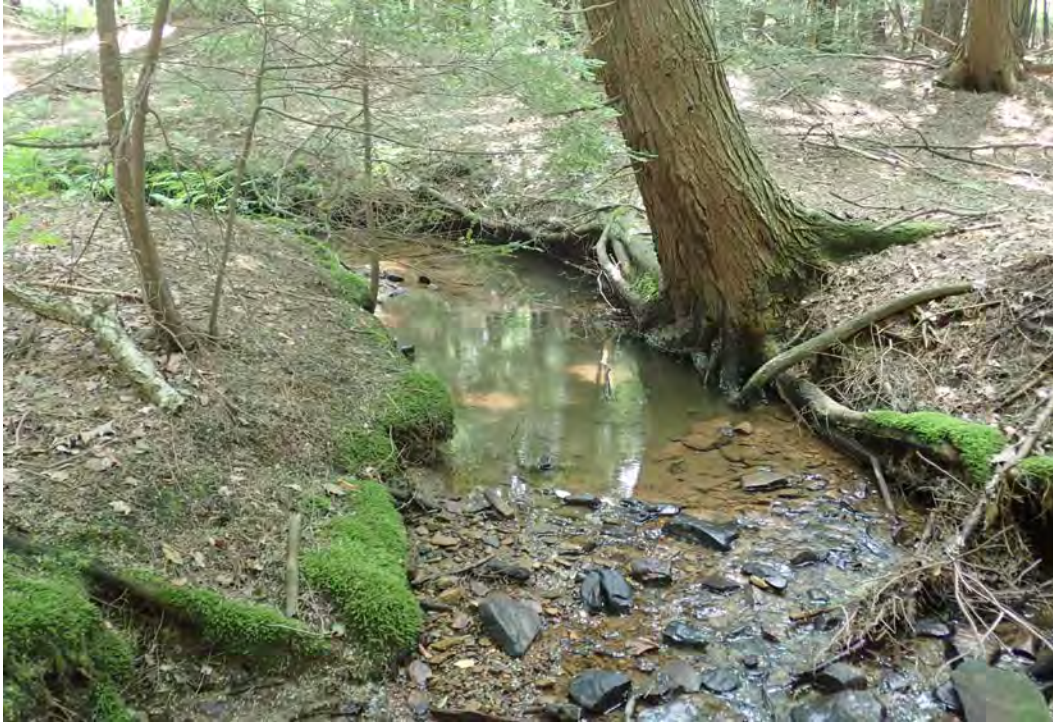
Photo 3. Trout habitat in the form of an undercut bank, flow variability, and exposed root and cobbles in EC04.

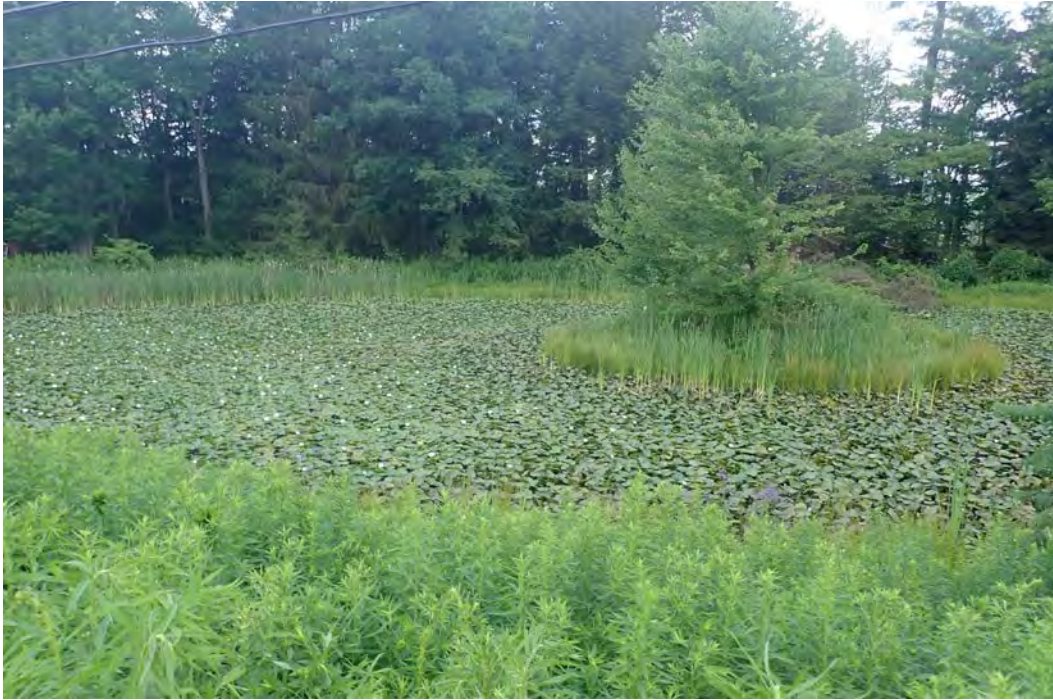
Photo 9. Wetland near St. Marys Auto Repair in EC04. Elk Creek becomes a lower-gradient, slow-flowing stream after it crosses under Windfall Road near Amphenol Sensors then enters a wetland complex (above) across from Windfall Car Wash. EC04 continues through a wetland until the crossing under Weidow Crest Road.

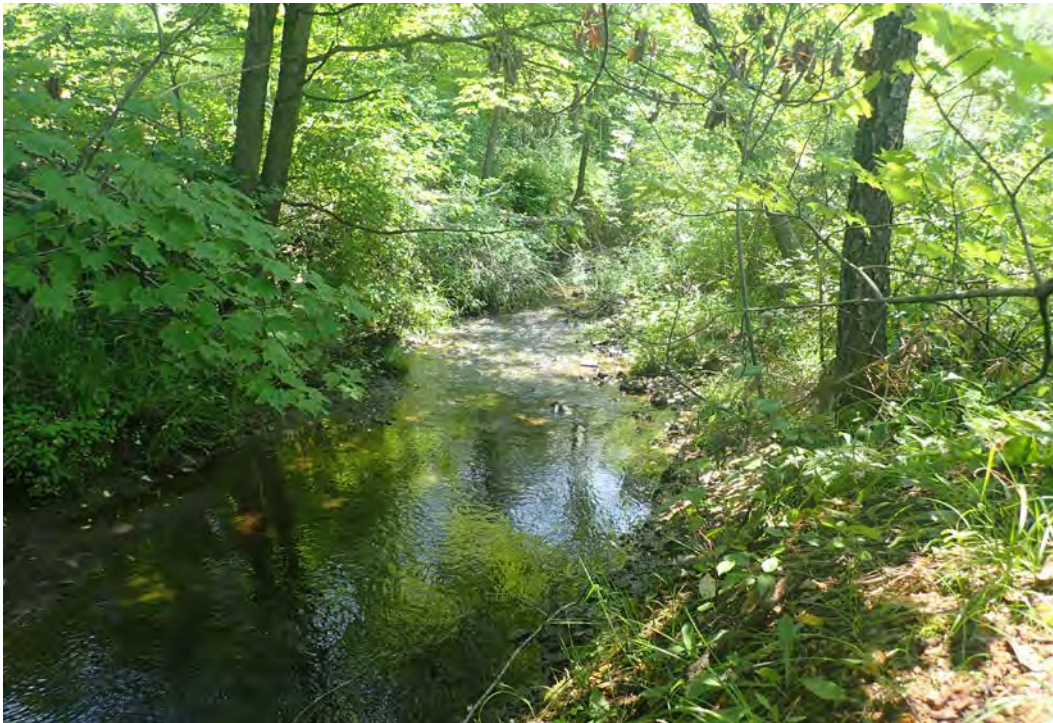
Photo 10. End of segment EC04 behind Pesce Metal Fabrication on Washington Street.

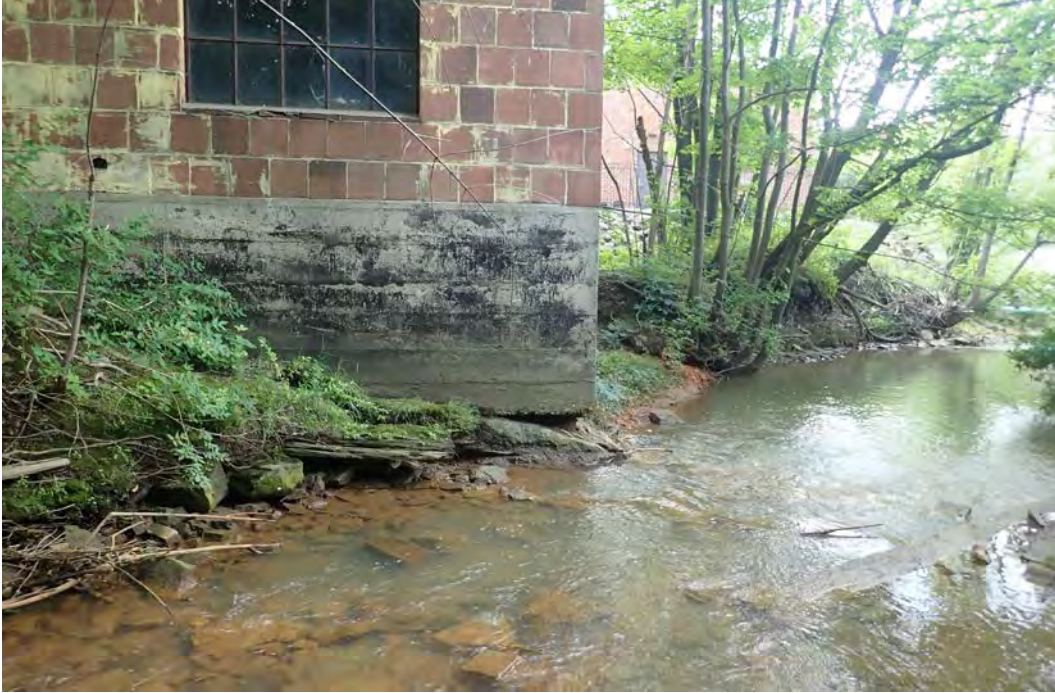
Photo 28. An abandoned building with the foundation undercut by Elk Creek in EC05.

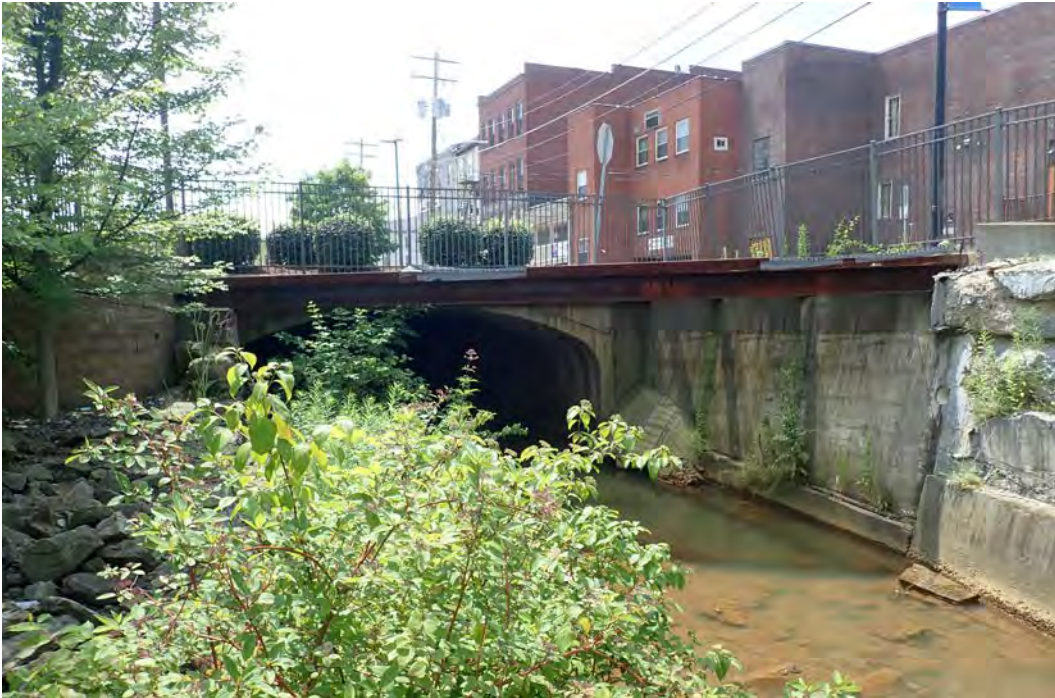
Photo 29. EC05 before it flows subsurface near Sheetz.

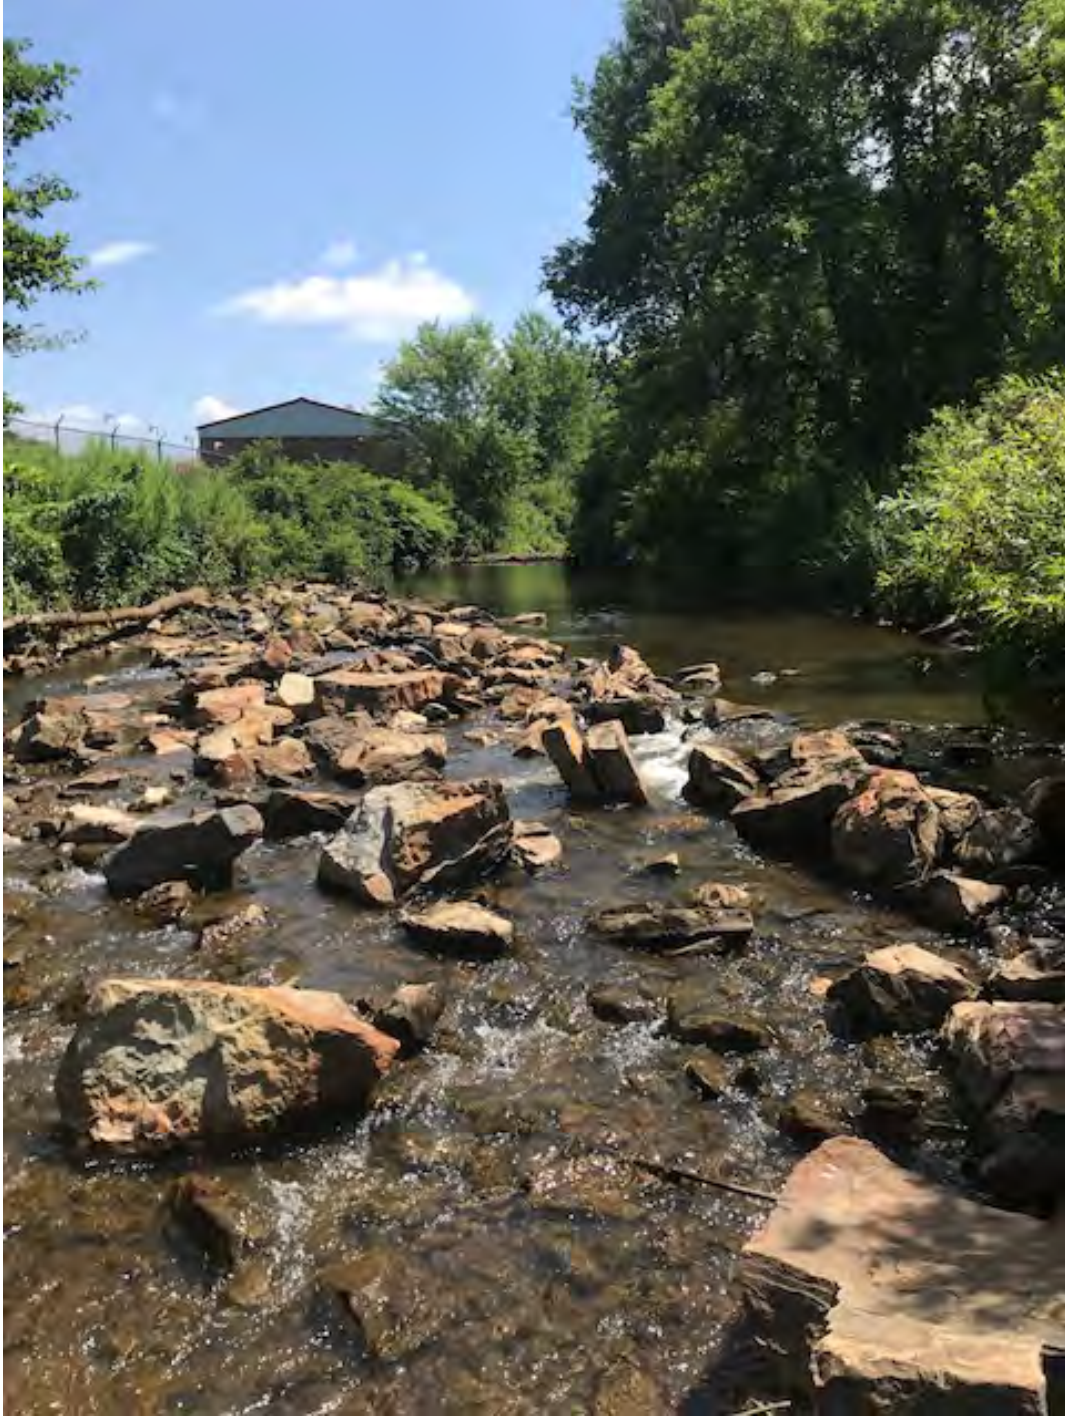
Photo 45. Looking upstream at the rock vane from photo 44. The rock vane appears to be manmade or accumulated large material overtime due to a pipeline lying on the stream bottom. No pipes were observed during assessment, however.

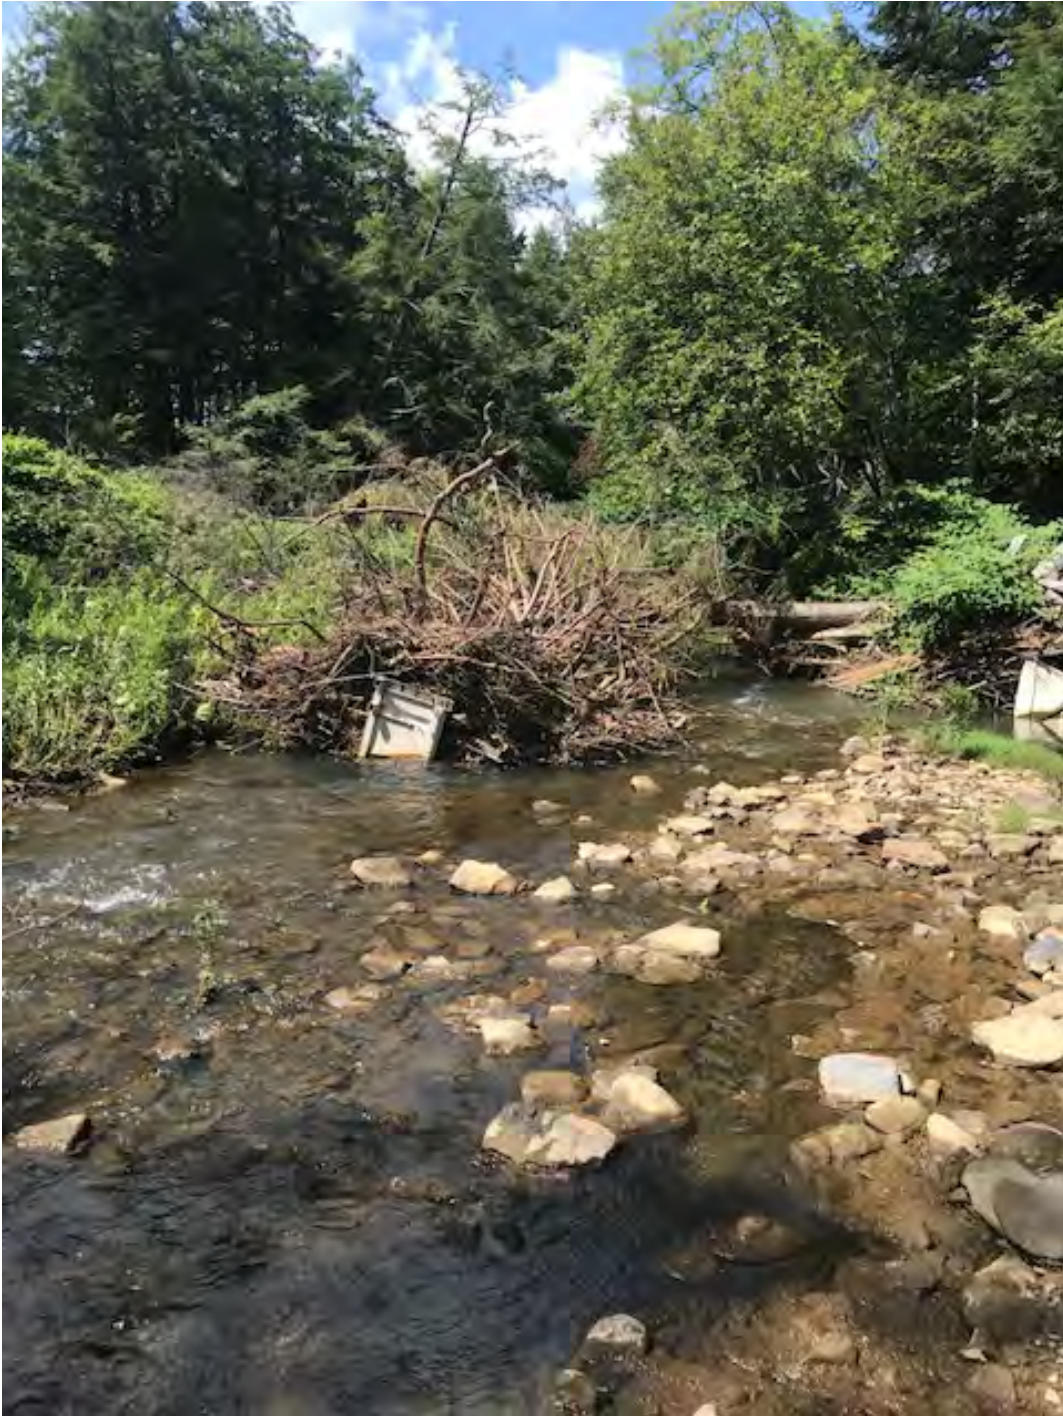
Photo 46. Debris jam in EC10. The root wad creates habitat for aquatic organisms, but filamentous algae mats remove potential habitat by covering the substrate.

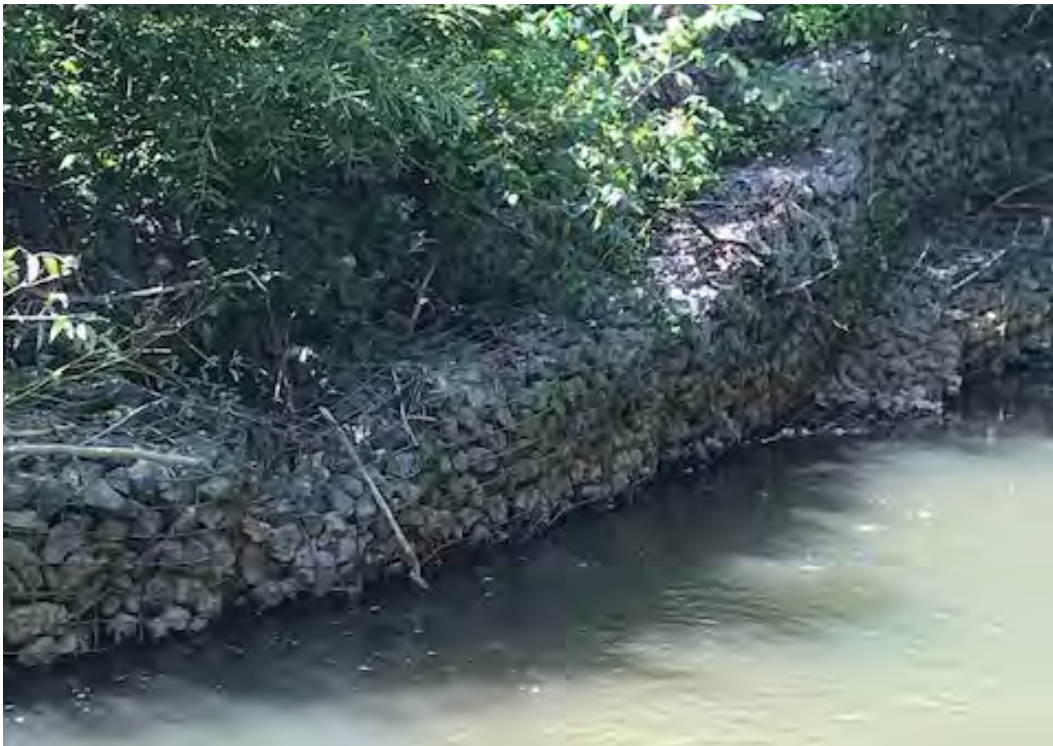
Photo 49. Slumping gabion baskets in EC10. Gabion baskets often fail over time and provide no habitat for aquatic organisms. Damaged basket wires can be an injury hazard.

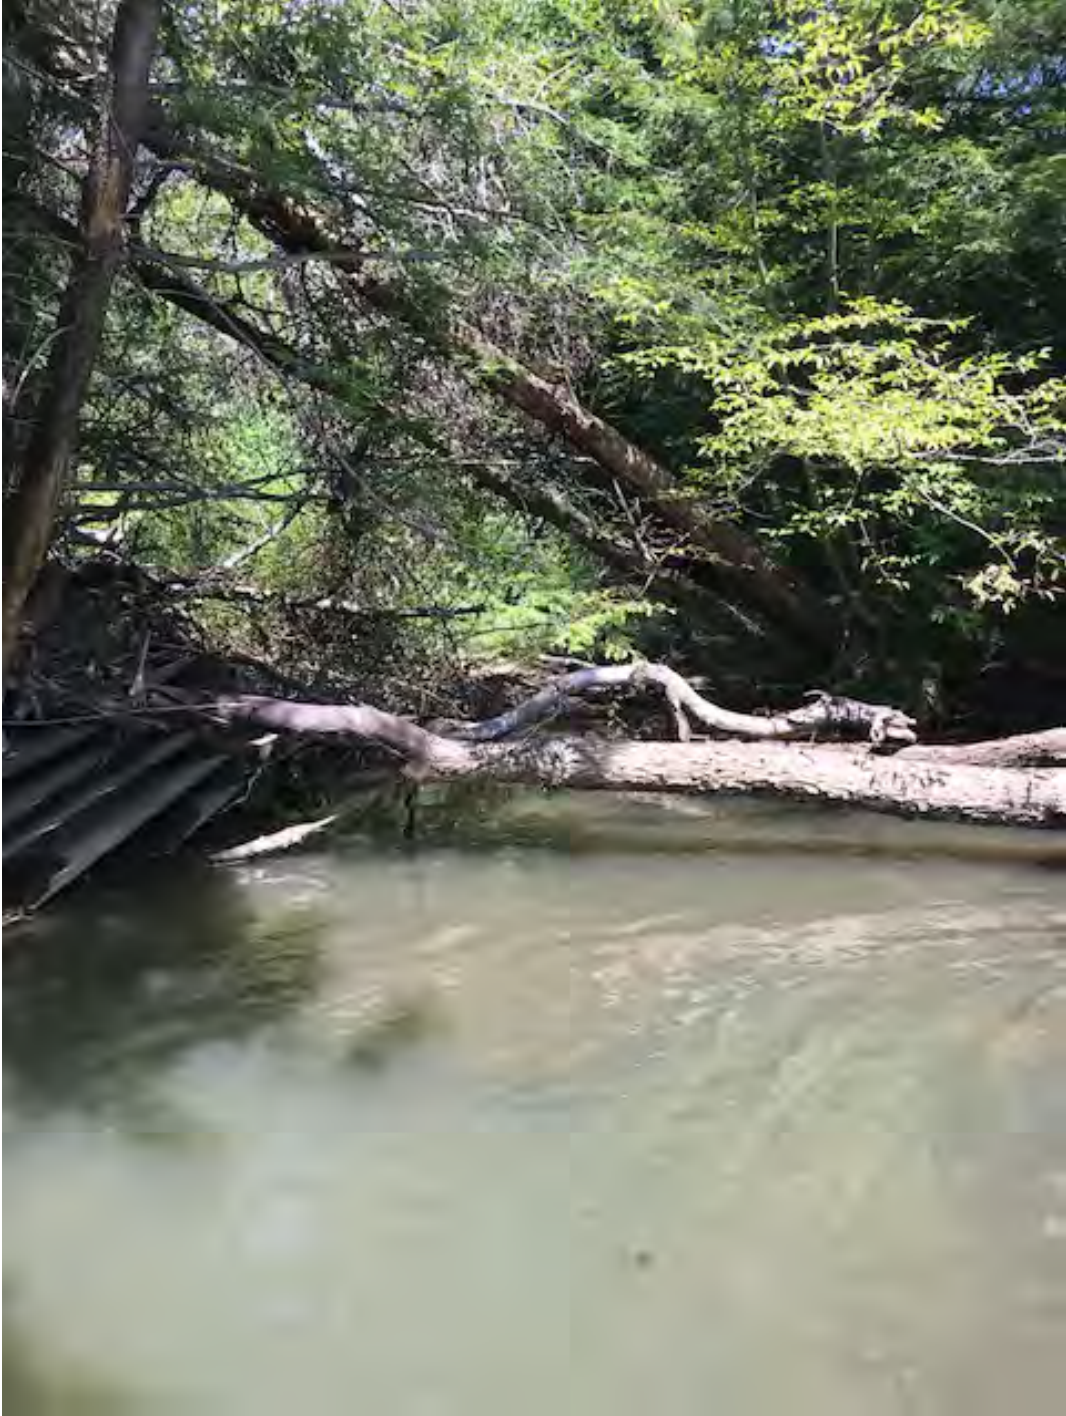
Photo 50. End of EC10 looking downstream at the confluence with Silver Run and a debris jam.

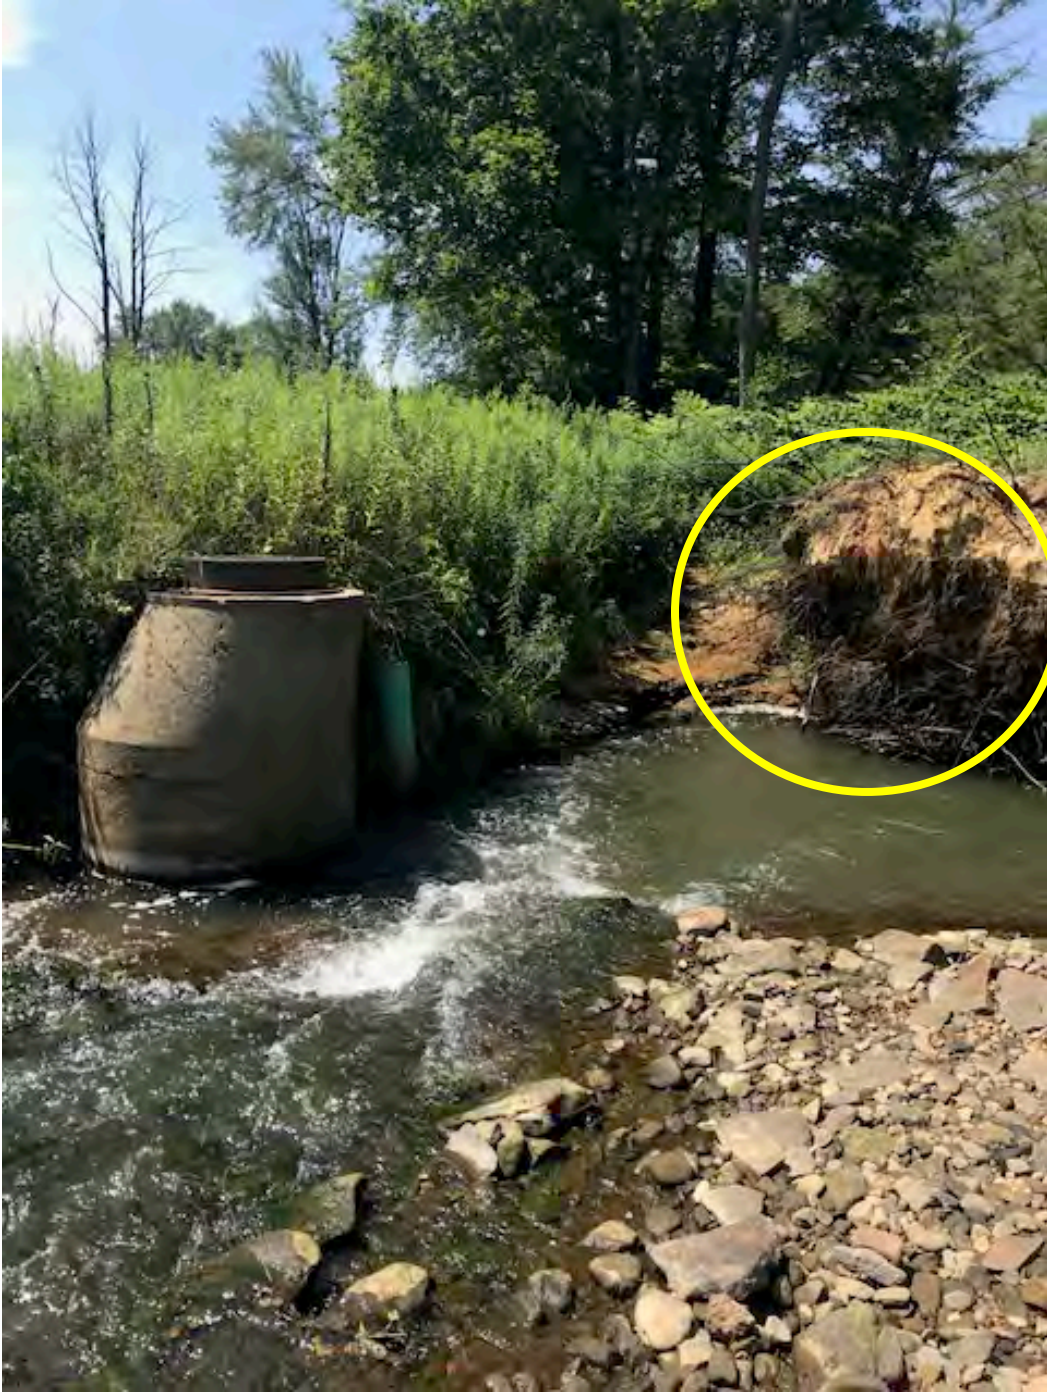
Photo 52. Sewer line manhole lid stack in the stream channel. The manhole stack has rerouted stream water in to the left bank to cause erosion. The erosion caused a tree to uproot (yellow circle).

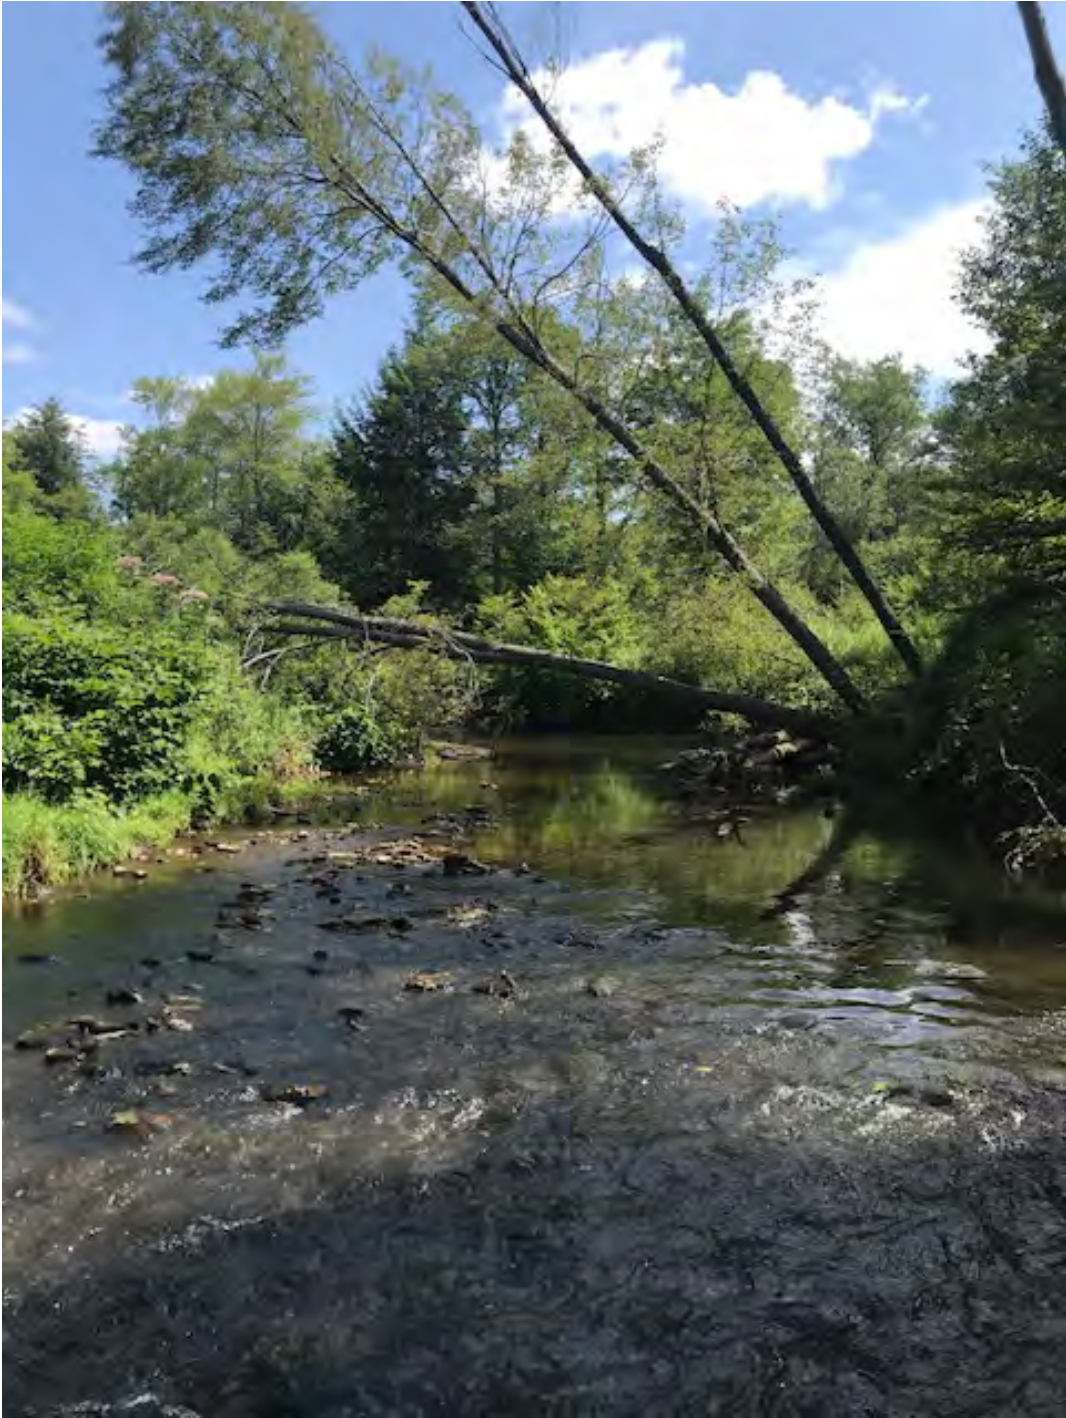
Photo 53. End of EC11 looking upstream at falling trees.

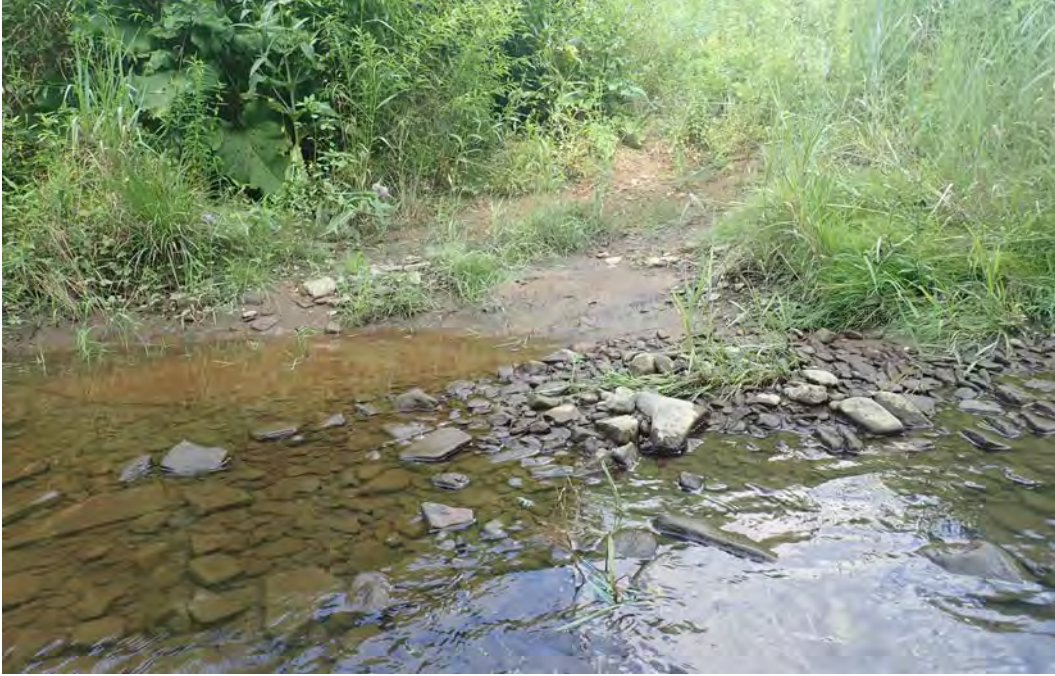
Photo 106. ATV trail crossing in EC09 which cause localized siltation.

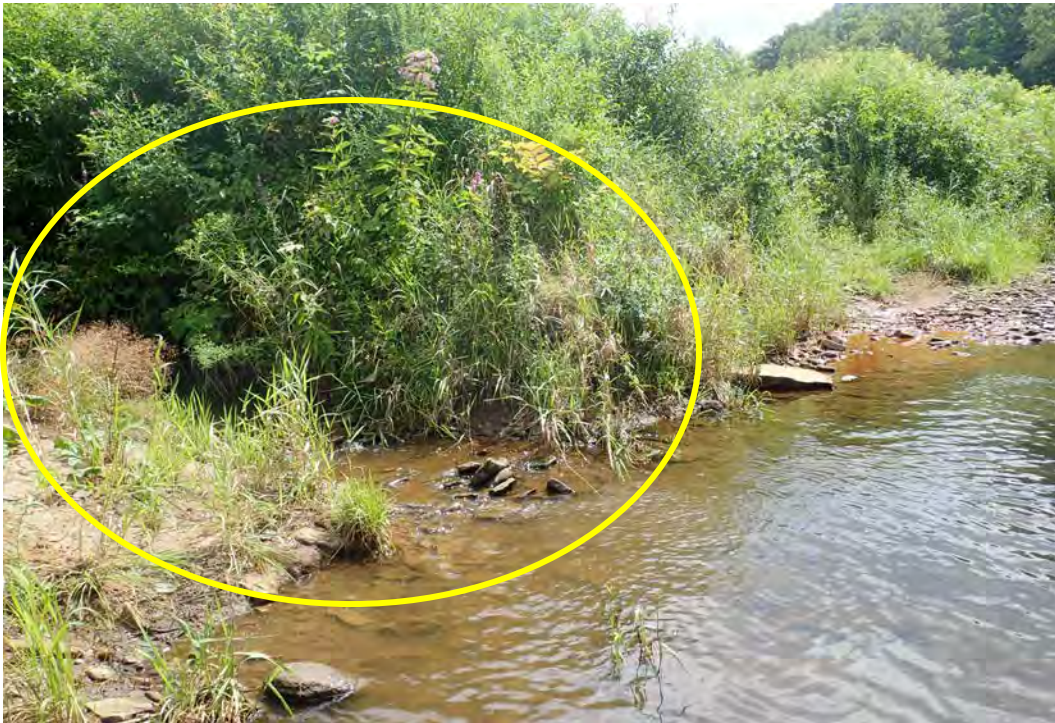
Photo 107. Confluence of EC09 with Rocky Run (yellow circle) where EC16 begins.

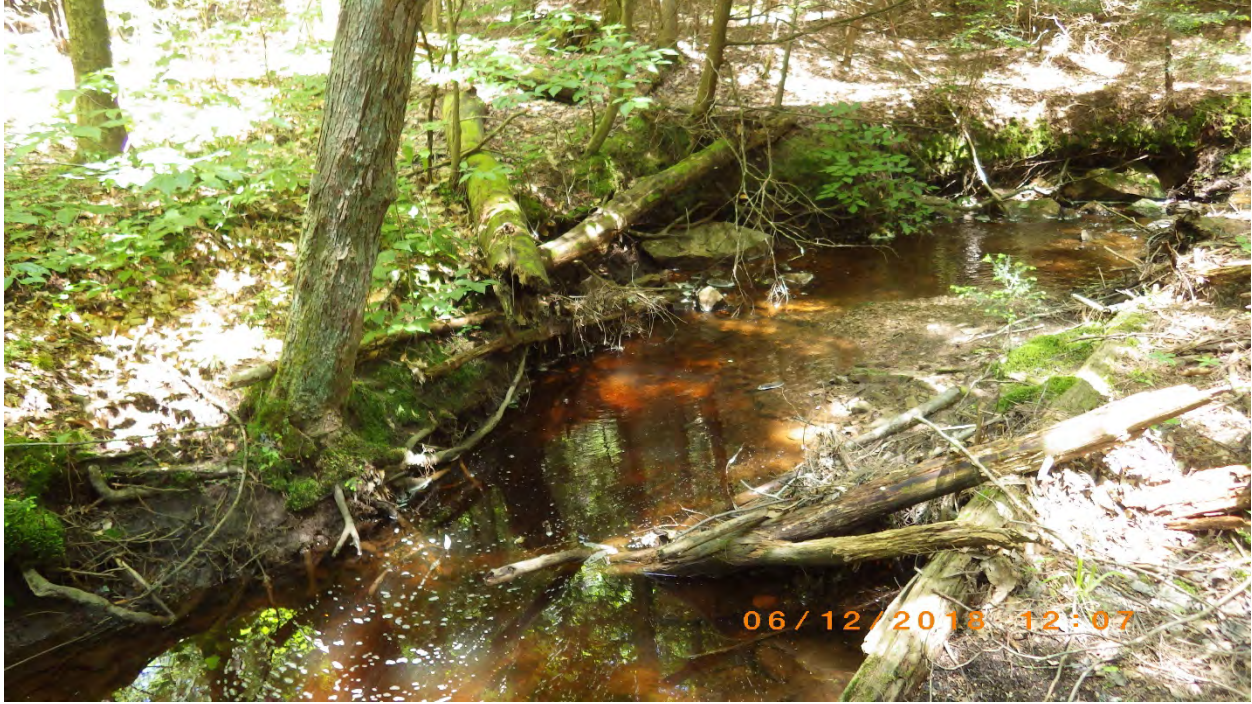
Photo 1. Dark, tannic water in BV02.

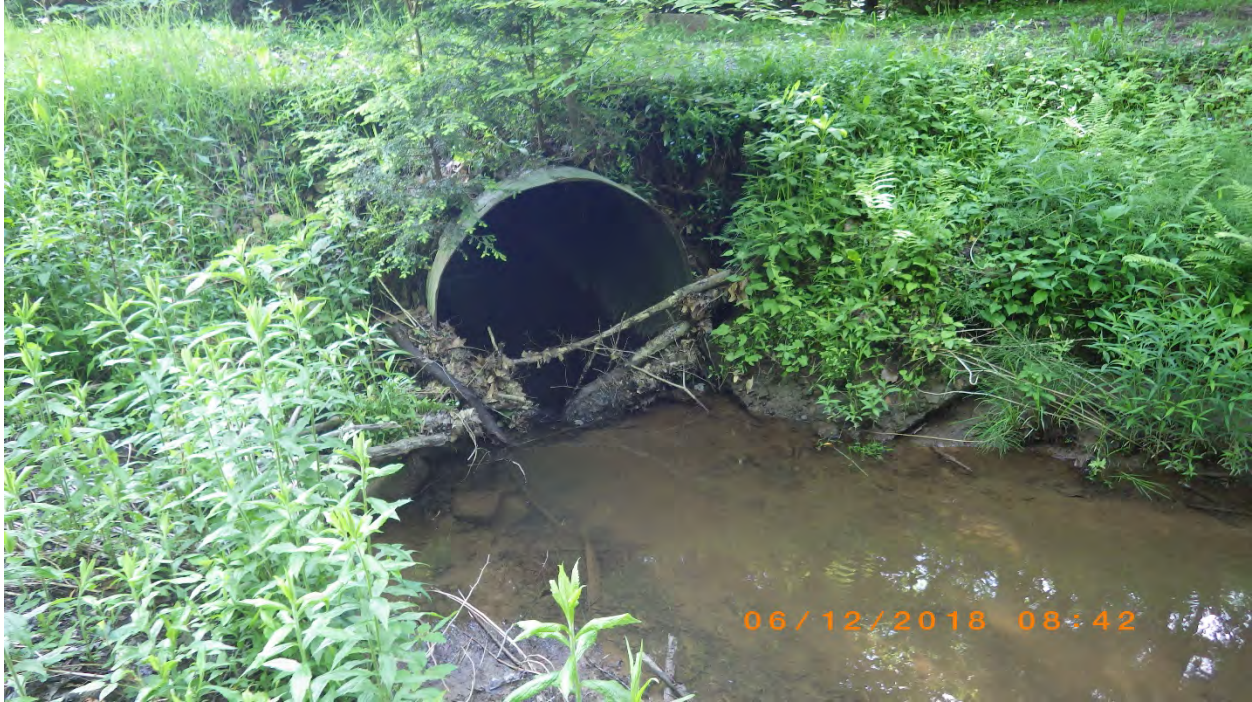
Photo 1. Beginning of DG01 at culvert on Timm property. Blacknose dace were observed at this stream crossing.

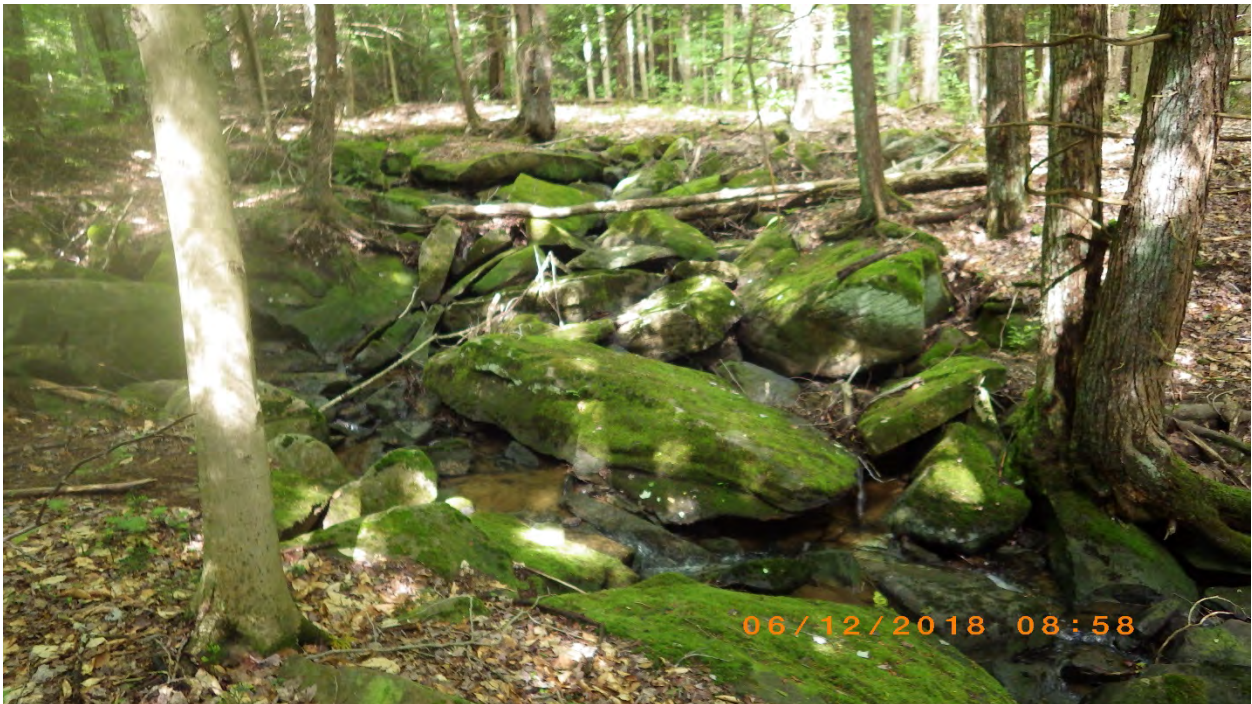
Photo 2. Segment of DG01 dominated by large substrate. DG01 was comprised of mostly boulders (45%) and riffle/pool habitats were the most common.

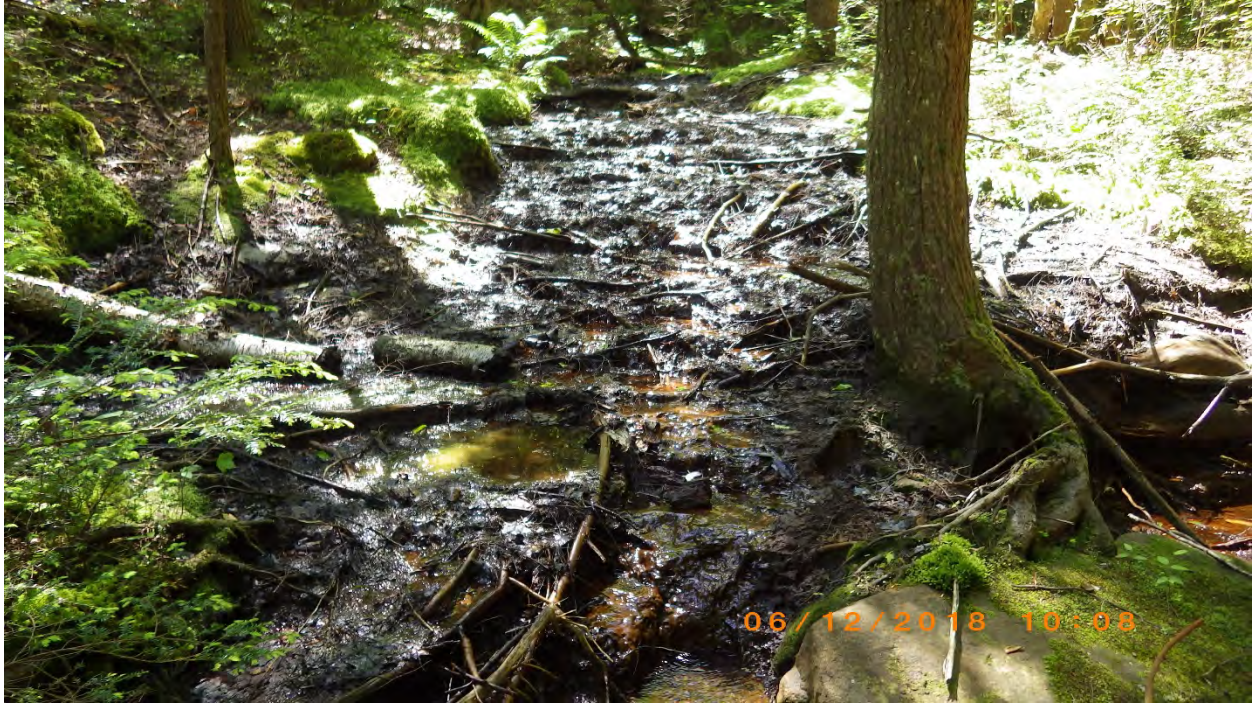
Photo 11. The third AMD seep observed in DG06 (41.37833, -78.63177). Discharge from this seep was low during assessment. pH was 2.7 and specific conductivity was 1395 $\mu\text{S}/\text{cm}$ in this seep.

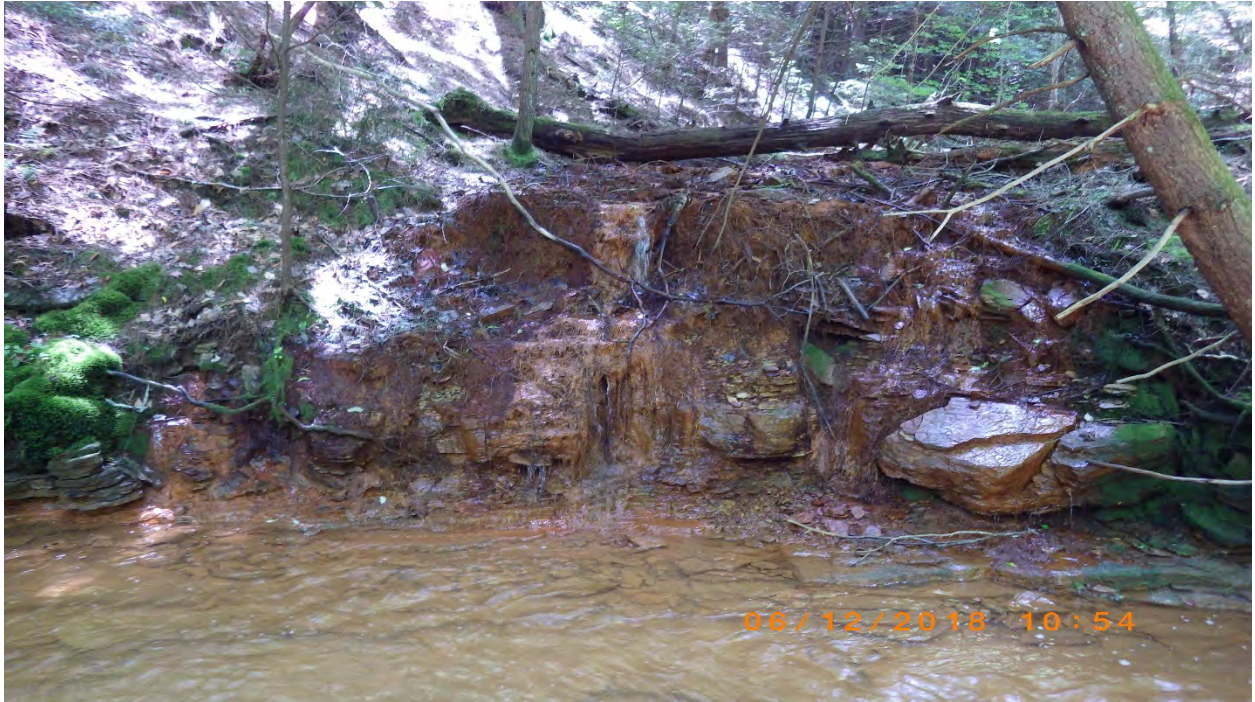
Photo 12. The fourth seep in segment DG06 (41.38760, -78.63167). Specific conductivity was 663 $\mu\text{S}/\text{cm}$ and pH was 4.0.

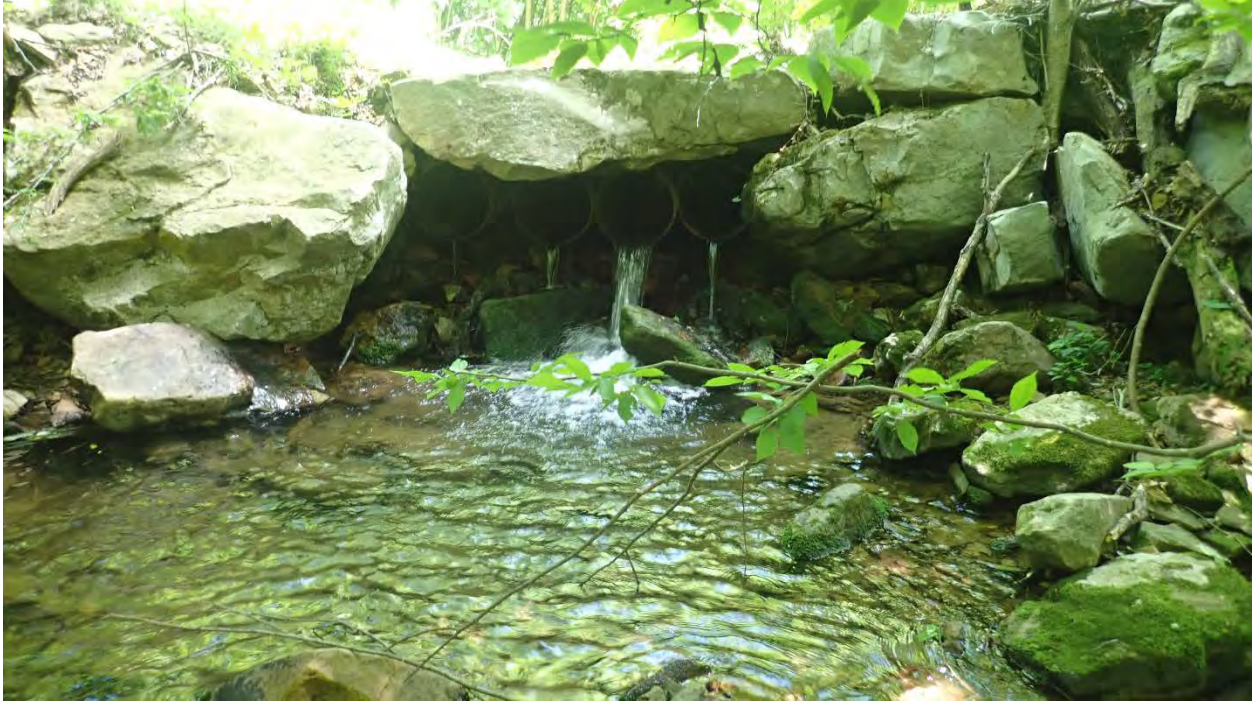
Photo 1. Outlet of culvert immediately upstream from the Daguscahonda/Decker Run confluence.

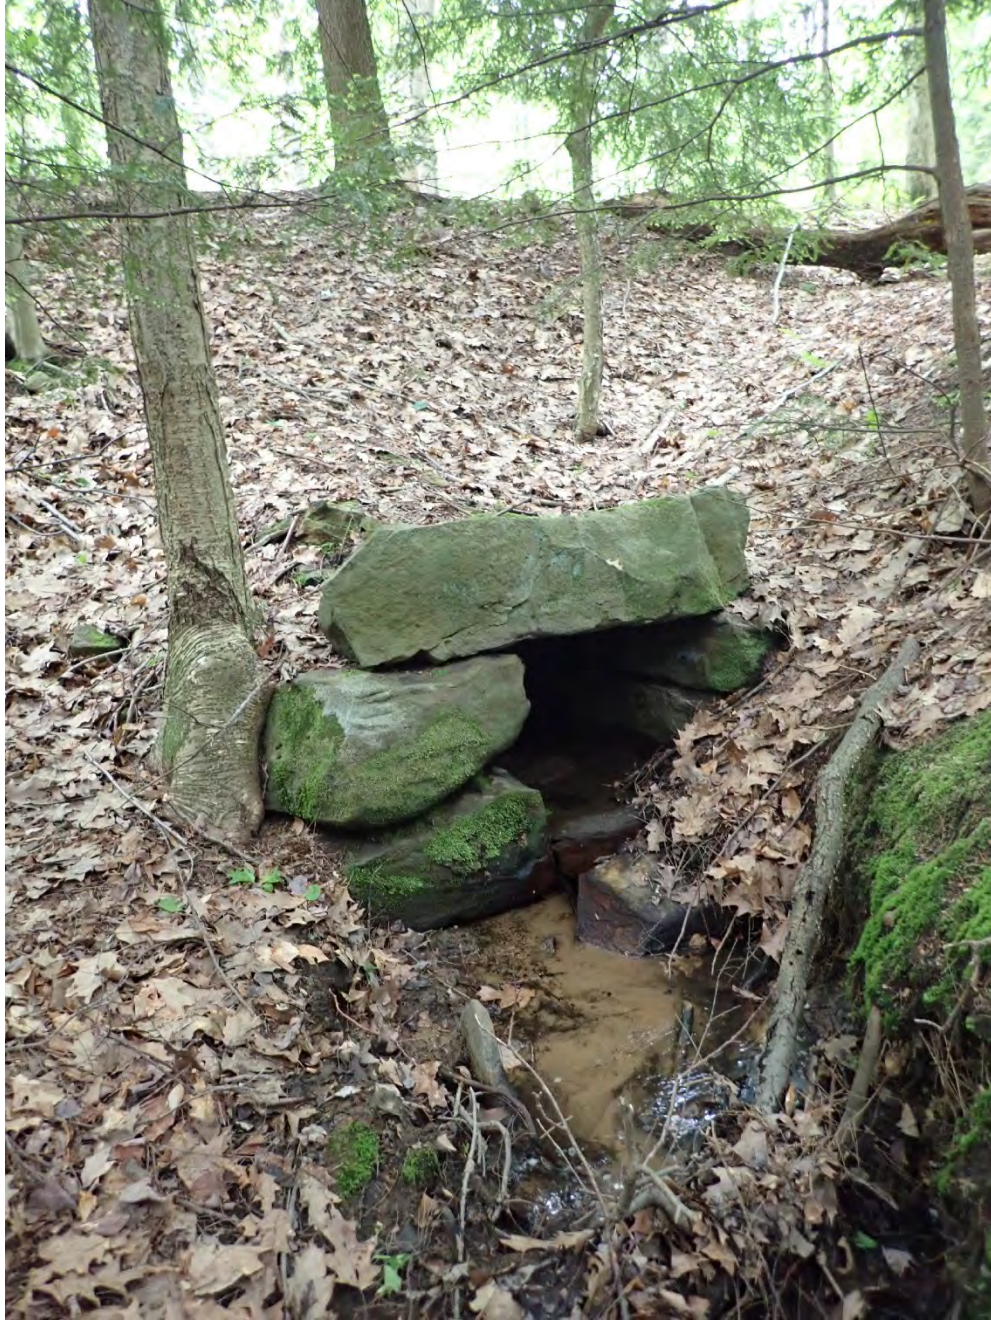
Photo 1. Beginning of Gallagher Run from spring landscaped with boulders.

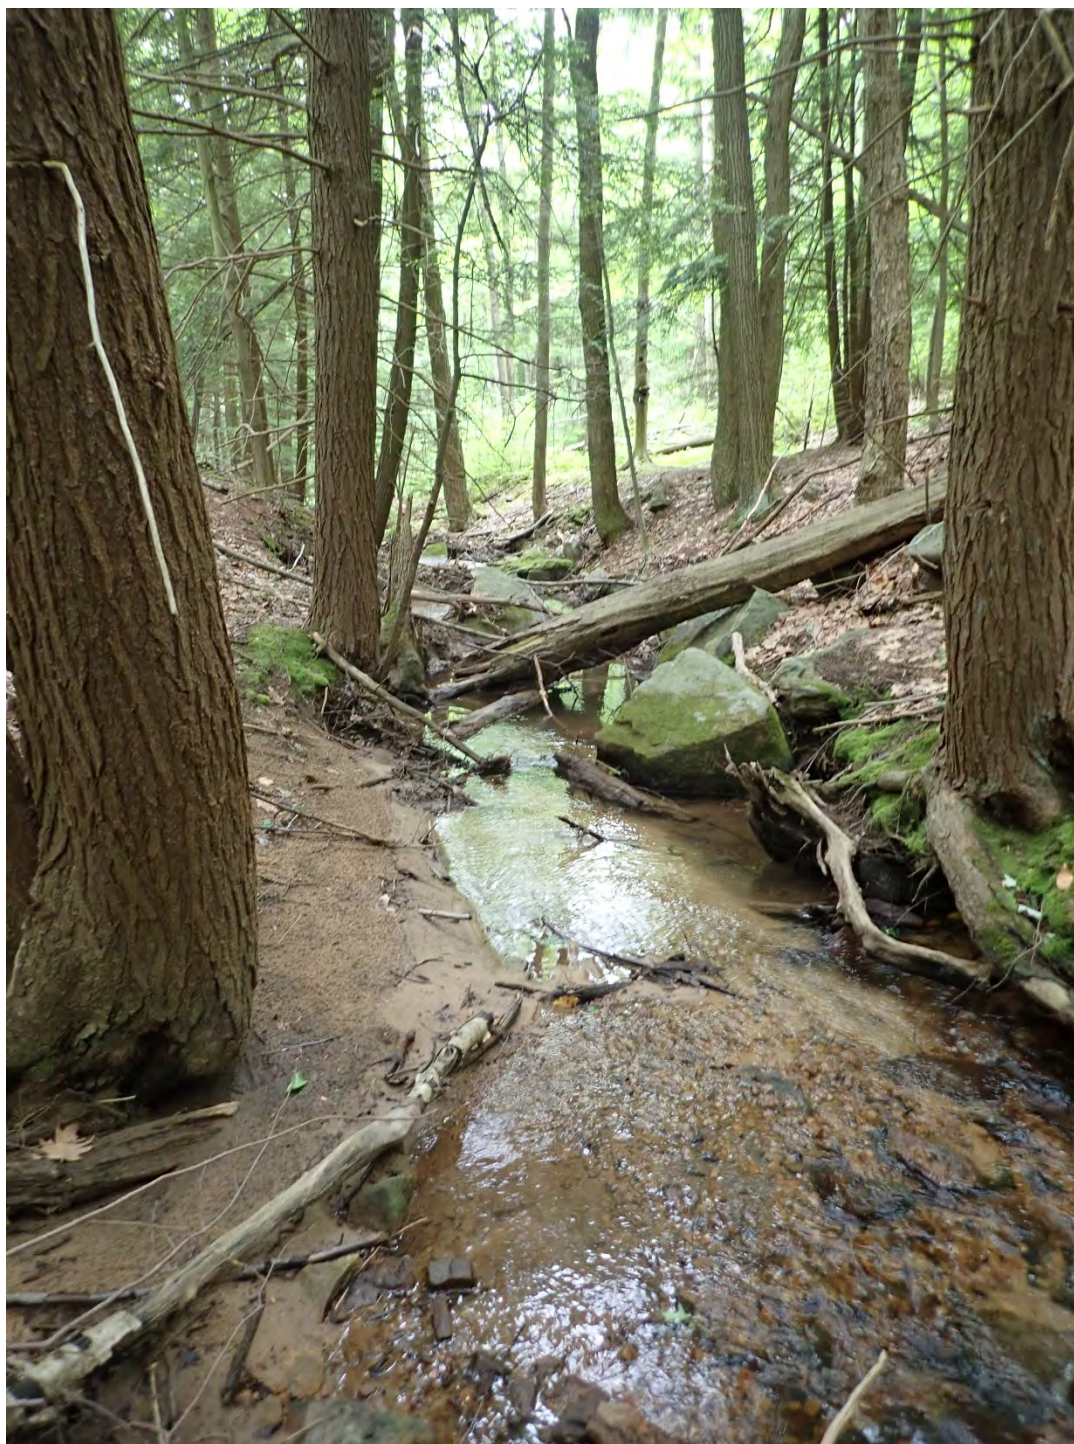
Photo 4. V-shaped valley of Gallagher Run Watershed. Gallagher Run flows along the bottom of steep hill to its East. Substrate was small and a lot of silt was observed in the headwaters. A native Brook Trout was observed in this location.
