Elk Creek Coldwater Conservation Plan

Prepared by

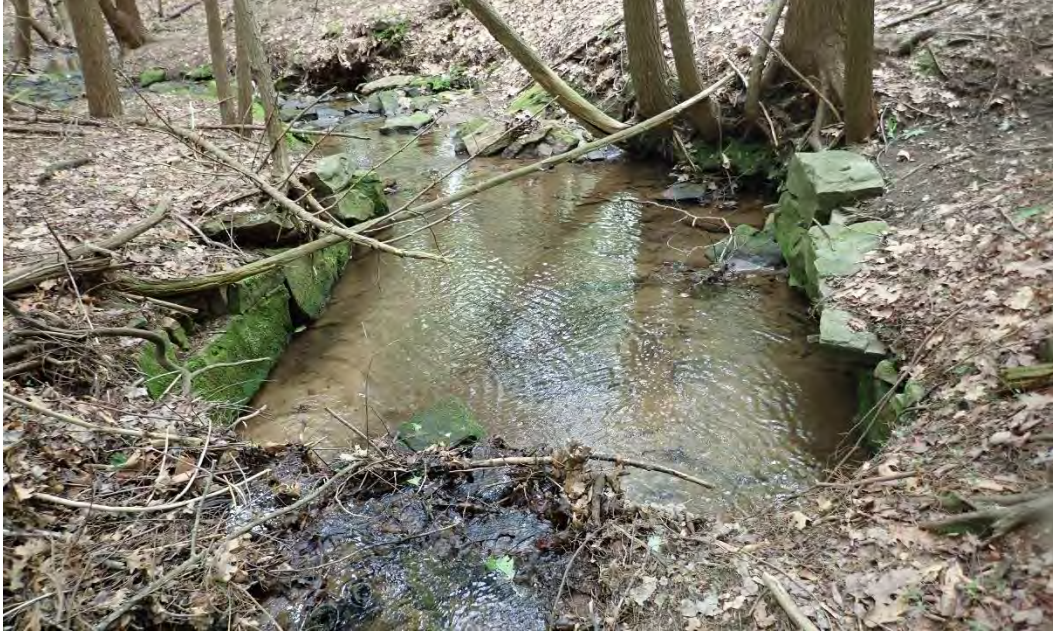
Photo 5. Looking downstream at old bridge abutments made from large, cut boulders.

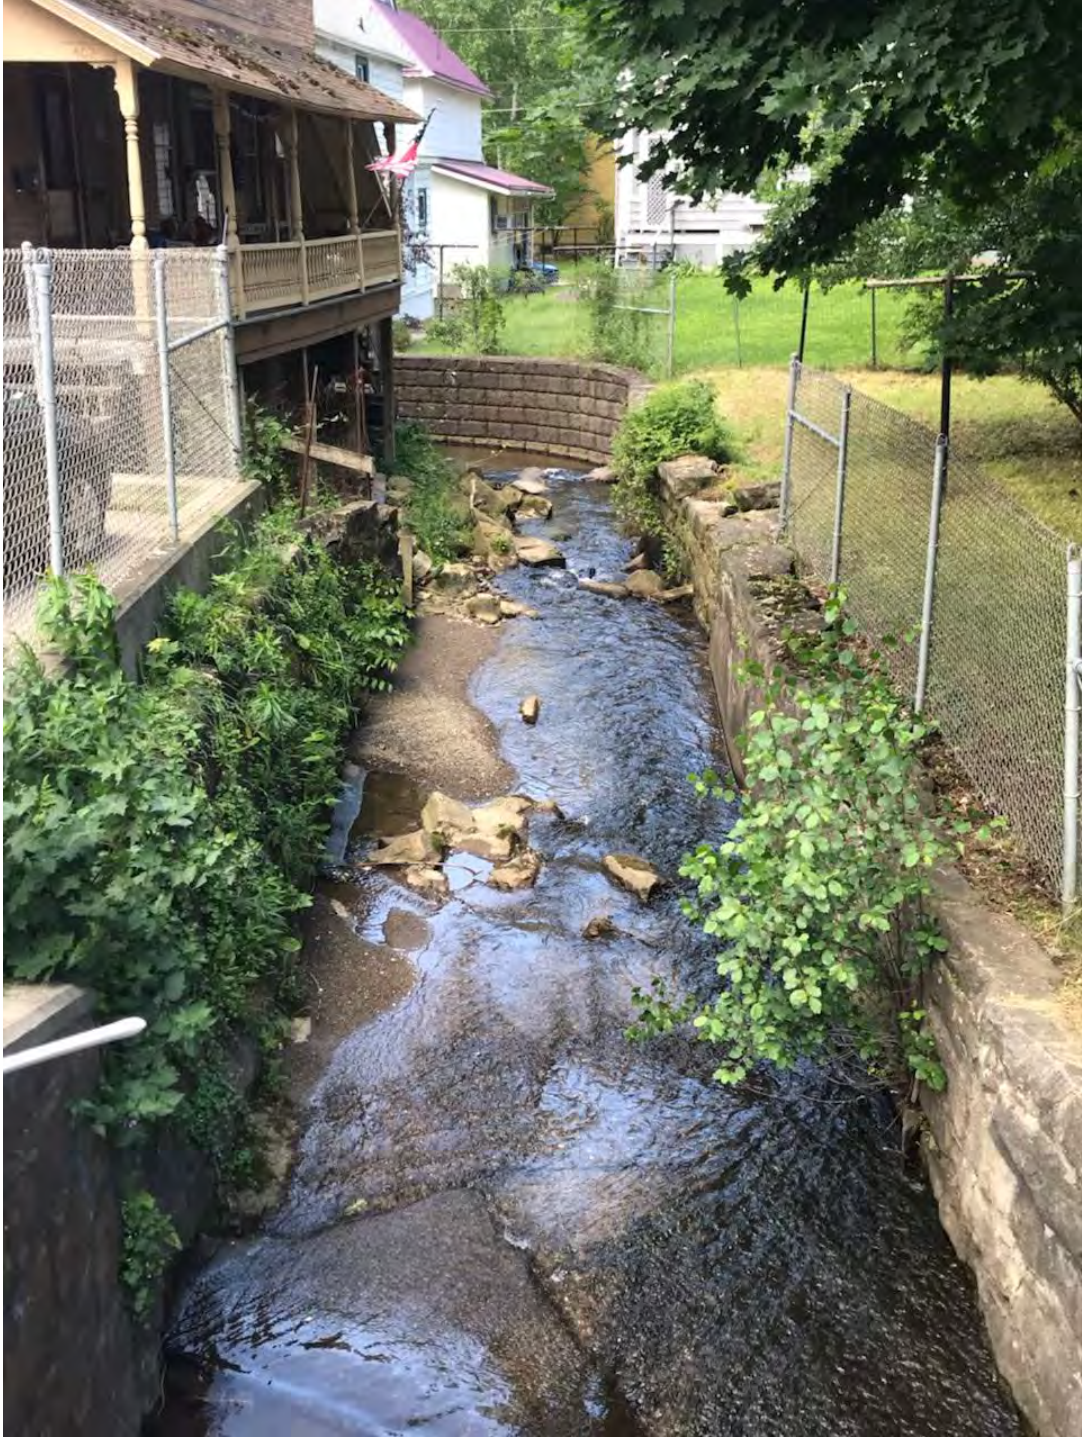
Photo 16. Looking downstream from bridge under Bootjack Road. Gallagher Run is impounded by walls and flows hazardously close to residential structures.

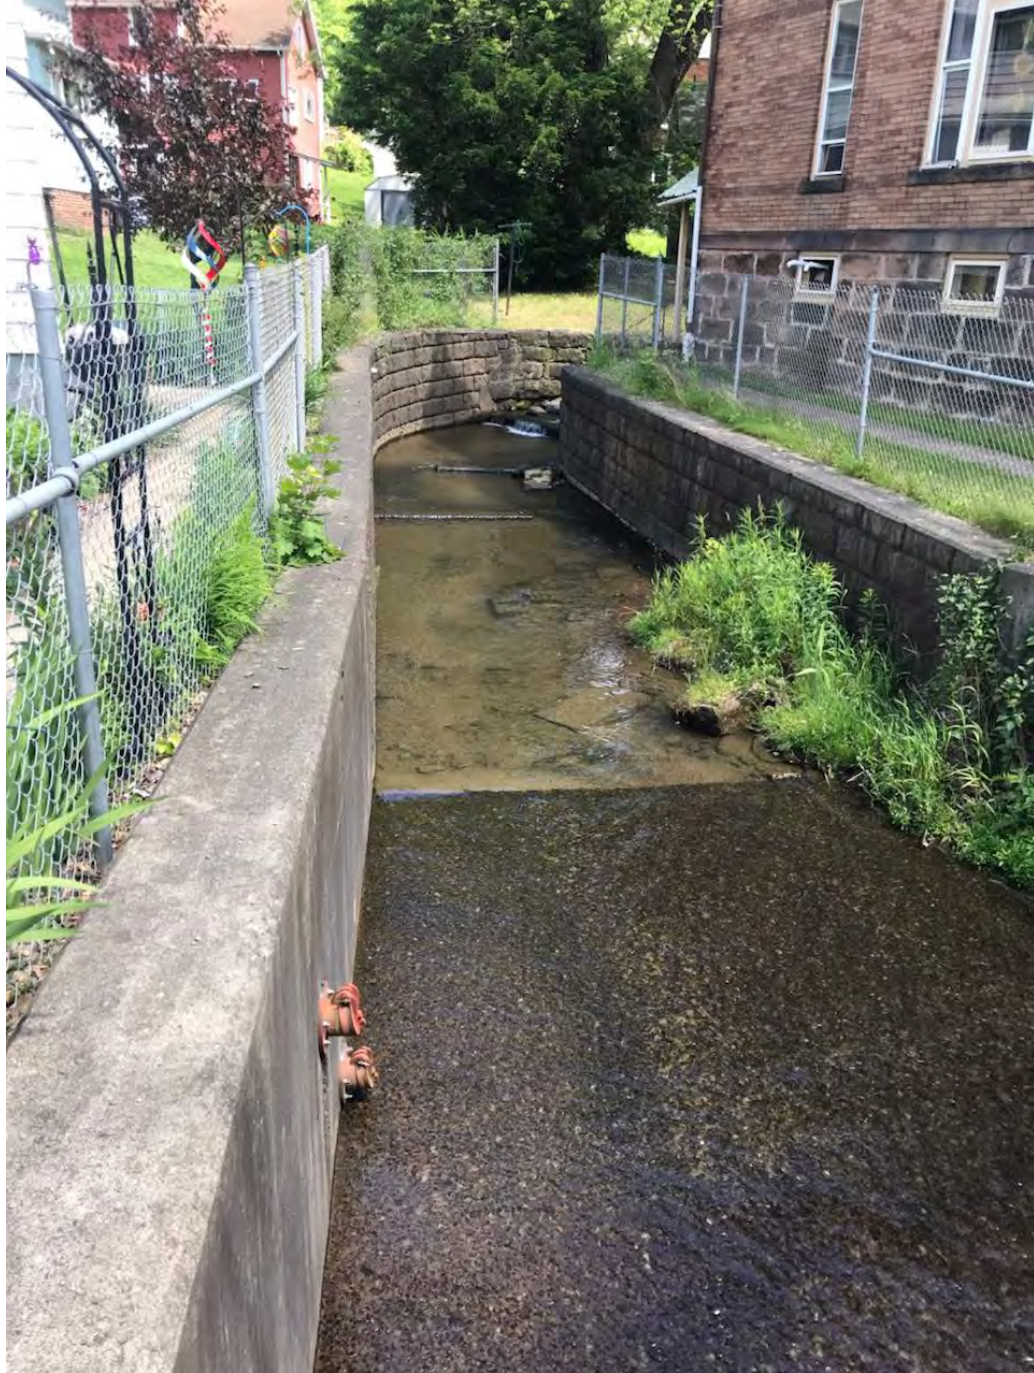
Photo 17. Looking upstream at Gallagher Run from the bridge under Depot Street. Gallagher Run has very little habitat for aquatic organisms.

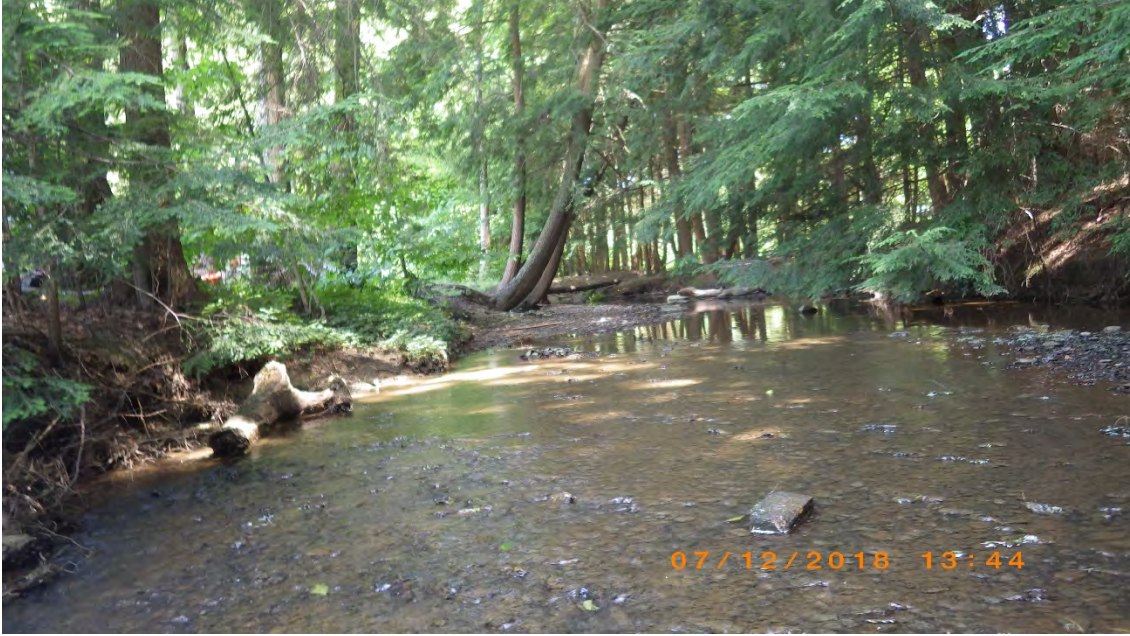
Photo 1. Looking upstream at IR01 as it leaves Benzinger Park property.

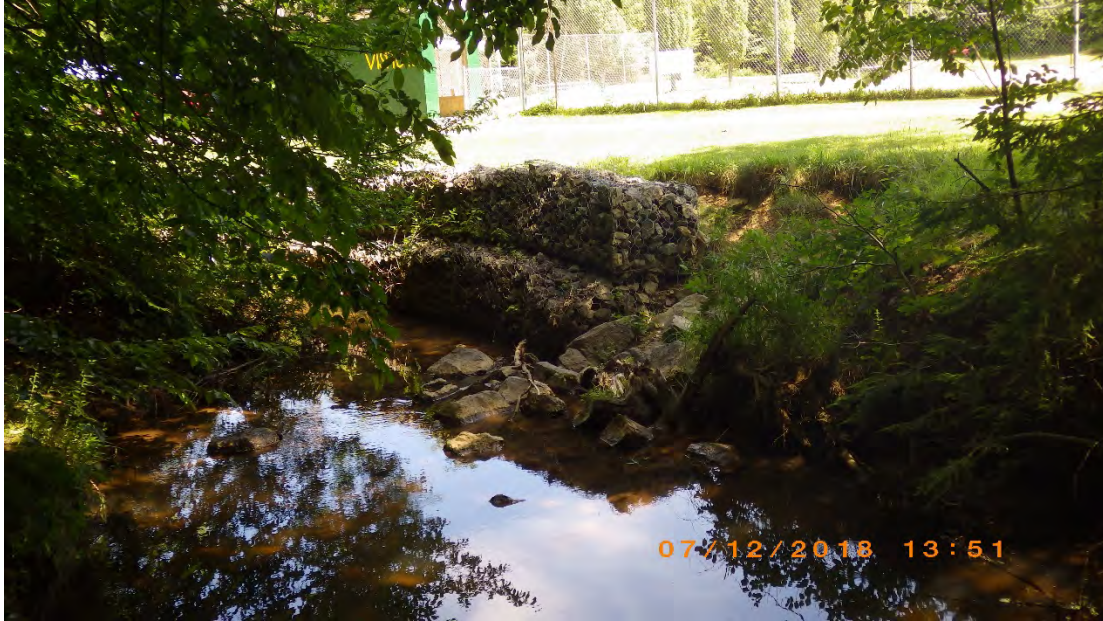
Photo 3. Looking upstream at gabion baskets along the streambank in Benzinger Park. The stream eroded the right bank near a paved walking trail. The gabion baskets were in poor condition and had protruding wires and were losing rocks to the stream.

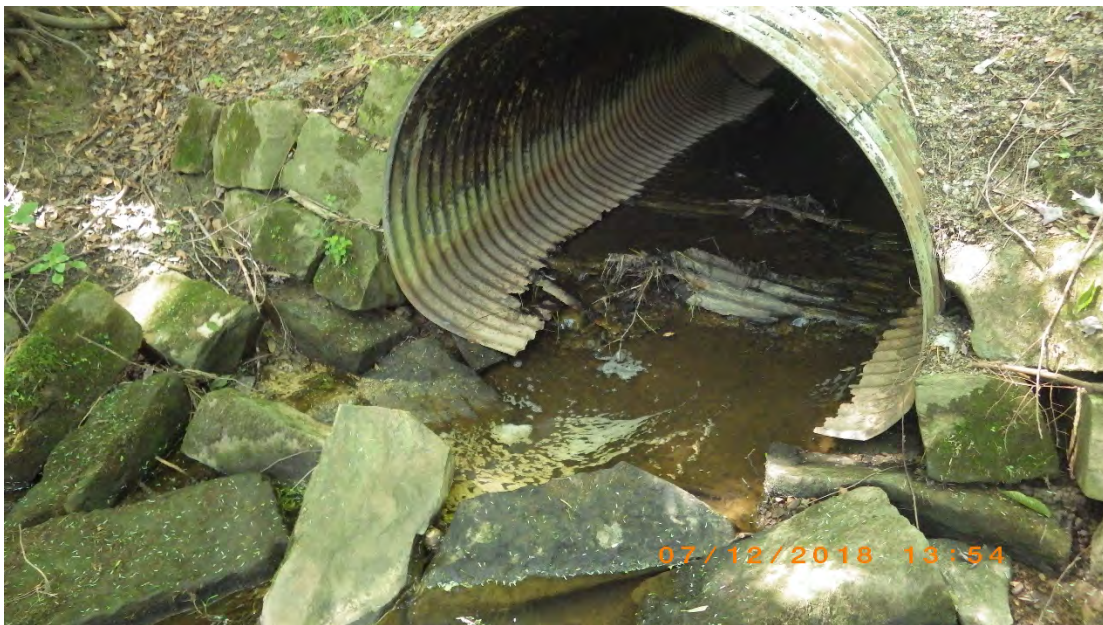
Photo 4. Culvert outlet in poor physical condition on the unnamed tributary to IR01 through Benzinger Park. The culvert was a barrier to fish passage during assessment due to low flow.

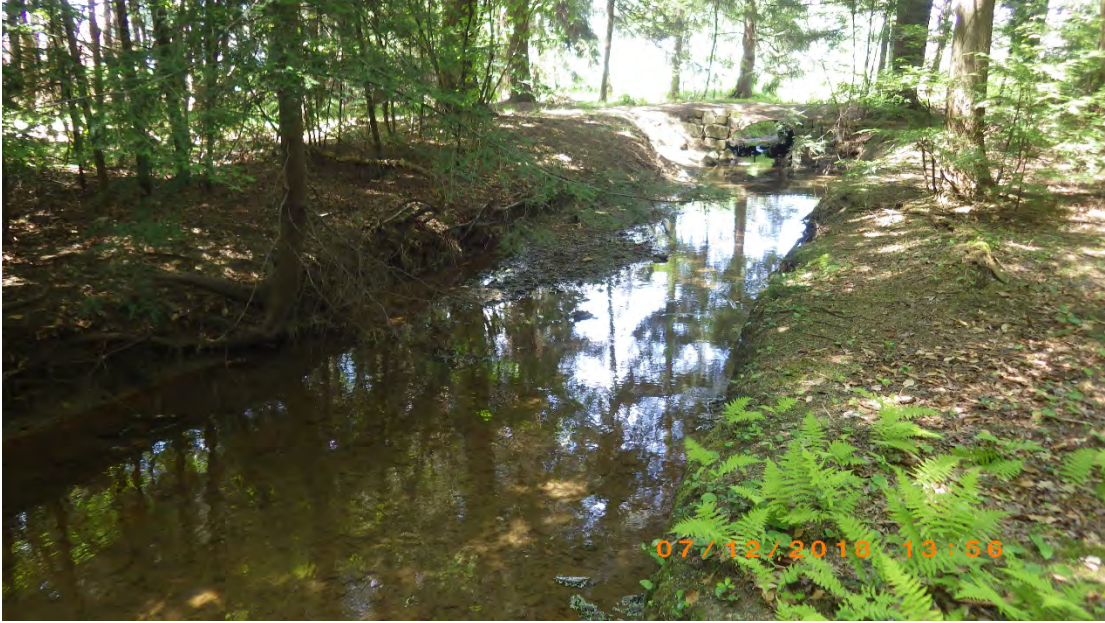
Photo 5. Channelized stretch of the unnamed tributary to IR01 which could benefit from habitat projects like large wood addition.

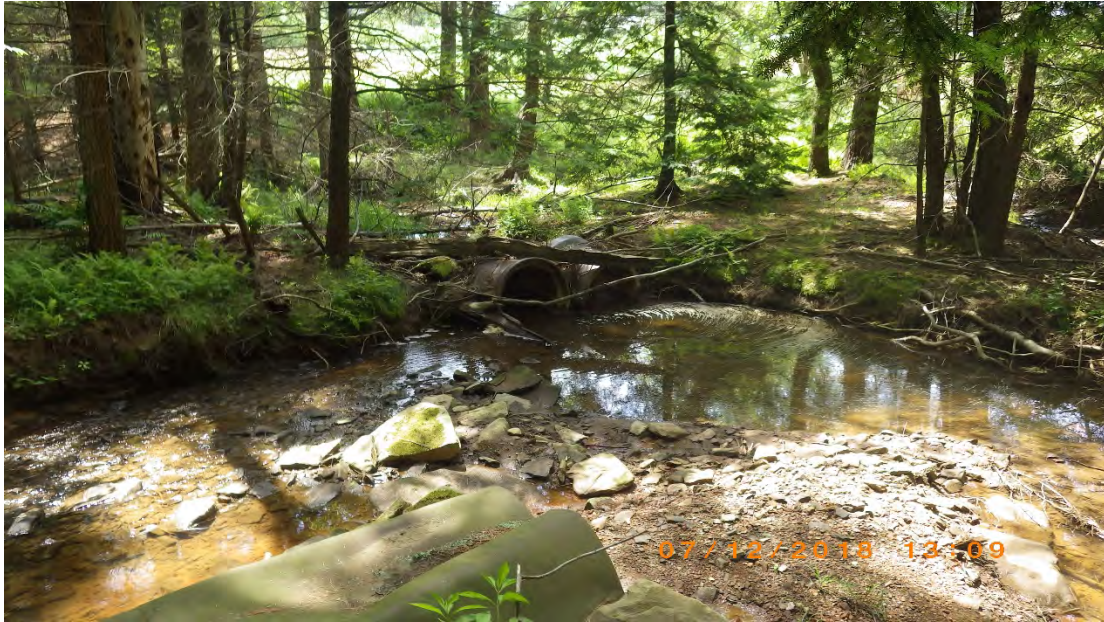
Photo 13. Multiple terra cotta culverts at the end of IR02. The culverts restricted the stream channel width to cause a pool to form around the inlets.

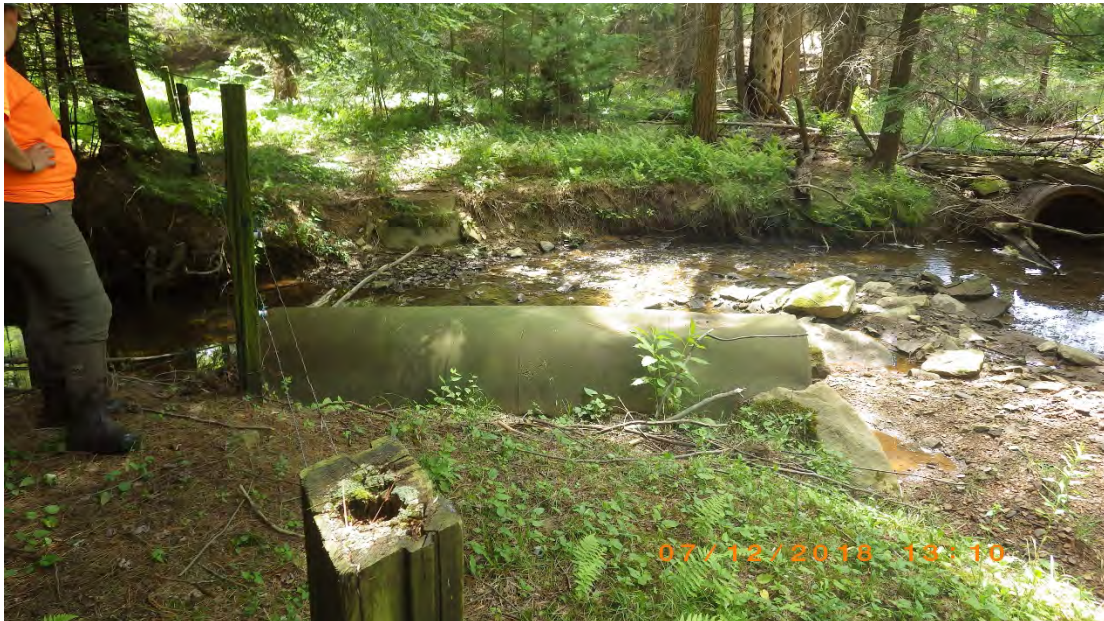
Photo 14. Pasture fencing at the end of IR02. The fence extended out into the stream channel and allowed access to the stream for cows. A cement culvert pipe remained in the channel, but water routed around and underneath the pipe and the pipe was dry upon assessment.

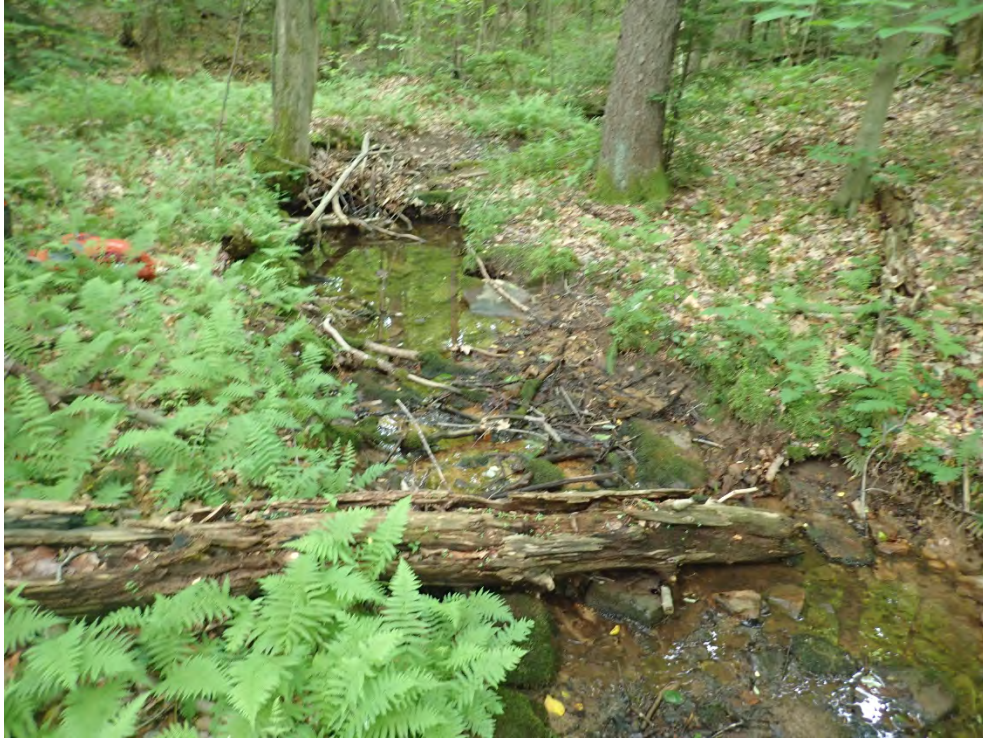
Photo 1. Looking upstream from the beginning of the assessed portion of LR01. LR01 was intermittent upstream from this photo.

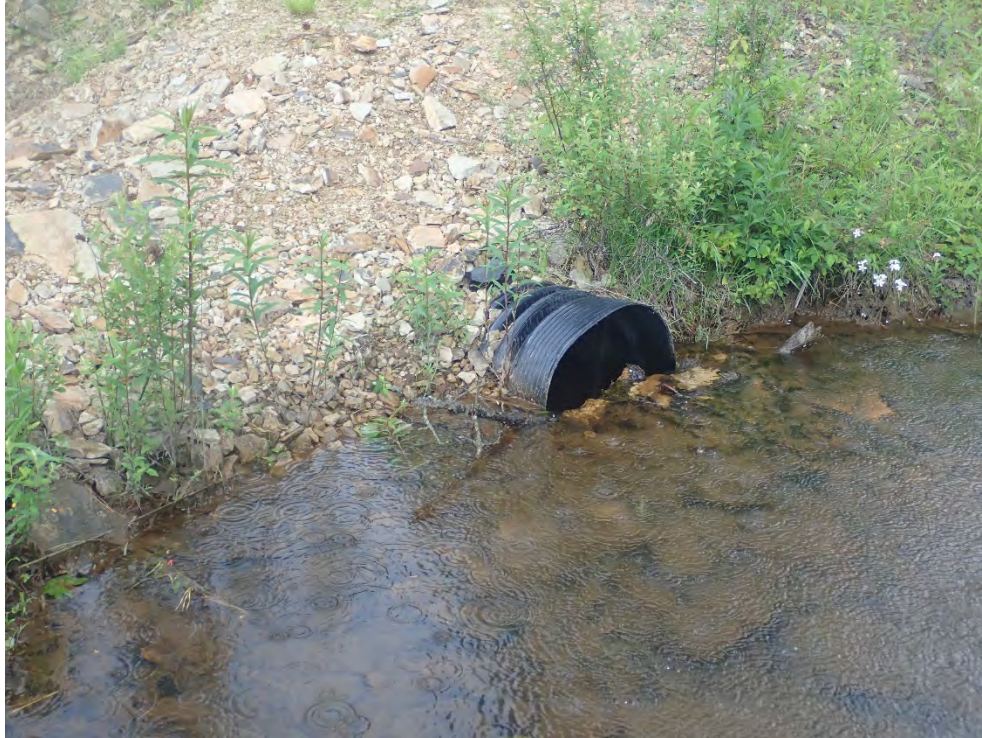
Photo 11. Culvert inlet in LR03 that goes beneath a Saint Marys Water Authority property road. Sediment aggraded and caused an 8-inch drop that could present an aquatic organism passage issue.

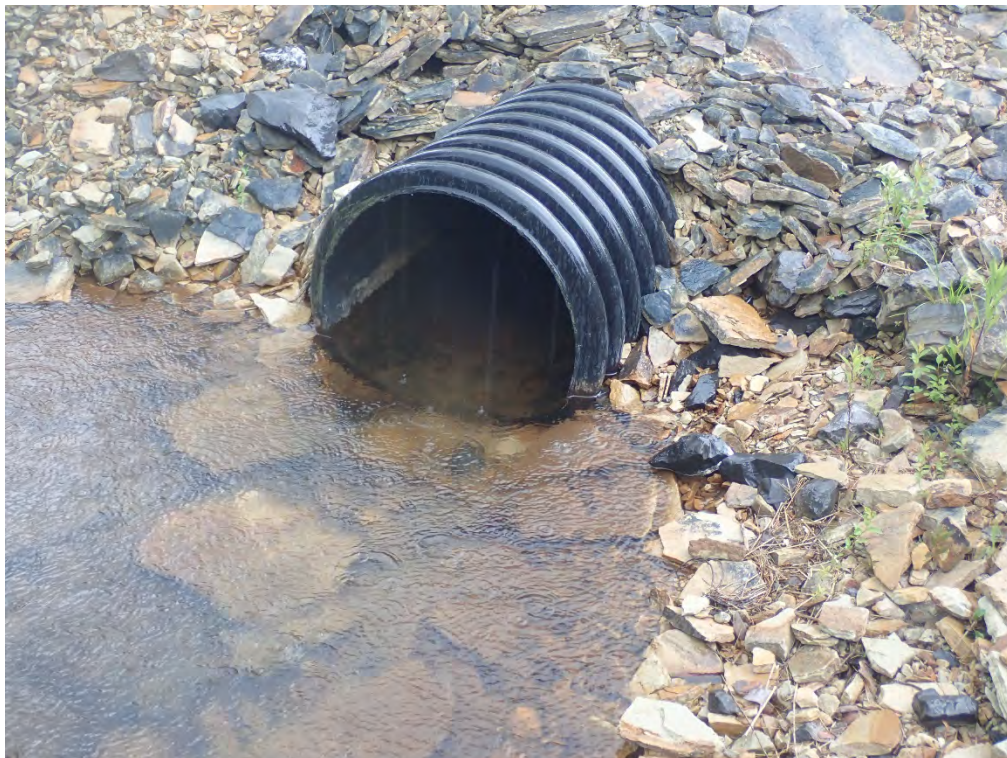
Photo 12. Outlet of the culvert in Photo 11.

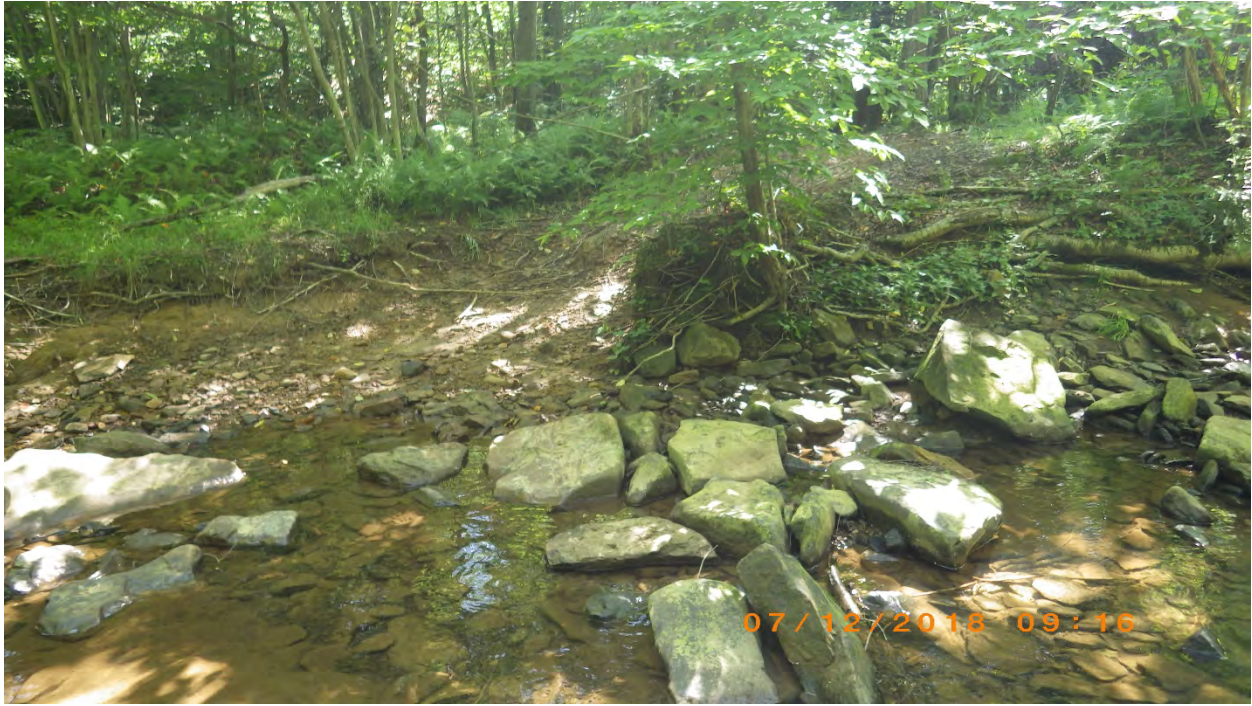
Photo 31. Right bank erosion in LR09 caused by ATV trail erosion.

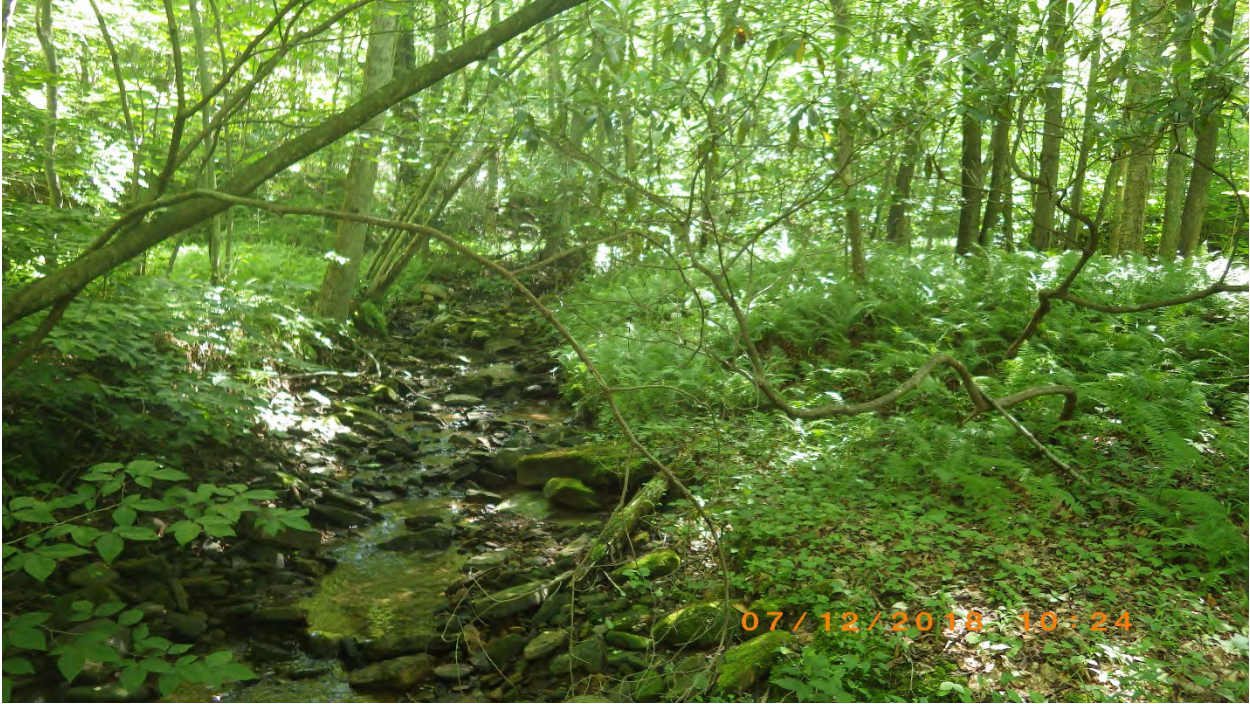
Photo 32. Looking upstream at a headwaters stream where it conflues with segment LR10.

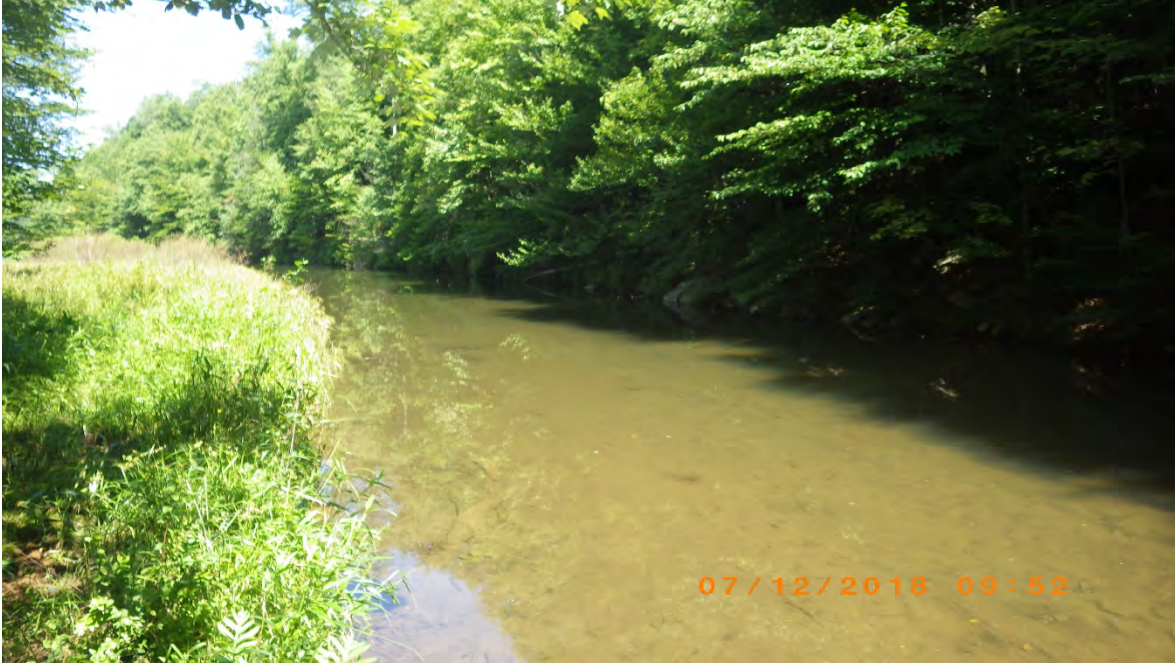
Photo 38. LR11 became a slow-moving, shallow, warm stream before it entered the reservoir. Warmwater fish species were observed in this section of the stream.

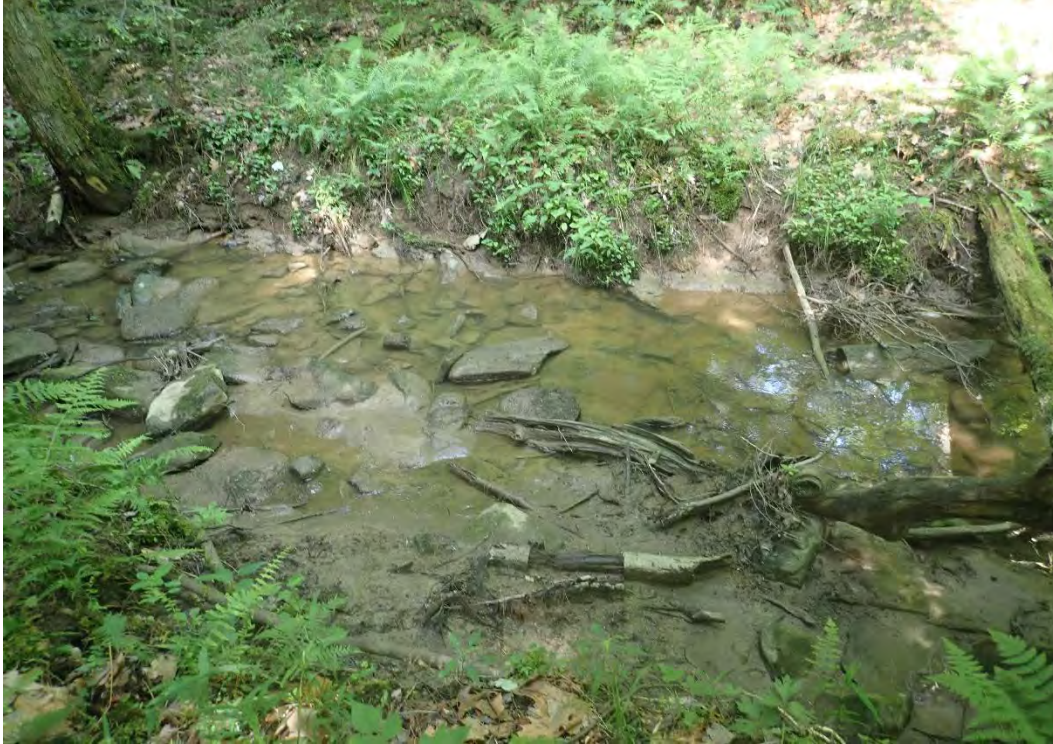
Photo 1. Silted section of MR01. Embeddedness was suboptimal in segment MR01.

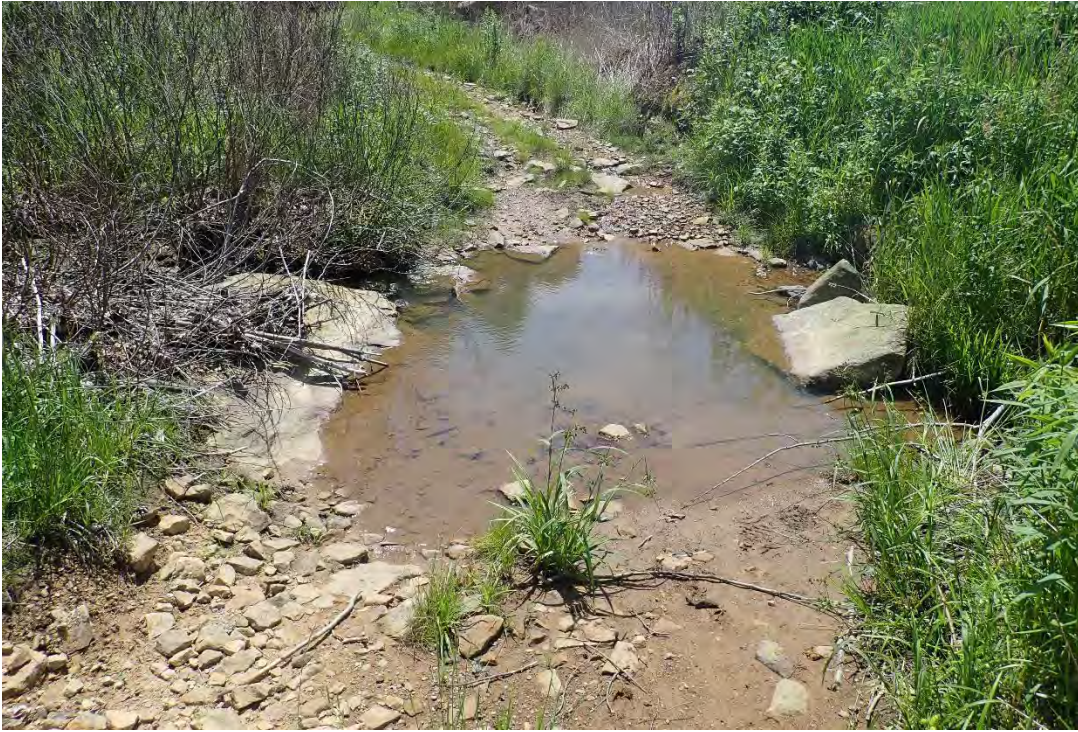
Photo 7. ATV stream crossing along the powerline right-of-way in MR02. The crossing eroded and caused the stream substrate to become very embedded.

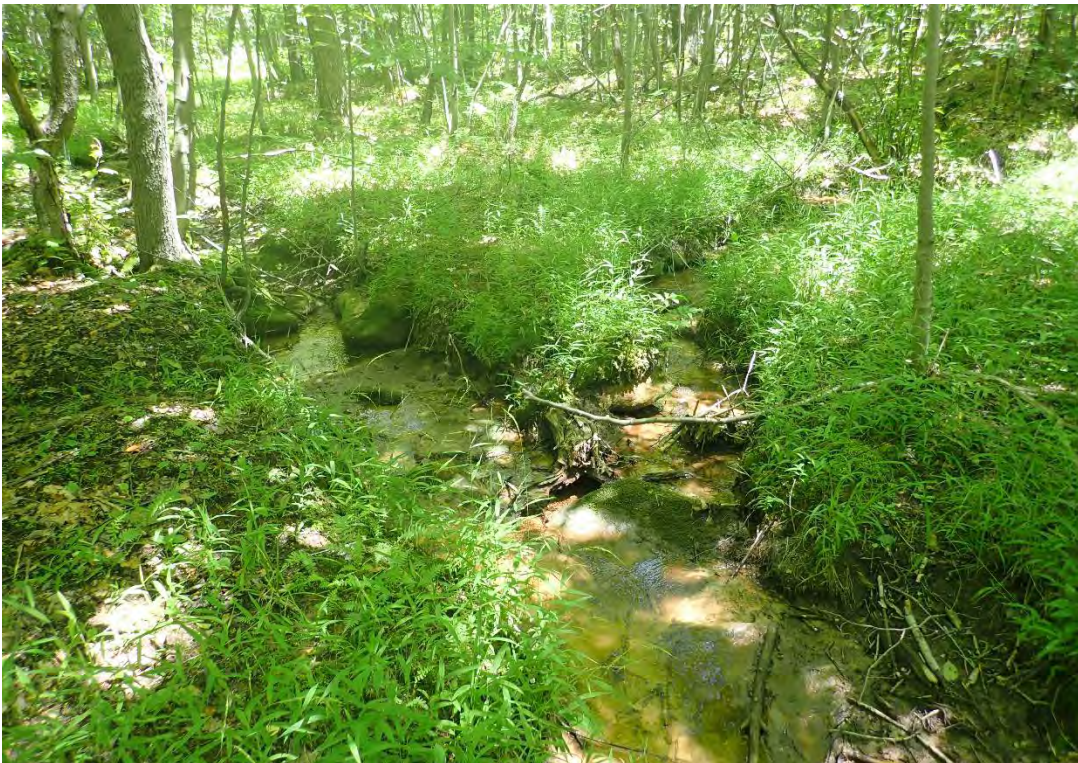
Photo 8. Beginning of segment MR03 where two small intermittent streams confluence.

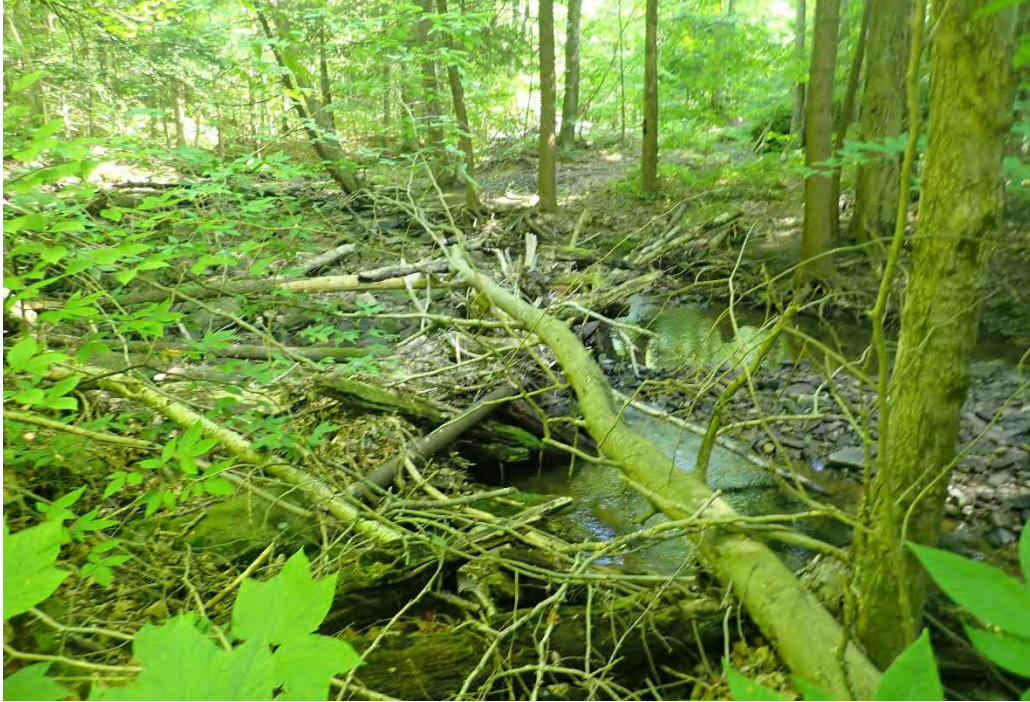
Photo 19. Debris jam in MR04 caused by a pipeline crossing.

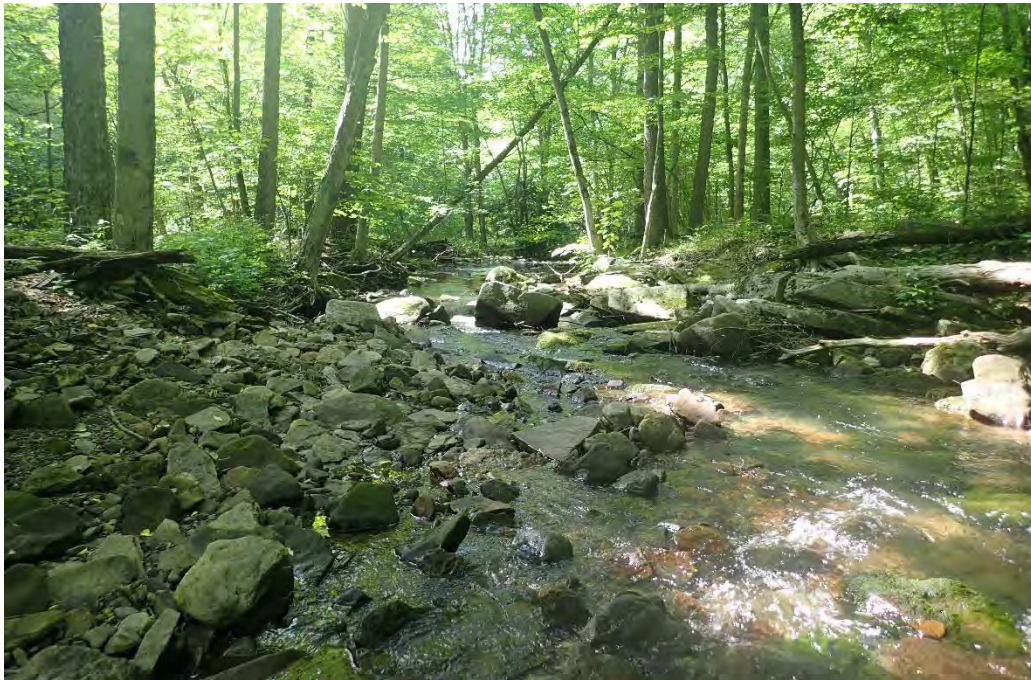
Photo 20. Looking downstream from the beginning of segment MR05.

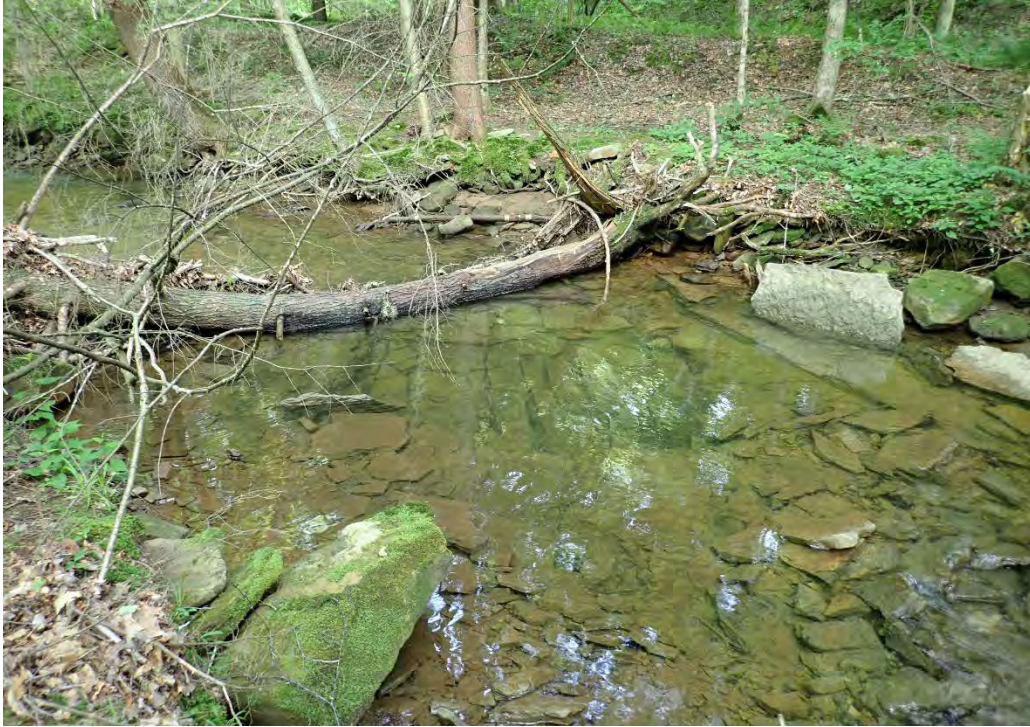
Photo 22. Pool habitat in MR05 where trout were observed.

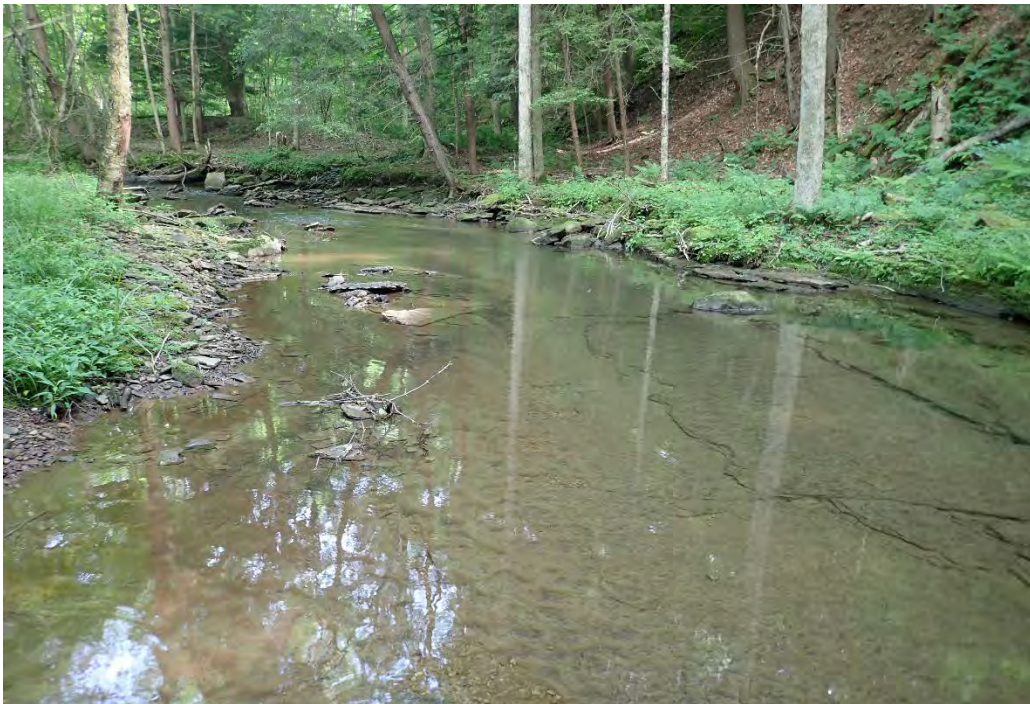
Photo 23. Long, bedrock bottom segment of MR05. This section of the stream channel has poor habitat quality.

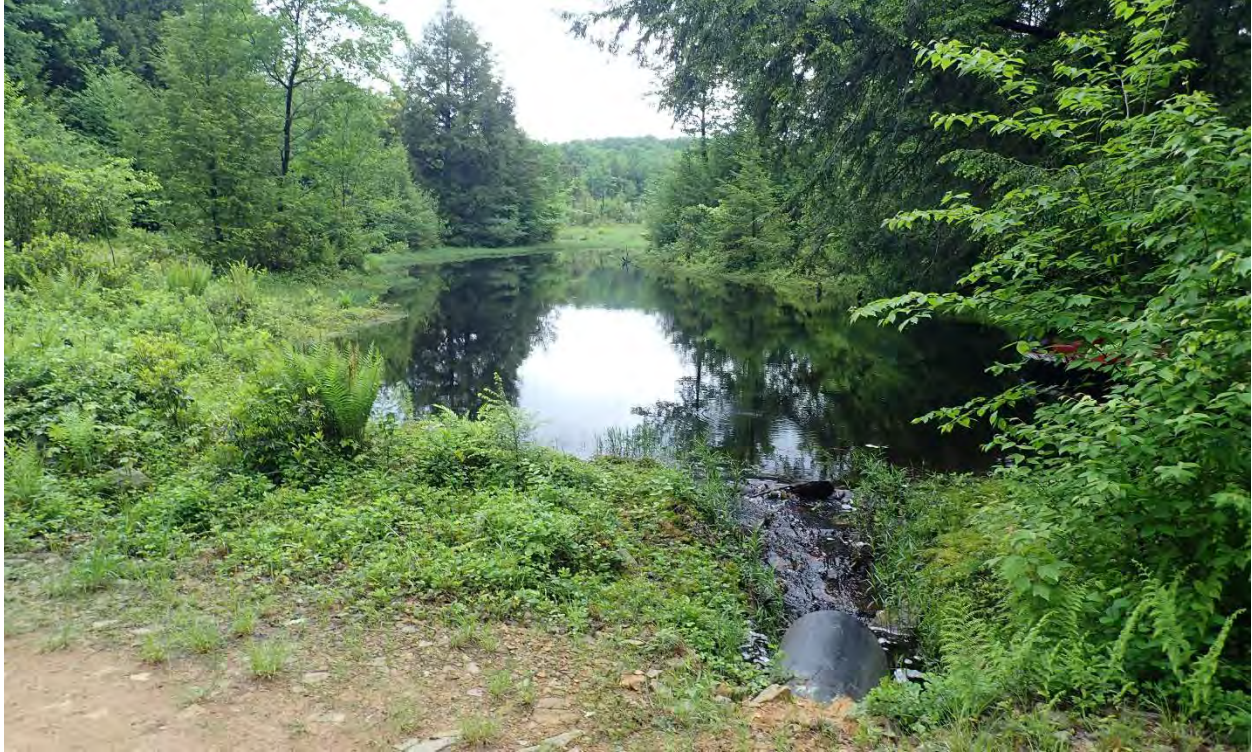
Photo 1. Beginning of Rocky Run. Rocky Run headwaters begin as wetlands and flow through a culvert beneath a camp driveway.

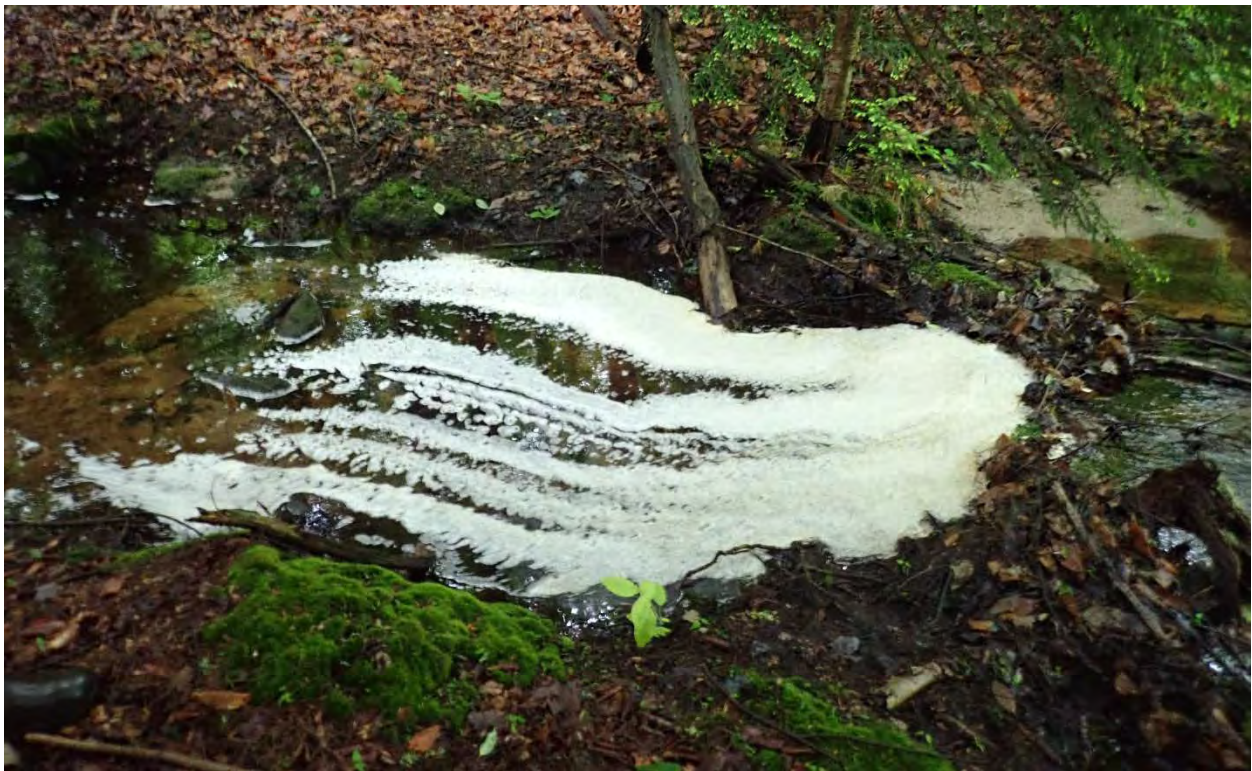
Photo 2. Flocculation in Rocky Run. Water leaving the wetland is rich with dissolved organic carbon. Flocculation was frequently observed below riffles.

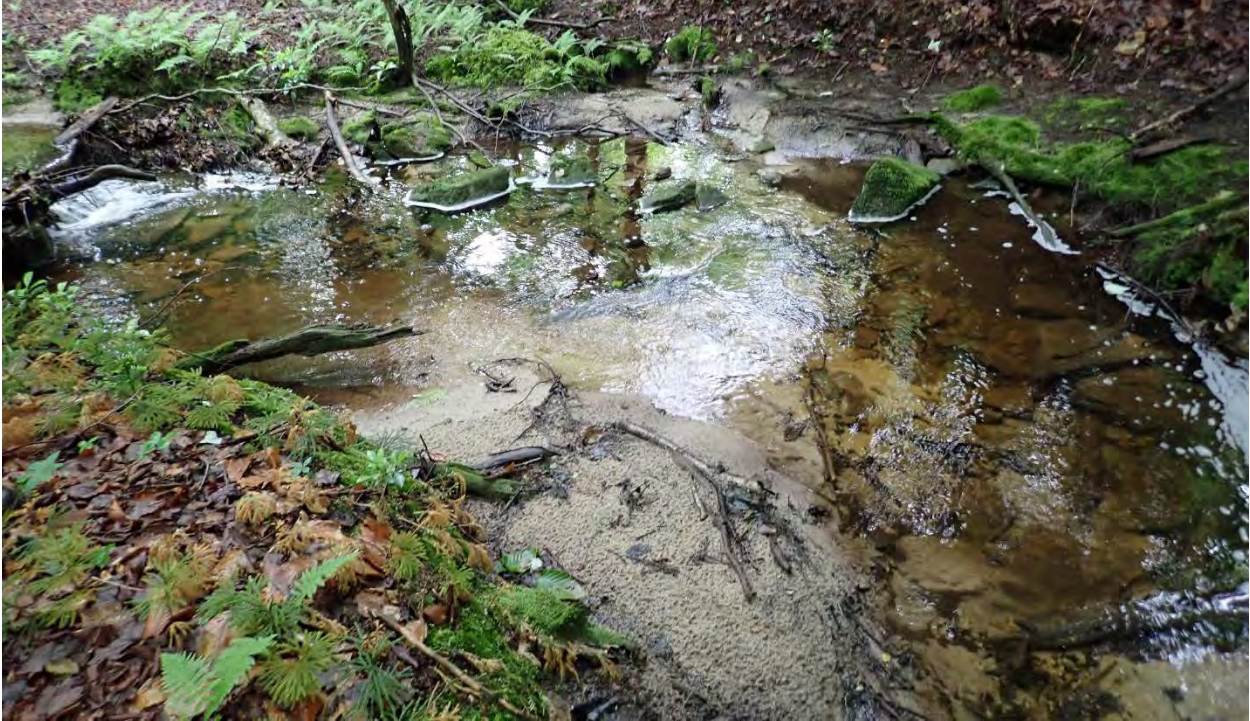
Photo 3. Sand and silt aggradation. Pools with sandy, silty substrate dominated instream habitat in the headwaters of Rocky Run.

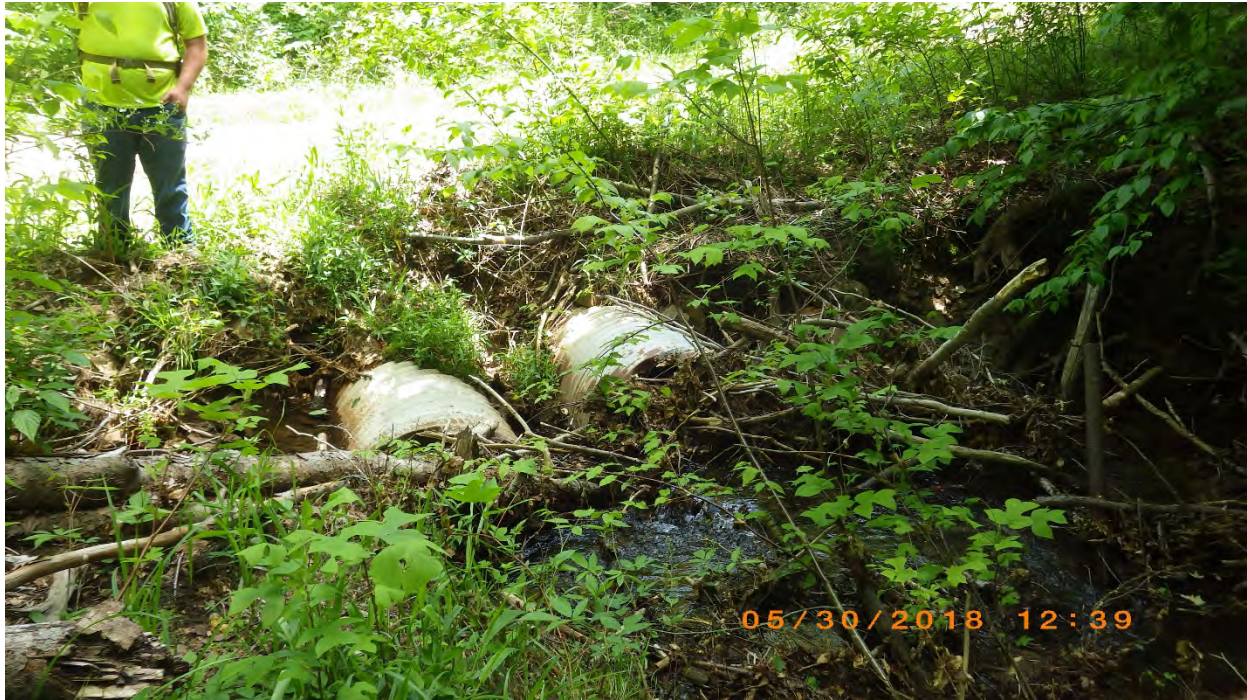
Photo 1. Inlet of triple culvert underneath gravel road. The culverts did not have the capacity to allow woody and inorganic debris to pass downstream and collect debris at the inlet. The debris, in this instance, created a barrier for water, debris, and aquatic organisms to pass.
