Elk Creek Coldwater Conservation Plan

Prepared by

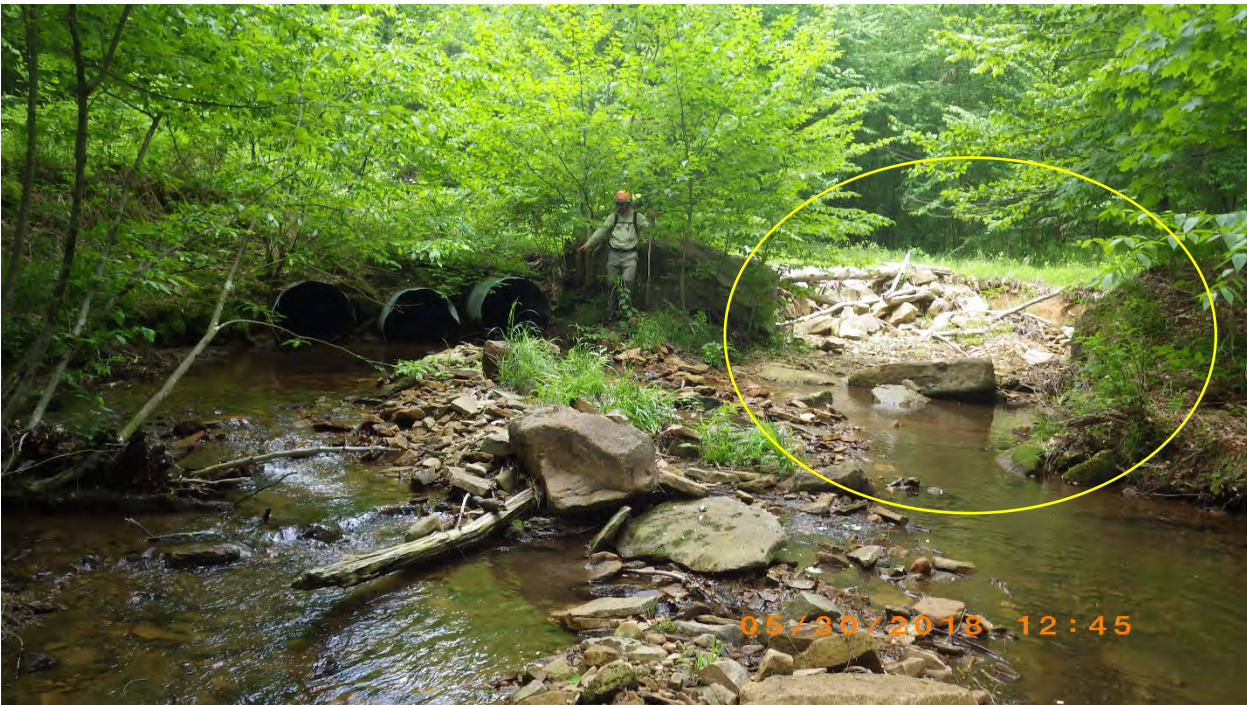
Photo 2. Outlet of the triple culvert in Photo 1. The gravel road was eroding into the stream within the yellow circle. The undersized culvert caused water to pool, route around the stream crossing, and flow back into the stream at the circled location. The erosion was secured with rip-rap, though erosion continued to actively occur.

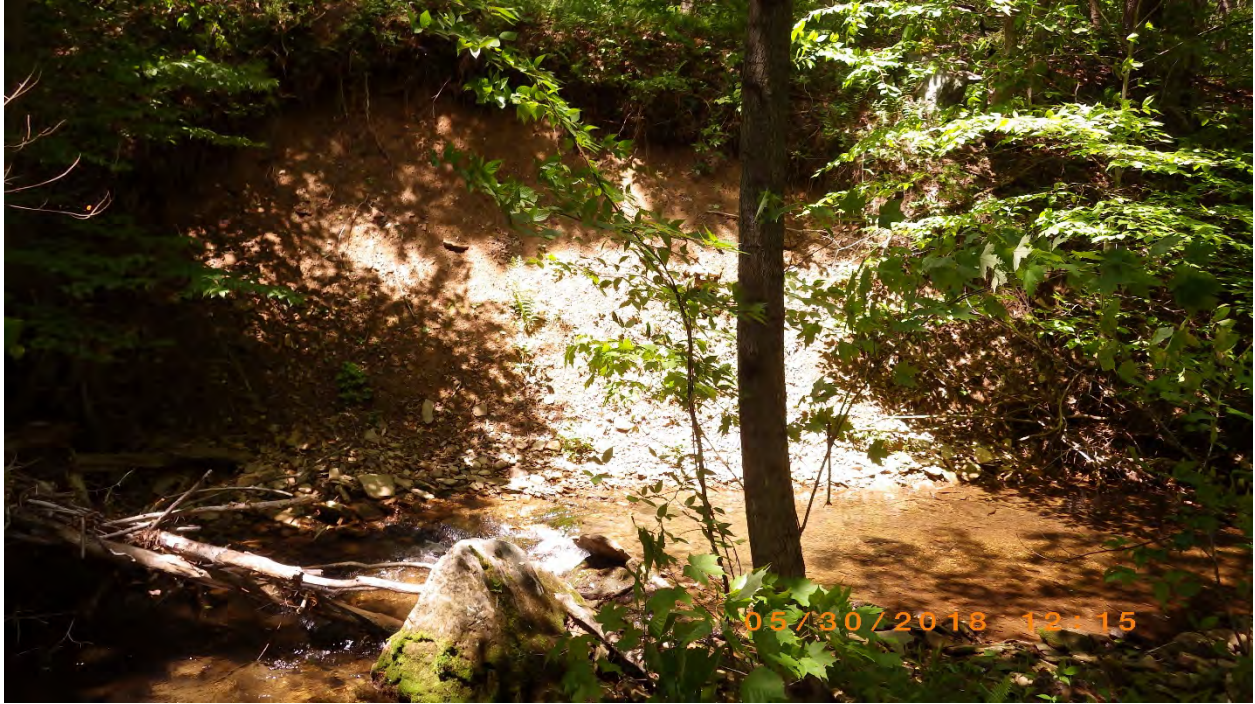
Photo 3. Steep, eroding bank. The above bank was approximately 12 feet tall. The erosion was caused by water leaving a relict trail and cutting down the slope.

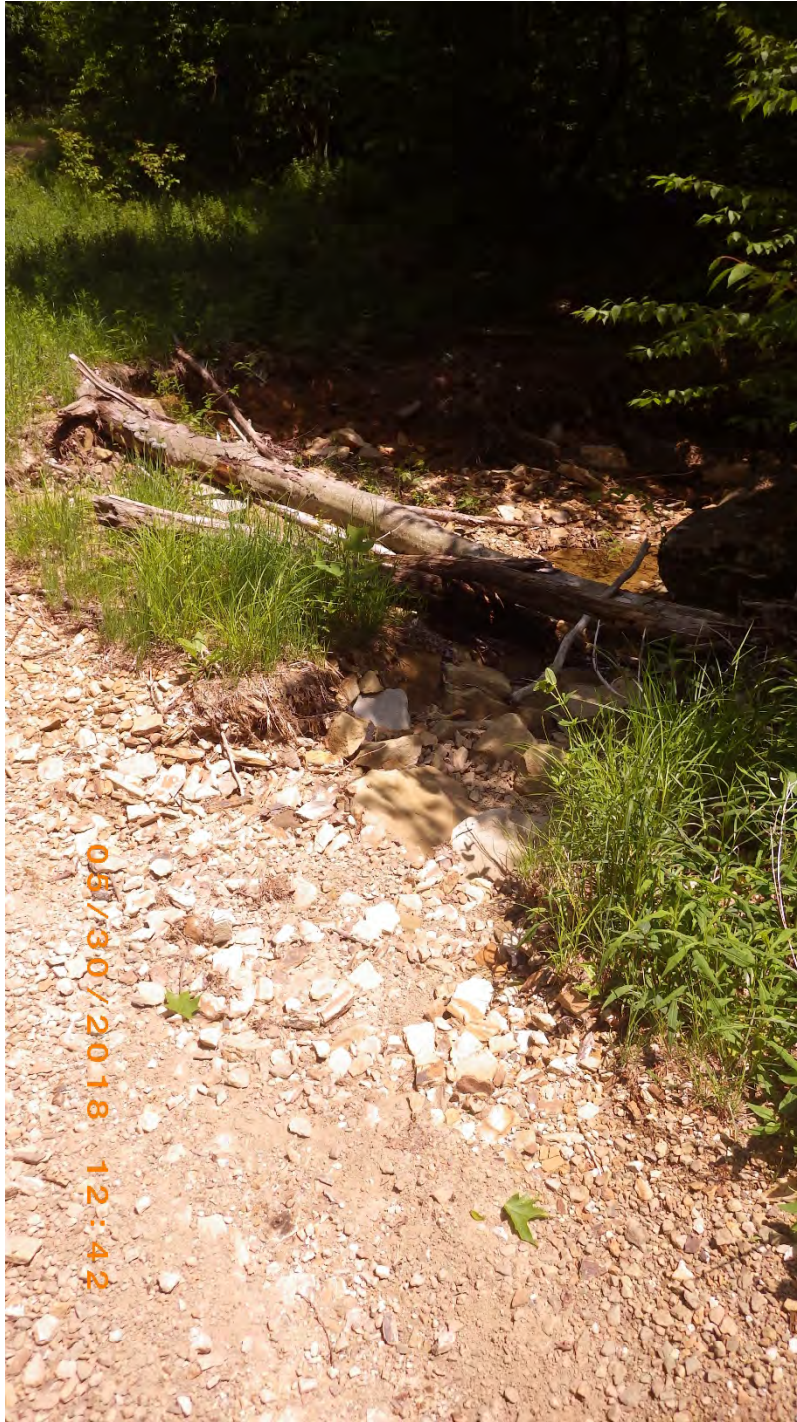
Photo 4. Erosion from gravel road. Water leaving the gravel road removed sediment from the road surface and deposited it into the stream.

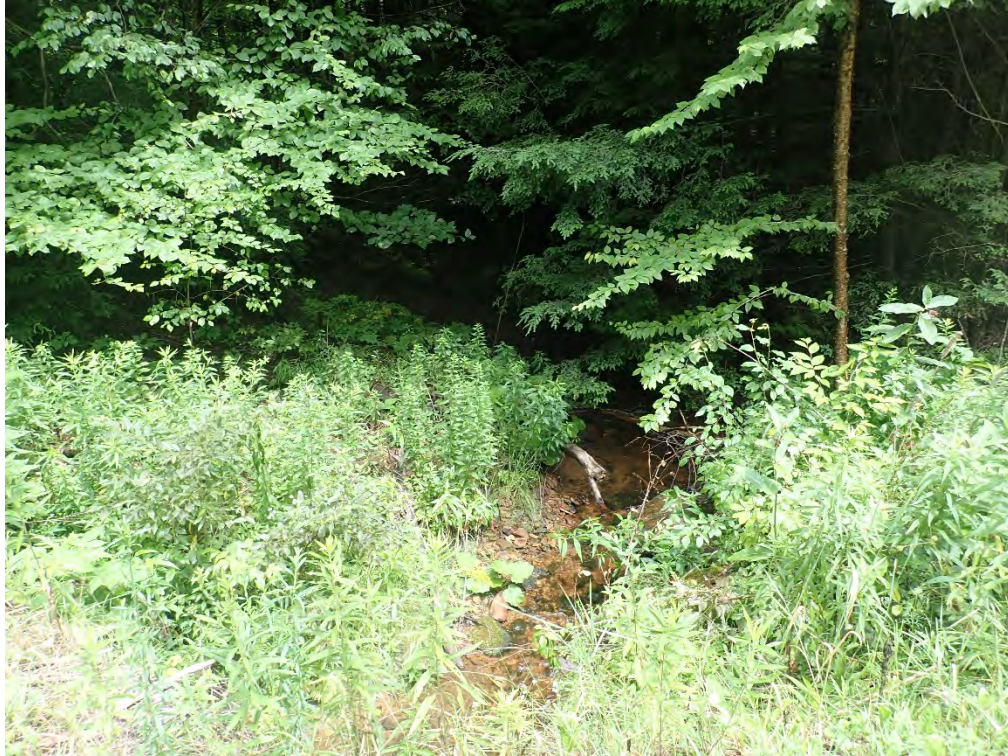
Photo 1. Silver Run Headwaters off Keller Road in North Saint Marys.

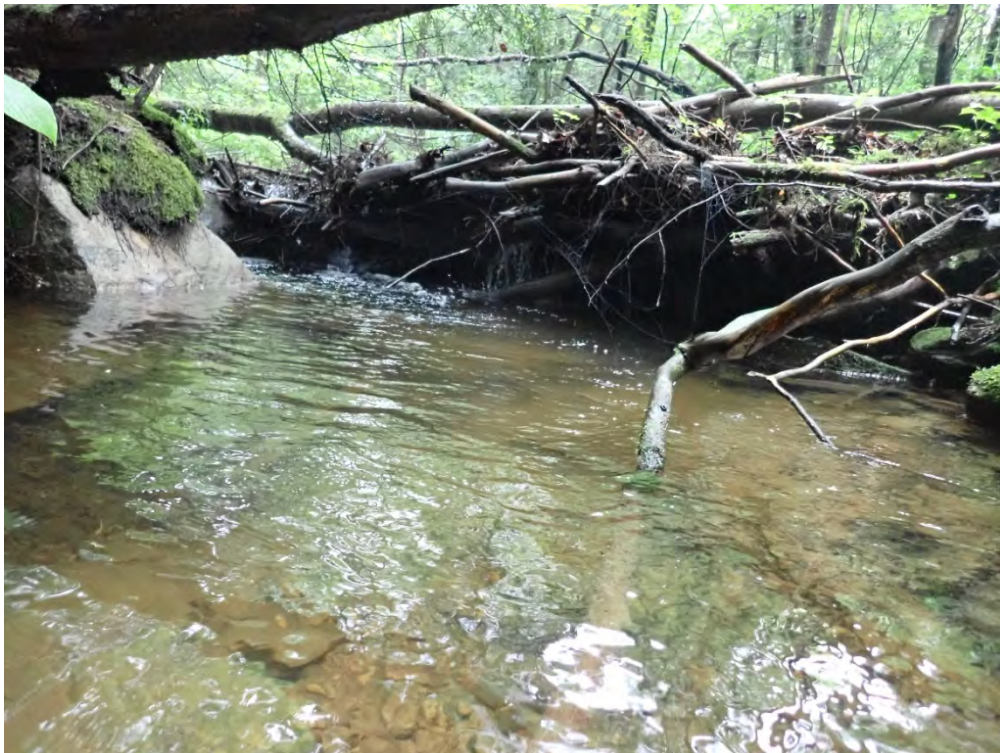
Photo 2. Debris jam in SR01 where wild trout were observed.

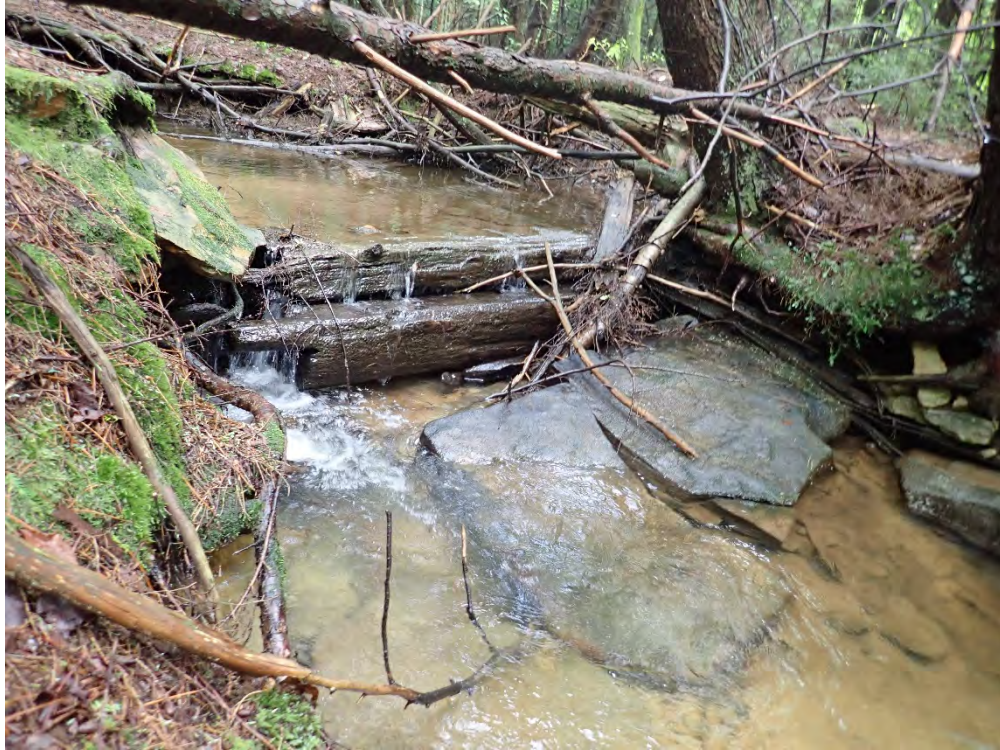
Photo 3. Manmade dam constructed from railroad ties.

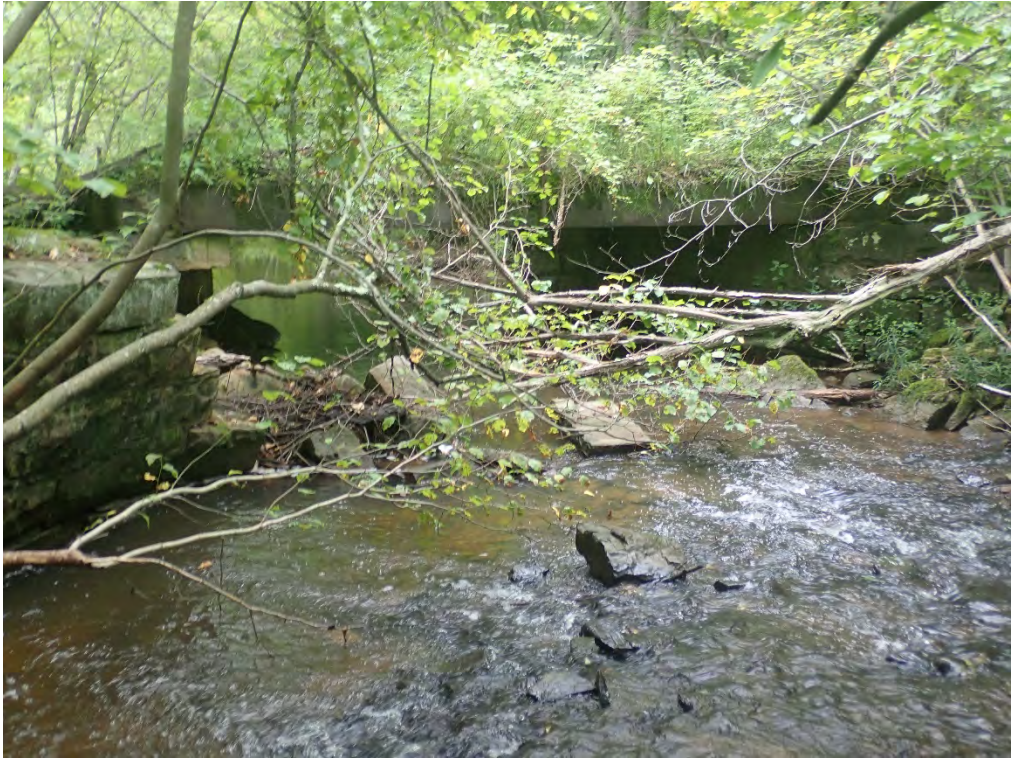
Photo 20. Looking downstream at bridge where ATV trail crosses SR03. Abutments fell into the stream and caused a plunge pool beneath the bridge.

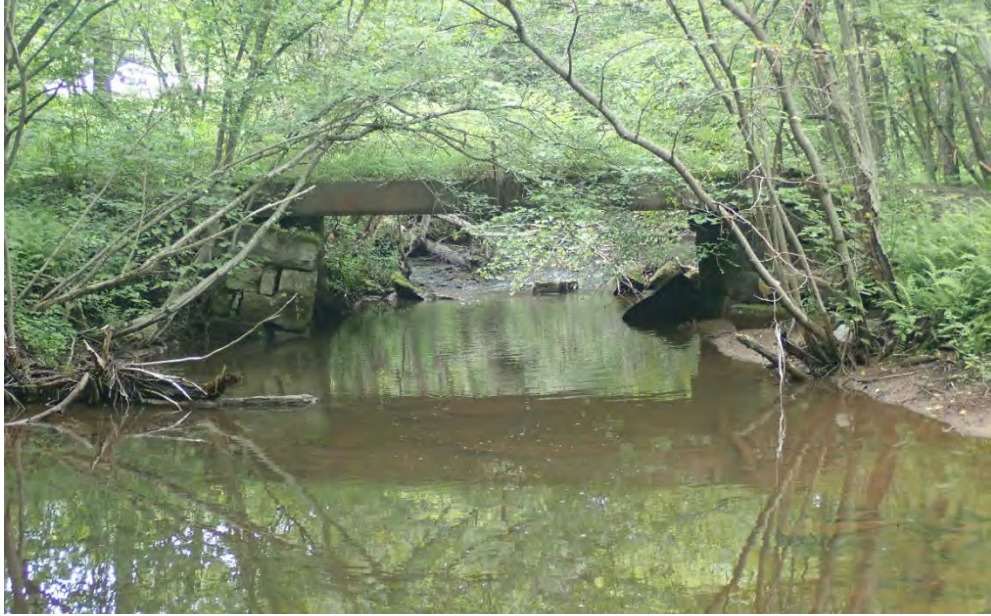
Photo 21. Looking upstream at the ATV trail bridge in SR03.

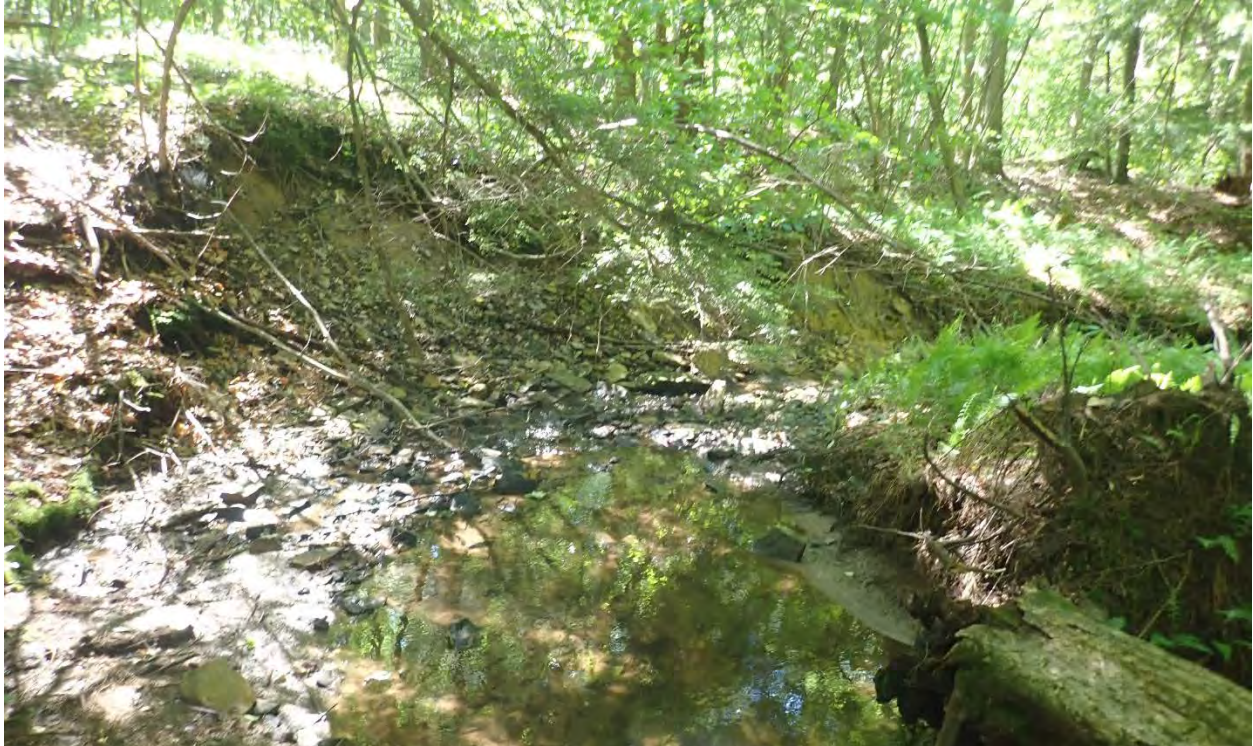
Photo 1. Eroding bank on an outside bend in TC02. Adding large woody debris in this section of the stream would help slow and redirect water to reduce erosion and downstream sedimentation.

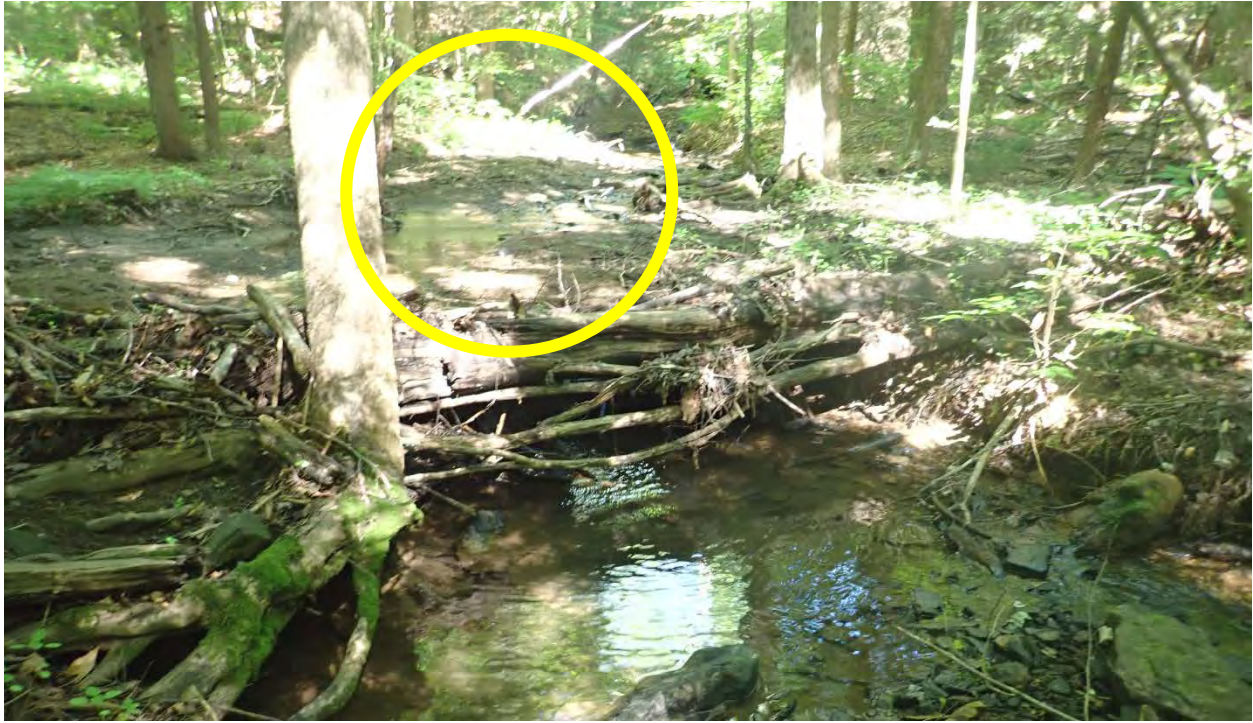
Photo 2. ATV trail (yellow circle) beside the stream channel. Sediment washed into the stream channel from the trail and caused embeddedness in the pool beneath the undercut log.

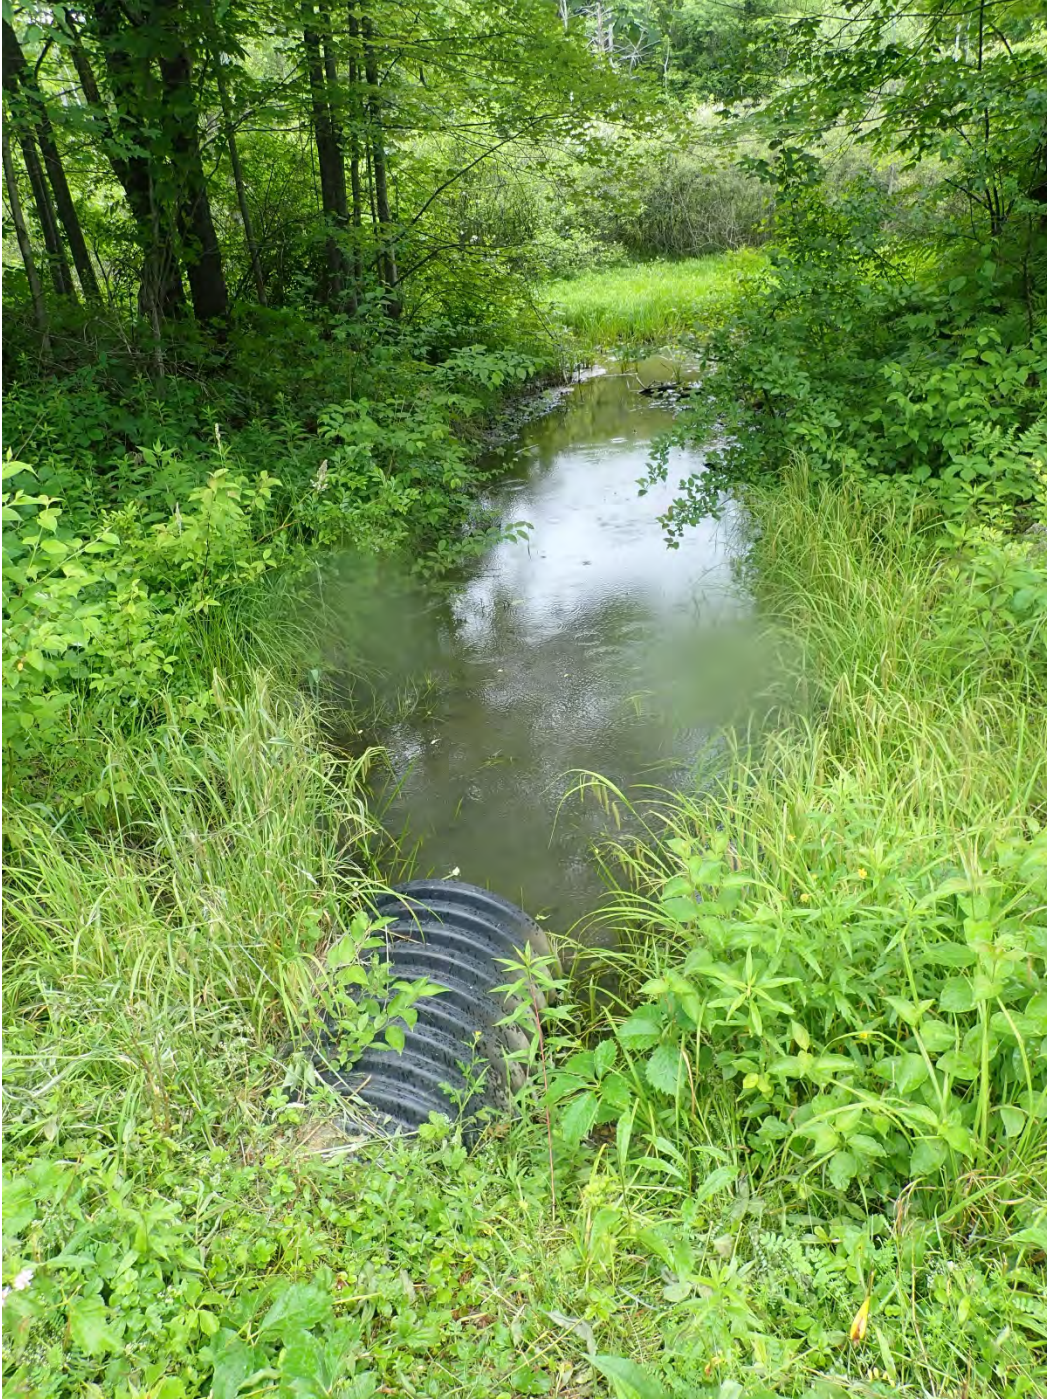
Photo 3. Culvert at the end of TC02 beneath Joseph Road. The culvert was undersized. From the dirt residue on the pipe, it is obvious that the stream overtops the culvert during high flow. Aquatic organisms, greater water volume, and material could pass more efficiently through the culvert if it were to be replaced with an appropriately-sized structure.

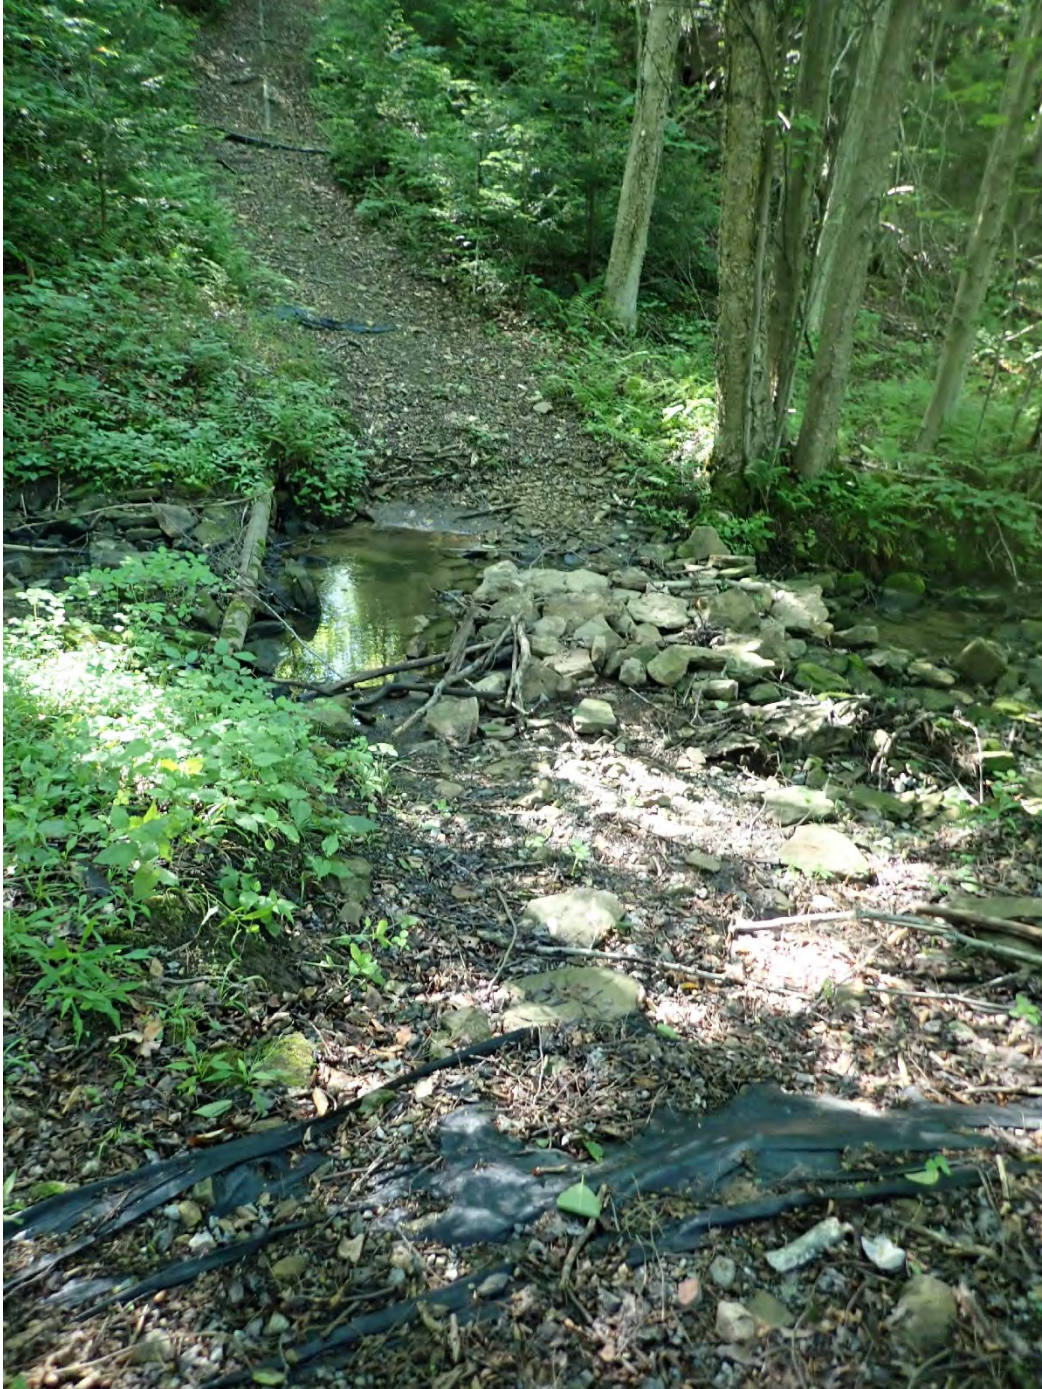
Photo 4. Gas pipeline (yellow circle) and ATV crossing. The trail was likely a gas pipeline that is currently used as an ATV trail. Sediment from the trail washed into the stream channel and caused sedimentation. Additionally, debris caught on the pipeline forced water to route around the pipeline during high flows, thus further contributing to the trail erosion. Cobble placed in the stream channel helped reduced sedimentation from ATV crossings; however, the cobble also created an aquatic organism passage issue at normal flow.

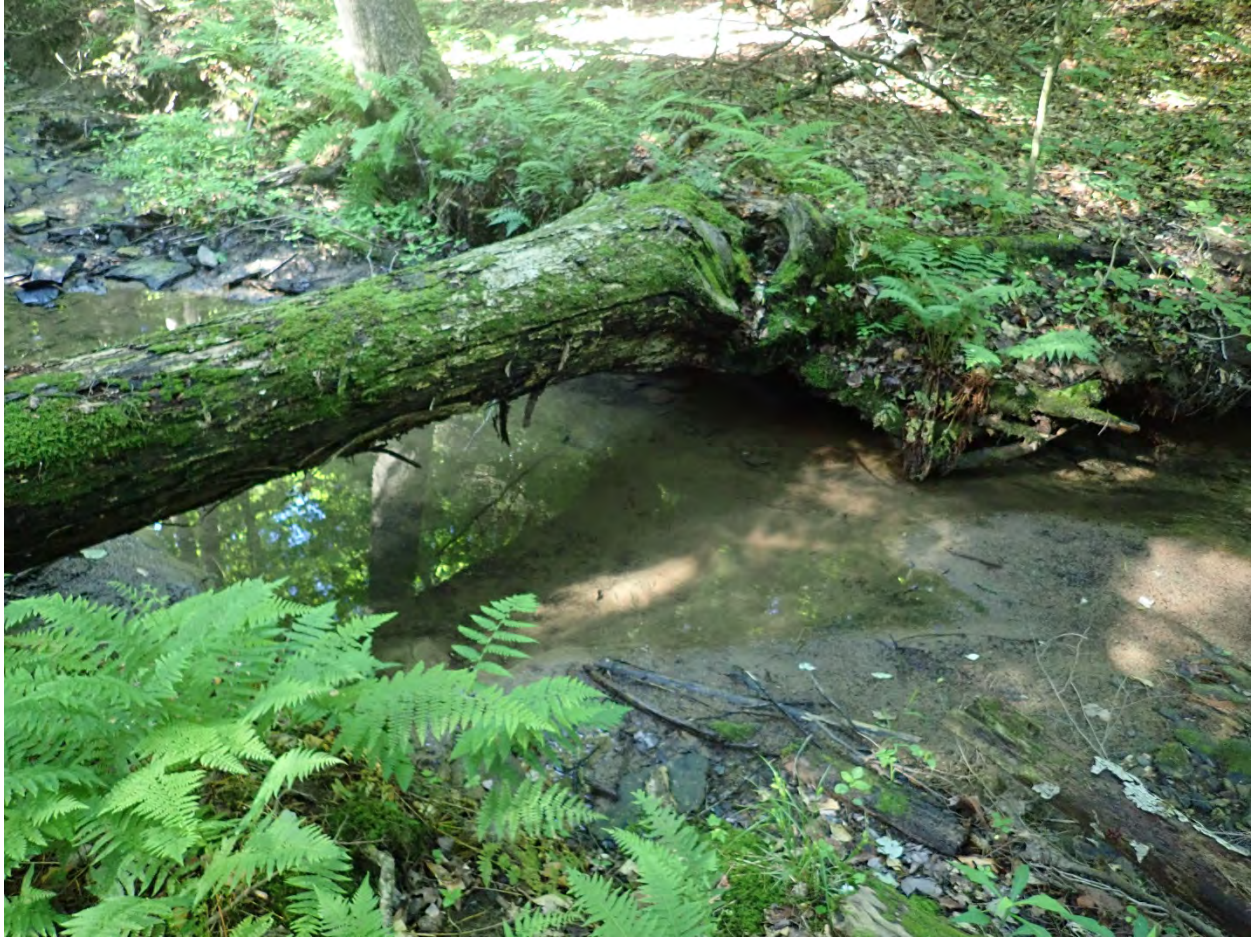
Photo 5. Example of fish habitat impaired by sedimentation and siltation in TC01. Depositional areas in TC01 were 25-50% embedded. Lack of interstitial spaces created poor macroinvertebrate habitat and siltation could potentially harm fish eggs.

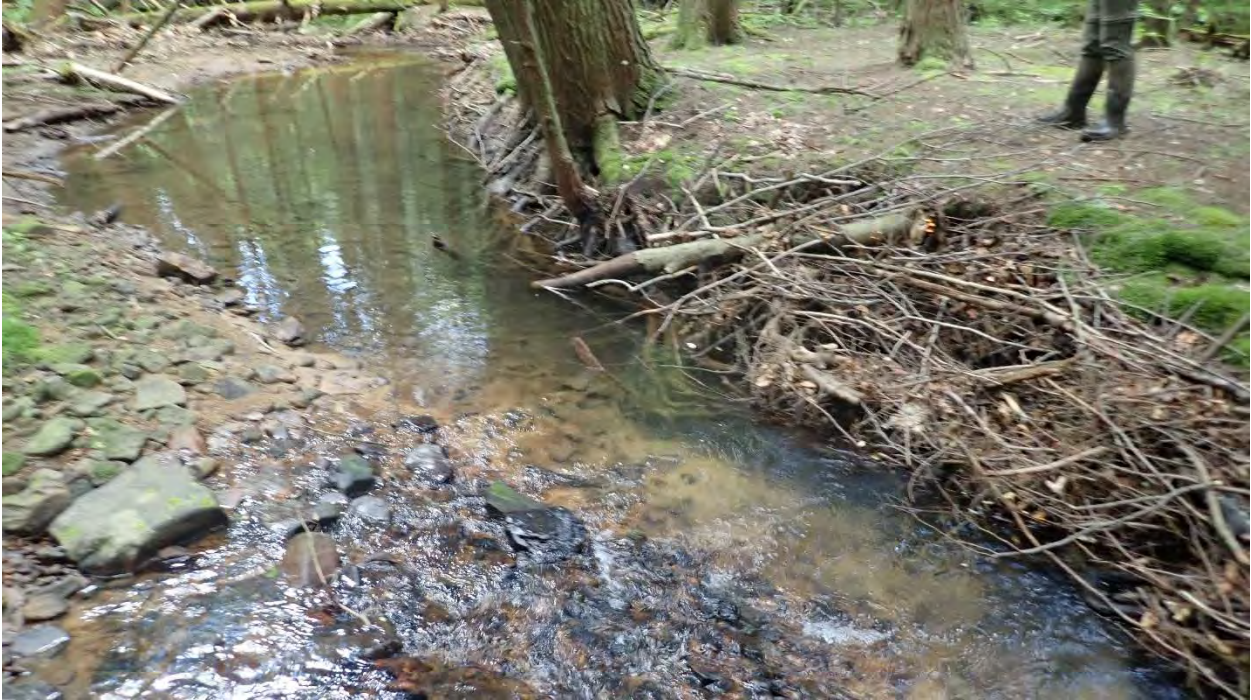
Photo 2. Exposed roots and woody debris in WT01. The debris, collected on the outside bend in a pool, prevented erosion and provided excellent fish habitat. Native Brook Trout were observed swimming into the woody debris during assessment.

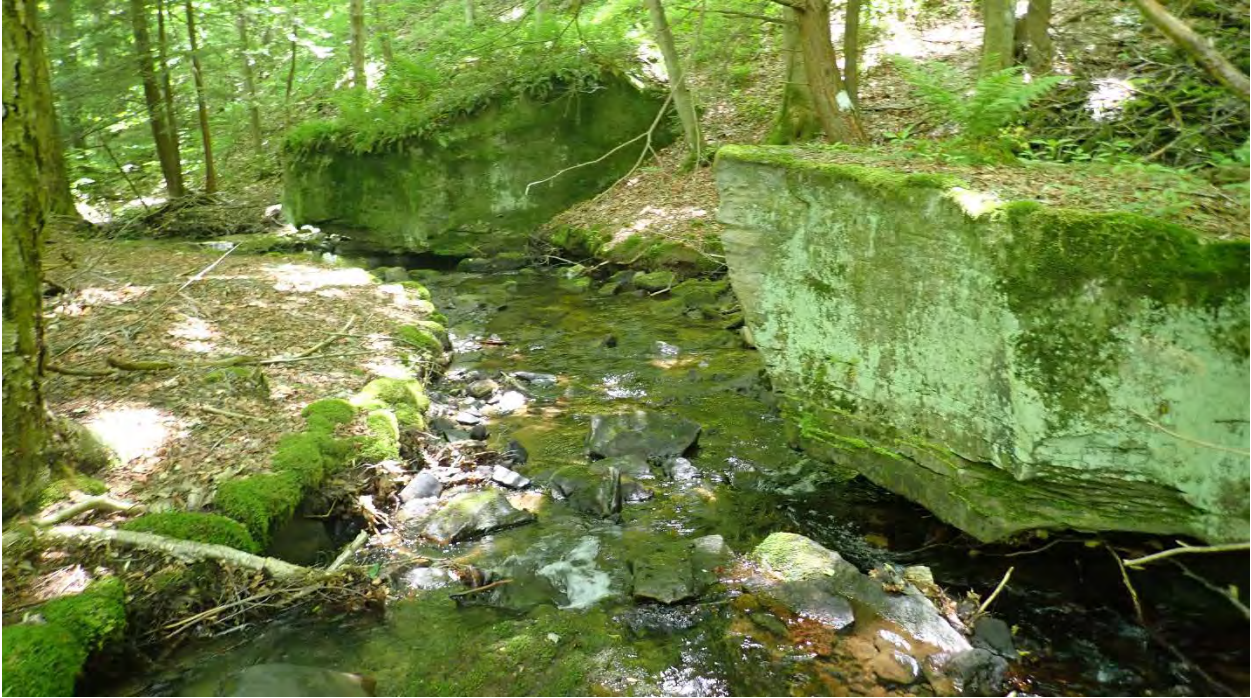
Photo 3. Overhanging boulders in WT01. Native Brook Trout were observed swimming into the small pool habitats beneath the boulders.

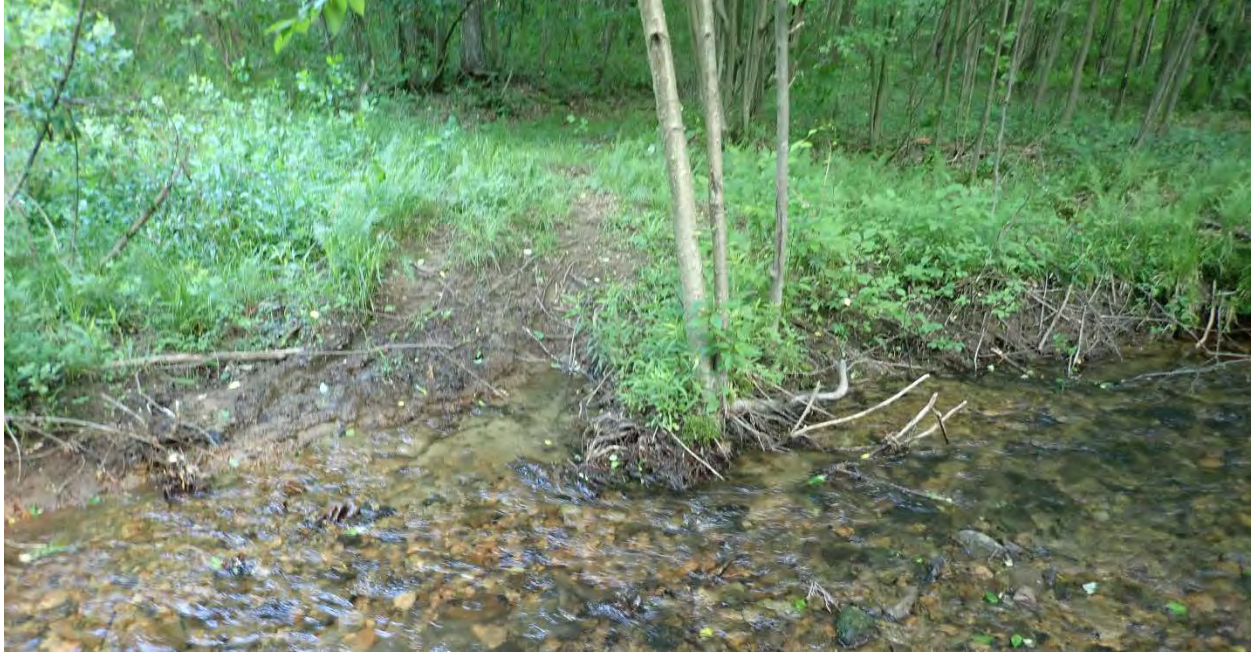
Photo 4. ATV trail on private property in WT01. Though the trail crosses the stream, it appeared to have little impact on stream habitat during assessment. The trail appears to be infrequently used.

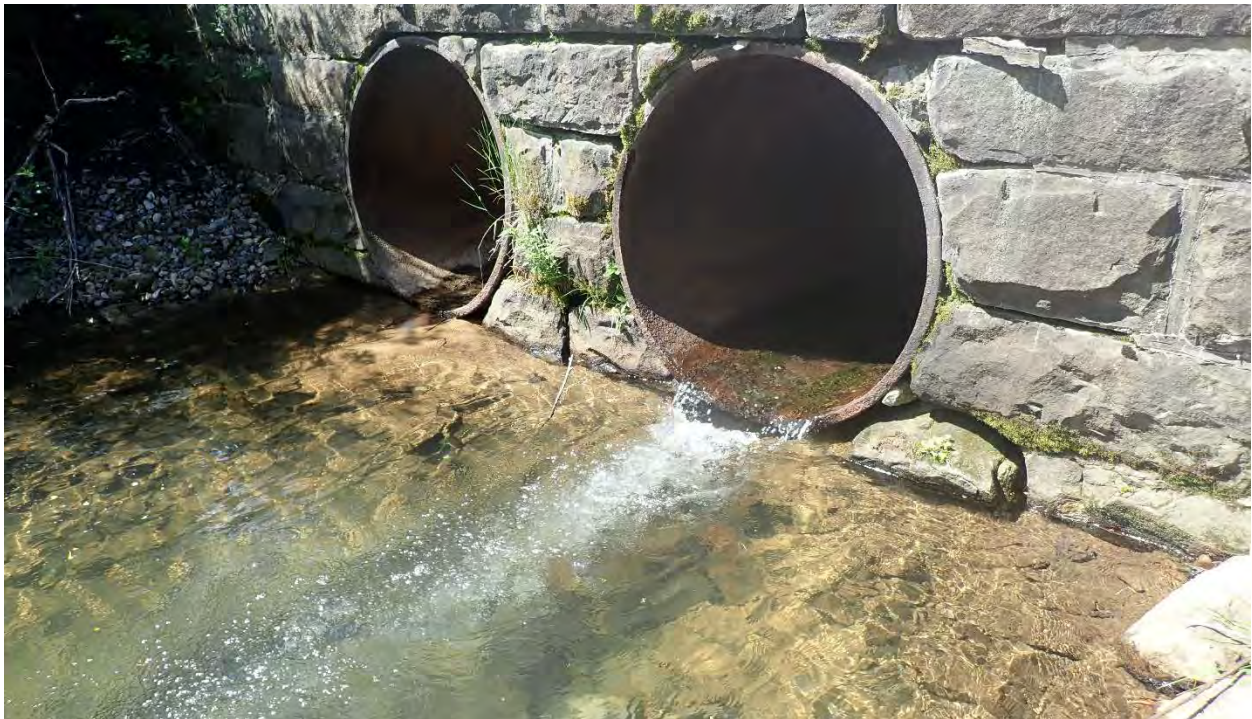
Photo 5. Outlet of the railroad culvert. The pipe on the left was nearly dry and the pipe on the right had low flow during assessment. Trout were observed to be stranded in the outlet plunge pools. In August, the plunge pools were the only available refuge between Elk Creek and the railroad culvert, as the stream in between was formerly a beaver pond with shallow, warm water.

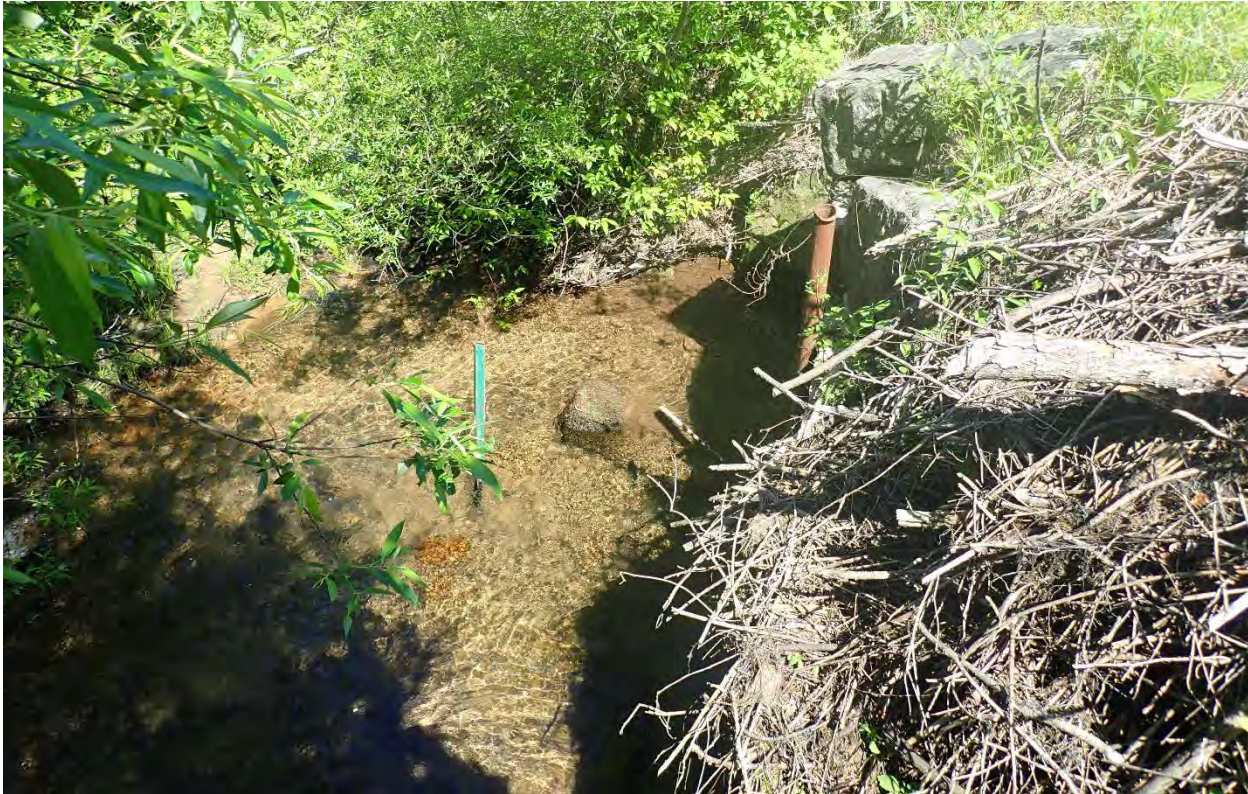
Photo 6. Looking down at the inlet of the railroad culvert. Stakes were placed at the inlet to prevent woody debris from entering and passing through the culvert. Though there was no debris jam observed during assessment, it was evident that debris collects at this point and is removed regularly (likely by the railroad) due to deposition and a drop to the pipe inlet.

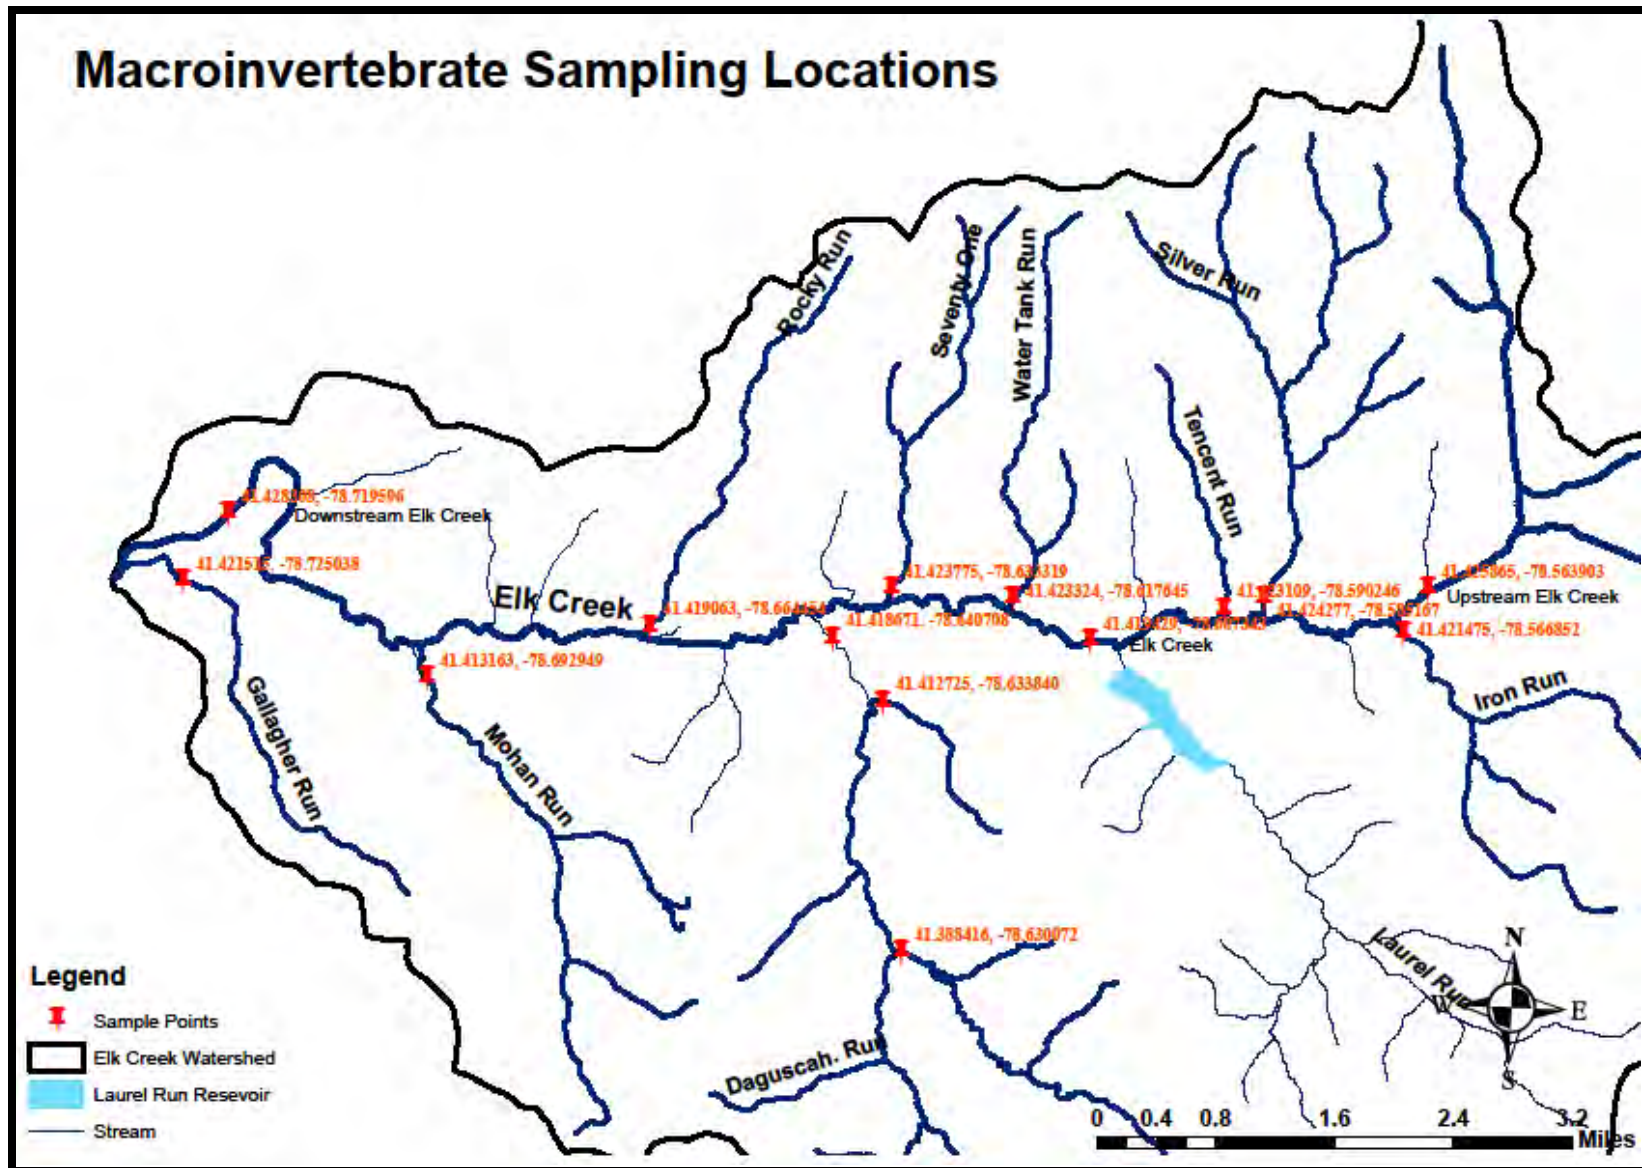
Figure 12. Macroinvertebrate sampling locations in Elk Creek and tributaries.
