Wallace Run

***Wallace Run Assessment  
October 2008***

The Wallace Run Assessment was funded by the Coldwater Heritage Partnership and was a collaborative effort between the Bald Eagle Watershed Association and the Centre County Conservation District. The assessment was conducted by Ed Perry, retired USFWS biologist, assisted by Ann Donovan, Centre County Watershed Specialist. Special thanks to Beth Rider from the Centre County Office of Planning and Community Development for her assistance with mapping for this project. Thanks to Joy Teeter from the Centre County Conservation District for her help with formatting the document. Thank-you to Genie Robine of the Centre County chapter of the Senior Environment Corps for monitoring and to the Centre County Government for providing PSU in kind services for printing. For more information about this assessment contact the Centre County Conservation District at 355-6817.

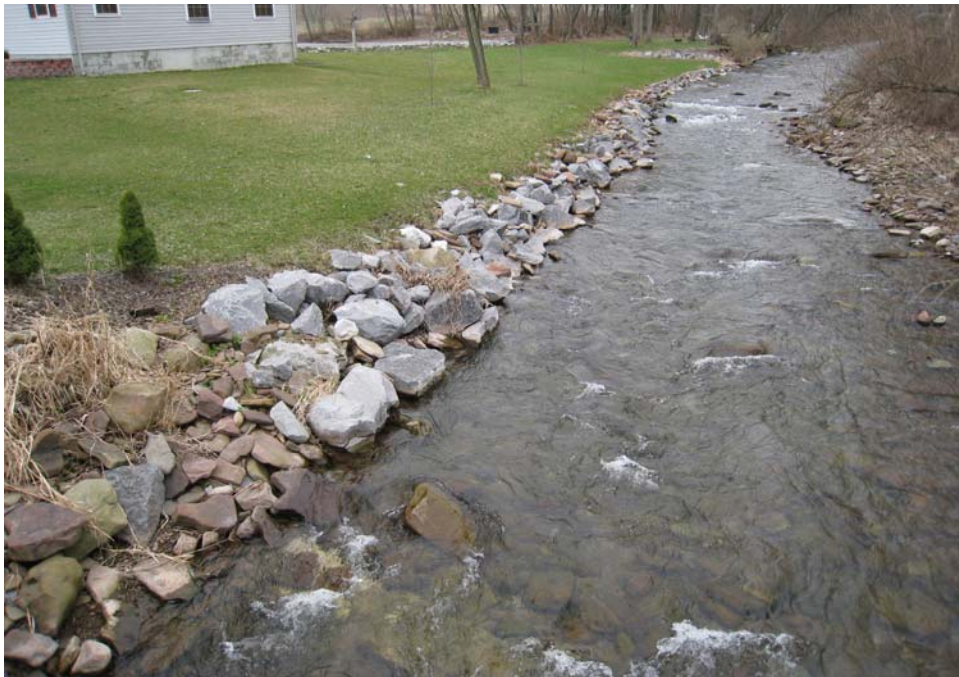
Figure 4. When riparian vegetation is removed, home owners immediately begin trying to stabilize the bank with rock.

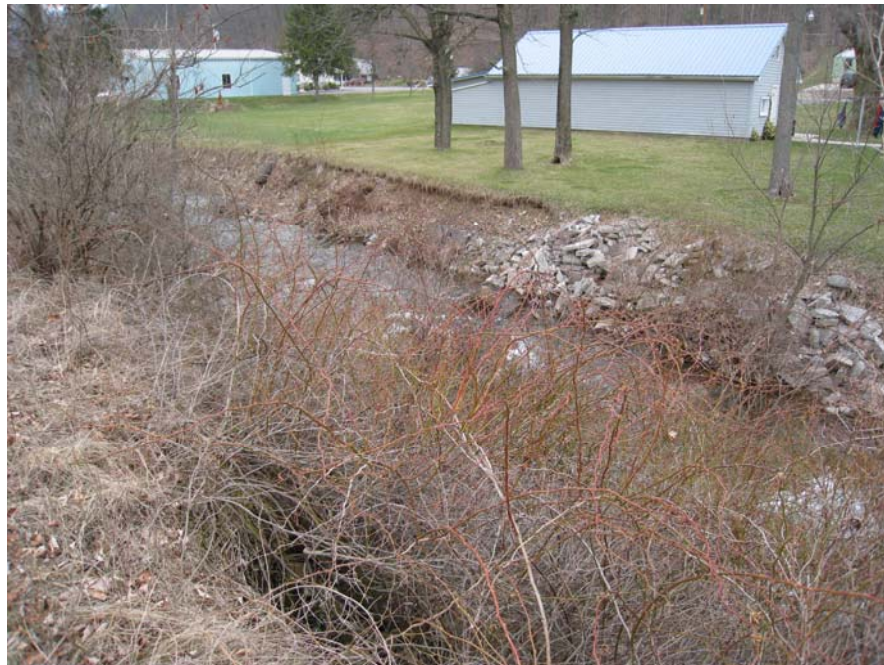
Figure 5. Homes and businesses border the lower four miles of Wallace Run. Much of the riparian vegetation has been replaced with lawn, resulting in substantial bank erosion that needs continuous maintenance.

Because the riparian buffer zone has been removed, severe bank erosion is common in this section. Homeowners have repeatedly had to replace riprap to prevent the stream from cutting into their lawn (Figure 5). Even large concrete blocks were not effective in preventing the stream from eroding the banks (Figure 6).

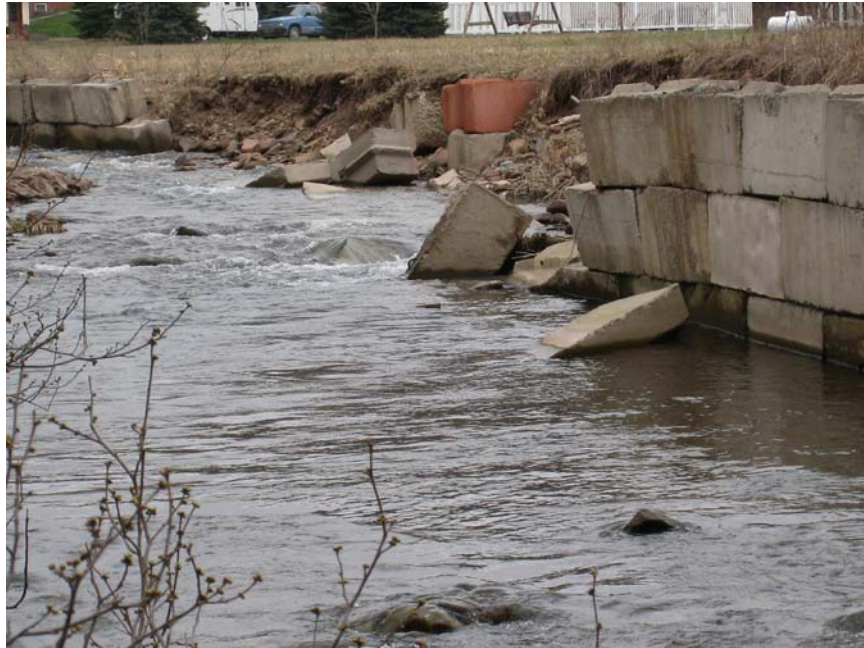
Figure 6. Even large concrete blocks were not sufficient to stabilize the bank.

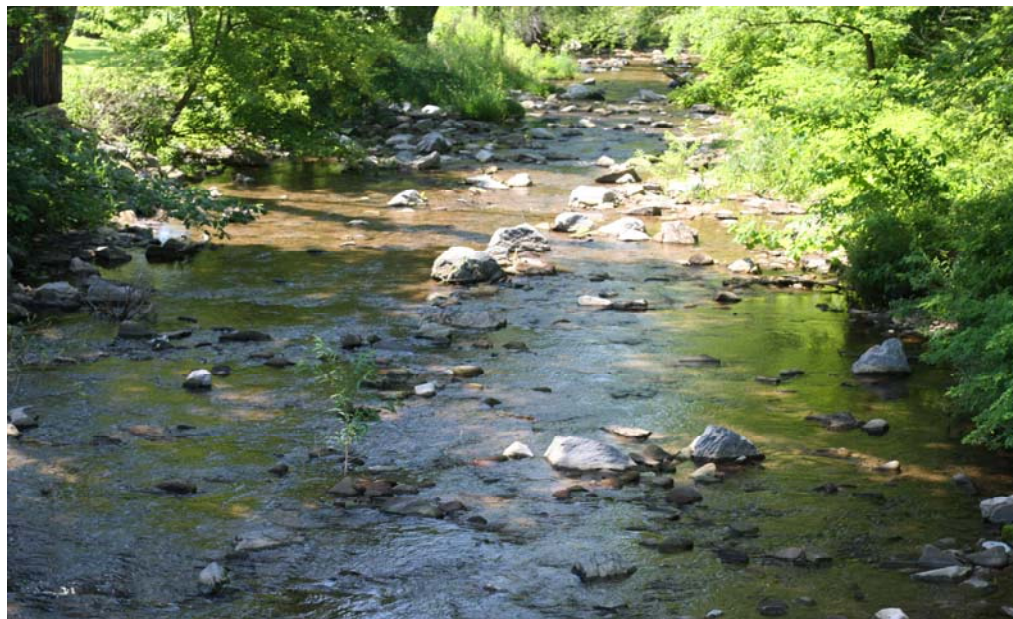
For long stretches, the stream appears to have been channelized, and the normal ratio of riffles occurring at roughly five to seven stream-widths apart (Hynes, 1972) has been drastically altered (Figure 7), so that most of the this lower four miles is primarily riffle/run habitat. The lack of deep pools significantly reduces the number of larger size trout the stream can support.

Figure 7. Long straight sections of Wallace Run are too wide, lack pool habitat, and are therefore poor quality habitat for larger size trout.

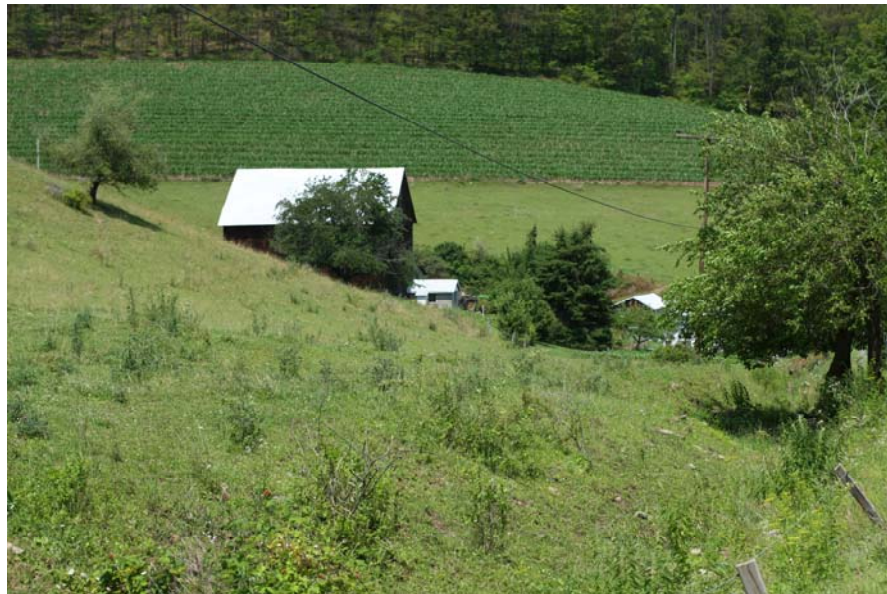
Figure 10. Farming on steep slopes adds sediment and other pollutants to streams.

Erosion and sedimentation problems in tributary valleys can be corrected by eliminating farming on steep slopes and by implementing best management practices with any earth moving activities.

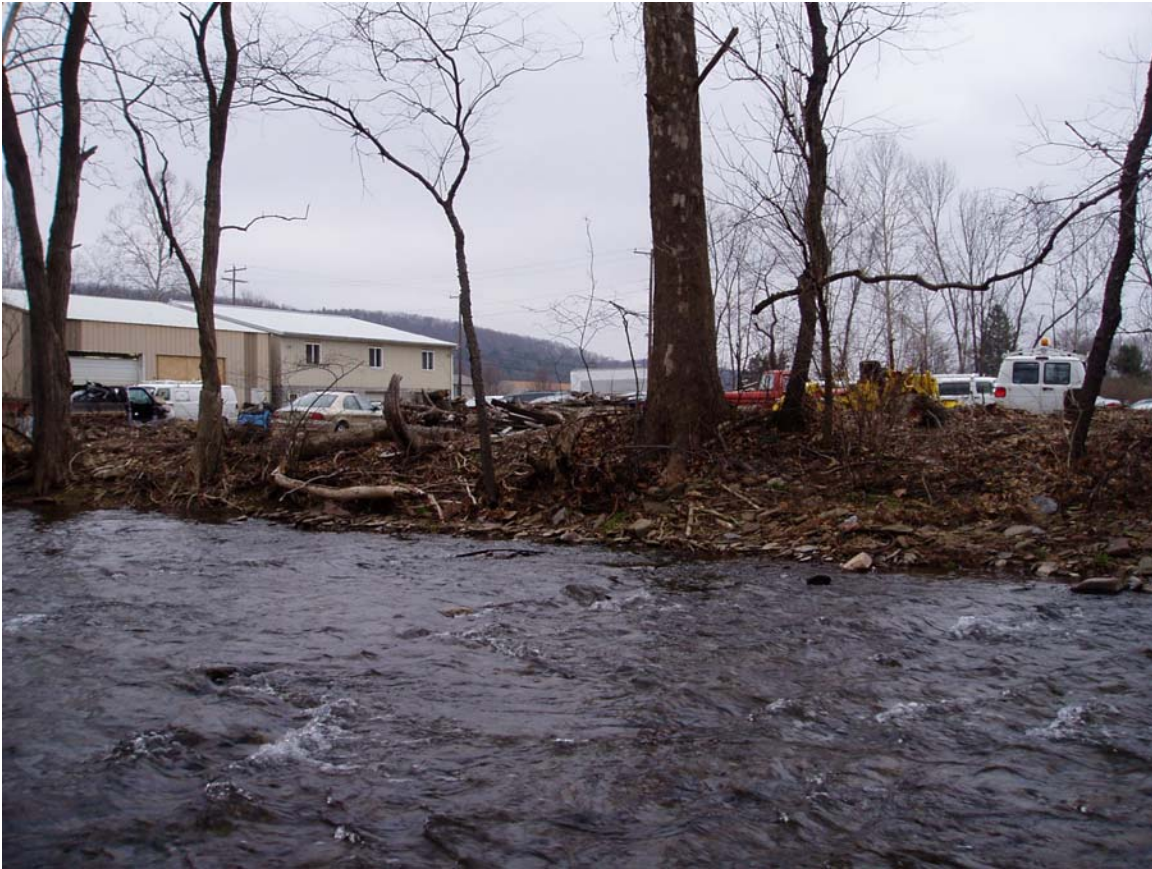
Figure 11. Unstable banks and lack of riparian buffer increase the amount of sediment in Wallace Run.

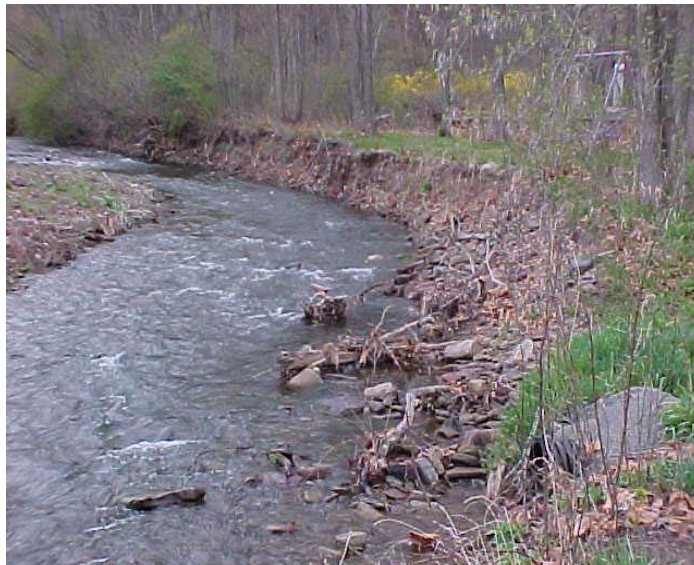
In the winter of 2008 DEP Department of Waterways and Engineering conducted a restoration project on the Brown property along Wallace Run utilizing Natural Stream Design techniques. Landowners Gary and Dolly Brown had tried for years to obtain assistance to repair their property along Wallace Run. Nothing had seemed to work and by 2006 the stream encroachment was threatening their home. DEP Department of Waterways and Engineering personnel visited the site and they were able to put this property on their project list. US Fish and Wildlife Service performed an emergency repair in June of 2007 that successfully prevented additional erosion before the complete restoration took place.

Figure 16: Wallace Run before restoration

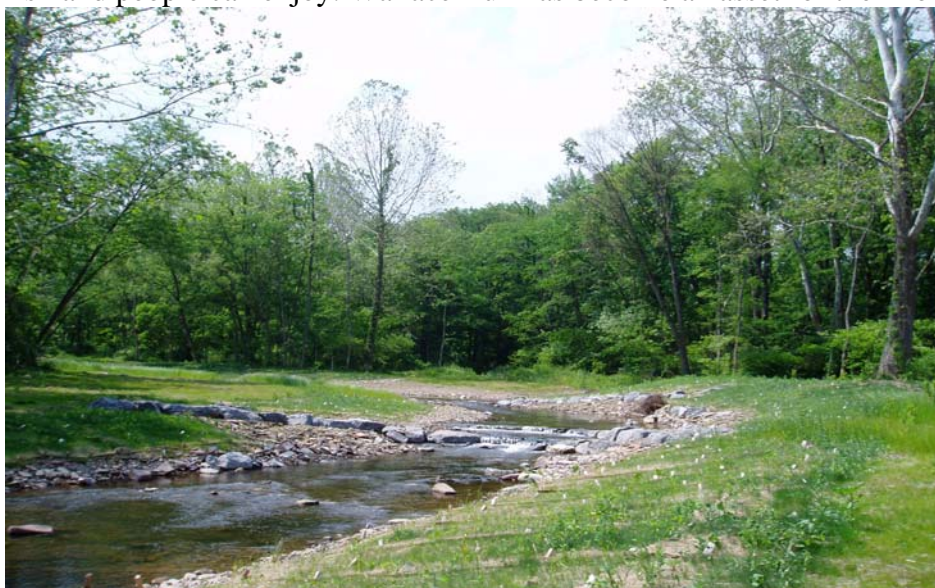
Figure 17: Wallace Run after restoration

Restoration included the installation of rock vanes and one root wad. The rock vanes consist of huge rocks that are placed in the stream that direct the energy of the water to the center of the stream instead of the bank. This effectively protects the bank and prevents erosion. The root wad is a large tree that has been dug up---the tree is placed in the side of the bank with the roots in the stream. Sediment will catch on the roots, build up and eventually result in added vegetation. The rock vanes produce the much needed pools of deeper water that fish like to have. Landowners Dolly and Gary Brown planted hundreds of trees in the riparian area in order to stabilize their new bank and to cool the water. The end result is a stream that both fish and people can enjoy. Wallace Run has become an asset for the Browns, not the menace that it was.

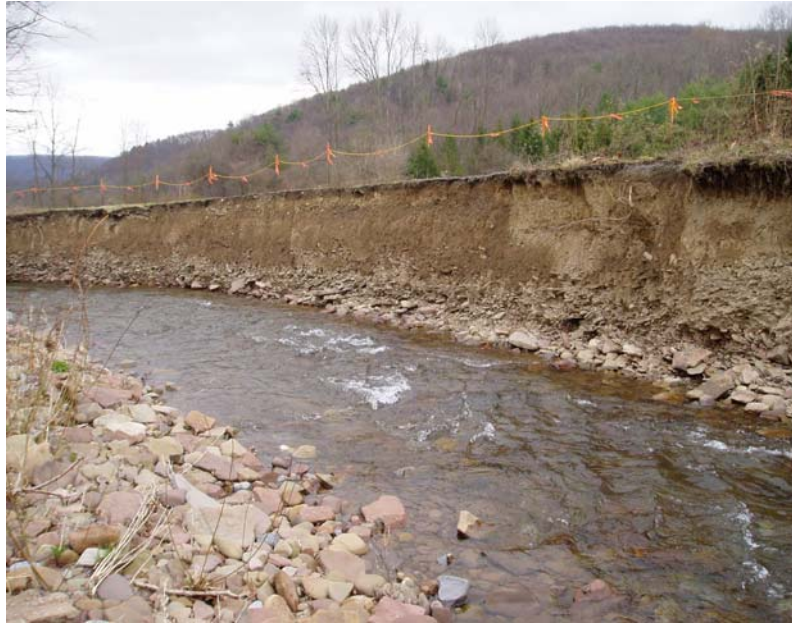
Just upstream of the Brown property Mike Davidson has installed a wall in an attempt to prevent his bank from disappearing. That wall appears to be holding, but farther upstream on the opposite side on Mike's property a similar wall that he installed in an emergency fix is now in disrepair. Across from this section is a severely eroded bank on the Lucas property. Both areas are scheduled to be restored in the fall of 2008. The work will be conducted by the US Fish and Wildlife Service employing Natural Stream Design techniques. Funding for this project will come largely from the Centre County Environmental Initiative Growing Greener Grant. Nisource, parent company for Columbia Gas, is contributing to the project since continued erosion on this bank threatens to expose their pipeline. Restoration of these two areas will further protect the Brown property downstream. Rock for the project will be donated by Jeff Confer and logs will be donated by Martin Melville.

Figure 18. Proposed restoration site, Fall 2008

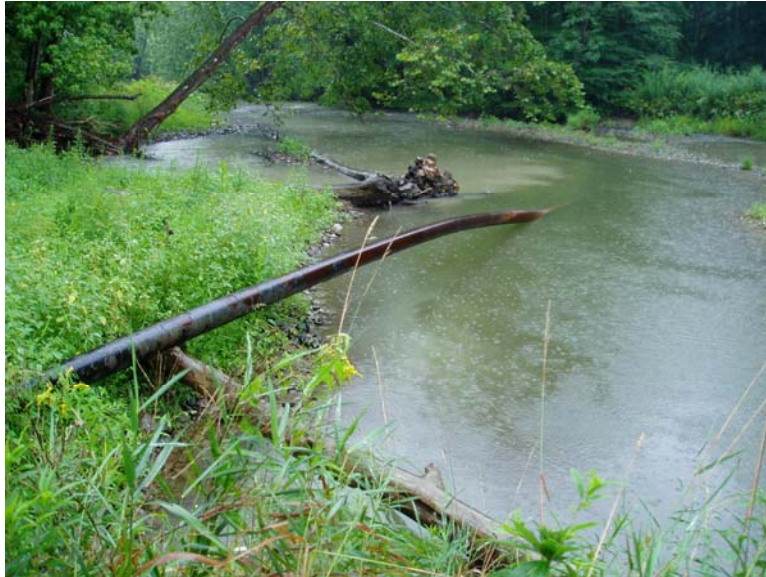
Another area of concern for area residents has been the Columbia Gas pipeline that is exposed at the confluence of Wallace Run and Bald Eagle Creek just below the village of Wingate. Efforts by Columbia Gas to repair this pipe were thwarted by high water two years ago. Members of the Bald Eagle Watershed Association have worked with Columbia Gas and DEP in order to ensure that the repair will take place in 2008. As of this writing, the work has begun on this project.

Figure 19. Exposed pipe at the confluence of Wallace Run and Bald Eagle Creek
