UPPER KETTLE CREEK FISH HABITAT CONSERVATION PLAN TRIBUTARIES ADDENDUM

For: Kettle Creek Watershed Association and Trout Unlimited
March 2005

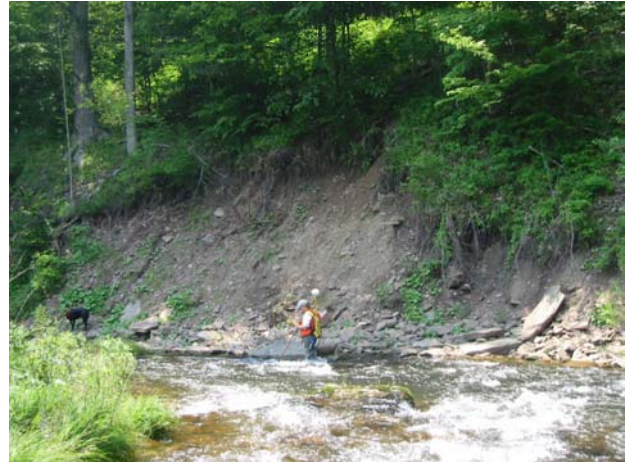
This reach appears to be more active as evidenced by bank erosion and numerous mid-channel bars. Typically the stream has a high bank on one side and an old lateral bar on the other as a result of stream channel evolution. During stream channel evolution, the channel will migrate across the valley until it stabilizes. This channel

FIGURE 4. Severe bank erosion where the stream channel is along the valley slopes

The two sections of bank erosion approximately 0.3 miles downstream of Germania Branch should be stabilized. These are large sections of erosion that contribute fine sediments to the channel thereby degrading downstream fish habitat. Other channel modifications to improve stream channel function would be of limited benefit to the overall watershed at this location.

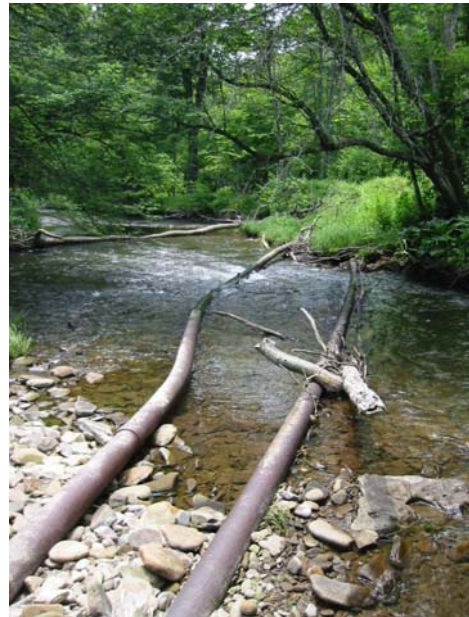
FIGURE 5. Exposed pipelines on Upper Kettle.

substrate. The headcut will continue to travel upstream until it is stabilized by the bedrock. As a result of the instability in the downstream portion of this reach, numerous mid-channel bars have deposited immediately upstream of the confluence with Long Run. Two miles downstream from the beginning of the reach a double pipeline crosses the channel. The pipeline is completely exposed in the stream and one of the pipes has shifted during a high water event. Signage on the bank indicates that the pipelines are carrying a fiber optic cable and high pressure petroleum. Assuming that this petroleum pipeline is still active, if it were to burst, it would have a devastating impact on Kettle Creek.

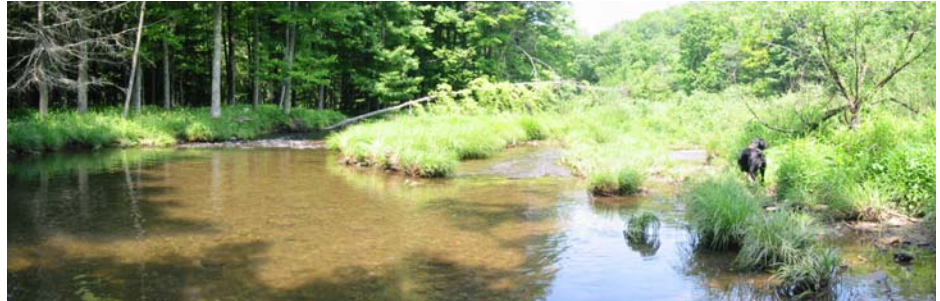
FIGURE 6. Upper Kettle multiple channels and mid-channel bars just upstream of Long Run.

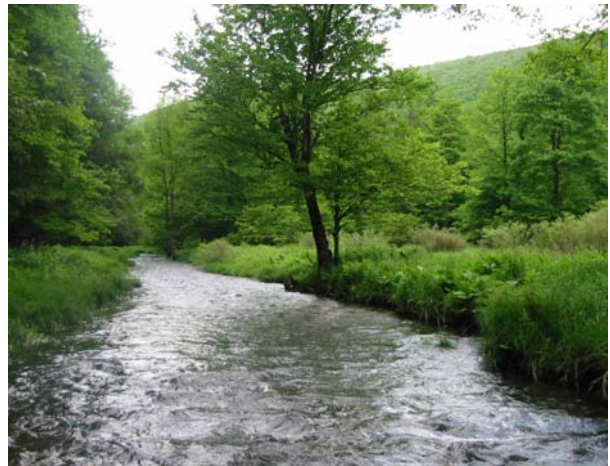
Canopy cover is highly variable in the upper and lower portion of this reach ranging from less than 20% cover to over 80% cover. The middle portion of this reach has excellent canopy. Tree species in this reach are dominated by beech, river birch, hemlock, and red maple. The understory is mostly ferns and herbaceous plants with some shrubs. The water temperature in this reach averages 11.8 to 13.2°C or 71.2 to 73.8°F on June 9, 2003.

FIGURE 10. Open canopy can be improved with additional riparian plantings.

Riparian plantings in this reach will improve canopy cover and bank stability. Recommended tree species are green ash, sycamore, and white pine.

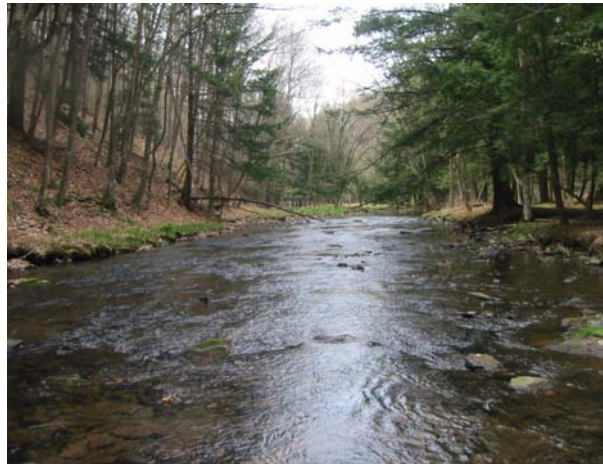
Approximately 0.15 miles upstream of the Short Run Road bridge, the channel is over wide and braided with numerous overflow channels. There is a beaver dam 25 meters upstream of Short Run Road on the east branch of the split channel. This detains excess sediment from moving downstream. As the valley widens, the floodplain width increases and the channel is able to meander

FIGURE 11. Overly wide, poor habitat reach on Cross Fork

Pool development in this reach is generally poor with coarse woody debris providing the majority of habitat. Pools could be increased with the placement of log veins. Riparian plantings would improve the canopy cover in the beaverdam area upstream of Short Run Road and near the cabin across from Yochum Run. Recommended tree species include sycamore, green ash, river birch, hemlock, or white pine.

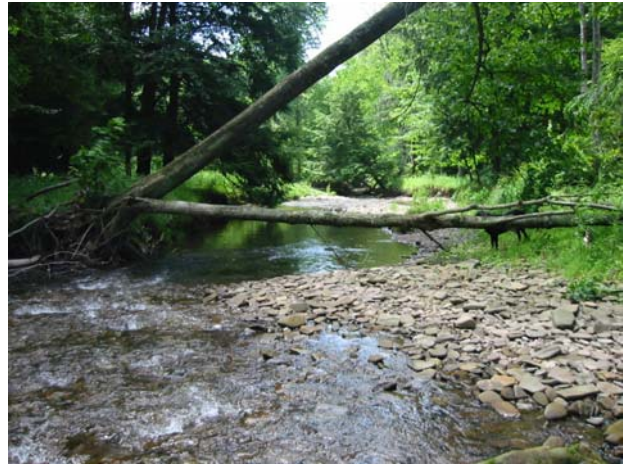
The stream flows in the middle of the valley for most of the reach except at the downstream end where it flows along the eastern hillside. The upper section of this reach has frequent erosion areas that often alternate banks depending on the location of the thalweg in the channel. The upper reach consists of eroded banks,

FIGURE 19. Headcut on Hammersley Fork.

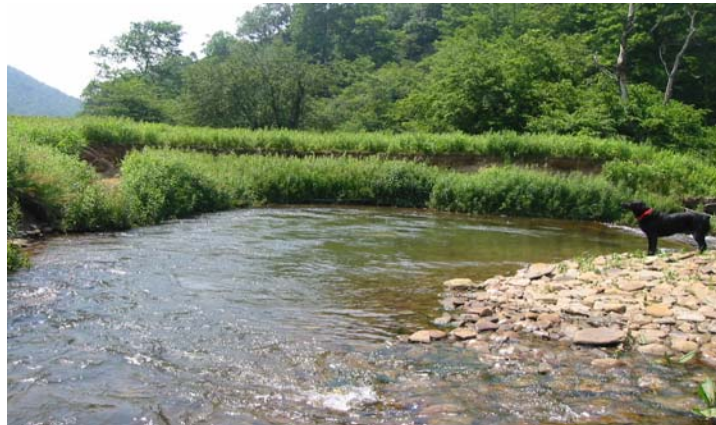
Most of the stream channel evaluated in Upper Kettle Creek is recovering well without intervention. The primary focus of any stream work on Upper Kettle Creek should be the two areas of severe erosion located 0.30 miles downstream of Germania Branch. The first is rated as severe; it is a 2.5 meters high and 22 meters long section of nearly vertical clay bank (Figure 24 on page 42). The second erosion site is rated as extreme; it is a 9 meters high and 28 meters long section of sandy cobble (Figure 4 on page 11). This area is private land ownership.

FIGURE 24. Severe erosion on Upper Kettle Creek downstream of Germania Branch

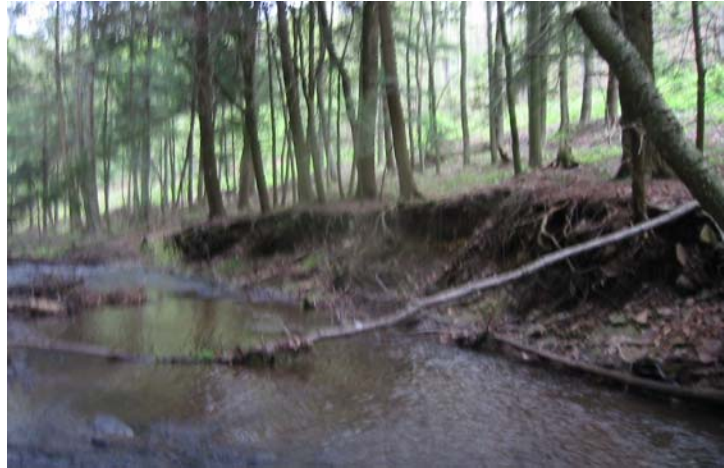
FIGURE 25. Severe erosion on Germania Branch

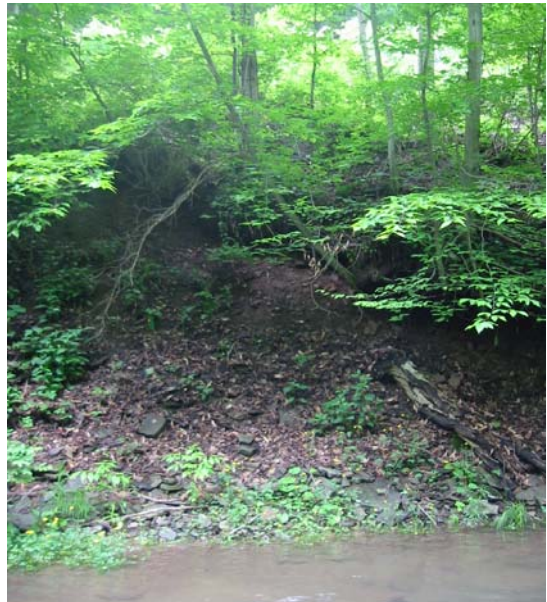
There are two areas of severe bank erosion located 0.85 miles downstream of the Hungry Hollow Bridge that should be stabilized. These areas may require structural as well as vegetative techniques for stabilization. The banks range from 4-5 meters high and 10-15 meters long. Both areas have thin vegetative cover.

FIGURE 26. Severe erosion on Little Kettle

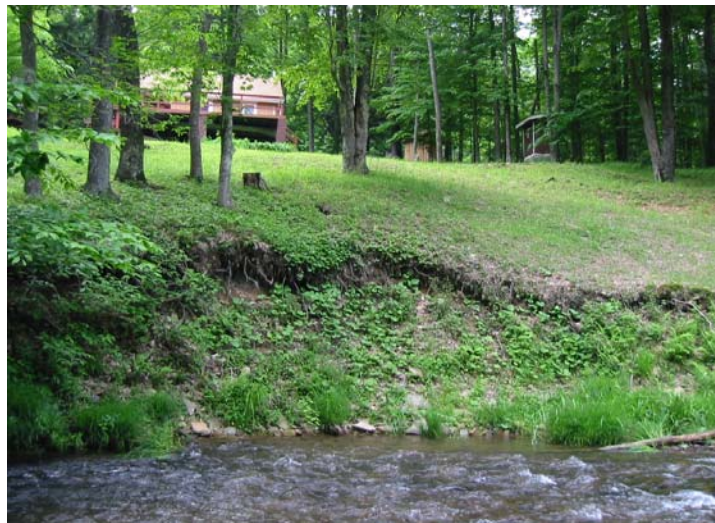
One priority area for streambank stabilization is located approximately 0.75 miles downstream of Yochum Run, near a cabin. Due to the curvature of the stream and the location of an older recreational rock dam, the stream has eroded both banks at this location. This area would also benefit from riparian plantings as there is only 28% canopy cover at this location. This area would have relatively easy equipment access.

FIGURE 27. Cross Fork erosion downstream of Yochum Run.

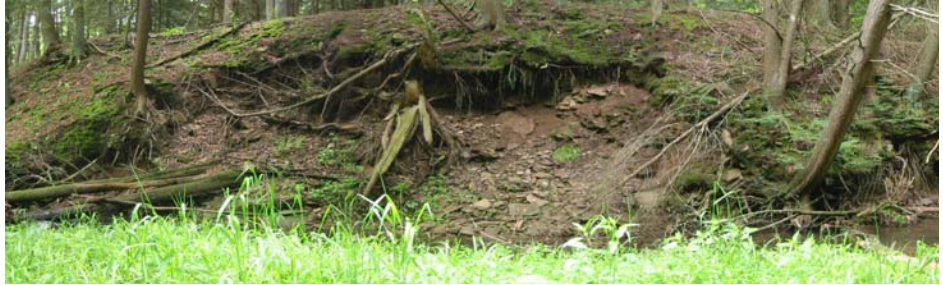
Stabilization should be considered for two areas of bank erosion on Windfall Run 1.15 and 1.65 miles upstream of bridge on Township Road 416. The severe erosion is 1.5 meters high, 19 meters long with sandy substrate and thin woody vegetation. The area of extreme erosion is 5.5 meters high, 24 meters long with cobble substrate and thin woody vegetation.

FIGURE 28. Bank erosion on Windfall Run

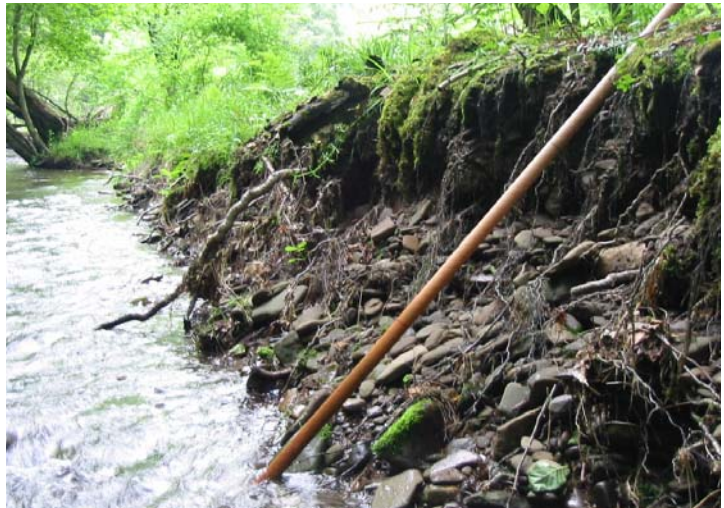
Yochum Run also has two bank erosion sites located 0.7 miles upstream of confluence with Cross Fork that should be stabilized. The severe erosion site is 2.5 meters high, 18 meters long with loam soil and with thick woody vegetation. The extreme erosion area is 6 meters high, 20 meters long in sandy gravel with thin herbaceous vegetation.

FIGURE 29. Bank erosion on Yochum Run.

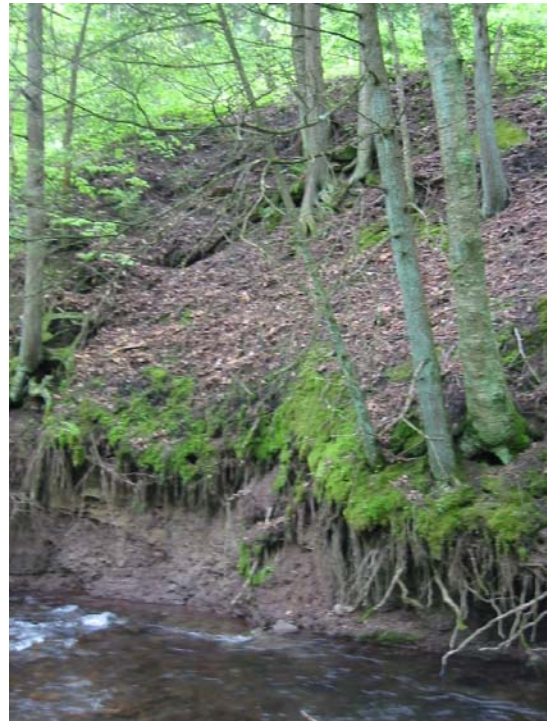
There is one area of extreme streambank erosion that should be addressed. The stream is eroding into a shale bank underneath Trout Run Road approximately 0.85 miles below the bridge on Trout Run Road. The bank is 5 meters high, 28 meters long in loam soil with thin woody vegetation. This area should be further examined and a stabilization plan developed. This may require structural techniques such as a retaining wall.

FIGURE 30. Trout Run bank erosion near road.

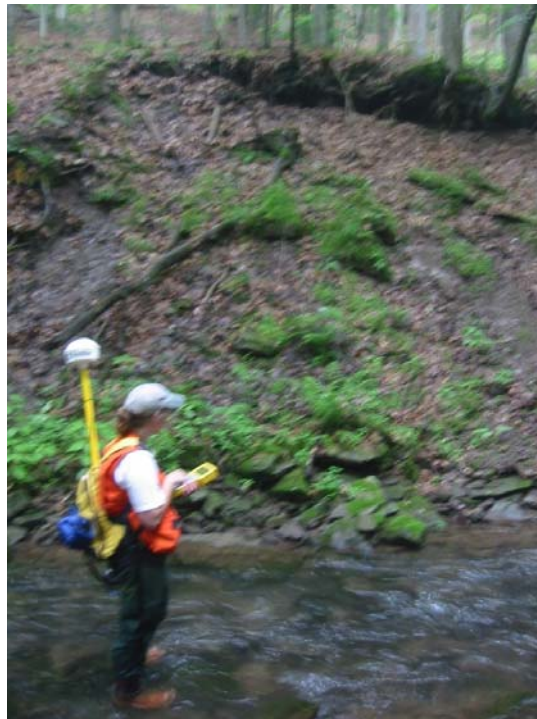
Beaverdam Run is also a properly functioning stream with relatively little channel migration and balanced sediment transport. An extreme bank erosion site is located 0.65 miles upstream of the bridge on Route 144. The site is 7 meters high, 20 meters long with loam soil and no vegetation. This area contributes a large amount of fine sediment to the system. The proper stabilization of the park road should reduce some of the fine sediments entering the system. Preservation of the large amounts of spawning gravel in the channel should be a priority by reducing the amount of fine sediments entering the system.

FIGURE 31. Bank erosion on Beaverdam Run.
