Coldwater Conservation Plan

Canoe Run

Cameron County

Cameron County Conservation District.

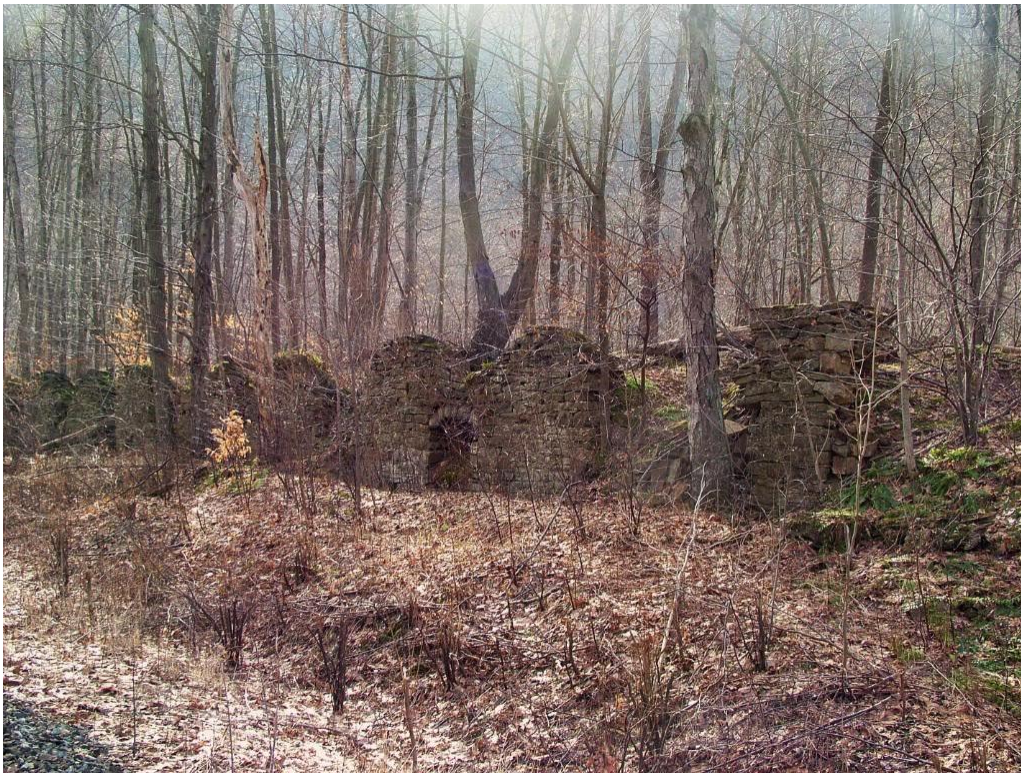
Coke ovens ruins near the mouth of Canoe Run

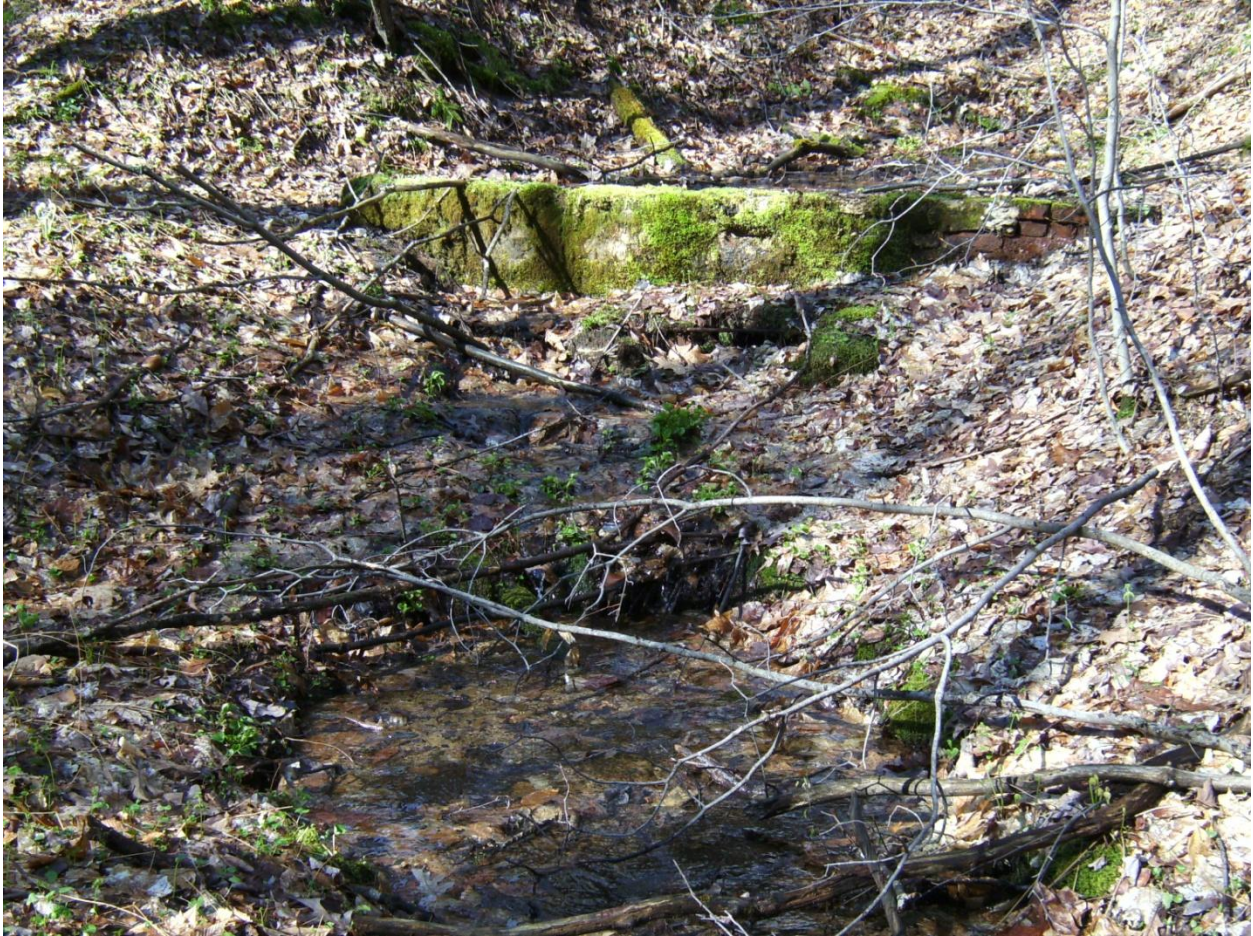
Headwaters of unnamed tributary to Left Fork of Canoe Run

This tributary showed low levels of metals but very depressed pH readings. It did not appear to have negative effects on the water chemistry of the Left Fork, as measurements were nearly identical upstream and downstream of the mouth of this unnamed trib. The Left Fork did however show some cases of being net acidic during more low flow events.

One major option for the Canoe Run watershed is the treatment of the only major source of AMD entering Canoe Run. The unnamed tributary to the Left Fork of Canoe Run has moderate AMD that does not appear to have adverse effects on the Left Fork probably due to the limited flow coming out of the deep mine. Although water quality issues are not real prominent it may be affecting the aquatic community to some extent. There are several options to treat this AMD.

A diversion well would work well for this site. This is where water is piped into a container holding a slurry of limestone sand. Water flows through the limestone and comes out with a high pH. These systems work fairly well but require a lot of maintenance and long term funding to continually add limestone. This type of treatment is called active treatment. A better option is that of the passive treatment.

An anoxic limestone drain (ALD) is a passive treatment system and is a good option for this site. ALD systems are not good for every situation. An anoxic limestone drain is essentially a treatment system containing high calcium limestone which is constructed underground into the bank where the discharge emanates. Water from the mine runs through the limestone, raising the pH of the water to a more acceptable level for aquatic life. The issue with ALD systems is when there are high levels of metals in the water. When high levels of metal are present, the iron, aluminum, or manganese can armor the limestone within the system and clog up. This discharge in Canoe Run does not have high levels of metal and would likely be a fairly cost effective measure to treating this AMD.

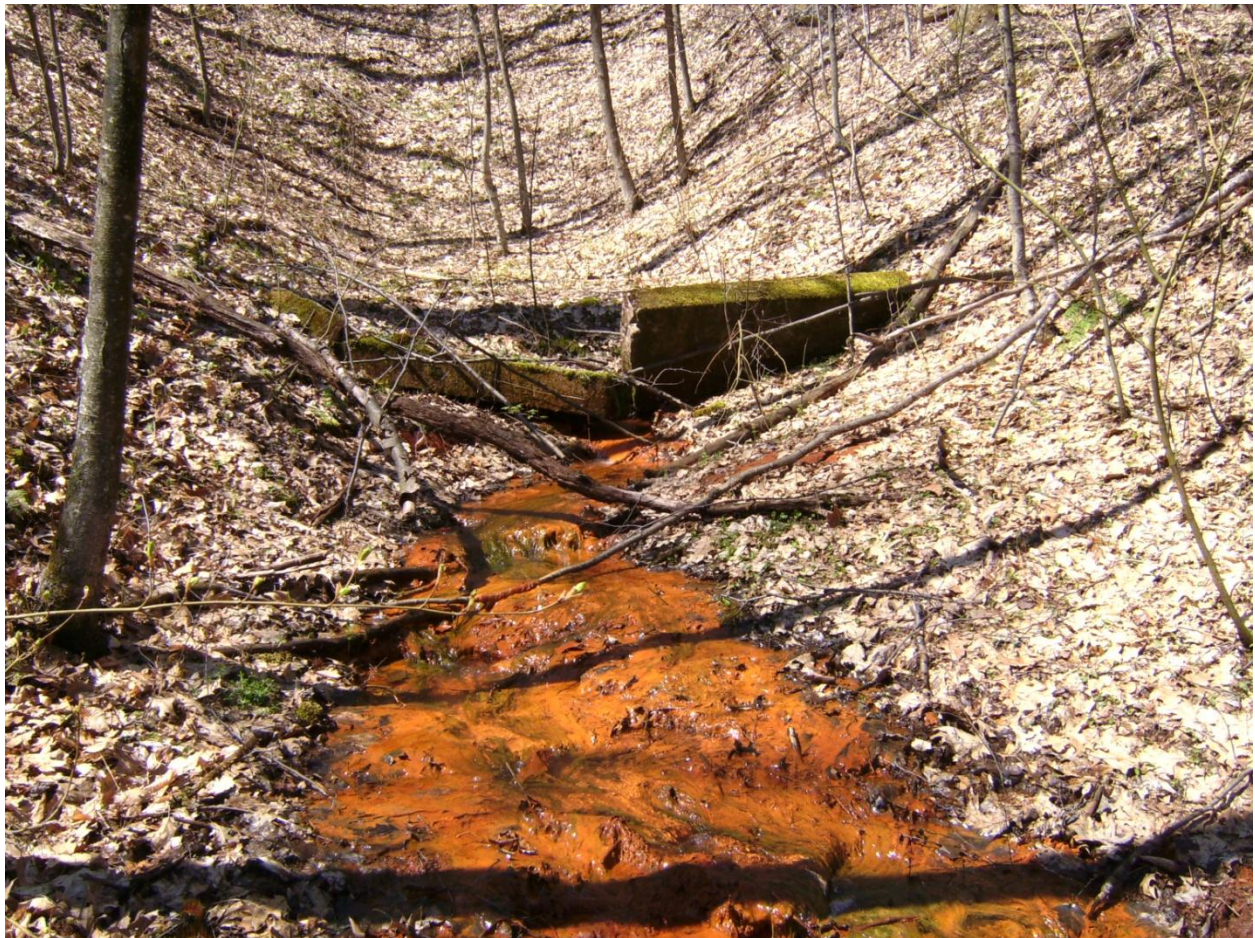
Only one other problem area showed up but was not monitored throughout the length of the study. Downstream another mine shaft appeared but really quite a distance from the mainstem of Canoe Run. What appeared to be very poor quality water emanated from the shaft and had a very bright orange cast to it indicating high levels of iron. When field measurements were done it showed that this water had very good pH readings (6.8). The water was iron laden but to our knowledge did not have a

direct discharge into Canoe Run. This seep flowed downhill for a short period of time before entering back into the ground never to reappear. This site was checked numerous times throughout the study to ensure that a discharge was not being overlooked but it always flowed back into the ground. Looking at maps this appears to be the one of the original Mount Hope Mines because it is very close to where the village of Bradytown was located.

Old Mount Hope Mine Shaft
