# East Branch Tionesta Creek

## COLDWATER CONSERVATION PLAN

McKean, Warren, and Elk Counties

May 2017

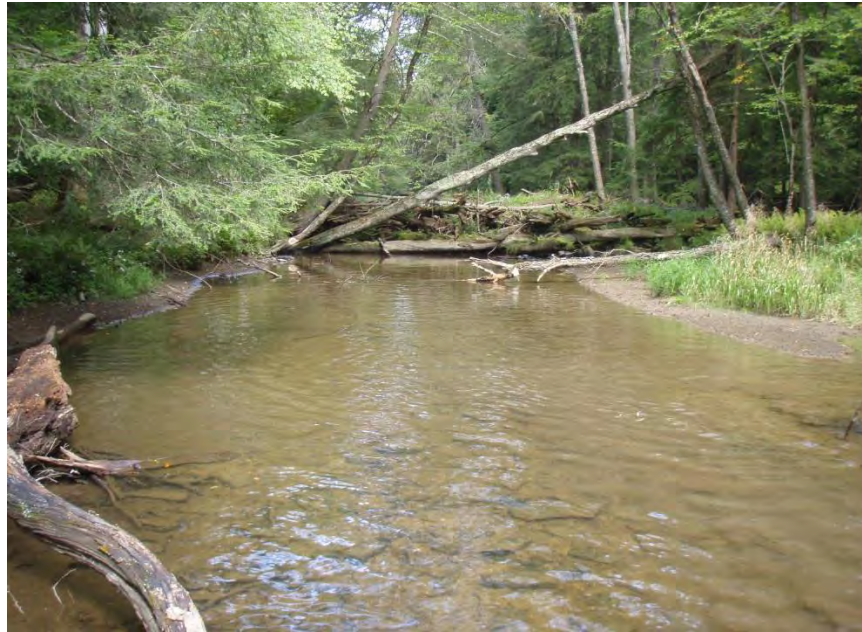
*5868: Channel spanning log jams were observed sparingly throughout EBTC. Specimens like this on segment 5868 provided natural inspiration and examples of great habitat present. However, this entire reach did not quite have enough pieces of LWM per mile to qualify as "Significant"*

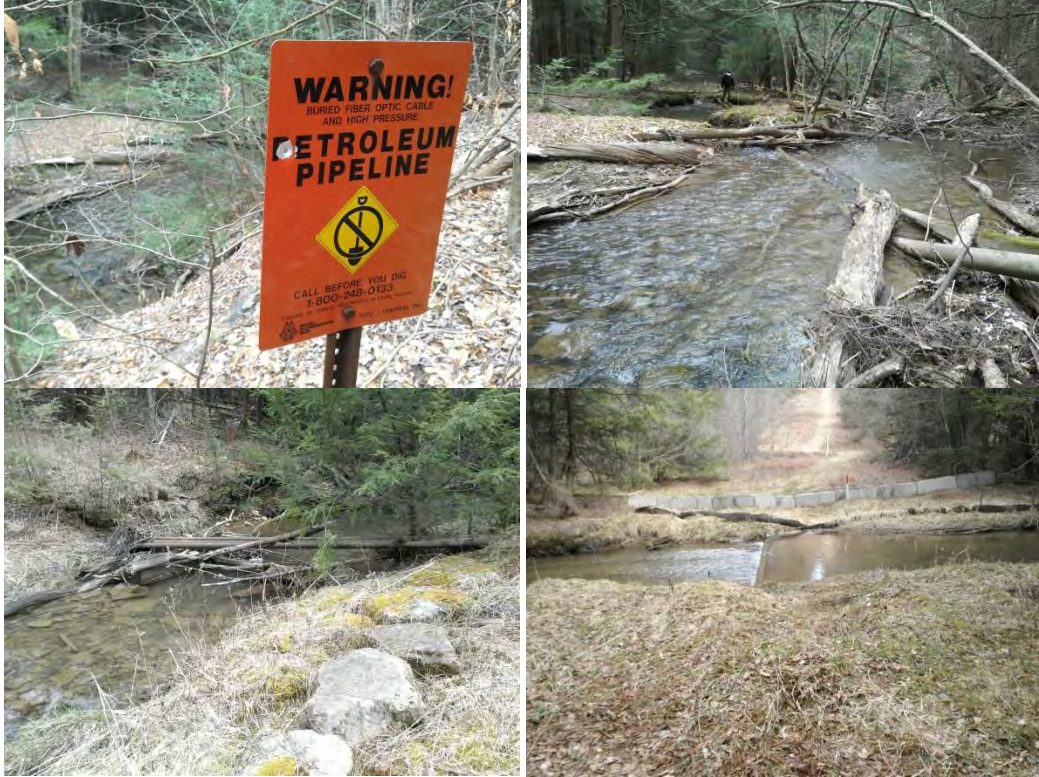
6234: Mobile pieces of wood in the channel may pose risks to exposed infrastructure. Note the absence of larger pieces of wood near these concerns.

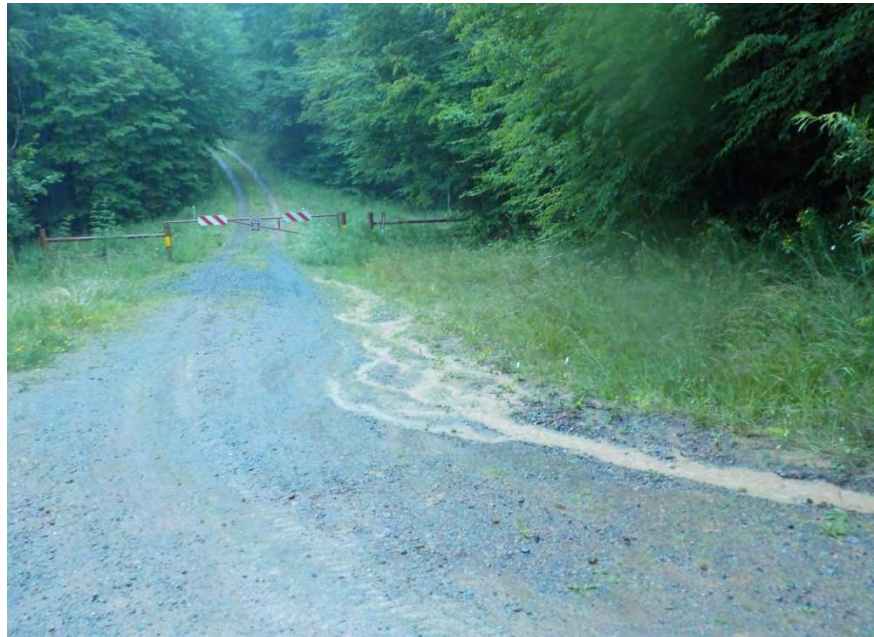
5806: Poorly maintained dirt and gravel roads throughout this and other drainages contributed sediment during heavy precipitation or runoff events, at times even preventing accurate assessments (and thus a canceled field day).

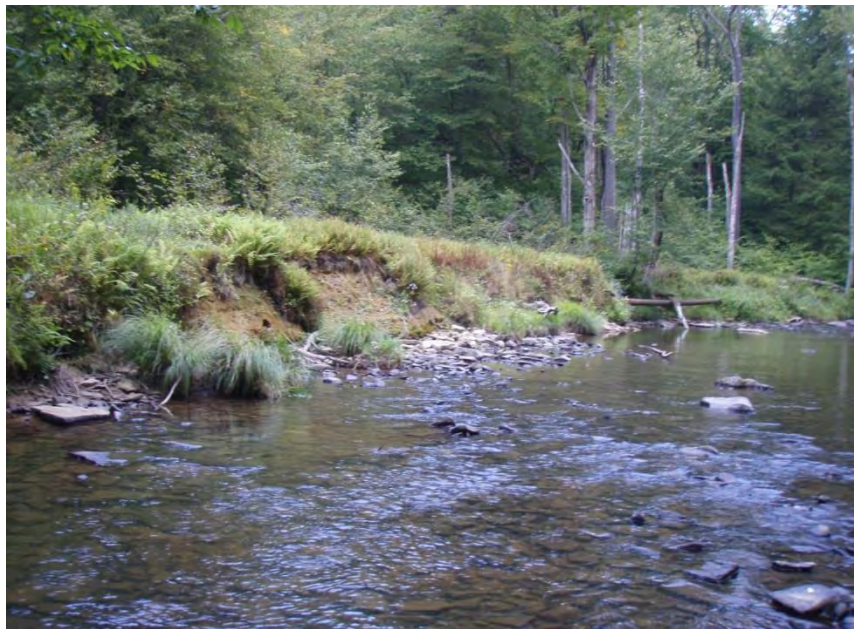
*5868: Eroding bank along East Branch Tionesta Creek mainstem. Note exposed pipeline.*

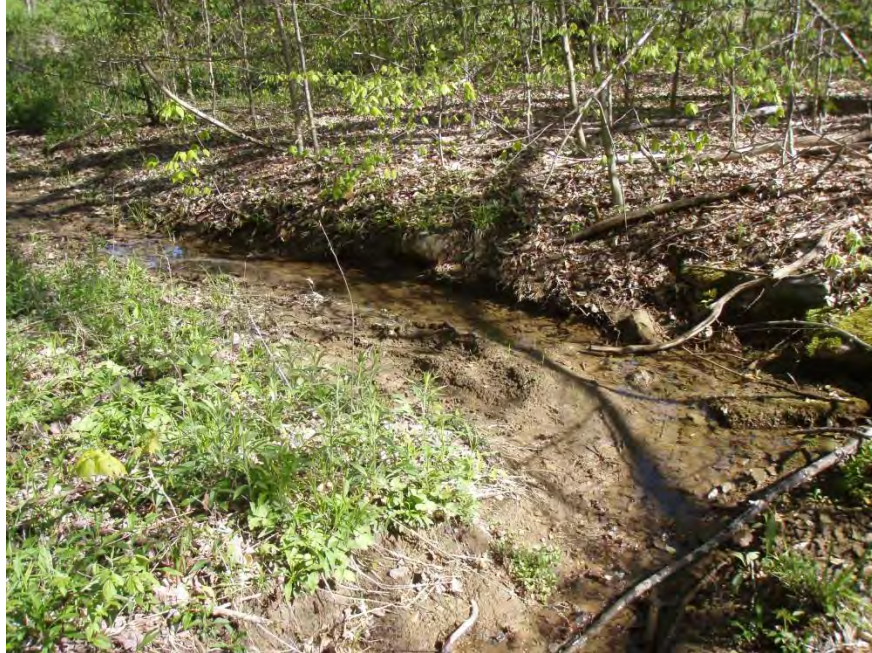
*6281: Erosion near the headspring of East Branch Tionesta Creek mainstem. This section is directly below an agricultural area.*

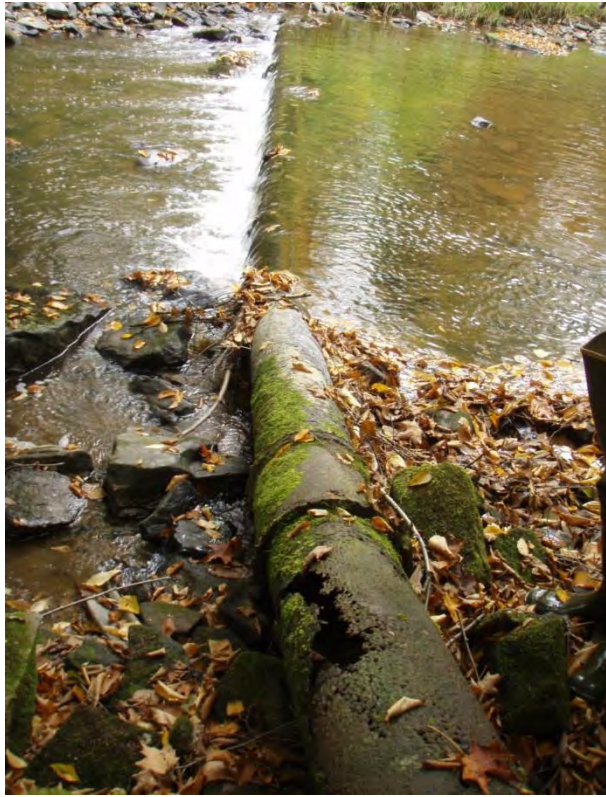
5963: Old, inactive metal pipe creating a potential AOP barrier, as well as safety hazard.

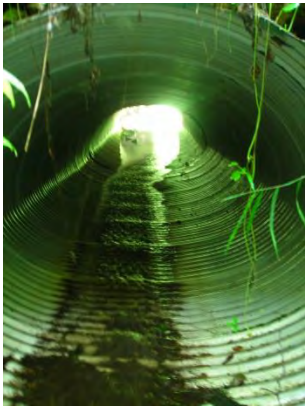
*5806: Culvert posing an AOP barrier. Culvert lacks suitable substrate for AOP passage.*

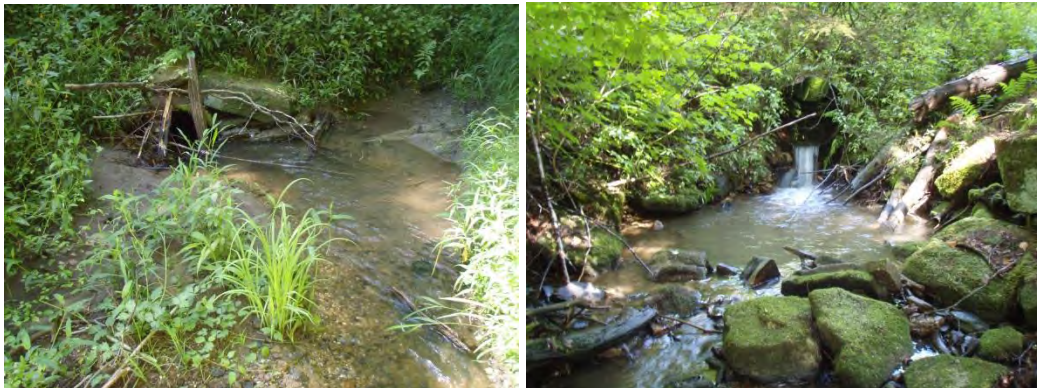
*5816: Culvert inlet (left) and outlet (right) posing an AOP barrier. Culvert is perched and clogged.*

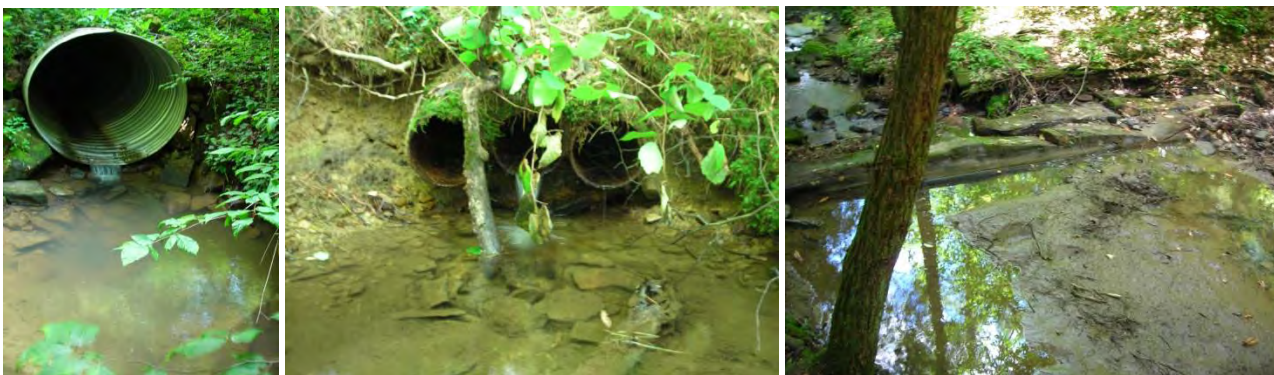
*5823: Perched culvert outlet, relic undersized pipes, relic log dam (separate locations on 5823).*

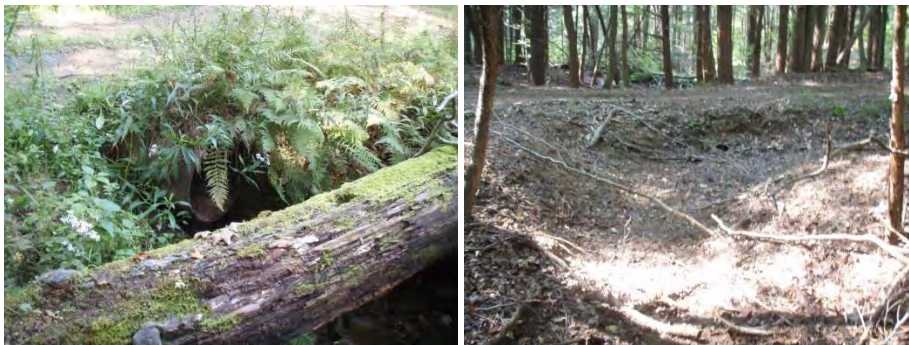
*5869: Perched culverts downstream (left) and upstream (right, near ephemeral point of stream)*

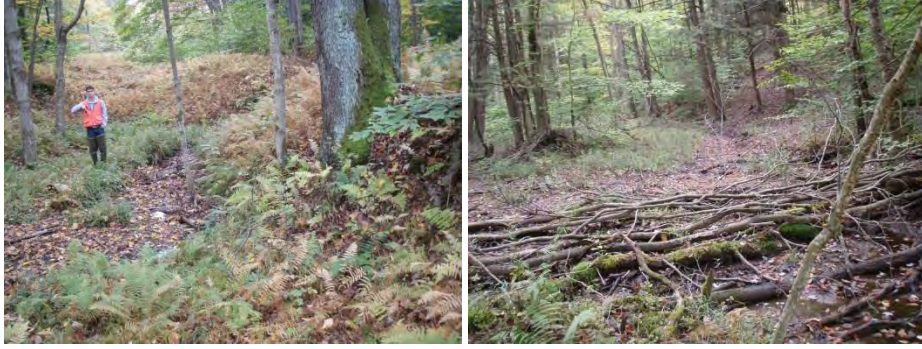
*5964: Historic logging railroad (left) impacted original course of stream, potentially leading to seasonal connection through floodplain wetland and sediment (right).*

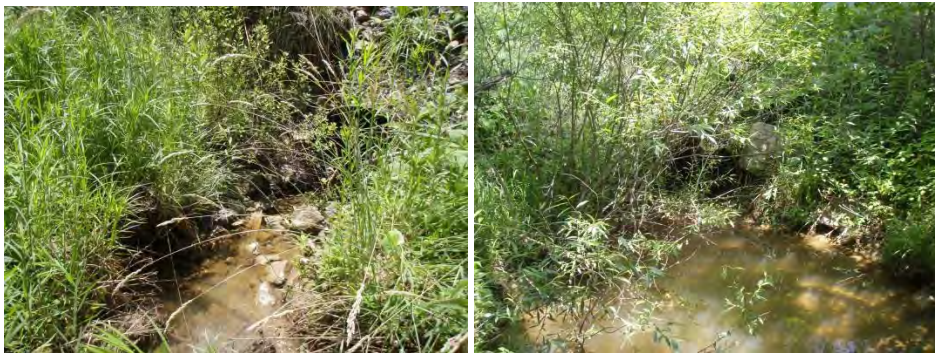
*5965: Undersized culvert inlet (left) and outlet with scour pool (right).*

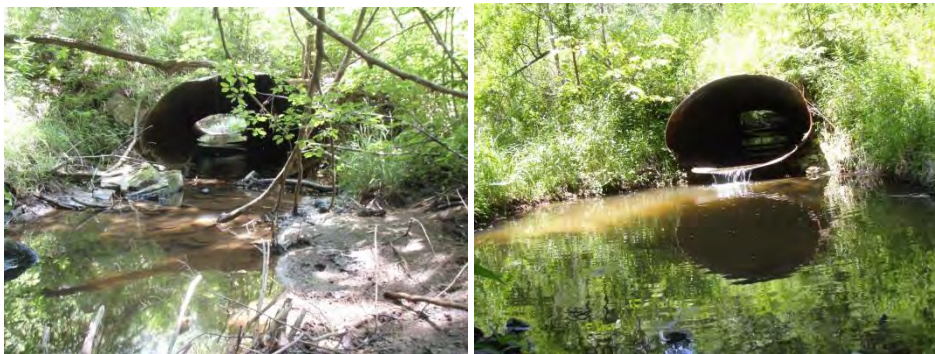
*5966: Culvert inlet (left) and perched outlet (right) with scour pool.*

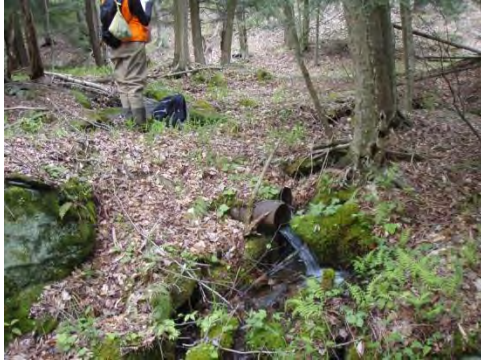
*5978: Perched culvert outlet, 1 of 3 channels on this UNT at this inactive pipeline crossing.*

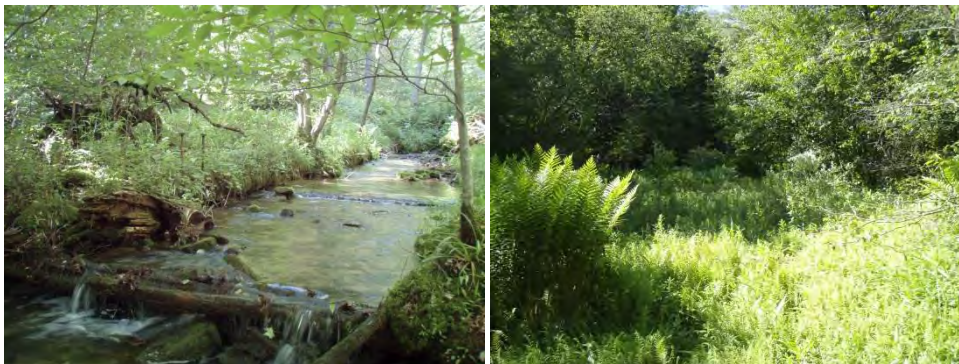
*6033: A relic mill dam (breached, left photo) and aggraded sediment upstream from it (right) forced the stream to flow subterranean.*

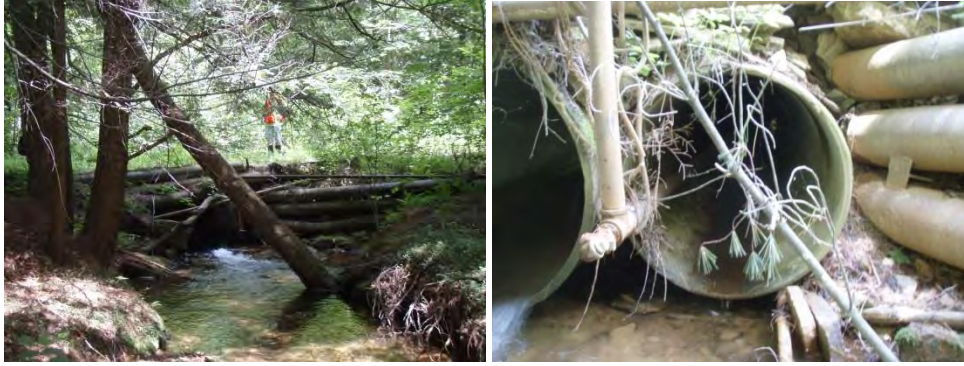
6034: Perched culverts on Rock Run (left), with 1 culvert containing an active 2" natural gas line (right).

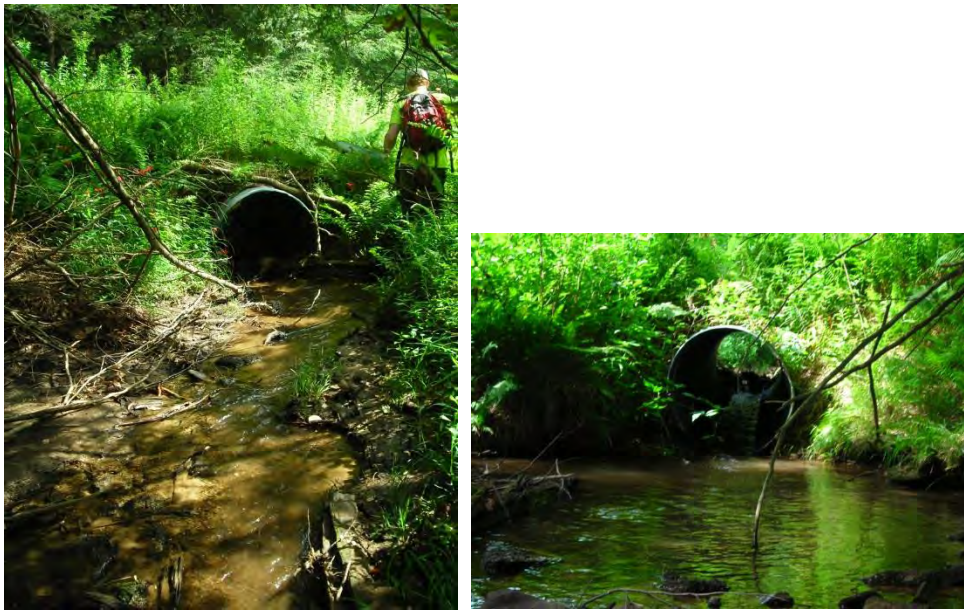
6035: Culvert perched, lacking substrate.

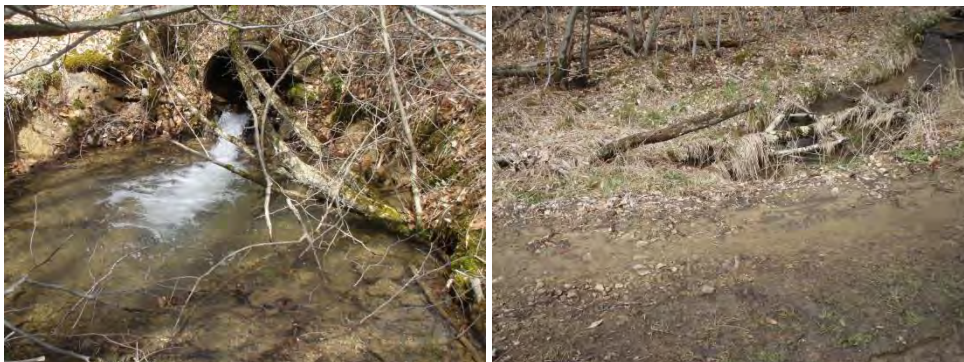
6041: Several undersized/perched culverts for multiple sinuous DGR crossings. Outlet on the left and clogged inlet on the right.

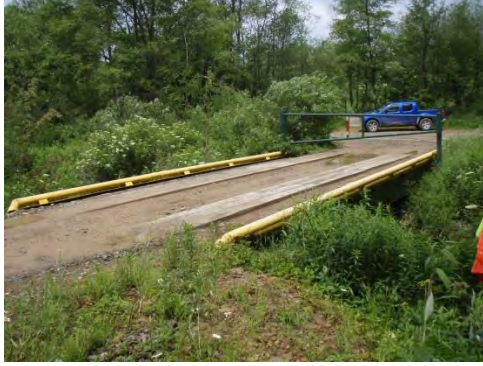
*6045: Bridge causes slight constriction at high flows, but has good floodplain development beneath. Low potential for AOP barrier.*

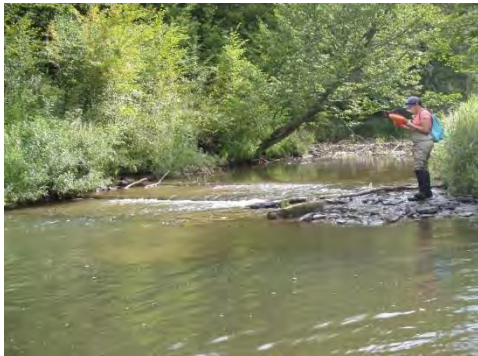
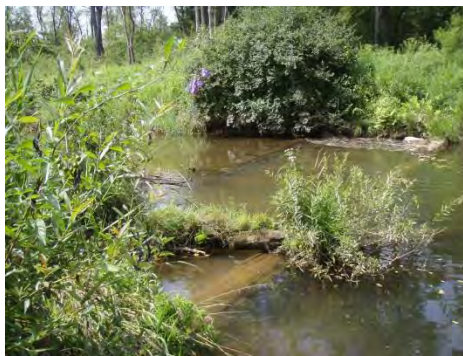
*6046: Two relic log dams, reclaimed by nature and posing little threat of being AOP barriers.*

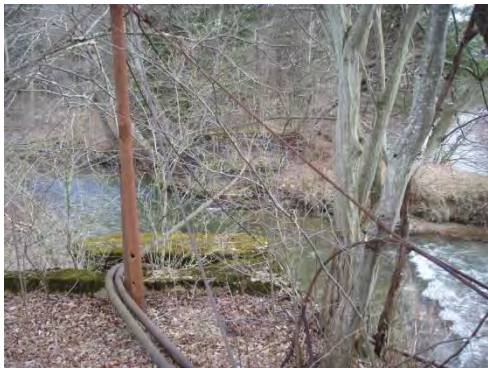
*6049: Relic bridge abutments and a pipeline form a constriction and low potential AOP barrier.*

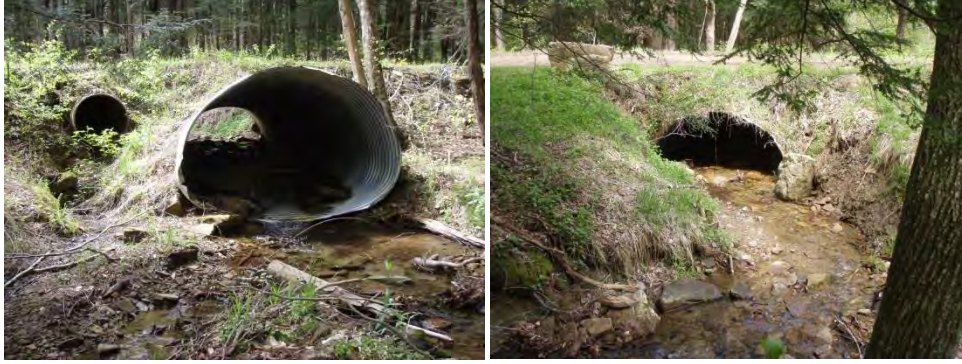
*6052: Recently replaced culvert is perched with substrate falling short of pipe outlet (left). Erosion near inlet (right).*

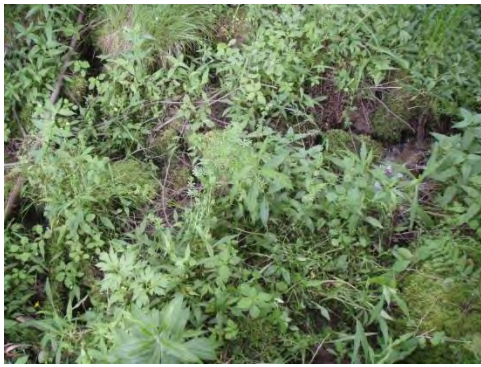
*6066: Stream is more floodplain wetland than a stream, but does have a small culvert on it.*

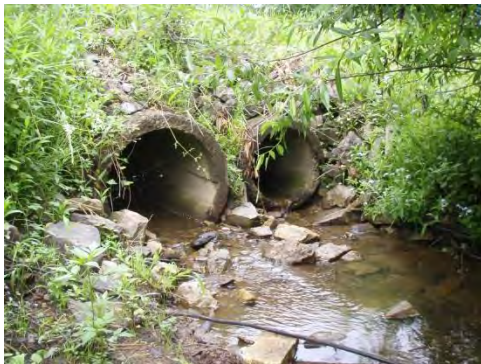
*6079: One set of double culverts at their outlet. Permission and logistics prevented further survey of the 5+ other AOP barriers on this segment. (Future endeavors may reap different results).*

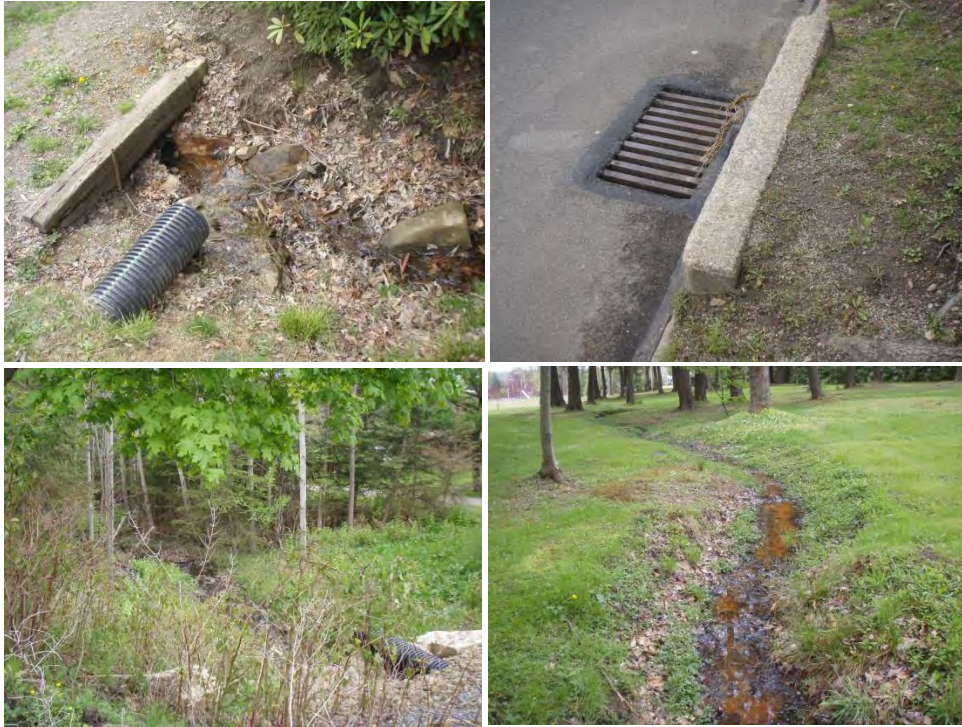
*6090: Clockwise from Top Left: Stream enters urban stormwater system from headspring in Evergreen Park; street stormwater grate draining directly to stream; small discolored tributary in Evergreen Park; Stream exits culverted stormwater system, with Japanese knotweed in foreground.*

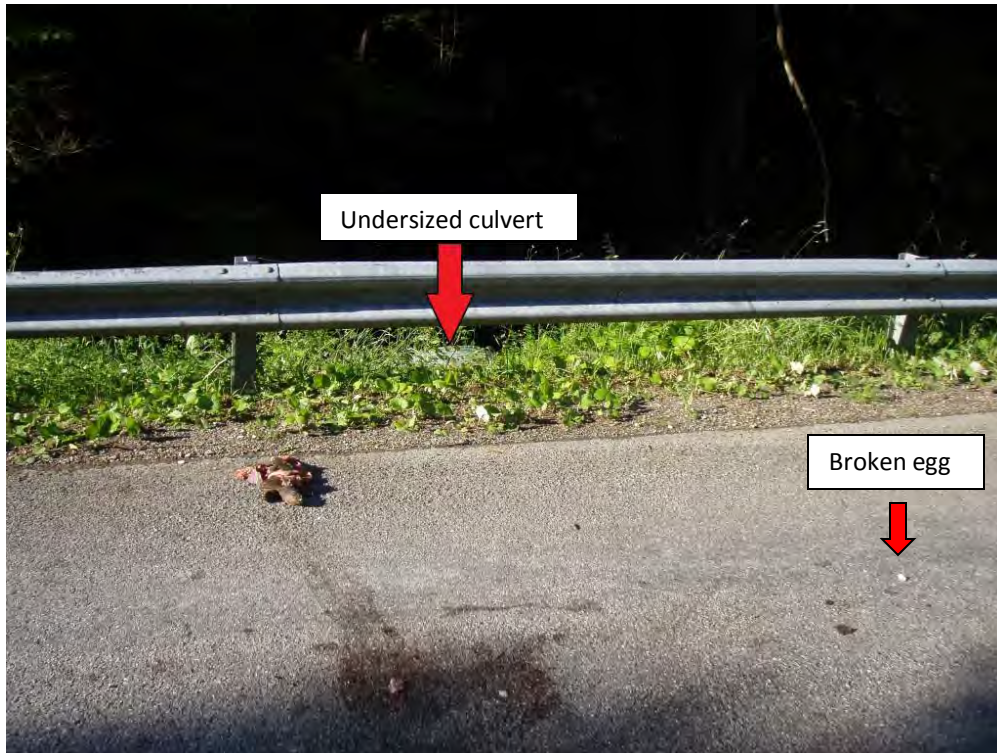
6105: A prime example of an undersized crossing structure impacting aquatic populations. This gravid female snapping turtle was found hit by a vehicle, just above an undersized culvert on West Kane Road.

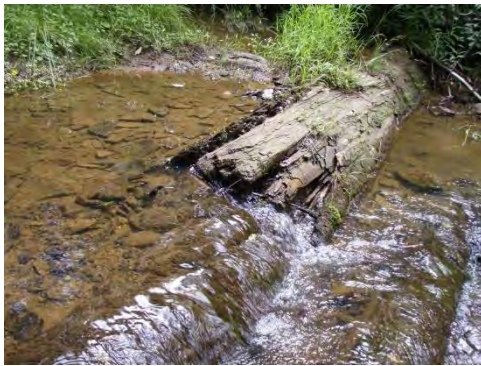
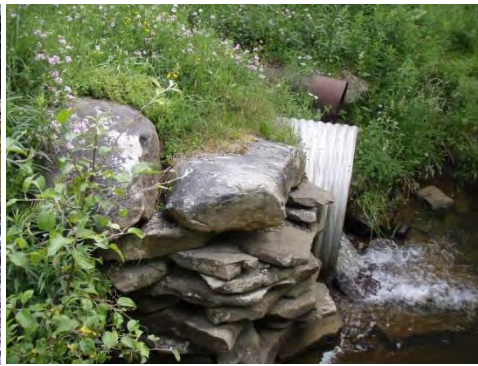
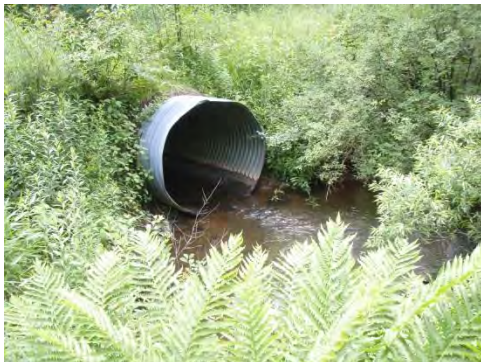
6105: Relic log dam forms partial AOP barrier (top left), Reigel Road culverts (top right), private road culvert (bottom left).

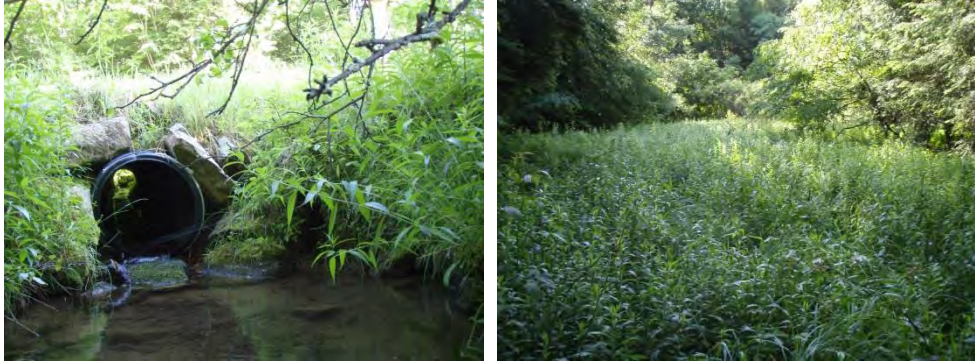
6110: Undersized culvert at West Kane Road (left); sedimented basin of relic log pond (right).

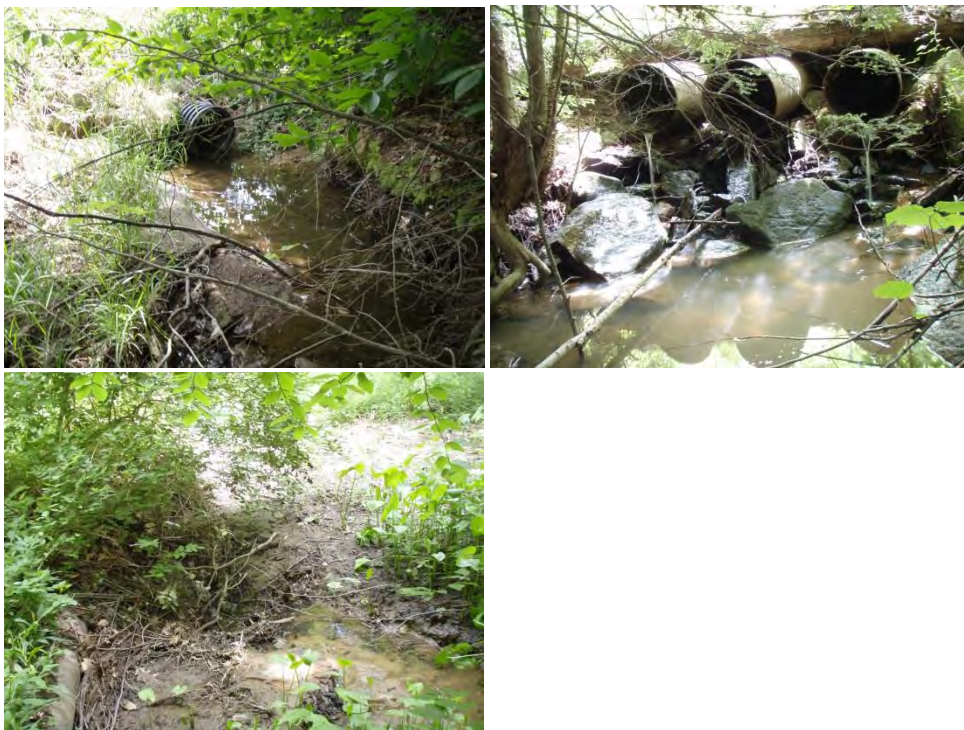
6114: Clockwise from bottom left: Inlet to underground section; outlet of undersized culvert on Pennsylvania Avenue, three undersized pipes on private gas road crossing.

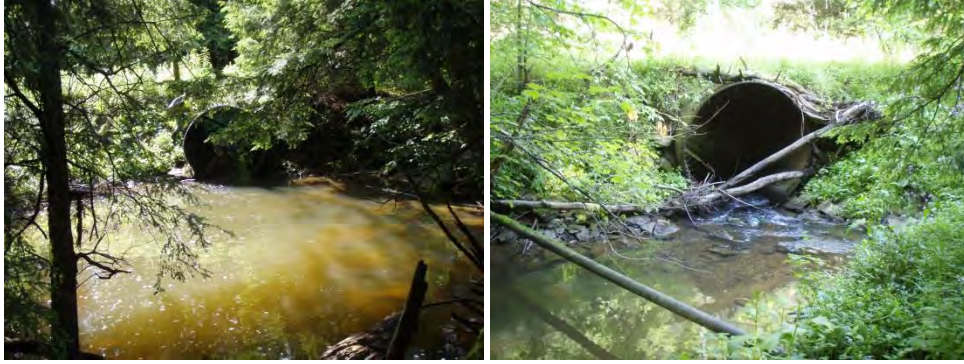
6115: Outlet (left) and inlet (right) of old oil tank used as culvert on private road/trail. Note log/debris blockage at inlet.

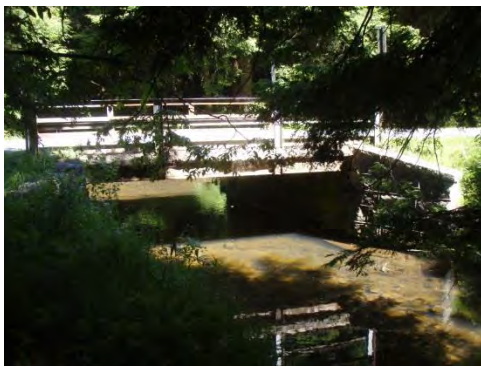
6141: Potential AOP barrier due to narrowness and lack of floodplain beneath bridge.

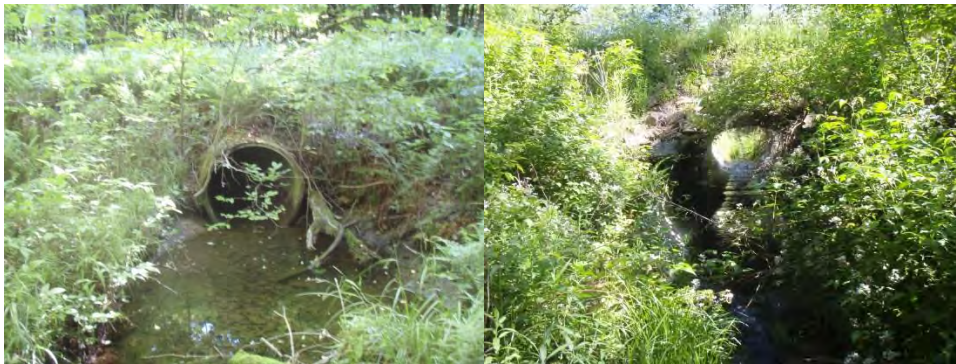
6142: Undersized culvert on intermittent section of stream in headwaters (left), undersized squash pipe at Forest Road 473 crossing (right).

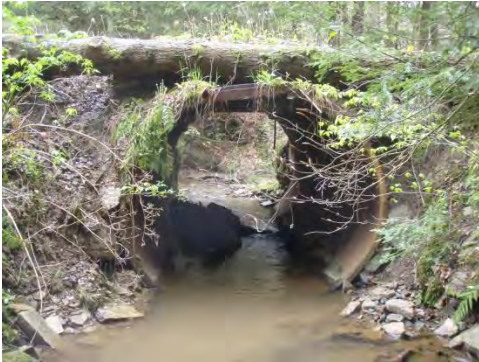
*6202: Undersized culvert on private access road.*

As in the case of segment 6202, a private access road to a large parcel of actively managed timber land is undersized, putting the stream and roadway at risk. This structure should be replaced with a larger one, be it a squashed pipe, bottomless arch, or bridge. Structure type and installation will vary by site based on the stream, landowner, and roadway needs, as well as available funding. The structure should be sized to one hundred and twenty percent (120%) of the stream's current bankfull width that is out of the "zone of influence" of the existing crossing structure. A substrate/bedload mix comparable to that present naturally in the stream channel should be used to simulate it through the crossing. Floodplains should be allowed to develop inside the crossing structure to facilitate higher flows expected to be associated with climate change trends (thus reducing future maintenance), as well as assist non-fish species in utilizing the waterway for travel (see photo of segment 605 on page 32).

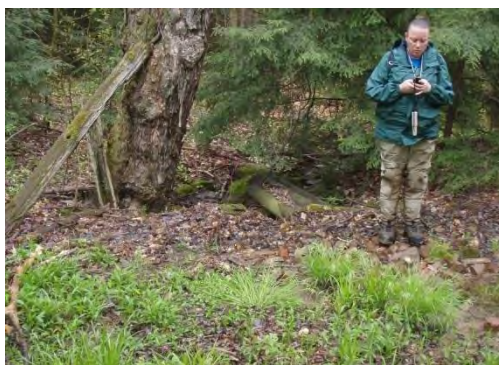
*6203: Perched culvert on private access road (left), three pipes on relic logging road (right).*

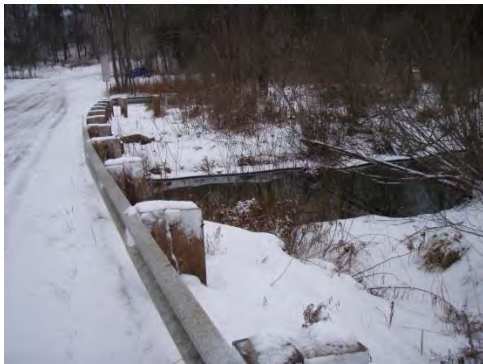
*7200: Bridge at top of segment constricts flow, no floodplain development underneath.*

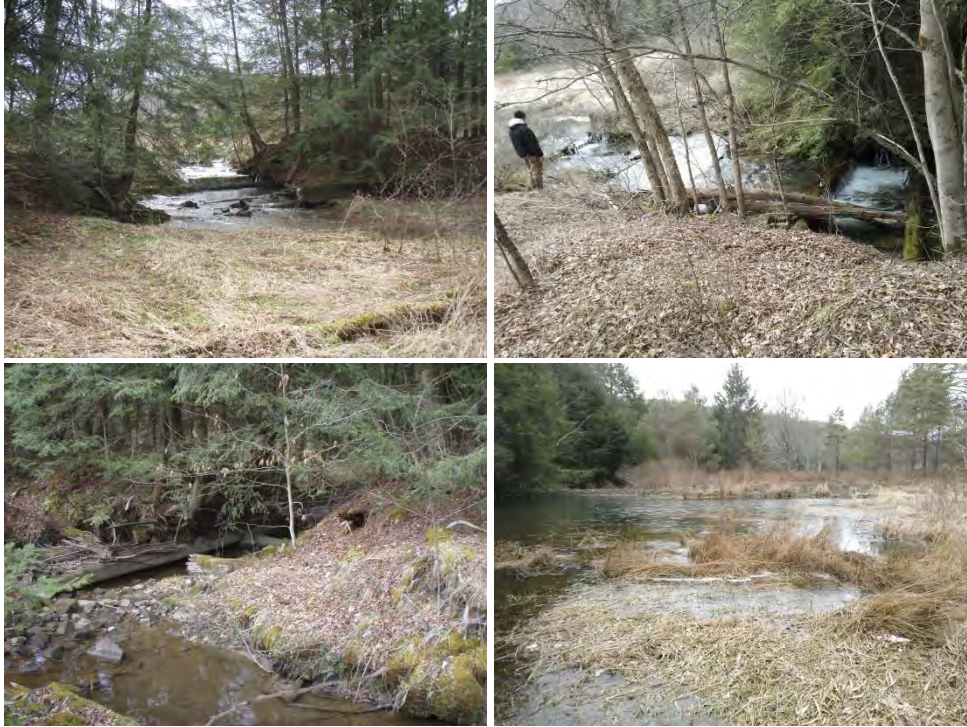
6234: Clockwise from top left: breached dam, timbers of dam structure, beaver ponds in relic impoundment, secondary breach. This breached dam creates a partial AOP barrier.
