# **SANDY LICK CREEK HEADWATERS COLDWATER CONSERVATION PLAN**

**Allegheny Mountain Chapter of Trout Unlimited  
P.O. Box 541  
DuBois, PA 15801**

**Clearfield County Conservation District  
511 Spruce Street, Suite 6  
Clearfield, PA 16830**

**Spring 2015**

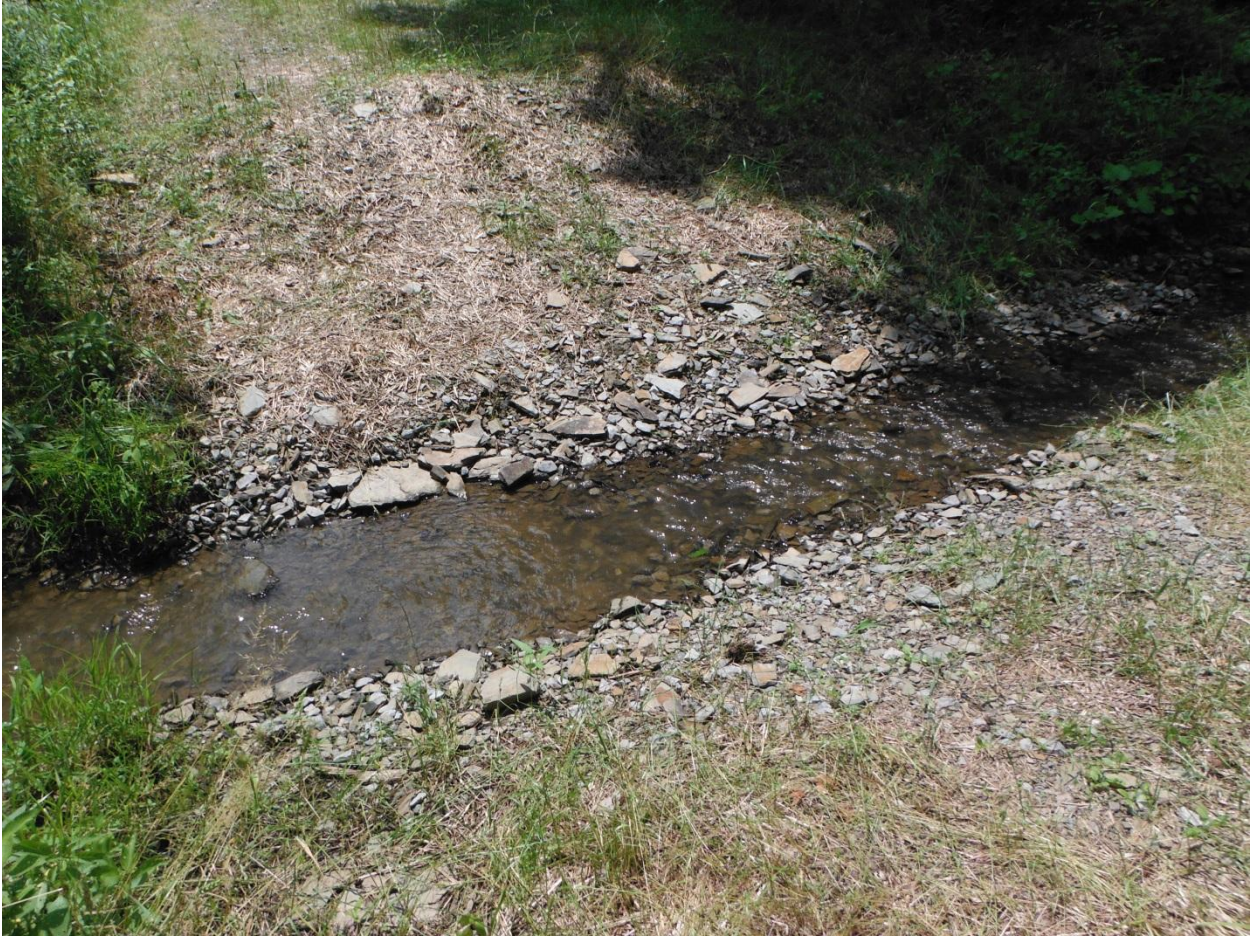
Sandy Lick passes over dirt road on surface at site SL5.

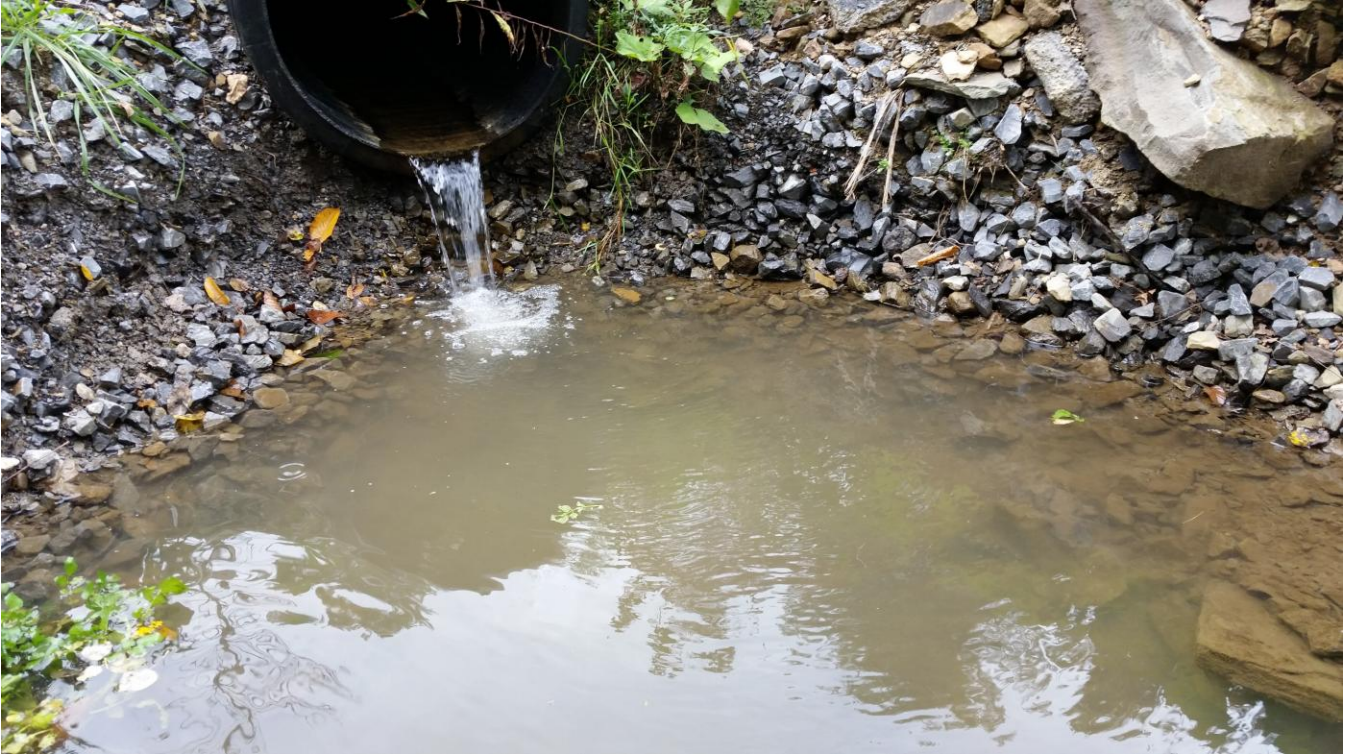
Figure D-5: Culvert at SL4

There are five road crossings on the headwaters of the Sandy Lick Creek. Of these, two are bridges while the remaining three are culverts. The bridges are located where SR255 crosses the Sandy Lick just upstream of Sabula Lake and where Paul Short Road crosses the Sandy Lick. Both bridges appear to be constructed in a manner that does not visually appear to hamper fish passage. The culvert installed where UNT #3 crosses Mountain Run Road is severely perched and impedes aquatic organism passage. The downstream end of the culvert sits two feet above the top of bank and causes a waterfall into a small pool.

As detailed in the results below, there were brook trout discovered upstream of the culvert but not downstream. There was however one occasion during the water sample collection that a single native brook trout was discovered below the culvert. Due to water levels and the height of the culvert from the pool, it was not able to go upstream or downstream. Given the results of the fishery survey, it is believed that this trout was swept through the culvert from the upstream population.

1. A more in depth culvert inventory and aquatic organism passage study should be conducted on the culverts in the watershed. The culvert on the unnamed tributary #3 is the primary area of concern as it prevents fish passage freely through this tributary. Efforts should be made to work with Sandy Township to pursue proper replacement of this culvert.

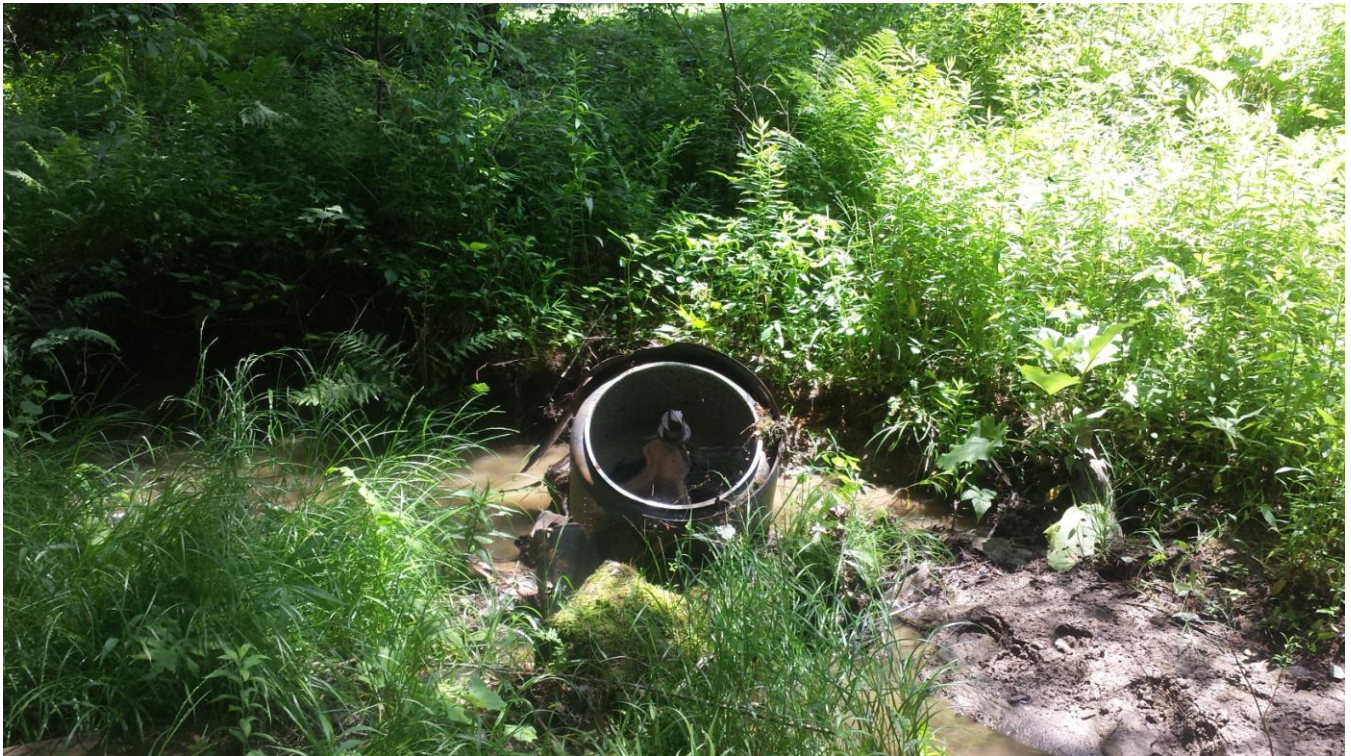
Figure D-6: SL4 upstream of culvert

Site SL4 is at the mouth of unnamed tributary #3, adjacent to Brown School Road. The entirety of this tributary flows through forested land although there is an area near the mouth where the riparian area has narrowed due to Brown School Road on one side and a yard on the other. Additionally, in this same area there is some trash including an old wringer washer and tires among other things.

4. There are larger trash items such as a wringer washer and car parts located within the first 100 yards upstream of the previously mentioned culvert on unnamed tributary #3. A trash clean up at this site is recommended.

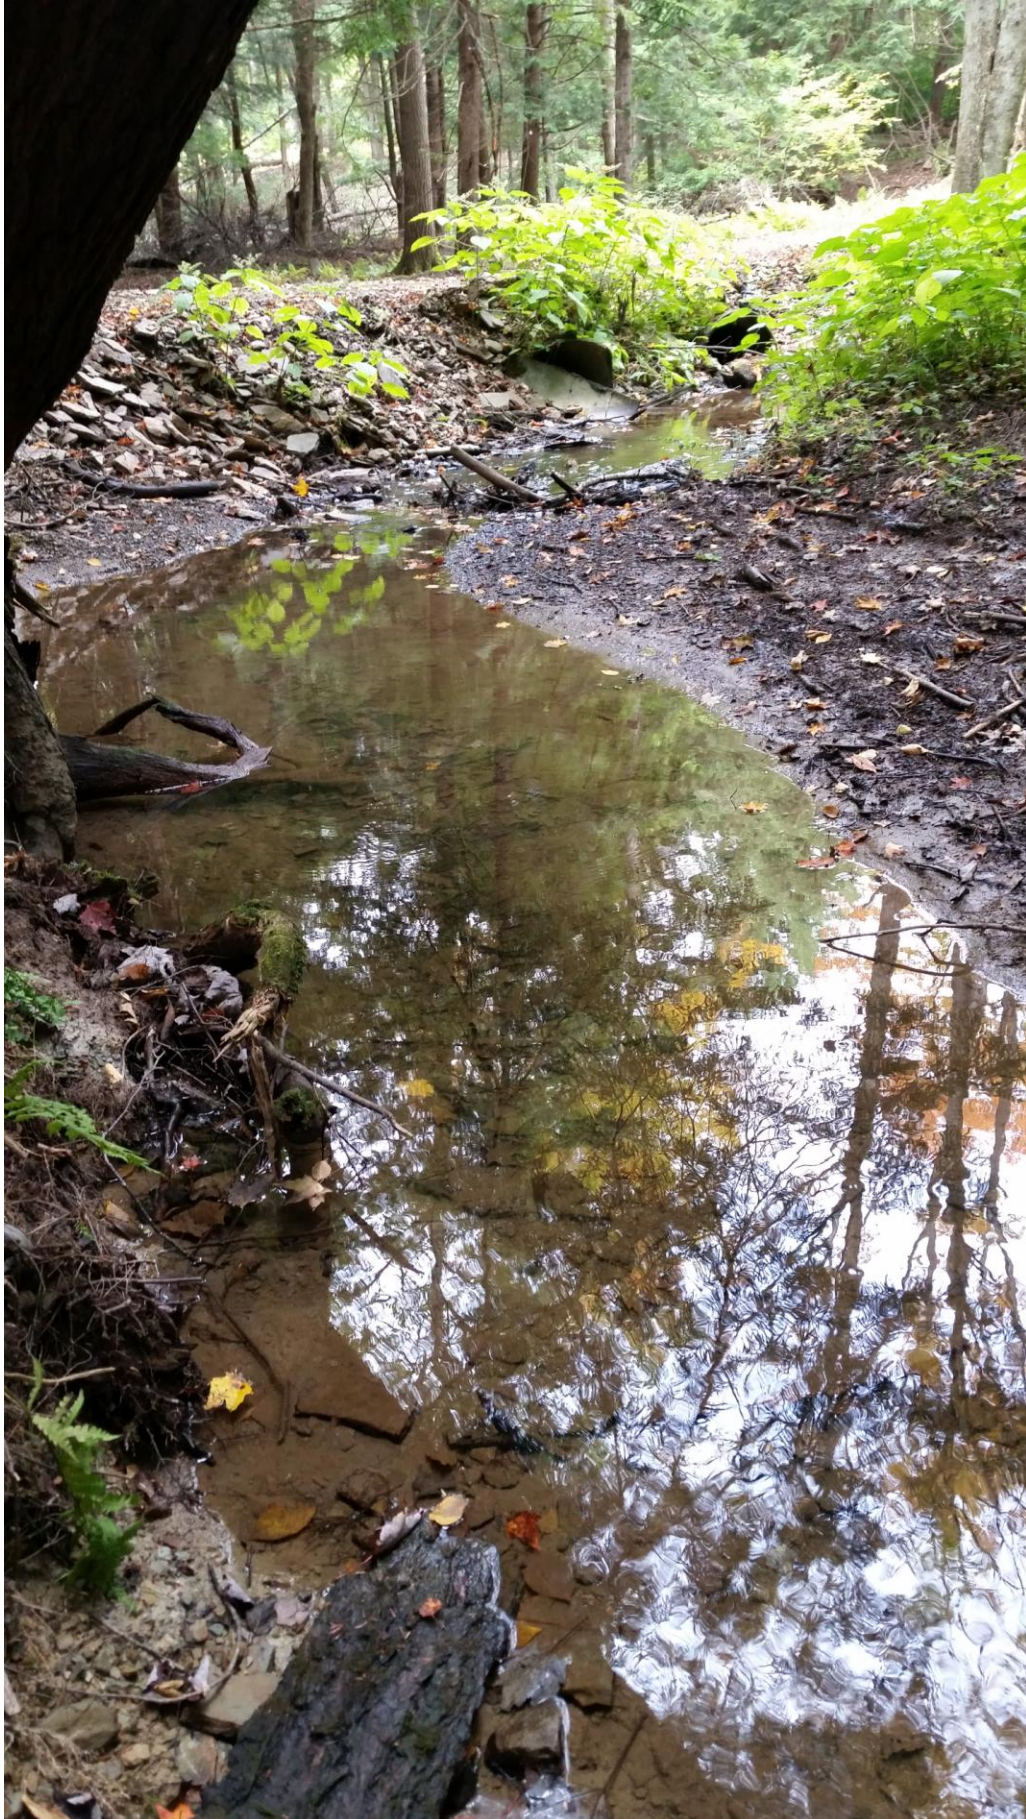
Figure D-8: Site SL6

At Site SL 6 there is a private drive used for past logging. The culvert at this location though not perched, may be undersized and is misaligned causing some erosion issues on the upstream end.
