**Fort Bedford
Trout Unlimited**

Shobers Run Coldwater Conservation Plan

Prepared by Fort Bedford Trout Unlimited Volunteers
August 2006

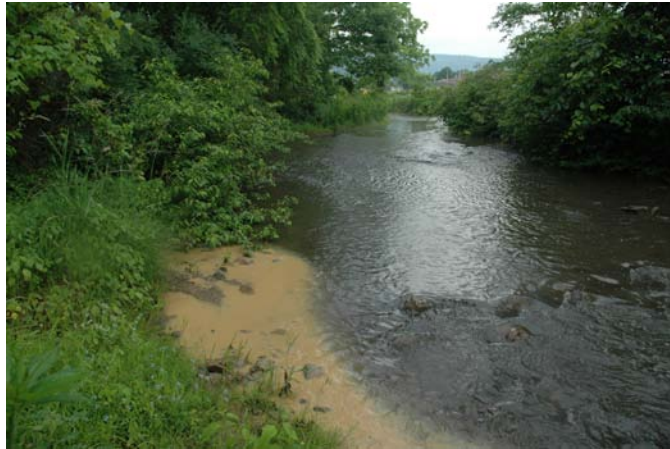
Near the mouth of Shobers Run, on the eastern side of the stream along Donahue Road, recent development has increased stormwater runoff. During construction, improper implementation of erosion and sedimentation best-management practices resulted in several pollution events. The county conservation district and PA DEP have been diligent in responding to these and other events in the watershed.

Figure 3 Runoff from unsatbilized construction site along Shobers Run during a light rain

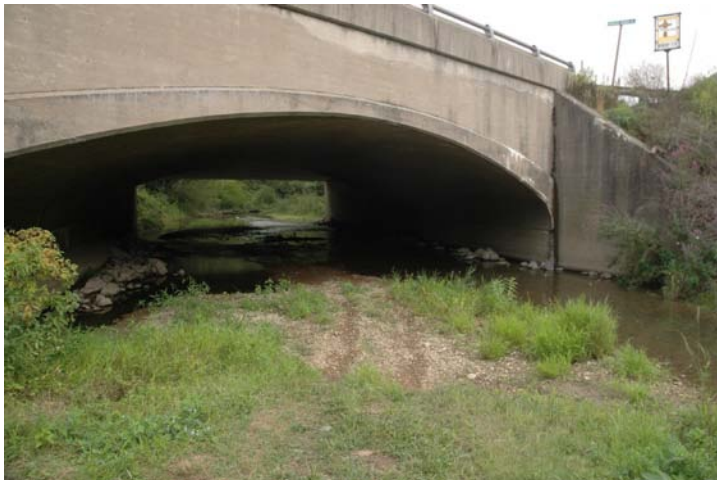
Figure 4 Route 30 bridge at mouth of Shobers

straightening and widening, probably associated with bridge and road construction. Longitudinal gravel bars have developed and the stream above the bridge has begun to restore natural meanders. In addition to poor macroinvertebrate habitat, this lowest portion of Shobers Run has poor fish habitat, little shading from streamside trees, and runoff and litter problems from the adjacent roadway and nearby paved business lots.

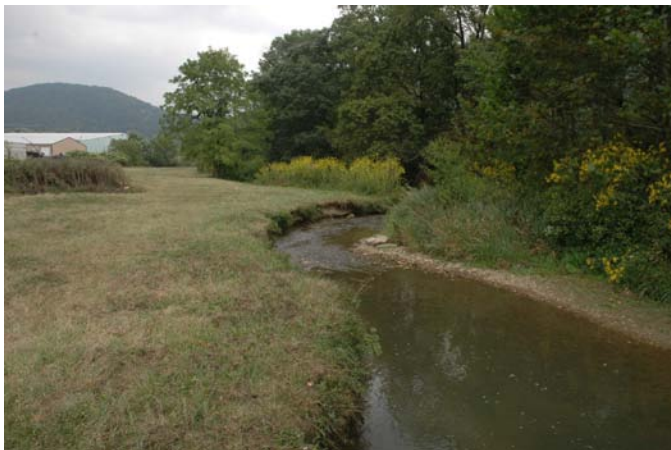
Figure 6 Streambank adjacent to Bedford Borough sewage treatment plant

mowing to the stream edge had again occurred. FBTU contacted both the municipal authority and the office of the borough manager concerning this and a solution will be worked out with PA DOT. Replanting of the buffer by FBTU and others is planned for spring of 2007.

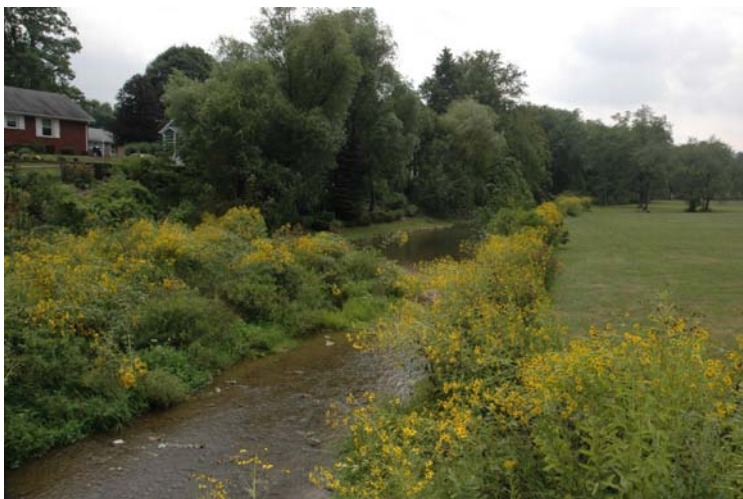
Figure 7 View upstream from Watson Street bridge

across Shobers Run from Meadowbrook Terrace. This was removed during sewer line replacement work in 2002, with a new buried line crossing downstream nearer the treatment plant. A mid-channel, longitudinal gravel bar has developed where this dam crossed, partially seen in above photograph. Upstream from the bridge, a similar mid-channel bar has developed over a long time and now is large enough to support small trees. These

bars have forced bank-full, channel-forming flows to move laterally and, with inadequate bank stabilization have caused the stream to widen, becoming shallower and slower. Shobers Run in this section is nearly twice as wide as it was 30 to 40 years ago. The former dam and the bridge design are probably responsible for the establishment of the gravel bar grown into a vegetated island. Replacement of the bridge (a wooden deck, single lane span) is planned soon and it is anticipated that restoration of a stable, midstream channel can be accomplished at that time. FBTU has been granted permission by the school district to establish a minimal buffer along the west bank; this work awaits completion of the bridge project.

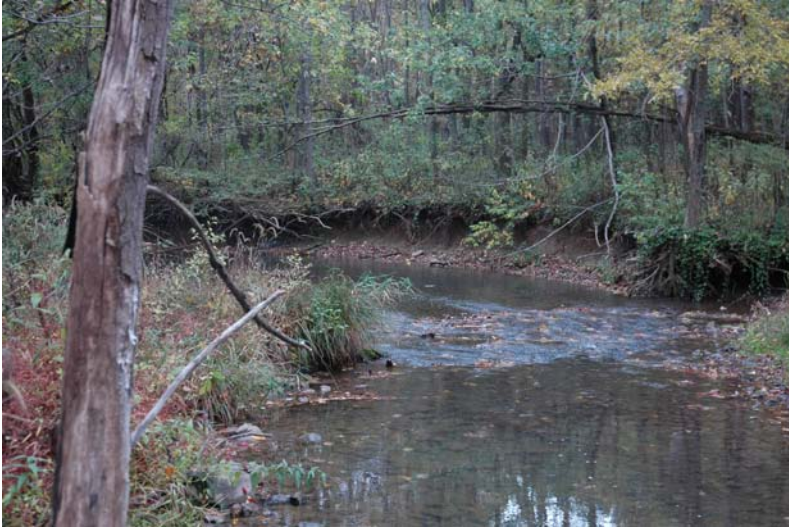
Figure 11 View of eroding stream bank (legacy sediments) on Bedford Springs' property

road, there is an old log house and outbuilding sited between the stream and the road. A large pool at a meander of Shobers Run in this area exposes an eroding bank of 1 – 2 meters in height that reveals the overlay of legacy sediments. Could this site be part of Henry Wertz's millpond that was so controversial two centuries ago; or another undocumented milldam?

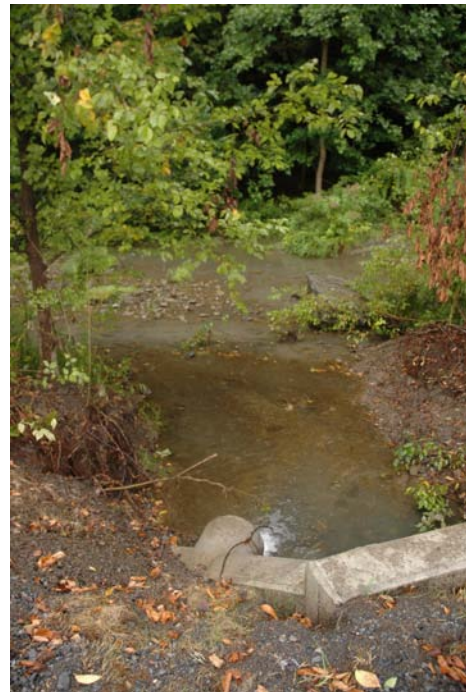
Figure 12 Storm water outfall at Bedford Springs hotel

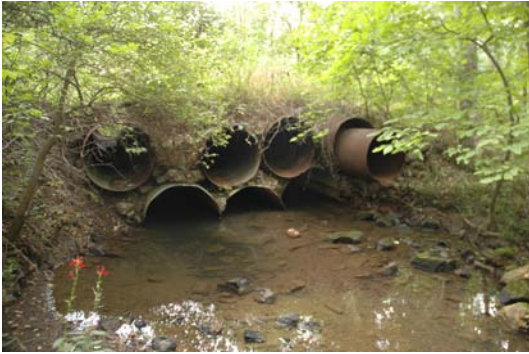
Figure 17 Shobers Run Lane crossing and sediment-laden stream channel

Shobers Run Lane crosses the stream that is carried below in a stack of seven corrugated metal pipes. The road in this section is unpaved and exhibits maintenance problems associated with high flows in Shobers Run. Conversely, the road negatively impacts the stream, evident in sediment and stream bank stability problems.

- Action Step 2 – Meet with landowner of private road (Shobers Run Lane?) to discuss replacement of multiple pipe crossing that acts as a fish barrier
 - Partners - landowners, FBTU
- Action Step 3 – Obtain permission to install plantings to enhance riparian vegetation at sites where adequate buffer is lacking
 - Partners - landowners, FBTU, Bedford County Conservation District

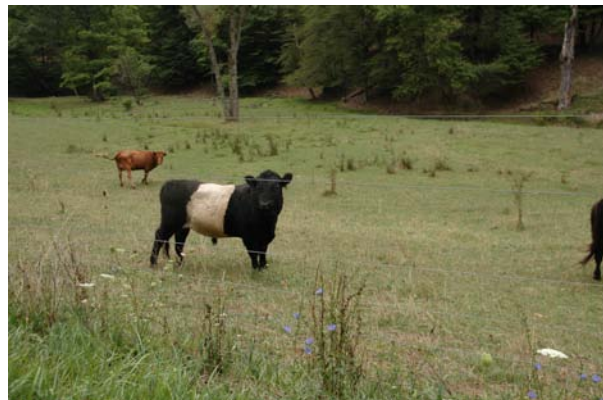
Figure 18 Pasture along southern tributary near Browns Road

understory and ground cover due to cattle grazing and the stream banks and riparian zone are also impacted. To the west of Teaberry Road, the tributary has little diversity of habitat for macroinvertebrates or fish but the bottom sediments, mostly gravel, remain relatively free of fine silts and embeddedness is less than in other sections of the watershed. Canopy cover on the western portion of the drainage is poor to fair.

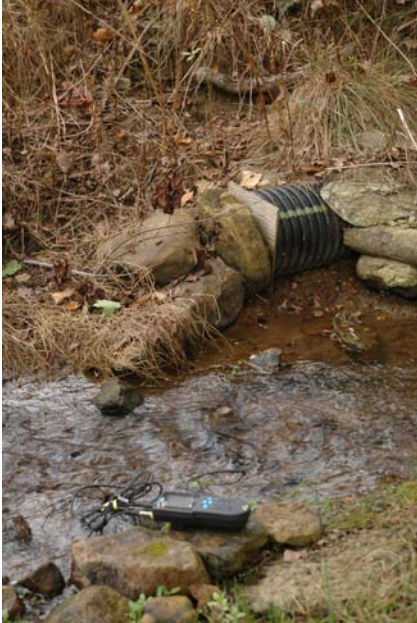
Figure 19 Former water diversion along southern tributary near Teaberry Road crossing. (stream flow is from left to right)

Downstream (east) of the Teaberry Road crossing, the tributary flows about 0.3 mile through a scrub and forested area before joining the main stem of Shobers Run a short distance below the 7 pipe crossing on Shobers Run Lane described in the preceding section. Formerly, two ponds were situated on either side of the tributary (and Shobers Run Lane) and these are still noted on topographic maps of the area. The northern, larger pond still exists as an impounded depression but holds little if any water during most of the year (reportedly there is a breach in the dam wall). A high water diversion of flow, not in use, from the tributary to this pond is still found a few yards downstream from Teaberry Road.
