BENS CREEK COLDWATER CONSERVATION PLAN

Western Pennsylvania Conservancy

This Coldwater Conservation Plan (CCP) for the Bens Creek Watershed reports on watershed assessment activities completed by WPC in 2021 & 2022. The objective of this plan is to summarize the methods and results of the assessment as well as identify and prioritize potential actions which may be taken to further conservation of the coldwater resources within the drainage.

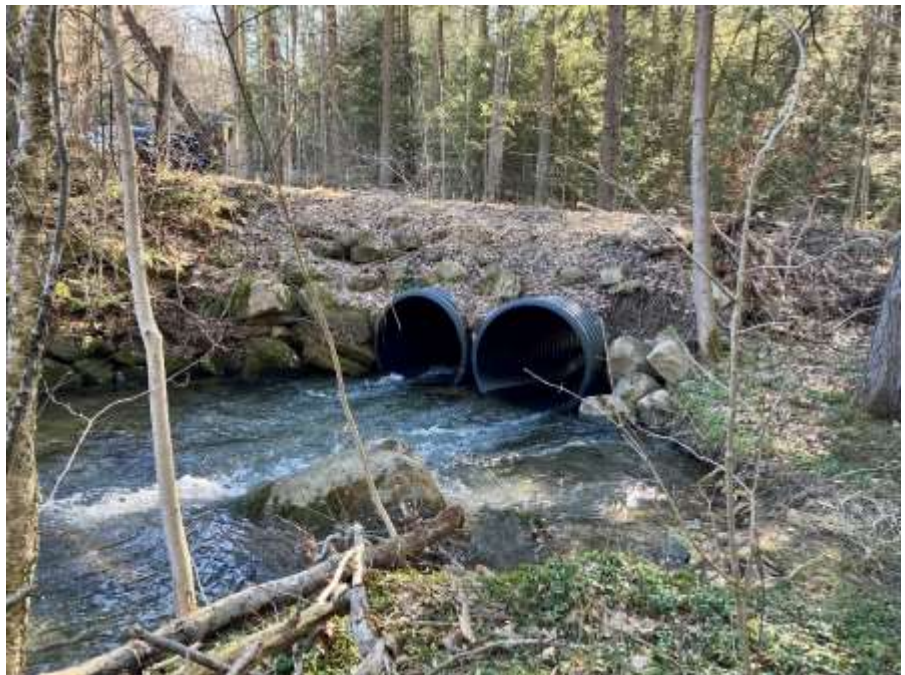
FIGURE 7 - A MULTI PIPE CROSSING ON MILL CREEK RESTRICTS AOP

movement upstream during high flows. Constricted crossings also often cause significant erosion, often referred to as the “fire hose effect” notable by an oversized pool at the outlet of the culvert caused by excessive erosion.

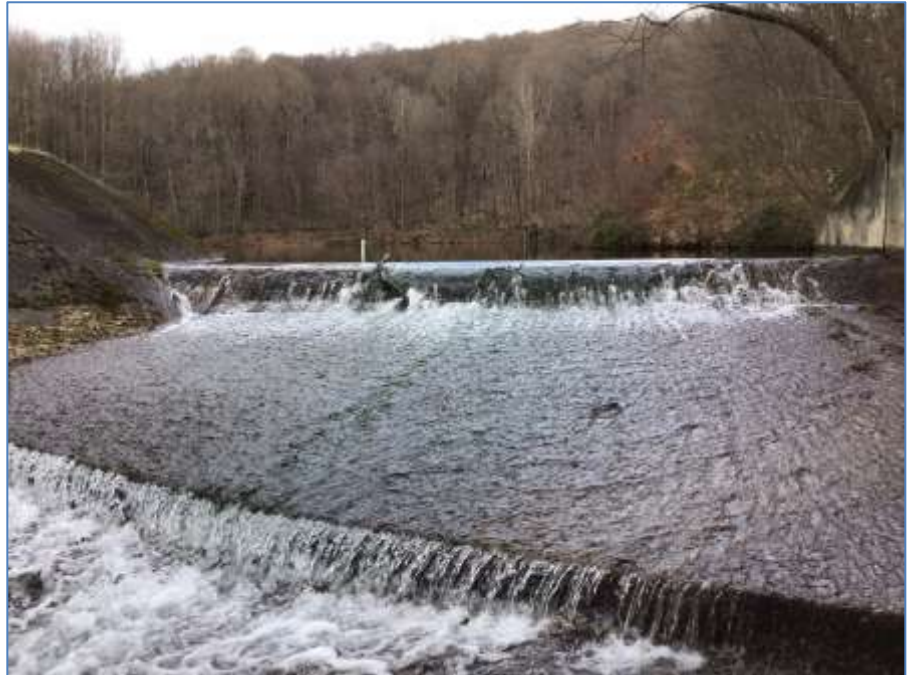
The headwaters of the South Fork Bens Creek support an isolated Class A brook trout population found above the Conemaugh Township Municipal Authority (CTMA) Reservoir. Although the reservoir is an AOP barrier, it provides quality drinking water to Davidsville and the surrounding communities in Conemaugh Township, Somerset County. A DGR access road parallels the South Fork from the reservoir downstream to its confluence with the North Branch South Fork Bens Creek at the Greater Ferndale Sportmen's Club. A perched culvert on this access road at the first unnamed tributary (UNT 45176) in an AOP barrier that disconnects 1.5 miles of tributary from the South Fork. As a result, this tributary is not known to contain a brook trout population.

FIGURE 9 - CONEMAUGH TOWNSHIP RESERVOIR SPILLWAY

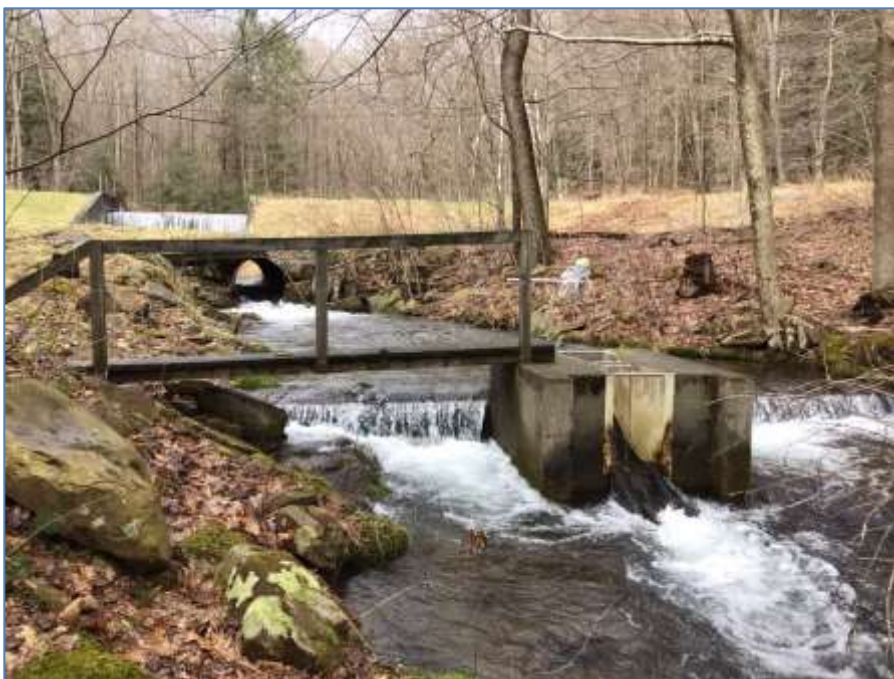
FIGURE 10 - MULTIPLE AOP BARRIERS AT OLD DAM SITE

Approximately 0.5 miles downstream of the reservoir spillway on the South Fork, is another older, smaller drinking water reservoir that was used prior to the construction of the larger CTMA Reservoir.

If the old dam was removed and restored along with the replacement of the access road culvert, approximately 2 miles of headwater brook trout stream could be reconnected. However, the old dam is also serving as a barrier upstream migration of brown trout, protecting the brook trout population from competition.

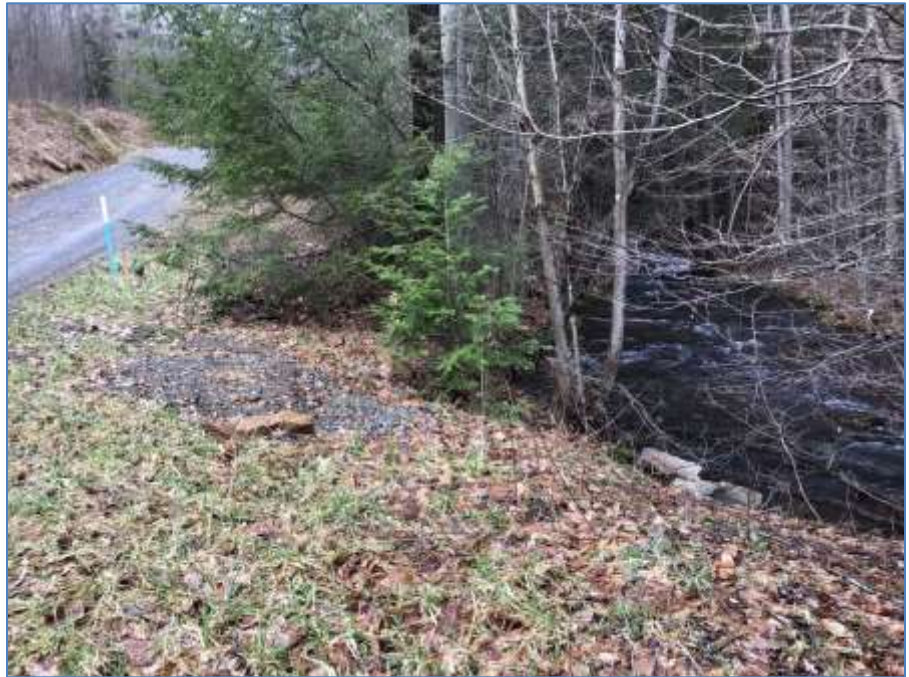
FIGURE 11 - DGR ACCESS ROAD ENCROACHING ON SOUTH FORK HEADWATERS

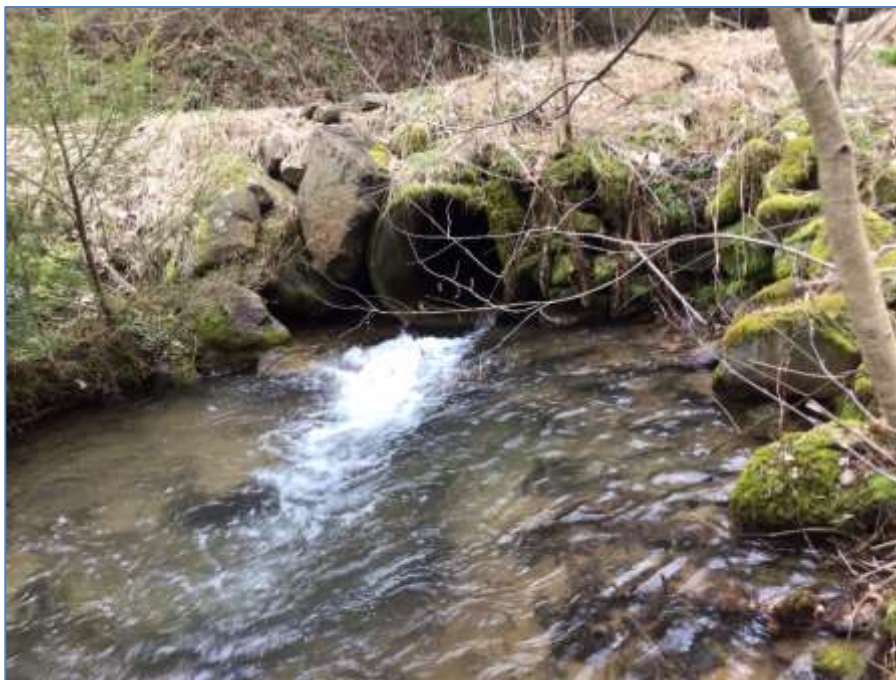
South Fork. While this culvert is not a total AOP barrier, since this tributary is known to support brook trout reproduction, connectivity could be improved if replaced with a properly sized and installed culvert.

FIGURE 12 - ACCESS ROAD CULVERT ON UNT 45175 SOUTH FORK BENS CREEK

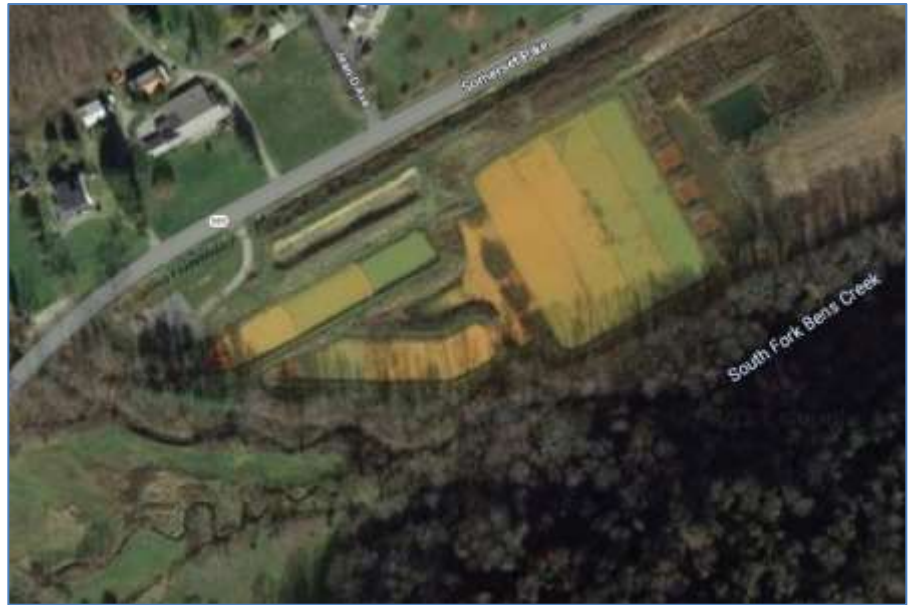
FIGURE 13 - LION MINE PASSIVE TREATMENT SYSTEM (PHOTO: GOOGLE)

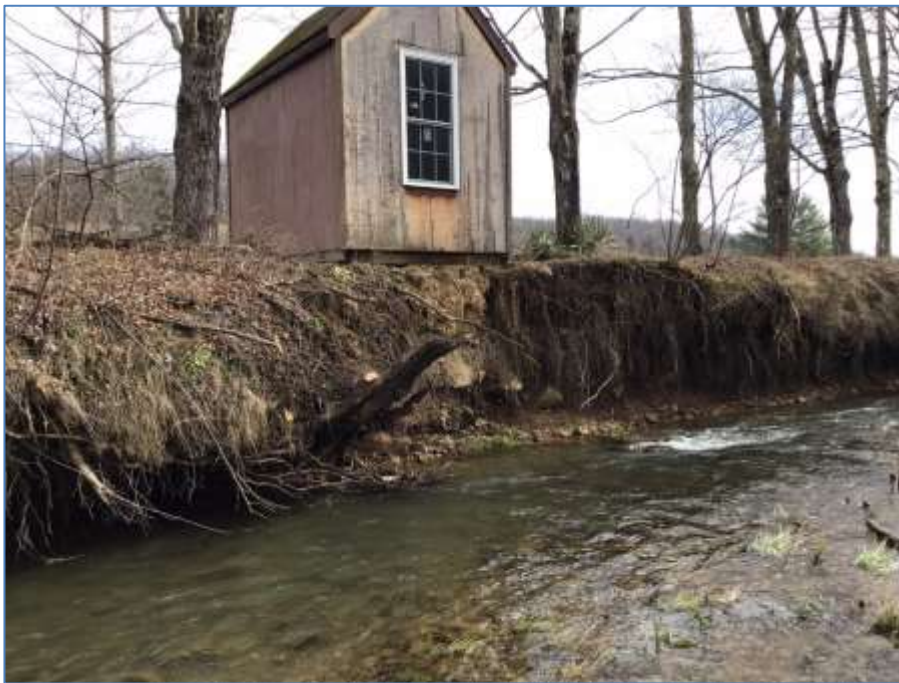
FIGURE 14 – BANK EROSION NEAR PRIVATE POND ALONG SOUTH FORK

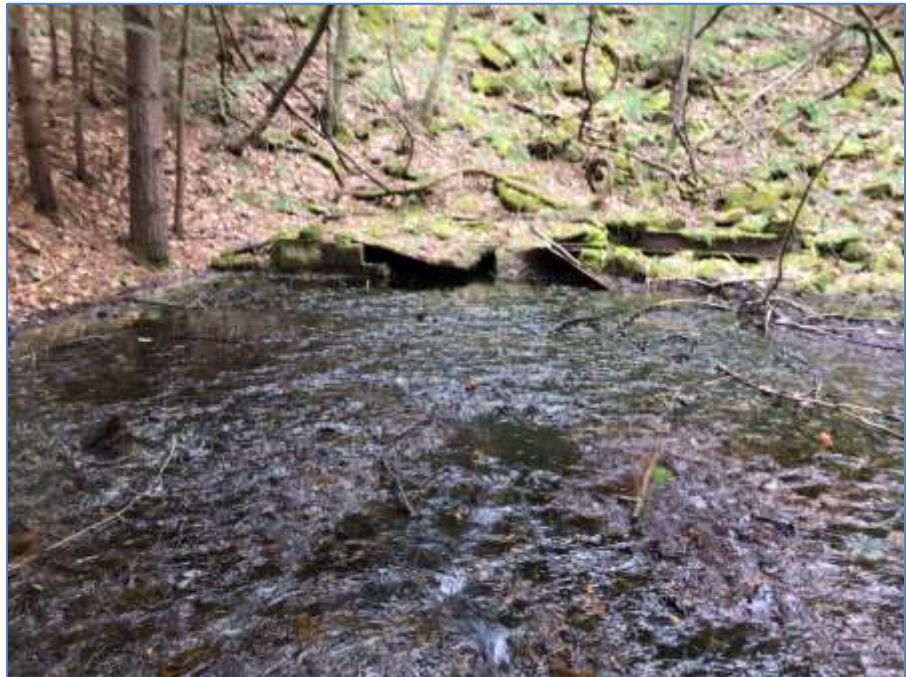
FIGURE 15 – UNABATED AMD DISCHARGE LOCATED UPSTREAM FROM ROCK TUNNEL

The remaining untreated discharges to the South Fork upstream of Thomas Mills could likely be treated in the vicinity of Rock Tunnel, if additional property could be acquired. The largest of these discharges, shown in Figure 15, needs to be monitored for flow and chemistry to determine the necessary treatment method. A small mine refuse pile on an eroding streambank could also be remediated as part of Rock Tunnel area improvements.

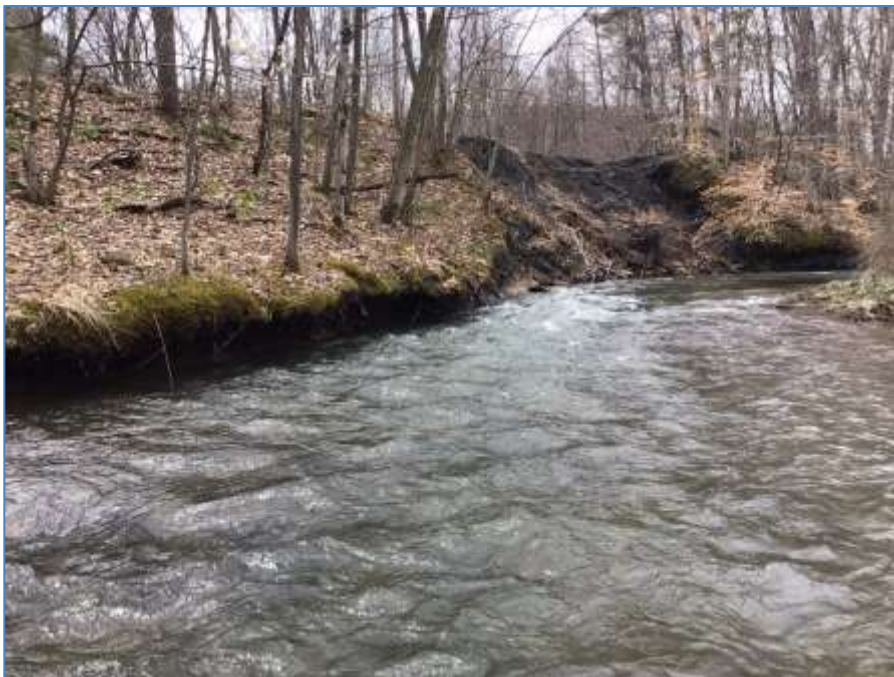
FIGURE 16 – ERODING COAL REFUSE ON STREAMBANK NEAR ROCK TUNNEL

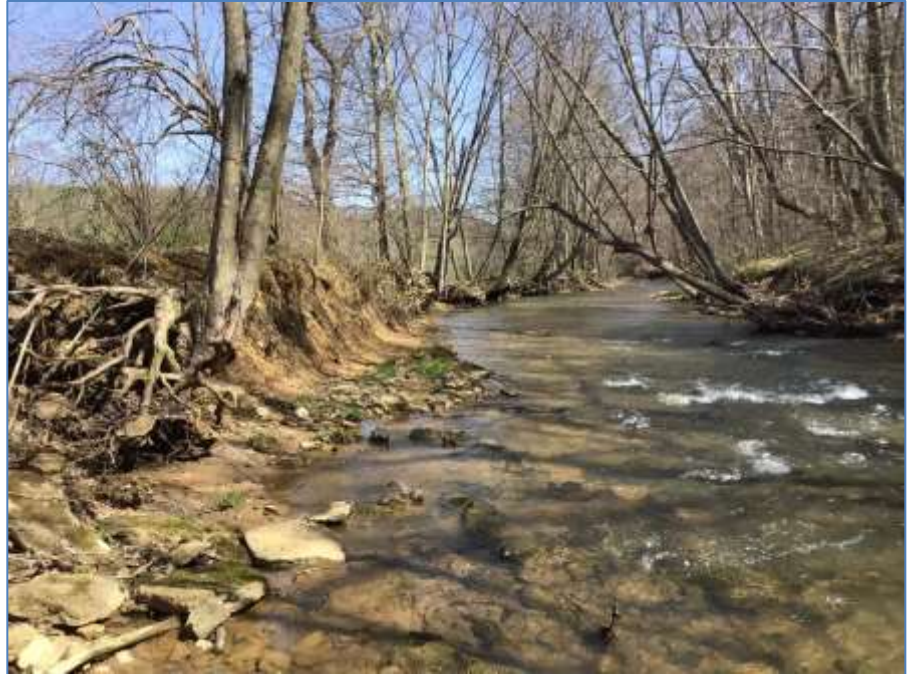
The South Fork has been historically channelized as it flows through the residential area of Thomas Mills resulting in an entrenched stream and disconnected floodplain. Some bank stabilization and riparian buffer enhancement could improve this section. Channelization of the South Fork continues leaving Thomas Mills as Somerset Pike (SR 985) encroaches on the stream, including an extensive section of concrete wall along the left descending streambank.

FIGURE 17 – ENTRENCHED CHANNEL AND DISCONNECTED FLOODPLAIN LIMITS HABITAT

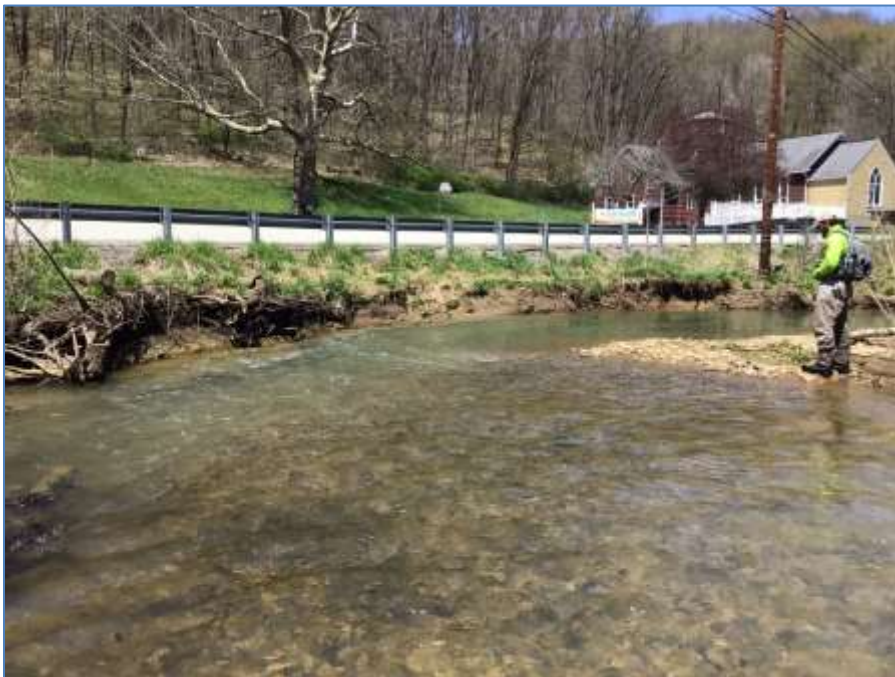
FIGURE 18 – ROAD ENCROACHMENT AND EROSION NEAR BENS CREEK LUTHERAN CHURCH

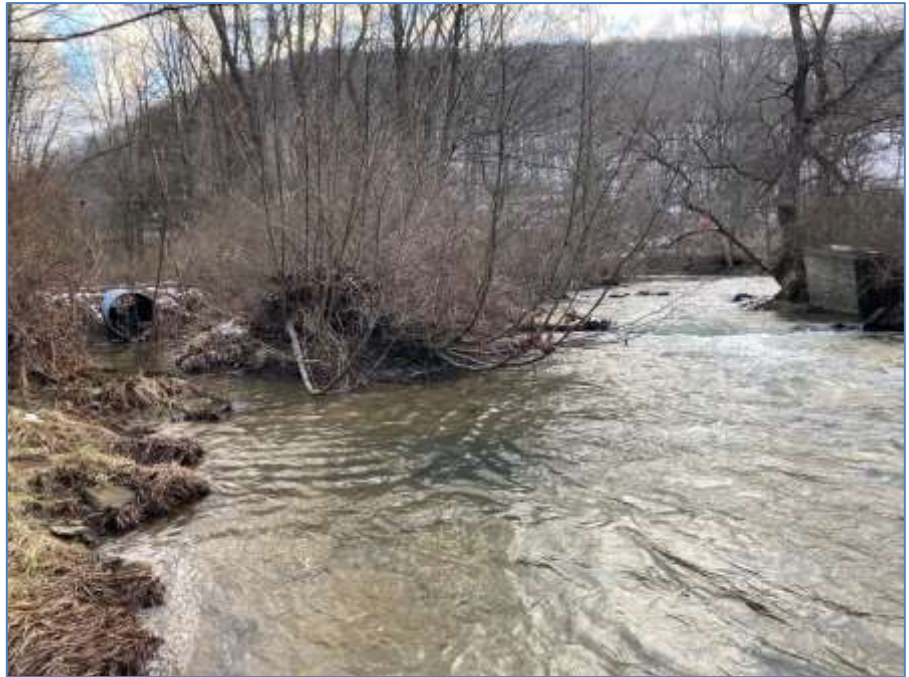
Residential development in the floodplain begins to impact the South Fork as it reaches the vicinity of Jim & Jimmie’s Bar and Grill. An abandoned attempt at a residential stream crossing serves a prime example of the need for proper permitting and installing of stream encroachments (Figure 19). Floodplain connectivity and AOP could be improved by removing this culvert and failing retaining walls.

FIGURE 19 – UNPERMITTED AND ABANDONED STREAM ENCROACHMENT ON SOUTH FORK

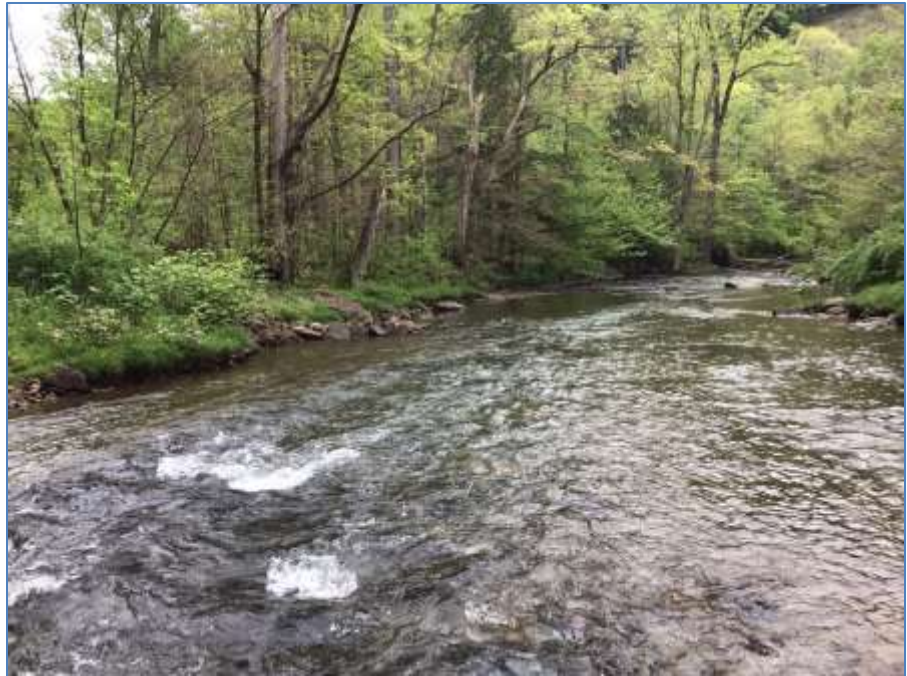
Instream habitat conditions are largely favorable throughout this section and include a past MLTU improvement project from the late 1990s in the vicinity of Sleek Trucking. Previously-installed habitat devices are near the end of their designed lifespan and this site could be revisited in the future for enhancement.

FIGURE 21 – SITE OF OLD MTLU HABITAT PROJECT AT SLEEK TRUCKING ON BENS CREEK

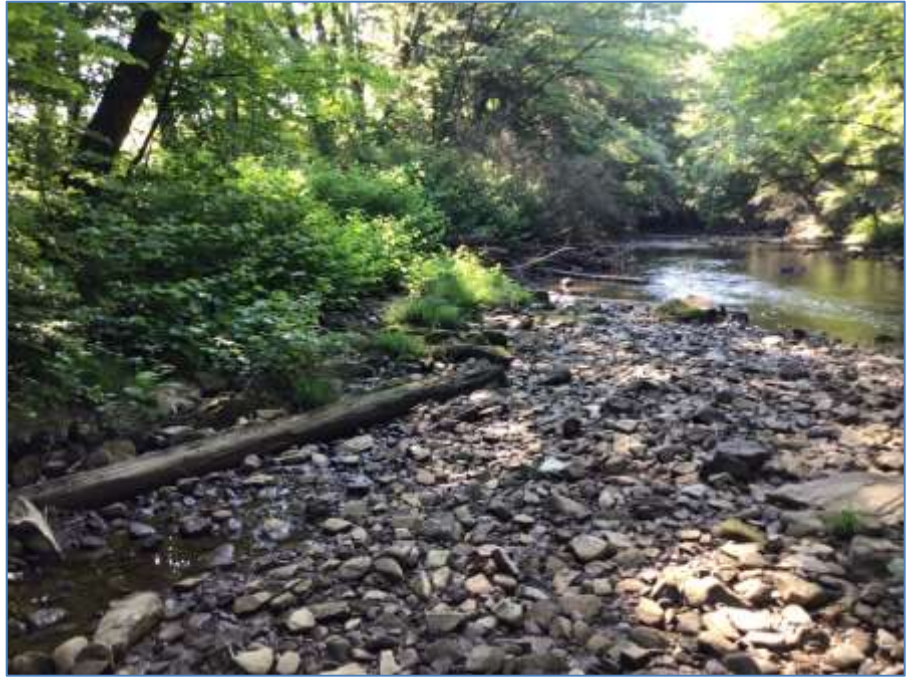
FIGURE 23 – SITE OF OLD MTLU HABITAT PROJECT ON BENS CREEK

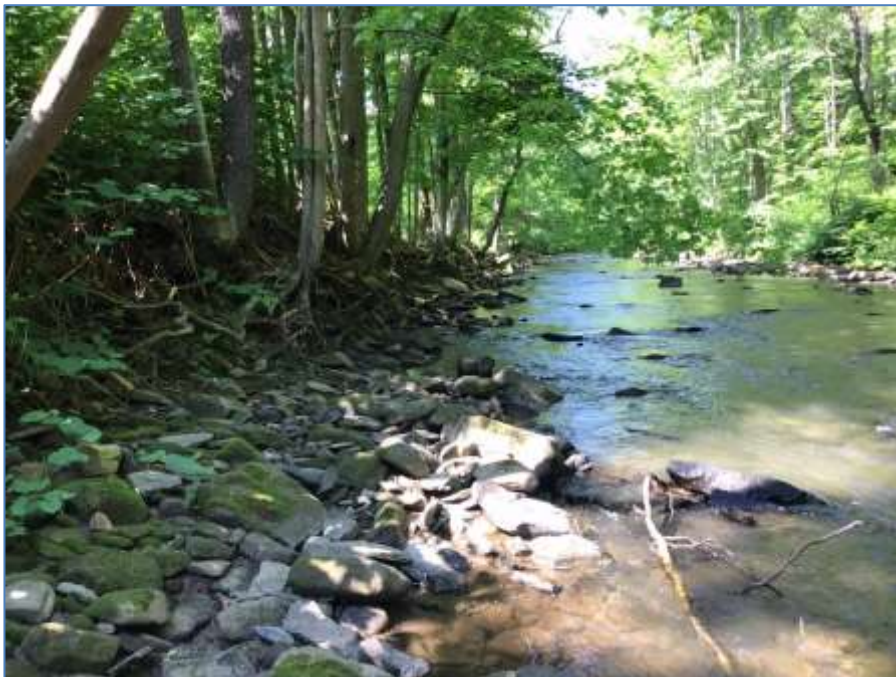
FIGURE 24 – ENTRENCHED AND CHANNELIZED SECTION OF BENS CREEK AT KIDSPORT

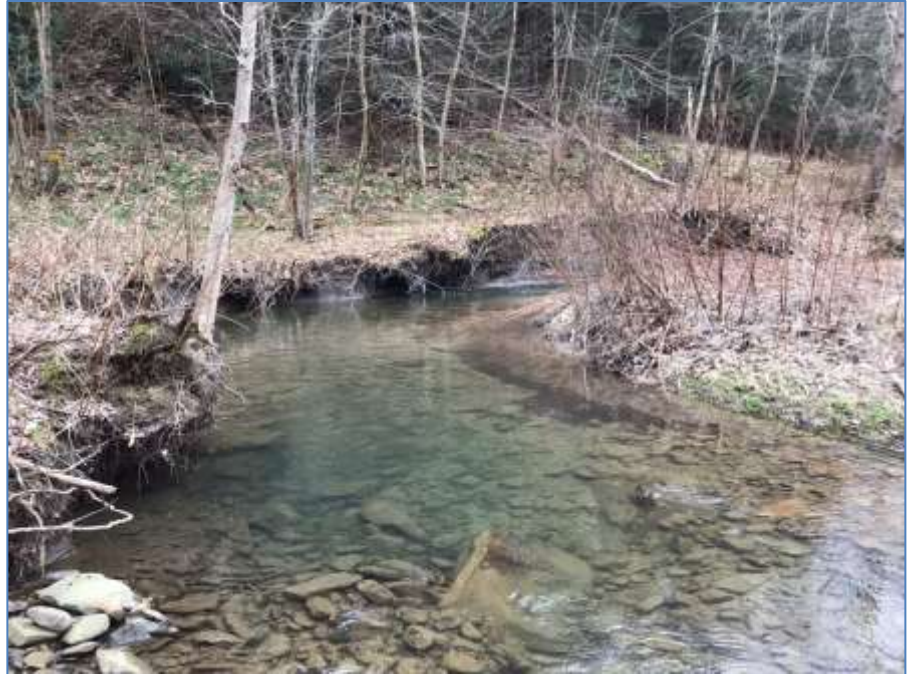
FIGURE 25 – BANK EROSION AT SITE OF FORMER MILL CREEK RESERVOIR

Mill Creek loses its undeveloped, mountain stream characteristics and habitat quality degrades at the site of the old Mill Creek Reservoir. While the removal of the reservoir has greatly improved connectivity and AOP, the impacts of the old dam remain in the form of bank erosion and sedimentation. This site is a great candidate for a floodplain and stream restoration project. Downstream of the old reservoir site, it’s historic impact can be seen all the way to Mill Creek’s mouth. Bank erosion and channelization are prevalent as the stream begins to parallel Millcreek Hollow Road and is lined by residential development, including Camoset Village mobile home park.

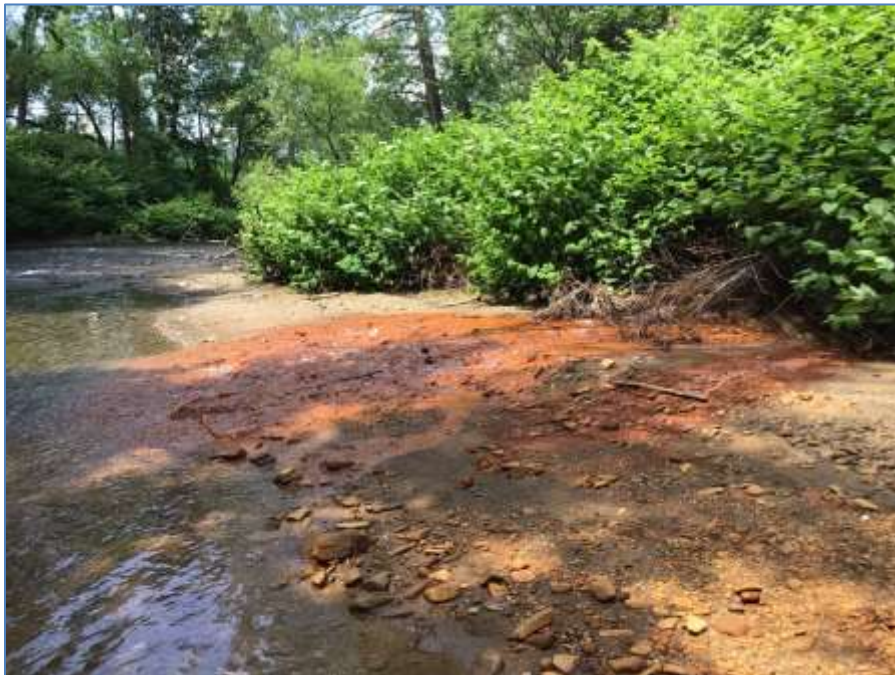
FIGURE 26 – IRON DEPOSITION FROM AMD DISCHARGE AT ST. ANDREW CHURCH
