2017 Coldwater Heritage Plan for the Rock Run Watershed Lycoming and Sullivan Counties, Pennsylvania

Susquehanna Chapter of Trout Unlimited

PROJECT OVERVIEW

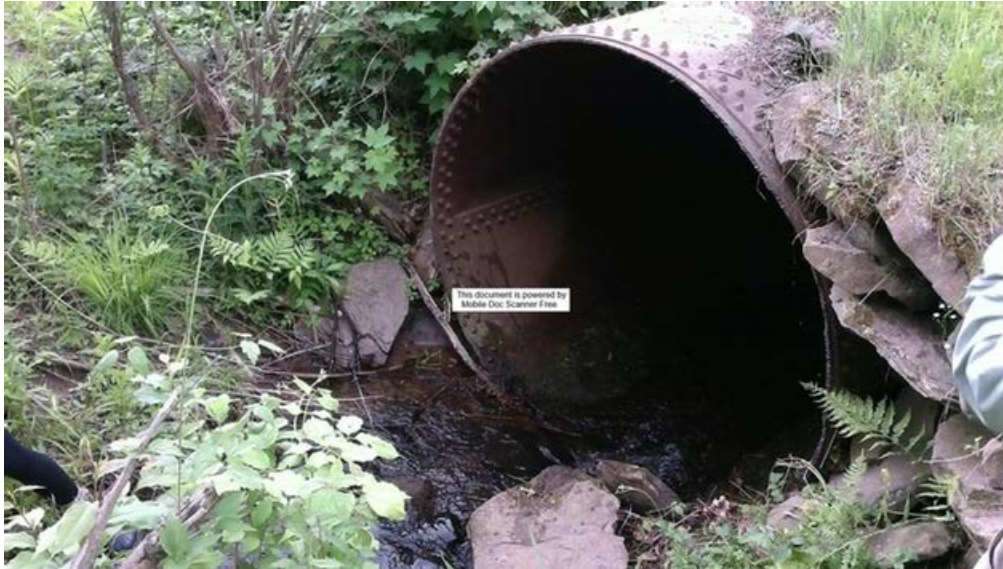
The culvert on Hawk Run is located at the Yorktown Road (T-676) crossing (Survey 31153) (Figures 21 and 22). This culvert was calculated to have an AOP coarse screen score of “No AOP” by the NAACC protocol with an aquatic passage score of 0.32 (range = 0.0-1.0). If replaced with a full AOP structure, 1.6 miles of upstream habitat in Hawk Run would be reconnected. There are some ponds and water impoundments located upstream of the current

culvert and access through or around those impoundments was not assessed for aquatic organism passage. The culvert is located on a single lane dirt road on privately-owned land. The reconnected stream miles would also be on private land. Since Hawk Run is the only stream designated as “Class A brook trout” by the PFBC, this should be a high priority reconnection project.

Figure 21. Culvert on Hawk Run (inlet)

It is recommended that the feasibility of these projects be evaluated prior to the pursuit of a replacement project. Discussions should be initiated with the entities responsible for these road-stream crossings as well as the land-owners to communicate the importance of AOP and to ensure that a design will be used that will ensure fish passage. Given that Hawk Run is the lone

Class A brook trout fishery in the watershed, it is recommended that future projects be directed to this area first.

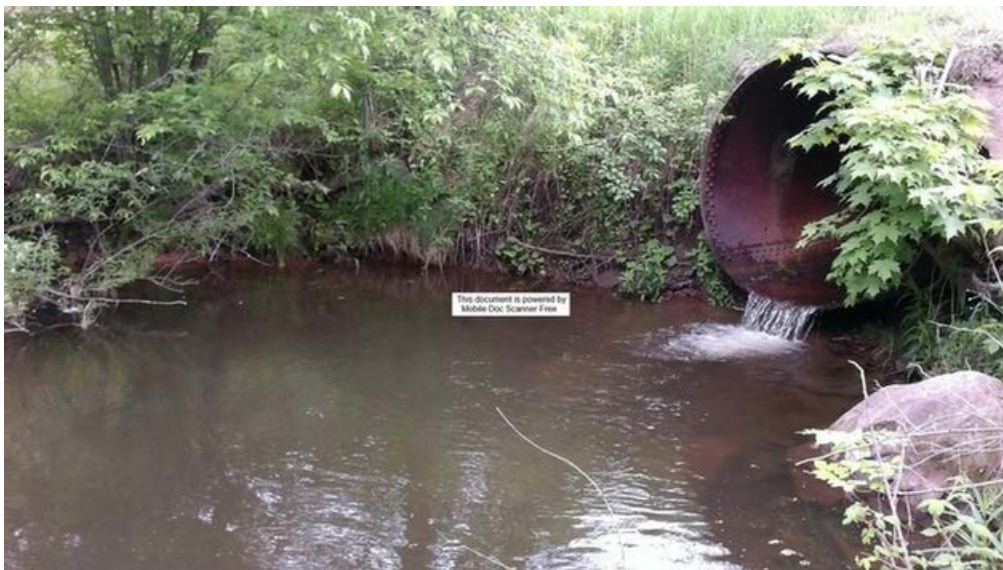
Figure 22. Culvert on Hawk Run (outlet)

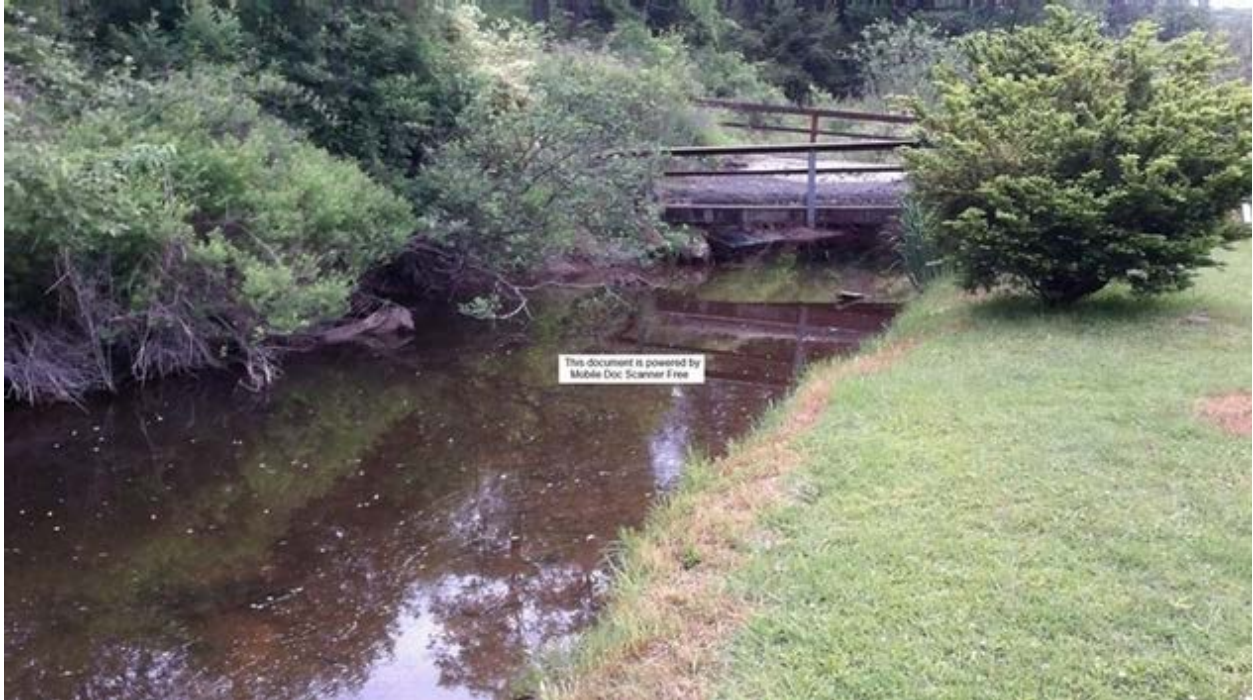
Figure 24. Road-stream crossing on Old Ellenton Mountain Road prior to flooding event.

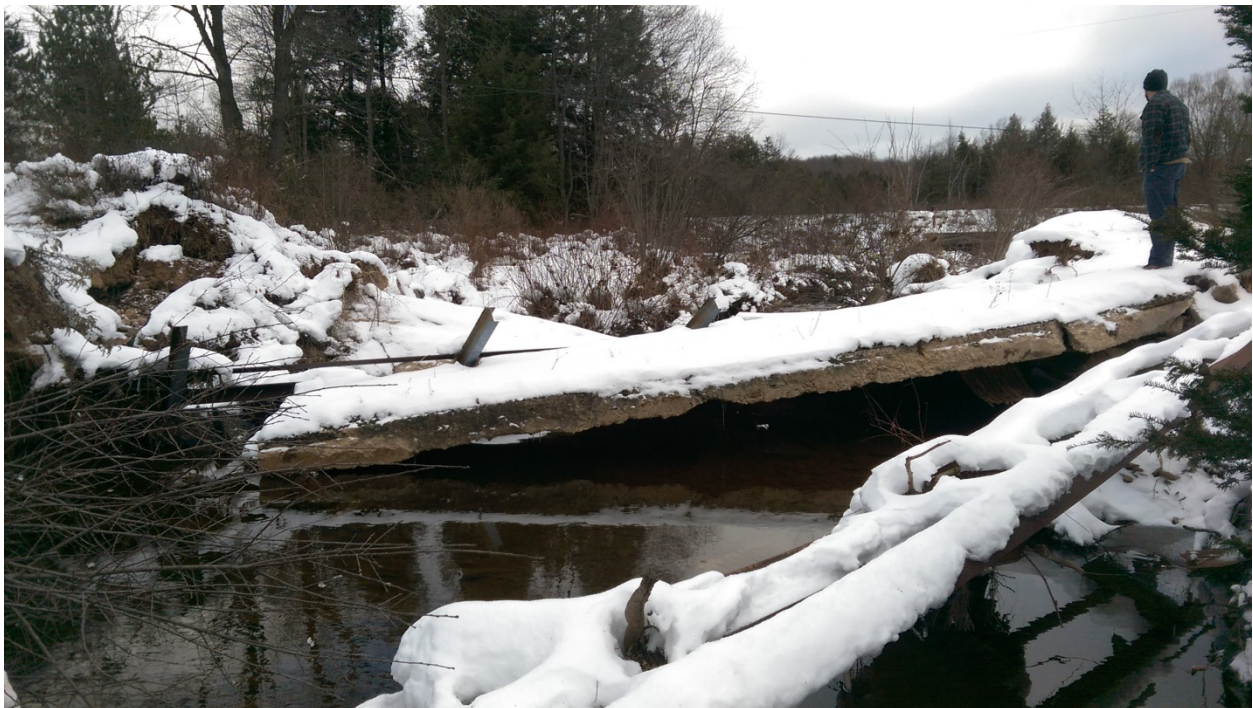
Figure 25. Collapsed road-stream crossing on Old Ellenton Mountain Road following flooding event.

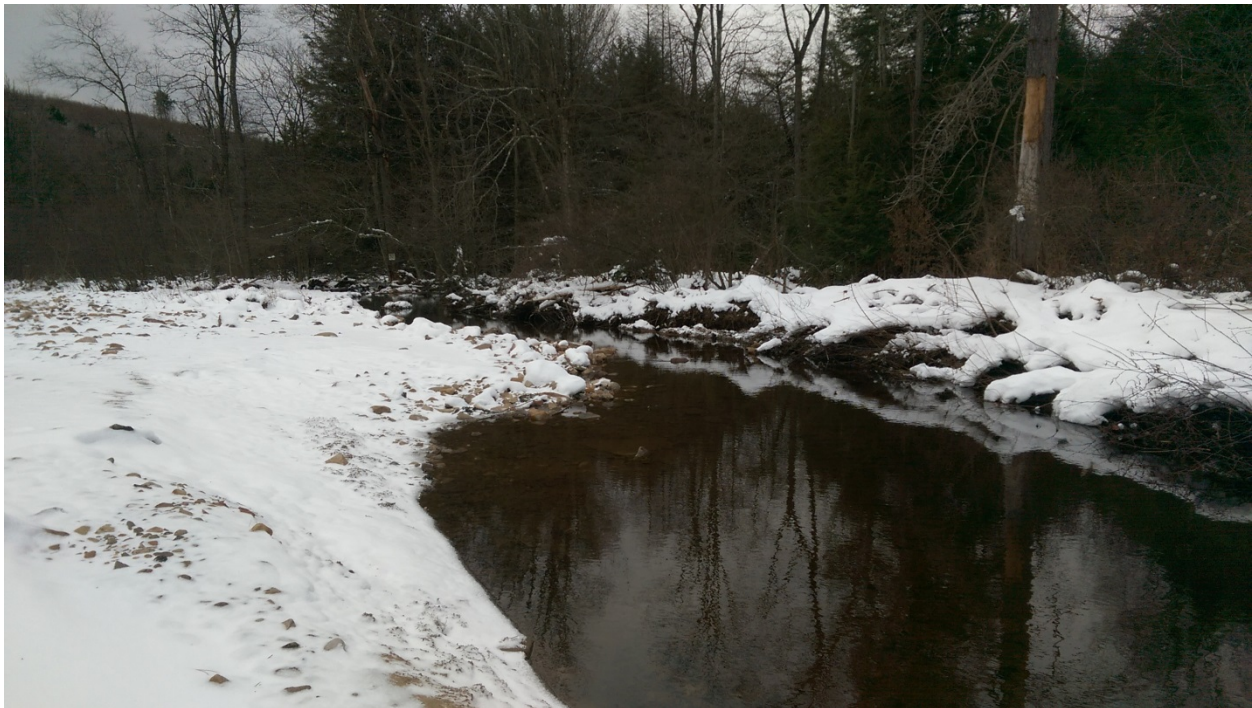
Downstream of AOP Survey 31146 on Ellenton Mtn Rd. and collapsed AOP Survey 31149 is the Rock Run Rod and Gun Club property. Erosion of banks and sedimentation is evident as well as lack of riparian vegetation on the left bank for approx. 100 meters near the club building. There is potential for habitat improvements in this reach in the form of mounds or other rock/wood structures to stabilize banks and planting of native vegetation (Figure 26) to better secure the left bank and provide instream cover in the existing pool.

Figure 26. Potential site for riparian planting.

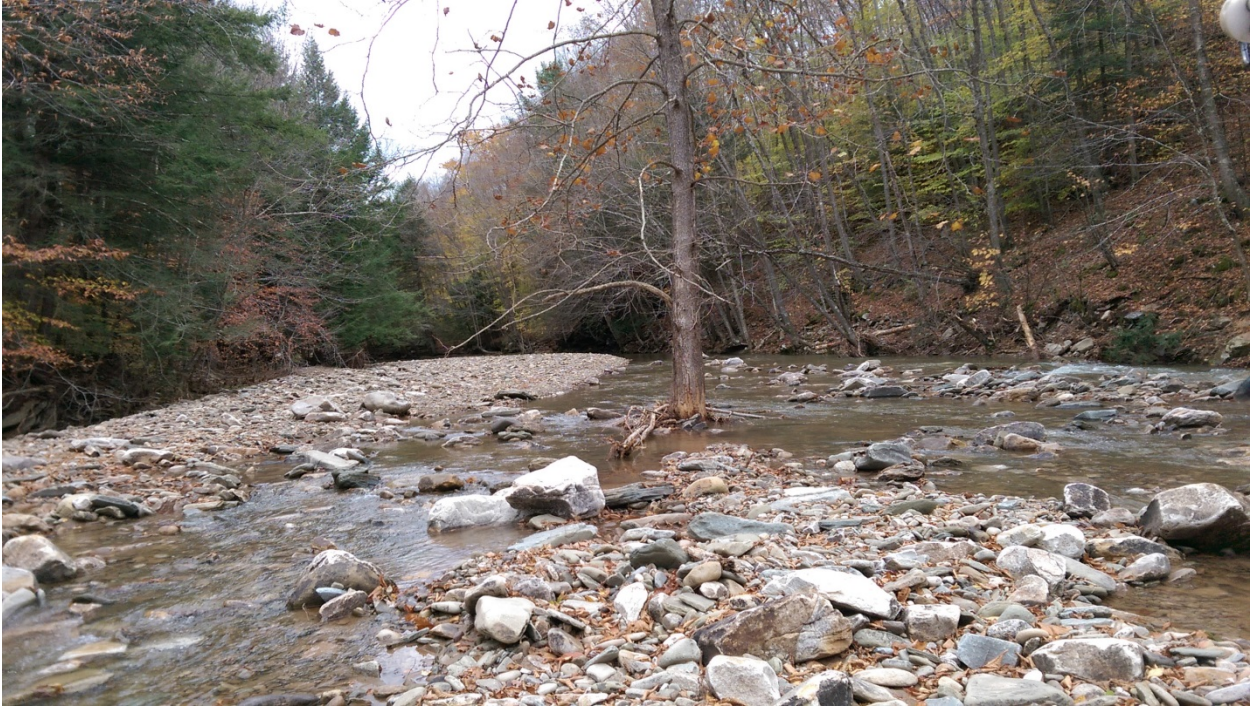
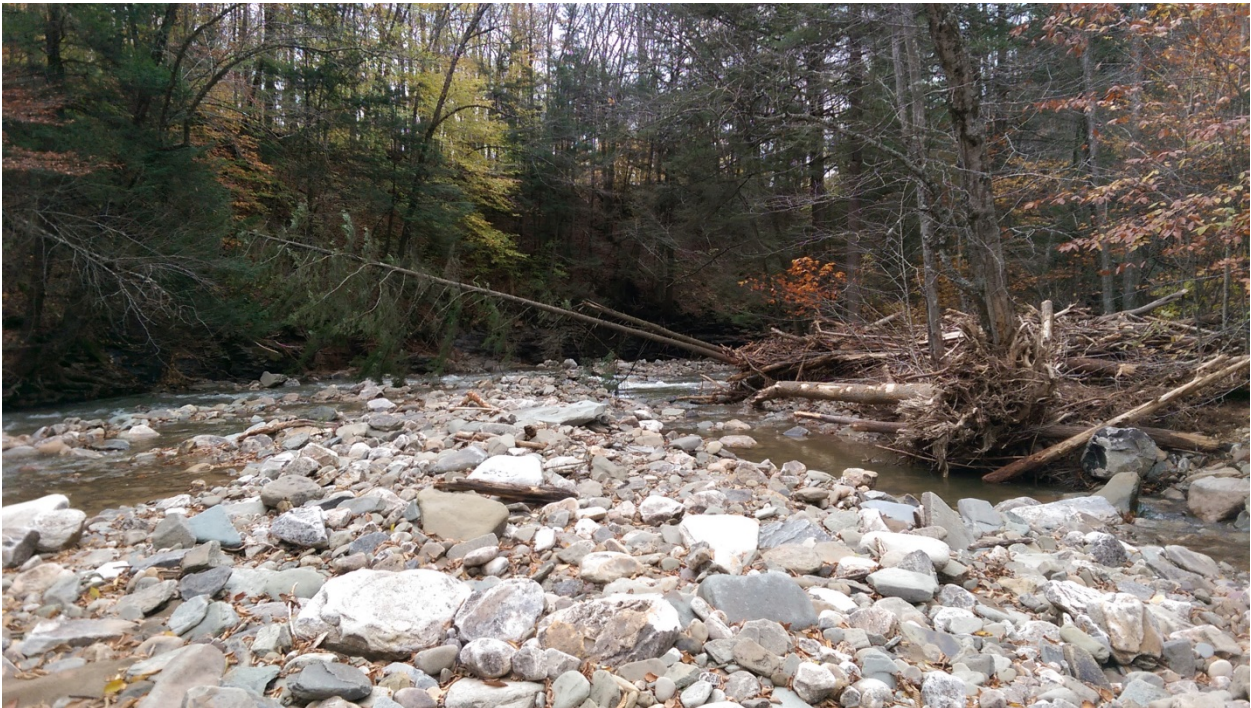
Figure 27. Material transported during the October 2016 flooding event.
