South Branch Bear Run Coldwater Conservation Plan

2018

Western Pennsylvania Conservancy

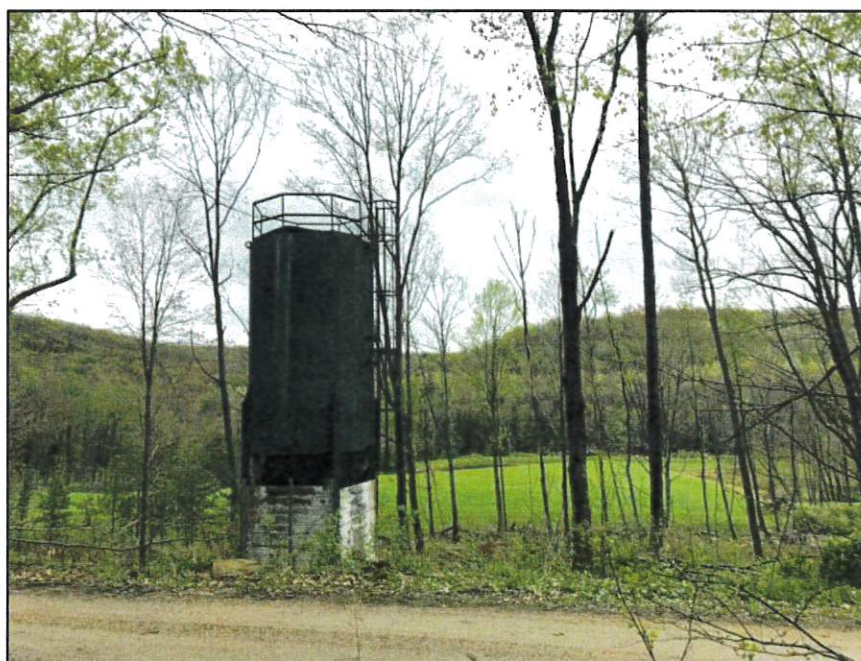
Photo 5 - A limestone dosing silo treating an AMD discharge on the South Branch

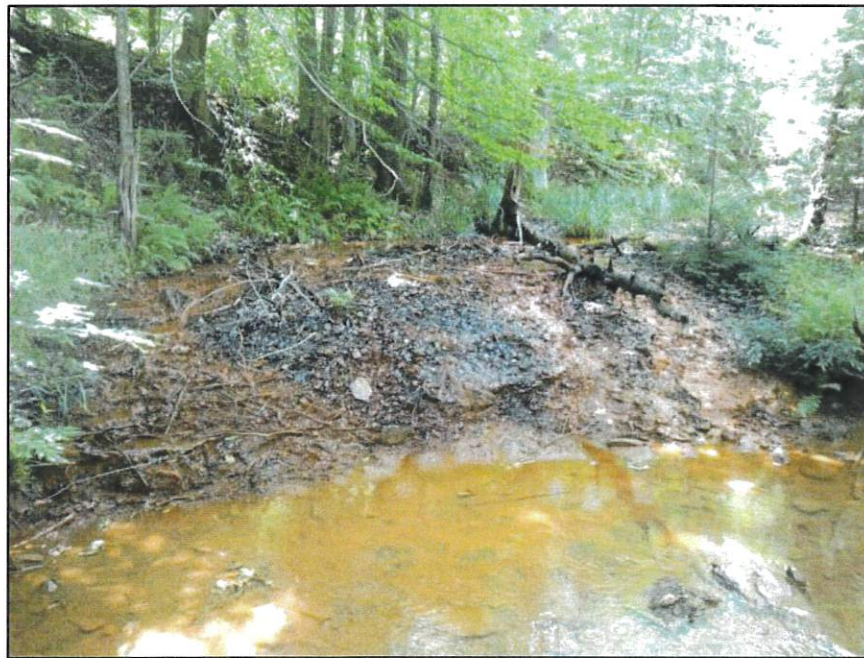
Photo 7 - AMD seeps degrade water quality on the South Branch downstream of Lochvale Bridge

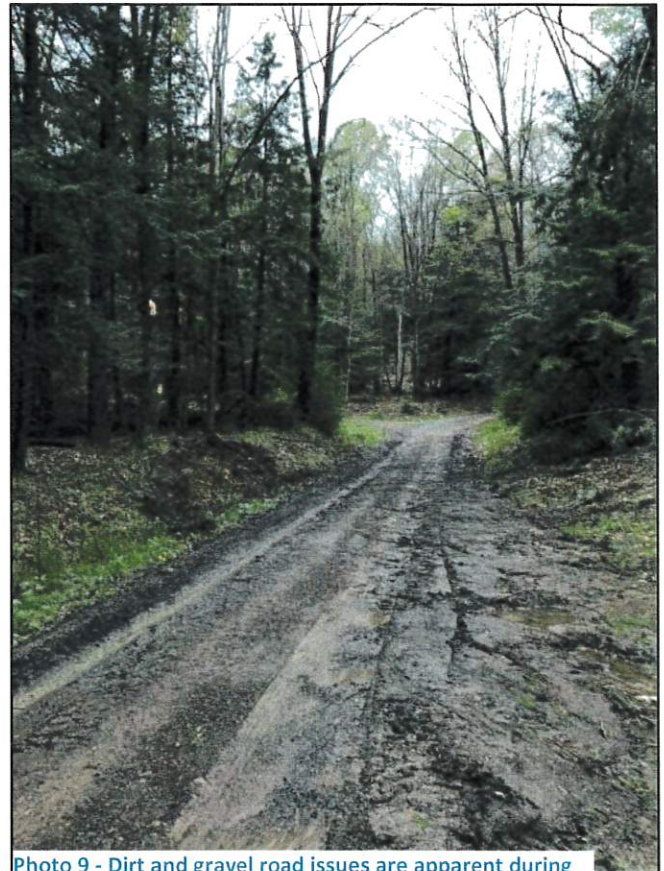
Photo 9 - Dirt and gravel road issues are apparent during or immediately following heavy rain events

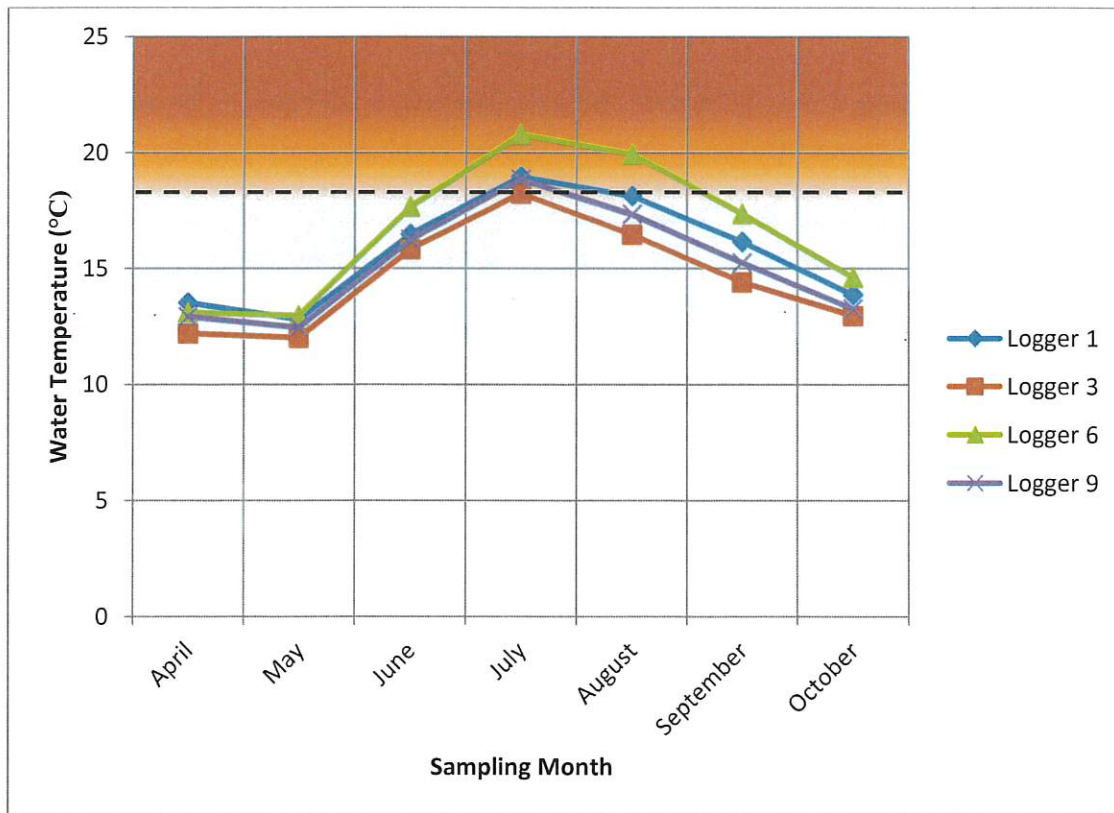
Figure 11 – Mean water temperatures on the mainstem South Branch stations April – October 2017.

Table 4 shows the four mainstem loggers in order from highest upstream to lowest in the watershed. It is interesting to note that some of the highest water temperatures occur in the headwaters of the South Branch, indicated by the results of logger 1. Logger 3 was the only logger on the mainstem that did not exceed the ideal water temperatures for native brook trout during any of the months in which the data loggers were deployed (Table 6 and Figure 11). Logger 6, which is directly downstream of two tributaries influenced by passive abandoned mine drainage treatment systems (see Loggers 4 & 5 in Table 7), had higher temperatures in the months of July and August.

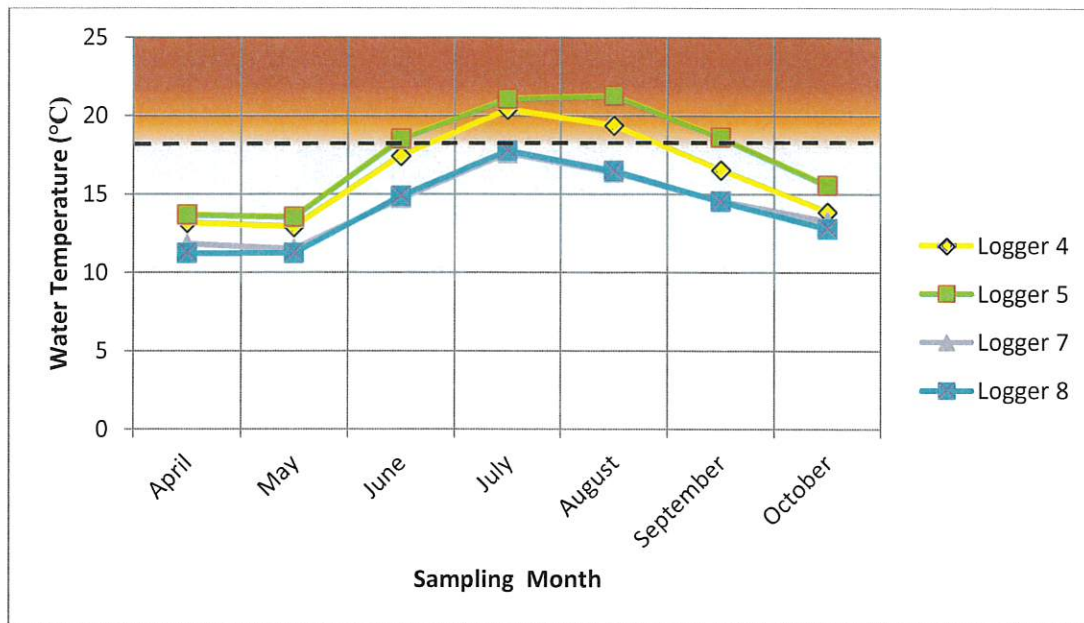
Figure 13 Mean water temperatures on tributaries to the South Branch.

Data loggers on tributaries to the South Branch tell two remarkably different stories. Tributaries which were influenced by abandoned mine drainage treatment systems (Loggers 4 & 5) had higher water temperatures during the entire sampling period of April to October (Table 7 and Figure 12). These temperatures were significantly higher in the summer months, exceeding the preferred water temperature threshold for native brook trout (Table 5 and Figure 13).

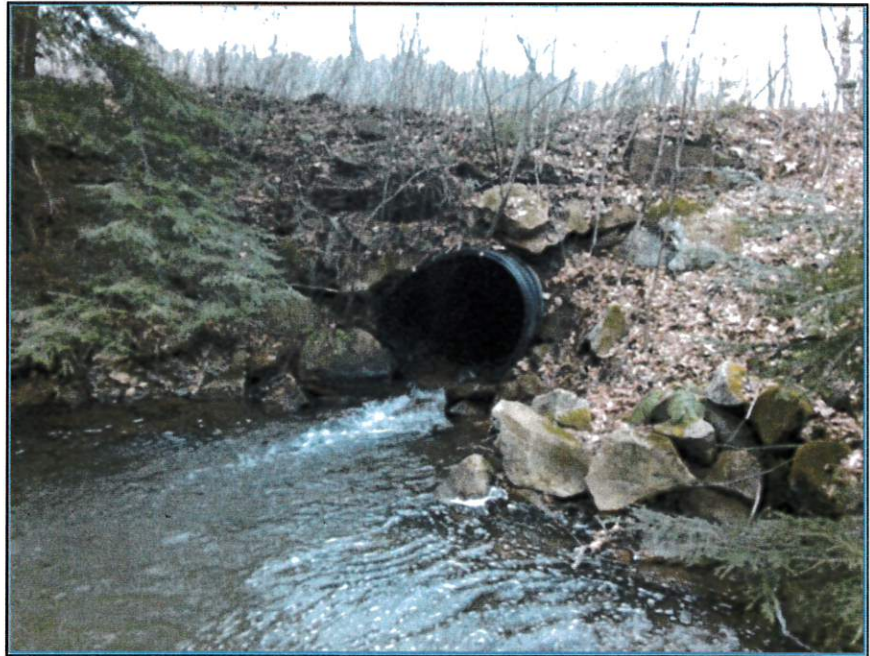
Photo 13 - An undersized culvert on Keal Run in need of replacement

Aquatic organism passage (AOP) restoration projects throughout the Bear Run watershed will benefit the entire ecosystem. Inadequate culverts, such as the one pictured to the right located on Keal Run, can be found throughout the Bear Run watershed. The example picture here is undersized. This creates a velocity barrier for fish passage as the stream is forced through a pipe that is smaller than the width of stream. This also creates a blowout effect on the outlet side of the culvert which can cause erosion issues on the adjacent streambanks.
