**Beaver Creek Watershed
Coldwater Conservation Plan
Schuylkill County, Pennsylvania
November 2009**

Prepared for:
Schuylkill Conservation District
Craig Morgan, District Manager
1206 Ag Center Drive
Pottsville, PA 17901
(570) 622-3742, ext. 5

Prepared by:
RETTEW Associates, Inc.
950 East Main Street, Suite 220
Schuylkill Haven, PA 17972
(570) 385-2270

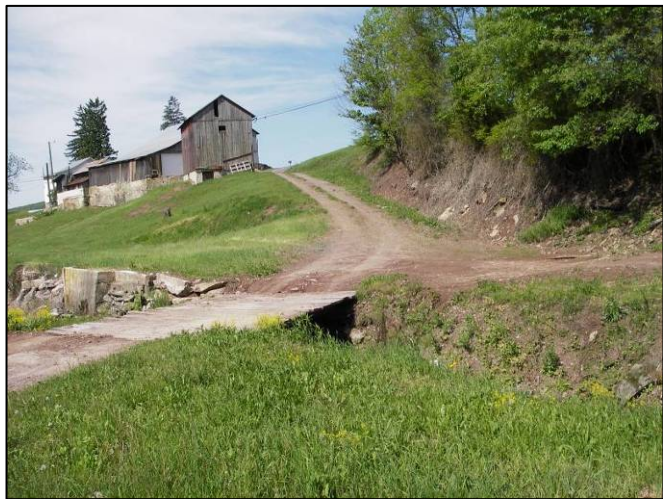
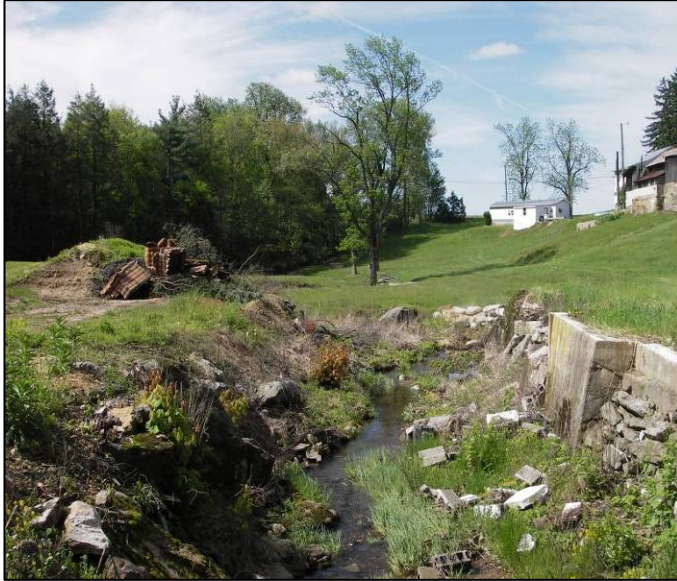
Impacted Stream Segment #12-14:

This stream segment includes a residential property, off-line pond, and a dirt lane that crosses a bridge over Beaver Creek. The dirt lane likely contributes sediment to Beaver Creek as stormwater flowing down it would directly enter the stream. This section of stream had excessive sedimentation present in the pools. Throughout this stream reach, the vegetation is mowed to the stream bank. An approximately 50 foot section of the stream bank is eroding.

Conservation work in this area should include addressing stormwater discharges from the dirt lane, stabilization of the approximately 50 foot section of stream bank and riparian buffer tree/shrub plantings. The stormwater flowing down the dirt lane from the north could potentially be diverted into a bioretention area via a waterbar or conveyor belt diversion located just north of

the bridge crossing. Work to stabilize the 50 foot section of stream bank could include installation of a small floodplain bench and a stable slope of no greater than 3:1. The use of toe rip-rap and/or restoration BMPs such as cross vanes or deflectors could be incorporated to add additional stability and fish structure to the reach. In order to filter runoff and aid in shading the reach, the riparian zone could be planted with trees and shrubs. While tree species are typically recommended, shrub species should be considered in this area to ensure the property owner retains the view of the pond located to the east of the stream.

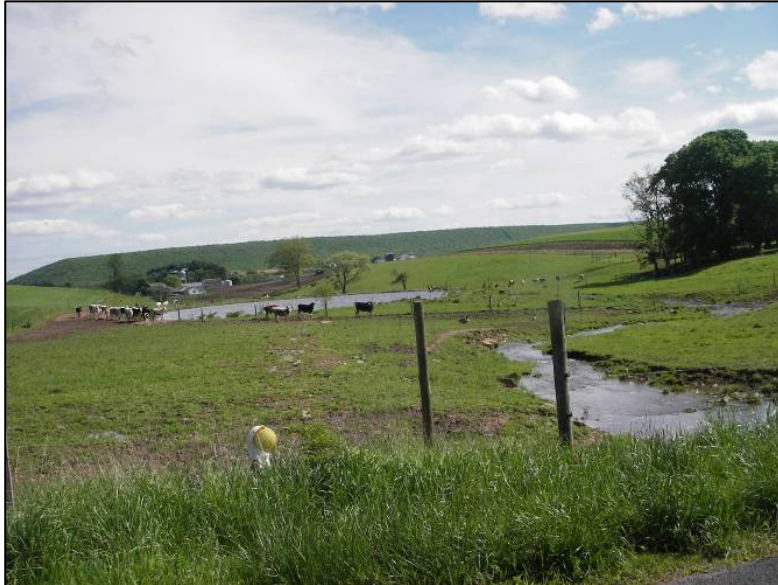
Impacted Stream Segment #39-40:

Cattle in this reach graze within the riparian zone and have free access to the stream. While rotational grazing appeared to be in use during the assessment, the pastures that were observed allow the cattle unrestricted access to the stream. In the downstream pasture, an off-line pond is also present within the pasture.

Stream bank fencing with stable stream crossings and watering areas should be installed to promote herd health and minimize impacts to the stream. Native tree and shrub species could be incorporated into a naturalized stream buffer to filter runoff from the upslope agricultural areas.

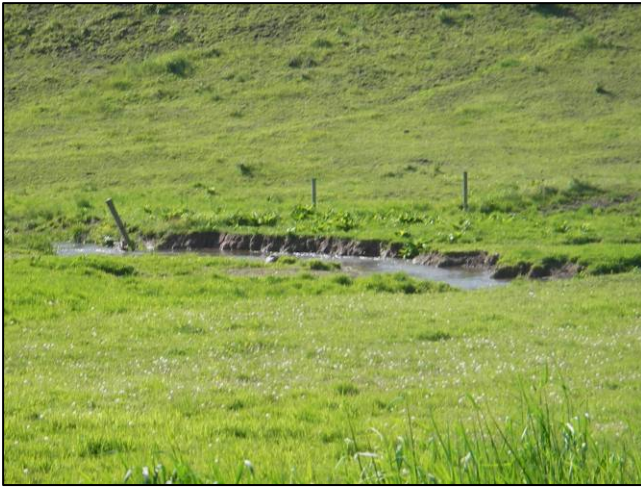
Impacted Stream Segment #49-50:

Cattle have unrestricted access to this unnamed tributary of Beaver Creek. There is approximately 100 feet of 1-2 foot high eroded stream bank in this portion of the stream.

Stream bank fencing, stable stream crossings, and stable watering areas should be installed to minimize the impacts of the cattle grazing in this pasture. The stream bank should be stabilized to minimize additional sedimentation and nutrient inputs into the stream from bank erosion. A native riparian buffer should be planted throughout this section of stream to prevent erosion in the future.

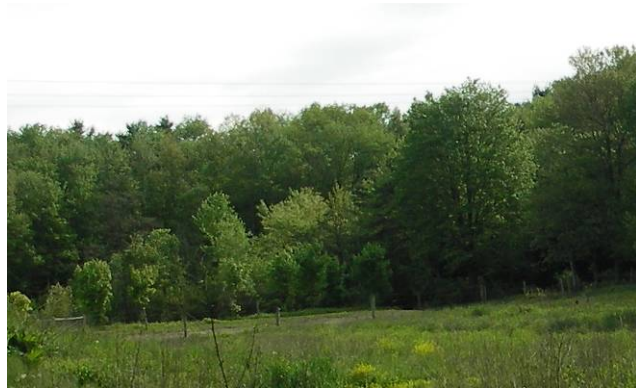
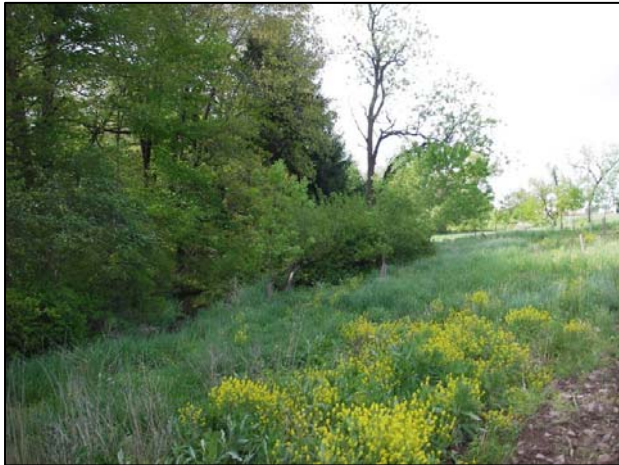
Stream bank fencing, stable watering areas, and stable stream crossings should be considered to minimize sedimentation and nutrient inputs to the stream. A native stream buffer should be planted.

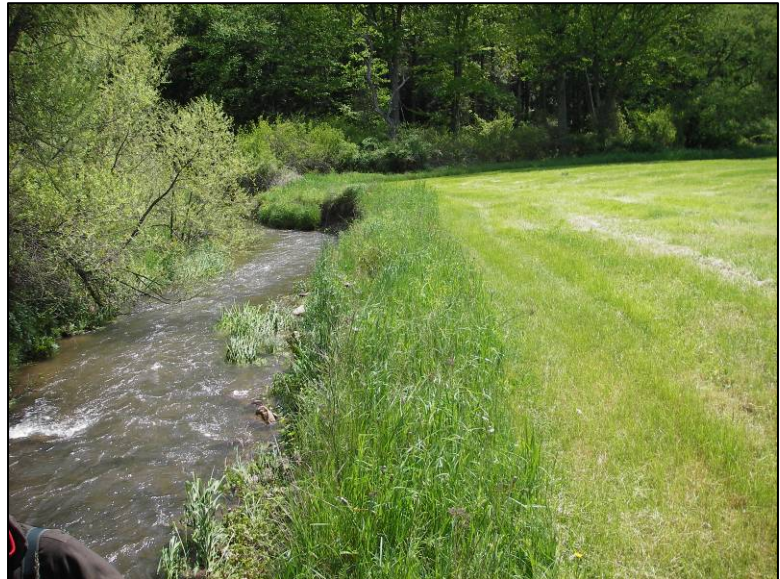
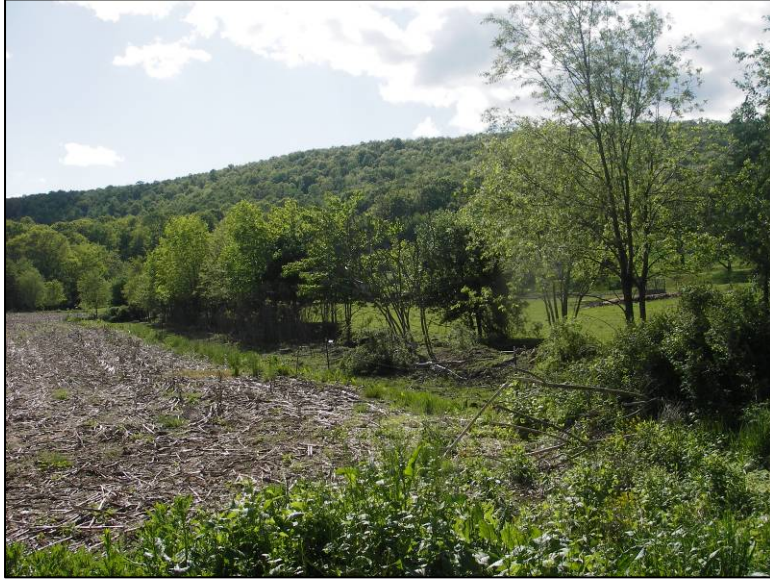
Impacted Stream Point #24:

The grass is mowed to the top of the stream bank. The west bank has four foot high eroded banks. This section of stream has experienced stream bank erosion during high flow events. The eroded banks extend approximately 100 feet. There is a forested buffer upstream of this segment.

The stream bank should be stabilized by constructing a floodplain bench and incorporating toe rip-rap and instream structures to minimize future erosion of the field edge. The mowed lawn could be planted with native tree species to extend the riparian buffer. A forested stream buffer would aid in reducing erosion and nutrient inputs to the stream.

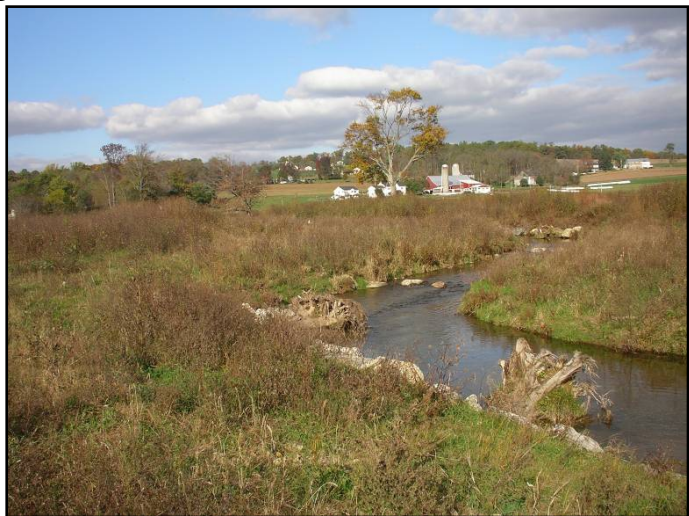
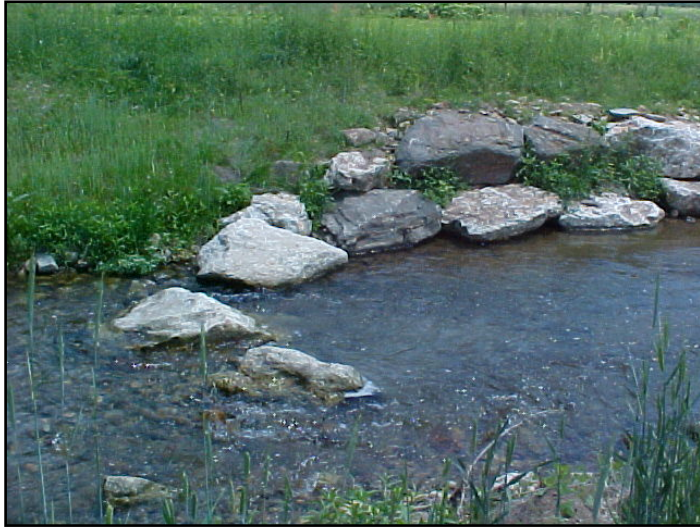
Stream Bank Stabilization & Restoration: Stream bank stabilization is the most basic step in restoring a degraded stream. Eroded vertical walls or undercut banks are often present where erosion has gone unchecked over time in agricultural areas. Traditional stream bank stabilization involves re-grading localized laterally eroded stream banks by grading the banks back to a more stable slope (3:1 horizontal to vertical), stabilizing the slopes with erosion control matting and vegetation and possibly adding in-stream structures or bioengineering techniques on the banks. Traditional in-stream structures may include the use of toe riprap and log or rock deflectors. Bioengineering methods that may be incorporated in bank stabilization could include the use of fascines, branch packing, brush mattresses, live cribwalls, and tree revetments and live staking.

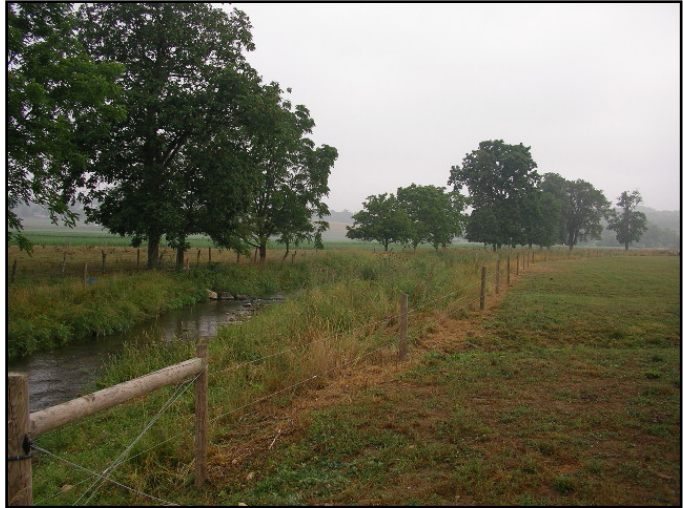
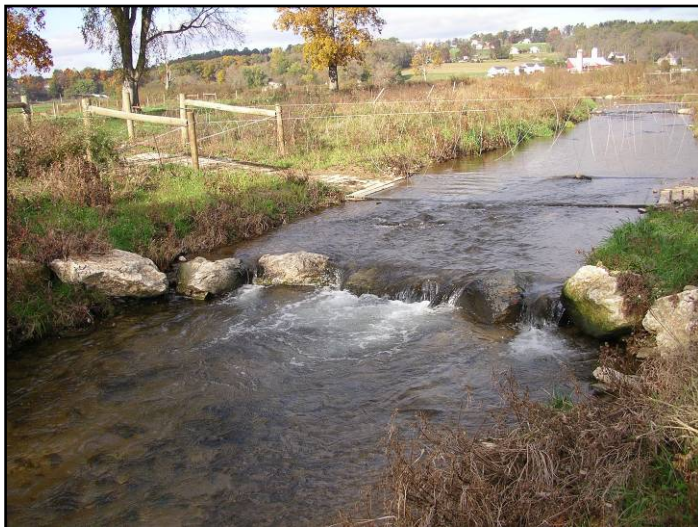
Stream Bank Fencing: Stream bank fencing protects stream banks, promotes re-vegetation, enables forest buffer plantings, protects in-stream habitat and eliminates cattle from entering and loafing in the stream channel. The installation of a two-wire, high-tensile electric fence (powered by AC chargers or solar/battery chargers) is preferred. For construction, eight-foot long locust or pressure treated wooden fence posts should be pounded into the ground on 50-foot centers. Corners should be braced and constructed of 8-foot posts. Temporary poly wire electric fencing can be erected around planted riparian buffers until permanent fencing can be installed.
