**Coldwater Conservation Plan
For
Big Creek Watershed
Blythe, Ryan, and Schuylkill Townships
Schuylkill County, Pennsylvania
October 2012
RETTEW Project No. 042342001**

APPENDIX A: Project Mapping	
Figure 1: Topographic Base Map	
Figure 2: Aerial Base Map	
APPENDIX B: Additional Photographs	
APPENDIX C: Macroinvertebrate Taxa List	
APPENDIX D: Professional Qualifications

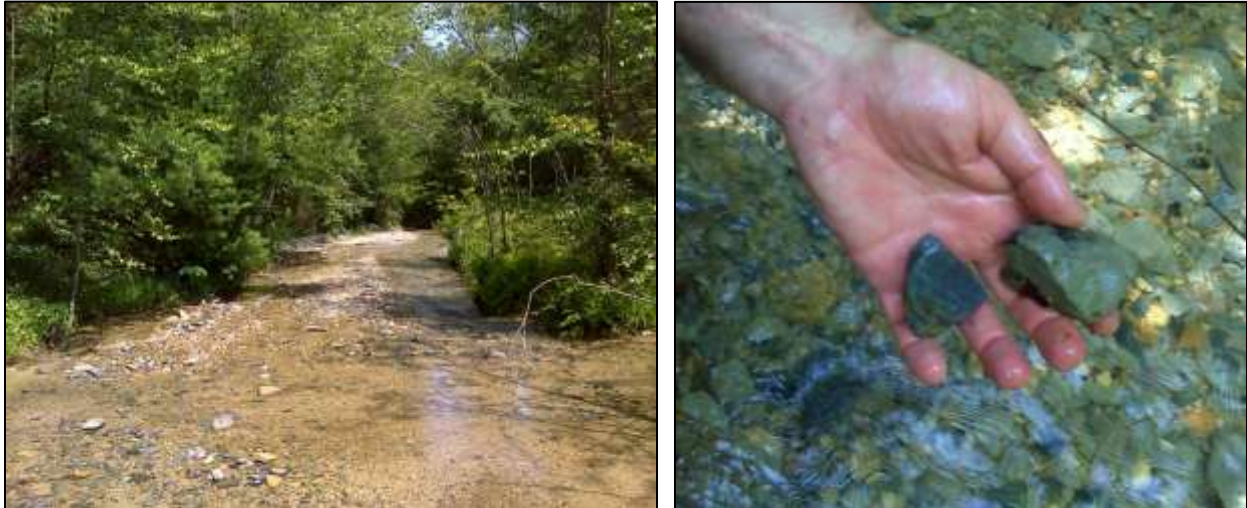
As previously mentioned, Big Creek originates at an abandoned stripping pit. The pH in this section of the stream was 5.0. In an attempt to improve pH levels, the SHA previously lined this section of the stream with limestone; however, much of the limestone has been washed away in recent flooding (Photo 1).

Photos 1 and 2. View of Big Creek where limestone was previously installed (left). View of uncoated and coated limestone rocks in the Big Creek headwaters area (right).

Solution: In order to increase the pH, a source of alkalinity must be introduced into the stream. The calcium carbonate in limestone would provide an adequate source of alkalinity. In fact, what was left of the previously installed limestone was causing an improvement to the water quality in this stream section. As seen in Photo 2 above, much of the limestone is coated with a metal hydroxide, which results from the interaction of the acidic discharge water with the limestone. As a result, a more stable and self-sustaining treatment system that includes a stormwater bypass should be installed in order to improve pH levels.

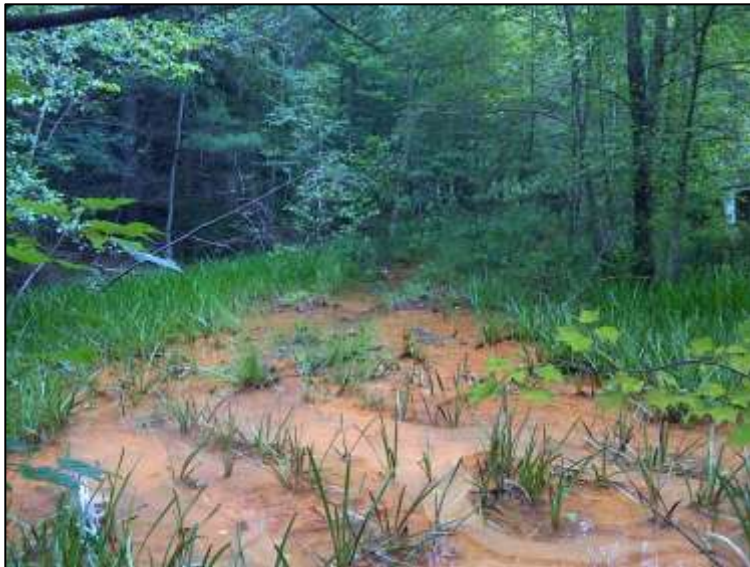
AMD discharge behind Moss Glen Rod and Gun Club: Water in this stream section was extremely acidic, and much of the stream bottom was coated in orange iron hydroxide sludge.

Photo 3. View of an existing wetland located within the AMD discharge behind the Moss Glen Rod and Gun Club.

Solution: An AMD treatment system should be constructed in order to improve water quality. The nearby shooting range could be an appropriate site for a treatment system. Furthermore, a wetland complex was observed along this discharge (Photo 3). Wetlands can be useful in treating AMD by aerating the water and promoting the oxidation and settling of metals. Therefore, water quality could be improved by utilizing and expanding this wetland complex.

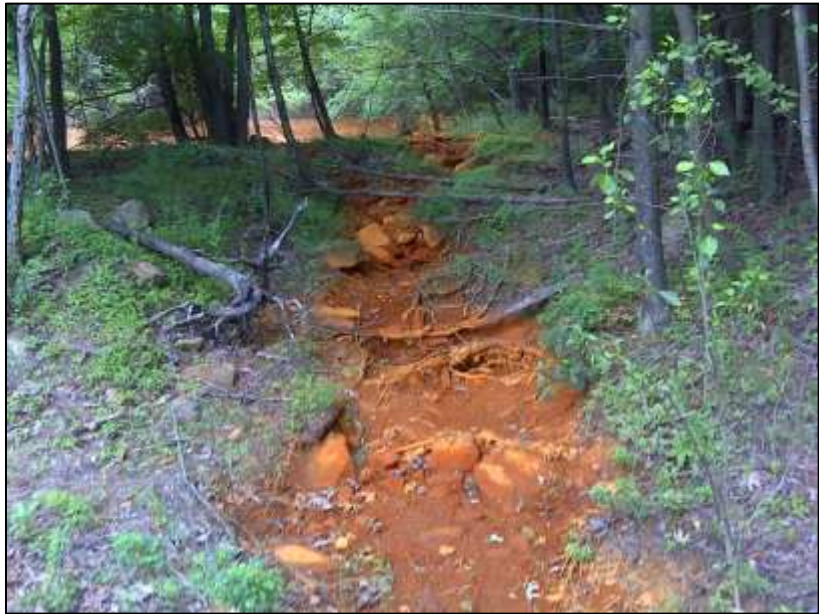
Two abandoned stripping pits exist north of the Moss Glen Rod and Gun Club and east of SR 1011. As seen in Photo 4, these stripping pits can overflow and contribute AMD to Big Creek. In addition, Sample Point #9 was located in the northern stripping pit. This water had the lowest pH (3.0) observed within the watershed.

Photo 4. View of the overflow channel from the southern abandoned stripping pit.

Solution: Overflow from these stripping pits could be diverted into a limestone channel to increase aeration and then into a passive AMD treatment system in an effort to neutralize the water and remove harmful metals

before it flows into the nearby UNT to Big Creek. Additionally, these stripping pits potentially could be filled in with lime-containing fly ash to reduce the flow of AMD into Big Creek.

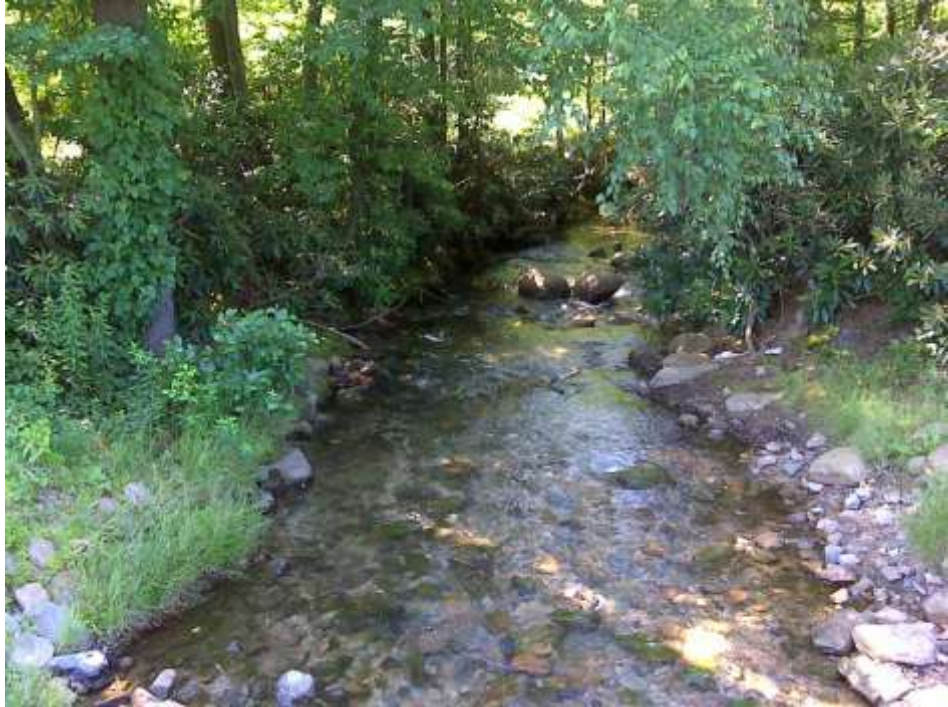
COMMENTS:
PHOTO 5
Looking downstream
from the Valley Street
Bridge at the
mainstem of Big
Creek and Sample
Point #1.

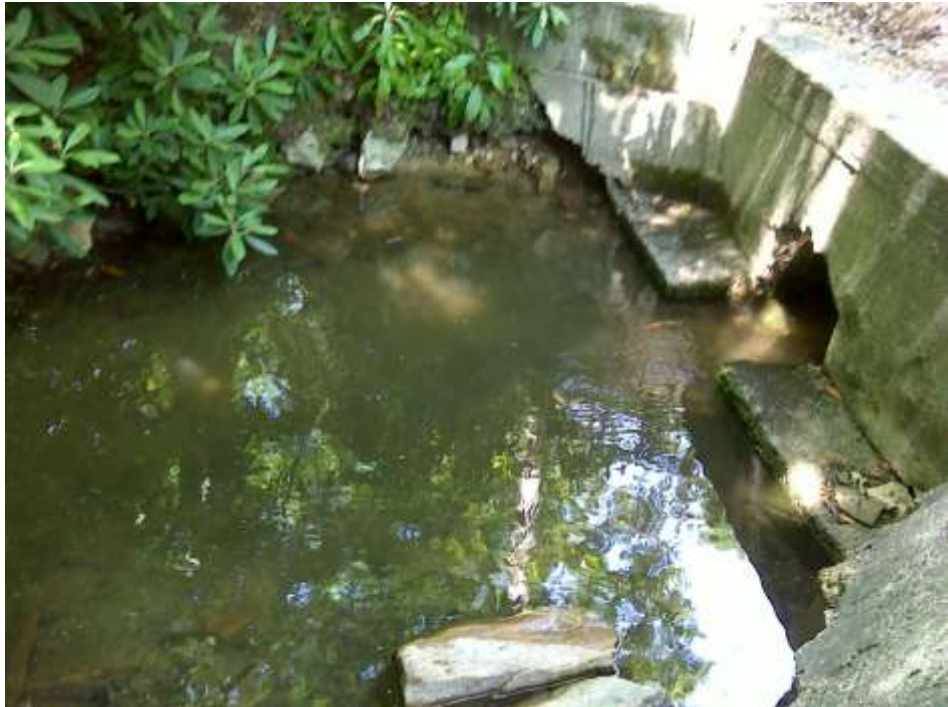
COMMENTS:
PHOTO 6
View of UNT to Big
Creek at Sample
Point #2. This sample
point was located
adjacent to State
Route 1011.

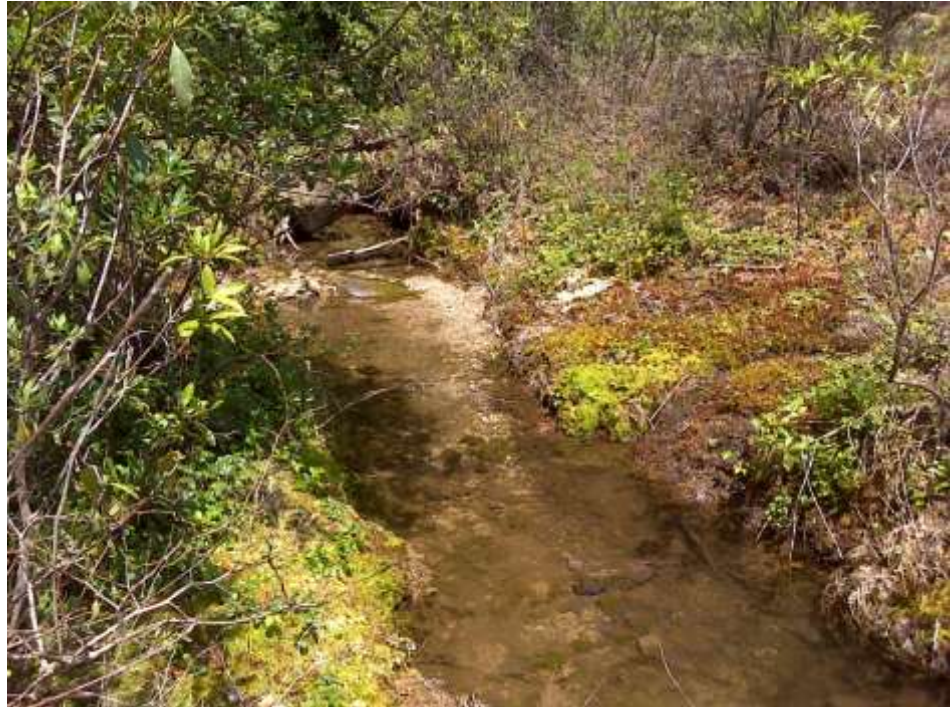
COMMENTS:
PHOTO 7
View of the UNT to
Big Creek at Sample
Point #3. This sample
point was located
adjacent to a power
line right-of-way.

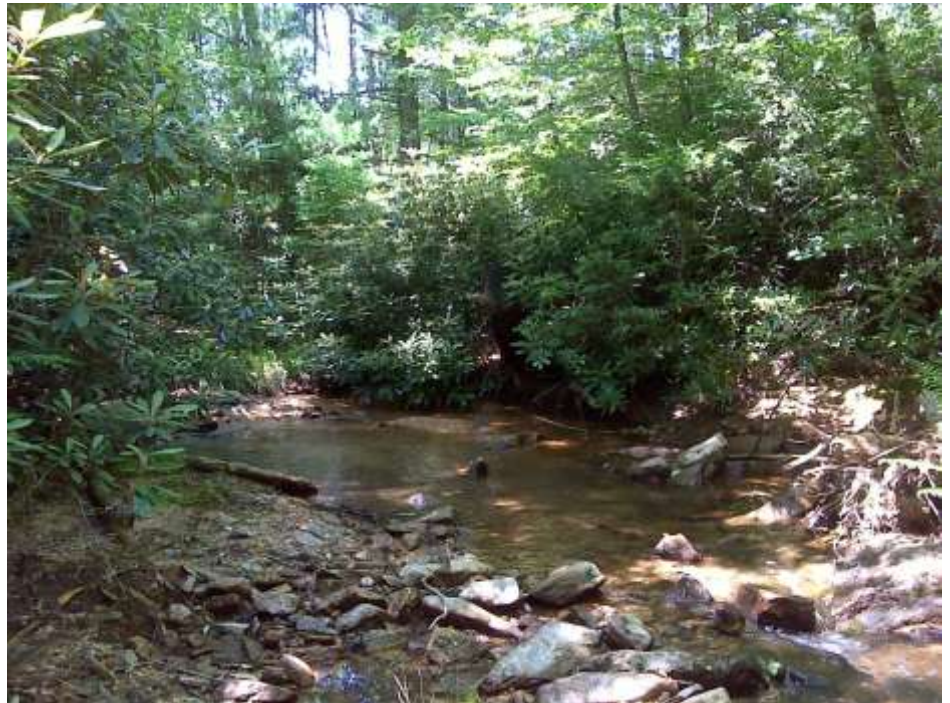
COMMENTS:
PHOTO 8
View of Big Creek at
Sample Point #4,
adjacent to the Moss
Glen Reservoir.

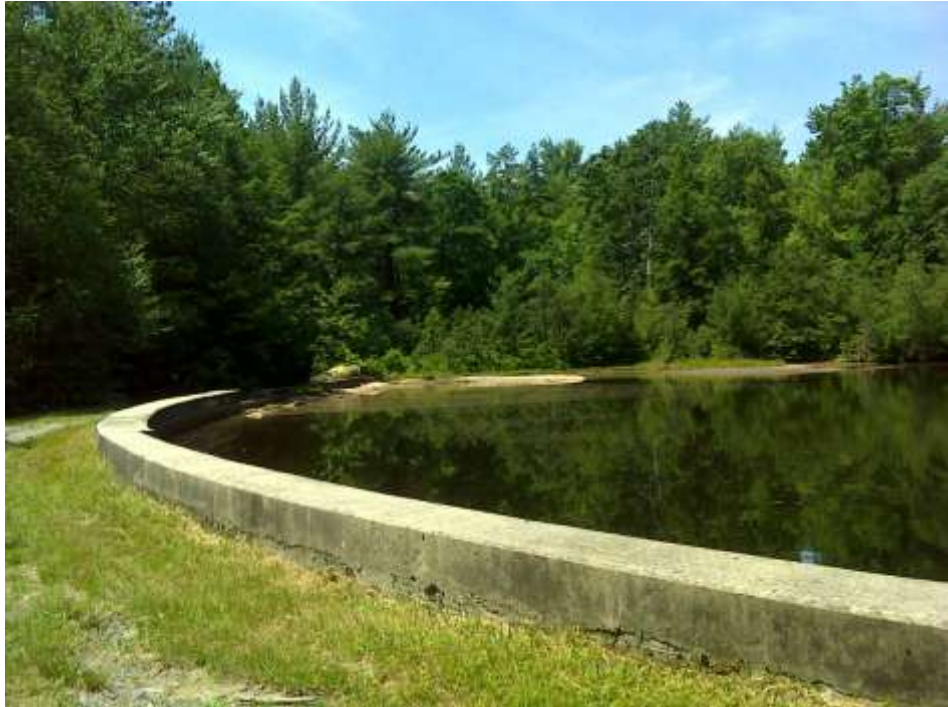
COMMENTS:
PHOTO 9
View of the Moss
Glen Reservoir, which
serves as a local
drinking water source
after chemical
treatment and
filtering.

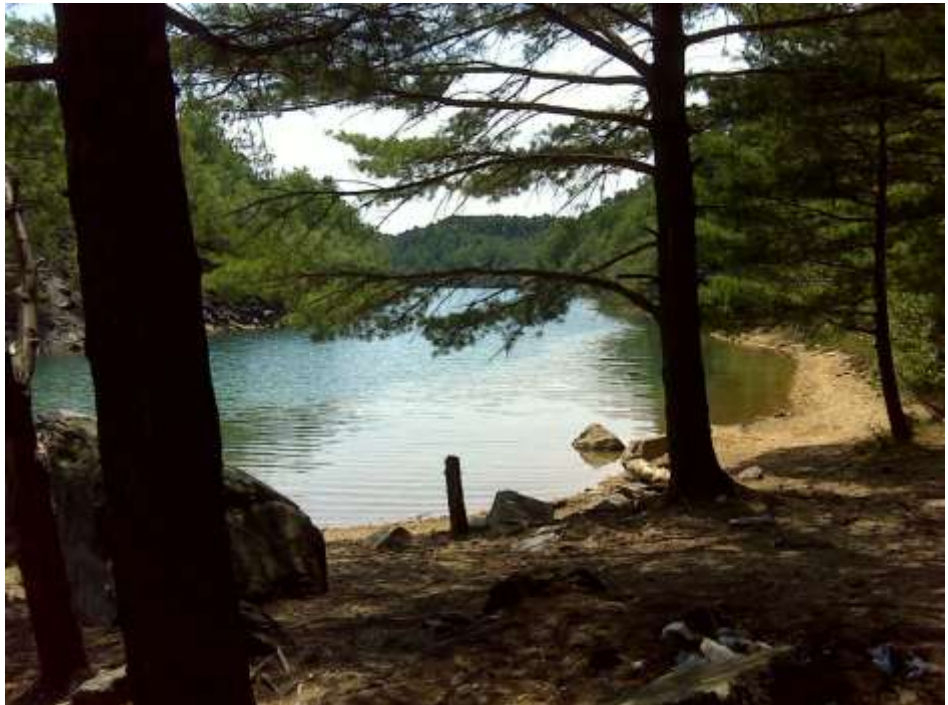
COMMENTS:
PHOTO 10
View of the
abandoned stripping
pit that serves as the
source point for Big
Creek.

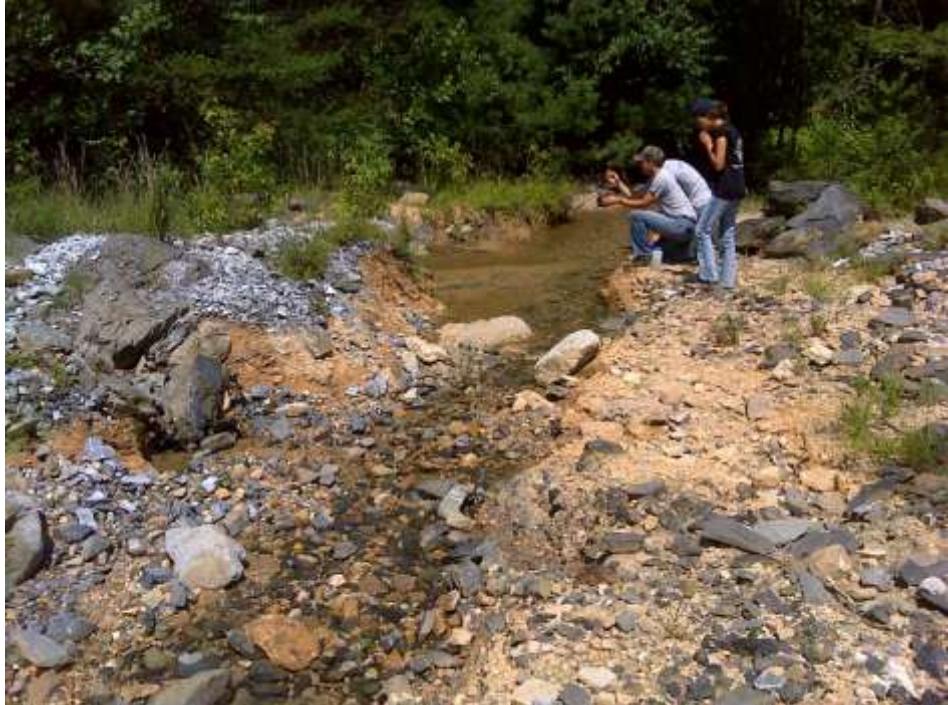
COMMENTS:
PHOTO 11
View of the headwaters of Big Creek at Sample Point #5. This portion of the stream was previously lined with limestone; however, high flows during the recent flooding washed away much of the limestone.

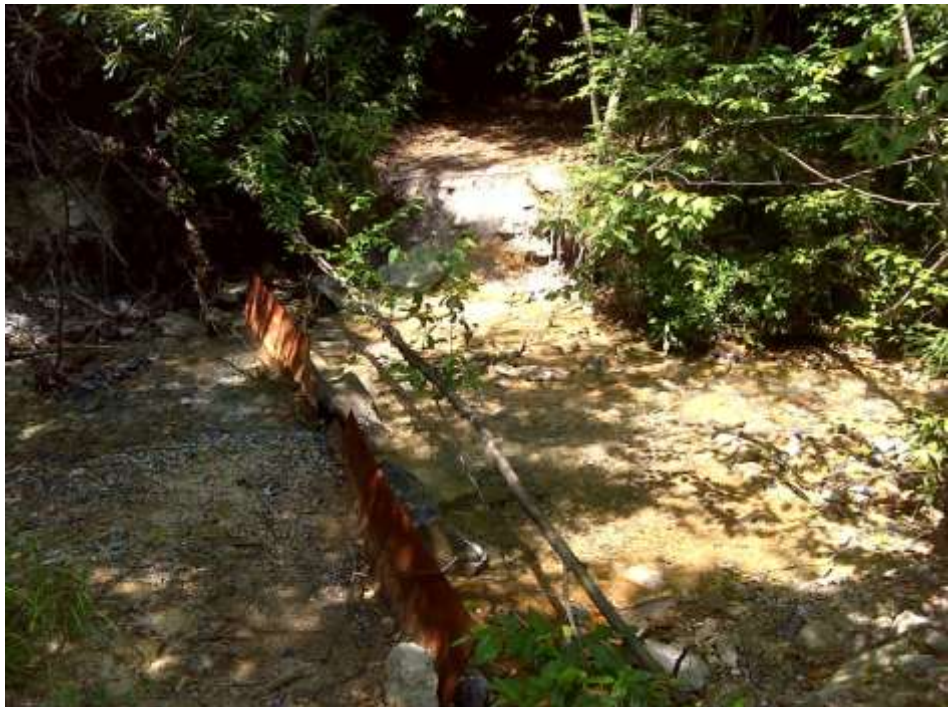
COMMENTS:
PHOTO 12
View of Big Creek at Sample Point #6. This sample point was located downstream of a previously installed flow monitoring weir and limestone rock filters.

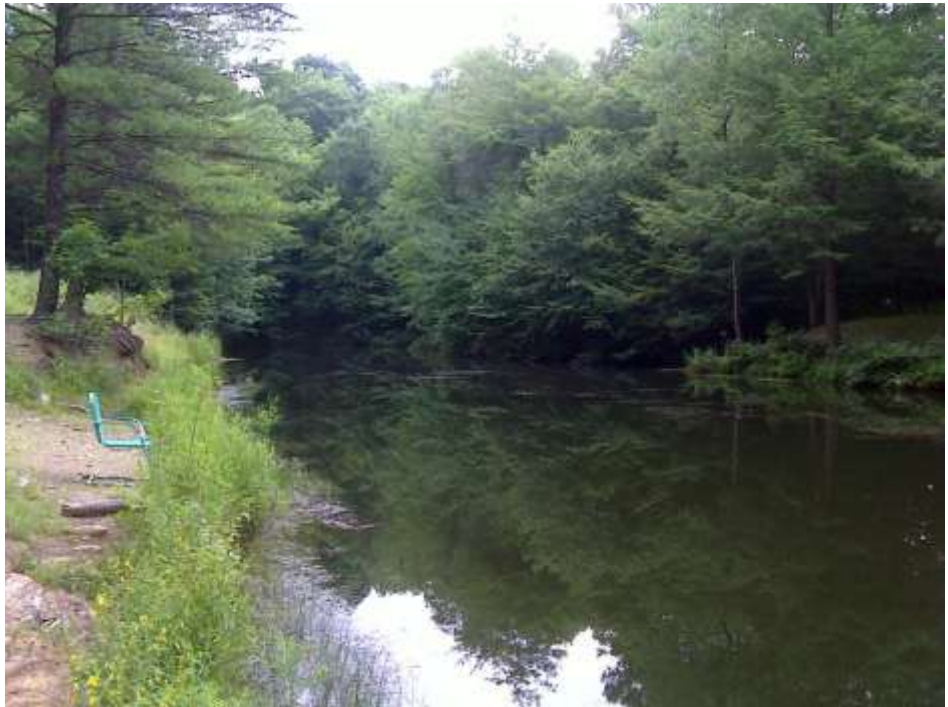
COMMENTS:
PHOTO 13
View of an
abandoned stripping
pit used as a fishing
pond by the Moss
Glen Rod and Gun
Club. This pond is
regularly limed and
stocked with trout.

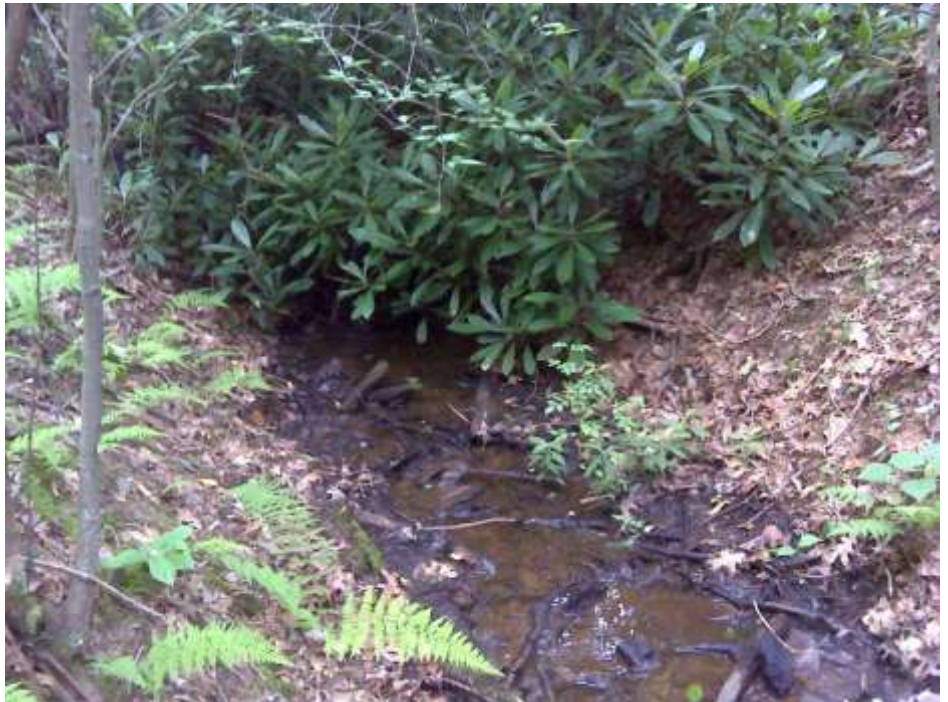
COMMENTS:
PHOTO 14
View of the outfall
from the above
mentioned pond.
Sample Point #7 was
located along this
stream.

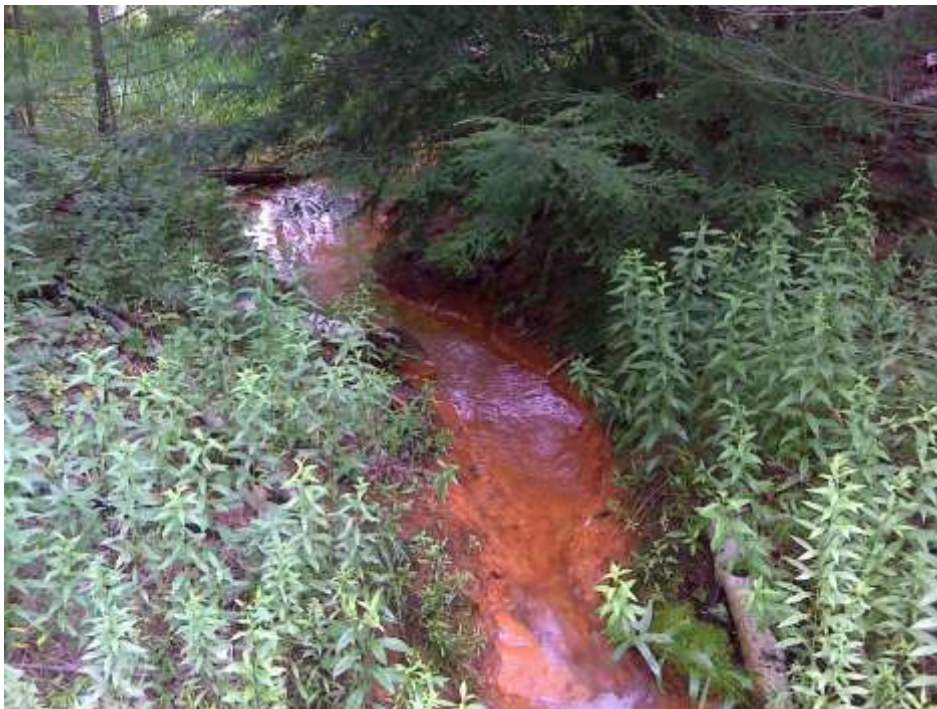
COMMENTS:
PHOTO 15
View of the
abandoned mine
drainage (AMD)
discharge at Sample
Point #8, located
behind the Moss Glen
Rod and Gun Club
clubhouse.

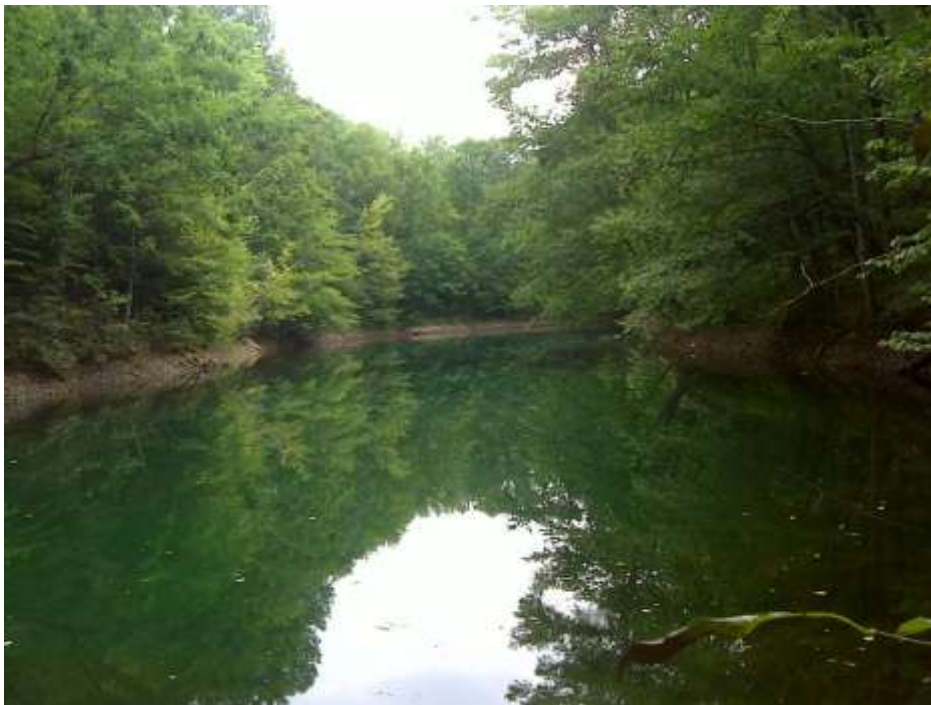
COMMENTS:
PHOTO 16
View of the
abandoned stripping
pit at Sample Point
#9.
