Briar Creek Watershed

Coldwater Conservation Plan Columbia County, PA

B.C.A.W.S - Briar Creek Association for Watershed Solutions

December 12th, 2012

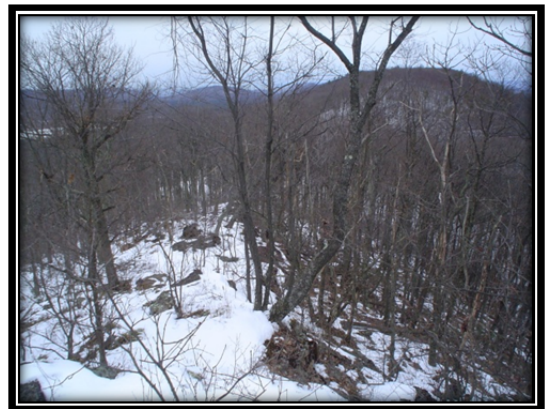
The drainage divide on top of Lee Mountain separates watersheds. BCW lays to the right.

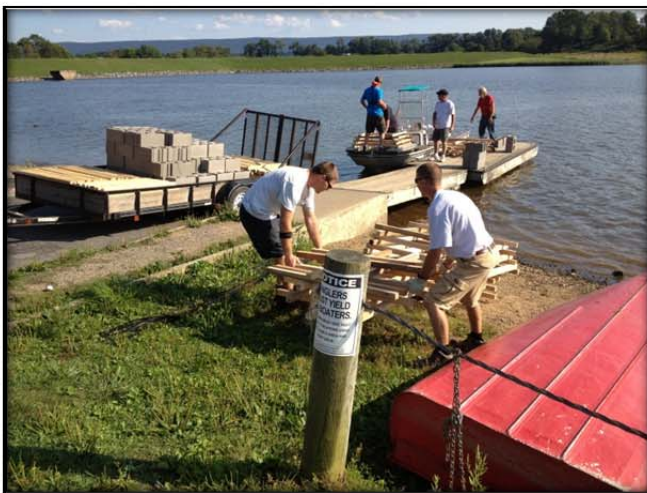
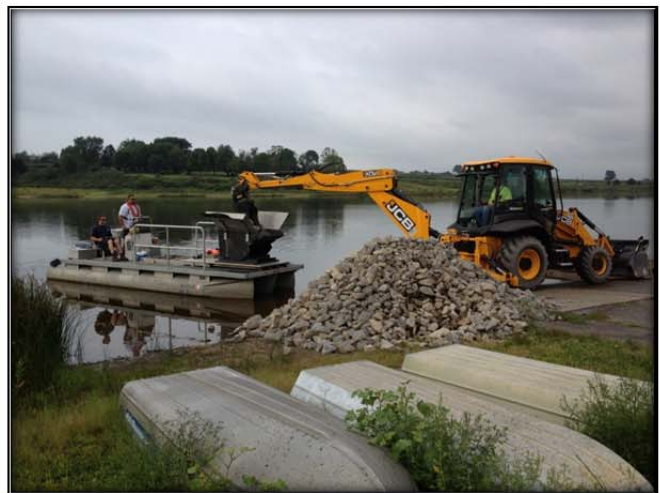
To augment habitat at the lake, BCAWS holds workdays to build aquatic habitat structures (see pictures, previous page). For three years, in cooperation with the PFBC, BCAWS volunteers have built submersible structures mimicking natural habitats, which are important for aquatic species such as native fish and turtles. Details of this plan may be accessed at <http://www.columbiaccd.org/html/bcaws.html>.

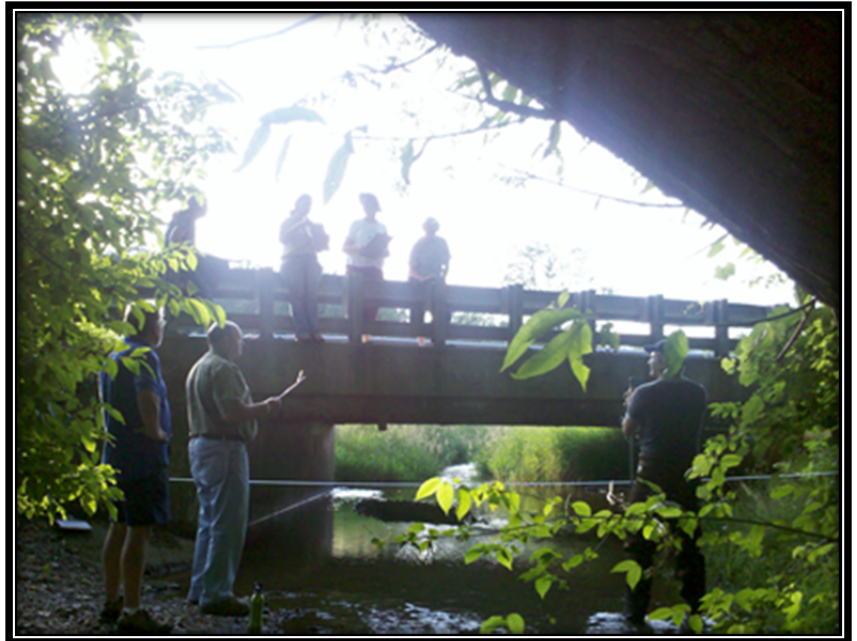
The above picture is of the BCAWS team on one of the field-methods training days. Techniques for proper equipment operation, site protocol, and data calculation were covered. Information collected at each site throughout the study included water temperature, TDS, and pH.

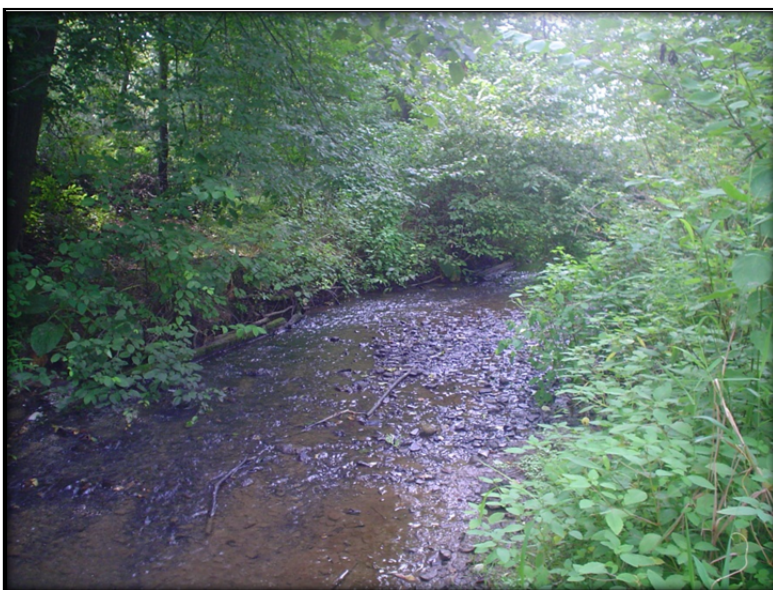
Site # 9: Looking upstream.

Site # 9 Findings:

- * Water temperature was higher than acceptable for CWF designation for 18 out of 26 samples.
- * pH values were within the acceptable range for CWF designation.
- * EC/TDS values were acceptable as required for CWF designation.
- * The visual assessment score was *fair* (7.1) with water appearance and nutrient enrichment the most impacted of the ten applicable criteria.
- * At times, Lead and Nitrate MCL's were exceeded.

- Further investigate/monitor the stream-water temperatures. Streams at all ten monitoring sites had maximum temperatures that exceeded the upper threshold for CWF designation. Using the visual assessment rankings, work with land owners to expand canopy cover, and riparian zone areal coverage along the streams. Continue to monitor until recommended conditions are met.

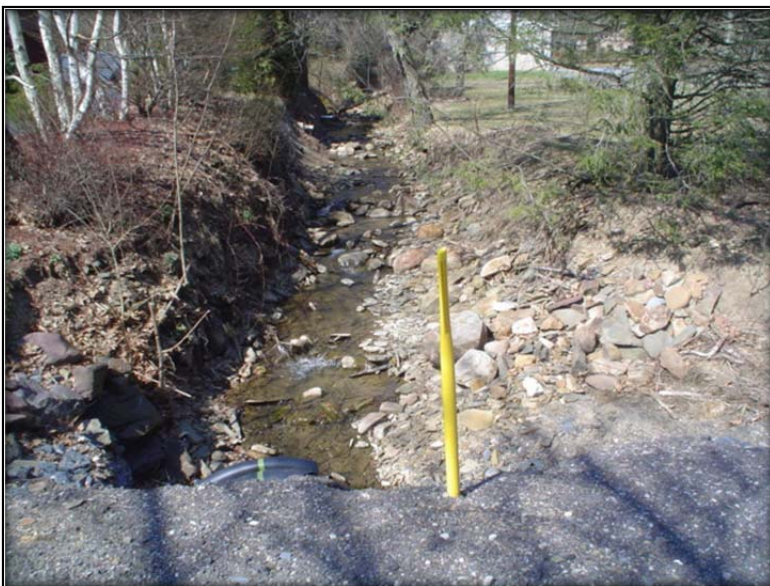
Site # 10: Looking upstream from the highway cross-drain.

Site # 10 Findings:

- * Water temperature was higher than acceptable for CWF designation for 19 out of 26 samples.
- * pH values were within the acceptable range for CWF designation.
- * EC/TDS values were acceptable as required for CWF designation.
- * The visual assessment score was *poor* (5.6) with bank stability and riparian zone the most impacted of the ten applicable criteria.
- * At times, Lead and Nitrate MCL's were exceeded.

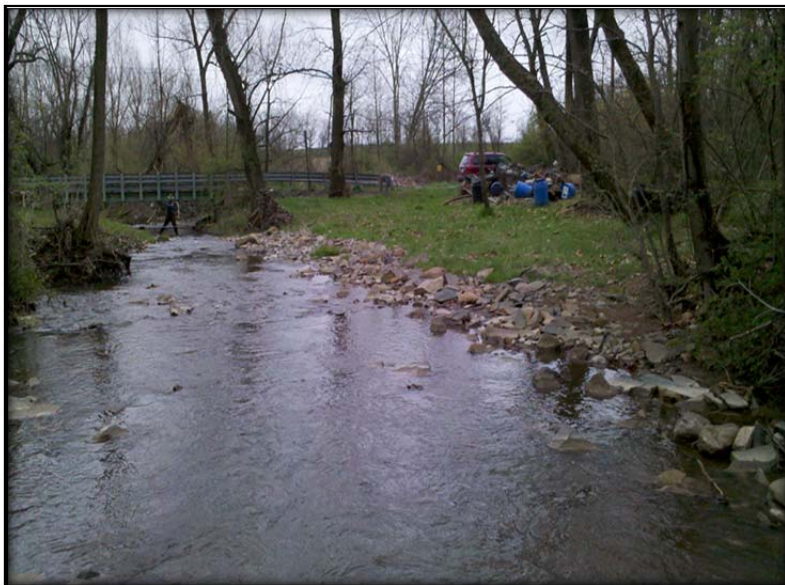
Site #1: Upstream from the bridge.

Site # 1 Findings:

- * Water temperature was higher than acceptable for CWF designation for 21 out of 26 samples.
- * pH values were within the acceptable range for CWF designation except for one sample - March 17, 2012 (pH 9.17).
- * EC/TDS values were acceptable as required for CWF designation.
- * The visual assessment score was *poor* (5.4) with four out of nine applicable criteria having a score of 3.
- * At times, the Nitrate MCL was exceeded.

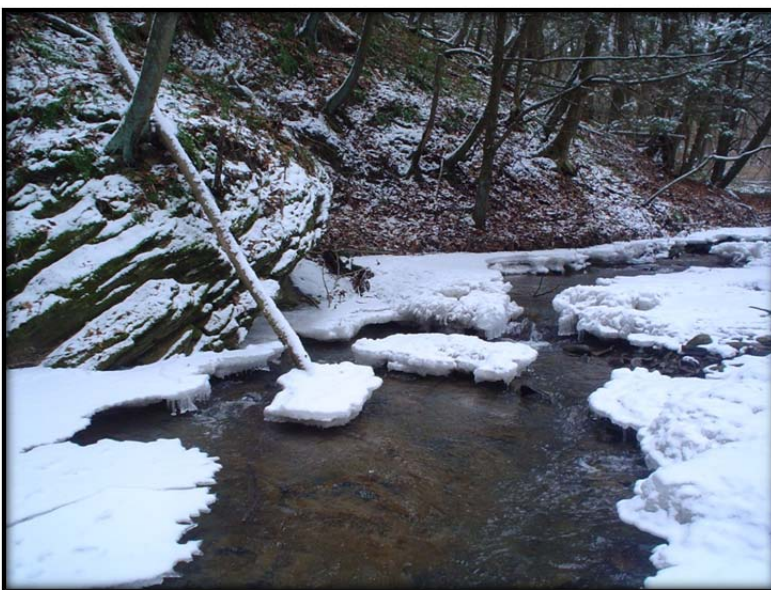
Site # 7: In winter time

Site # 7 Findings:

- * Water temperature was higher than acceptable for CWF designation for 13 out of 21 samples.
- * pH values were within the acceptable range for CWF designation.
- * EC/TDS values were acceptable as required for CWF designation.
- * The visual assessment score was *good* (8.9) with in-stream fish cover the most impacted of the ten applicable criteria.
- * At times, Lead and Nitrate MCL's were exceeded.

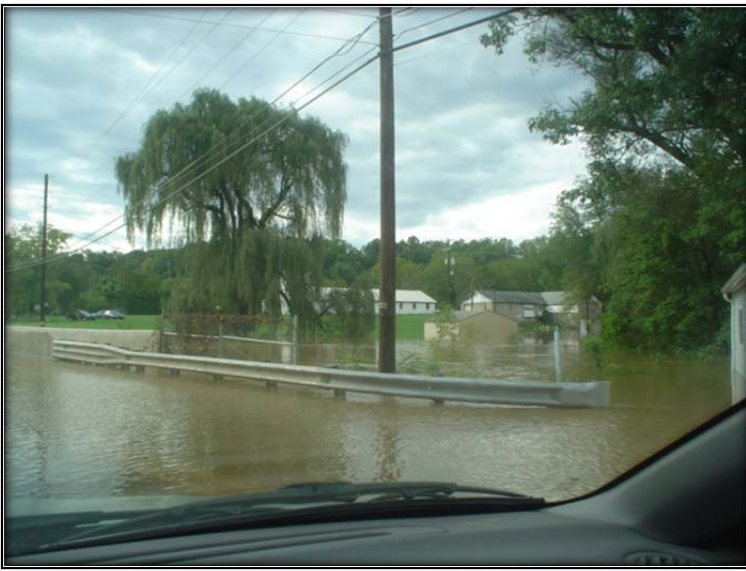
Site # 8 Findings:

- * Water temperature was higher than acceptable for CWF designation for 23 out of 27 samples.
- * pH values were within the acceptable range for CWF designation.
- * EC/TDS values were acceptable as required for CWF designation.
- * The visual assessment score (partial) was *poor* (3.8) with 4 out of 7 applicable criteria with a score of one.
- * At times, Lead and Nitrate MCL's were exceeded.

Site # 8 (see page 27): During the Hurricane Irene/Tropical Storm Lee event of 2011. The monitoring site which is usually visible on the upstream side of the bridge is located just beyond the telephone pole.

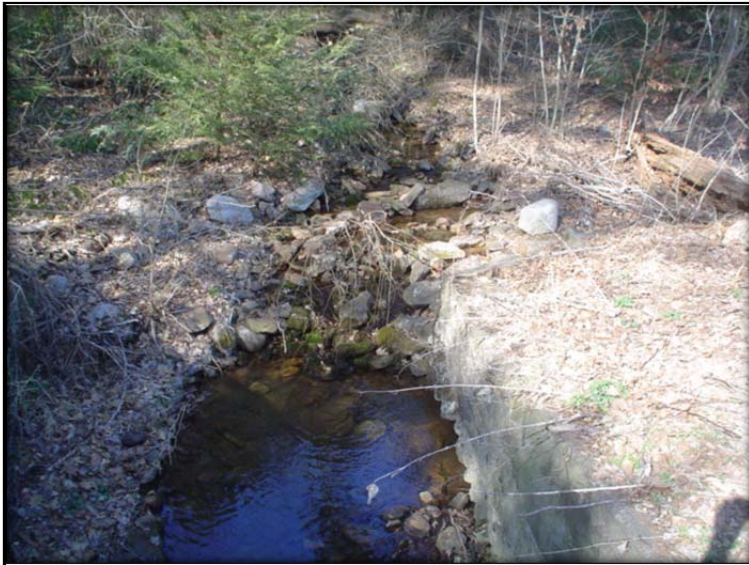
Site # 2 Findings:

- * Water temperature was higher than acceptable for CWF designation for 16 out of 25 samples.
- * pH values were within the acceptable range for CWF designation except for one sample – September 29, 2011 (pH 5.52).
- * EC/TDS values were acceptable as required for CWF designation.
- * The visual assessment score was *excellent* (10) with nine applicable scores at 10.

Site # 2 (see page 27): Monitoring took place upstream beyond the bridge abutment.

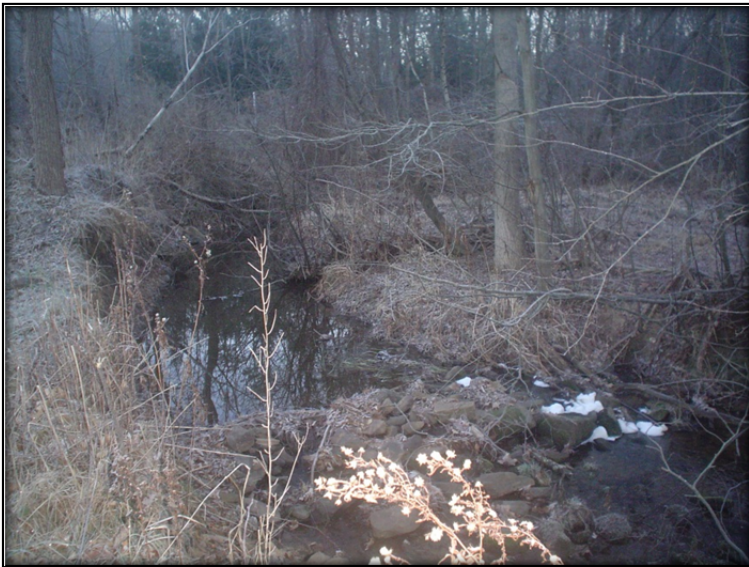
Site # 3 Findings:

- * Water temperature was higher than acceptable for CWF designation for 14 out of 22 samples.
- * pH values were within the acceptable range for CWF designation.
- * EC/TDS values were acceptable as required for CWF designation.
- * The visual assessment score was *good* (7.8) with fish barriers the most impacted of the nine applicable criteria.
- * At times, Lead and Nitrate MCL's were exceeded.

Site # 3 (see page 29): looking upstream.

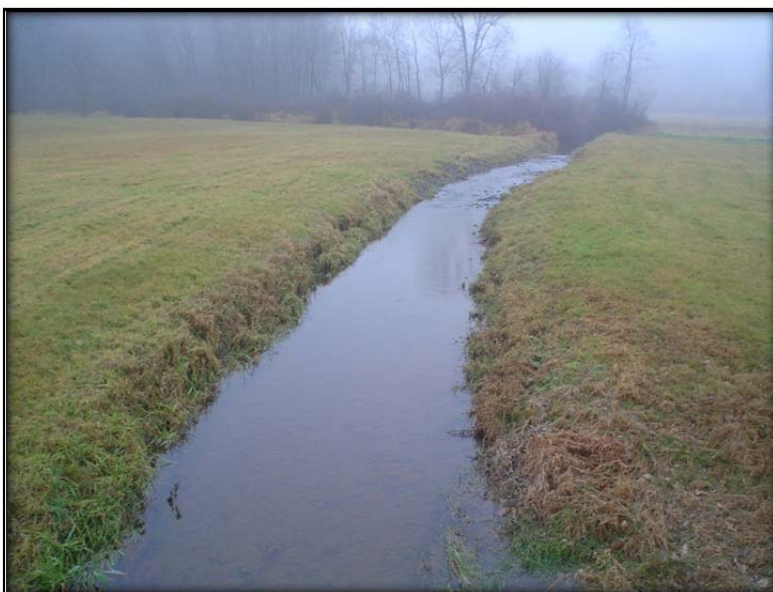
Site # 6: Looking upstream.

Site # 6 Findings:

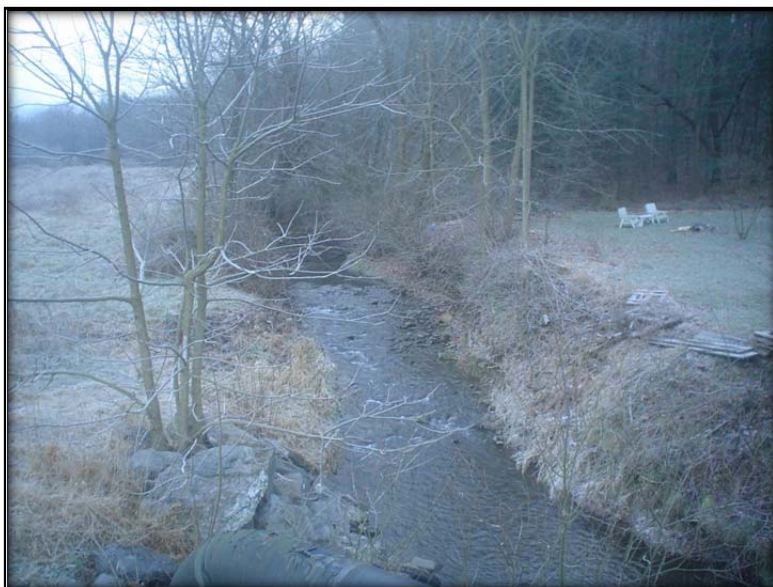
Site # 4: looking upstream.

Site # 4 Findings:
