A Conservation Plan for South Fork Powell's Creek:

What makes the stream special and how to keep it that way

Part One: All About the Stream

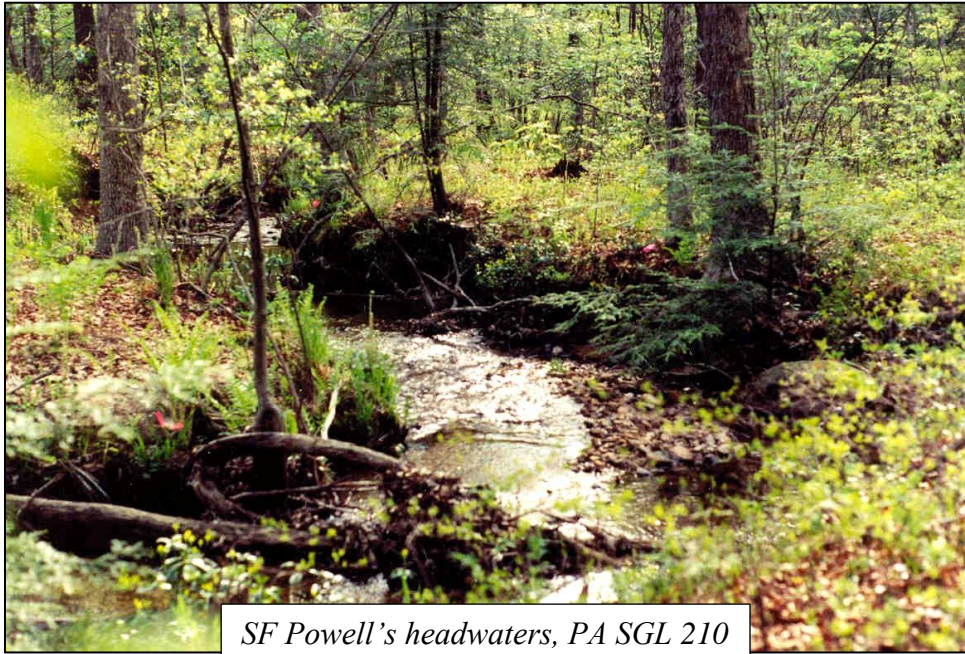
Land Use
Powell's Creek Watershed
and Surrounding Area
Jefferson Township
Dauphin County PA

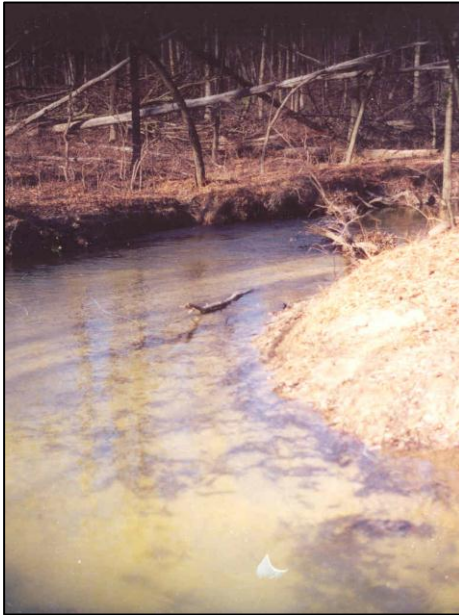
Meandering, sandy bottom channel typical of upper reaches SF Powell's Creek

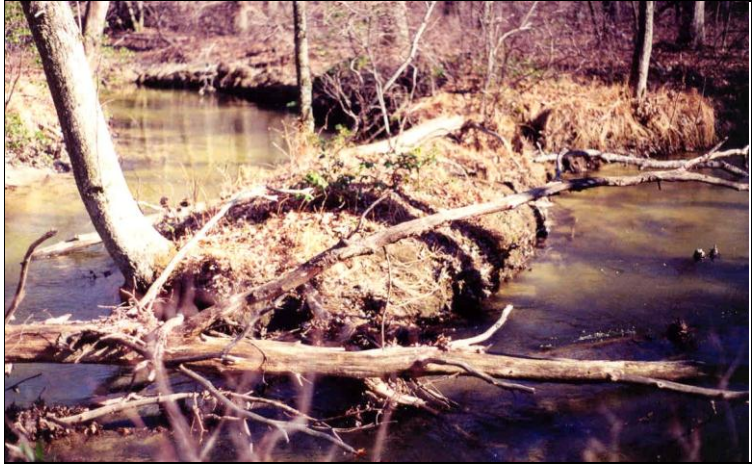
At lower elevations (after the Carsonville Road crossing), the soil is less sandy and bedrock shale is near the surface. A steeper slope reduces meandering, and the added velocity boosts the streams ability to flush sand deposits from pools. More available trout habitat is evident.

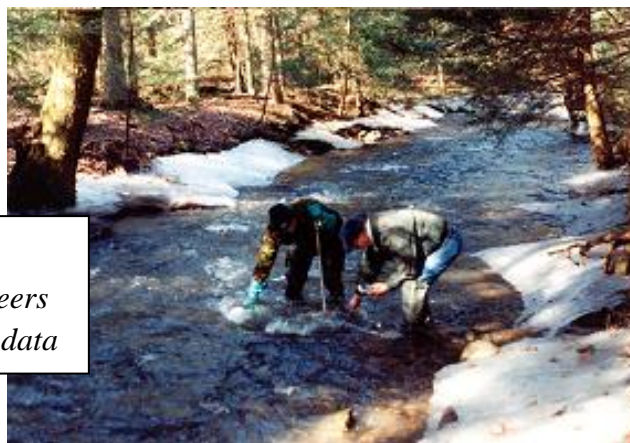
*Downstream of Back Road:
Twin Valley Conservation volunteers
collect samples for water quality data*

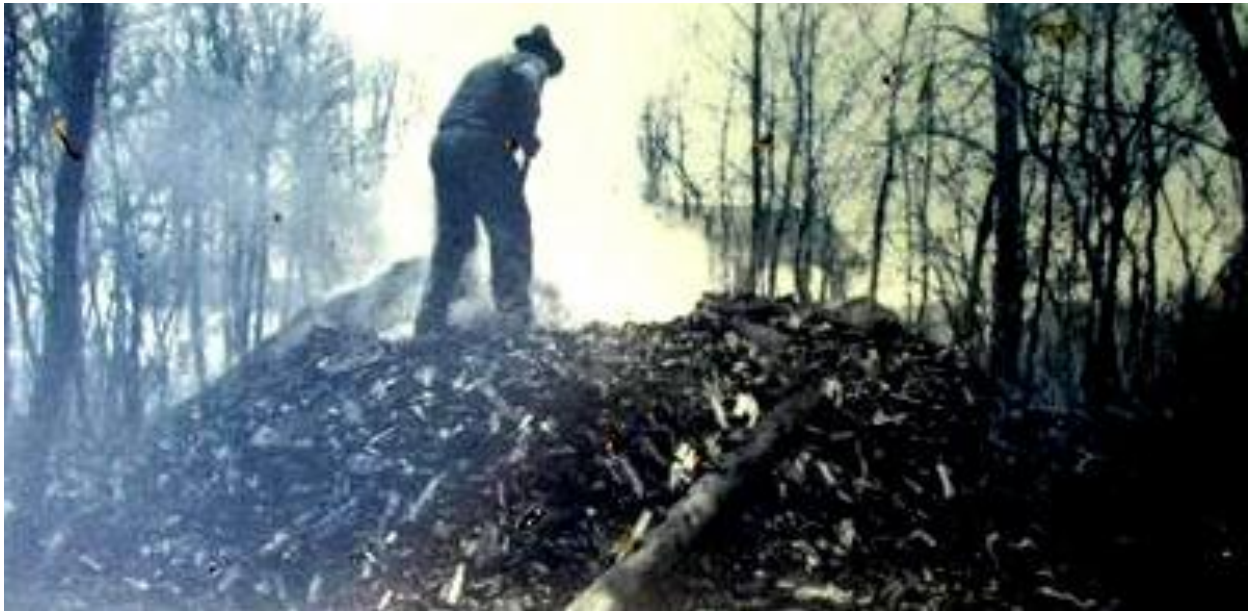
A collier build conical mounds of wood, then set them afire.

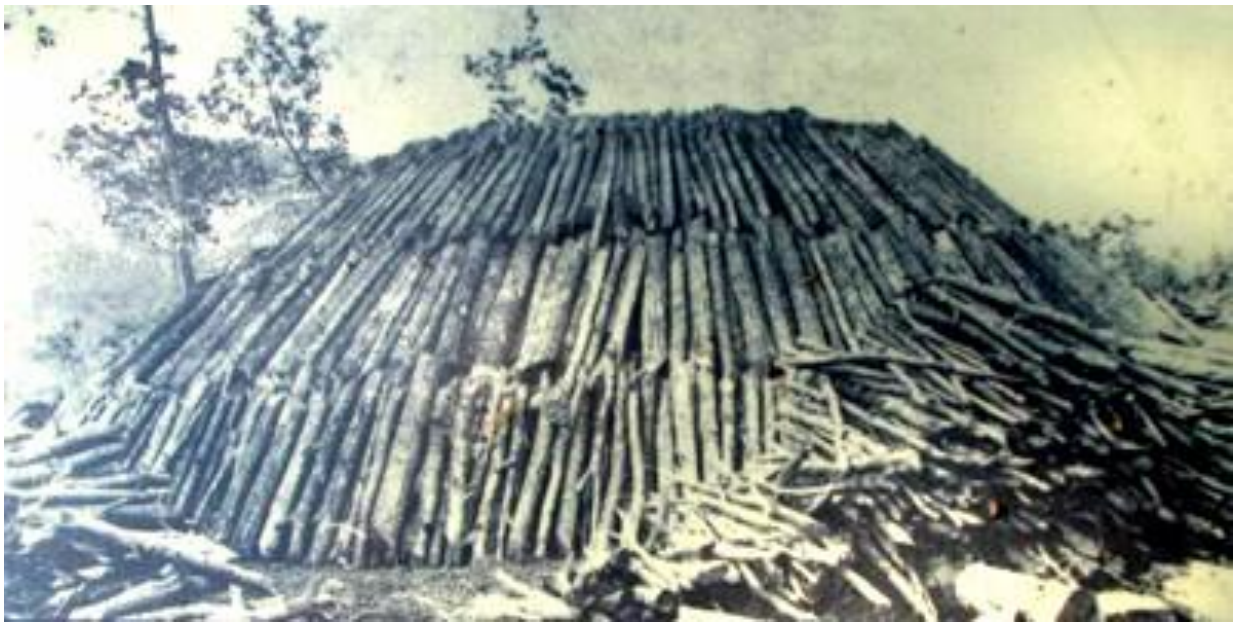
A controlled slow burning fire turned wood into charcoal

Controlling the burn was dangerous work. A collier who climbed the mound to add wood or inspect the fire could fall through if the outer walls had burned too thin to support the weight. The heat inside the mound was so intense that if a collier did fall in, rescue was considered futile and not attempted.

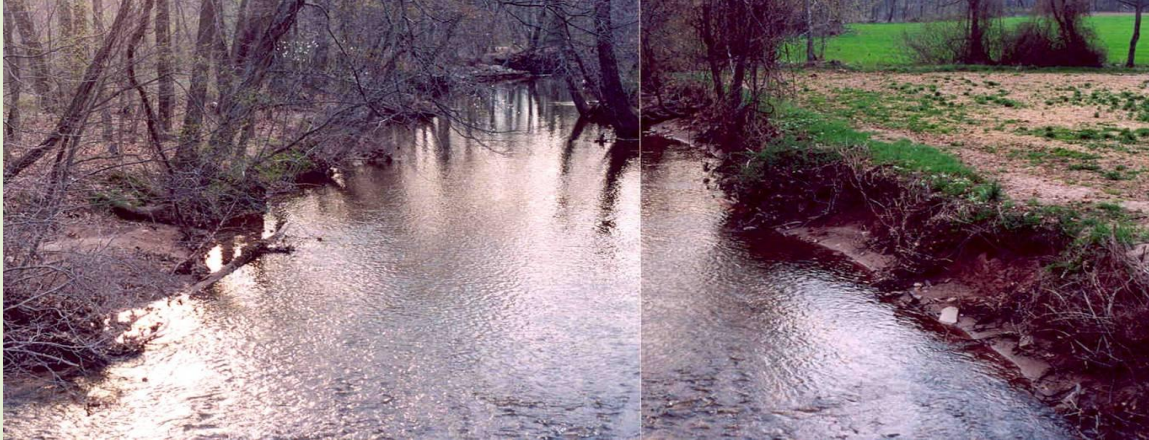
***Sandy soil near streams is highly erodible:** Composite photo view of both sides of creek shows impact of high water flows when protective forested buffers have been lost. Powell's Creek*

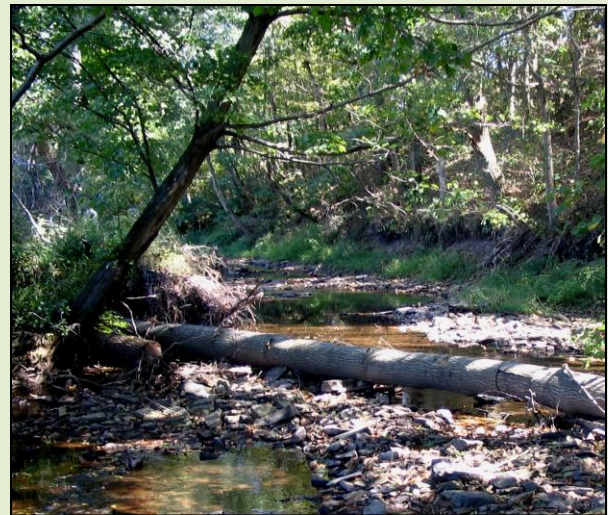
***Evidence of channel instability:** eroded banks, falling trees, over widened channel, excess gravel & sediment deposits blocking flow. Powell's Creek*

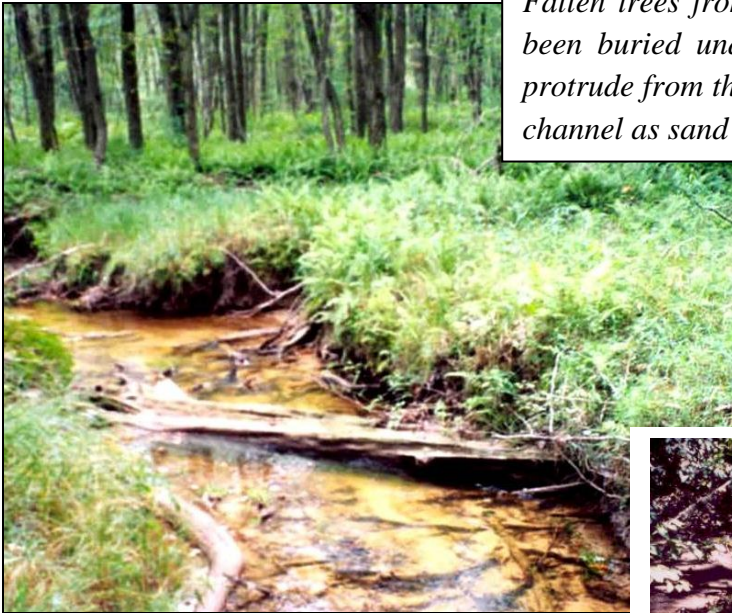
Fallen trees from many years ago which had been buried under nearly three feet of sand protrude from the bank, exposed by the stream channel as sand is carried downstream.

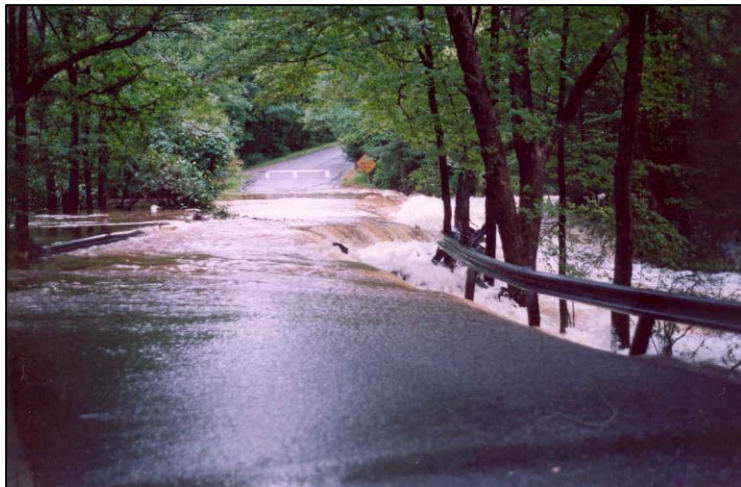
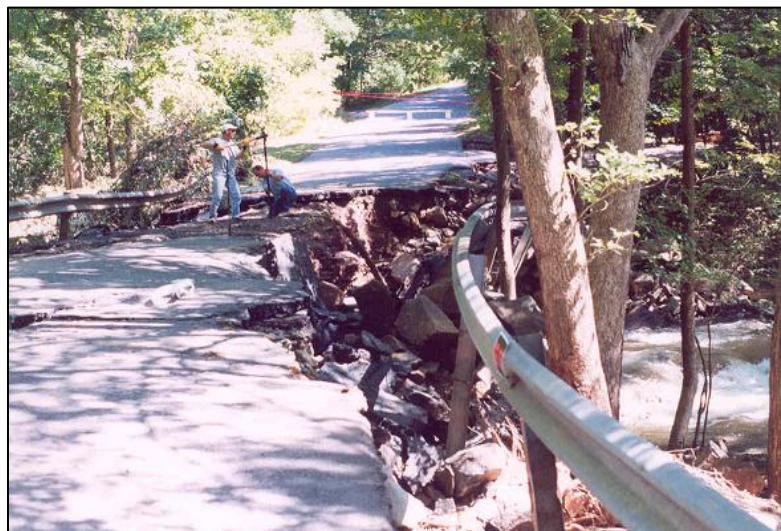
Left and below: South Fork Powell's, Carsonville Road crossing, during and after a flood event. The watershed's frequent heavy flows make protective vegetative cover even more important as a defense against erosion and sedimentation.

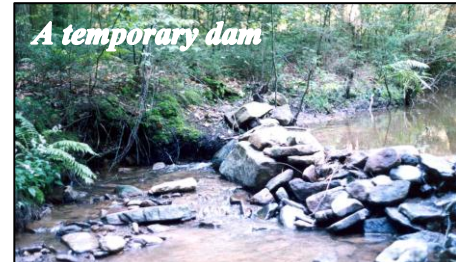
Permanent low head dam at Lucky Dutchman camp, SF Powell's just north of Back Road. It routinely fills with sediment, which reduces the macro invertebrate food sources in the vicinity. Water accelerates over dams in normal flows to create scour pools beneath. Deeper, cooler and aerated water is attractive to trout, which are stocked in the area, but stocked trout compete with natives for food and habitat. Erosion induced channel widening evident in photo.

A number of low head dams traverse the SF Powell's. There are a couple permanent structures intended to improve trout habitat. One (picture, next page) is just north of Back Road. Another smaller concrete structure is located upstream near the cottages in the area known as the Forks. There are also a few other very small dams assembled of rocks collected from the surrounding area. These are more temporary, and storm flows will likely dismantle them in time.

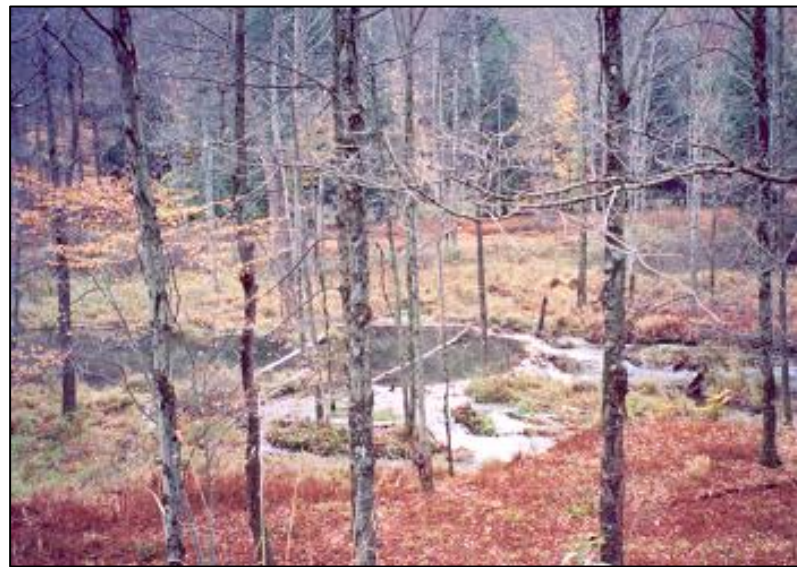
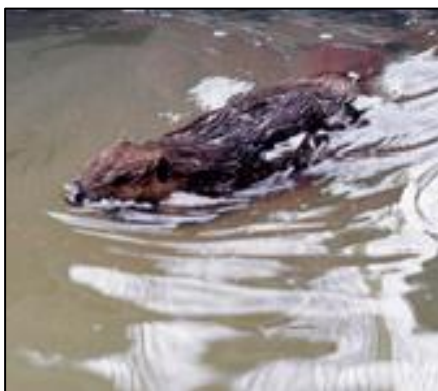
There is evidence of what was once a rather large dam near the lower end of the midsection, not far from Carsonville Road. The dam is no longer present, but there is an open area, thick with brush, adjoining the stream. The channel is quite wide, and the area nearby is very sandy. This colony has either been removed or may possibly account for the more recent, although less extensive, activity upstream.

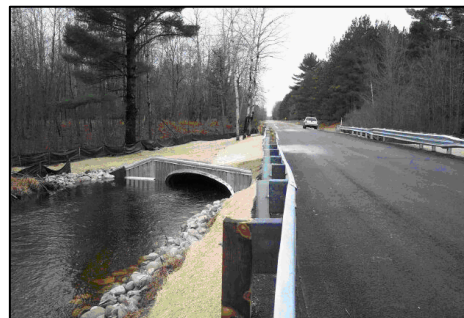
*In areas where multiple culverts are prone to blockage with branches and debris, the wider, longer, **bottomless arch and box culverts** are an ideal way to accommodate stream flows, especially during high water events.*

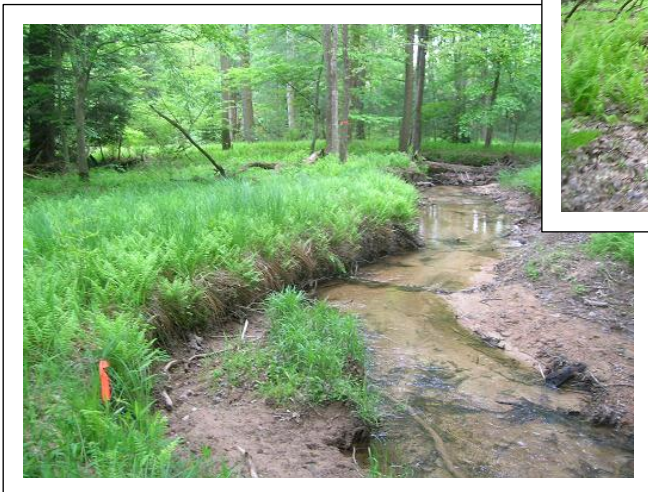
*Pool forms under tree root;
fallen branches provide cover.
Sand is evident in channel.*

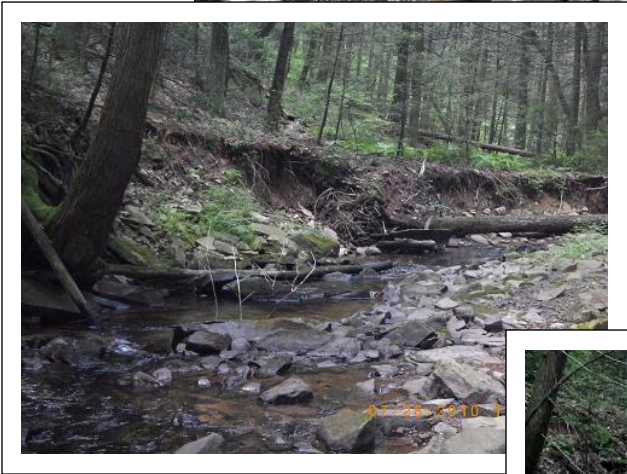
Site 2: Upstream of Back Road

Bank erosion is evident just below site. Steeper gradients flush sediment out of rock, gravel and pools; flat areas collect sand and sediment, filling in pools and smothering rocks & gravel.

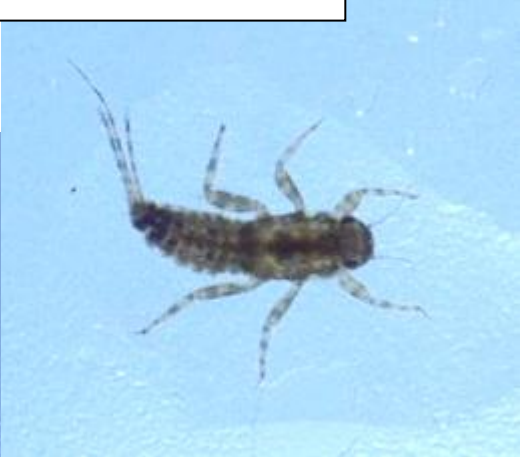
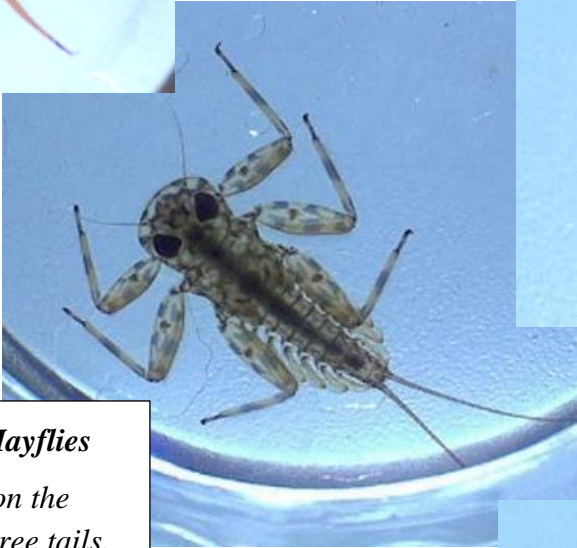
Several varieties of Mayflies
Mayflies have gills on the abdomen; most have three tails. Above, center, is Epeorus, the unusual two tailed mayfly – a sensitive species

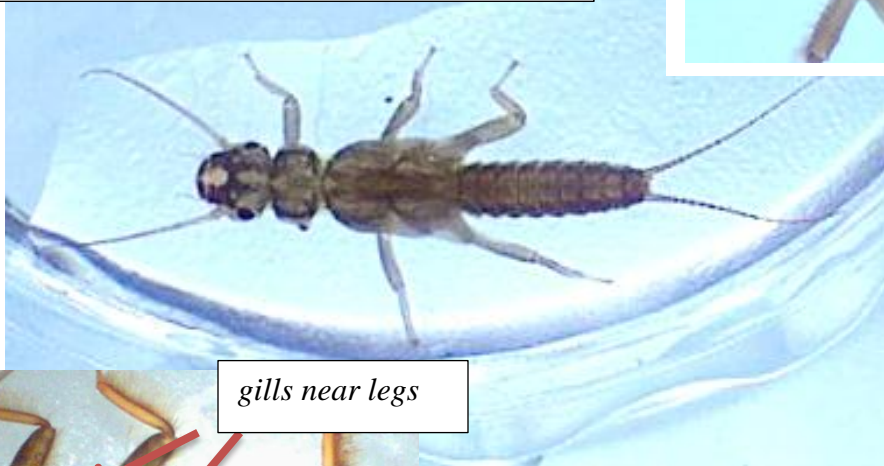
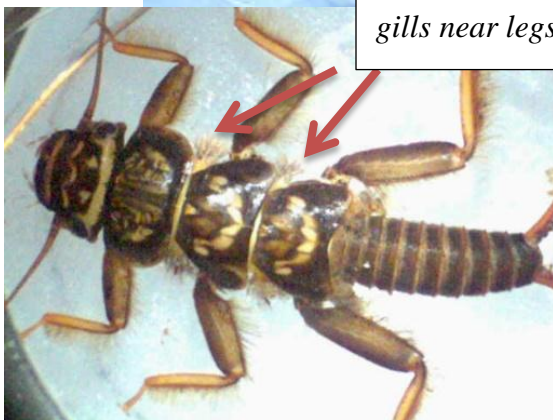
Stoneflies are sensitive to pollution. Stonefly nymphs have two tails. They have two pairs of wing forming pads (Mayflies have only one) and their gills are on the thorax rather than the abdomen. Color patterns, head and abdomen shape, and gill placement are some of their identifying features.

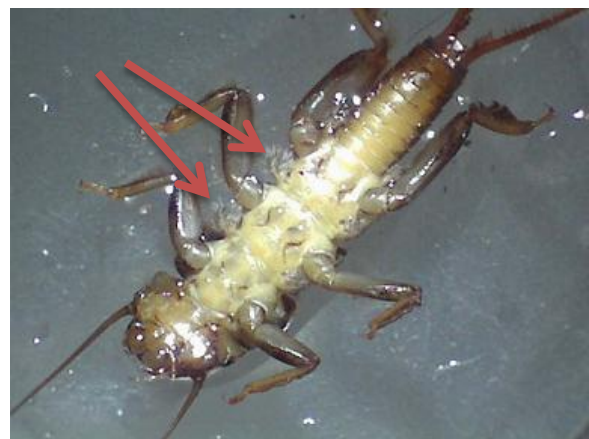
gills near legs

Some specimens were also photographed from the bottom to better view gill placement

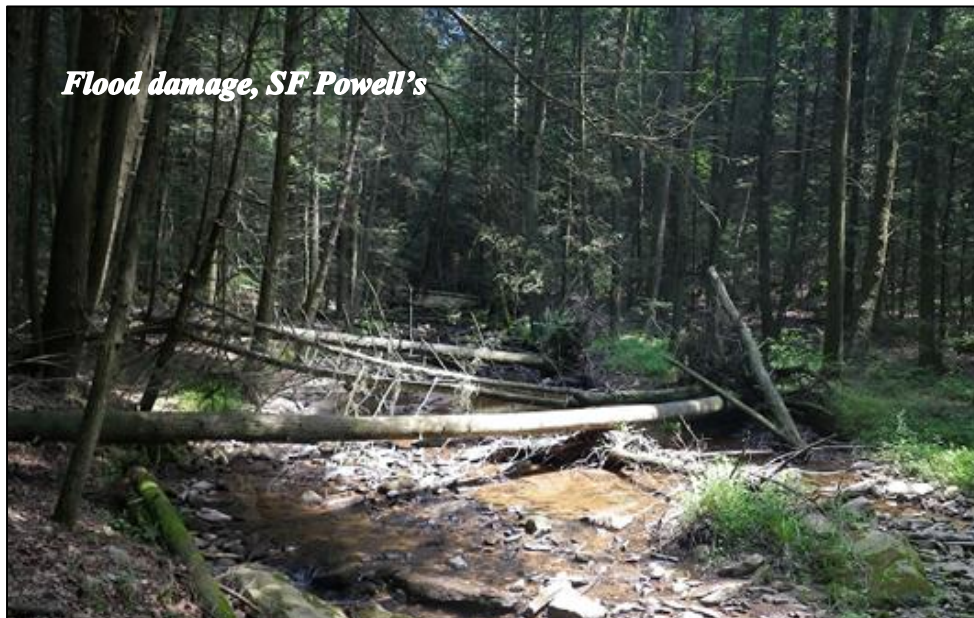
Precipitation, Powell's Creek Watershed 2011 – The wettest year on record

Rain - 79.2"; Snow - 33.25"

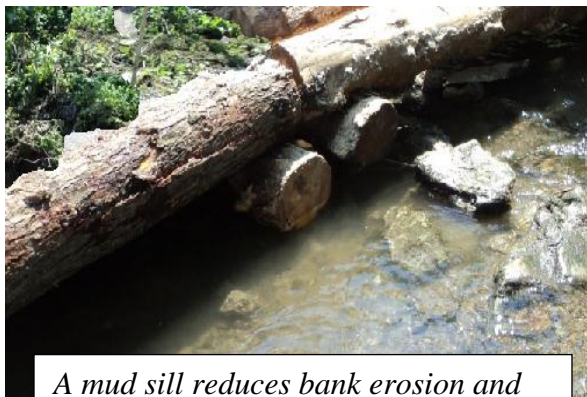
A mud sill reduces bank erosion and provides a hiding place for fish

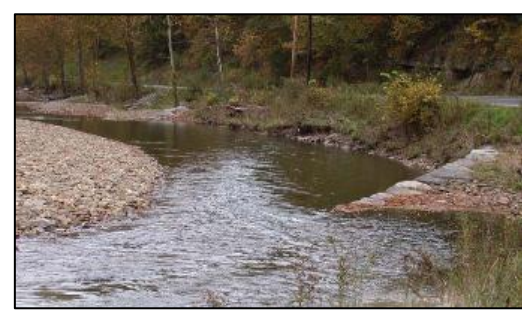
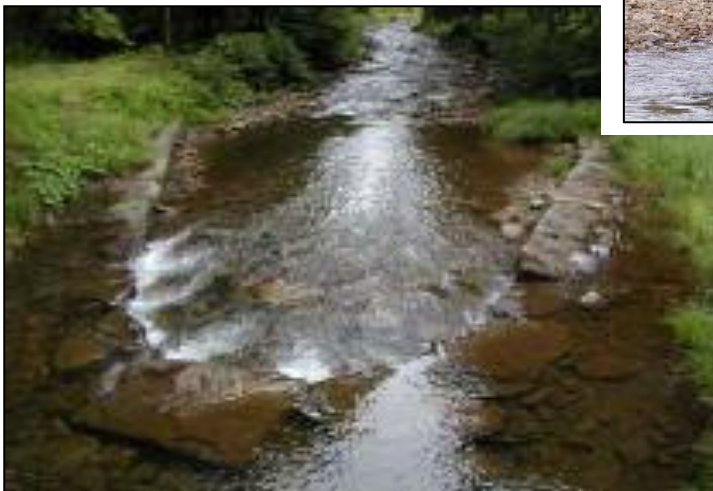
TVC volunteers inspect a professionally constructed stream bank protection and habitat restoration structure on a stream in Lancaster County. These types of structure (this one is a cross vane) mimic the natural processes of the stream.

These carefully designed structures direct the flow toward the center of the channel and away from the banks. They consolidate the flow during dry periods so that the stream can continue to flush sediment out of the scour pools they create. Sand & sediment collects near the upstream banks where it can be vegetated and help to reduce stream bank erosion.

By keeping the channel clear of excess sand and gravel, the structures improve aquatic insect habitat, an important food source for fish. Oxygenation is improved and scour pools, important for cover and for cooling temperatures in warm seasons, are maintained.

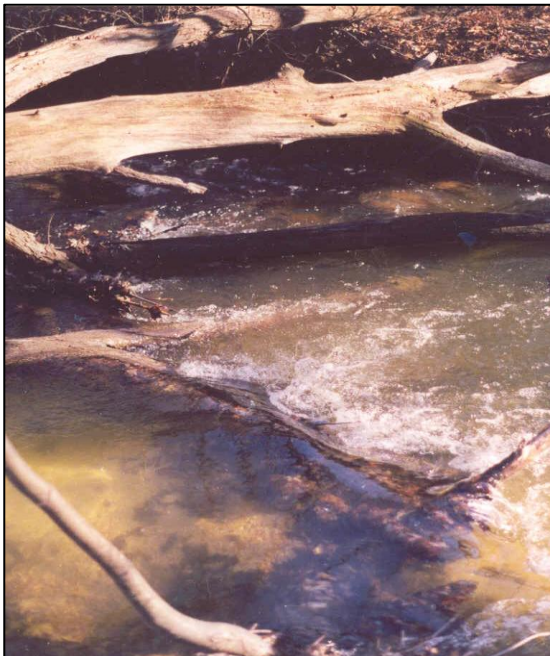
Fallen branches create a riffle dam, aerating water and scouring out a pool as it cascades over the branch. Trapped leaves are habitat and food source for aquatic insects, and provide cover for fish.

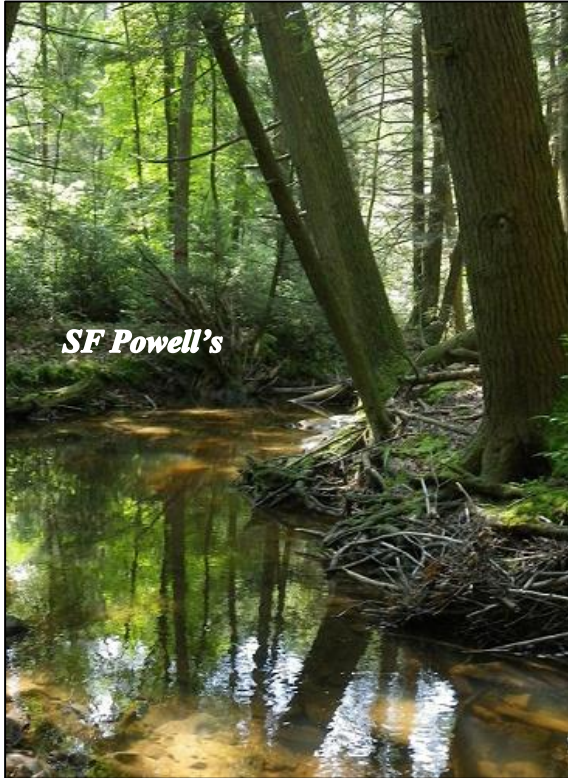
Forested buffers should include a brushy understory in addition to mature trees. Roots of mature trees re-enforce the channel and banks; their shade is important to maintaining cool temperatures during the warm season. Shrubs and brush also provide shade; they help slow down storm over-flows, filter sediment, and help to use up excess nitrogen during their growth periods. If the buffer is narrower than ideal due to nearby mowed or agricultural fields, a strip of uncut tall grass is also important to help filter soil and sediment being carried toward the stream by storm water.

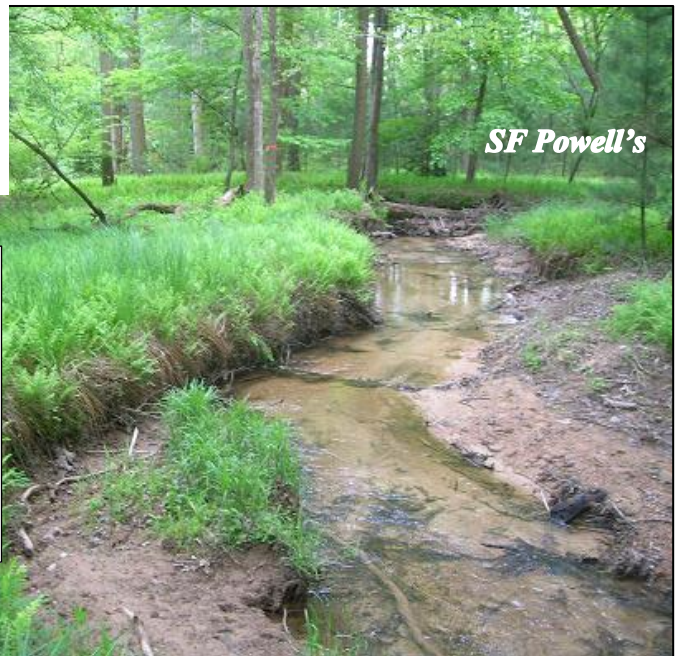
Thick brushy forest protects the stream from channel erosion and reduces sediment input from storm water run-off.

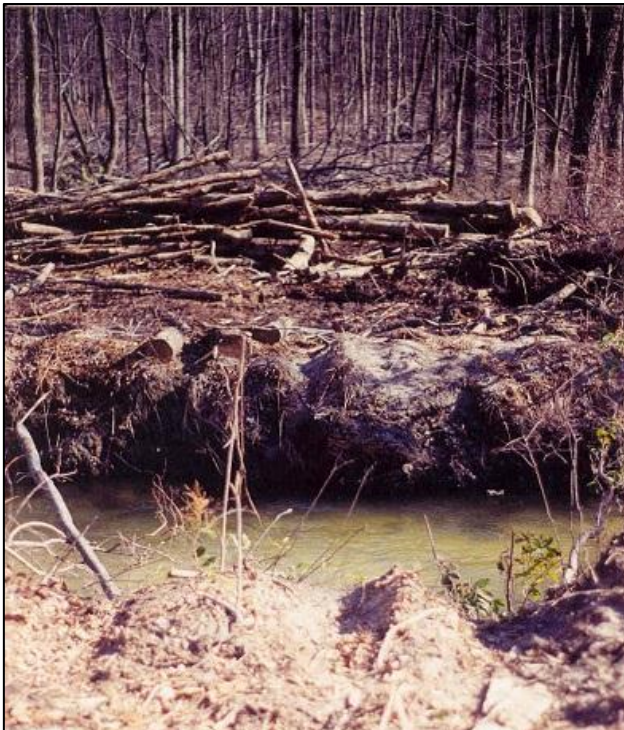
Logging in South Fork Powell's Watershed

Ruts where equipment was driven across stream; protective forest buffer removed, exposing sandy soil to storm water erosion

Due to the secluded location, land owners or their representatives are usually not present during timber harvesting activities in the SF Powell's watershed, and evidence of poor practices has been observed in the watershed. Avoiding stream crossings, disturbing wetlands and damaging trees that will be left standing for forest re-seeding is important, as well as leaving dead trees standing as wildlife habitat. Other best management practices include minimizing road width and the size of staging areas. Monitoring logging activities by land owners or their representatives should be encouraged to ensure best management practices are being followed.

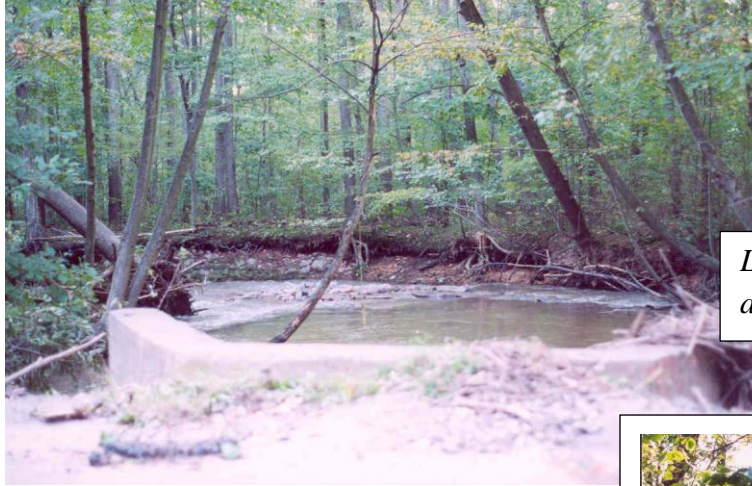
Left: "water cannon" effect – bank erosion and falling trees downstream

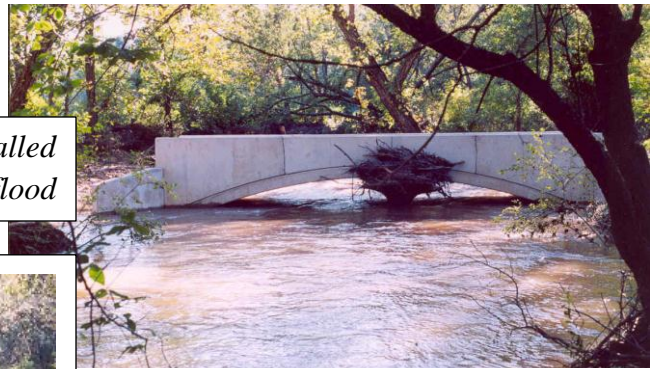
Above: this bridge obstructs even normal wet season flows.

Undersized **bridges and culverts** can impede storm flows and cause sedimentation upstream and erosion downstream. As the storm water backs up behind the obstruction, pressure builds up, increasing velocity as water is forced through the opening - the “water cannon” effect. As flow is forced around and through the obstruction, the banks and channel erode. The ponding that builds up behind an obstruction also leads to excess sediment accumulation upstream as the trapped water backs up. The pooling water loses velocity and no longer has the capacity to carry the sand and sediment that was washed in with the storm water. The sediment settles out along the banks and channel bottom as the flood waters recede.

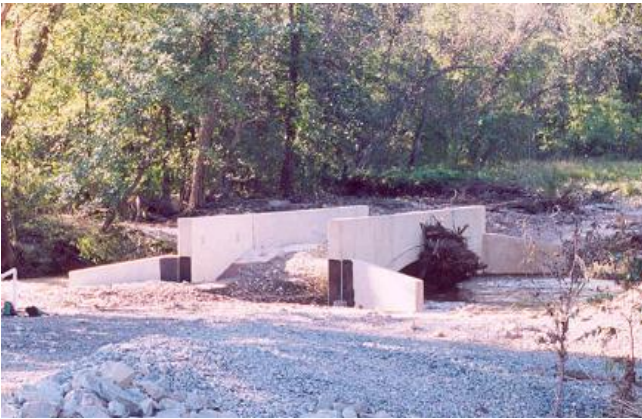
Above and right: bank erosion and deposition left by storm flows

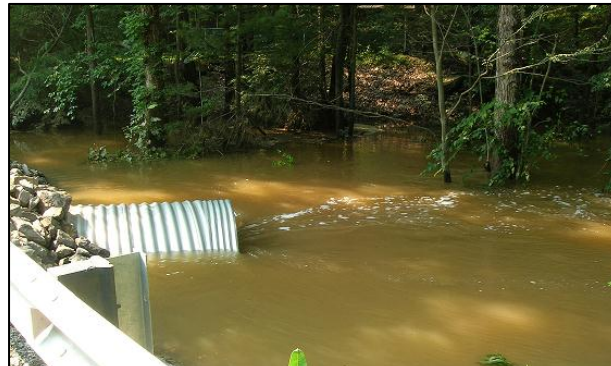
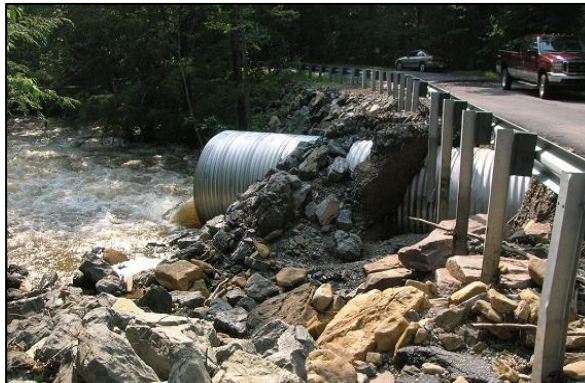
Carsonville Road crossing after a storm event: Ponding reduces velocity of backed up storm water, which will drop sediment up stream; increased velocity downstream scours out the channel bottom; erosion occurred where peak storm flow was forced over the road

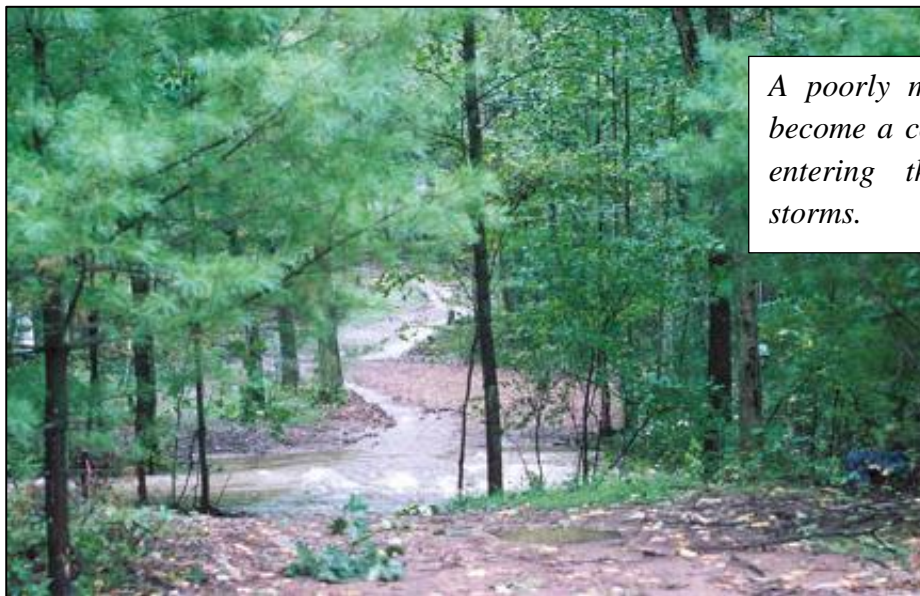
A poorly maintained dirt road can become a conduit for soil and gravel entering the stream during rain storms. Photo: NF Powell's
