Coplay Creek Watershed Assessment

COPLAY CREEK WATERSHED ASSESSMENT

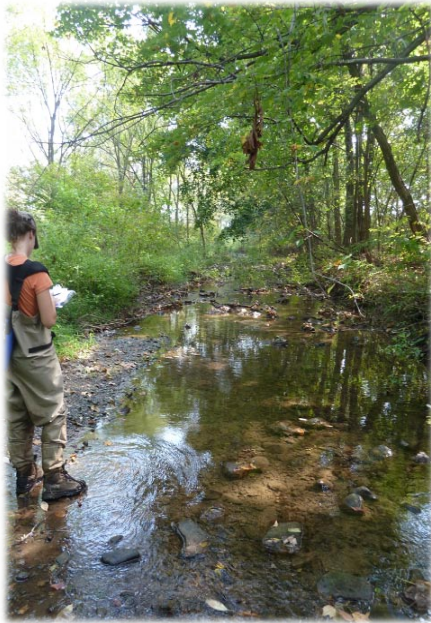
The visual assessment protocol used was generally based upon the United States Department of Agriculture (USDA)/Natural Resources Conservation Services (NRCS) Stream Visual Assessment Protocol, with modifications to the method so that it is easier for volunteers to use. Additions were made to the standard protocol to collect data on the material on the stream bed, and in the stream banks, which will assist with future stream and flood plain restoration projects. The visual assessment protocol used an excellent/good/fair/poor rating scale for certain parameters, and asked for a narrative explanation of others. A copy of the assessment sheet is included as [Figure: Visual Assessment Data Sheet](#).

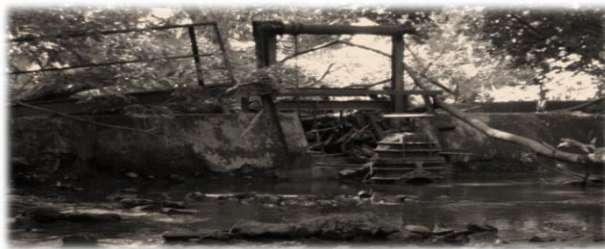
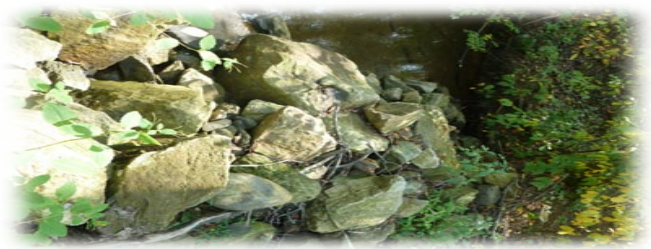
Stream Alteration: This describes the degree to which the stream has been visibly altered or confined by human activity. Bridge crossings, retaining walls, dams, dykes, or rip-rap banks (lined with large rocks) are all considered alterations. These structures are of concern because they constrain the natural functioning of the stream channel, reduce habitat, and reduce natural conditions for aquatic wildlife. There is generally little that can be done about most of the stream alterations, as existing bridges and stabilized stream banks cannot be removed. The presence of in-line dams and rock dams was also noted; these structures, especially rock dams, can be removed to restore the streams natural patterns.

Recommendation: Where feasible, when bridges are replaced, ensure that they are adequately sized to prevent acting as obstacles to the free movement of stormwater.

Recommendation: Remove all existing in-line dams and rock dams in the Coplay Creek (see [Map: Barriers to Fish Movement](#)).

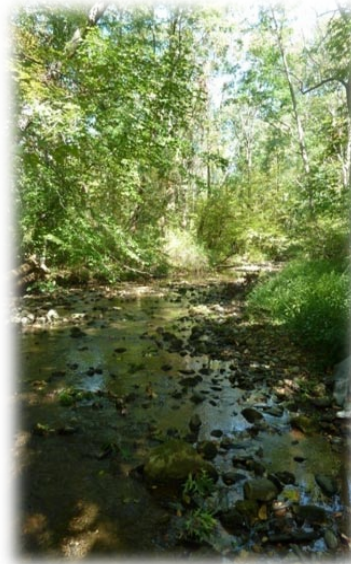
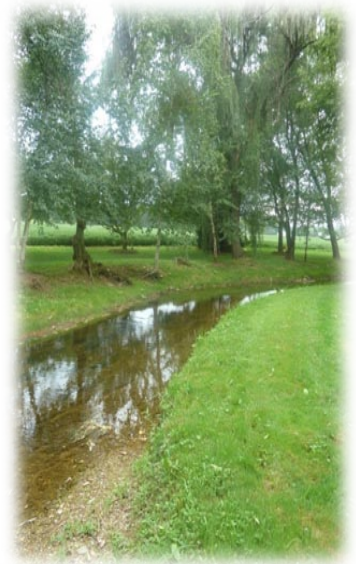
Riparian Zone Condition: Ideally, all streams should be protected by a forested or meadow riparian buffer of full-height (i.e., not mowed) trees or meadow grasses. This buffer protects the stream from overland runoff, removes pollutants such as nutrients and silt, and stabilizes the banks with deep, thick root systems. There was quite a bit of variability in the riparian zone condition along the Coplay Creek, from excellent (a buffer over twice as wide as the stream is) to poor (stream bank mowed to the edge or paved). Where ratings were other than “excellent”, opportunities exist for improving the buffer condition.

According to recent regulations put in place by the PADEP, all streams are best protected by a stream buffer of at least one hundred and fifty feet (150’).

Recommendation: Where riparian buffers are less than “excellent”, contact landowners with information about the benefits of riparian buffers and resources available to encourage their installation.

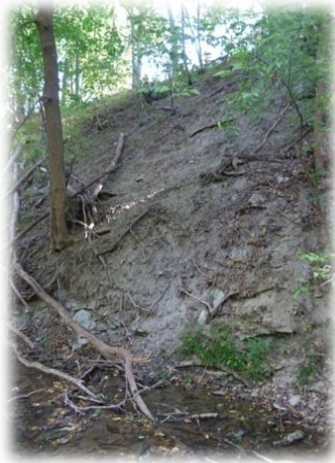
Floodplain Access/Channel Incision: A channel in a natural condition has low banks, less than a foot or so high, allowing the channel to easily access its flood plain during storm flows. When channels are deeply incised, there is enormous erosion pressure on the banks during flood flows, as fast-moving storm water cannot reach the flood plain, spread out, and slow down. The majority of the Coplay Creek had banks 3 feet in height, with little chance for flood waters to spread out and abate.

Recommendation: Regrade the banks where possible, creating shallow, vegetated banks.

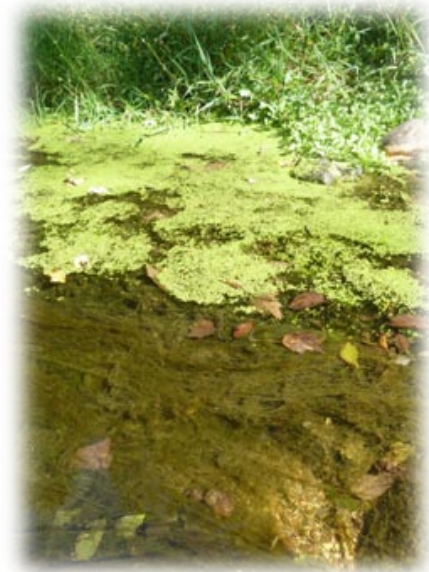
Nutrient enrichment describes the amount of aquatic vegetation on the stream bed and on the rocks on the stream bottom. The amount of aquatic vegetation generally reflects the amount of nutrients in the stream, specifically nitrogen and phosphorous. The excessive amount of vegetation becomes a concern when the algae begin to decompose and consume dissolved oxygen in the water column; fish are unable to survive when the dissolved oxygen in a stream falls below 6.0 mg/L. Sources of nutrients include lawn and farm fertilizers, poorly functioning septic systems, manure on fields, and sewage treatment plant discharges. Throughout the Coplay Creek, there is considerable variation in the level of nutrient enrichment. There were several areas where algal and aquatic vegetative growth was significant. In one location, it appears that fertilizer may be running off into the stream directly. On the agricultural lands, manure also contributes to nutrient enrichment.

Recommendation: Follow up with landowners whose property has significant nutrient enrichment with suggestions for improving the riparian buffer, and decreasing the amount of nutrients reaching the stream.

Recommendation: Take dissolved oxygen measurements in areas with severe nutrient enrichments.
