# **COLDWATER CONSERVATION PLAN**

## **Furnace Run and Segloch Run 2004**

**Furnace Run / Segloch Run Watershed Alliance**

**Rettew Associates, Inc.**

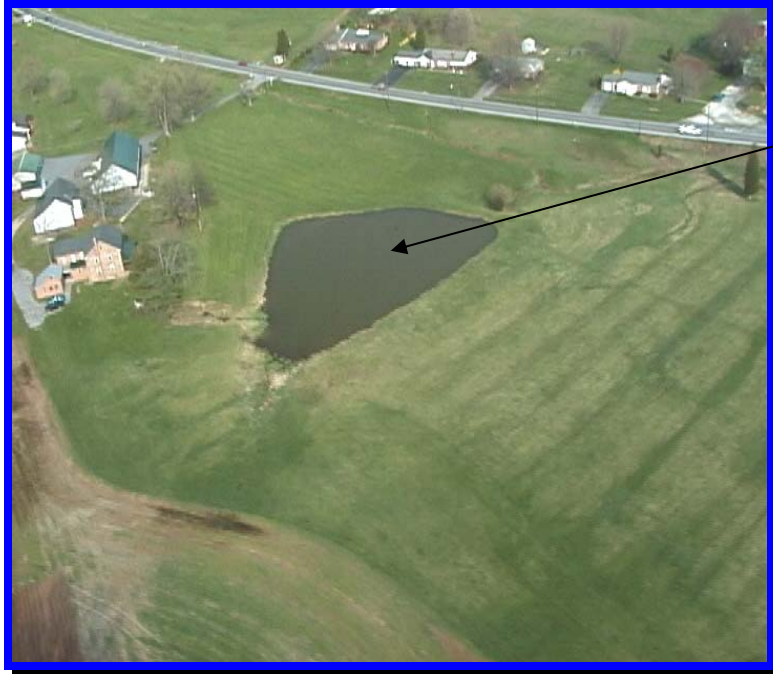
### Photos #1 and #2

Improvements in the way of installing a bottom discharge to draw the cold bottom water from the pond would greatly aid in maintaining Furnace Run as a coldwater fishery as would the planting of a forest riparian buffer around the pond and the stream channel.

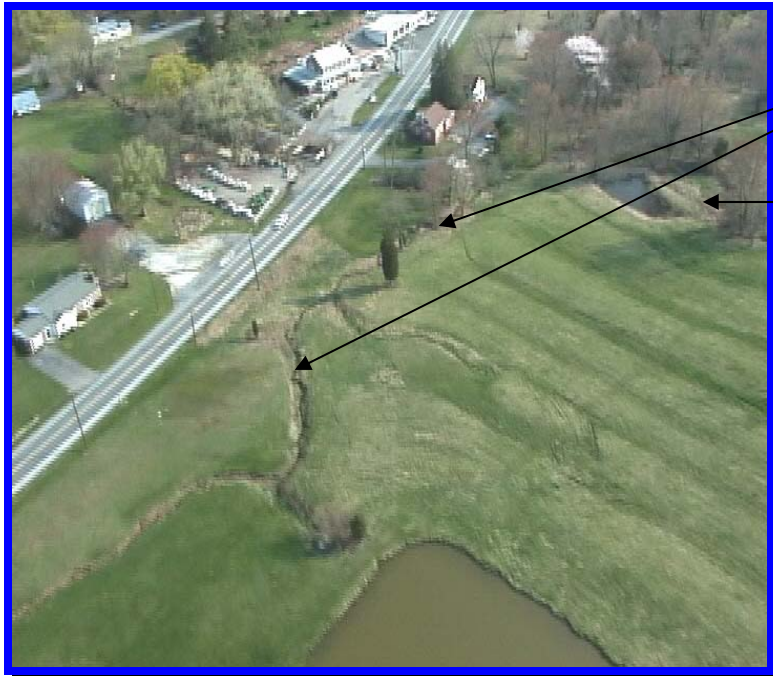
The second, smaller pond is fairly well shaded and less of a priority in regards to installing a forest buffer.

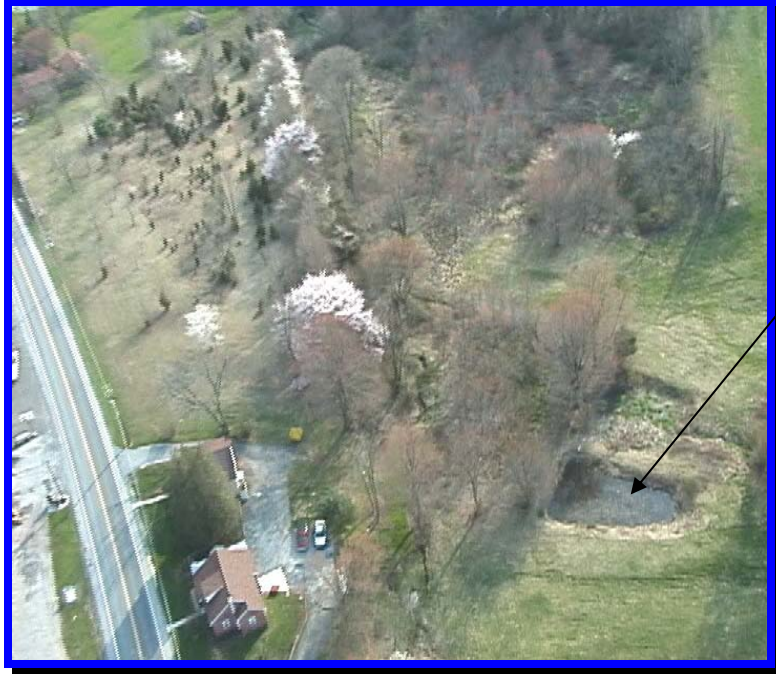
**Photos #3 and #4**

The same small pond as previously pictured in photo #2.

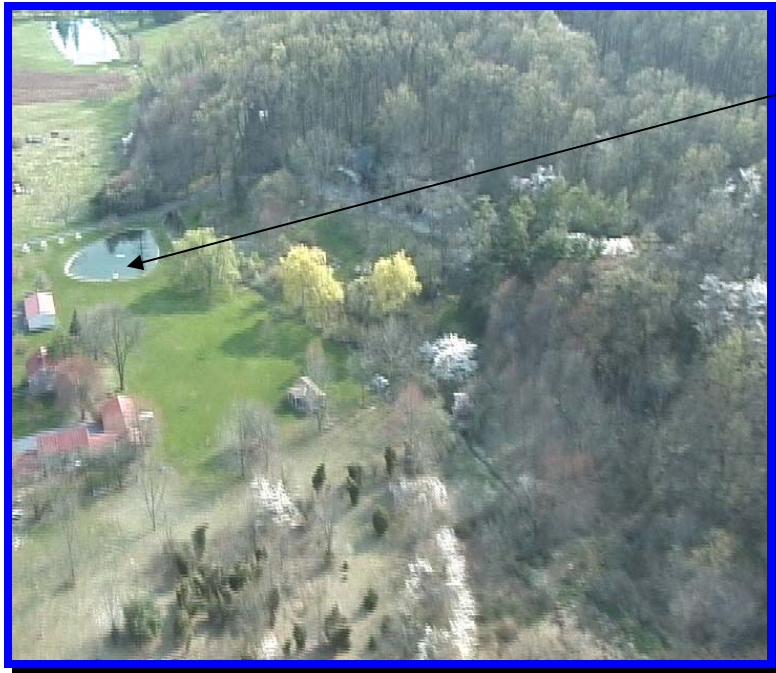
A third pond on Tract #1.

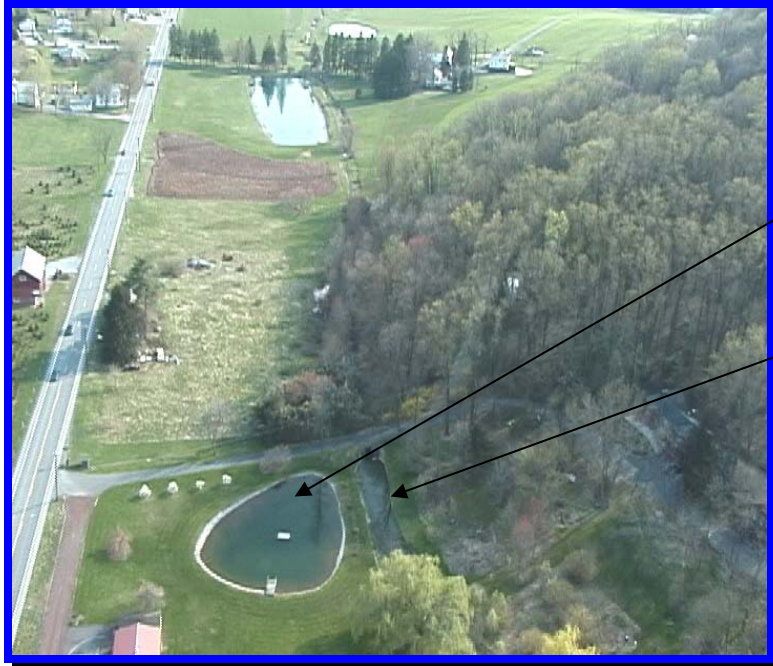
### Photos #5 and #6

Furnace Run can be seen to the right of the pond. A lawn condition is maintained right up to the top of the stream bank in this backyard setting.

It is suspected the pond is chemically treated with possibly “Aqua-shade” given its unnaturally blue color as viewed from the air. The “Aqua-shade” product is not necessary harmful to Furnace Run, but other chemicals such as copper sulfate commonly used to control algae blooms could be damaging to the aquatic community in Furnace Run because of its possible disruption to the food chain beginning with in-stream plant materials (including necessary algae).

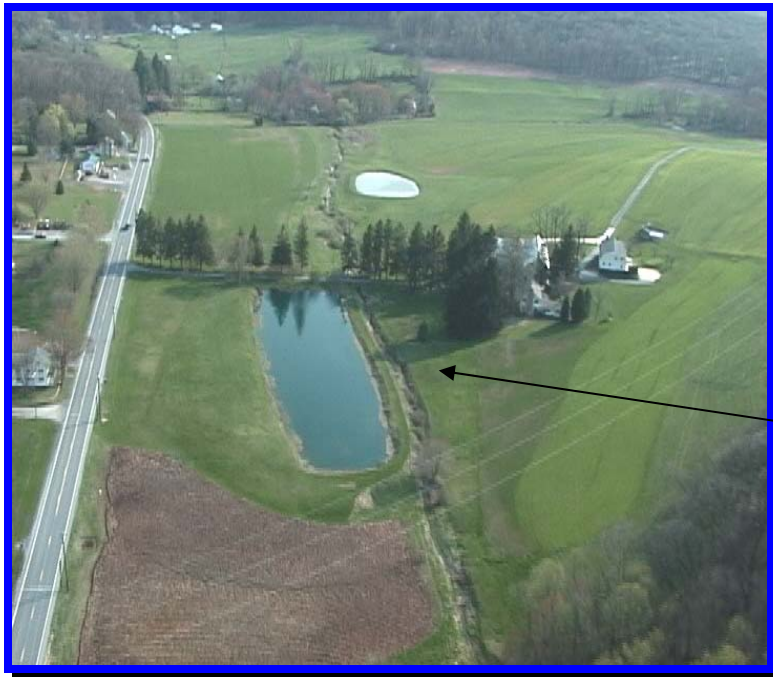
Tract #11 and its two farm ponds. As was the case with the ponds on Tract #1, these ponds and stream channel could be improved with forest buffer plantings and bottom discharges in the ponds.

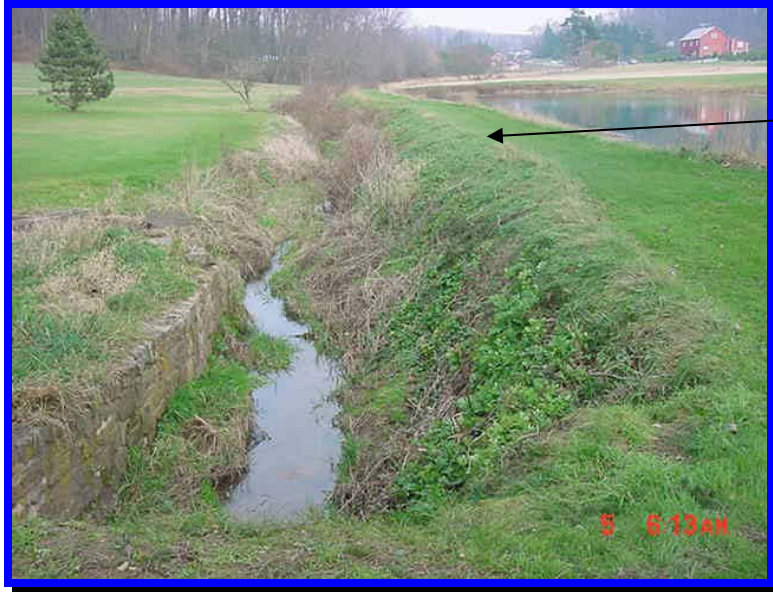
**Photos #7 and #8**

Photo #7 was taken from the driveway crossing looking upstream at Furnace Run. Tract #11's larger farm pond can be seen on the right side of the photo.

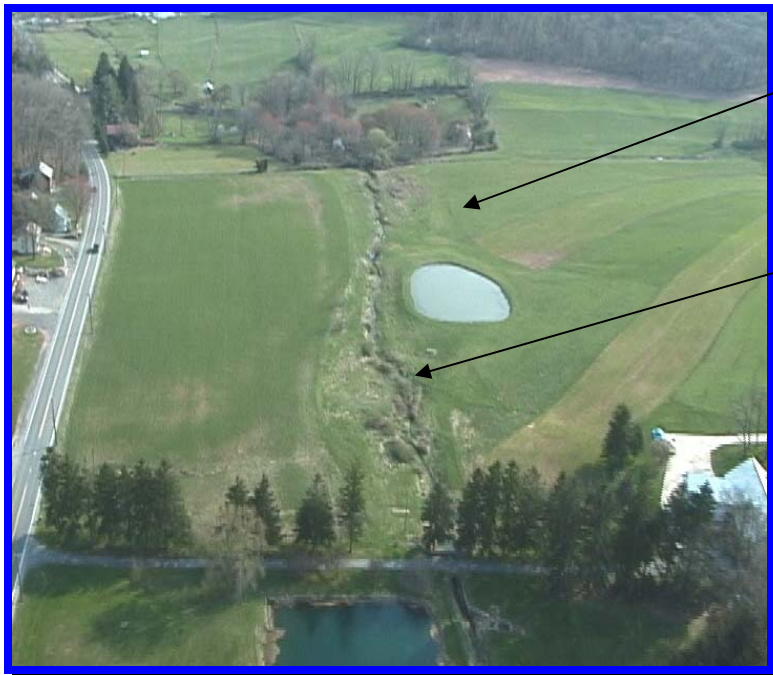
Photo #8 is an aerial view looking at the second, smaller pond on Tract #11.

A well planned and planted forest buffer would be a beneficial "best management practice" to install along the stream channel as seen in this photo. This landowner could greatly benefit from the CREP program.

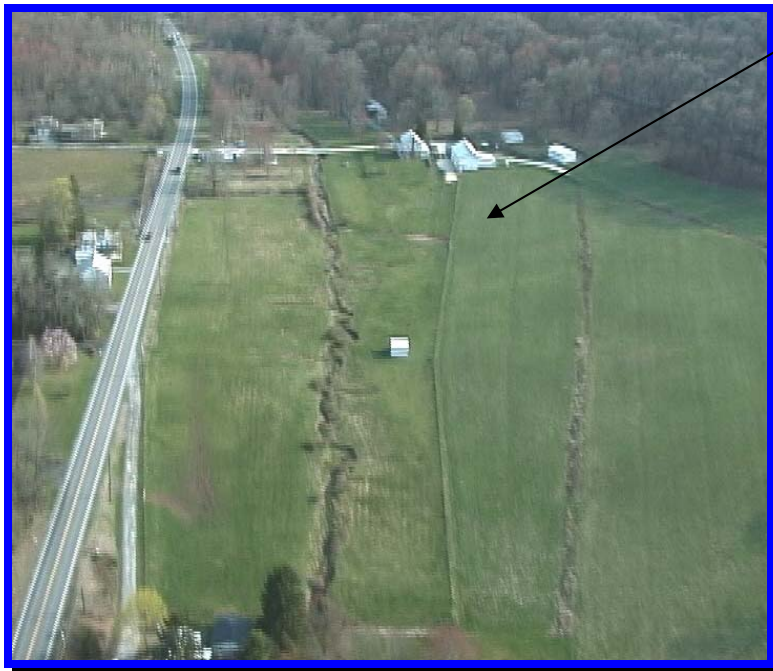
Photo #10 is an aerial view of an active pasture on Tract #21 where livestock have free access to the stream channel. Stream bank fencing and a forested buffer would be beneficial. The stream bank erosion that was evident would likely heal by itself if livestock access was denied. A stone ford cattle crossing could be used to provide access to both sides of the stream and also serve as a watering location. This landowner could greatly benefit from the **CREP** program.

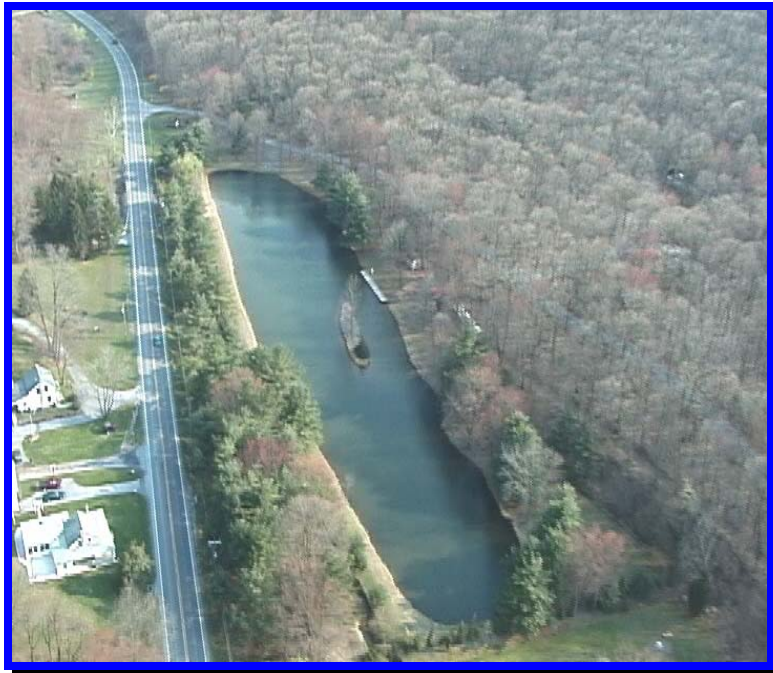
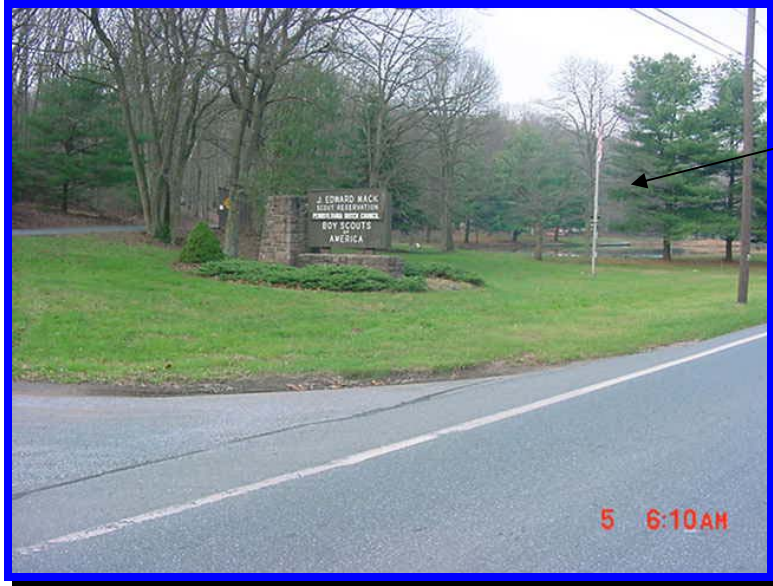
**Photos #13 and #14**

The entrance to the J. Edward Mack Boy Scout Reservation (Camp Mack) off of Rte. 501.

The Alliance should consider approaching the boy scouts and inviting them to participate in stream restoration activities. Because of their active location within the watershed and their close proximity to a number of projects well within their “hands on” capabilities, the boy scouts could prove to be an invaluable asset.

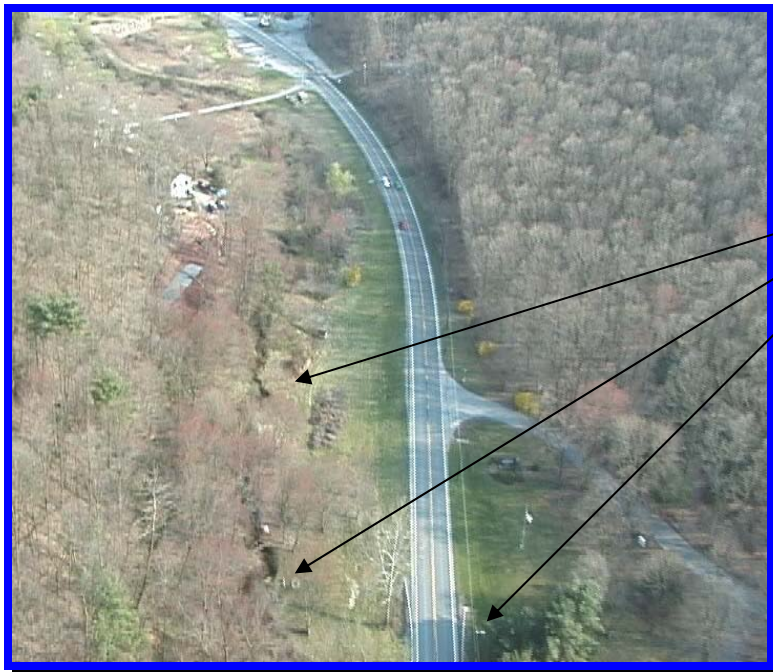
Photo #14 shows an aerial view of Furnace Run where it crosses to the other side of Rte. 501 near the Camp Mack entrance.

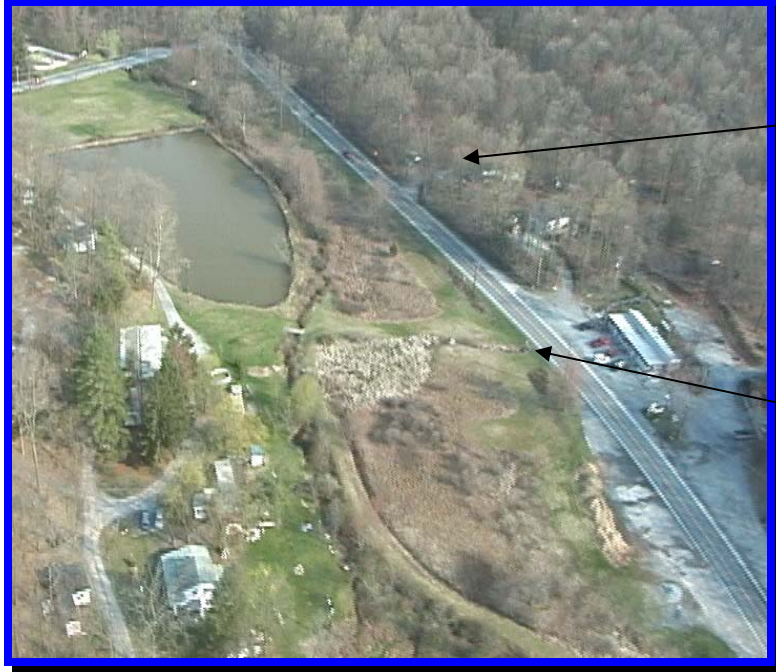
**Photos #15 and #16**

Spring Lake is yet another obvious thermal pollution source which could be improved upon with the addition of a bottom discharge.

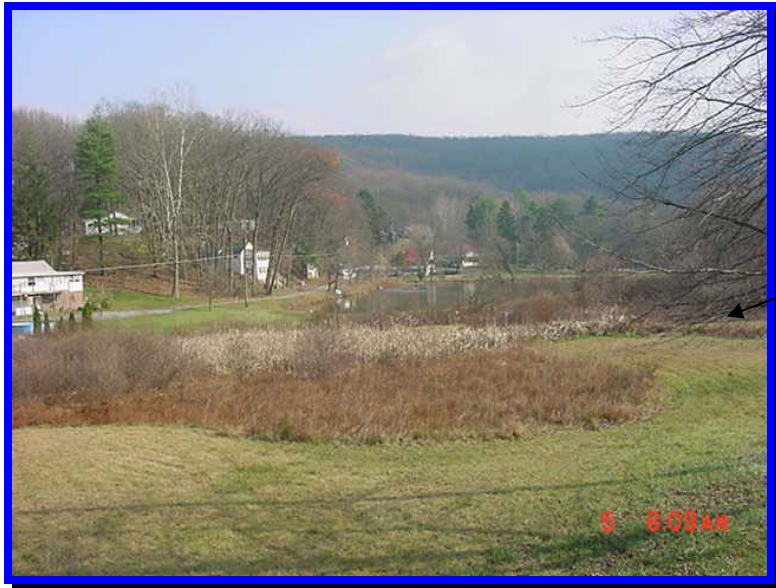
A ground view of the wetland with Spring Lake in the background.

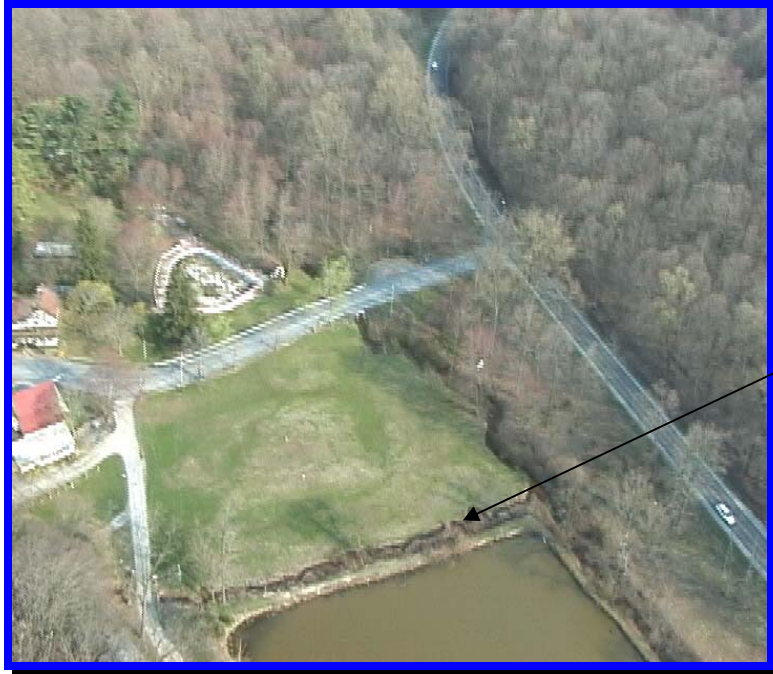
### Photos #17 and #18

Closer view of the bottom end of Spring Lake and the old public swimming pool no longer in use.

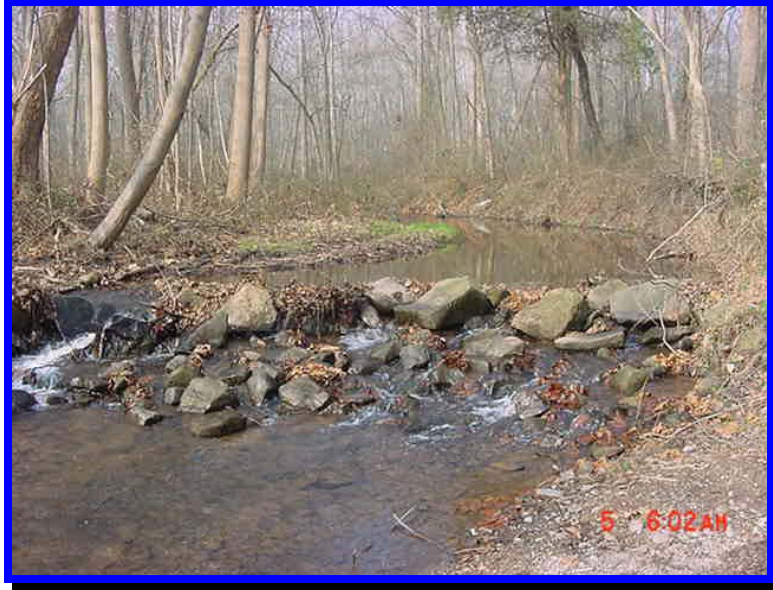
### **Photos #19 and #20**

Photo #20 shows the downstream (southside) end of the PA Turnpike underpass culvert through which both the stream and farm vehicles pass. This culvert also creates somewhat of a migration block in that the substrate is forced to be wide and shallow.

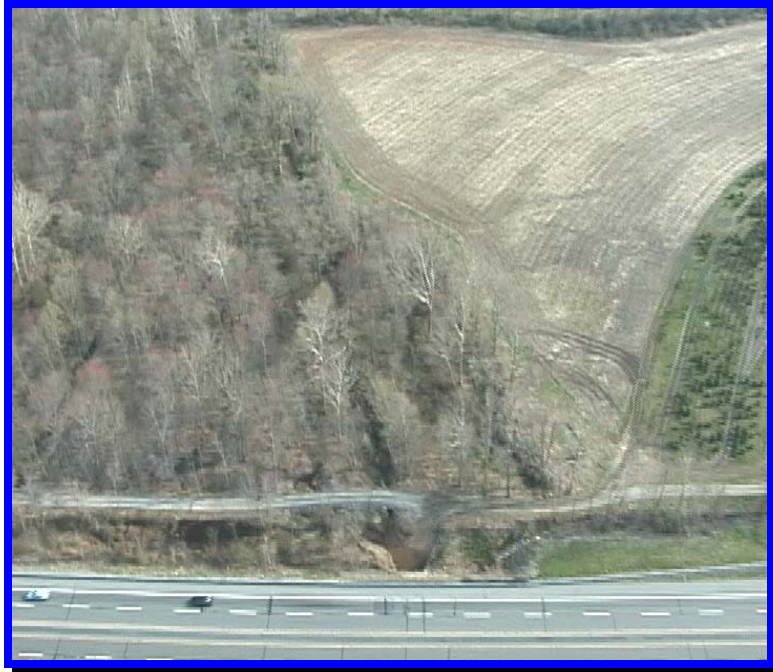
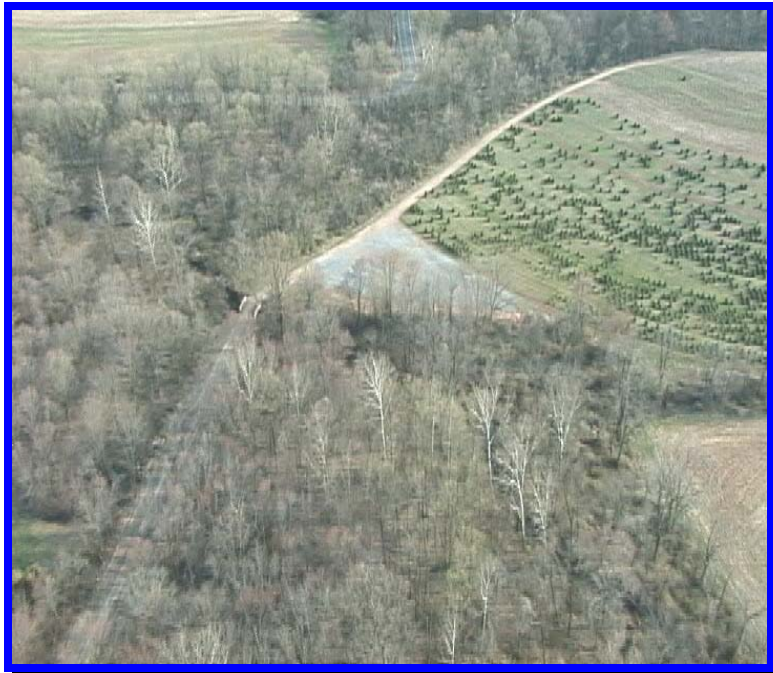
### **Photos #21 and #22**

Aerial photos #21 and #22 show Furnace Run on the south side of the PA Turnpike on Tract #54. The stream is well surrounded by a forest buffer, though much of the understory is dominated by multiflora rose. The limiting factor in regards to trout habitat is the availability of instream habitat. Trout (mainly native Brook trout) are present above and below the PA Turnpike but are limited to a few suitable runs and pools. The numbers and especially the size of the trout could be enhanced with the addition of instream fish enhancement structures such as log deflectors, cribbing and the like.

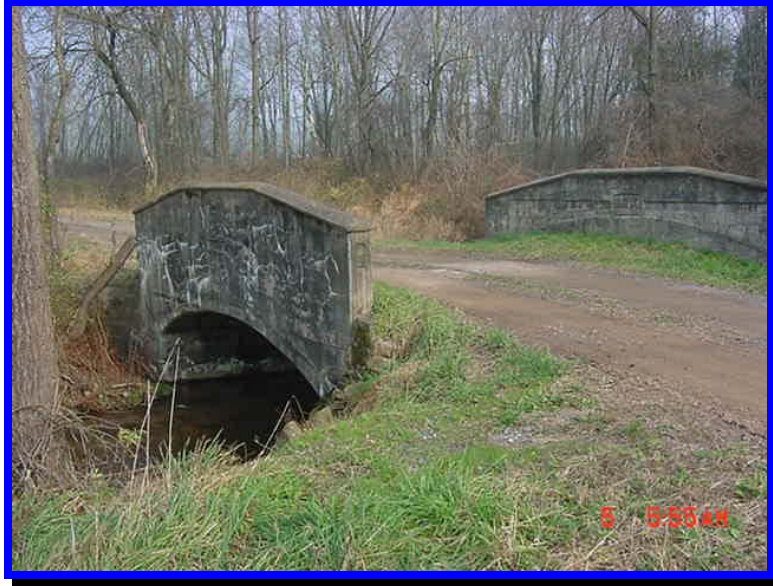
### Photos #23 and #24

This old bridge within Tract #56 at one time was part of Hopeland Road prior to the construction of the PA Turnpike. It now serves as a crossing for farm equipment. Fairly good trout habitat exists immediately below the bridge though again the forest understory is dominated by multiflora rose.

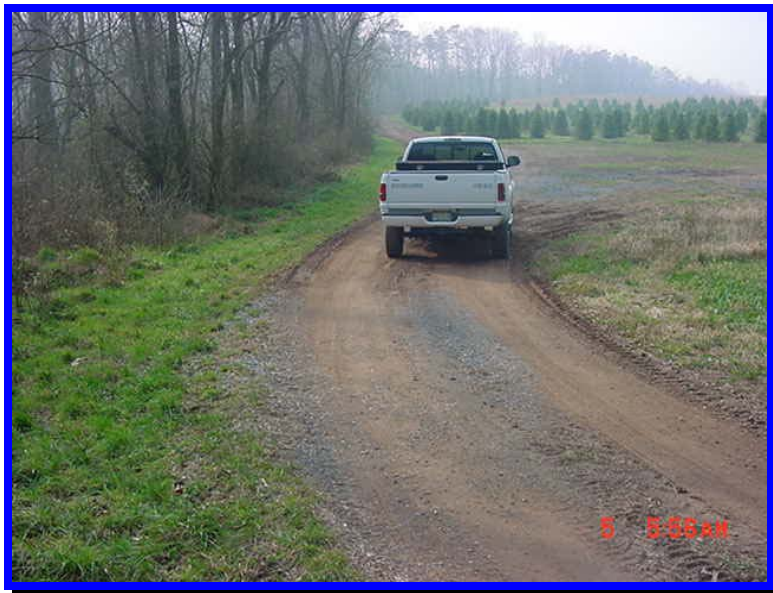
This farm lane on Tract #56 could be improved with various erosion and sedimentation measures so as to avoid sedimentation during rain events. Devices such as broad base dips could divert sediment laden runoff into grass and forest lands for filtering. Grass swales along the lane coupled with culverts could keep upslope water clean and diverted rather than having it enter onto the farm lane.

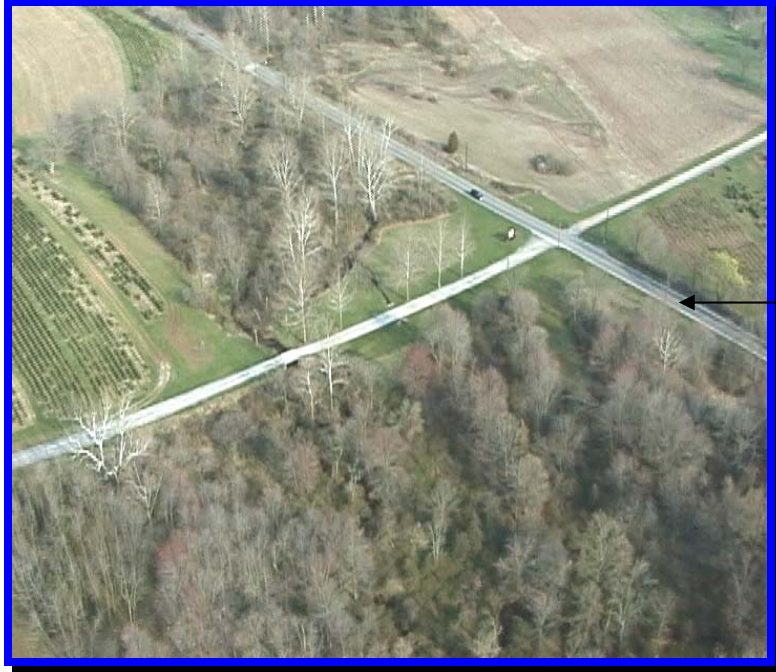
**Photos #25 and #26**

Aerial photo #25 and #26 show Furnace Run as it continues in a southwest direction.

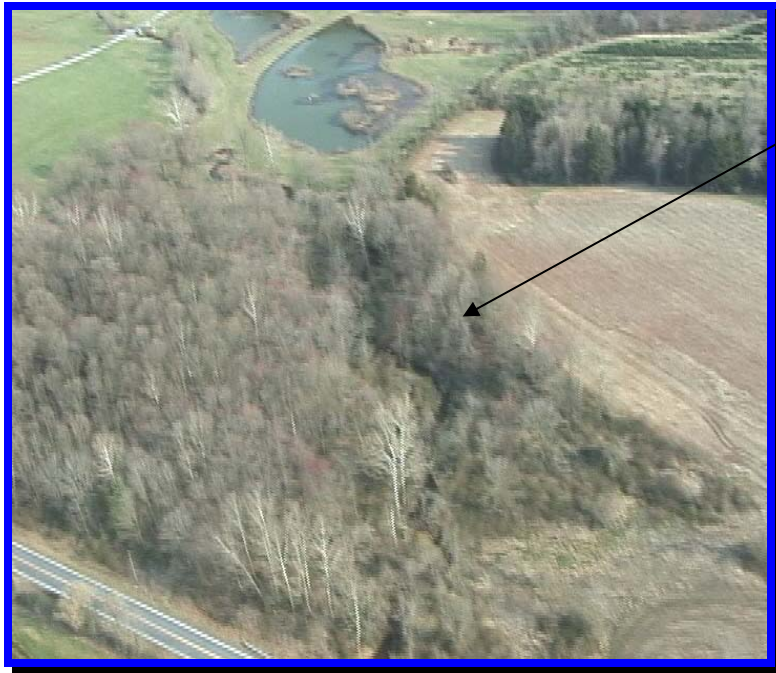
This little wooded patch south of Hopeland Road harbored both wild Brown trout and native Brook trout.

Habitat through this section of Furnace Run needs little improvement.

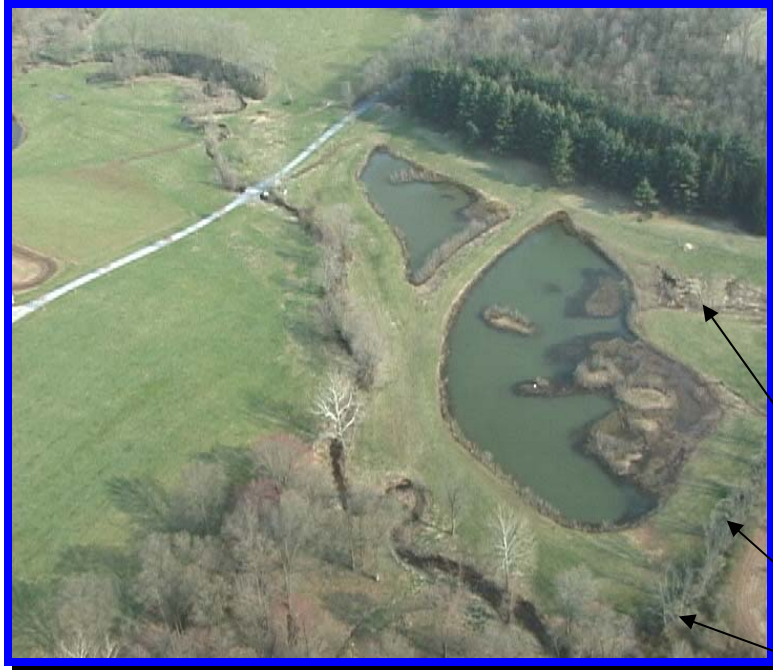
**Photos #27 and #28**

Aerial photo #27 shows two man made wetlands on Hopeland Farm (Tract #59).

The trade off of diverting the spring from Furnace Run into the created wetlands is questionable and certainly something that would not have been done in the interest of maintaining a coldwater fishery in Furnace Run. RETTEW suggests diverting the majority of spring flow back into Furnace Run and letting the wetlands become more of a palustrine wetland type rather than the open water condition now so prevalent throughout much of the created wetland area.

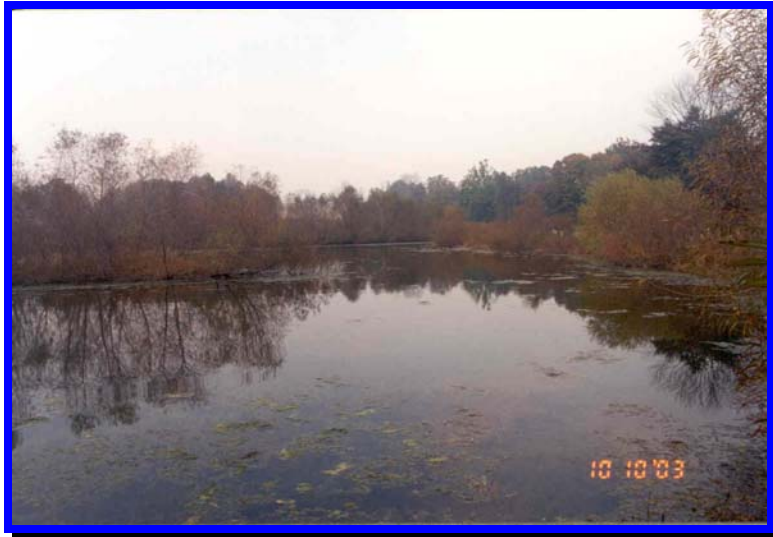
Above – A view of the larger impoundment which serves as a thermal pollution source to Furnace Run.

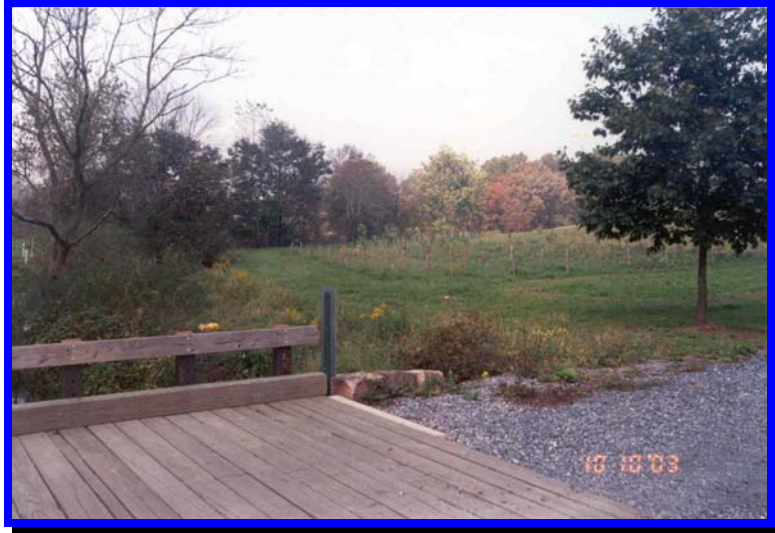
**Photos #29 and #30**

The new wooden bridge at Elser Hill Road installed by Elizabeth Township with financial assistance from Hopeland Farm and the Commonwealth's Dirt and Gravel Road maintenance program was a much better alternative than the originally planned pipe culvert crossing. The wooden bridge spans the stream channel and allows for a natural substrate underneath the bridge as compared to the metal surface of the inside of a pipe.

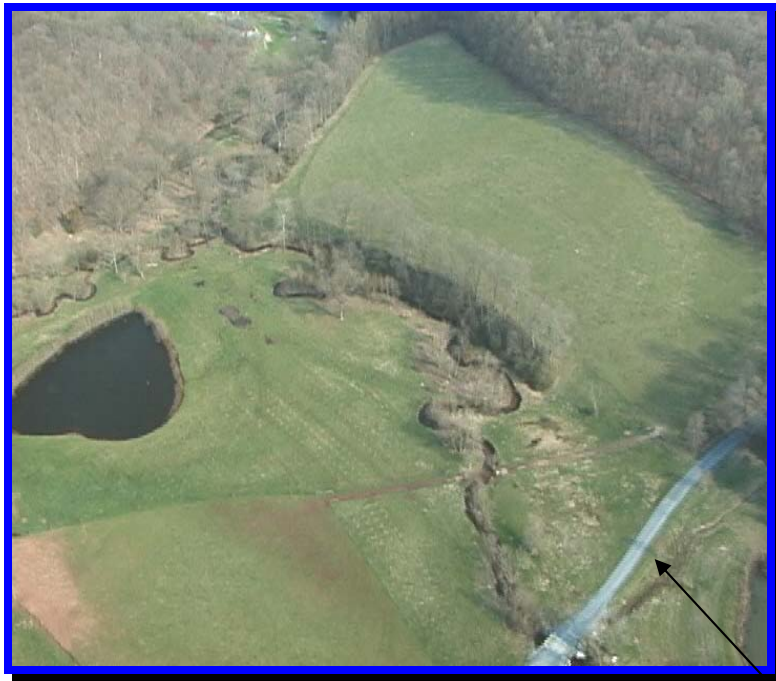
### Photos #31 and #32

Although the aerial photo doesn't show it, this section of Furnace Run flowing through Hopeland Farm is part of a huge forest buffer planting and streambank fencing project made possible through the cooperative efforts of Hopeland Farm, the Chesapeake Bay Foundation, the Stroud Water Research Center and the Commonwealth's CREP program. Only time and maintenance of the installed best management practices is all that will be necessary to improve this reach of Furnace Run.

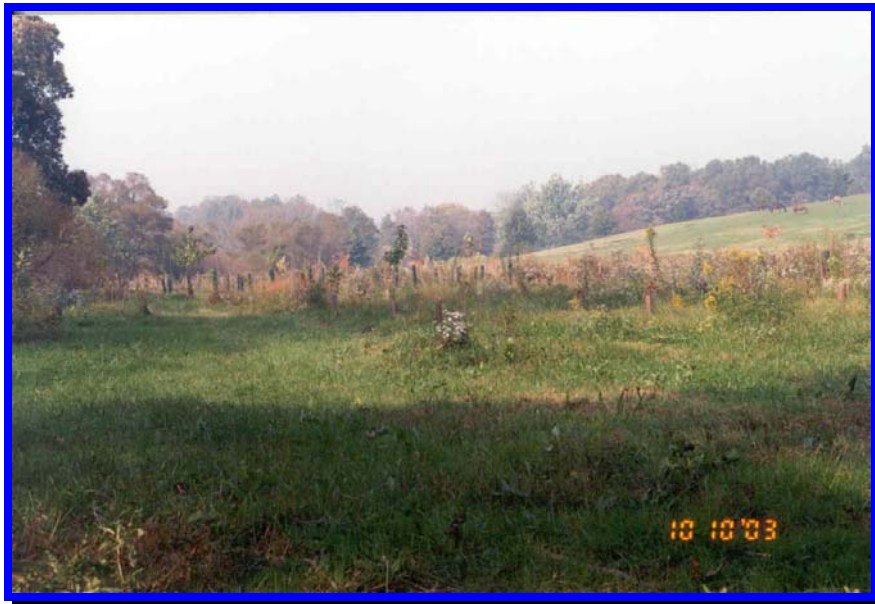
**Photos #35 and #36**

A ground photo of the planted forest buffer along Furnace Run just upstream of the confluence with Segloch Run.

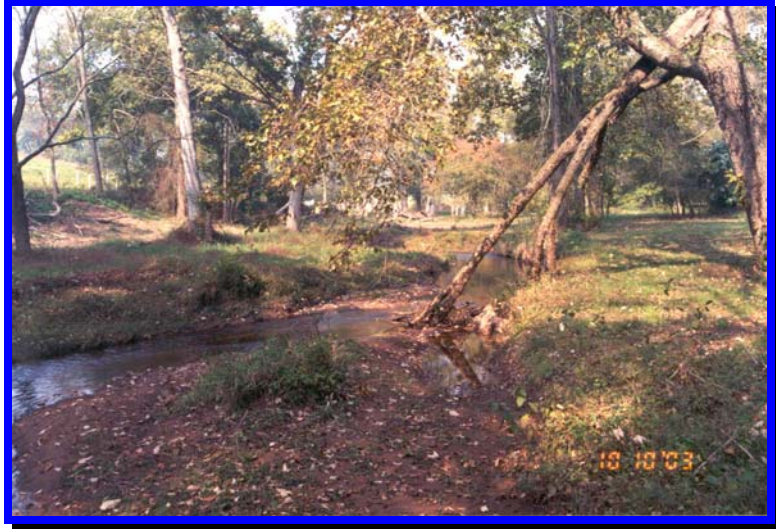
### **Photos #37 and #38**

Photos #37 and #38 show the downstream end of Hopeland Farm (Tract #61) before entering Tract #63.

Instream habitat structures could surely boost trout numbers.

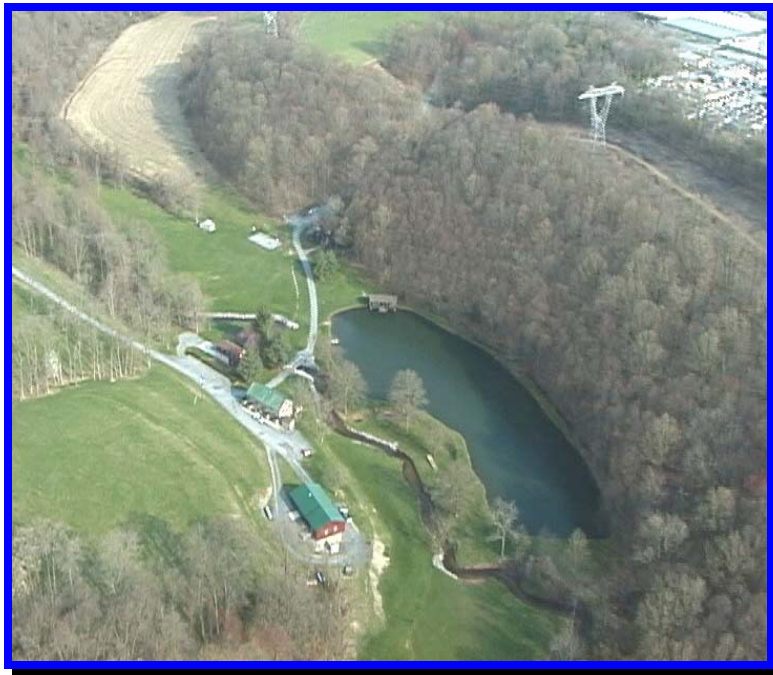
**Photos #39 and #40**

An aerial view of Tract #63. The property is well manicured with a lawn condition being maintained right to the stream channel thus the need for a riparian forest buffer. It would be possible to incorporate a scenic yet environmentally practical forest buffer in the estate setting. Well placed species such as White-flowering dogwood, Silky dogwood and White pine could provide both an aesthetic and biological function.

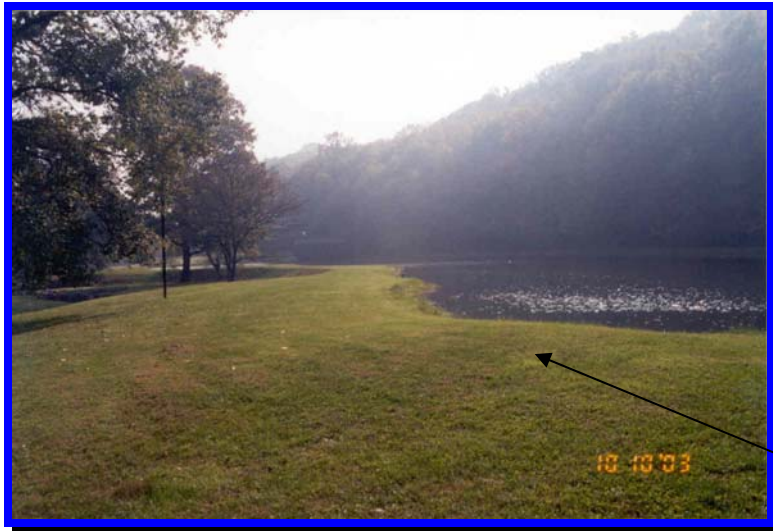
The pond discharges via a surface spillway – Again a bottom discharge would be an improvement.

A portion of the well manicured pond.

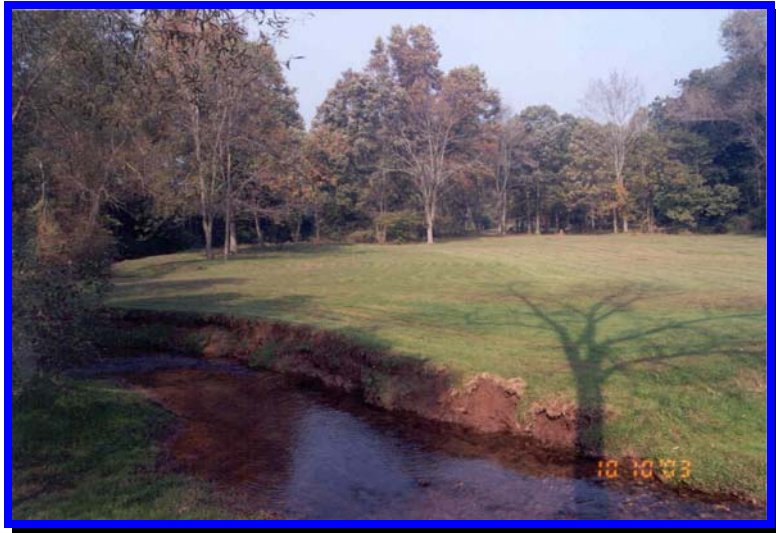
**Photos #41 and #42**

More photos of Tract #63.

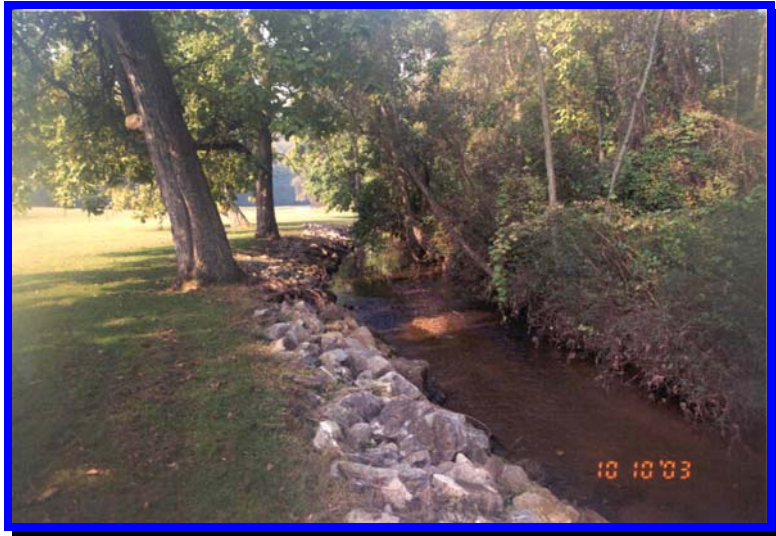
**Photos #43 and #44**

Another view of the rip-rap on Tract #63.

No trout were captured on Tract #63 except for one lone Brown trout at the very upper end of the property. This is mainly due to unsuitable riparian habitat, thermal pollution and inadequate instream cover.

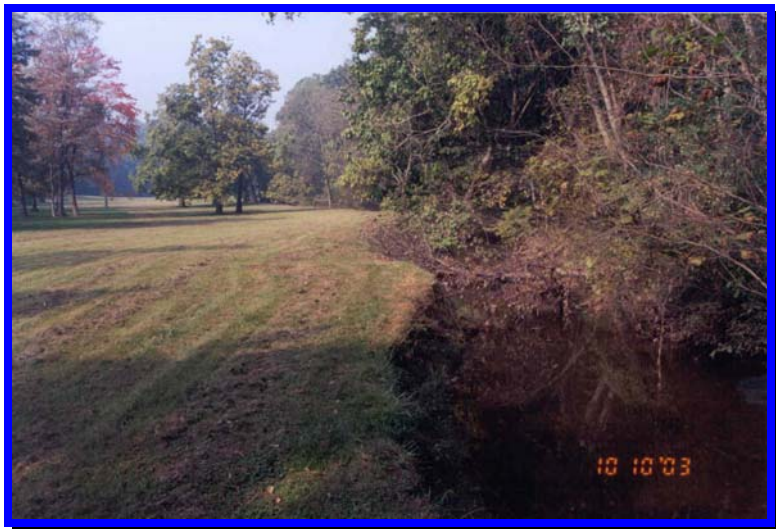
The downstream limits of Tract #63 along Furnace Run. Notice the mowed condition right up to the stream channel. What a great opportunity to put in a well planned forest buffer and instream habitat structures.

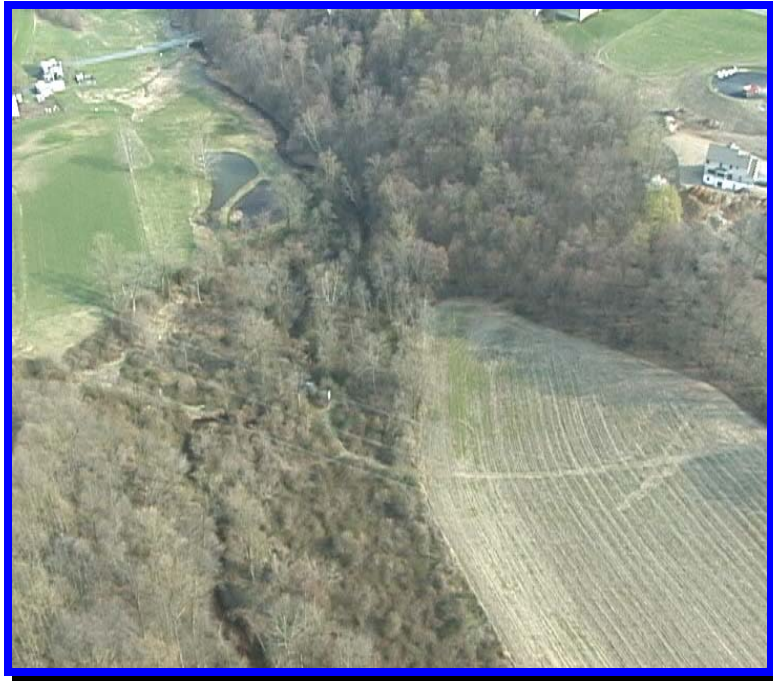
### Photos #45 and #46

Aerial photo #45 depicts the forested condition surrounding Furnace Run on Tracts #62 and #64 downstream of the previous Tract #63.

There is little that can be improved upon within these two tracts other than the removal of a small irrigation dam at the downstream end of Tract #64. Instream habitat is as good if not better than that found in Segloch Run, however the thermal pollution impacts from Tract #63 currently limit the carrying capacity of downstream Tracts #62 and #64.

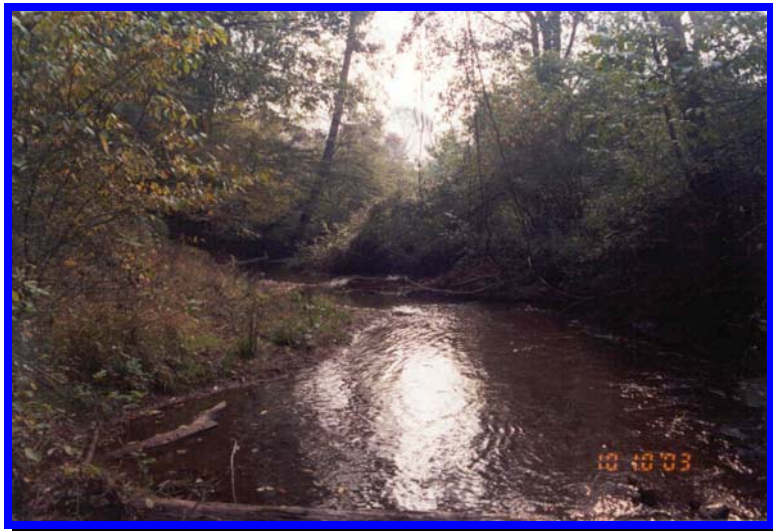
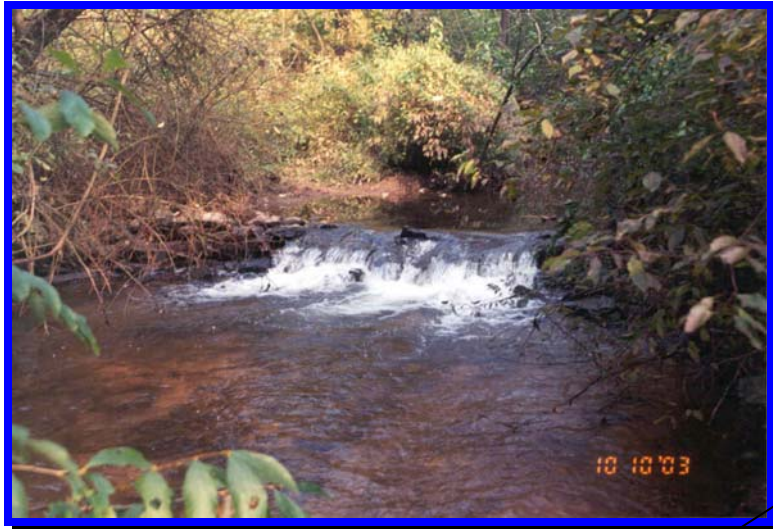
**Photos #47 and #48**

A view of the small irrigation dam previously mentioned on Tract #64. However it is worth mentioning two (2) native Brook trout were captured within the scour of this small dam.

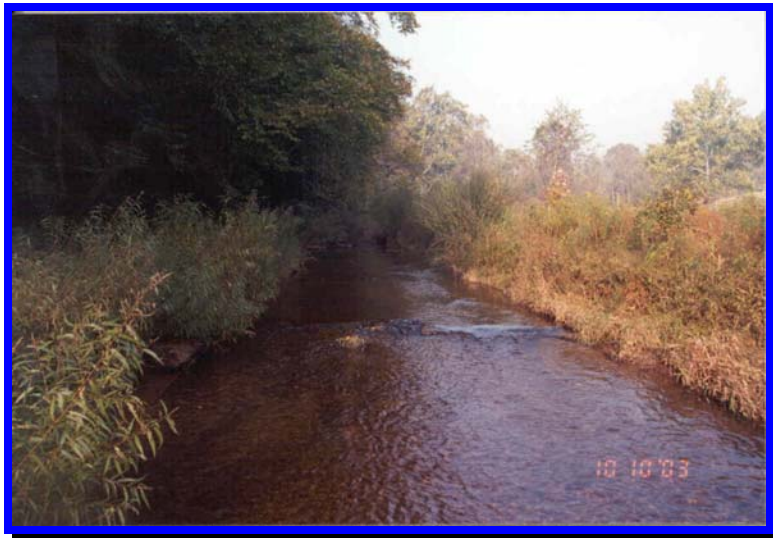
### Photos #49 and #50

A view of Tract #78 downstream of Yummerdall Road. Here Furnace Run flows through an active cattle pasture but fortunately has been fenced to keep livestock out of the stream channel.

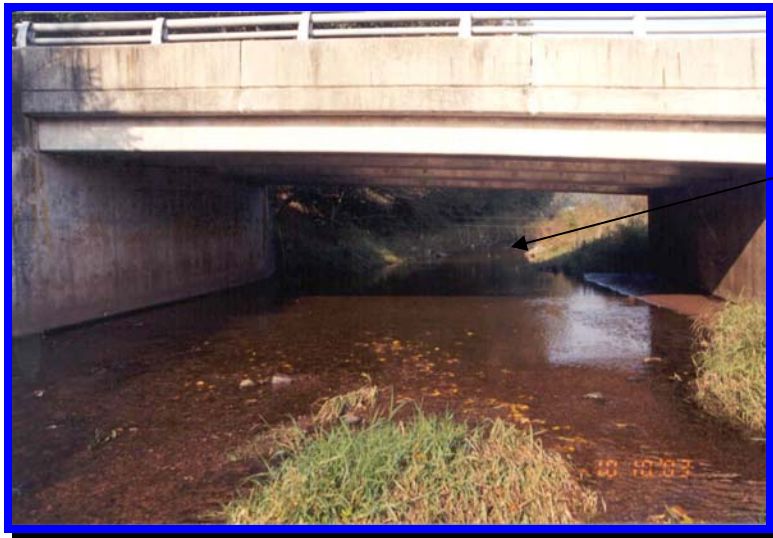
**Photos #51 and #52**

The way in which the bridge was constructed tends to make the stream wide and shallow, though fish can migrate through the structure in higher flows.

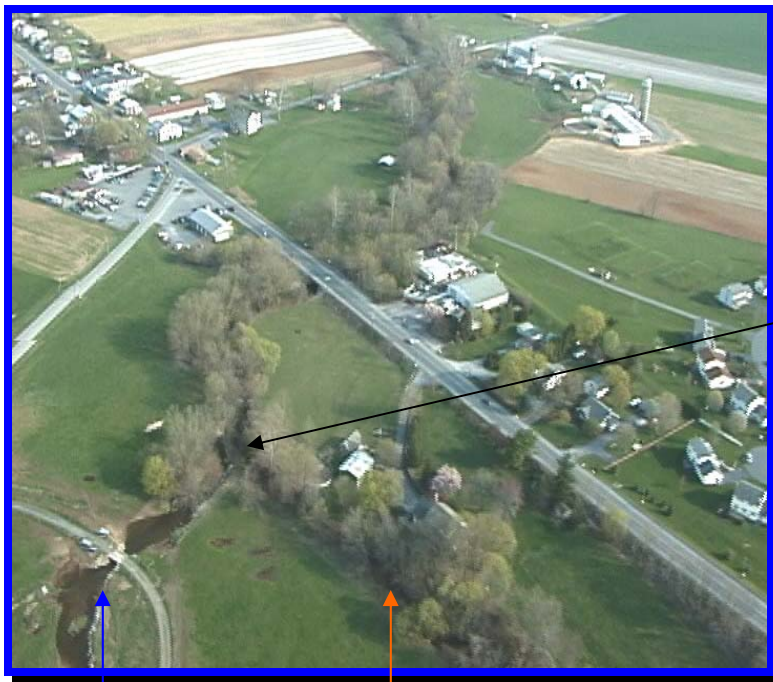
An aerial view of the confluence of Middle Creek and Furnace Run just north of the 28<sup>th</sup> Division Highway (Rte. 322).

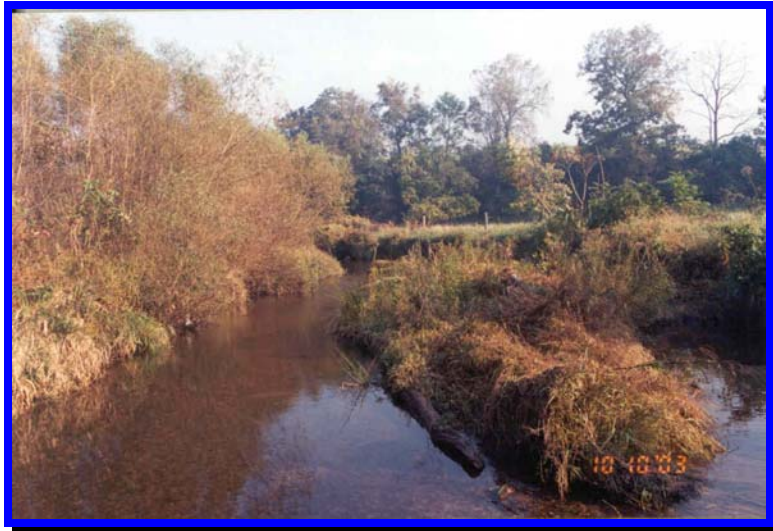
**Photos #53 and #54**

A view of the downstream end of Tract #78 just prior to Tract #66. Again, one can see evidence of prior damage caused by free ranging cattle prior to the installation of the streambank fencing. This gravel bar will likely continue to grow until one half of the stream channel is closed off and the channel returns to a more suitable width.

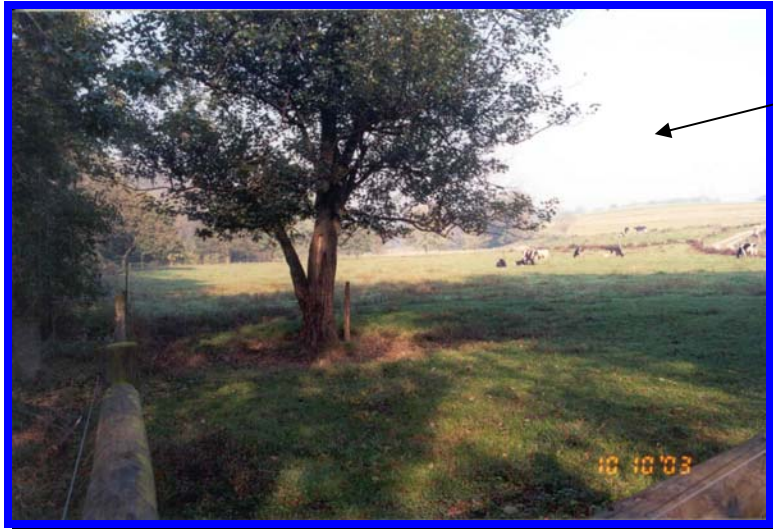
A view of the streambank fencing and pastureland in Tract #78.

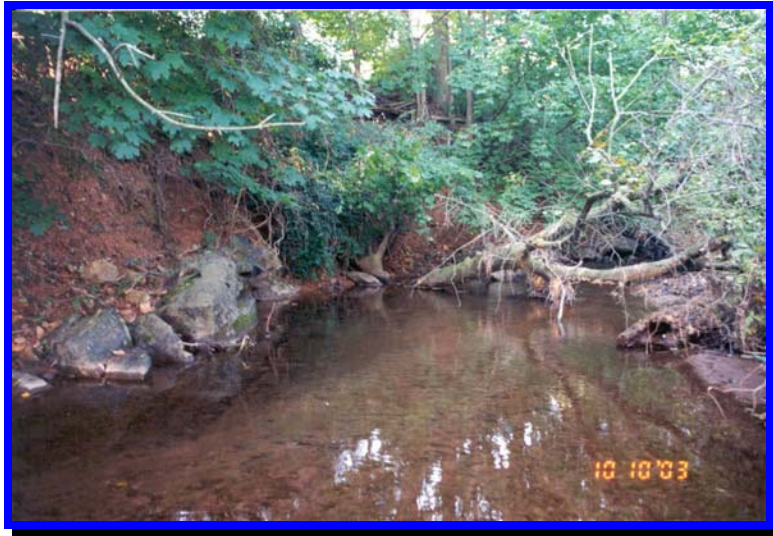
**Photos #55 and #56**

Significant bank erosion on Tract #66 just upstream of the confluence with Middle Creek.
