# **COLDWATER CONSERVATION PLAN**

## **Furnace Run and Segloch Run 2004**

**Furnace Run / Segloch Run Watershed Alliance**

**Rettew Associates, Inc.**

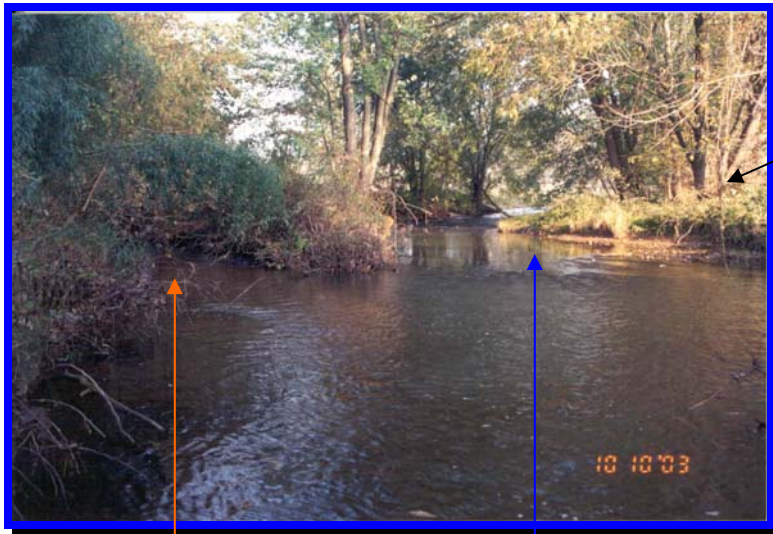
This pool with overhanging tree look promising for trout however none where found.

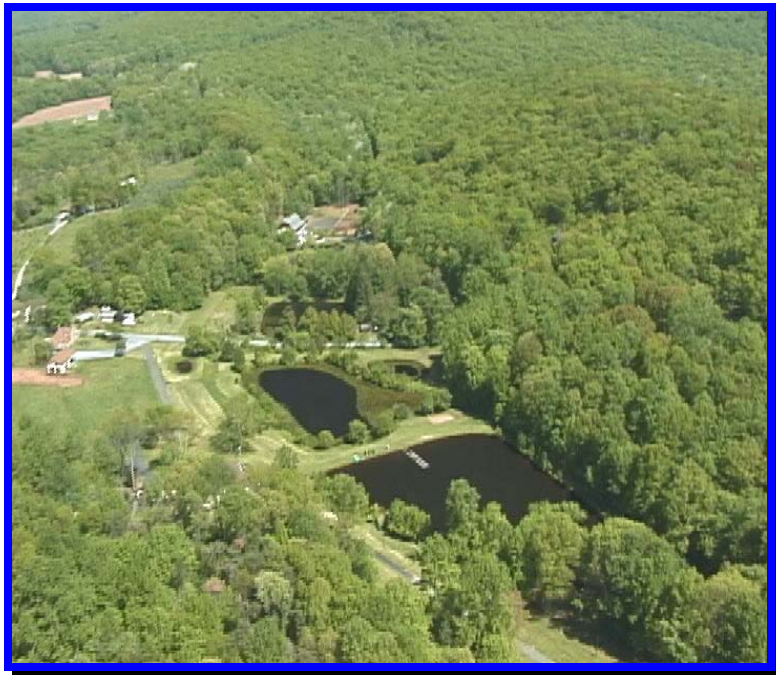
### **Photos #57 and #58**

These ponds in the Village of Dogtown make up a portion of the headwaters of Segloch Run. The majority of forestland seen in this aerial photo is part of Pennsylvania State Gamelands #46-70. The ponds are warmwater fisheries and reside on Tract #4 and #7.

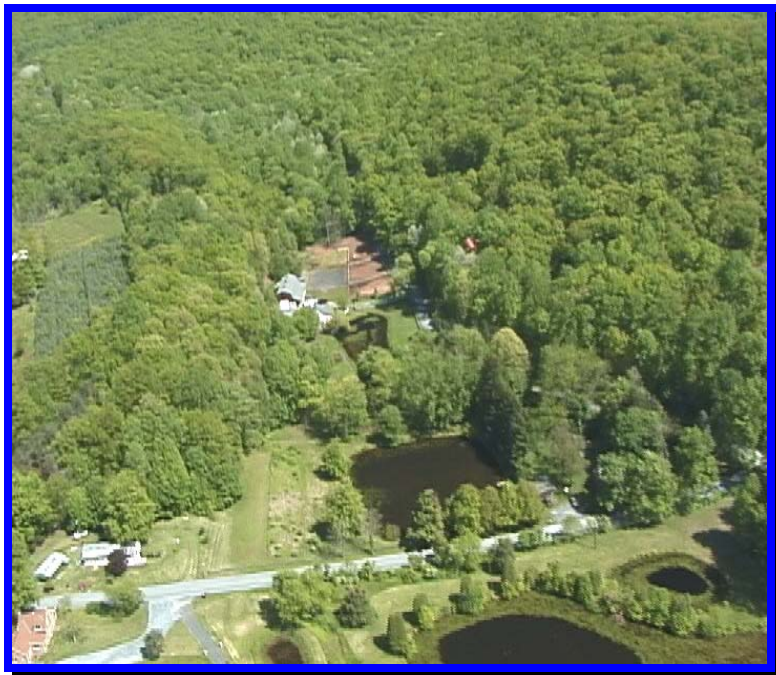
Aerial photo #58 depicts Tract #7 and a horse pasture (the brown area). Though it would appear from quick observance the horse pasture would be a significant source of sediment to Segloch Run, a closer look revealed this is not really the case. The water from the pond does not surface flow through the horse pasture.

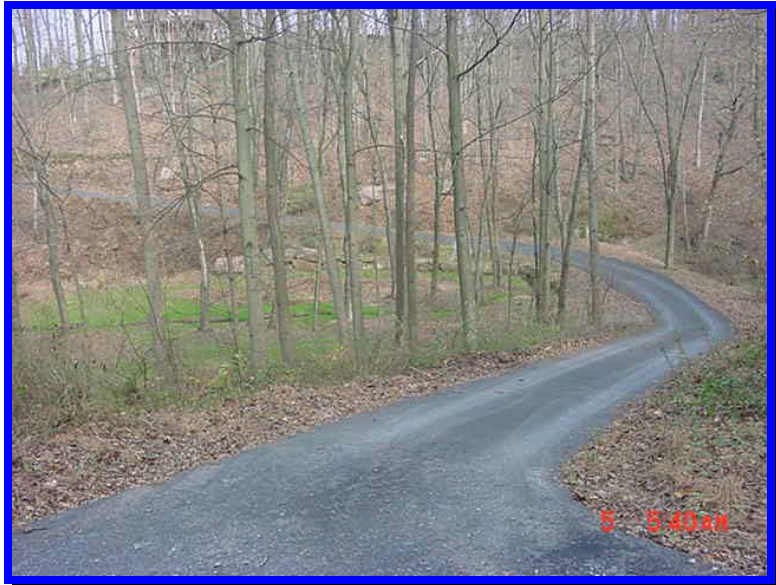
A ground of unpaved Fox Road in the headwaters of Segloch Run at its intersection with Seglock Road.

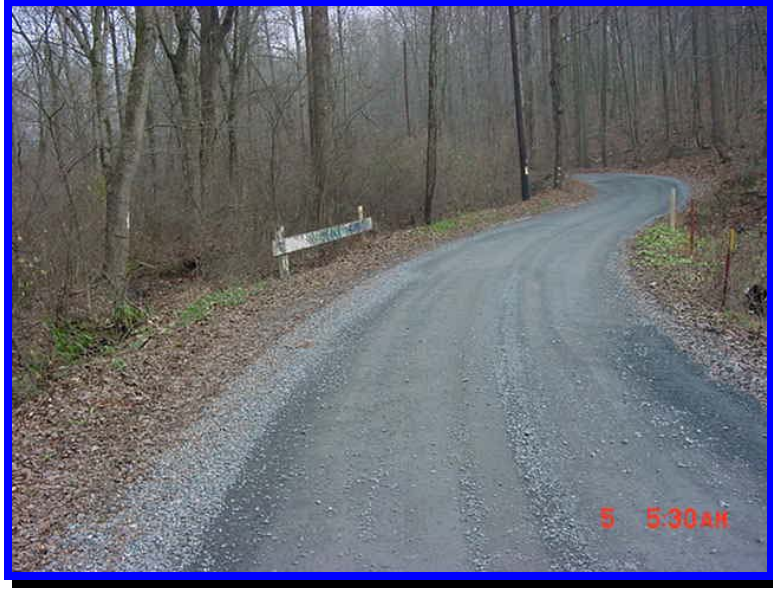
**Photos #61 and #62**

Photo #62 shows bank erosion at the discharge end of the culvert – A problem that could be addressed with better culvert pipe alignment and bank protection such as a mud sill or log cribbing.

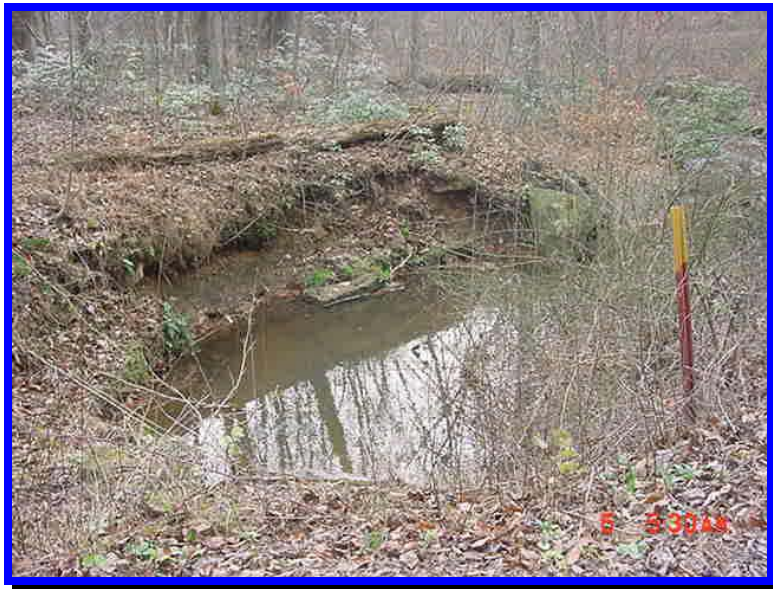
Other views of Fox Road and the culvert crossing of Segloch Run.

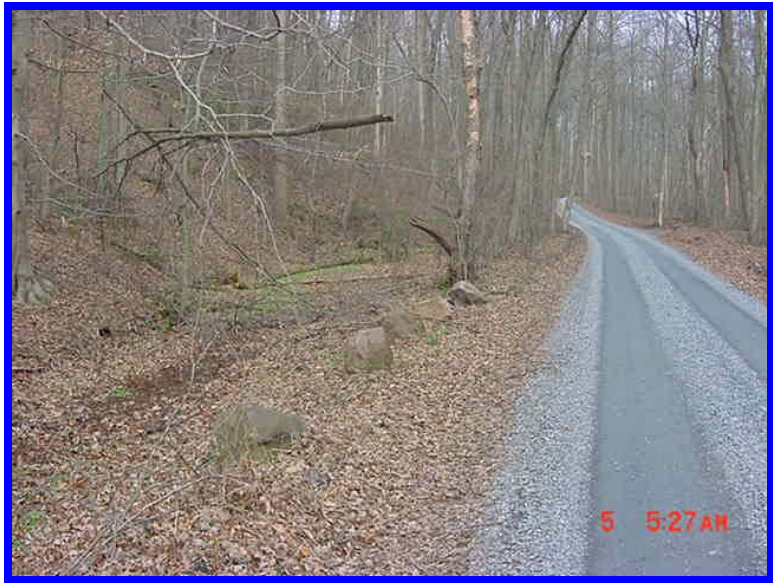
A view of Seglock Road looking north towards the Fox Road intersection near the Village of Dogtown. In this location, Elizabeth Township is doing an adequate job of maintaining the dirt and gravel road.

Notice the wetland on the left side of the photograph. This particular wetland is locally known as a breeding ground for various salamander and frog species. The wetland provides a cold water source to Segloch Run and care should be taken to protect this natural resource.

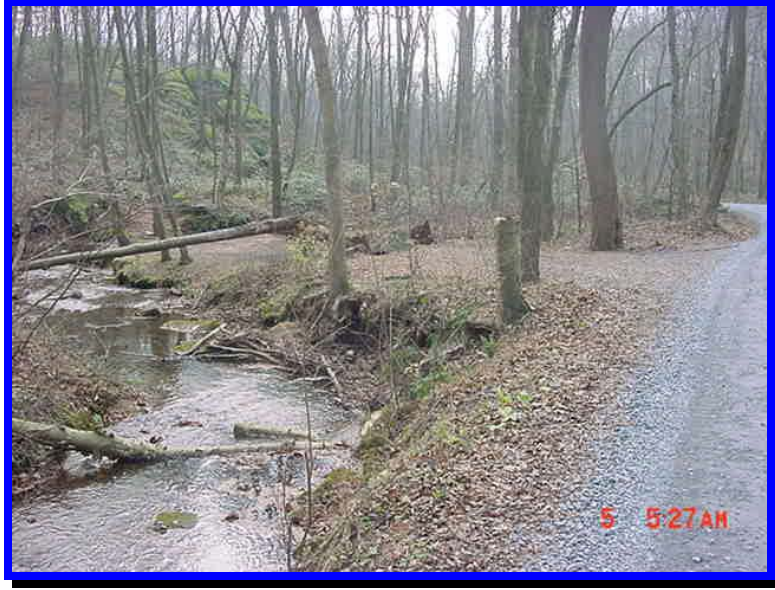
**Photos #65 and #66**

A pull off area upstream of the bridge on Seglock Road serves as a sediment pollution source to Segloch Run and encourages littering and dumping. The Alliance should work with the Pennsylvania Game Commission to explore possible remedies for such problems.

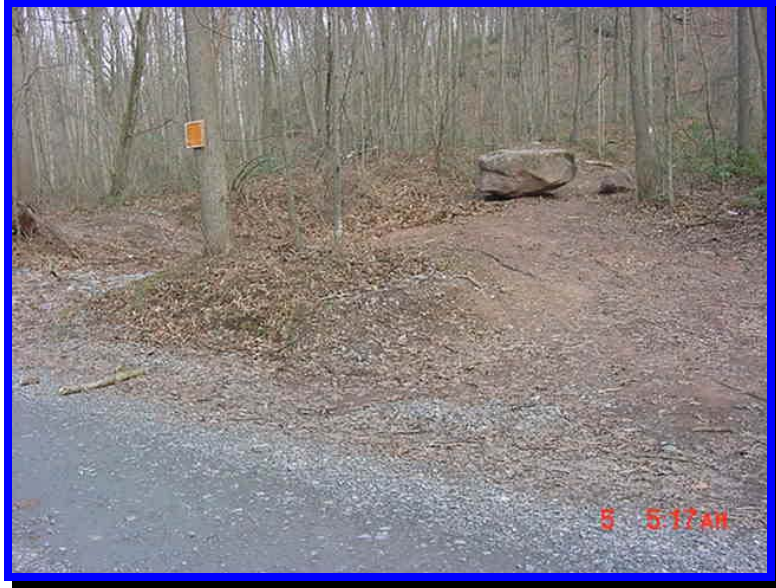
The Lancaster County Youth Conservation School had installed waterbars throughout the Horseshoe Trail in this location but they’ve since been ruined by 4-wheel drive vehicles.

This sloped area was purposely installed in the 1990’s to serve as a stable watering location for horses using the Horseshoe Trail – It’s true value in light of it also serving as an access point for 4 wheelers is questionable.

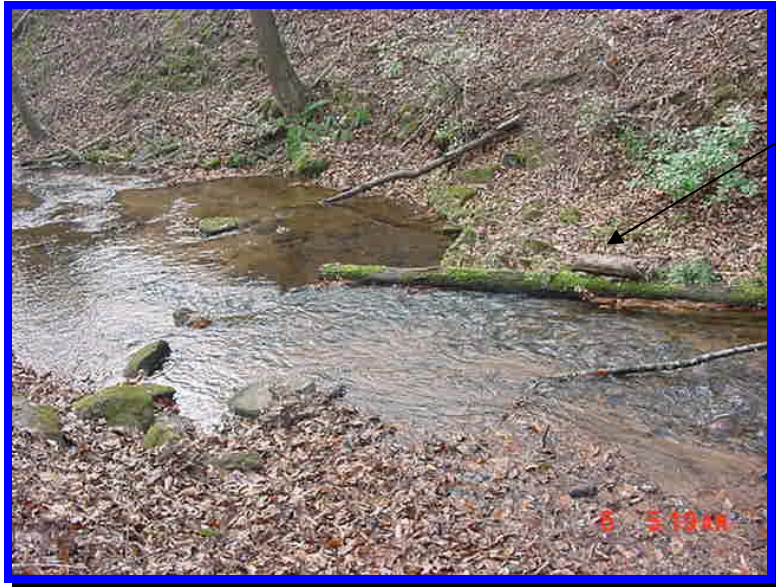
This log frame deflector was installed by the Pennsylvania Fish and Boat Commission and the Lancaster County Youth Conservation School in the late 1990's.

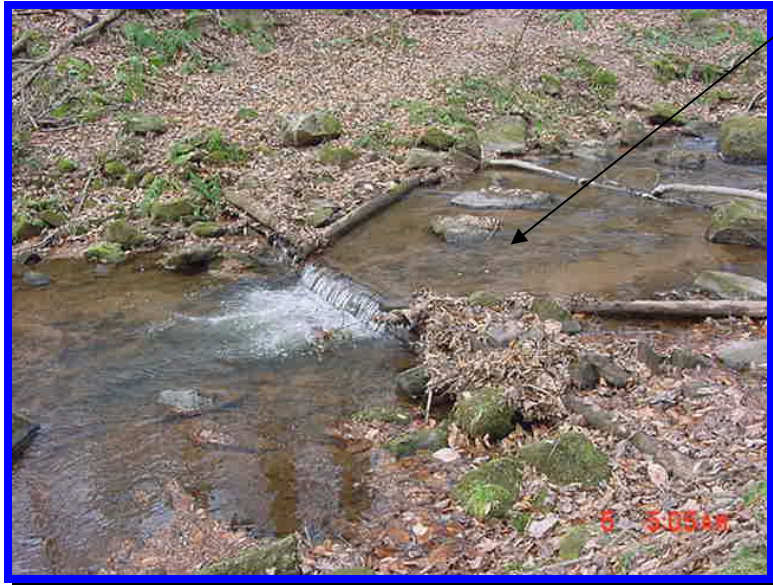
**Photos #71 and #72**

This is another log frame deflector installed by the Lancaster Youth Conservation School as part of their Adopt-a-Stream project with the Pennsylvania Fish and Boat Commission.

This log framed jack dam is yet another such installed structure.

Such man-made devices can provide much needed instream habitat for Segloch Run, but they do need to be design and installed by someone familiar with their function and effect on the stream channel configuration. Misuse of such structures can lead to accelerated erosion and create localized sedimentation problems.

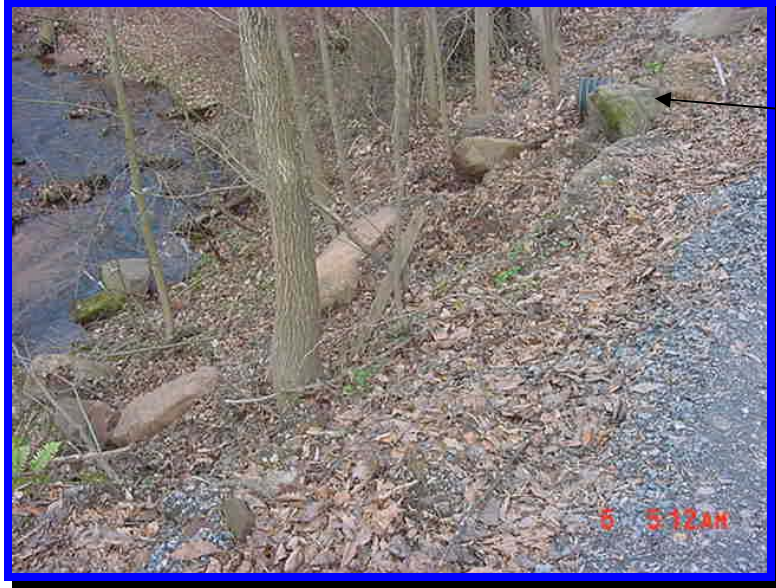
**Photos #73 and #74**

A poorly placed culvert pipe in Seglock Road. This culvert should discharge at the bottom of the bank rather than the top of the bank. Its current placement will only serve to erode the bank because of the created “waterfall effect” and the absence of any kind of rock apron or rock lined channel to dissipate energy.

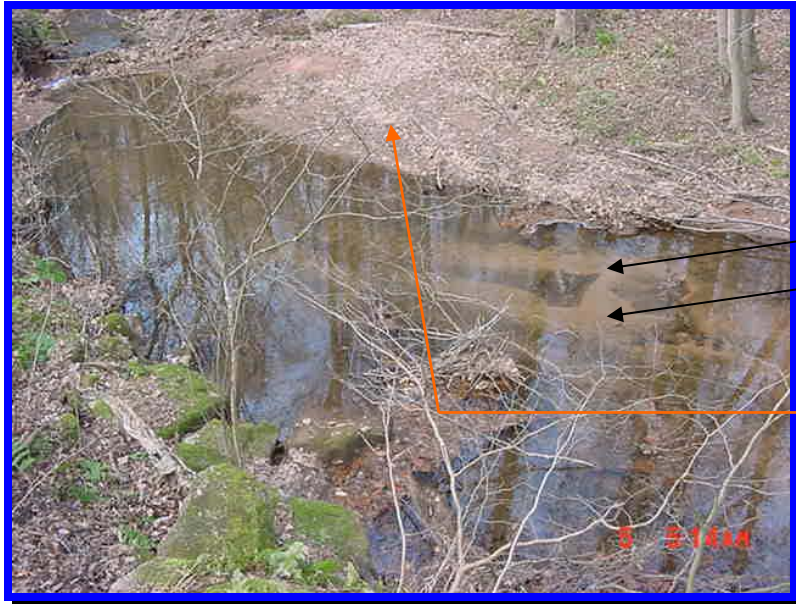
Segloch Run unfortunately has a sedimentation problem as can be seen in this photograph.

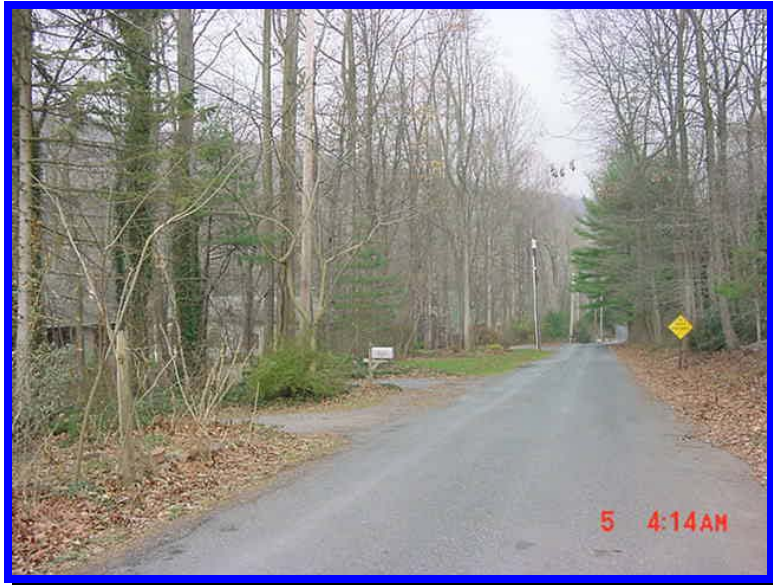
**Photos #77 and #78**

A portion of Seglock Road with adequate buffer between it and the stream. In this location the road is properly graded, drained and stabilized with limestone.

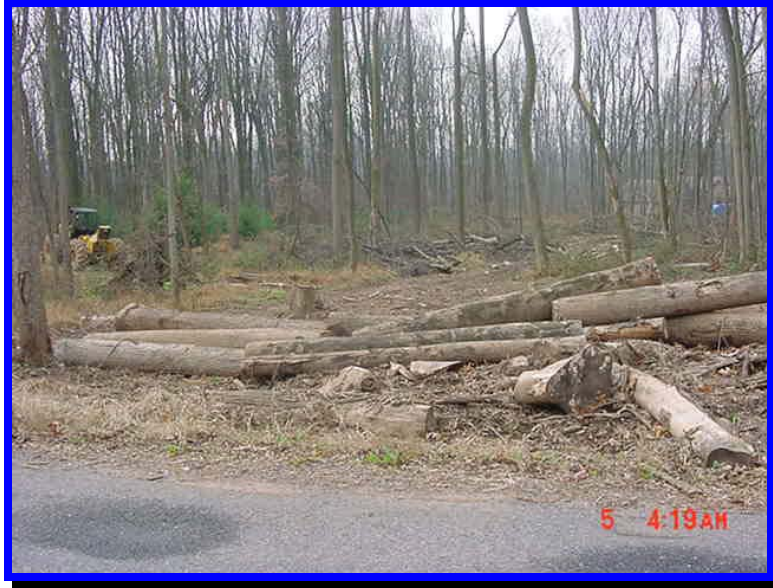
**Photos #79 and #80**

This timber harvest took place on the west side of Segloch Road just north of the PA Turnpike. This particular harvest did not cause any damage to Segloch Run, however the Alliance should be alert to such timber harvesting in the future. Poorly conducted timber harvests can result in sediment loading to stream through the construction of skid trails and landing areas without good erosion and sedimentation controls.

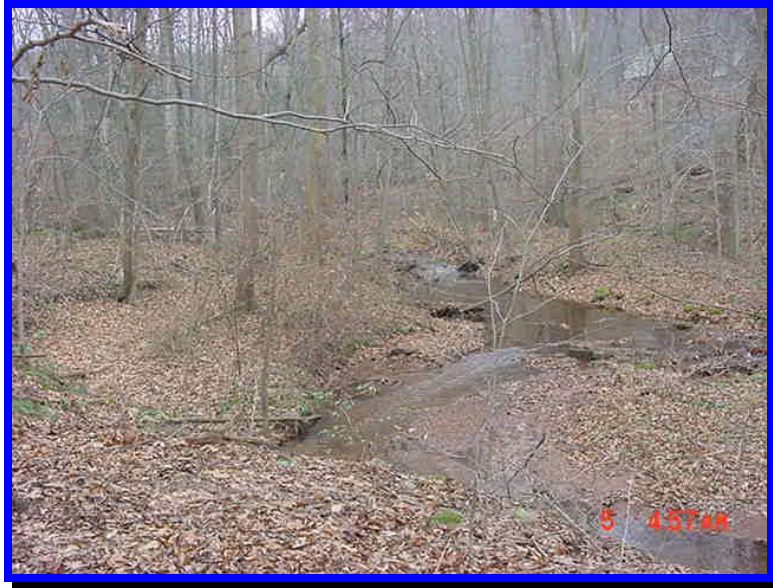
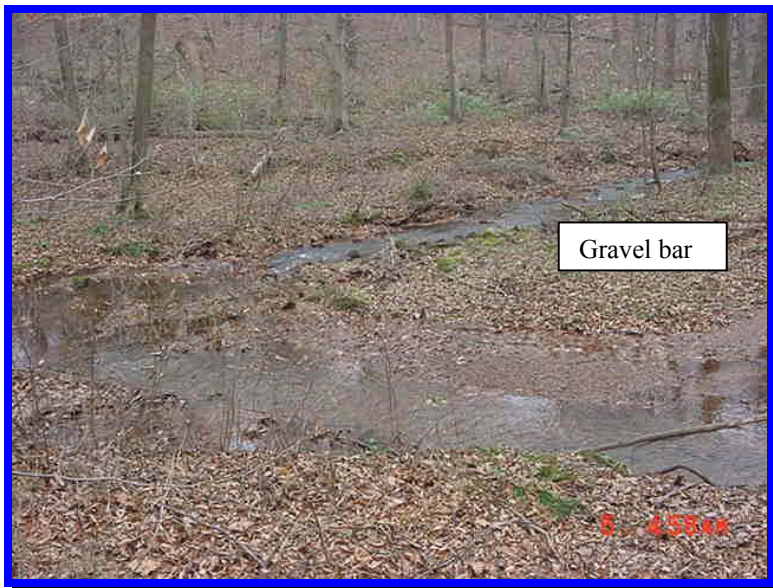
### **Photos #81 and #82**

These two photos show the formation of a gravel bar and the splitting of the stream channel on Gamelands #46-70 midway between the PA Turnpike and the bridge of Seglock Road.

In this situation, a channel block and well place deflectors could serve to create on main channel while maintaining gravel bar formation thus providing the stream an area to discharge its sediment load during storm events.

A project such as this would need careful planning and on-site direction from someone knowledgeable in the use of such structures.

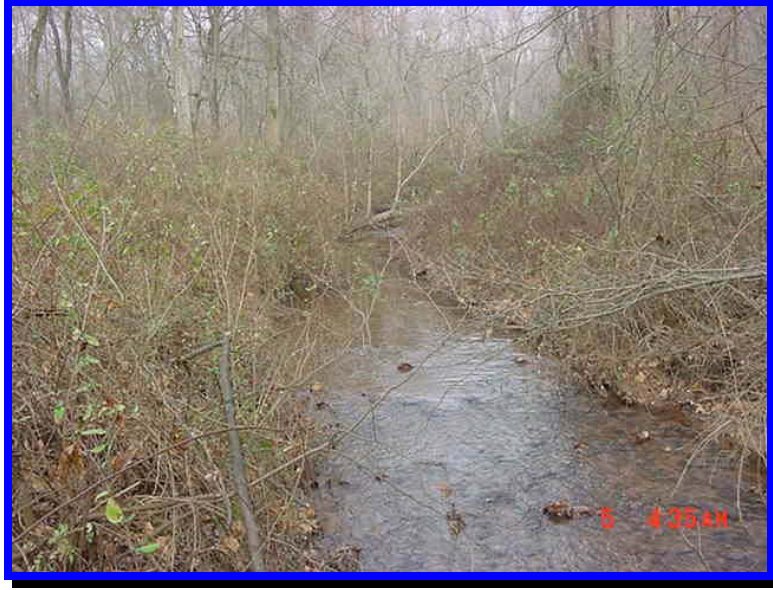
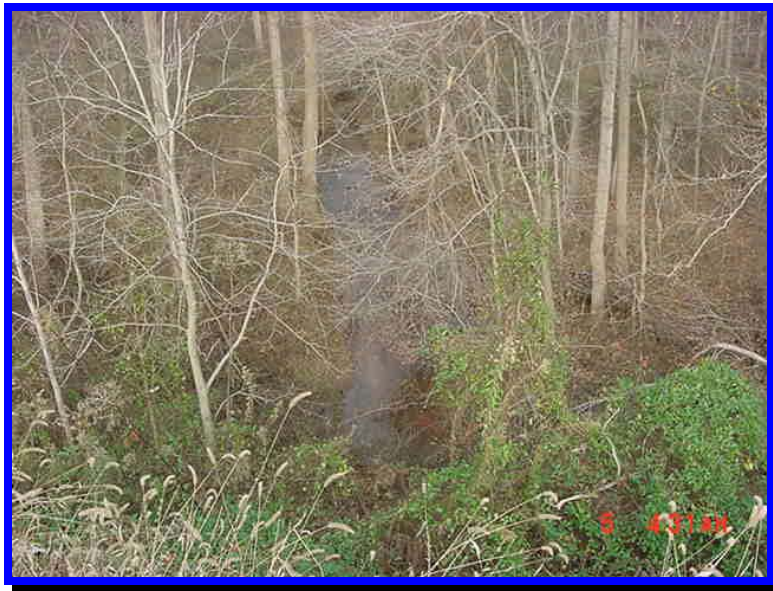
#### **Photos #83 and #84**

Views of Segloch Run immediately upstream of the PA Turnpike on Gamelands #46-70.

Trout were present in this location but were typically less than 6-inches long mainly because of the lack of deeper pools and runs. Much of the stream immediately north of the PA Turnpike tended to be wide and shallow.

Instream fish enhancement structures could provide better angling opportunity.

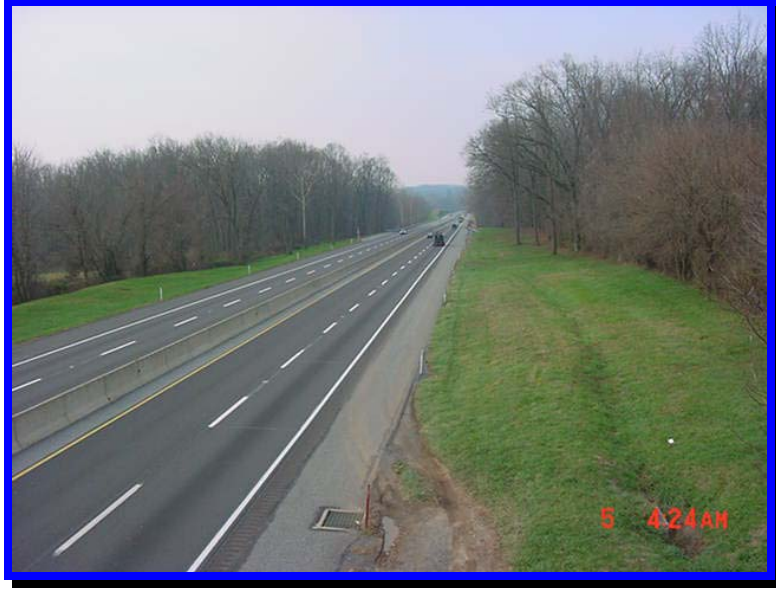
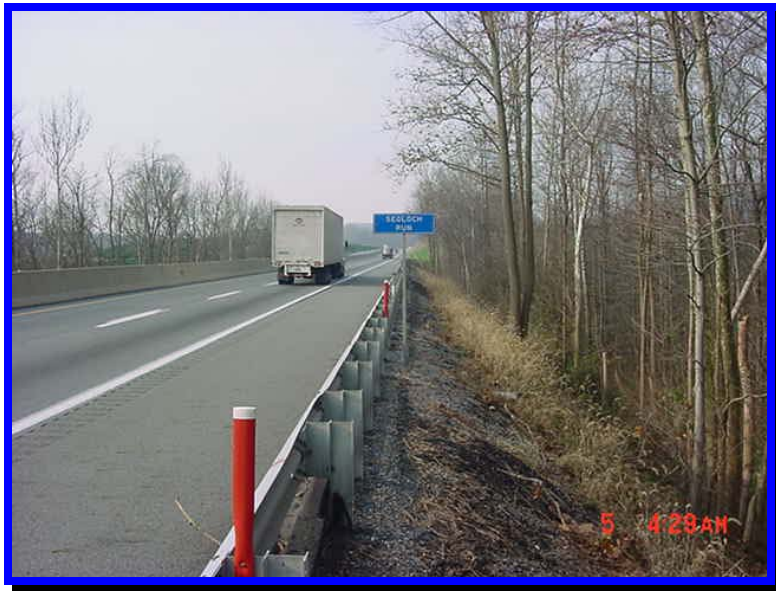
**Photos #85 and #86**

Views of the PA Turnpike in the area of Segloch Run.

The turnpike is a source of litter, thermal pollution and accelerated stormwater runoff. However the most critical threat posed by the highway is the possibility of an accident and the spillage of a substance deleterious to fish such as fuel oil, gasoline or ammonia.

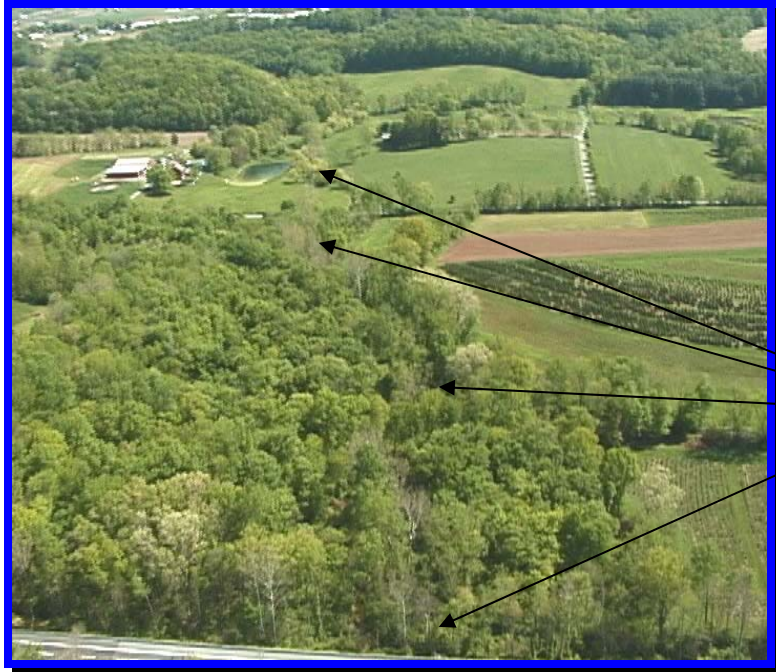
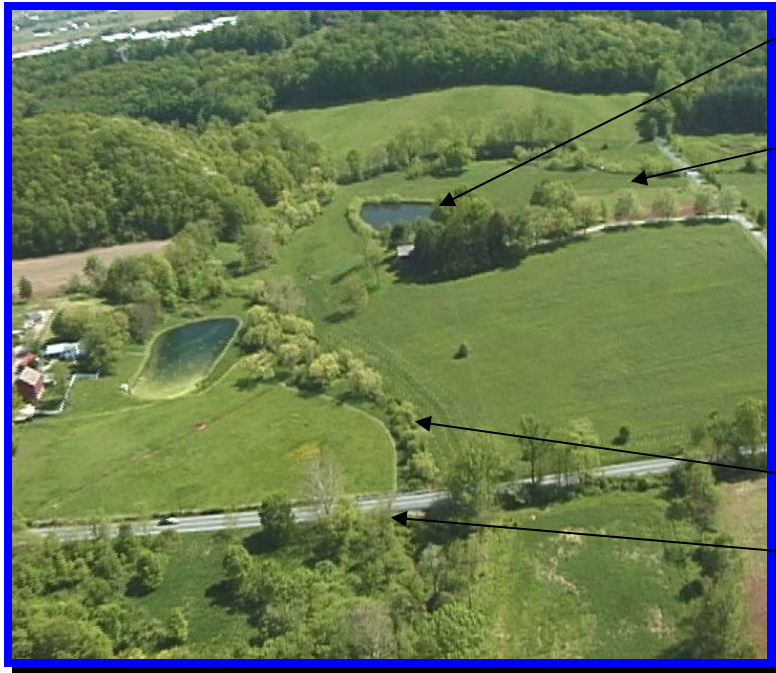
**Photos #87 and #88**

Aerial views of Segloch Run south of the PA Turnpike and Tracts #53, 75, 76 and 57 at Hopeland Farm.
