# ***Green Lick Run Coldwater Heritage Partnership Assessment***

***Bullskin Township, Fayette County, Pennsylvania***

***Prepared by:  
Anne Quinn, Executive Director  
Jacobs Creek Watershed Association  
10 Mt. Pleasant Rd  
Scottsdale PA 15683  
Website: [www.jacobscriekwatershed.org](http://www.jacobscriekwatershed.org)***

***December, 2019***

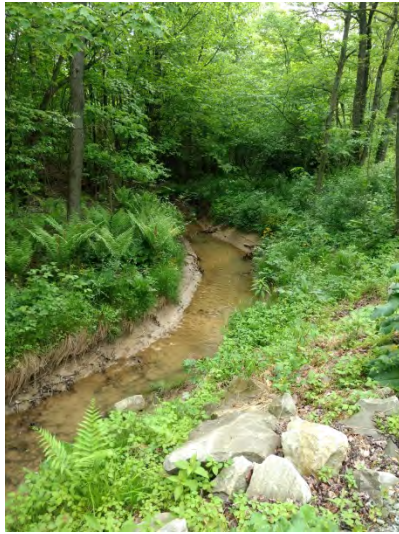
- a) **Location** Green Lick Run is located in Bullskin Township, Fayette County, in southwestern Pennsylvania (Figure 1). The watershed starts on top of Chestnut Ridge as a very small mud/sandy headwater stream as shown in the photo. Chestnut Ridge is the first major ridge east of the Rocky Mountains and has become an important

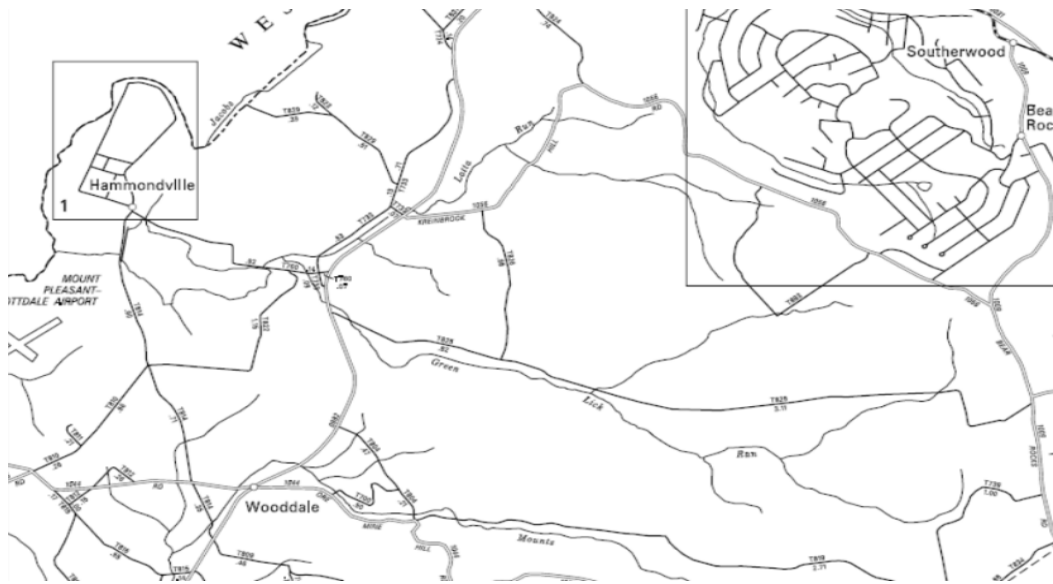
Figure 2: Roads In and Around the Watershed

The main stem of Green Lick Run is accessible from Greenlick Hollow Road (T825). (See Figure 2 below) The western access to Greenlick Hollow Road is from State Route 982 (Pleasant Valley Rd) and the northeastern access on Chestnut Ridge is from Bear Rocks Road (T1009). Latta Run, the major tributary to Green Lick, drains off of Chestnut Ridge from Kreinbrook Hill Road (T1056) and Sweitzer Road (T883) and crosses State Route 982 (Pleasant Valley Road) before joining with Green Lick at Mudd School Road (T760).

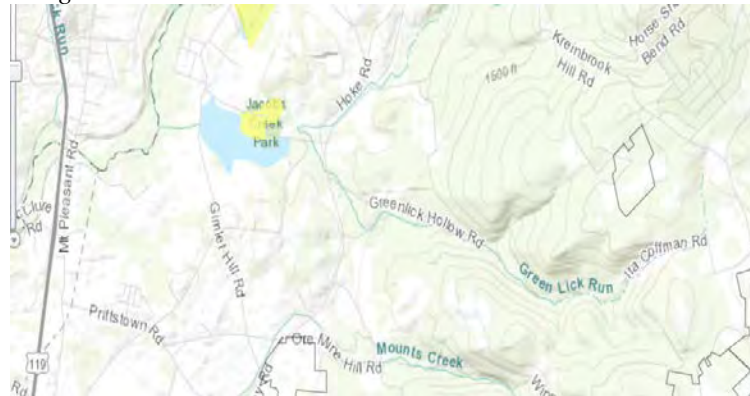
*Figure 11: Green Lick Reservoir and Jacobs Creek Park*

**j) Ownership – public and private – large tracts** – there are no public lands located in the headwaters of Green Lick or Latta Run. However, in the lower portion of the watershed there is the Green Lick Reservoir. This reservoir, seen in Figure 11 below, is a 101 acre lake owned and operated by the F&BC and home to Jacobs Creek Park (located within the reservoir) owned by Fayette County.

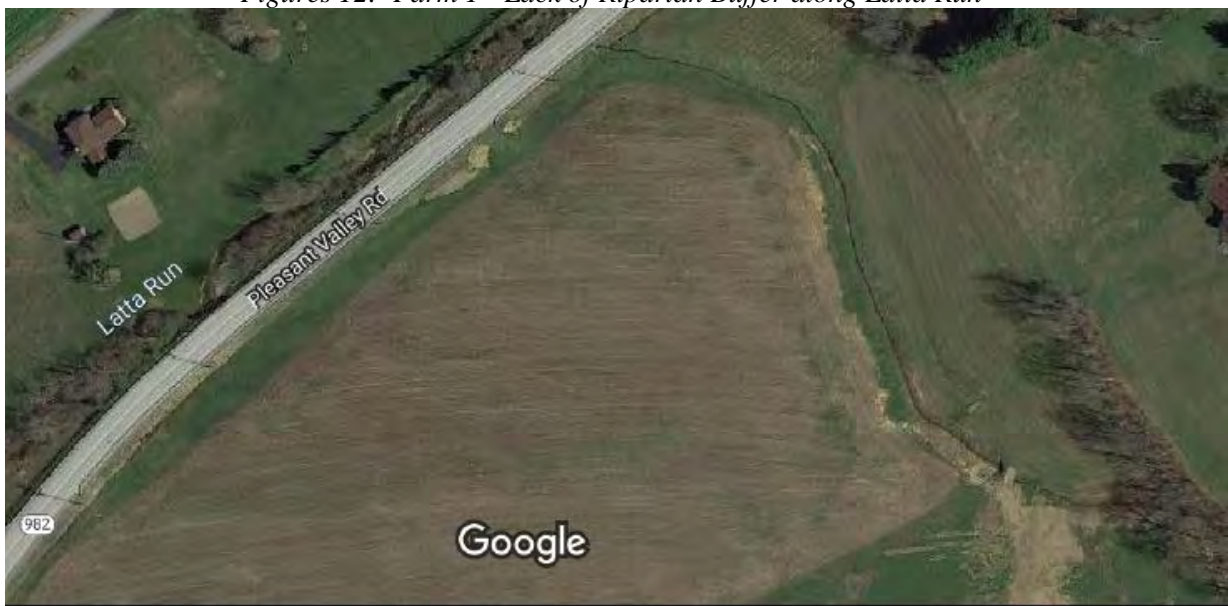
Figures 12: Farm 1 - Lack of Riparian Buffer along Latta Run

- 5) **Agriculture** – This is occurring throughout the watershed. However, the farms at the top of Chestnut Ridge are using established best management practices and several are in the Farmland Preservation program. The Latta Run watershed seems to be the most impacted. Farms in this tributary have no riparian buffers along the stream. Figures 12 below and 13 on Page 22 show lack of vegetated cover (riparian buffer) along Latta Run. Several projects have been identified in JCWA’s 2019 WIP. Recommendations from the WIP include stream bank fencing, riparian buffer plantings and instream habitat restoration.

Projects could also be implemented by JCWA and/or their project partners such as the FCCD using other funds available, such as: the DEP Growing Greener funds, DCNR watershed restoration funds and riparian buffer grants, Department of Community and Economic Development (DCED) Act 13 Watershed restoration funds, and private foundations. Partners would include the WPC, Westmoreland Land Trust, and other regional land groups who work with landowners to obtain future conservation easements, land donations, and preservation in perpetuity. As an example, through this outreach, JCWA would use the WIP and visual inspections to identify all of the areas where the loss of riparian buffer has occurred and engage those residents in allowing JCWA to obtain grants to re-establish the buffer.

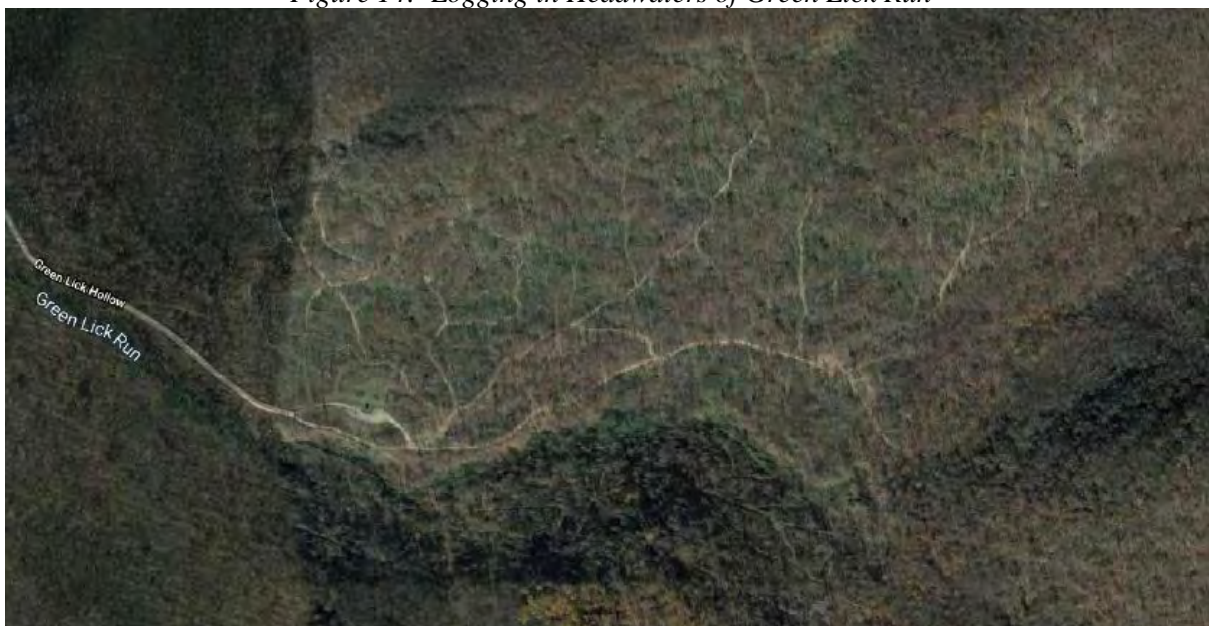
Figure 14: Logging in Headwaters of Green Lick Run

- 6) **Logging** is occurring in small lots throughout the watershed and has caused minimal damage. However, approx. 90 acres was logged in the headwaters of Green Lick Run and equipment was driven through the stream. Figure 14 below shows the extent of the logging along the headwaters. The F&BC was notified and the owner cited. JCWA should reach out to landowners with information as to the best practices to use that will protect the stream during logging.

- 2) Riparian forest buffers have to be replaced in this watershed. Several areas were clear cut and machinery was run through the small headwater streams. Specific locations are in the headwaters of Green Lick Run; Paradise Church property; most of the Latta Run sub-watershed.

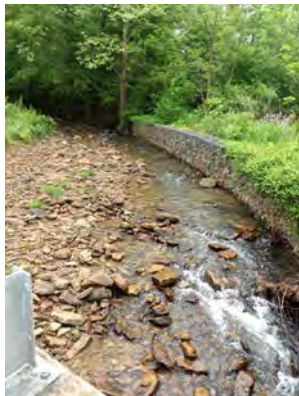
**c) Aquatic organism passage (stream crossings)** Green Lick Hollow Road, Pleasant Valley Road and Mudd School Road have culverts channeling the streams but all are in good repair. As seen in the photo below, after a culvert, the gabion basket area has filled in nicely with vegetation thereby minimizing erosion and sedimentation. However, there are noticeable areas where ATV trails are crossing the streams on the property owned by MAWC and one of the landowners logged in the headwaters. In addition, there are two old dams constructed on the main stem of Green Lick Run which has been rebuilt several times since the late 1800’s when it was used as a water supply. The current owner, MAWC is not using Green Lick Run as a water supply.

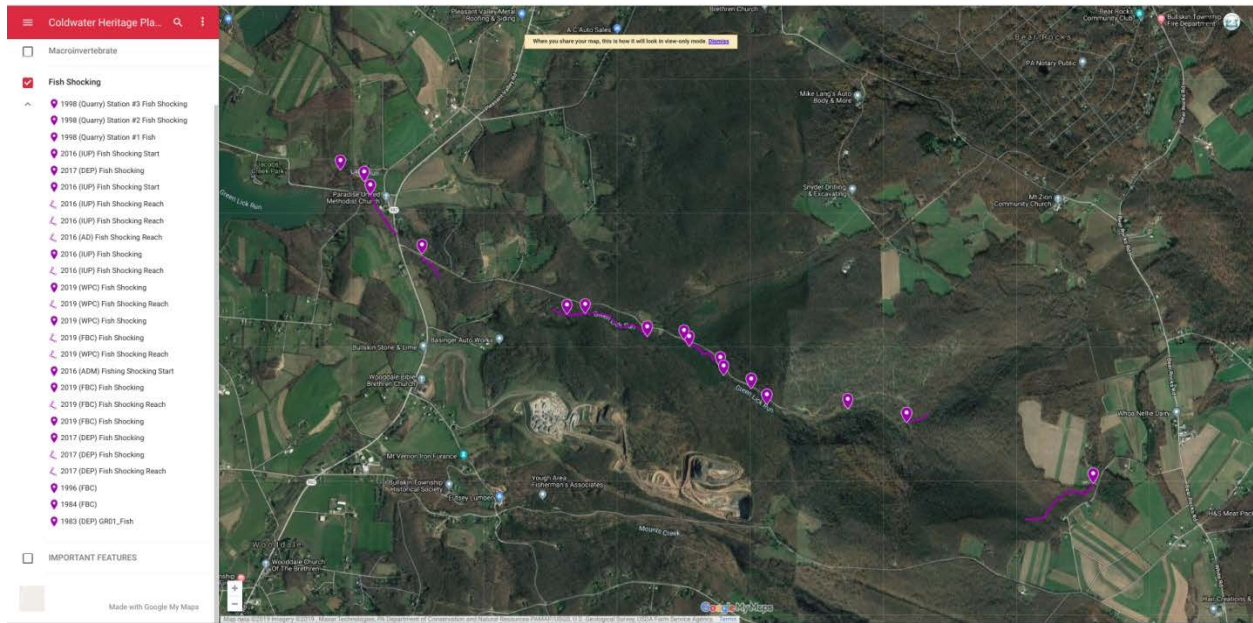
Figure 22: Historical and Current Fish Shocking Locations

The figure below summarizes three historical assessments and the JCWA sampling in April, 2016. The F&BC sampled at two sites: one immediately above and one immediately below the small low head dam. The Rainbow Trout caught were below the dam. The EcoSolutions assessment sampled at three locations. Eight Rainbow trout were captured below the dam and the 13 Brook trout were collected above the dam. In the DEP assessment, they collected fish at one location, near the dam. They found Rainbow trout, but the report does not say how many or whether the sample site was above or below the dam. JCWA sampled at nine locations; seven on Green Lick Run and two on Latta Run. Six Rainbow trout and two Brook trout were collected below the dam area where Green Lick Run crosses under SR 982. Two Rainbow Trout were collected immediately above the dam area. One Rainbow Trout and one Brook Trout were collected further upstream from the dam in the area of where the logging had taken place. This presents a challenge to JCWA. In the EcoSolutions sampling several Brook Trout were found above the dam and no Rainbow Trout were collected. In JCWA’s sampling a Rainbow Trout was collected and only one Brook Trout leading

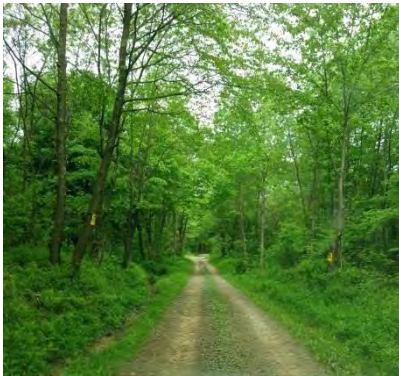
8. Several township roads throughout the watershed are in need of improvement to keep sediment out of the stream. Bullsken Township has used the Dirt and Gravel Road Program but needs to concentrate their efforts on utilizing environmentally sensitive maintenance practices on the steeper sections of the roads. The gravel is washed away in these sections, and the water picks up dirt and rocks and carries them into the stream. Several sections of the roads have deep ruts in the middle of the roads as well as the ditches that have been carved out from periods of intense precipitation. Installing water bars across sections of the road to divert the sediment laden water into grass swells will significantly improve the water quality in these areas.

Greenlick Hollow Road – vegetated edge

**Improve Dirt and Gravel Roads.** Meet with the landowners and township to work out the dirt road issues and identify improvements that would help prevent sediment from entering the stream from the roadways.

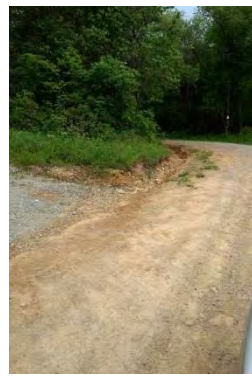
them. The dirt roads are not properly graded or sloped and many ruts are present that discharge sediment directly to the streams.

Greenlick Hollow Road – dirt and erosion
