Hosensack Creek Conservation Action Plan

Prepared by the Perkiomen Watershed Conservancy
Based on Community Input

Hosensack Creek Action Conservation Plan

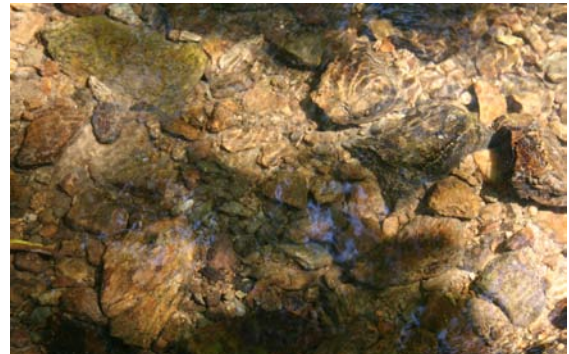
Figure 2. The rocks in the Hosensack Creek reflect the local geology of the area; the geology in turn, defines the characteristic of the soil.

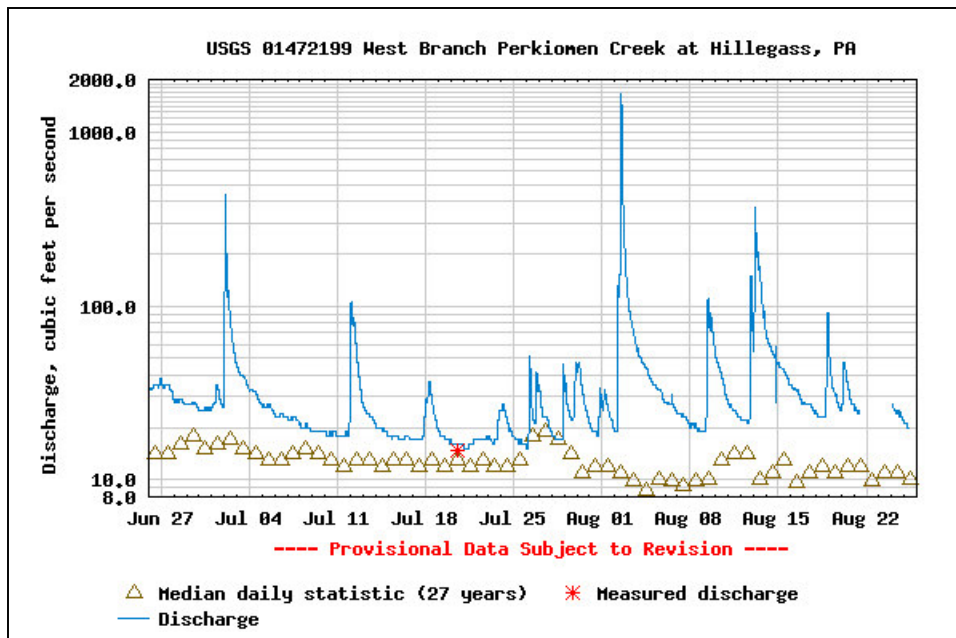
Figure 6: United States Geologic Survey stream gage indicating that the Perkiomen Creek discharge at the Hillegass gage is significantly above the median water levels at the time of the Hosensack Creek stream evaluations.

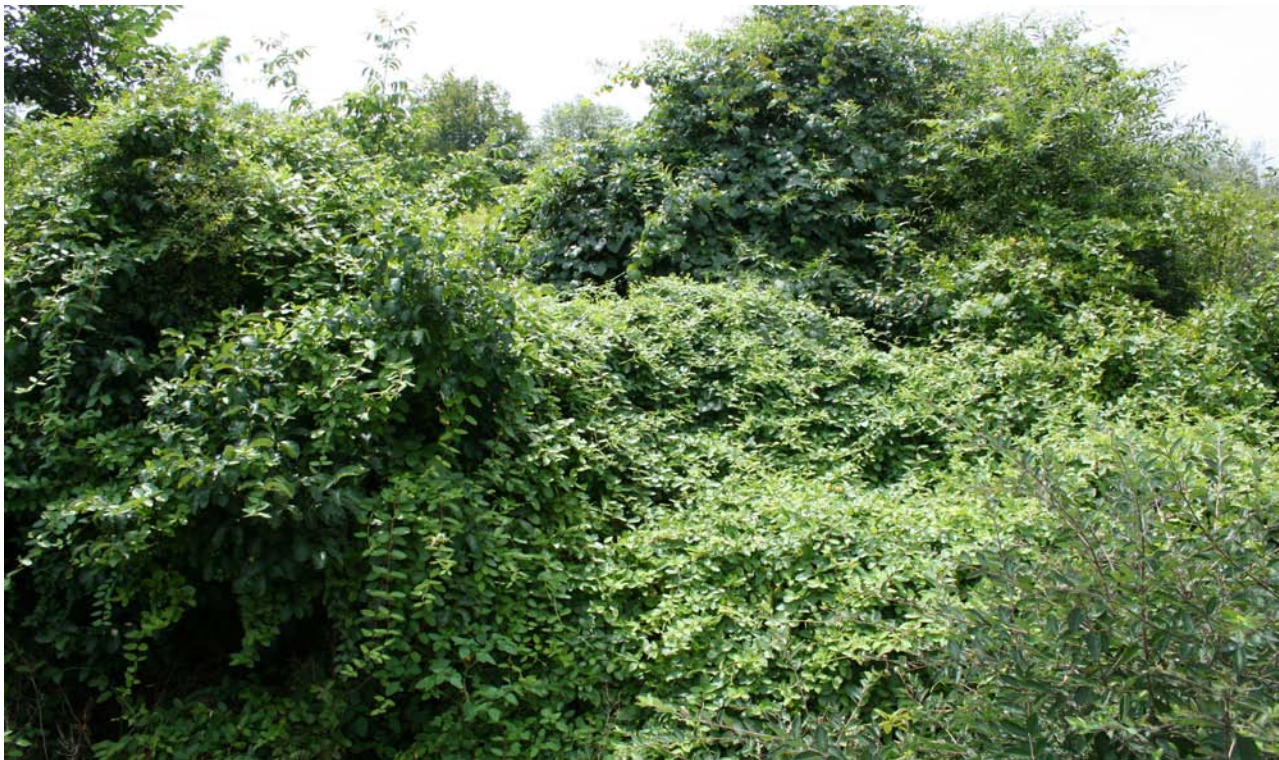
Figure 7: Multiflora rose and Japanese honeysuckle are among the more prolific invasive, non-native plants in the Hosensack Creek watershed.

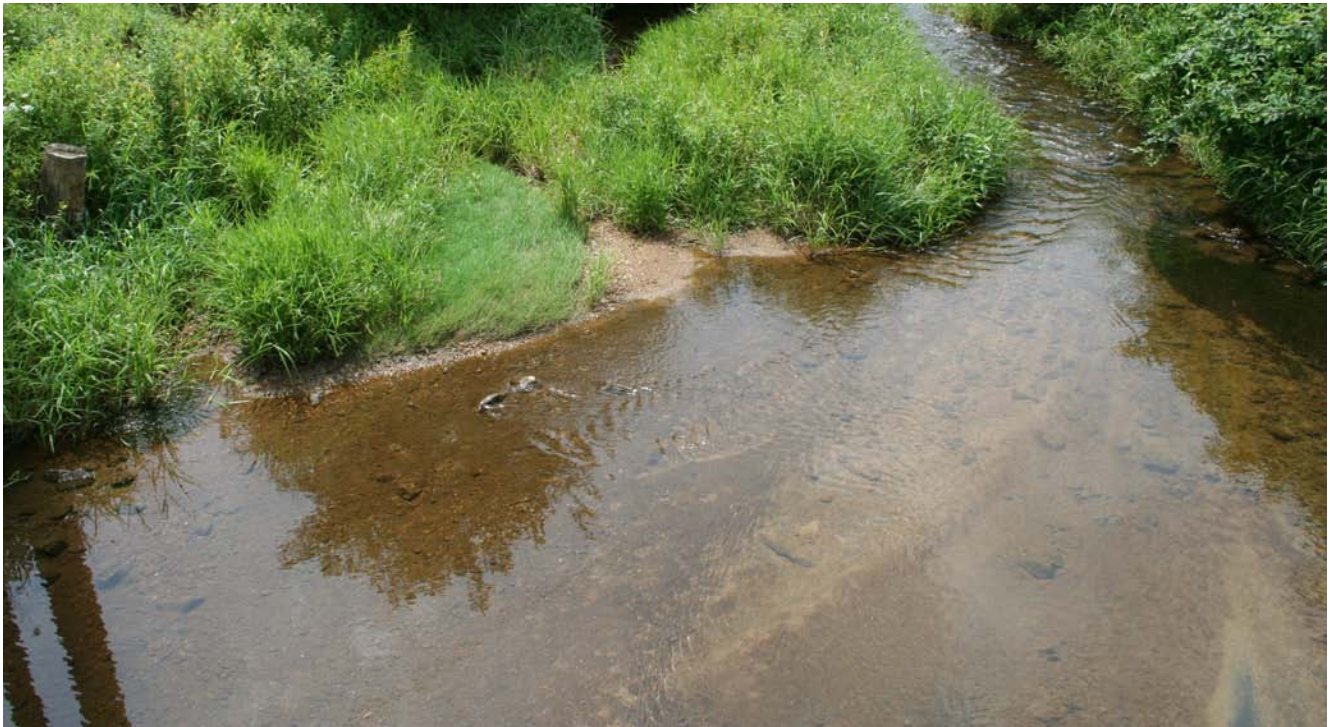
Stream segments in the Hosensack Creek appeared to have significant sedimentation and thick sandy gravel bars in a number of locations. There were also a number of significantly eroded streambank segments in the evaluated locations. Erosion of streambanks is a principle reason for sedimentation of creek beds.

Figure 8: A thick layer of sediment is evident in this photo of the Hosensack Creek. Soil washes off of creek banks upstream and settles out in slow water. Sediments make it difficult for aquatic organisms to breed and feed.

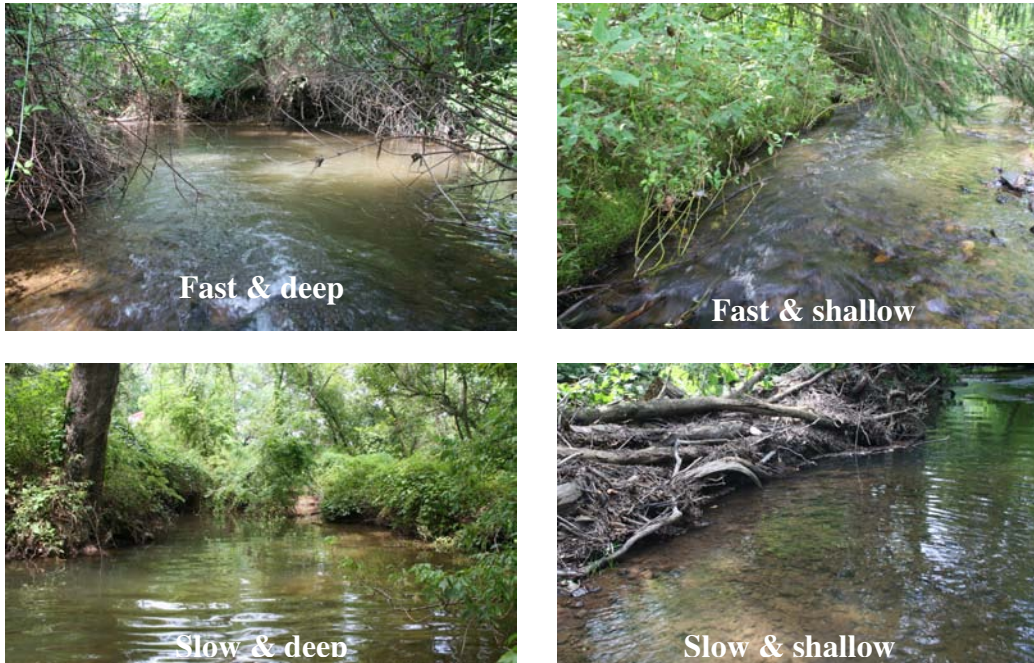
Figure 9 illustrates the four flow characteristics of healthy streams.

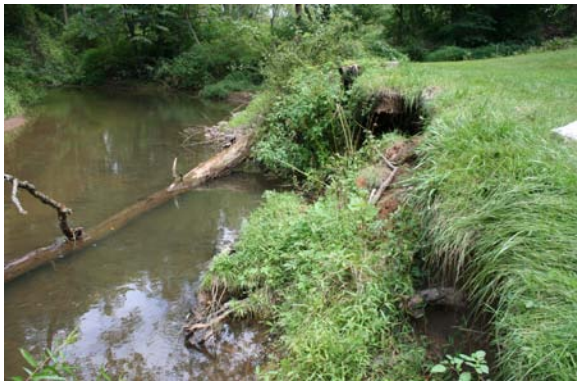
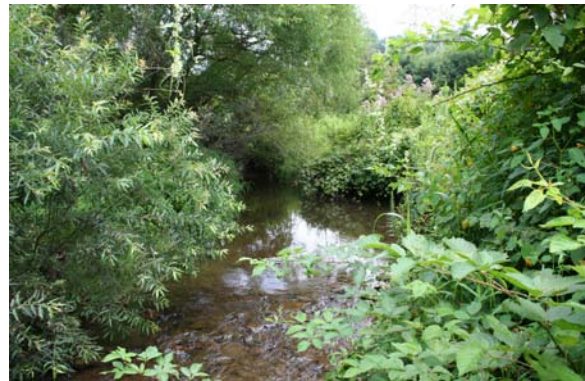
Riparian buffers within the Hosensack watershed are generally very good, including extensive mature forests. However, areas of deep streambank erosion are evident at numerous locations; many locations coincide with areas of minimal or non-existent riparian buffers.

Figure 10. The buffer on the left consists of mown grass only and is being undercut by the creek. The result is increasing erosion, more sediments in the creek, lost frontage along the creek and degraded habitats. The buffer on the right is fully vegetated with native plants, which help keep the soil intact, provide shade and protect aquatic habitats from sedimentation.

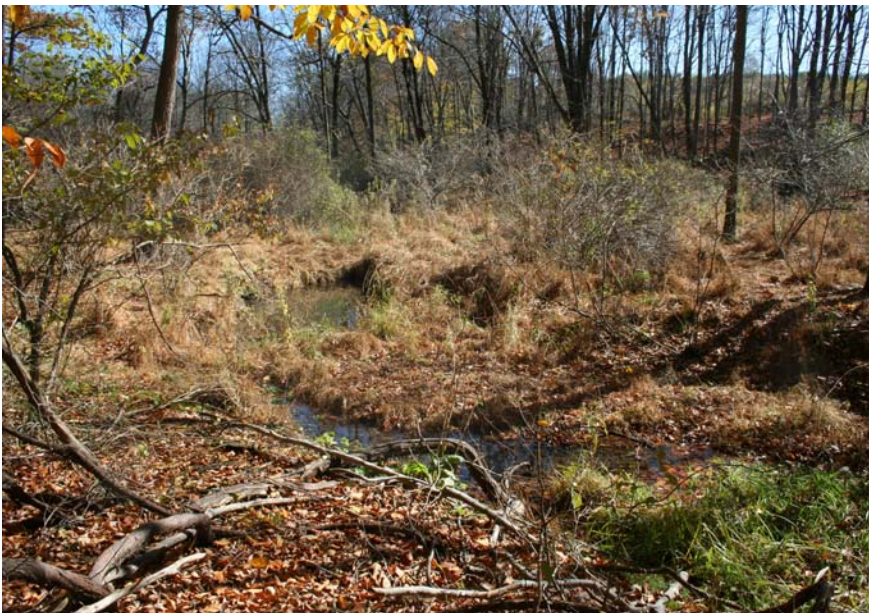
Figure 11. Small, wet areas like the one in the photograph to the left are important headwaters areas and help mitigate rainy and dry seasons by storing water and slowly releasing it into the larger creek system.

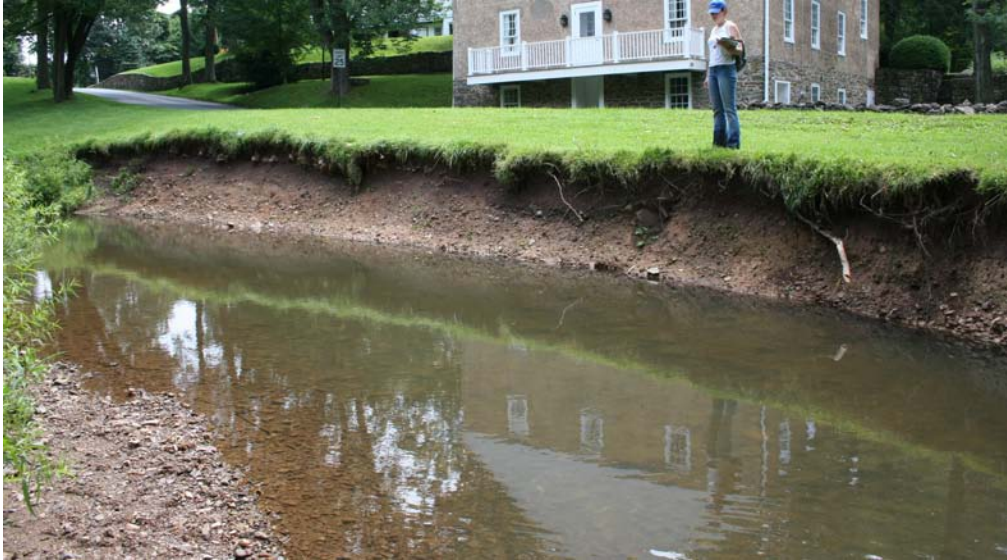
Figure 12. This severely eroded streambank is adding sediments to the overall creek system and could jeopardize the nearby roadway if erosion is not controlled. Restoration of this section of the Hosensack Creek could be a prominent demonstration project.
