**2013 COLDWATER
HERITAGE PARTNERSHIP
GRANT**

LACKAWANNA RIVER TRIBUTARIES
STUDY/PLAN

Cheryl Nolan
Watershed Specialist
Lackawanna County Conservation District

Coldwater Heritage Partnership Grant
Final Report
June 25, 2014

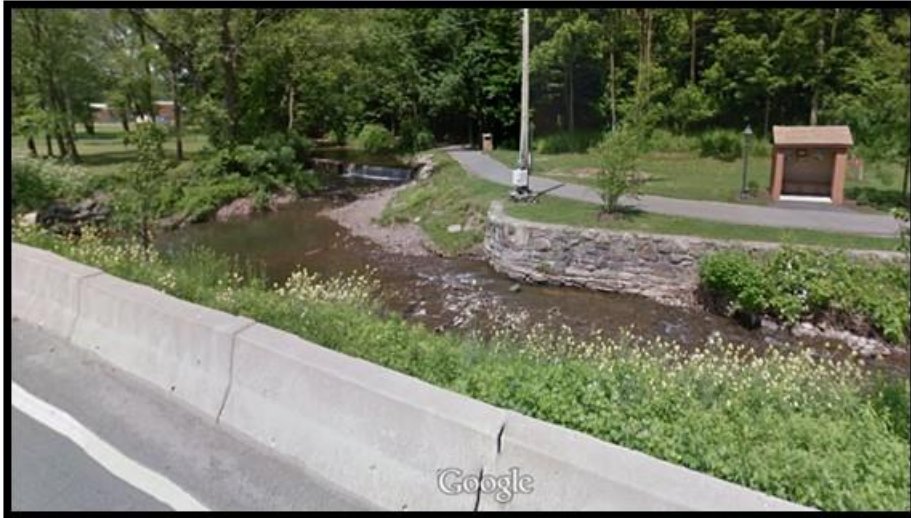
Just upstream of I-81, Leggetts Creek flows into a small pond, from which an intake pipe conveys water downstream to a wastewater treatment plant in Chinchilla. The stream then crosses under

I-81 and an entrance ramp to the North East Extension of the PA Turnpike, before flowing through South Abington Park (left). A riparian zone of native trees and understory flank the north bank. A walking trail has been developed through the park along the north bank. It extends about 0.4 miles downstream

of the park to Layton Road and receives regular use. The park, an elementary school, and PA Rtes. 6 & 11 lie off the south bank, restricting the riparian corridor.

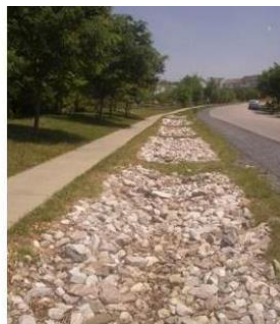
Infiltration Trenches

Infiltration trenches can be used in place of curbs and rain barrels can be used when disconnecting downspouts. Rain Gardens can be installed at extended down spouts. Grassed swales, green parking designs and vegetated roofs can be used wherever appropriate and will help to allow infiltration of stormwater into the ground.

These BMPs allow for infiltration of stormwater and can help to eliminate pollutants from stormwater before it reaches the waterways such as streams, rivers and lakes. The EPA has a comprehensive list of BMPs at: http://www.epa.gov/oaintmnt/stormwater/best_practices.htm#best_practices and the PA DEP has a stormwater best management manual that can be found at: <http://www.elibrary.dep.state.pa.us/dsweb/View/Collection-8305>.
