Coldwater Heritage Partnership

LITTLE LEHIGH CREEK COLDWATER CONSERVATION PLAN

October 2007

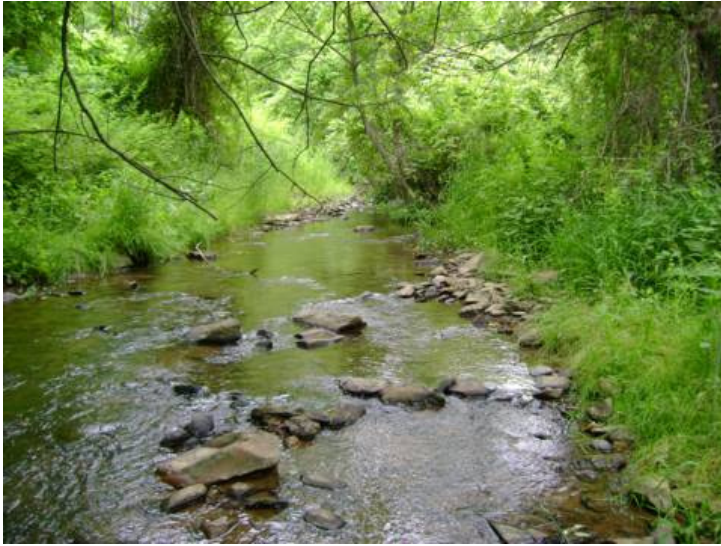
This reach of the main stem of the Little Lehigh Creek represents ideal conditions that will ensure the highest water quality and greatest biodiversity.

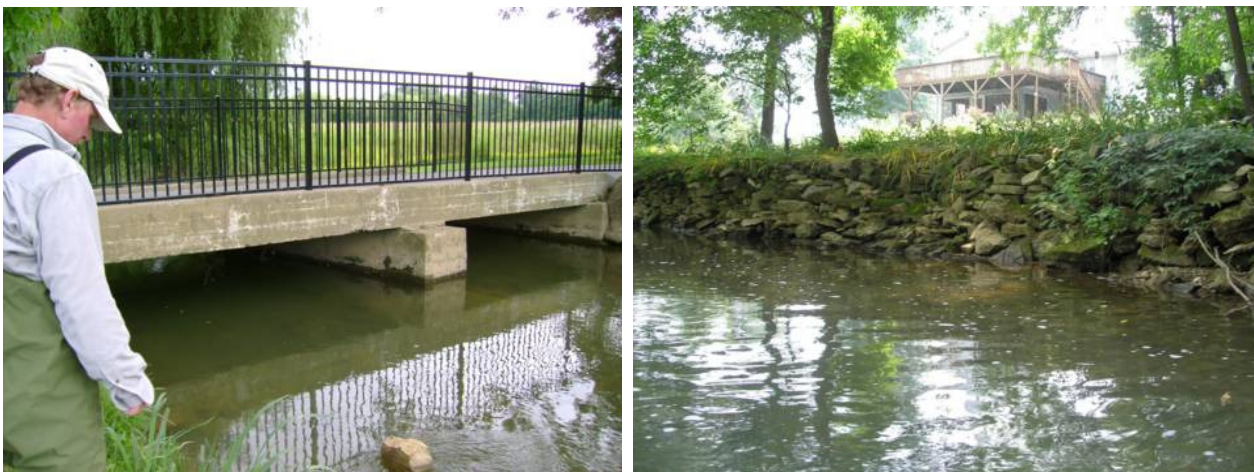
CHANNEL CONDITION

During large storm events, bridges (left photo) can create water flow obstructions, exacerbating localized stream bank erosion, and accelerating flooding. The stream bank (right photo) has been stabilized with stones to address decades-long erosion during storms. The stream has become disconnected with its floodplain, so during rain events the velocity builds and the stream banks erode at an accelerated rate. Maintenance of the stone wall will be ongoing.

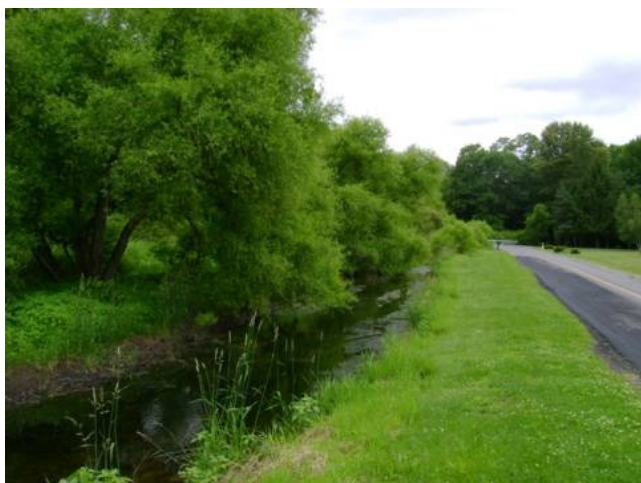
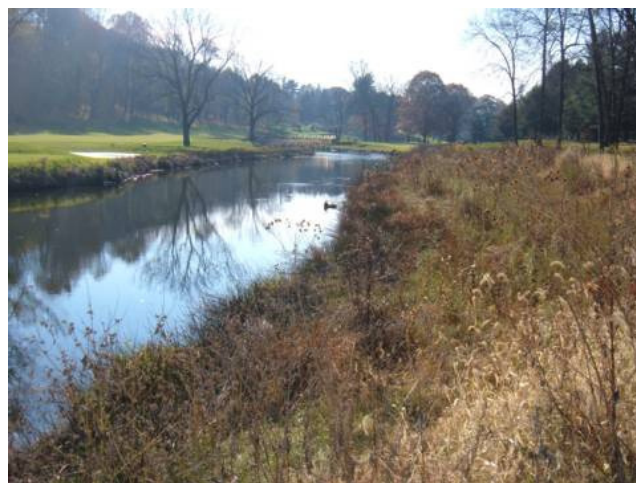
RIPARIAN ZONE

The mown grass along the Little Lehigh Creek (left photo) does not provide significant filtering capacity and can reduce water quality. Impervious surfaces such as parking lots and roads collect chemicals and heavy metal residues from cars. During a storm, these pollutants are washed directly into the creek. However, if this land adjacent to the creek was well-vegetated, there could be a reduction in pollution entering the stream. Forested riparian zones provide the greatest protection for water quality. If physical constraints limit the number of trees that can be planted, alternative choices exist. Native wildflower meadows (right photo) enhance the water quality while allowing people to enjoy the view of the creek. This type of riparian corridor is perfect in recreation areas and near busy roads.

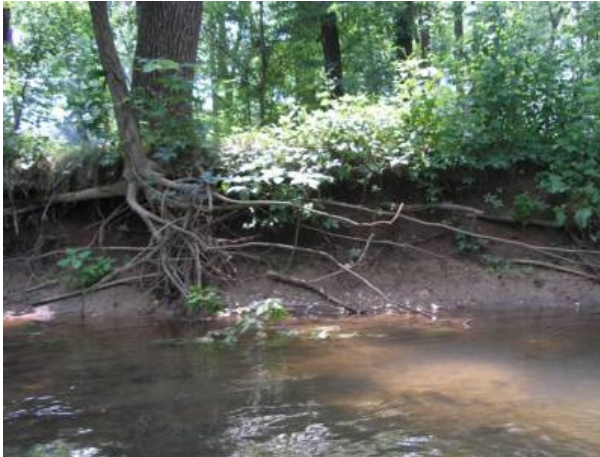
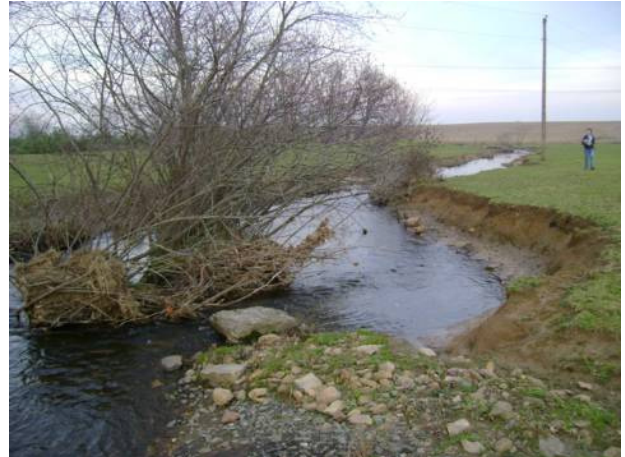
BANK STABILITY

Water flowing rapidly downstream can be destructive. Portions of the creek that have been altered by farming practices or construction activities in the past to accommodate bridges, and developments already show signs that the stream has become degraded. The conditions may only worsen with the projected future development of the watershed and the potential that more sections may be ineptly managed by landowners. A creek not functioning properly will contain trees with exposed roots (left photo). Over time these trees will fall into the creek. Normally, the network of roots from a mixture of trees, shrubs, grasses and wildflowers stabilize the banks effectively. Some property owners experience a loss of a foot of land every few years or worse (right photo) because there are too few roots to keep the soil in place during heavy stormwater flows.

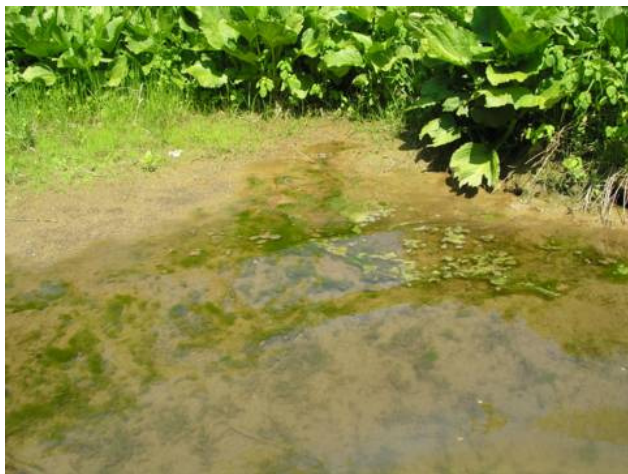
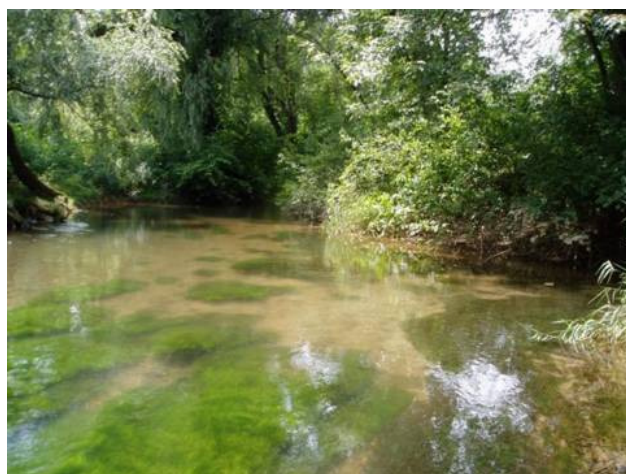
NUTRIENT ENRICHMENT

Excessive nutrients create problems in aquatic ecosystems and in severe conditions they may cause a reduction in dissolved oxygen when large algal masses decompose. This affects the presence and diversity of fish species. These photos document sunny, slow-flowing reaches on the Little Lehigh Creek where algae (left photo) and aquatic vegetation (right photo) are present. Large amounts of algae were also found in a shady wooded reach in Berks County.

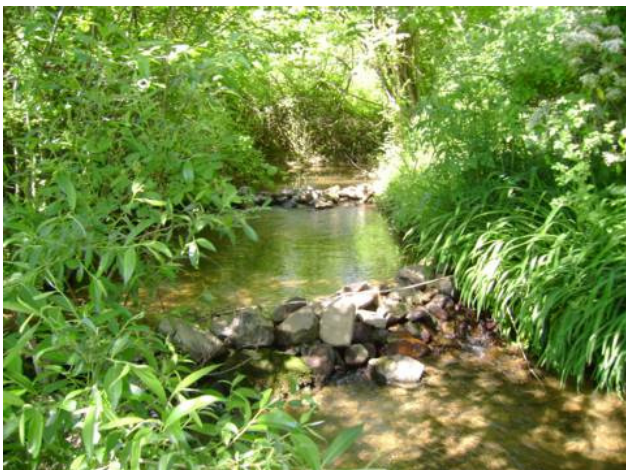
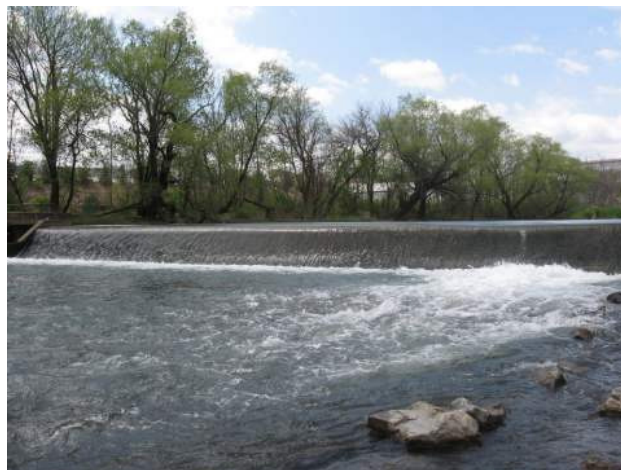
BARRIERS TO FISH MOVEMENT

Barriers to fish can be as simple as piles of rocks purposefully placed across a stream (left photo) to a large engineered dam (right photo). There are even the remnants of an old water wheel along the Little Lehigh Creek where water is currently piped to bring the water directly to the water wheel no longer in operation.

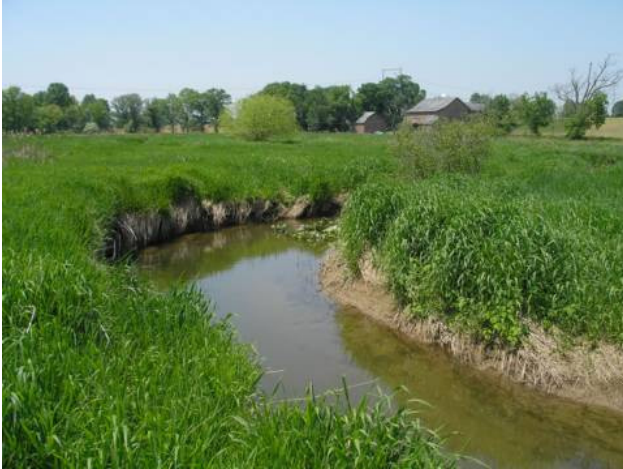
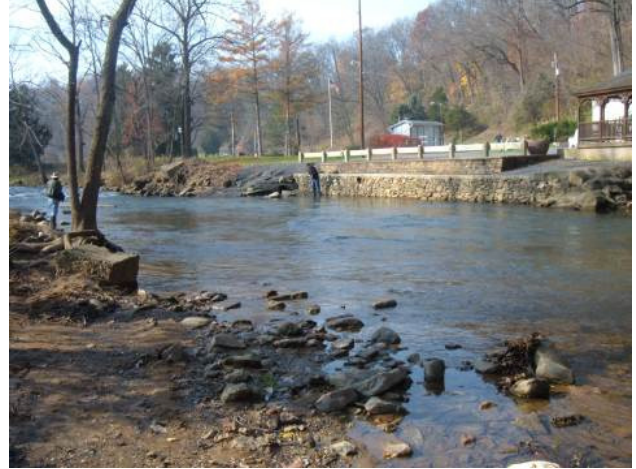
INSTREAM FISH HABITAT

Ideal habitat along the Little Lehigh Creek provides fish with hiding places under logs and overhanging vegetation. Rocks would be plentiful, sheltering the aquatic insects that fish feed on. Habitat that does not benefit fish (left photo) are sections of the creek that contain no trees or overhanging vegetation, leaving fish vulnerable to predators with no shelter. Also in this reach pictured here, past farming practices buried cobbles and boulders under silt. In more urbanized areas, heavily-used recreation areas like the Little Lehigh Parkway (right photo) offers excellent creek access, but to the detriment of fish. Upstream and downstream reaches can then be more ecologically managed with large stands of trees and plantings left in tact. This balances the negative affects of numerous recreational-park users with the ecological needs of the creek.

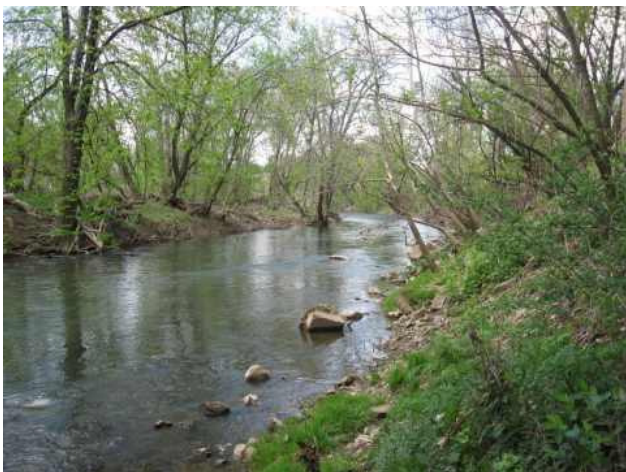
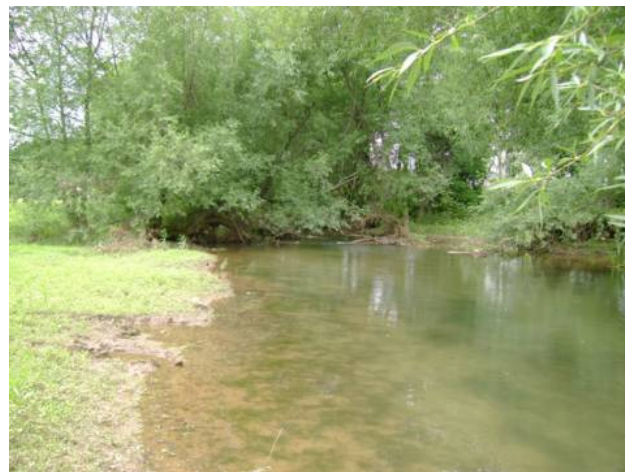
INSECT/INVERTEBRATE HABITAT

Aquatic insects like mayflies and caddisflies are a critical part of the stream, and fish depend on them as a food source. Ideal habitat along the Little Lehigh Creek provides these aquatic insects with submerged logs, plenty of rocks in the stream channel and piles of leaves tucked between rocks or caught on woody debris. In more urbanized areas, like Fountain Park in the City of Allentown (left photo), a section that remains wooded, well-shaded, and not inundated with stormwater can support a diversity of aquatic insects. Habitat that does not benefit aquatic insects (right photo foreground) are sections of creeks that contain no trees or overhanging vegetation. Various sized rocks in the stream channel are absent in this section in Lower Macungie Township, reducing the availability of habitat. The lack of shade and excess nutrients also negatively impact the insect habitat at this site.

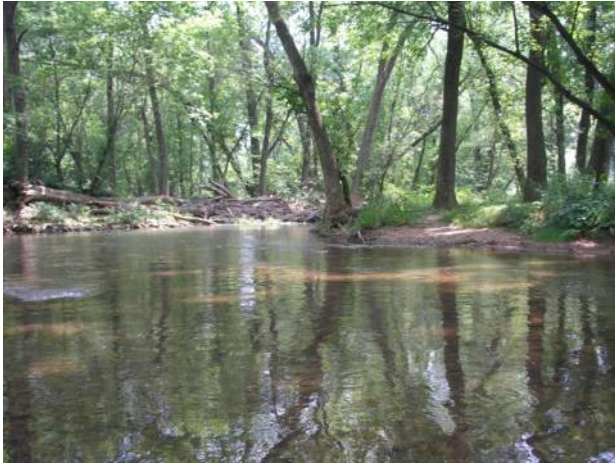
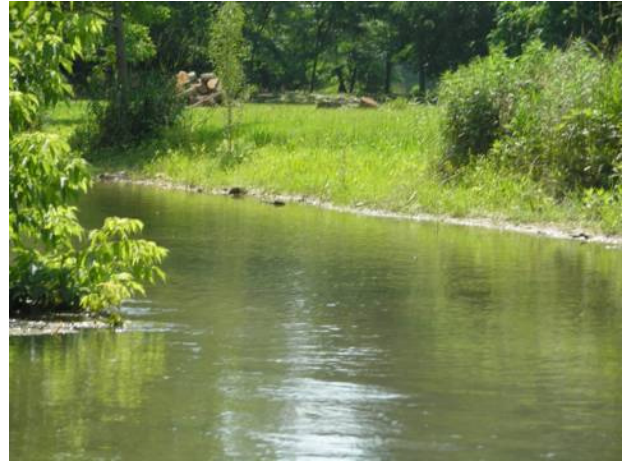
CANOPY COVER

The amount of shade that covers the creek channel is an important part of a functioning aquatic ecosystem. Dense shade, especially during the summer months, keeps the water temperature from rising. The colder the water, the higher the oxygen concentration. The tree canopy also represents an important food source for aquatic life in the creek. The stream reach (left photo) that is surrounded by dense woodlands creates the ideal conditions for fish and macroinvertebrates. Portions of streams where the trees have been removed and replaced with grass (right photo) can reduce the biological diversity in that section.

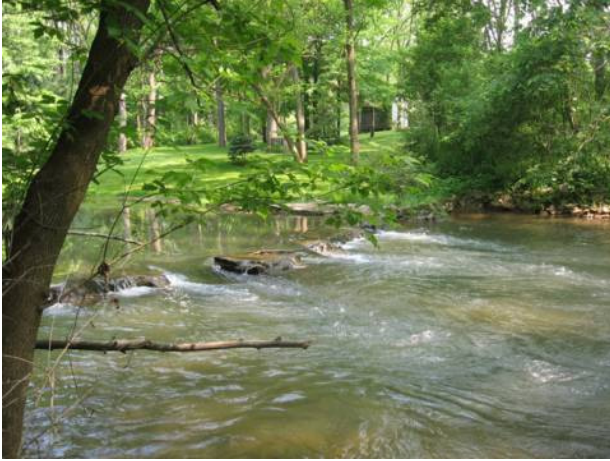
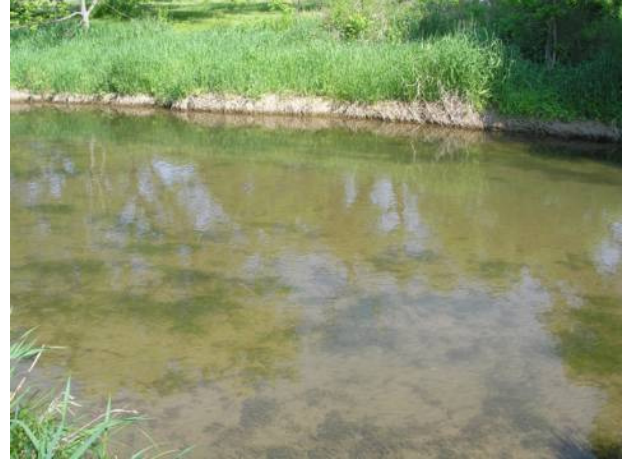
RIFFLE EMBEDDEDNESS

Riffles are a collection of rocks in a shallow stream that create a break in the water. This area represents an important habitat for aquatic insects and provides an influx of oxygen from the air into the water. Despite a residential development adjacent to the Little Lehigh Creek (left photo) a riffle remains intact. In areas that have either overland or instream erosional issues, the stream channel becomes silted in over time and the riffle becomes buried (right photo).
