Lost Creek Coldwater Conservation Plan

2013

Prepared by the Juniata County Conservation District

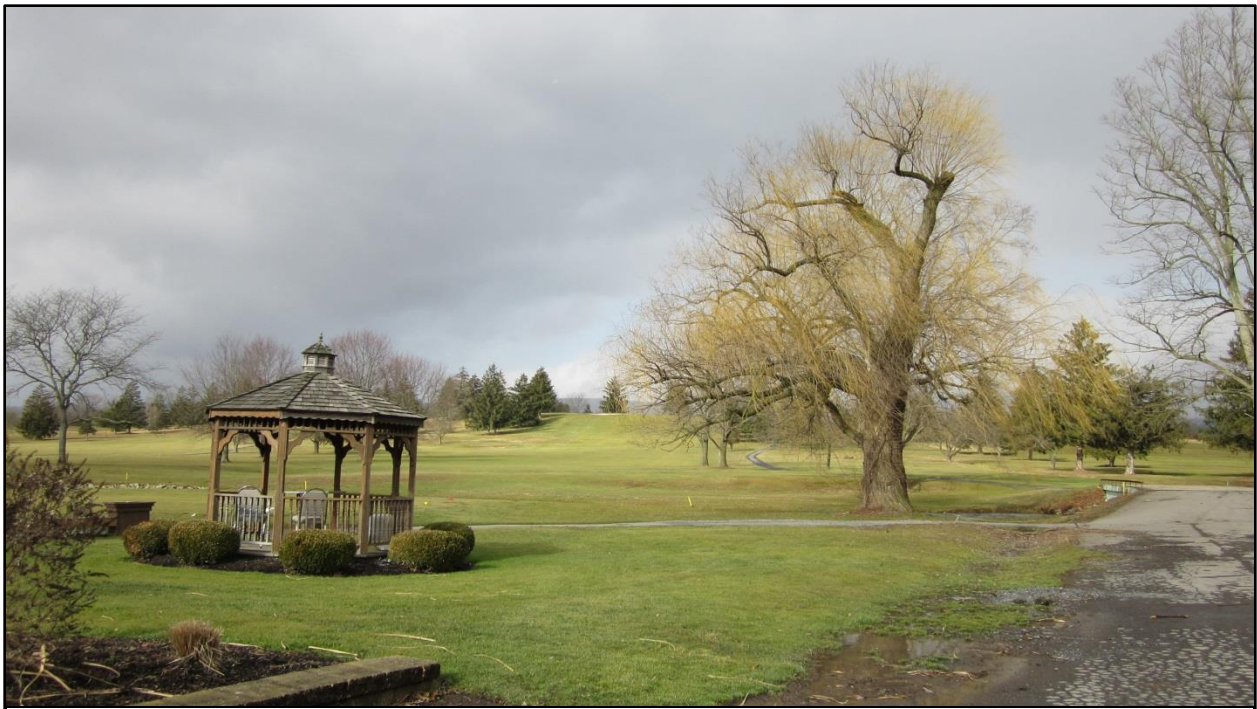
Lost Creek Golf Course is located at the very tip of the HQ-CWF portion of the Lost Creek Watershed. The Main Stem of Lost Creek flows directly through the golf course green.

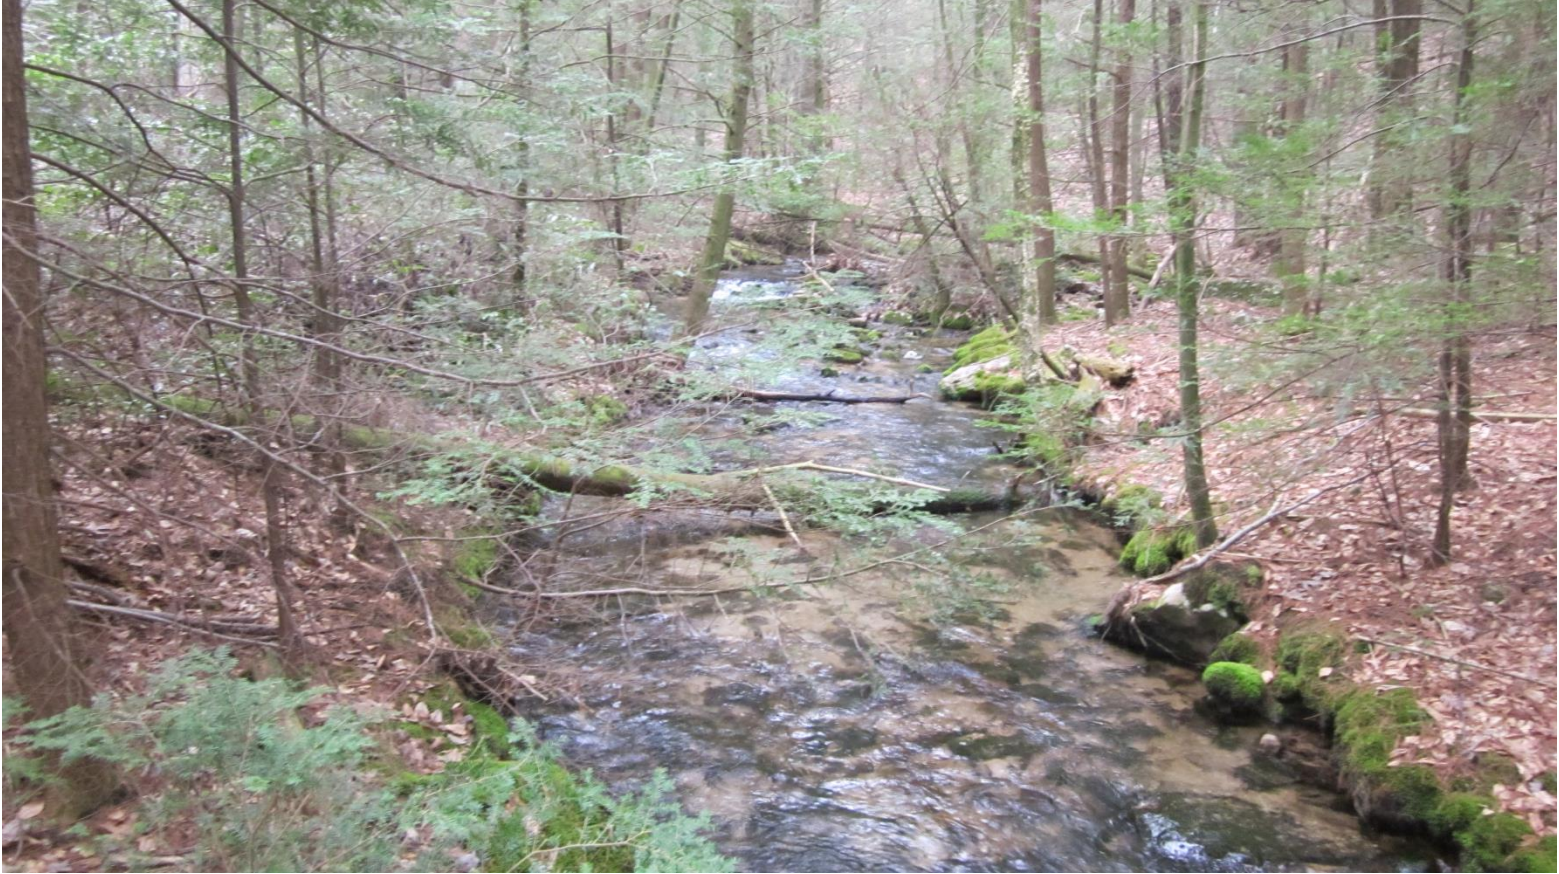
LC-CWH 1:

LC-CWH 1 is located in the headwaters of the Lost Creek watershed on Lost Creek Rod and Gun Club Property, near the Juniata/Snyder county line. The site somewhat remote, and is accessed by a gated, private dirt road that winds down a steep grade until reaching the stream. The site is also crisscrossed by several hiking trails.

Within the past several years, property near the site has been logged. The site has most certainly suffered an increase in sedimentation as a result. Fortunately, a sizeable buffer was left uncut near the stream.

This site scored 201 out of 240 on the Stream Habitat Assessment Field Data Sheet, placing it in the Optimal category. The areas only notable degradates were in Instream Cover and Embeddedness, and Sediment Deposition due to sedimentation in the channel from recent logging activities.

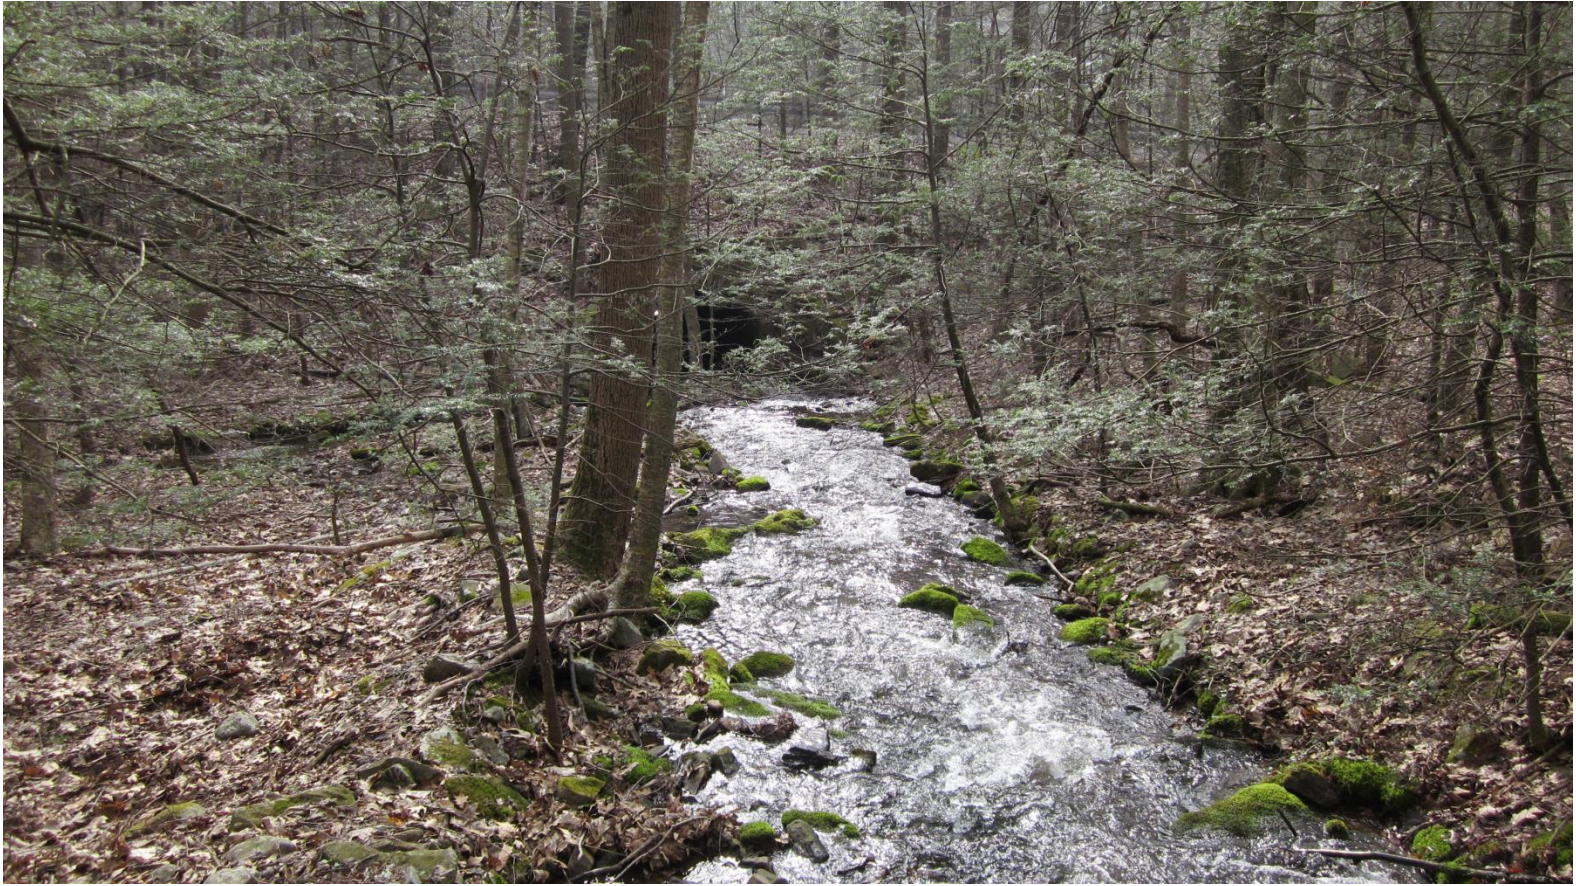
LC CWH 2:

LC CWH 2 is a sampling site along a tributary to Lost Creek known as Lick Run. This site is located near a pull-off along SR 235, and is on Lost Creek Rod and Gun Club property. The site is crisscrossed by hiking trails. Just downstream of the site, Lick Run flows through an old stone culvert under SR 235, and meets Lost Creek shortly thereafter.

This site may be somewhat affected by its proximity to the nearby roadway, but otherwise seems to suffer from no major degradation.

LC CWH 2 scored 199 out of 240 on the Stream Habitat Assessment Field Data Sheet, placing it in the Optimal category. The site scored within the Optimal category for each individual assessment parameter besides sedimentation. Some sediment in the stream is likely due to historical logging within the watershed.

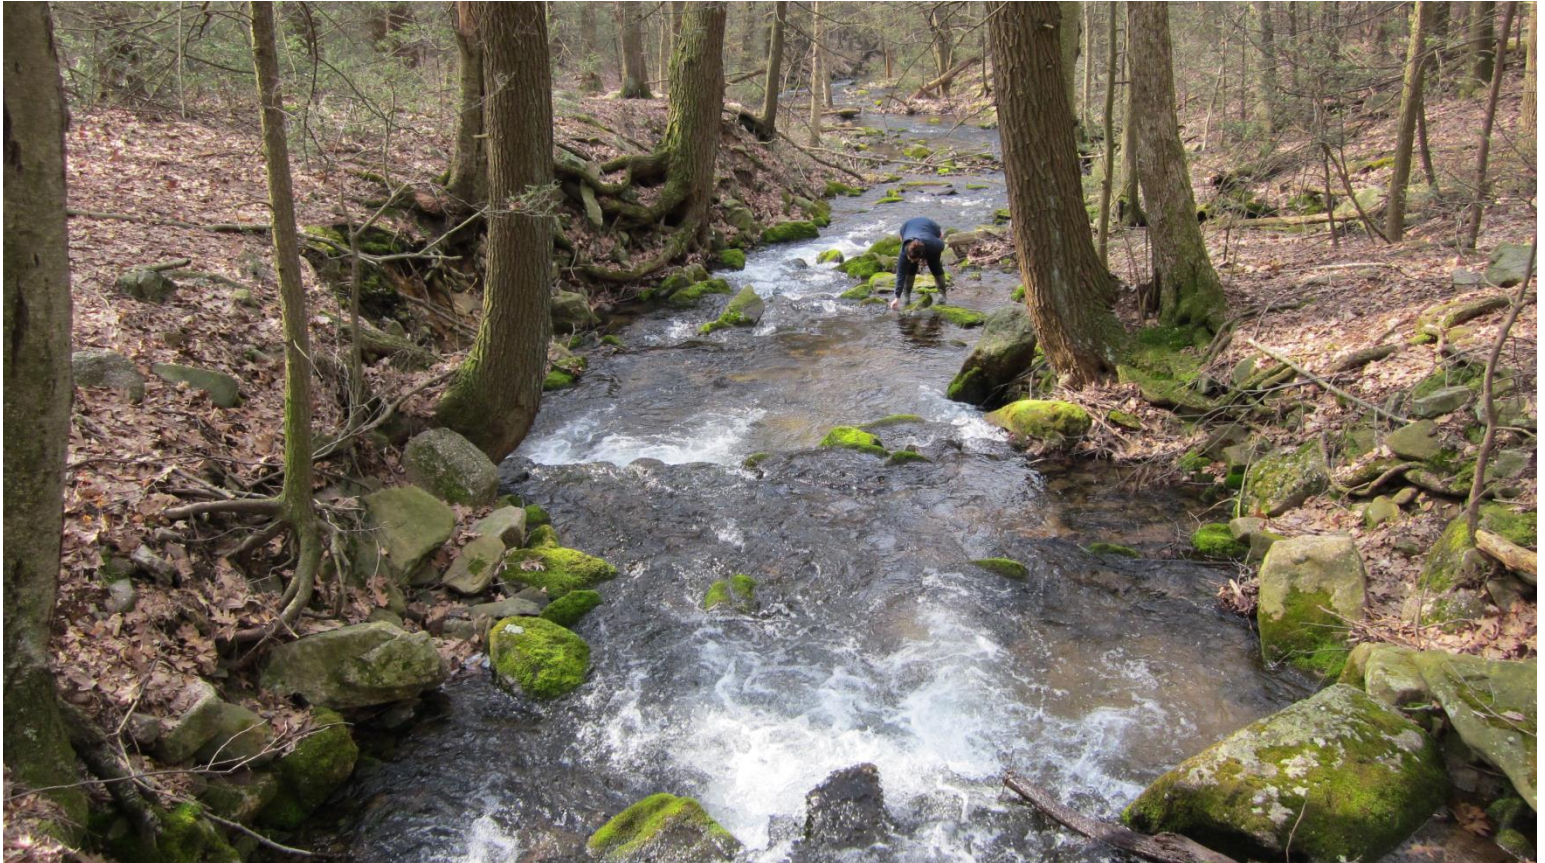
LC CWH 3:

LC CWH 3 is located off of SR 235 and accessed via the Lost Creek Rod and Gun Club's Camp Property. This sampling location is quite close to a cabin and parking area maintained by the Rod and Gun Club. This portion of the stream is closed to fishing. Trails crisscross the area. SR 235 parallels the site at a distance of several hundred yards. Here, the streambanks are steeper, and the stream gradient itself is quite steep. The area is marked by many drops and pools.

This site could potentially be affected by activities at the camp or in the parking area, although no degradation is apparent.

LC CWH 3 scored 196 out of 240 on the Stream Habitat Assessment Field Data Sheet, placing it in the Optimal category. The site scored within the Optimal category for each individual assessment parameter except Channel Alteration, Sediment Deposition, and Condition of Banks, which scored in the Suboptimal category. The channel is crossed by several foot bridges, and the steeper banks in the area are somewhat unstable in nature, leading to slight sediment deposition.

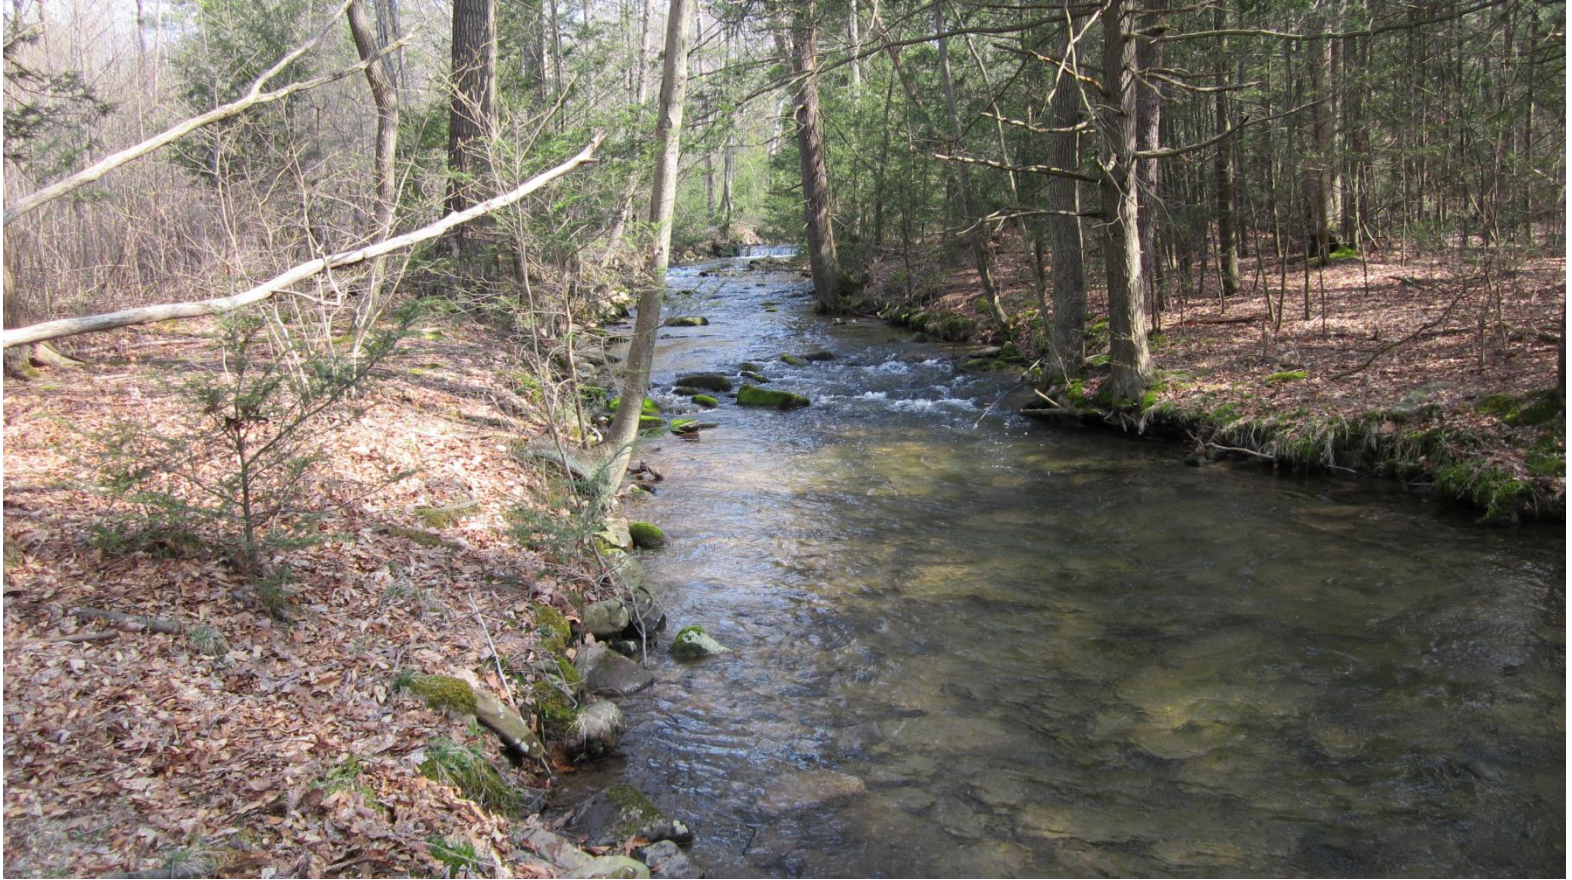
LC CWH 4:

LC CWH 4 is located off of Powel Road, a private drive used to access several camps, or privately owned temporary residences in the area. This sampling location is quite close to a privately owned cabin.

This site could potentially be affected by activities at the cabin, although no degradation is visible.

LC CWH 4 scored 191 out of 240 on the Stream Habitat Assessment Field Data Sheet, placing it in the Optimal category. The site scored within the Optimal category for each individual assessment parameter except Sediment Deposition, and Condition of Banks, and Riparian Vegetative Zone Width. The left bank (as seen in photo above) is where the privately owned cabin is located. The cabin sits within several yards of the streambank, and the bank is maintained in that area with little to no vegetation. The riparian zone on that bank is almost non-existent, leading to a patch of bank instability.

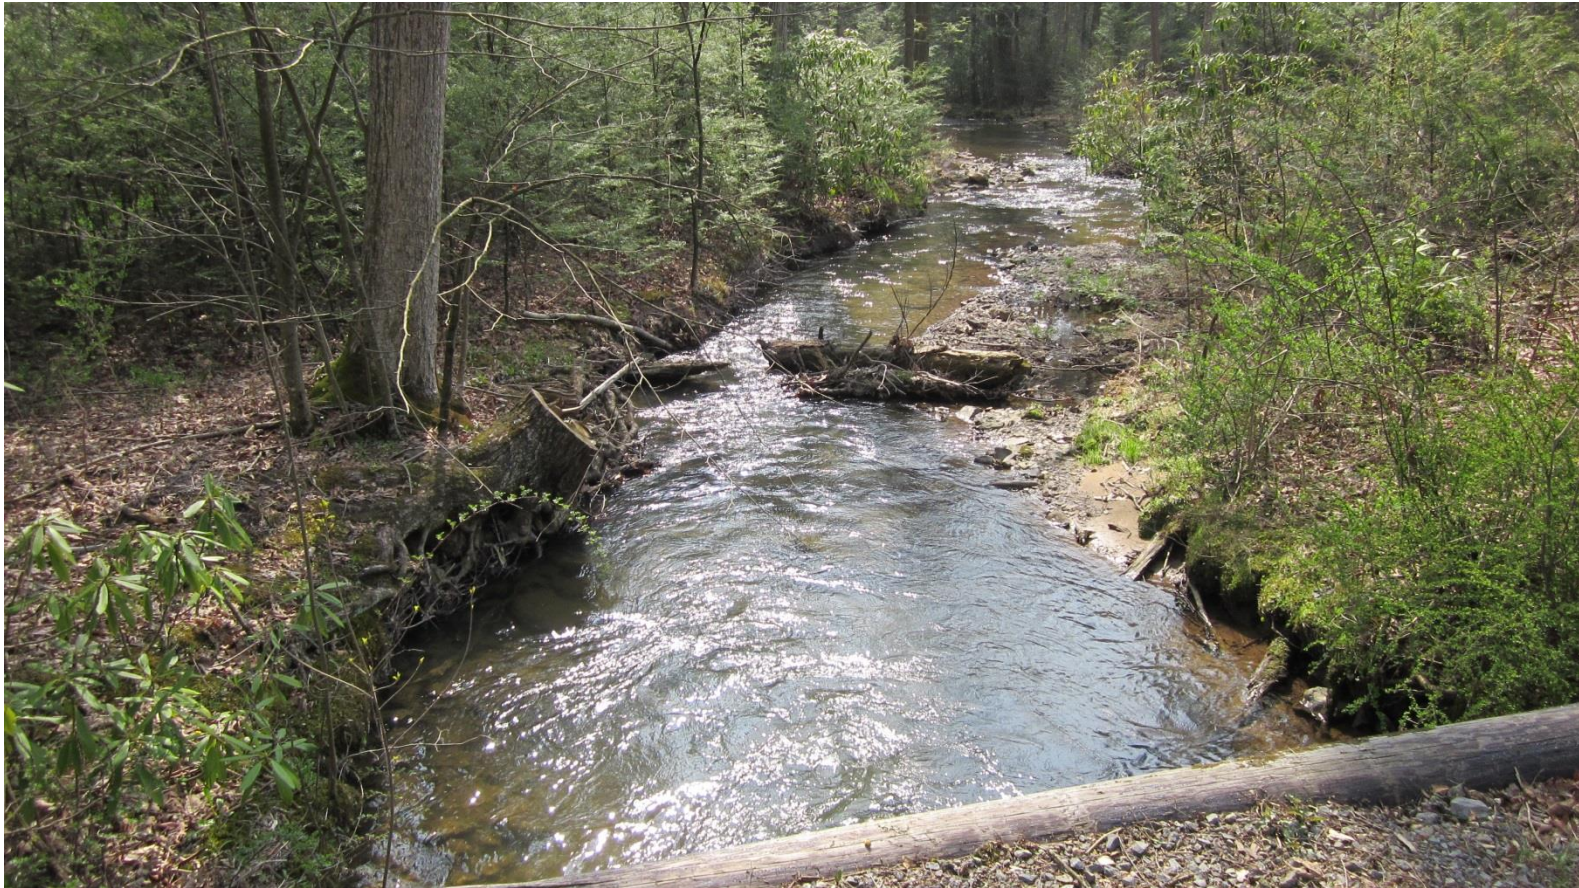
LC CWH 5:

LC CWH 5 is located on a tributary of Lost Creek known as Tennis Run, near the intersection of Mountain Road and Tennis Park Road. This sampling site is located on private property, and is crossed by a private driveway bridge. A personal garage is located within several yards of the streambank, and a permanent residence sits several hundred yards away.

Some impacts can be seen at the site due to its proximity to a permanent residence; mainly the results of the driveway crossing. Impacts have been minimal.

LC CWH 5 scored 185 out of 240 on the Stream Habitat Assessment Field Data Sheet, placing it in the Optimal category. The site scored within the Optimal or Suboptimal categories for each individual assessment parameter. Lower scores were received in categories such as Channel Alteration, Grazing or Other Disruptive Pressure, Riparian Vegetative Zone Width due to the garage and residence and their proximity to the stream.

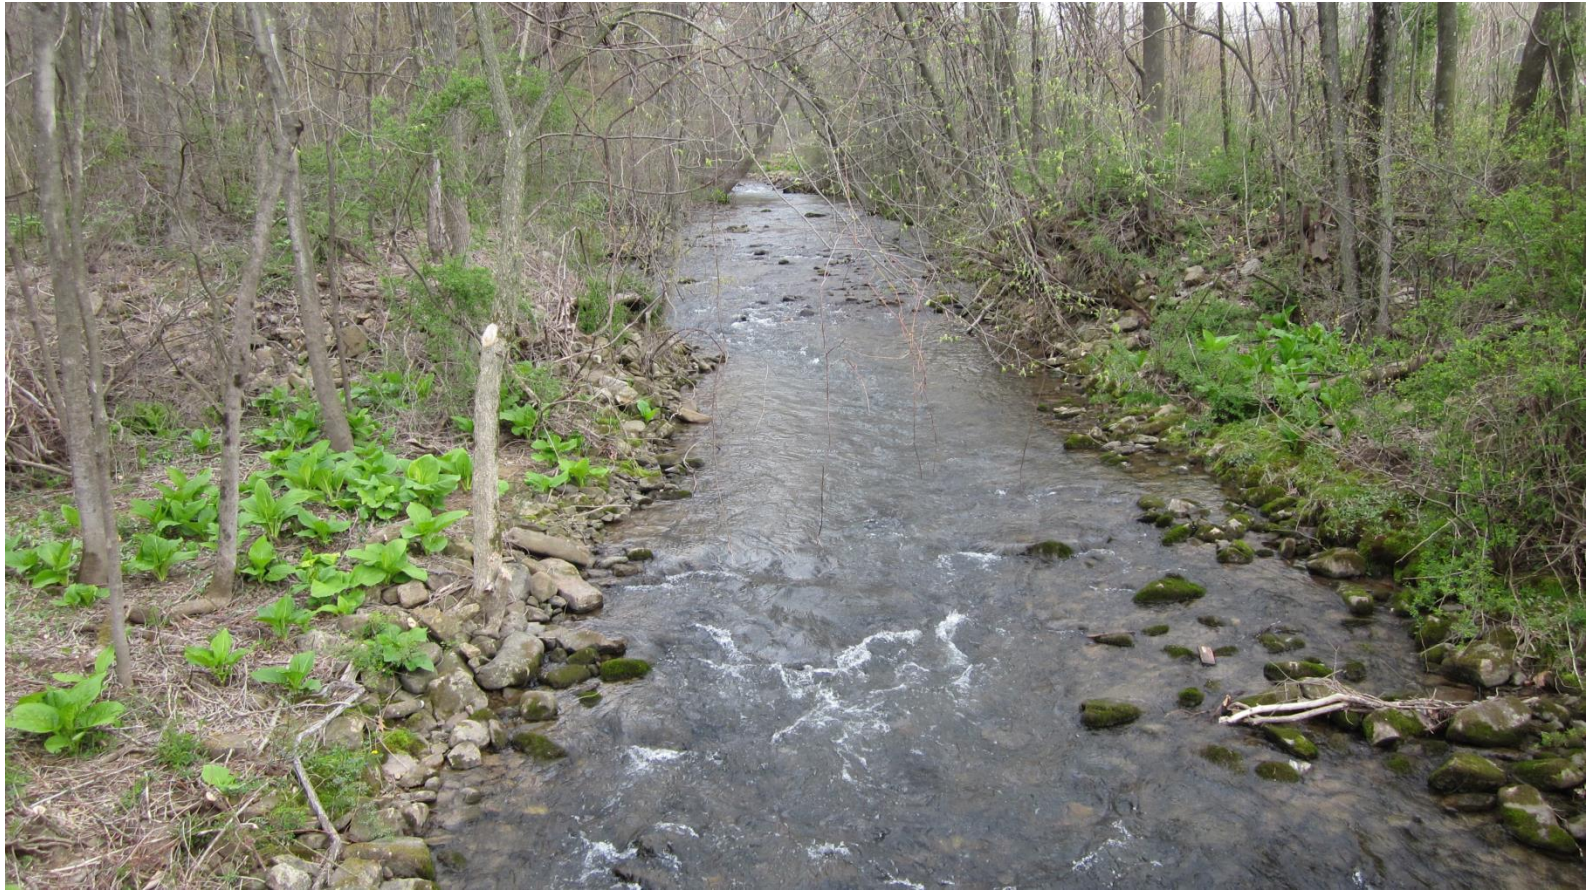
LC CWH 6:

LC CWH 6 is located on the main stem of Lost Creek, near where the stream crosses under Degan Road. This sampling site flows through private property, and is near a commercial garage operation and a poultry farm.

Some impacts can be seen at the site due to its proximity to industry, agriculture, and permanent residences. Direct impacts have been minimal despite these threats due to an intact buffer zone.

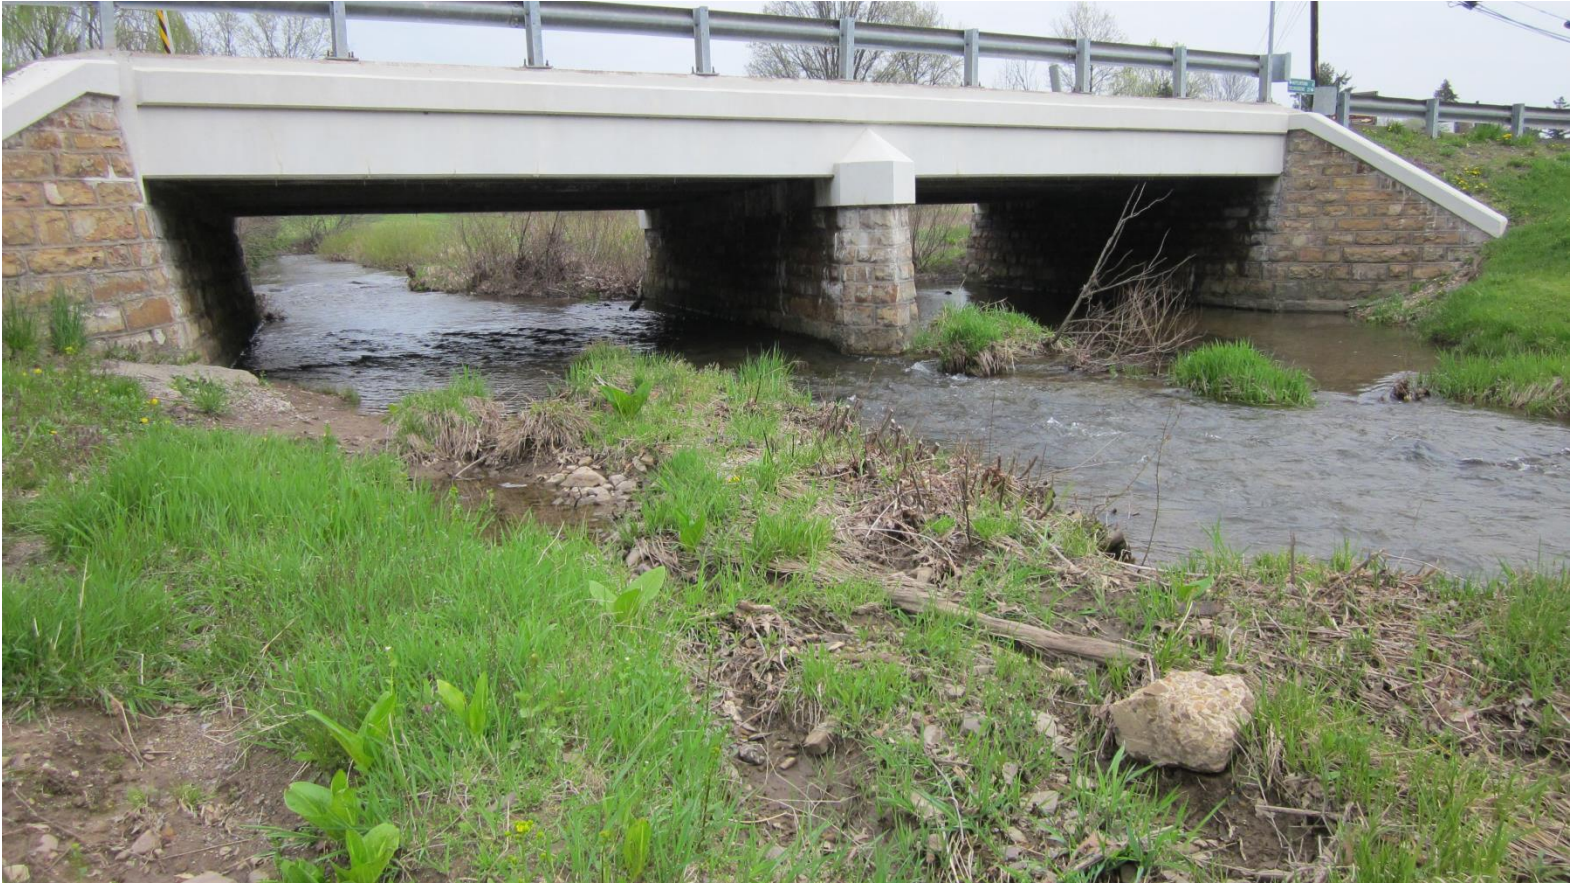
LC CWH 7:

LC CWH 7 is located on the main stem of Lost Creek where the project area ends, as Lost Creek crosses under SR 35.

Impacts at this site are visible. They have been caused by the roadway, and because this section of Lost Creek flows through the Lost Creek Golf Course. The riparian zone has been dramatically altered from its original state, and in-stream impacts are also noticeable as a result.

The macroinvertebrate sample for LC CWF 7 is 20% EPT, which is significantly lower than the 30% EPT that should be found in HQ-CWF watersheds. It is clear that chemical pressures as can be observed in the LC CWF 7 site's chemical data, and also sedimentation pressures have already impacted the biological functioning at this downstream-most portion of the HQ-CWF watershed. Pressures from the golf course, agricultural, and residential activities should be addressed in order to restore optimal functionality to the rest of the Lost Creek Watershed.

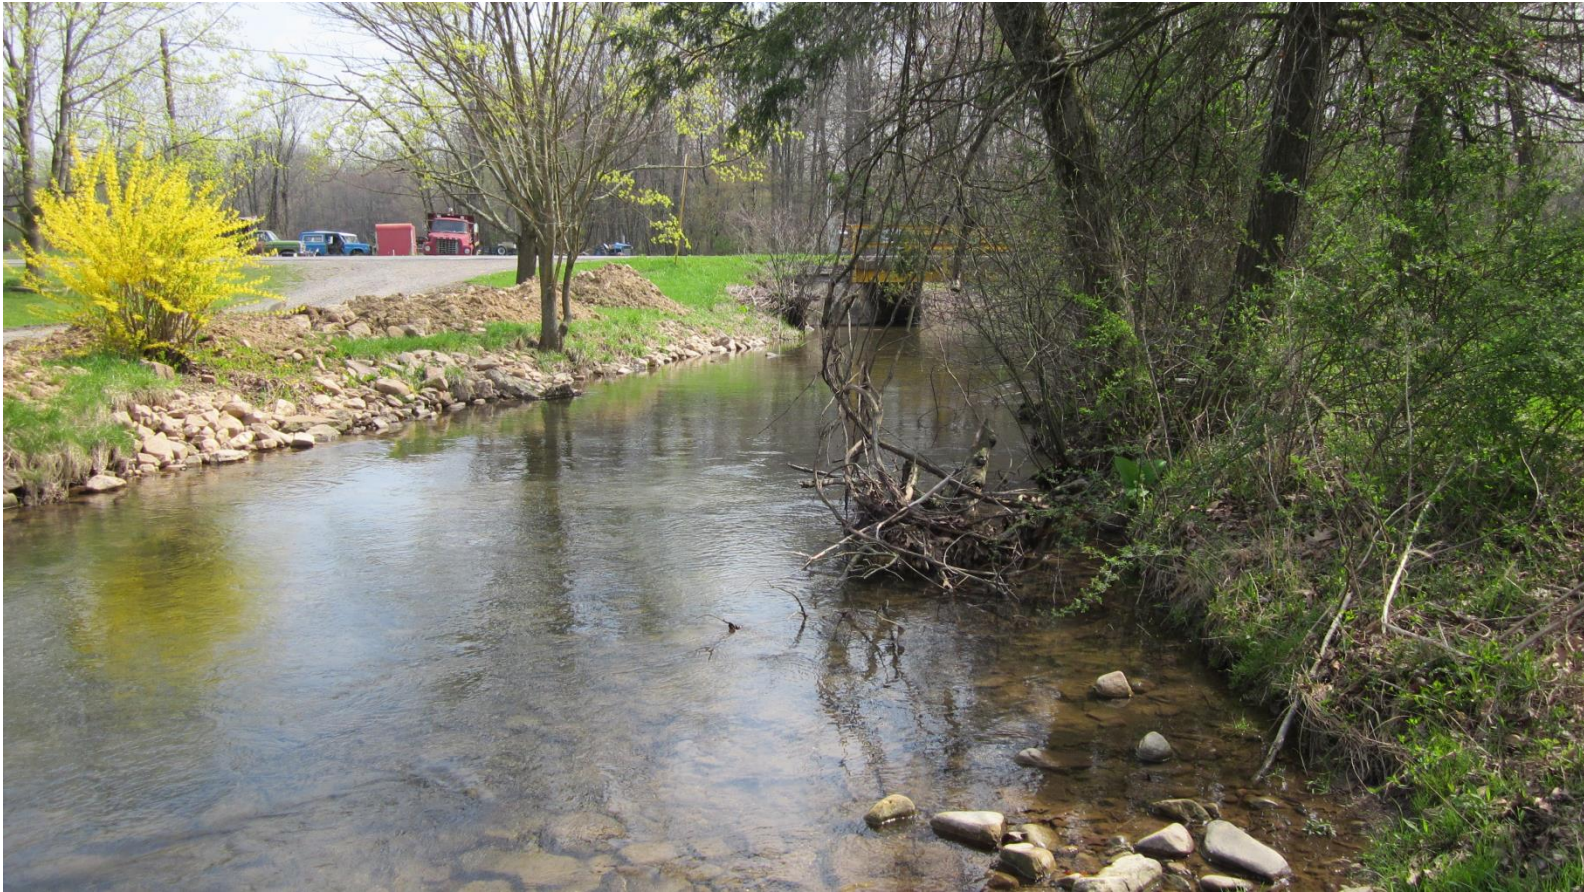
LC 1 / LC SC:

LC 1 / LC SC is an historic JCCD sampling site located along Saddle Club Road. It is flanked on one side by the Lost Creek Saddle Club property, and on the other side by private property.

LC 1 / LC SC scored a 167 out of 240 on the Stream Habitat Assessment Field Data Sheet, placing it in the Suboptimal Category. Major impacts occur in the areas of Channel Alteration, Condition of Banks, Grazing or Other Disruptive Pressure, and Riparian Vegetative Zone Width. The private residence seems to be attempting to build some sort of ineffective stone wall alongside the stream. Large rocks, debris, and dirt from this “wall” are constantly being washed in stream during high water events. Now, this foreign material dominates the stream substrate. There is a very small riparian zone due to the Saddle Club and Residence and their proximity to the channel. Impacts at this location due to these infringements are evident.

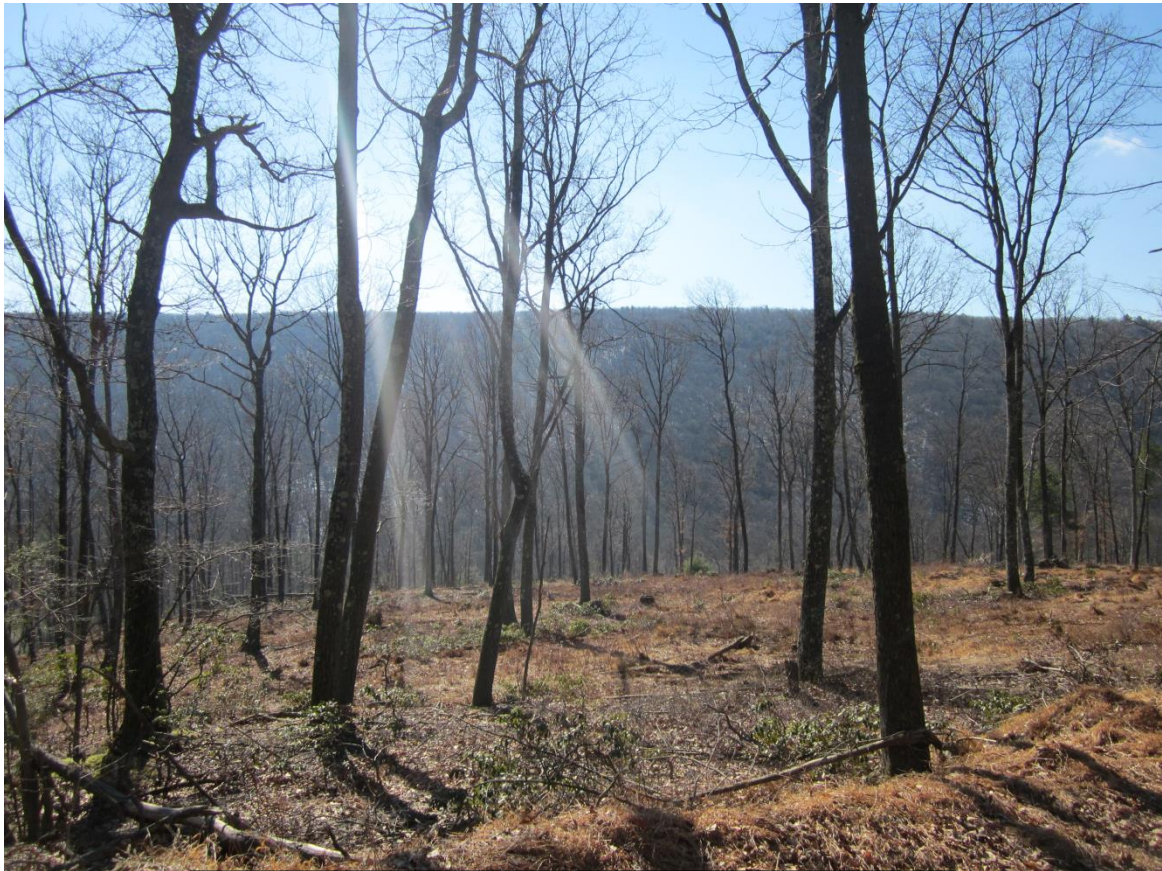
A recently logged area in the Lost Creek Headwaters
