# Little Paint Creek

## Coldwater Conservation Plan

Paint Creek  
Regional  
Watershed  
Association

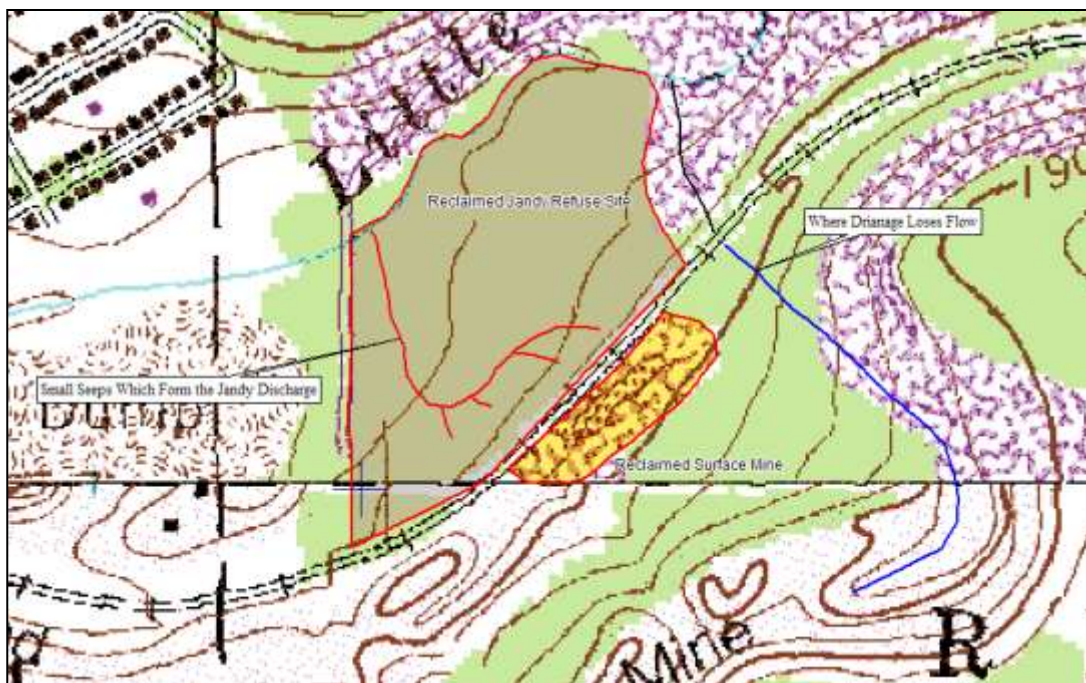
Figure 18. Drainage pattern of Jandy Discharge

Greenley Energy owns the former Jandy Coal Company Coal Refuse Pile. Several years ago, approximately 500,000 tons of refuse was moved from it to an adjacent permitted disposal site in cooperation with the DEP's Bureau of Abandoned Mine Reclamation. The contractor then installed erosion and sediment controls, filled in three ponds below the refuse pile, covered the disposal site with FBC [Fluidized Bed Combustion] ash, and regraded and revegetated the site (Clark 2005). The *Paint Creek Restoration Plan* states that, "Upon completion of the project, it was discovered that a discharge (LPC-D01) from an upslope reclaimed surface mine was still inputting heavy AMD loading into Little Paint Creek." The Jandy Discharge is comprised of this and surface water that infiltrates the refuse pile, as illustrated in Figure 18 from the *Paint Creek Restoration Plan*.

PCRWA received a DEP Growing Greener grant in 2003 to study the Jandy Discharge and design a treatment method for it. The consultants recommended grouting the discharge and directing it into the mine pool, but not all partners were convinced this method would work and the project was tabled.

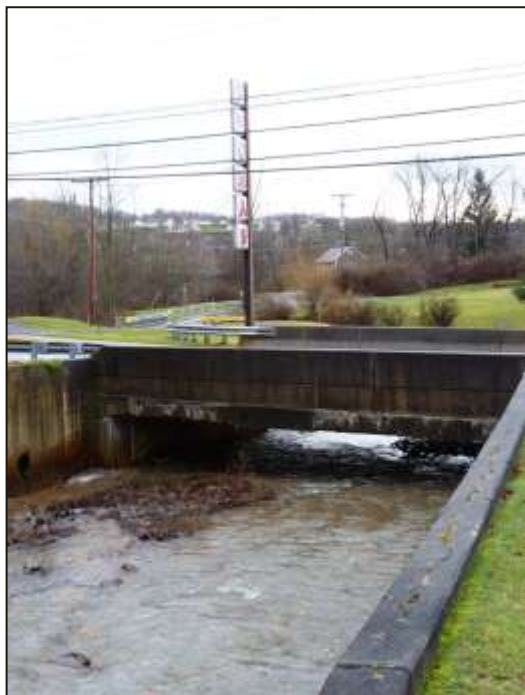
*Figure 19. Monitoring site KSTLPCM near the mouth of Little Paint Creek  
Photo by Melissa Reckner.*

The Conemaugh Valley Conservancy's Kiski-Conemaugh Stream Team, through an established partnership with the Pennsylvania Department of Environmental Protection, collected water samples from Little Paint Creek, at the Main Street Bridge, near the mouth of Little Paint Creek within the flood protection walls (Figure 19). This site is tagged as KSTLPCM (7488-361) in the DEP's Sampling Information System. Samples were collected monthly for two years and quarterly for four years between 2006 and present day. The PA DEP's Bureau of Laboratories analyzed these samples. Appendix 2 details the laboratory results from six years of water sampling.

At this site, below the village of Mine 40, the Jandy Discharge, and the Mine #40 Coal Refuse Pile, Little Paint Creek consistently had a pH between 6 and 8. Of 34 samples, the average pH was 7.19, as shown in Figure 20. The minimum alkalinity at this site was 11.20 mg/L and the maximum was 68.40 mg/L, while the average was 38.37 mg/L, as shown in Figure 21. The Pennsylvania Code 93 (Title 25 Watersheds/Water Quality) states that waterways should have a sustainable average alkalinity of 20 mg/L as CaCO<sub>3</sub> (Calcium carbonate) (Fry 2011).

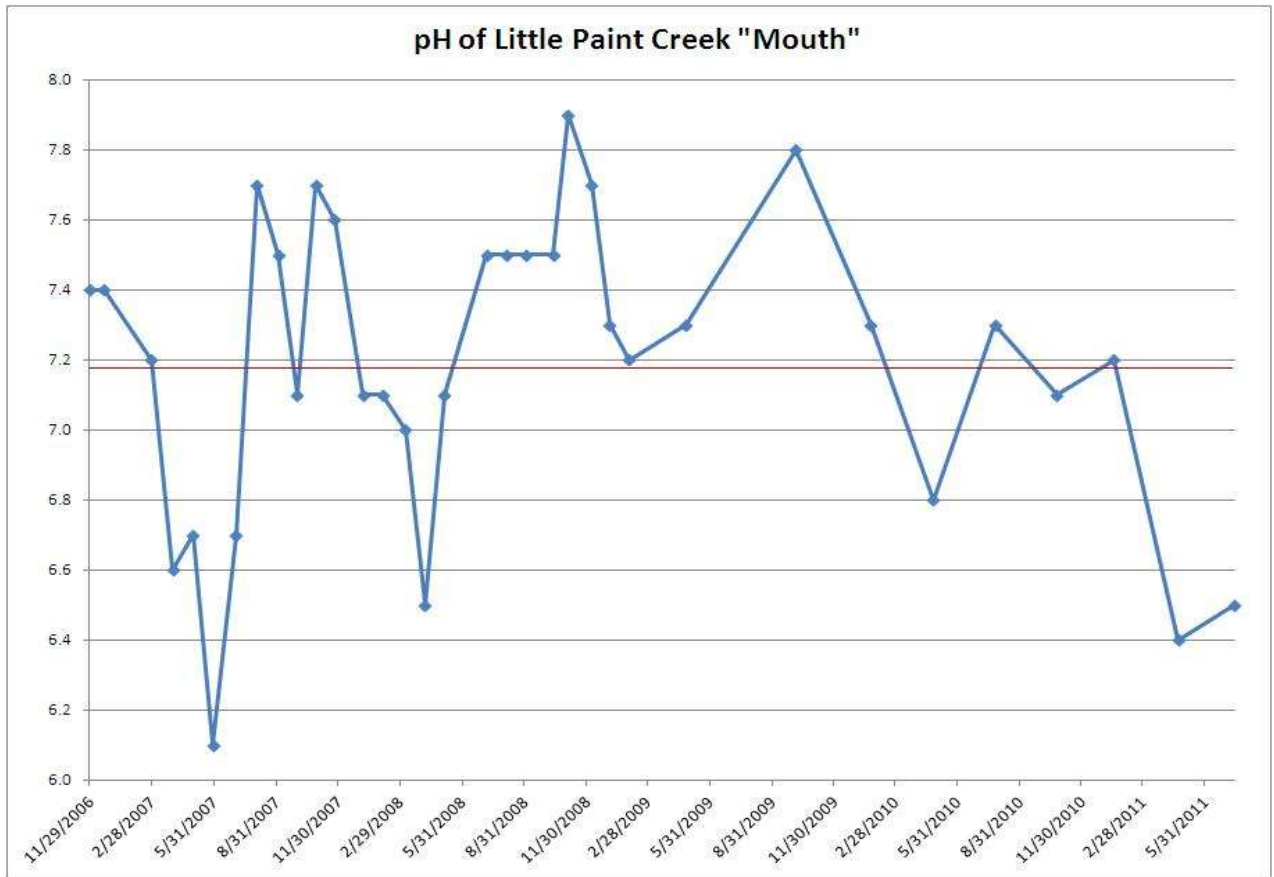
Figure 20. pH of Little Paint Creek near its mouth

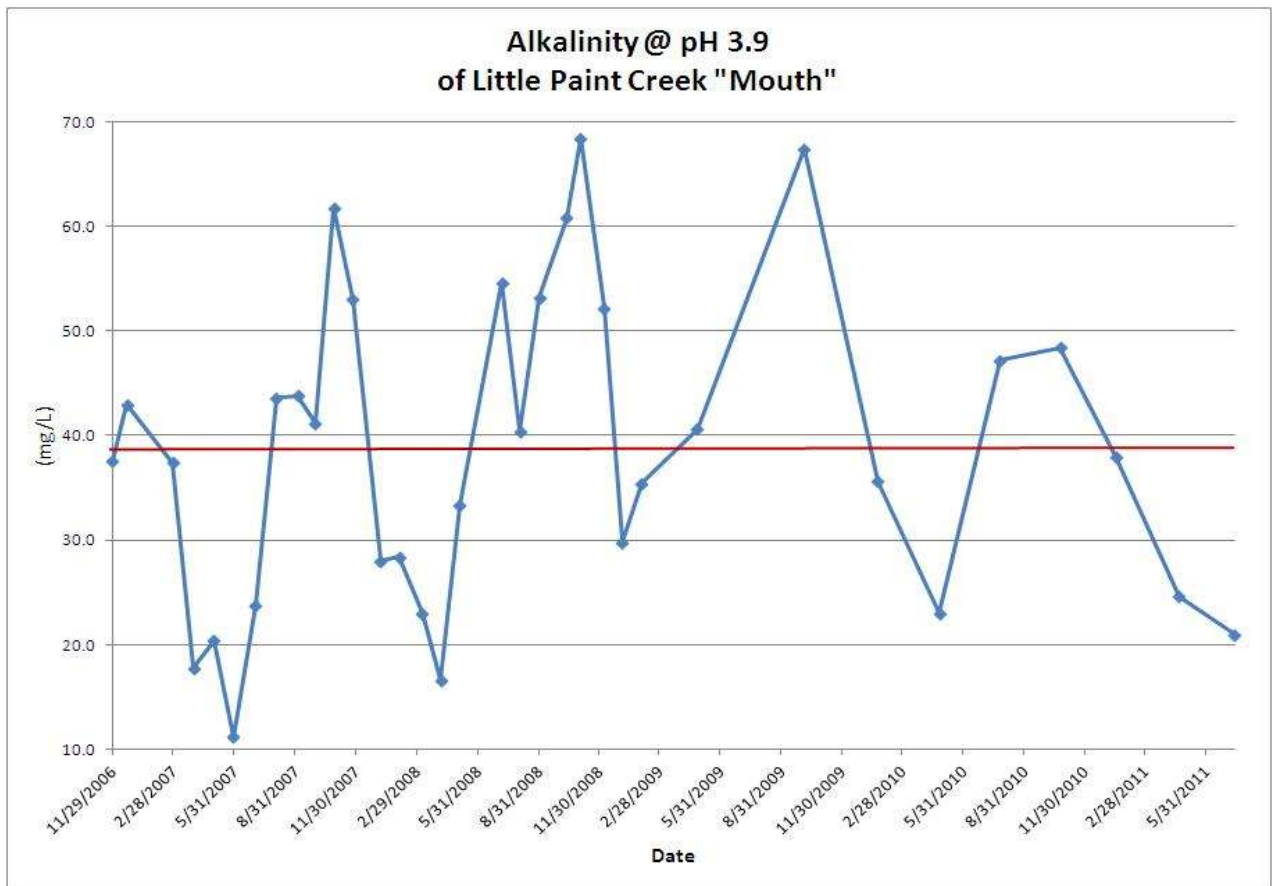
Figure 21. Alkalinity of Little Paint Creek near its mouth

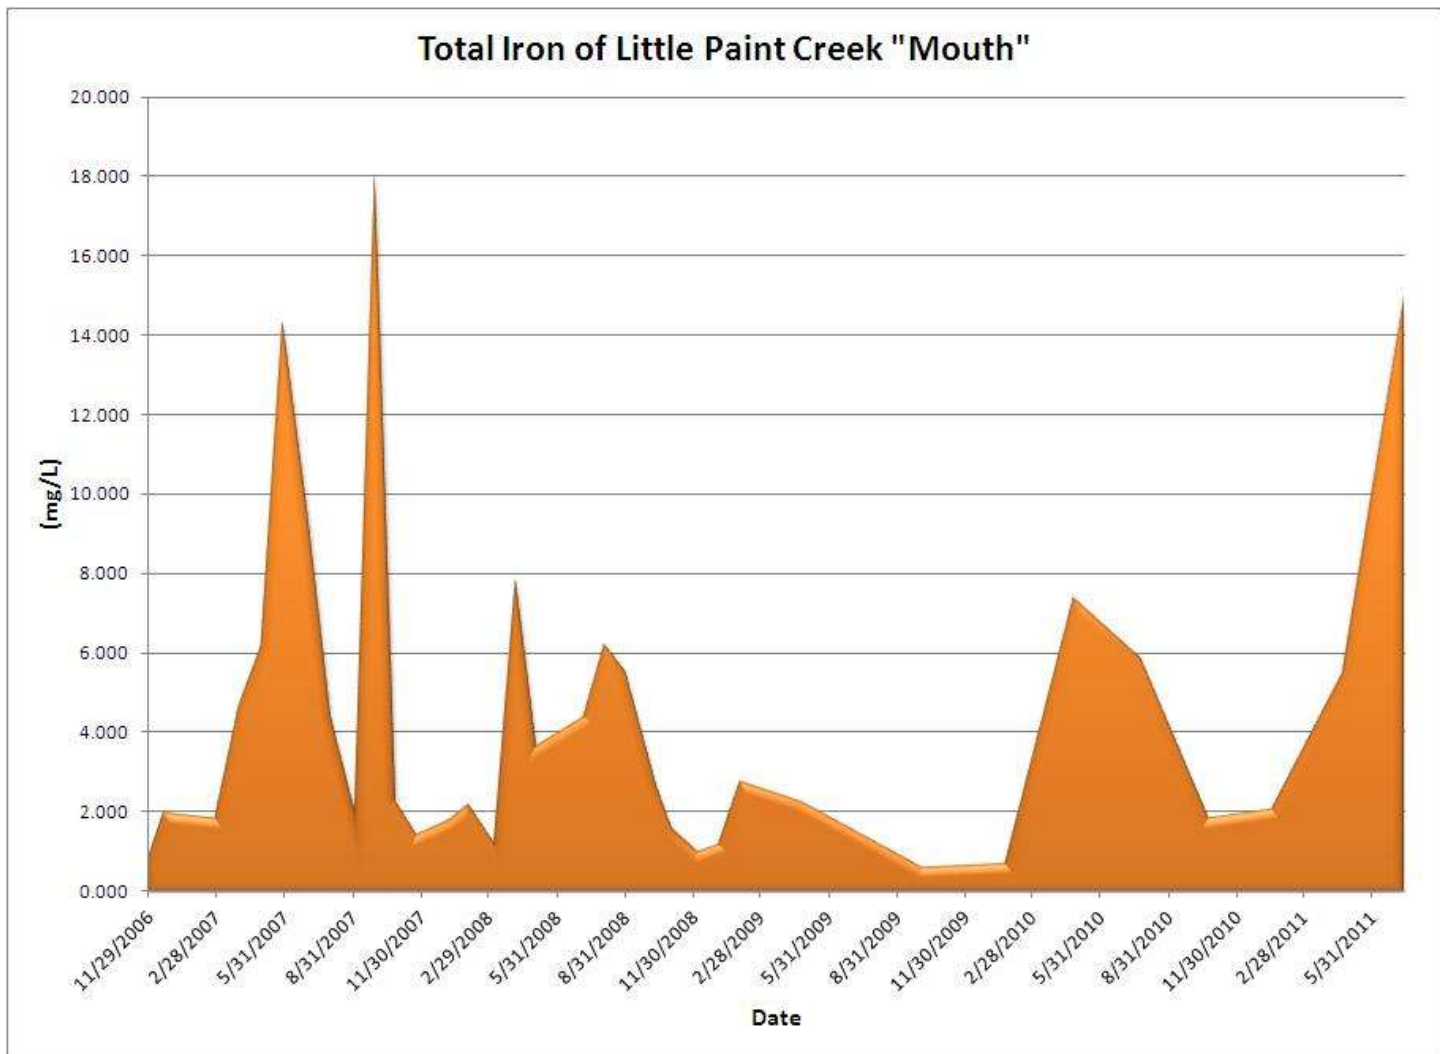
Figure 22. Iron concentrations of Little Paint Creek near its mouth from November 2006 – July 2011

The concentration of metals associated with AMD varied greatly over the sampling period at this site. The average total iron was 4.46 mg/L, with a minimum and maximum of 0.63 mg/L and 18.20 mg/L respectively. The average total aluminum was 1.77 mg/L, with a minimum of 0.53 mg/L and a maximum of 6.92 mg/L. The Pennsylvania Code states that iron concentrations should have a 30-day average of 1.5 mg/L. It also states that the maximum concentration of aluminum for fish and aquatic life is 0.750 mg/L. Little Paint Creek consistently exceeds the allowable concentrations for both iron and aluminum.

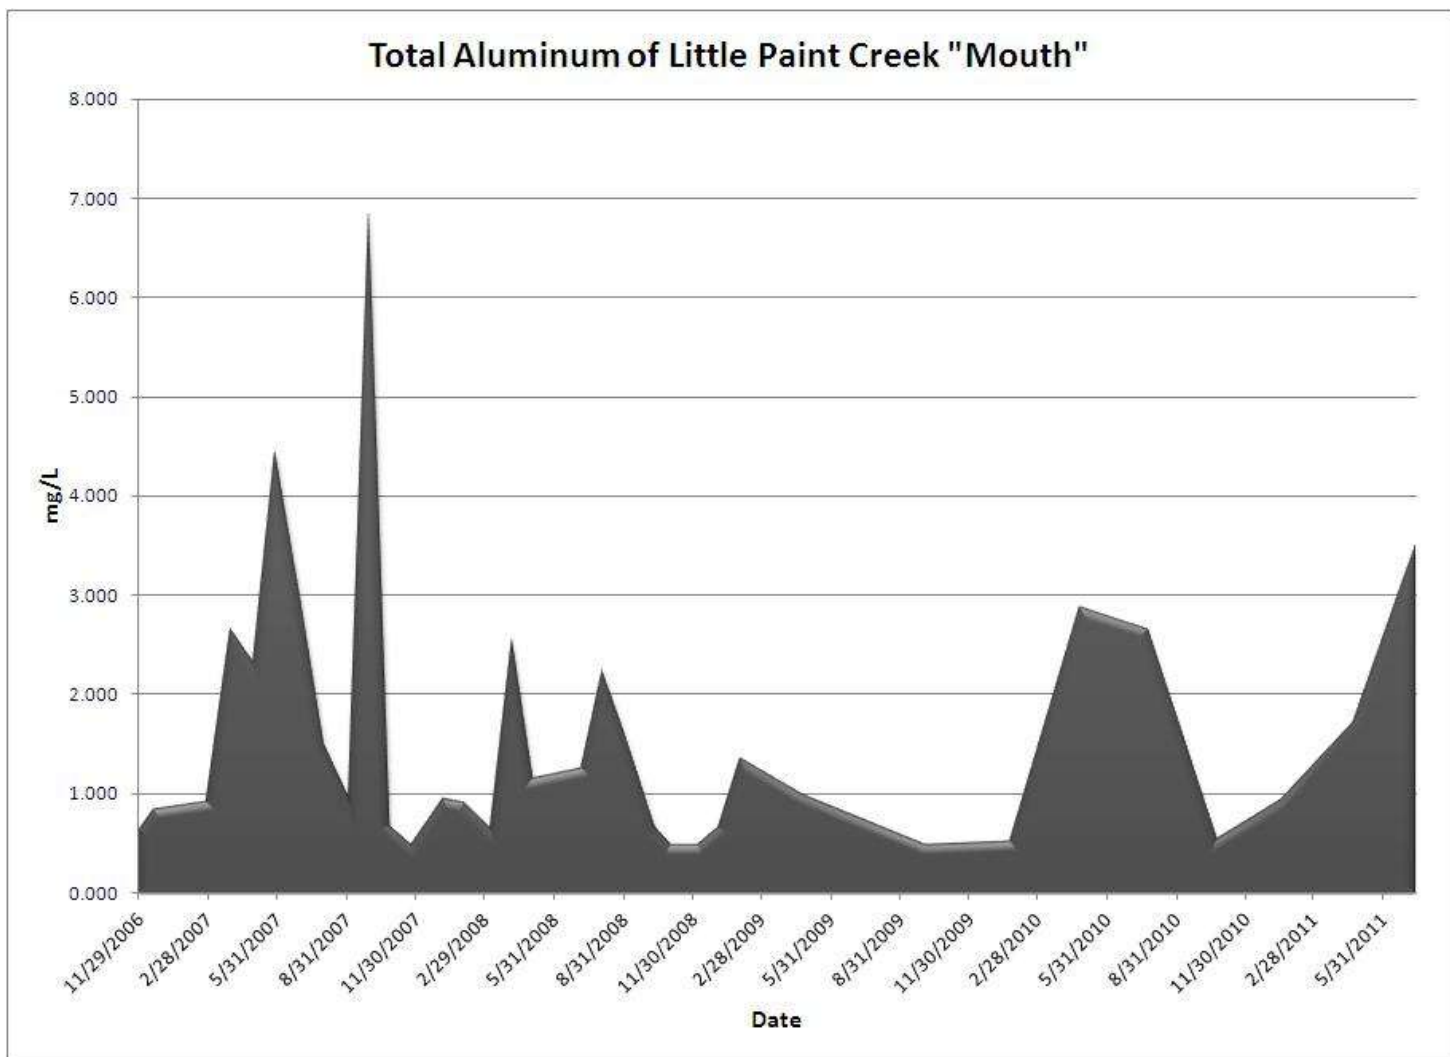
*Figure 23. Aluminum concentrations of Little Paint Creek near its mouth from November 2006 – July 2011*

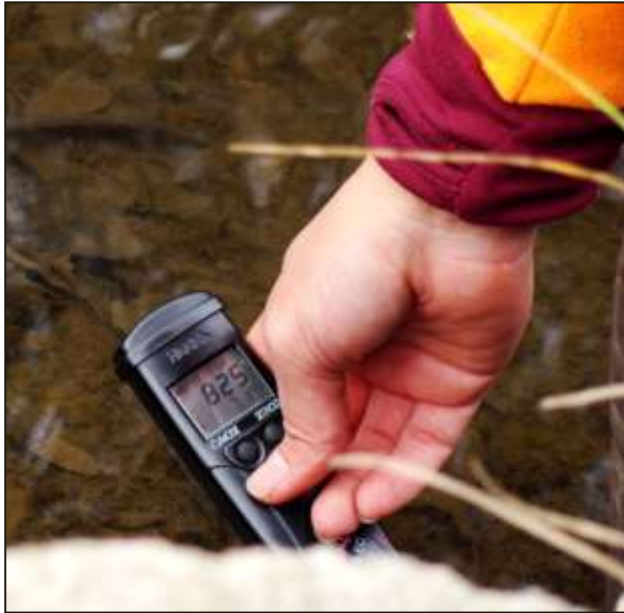
*Figure 25. Elevated conductivity in Rocky Run  
Photo by Eric Null*

professors, students placed a sonde in the lower end of Rocky Run, another in Little Paint Creek before its confluence with Rocky Run, and a third in Little Paint Creek below the confluence of the two streams. After three weeks, students retrieved the sondes and analyzed the data. Their data confirmed that the high levels of conductivity are originating in Rocky Run (Appendix 2). Water testing on November 15, 2010 with a Hanna All-in-One meter along the length of Rocky Run showed elevated conductivity levels, particularly in the stormwater retention wetland adjacent the Richland Towne Centre shopping complex. Here, conductivity measured 1,612 uS/cm. Downstream readings ranged from 626-1,033 uS/cm.

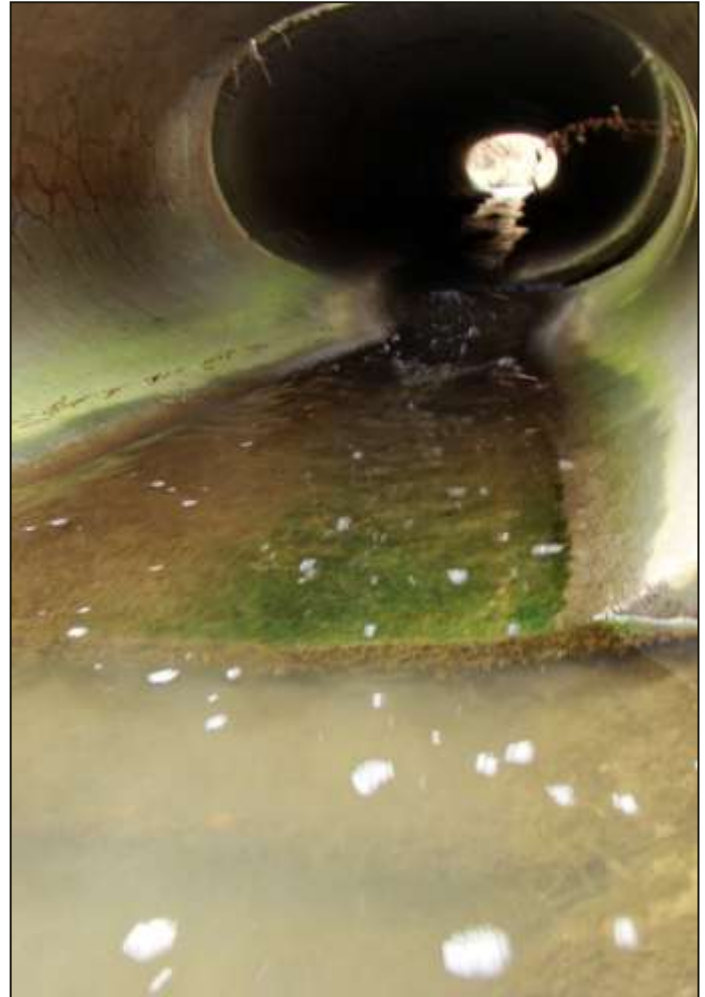
*Figure 26. Culvert in the headwaters of Rocky Run  
Photo by Melissa Reckner*

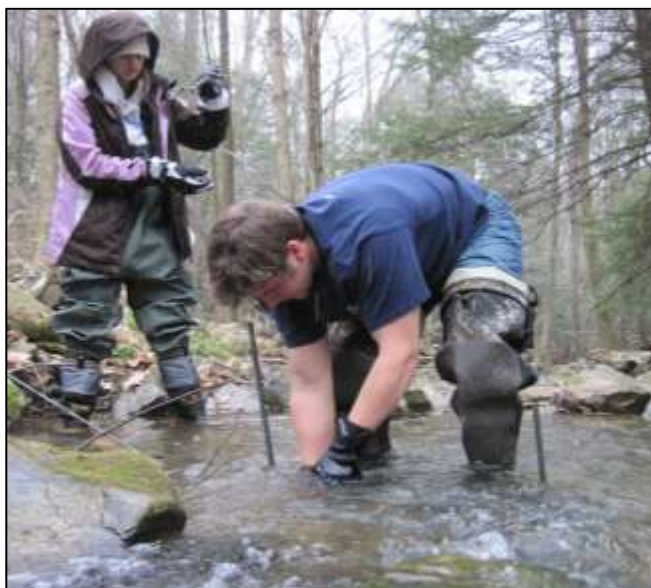
*Figure 27. Saint Francis University students deploy their sonde in Rocky Run  
Photo by Dr. William Strosnider*

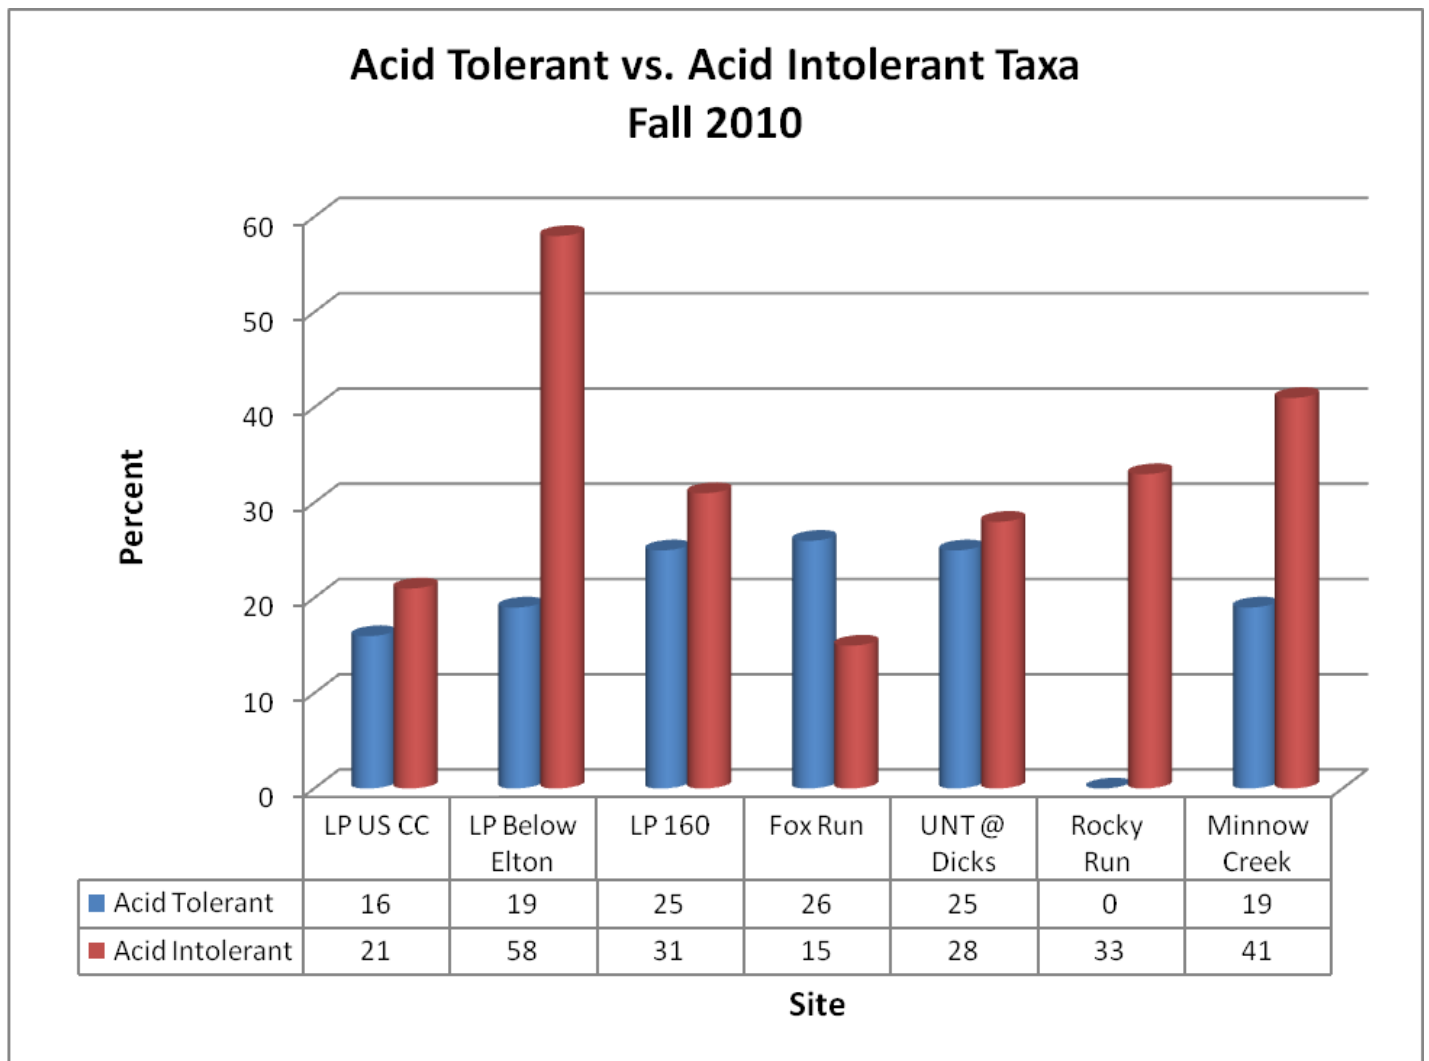
*Figure 29. Percent acid tolerant taxa versus acid intolerant taxa ~ Fall 2010*

Another metric used to measure acidity is the comparison of strictly acid tolerant taxa with strictly acid intolerant taxa. These acid tolerant taxa are the taxa that have specialized to survive in acidic conditions. If the percent composition of these individuals composes most of the sample, the likelihood of acid impacts is greater. The results for the acid tolerant to acid intolerant comparisons are located in Figures 29 and 30.

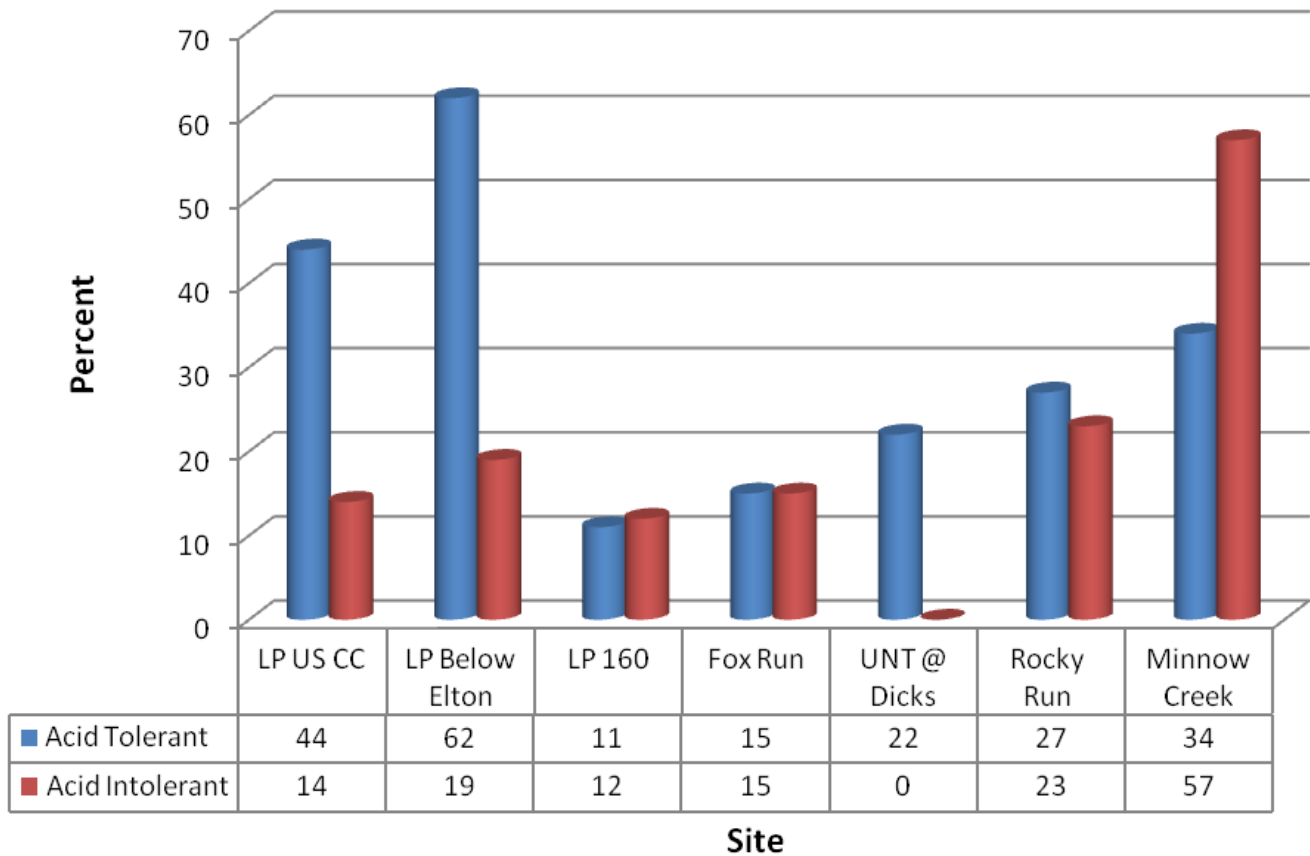
*Figure 30. Percent acid tolerant taxa versus acid intolerant taxa ~ Spring 2011*

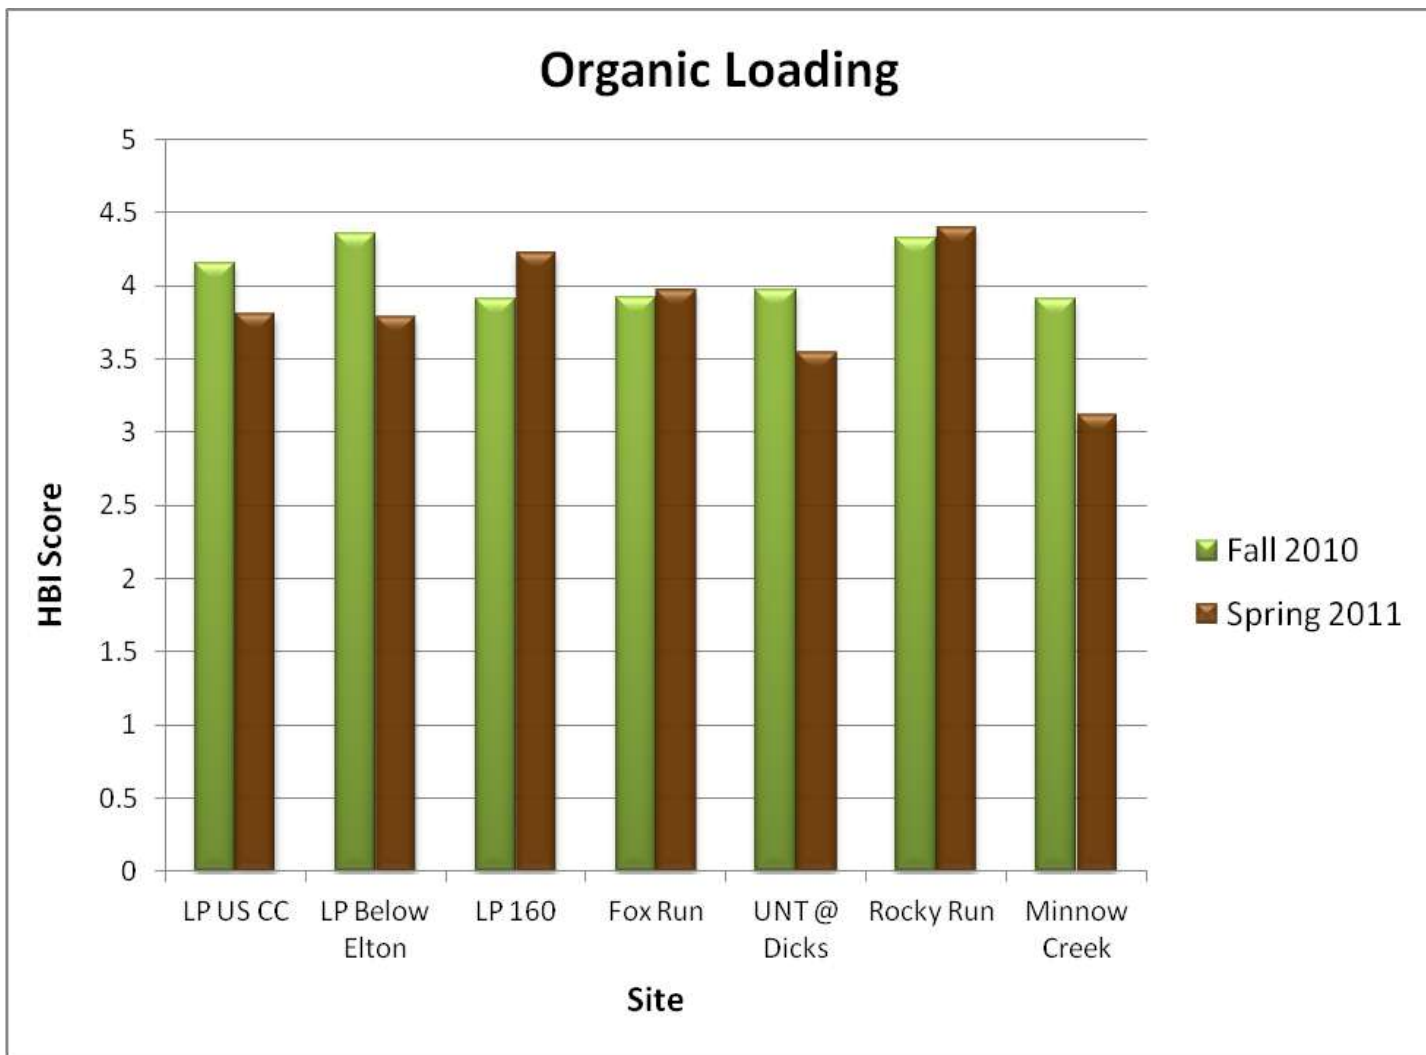
*Figure 31. HBI scores for sites in the Little Paint Creek watershed*

Organic loading impacts are measured using the Hilsenhoff Biotic Index (HBI). HBI scores increase as organic loading increases. HBI scores above 4.0 indicate organic loading is occurring within the stream reach (Barbour et al. 1999). The results for the HBI are located in Figure 31.

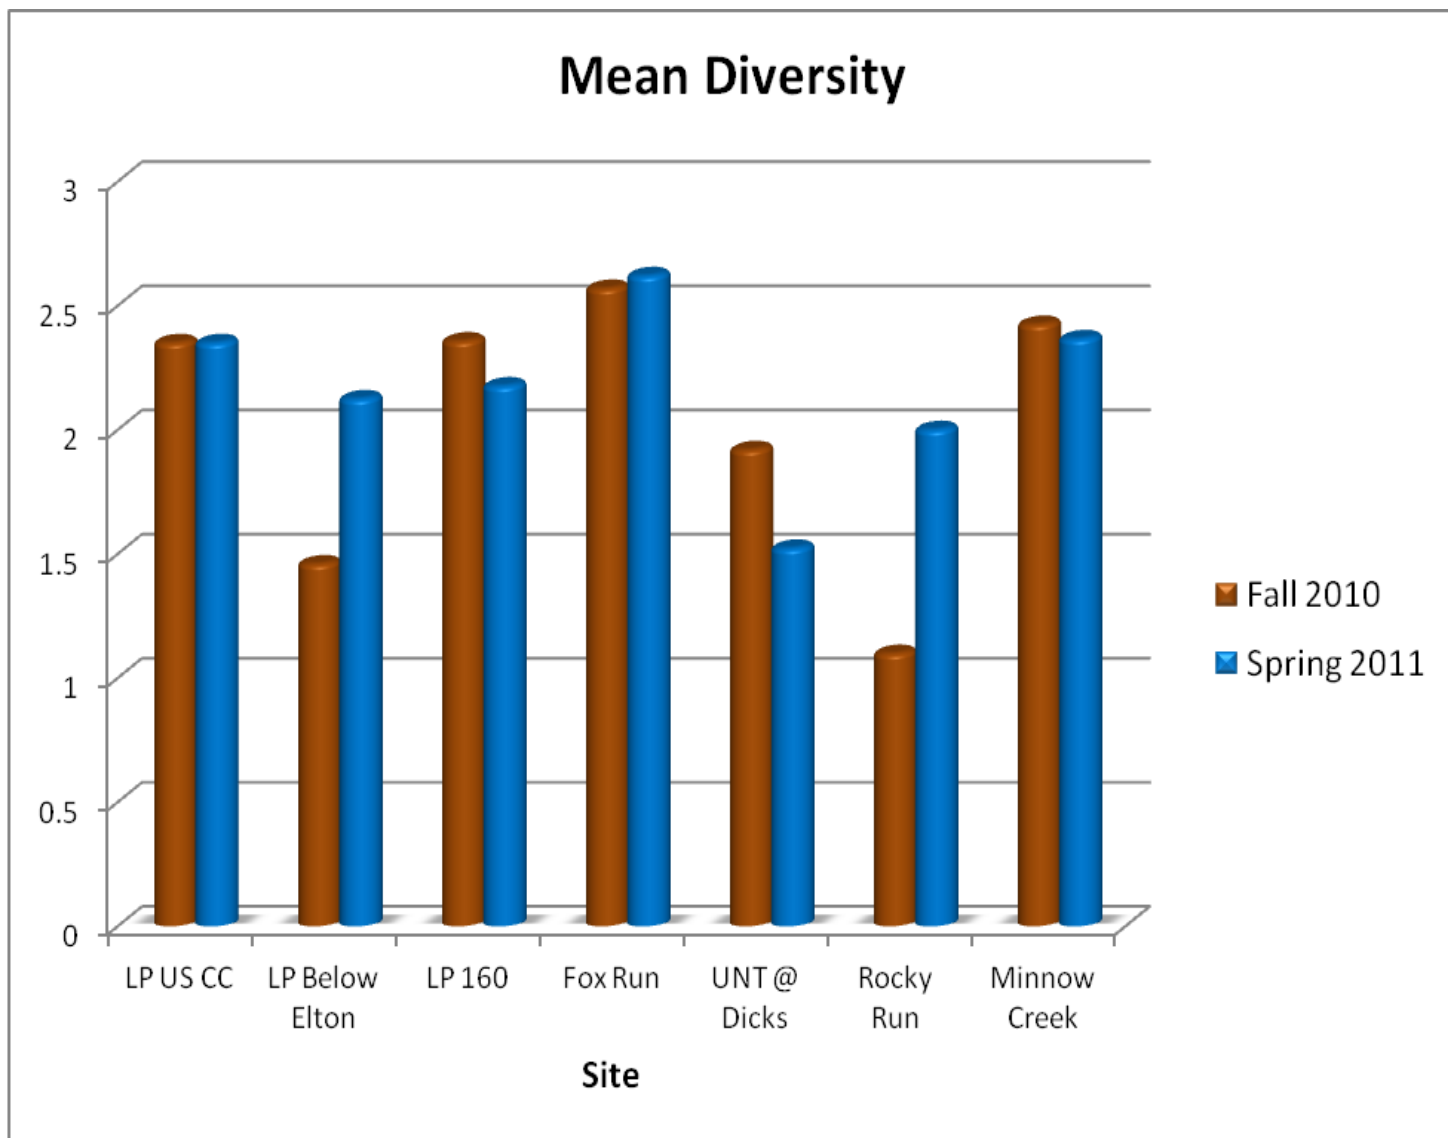
*Figure 32. Mean diversity of Fall 2010 and Spring 2011 macroinvertebrates in the Little Paint Creek watershed*

Mean diversity indicates if the community is evenly distributed. Evenly distributed communities indicate healthy communities. Fox's Run, Minnow Creek, and Little Paint Creek above the Windber Country Club and at the State Route 160 crossing had evenly distributed macroinvertebrate communities (Figure 32).

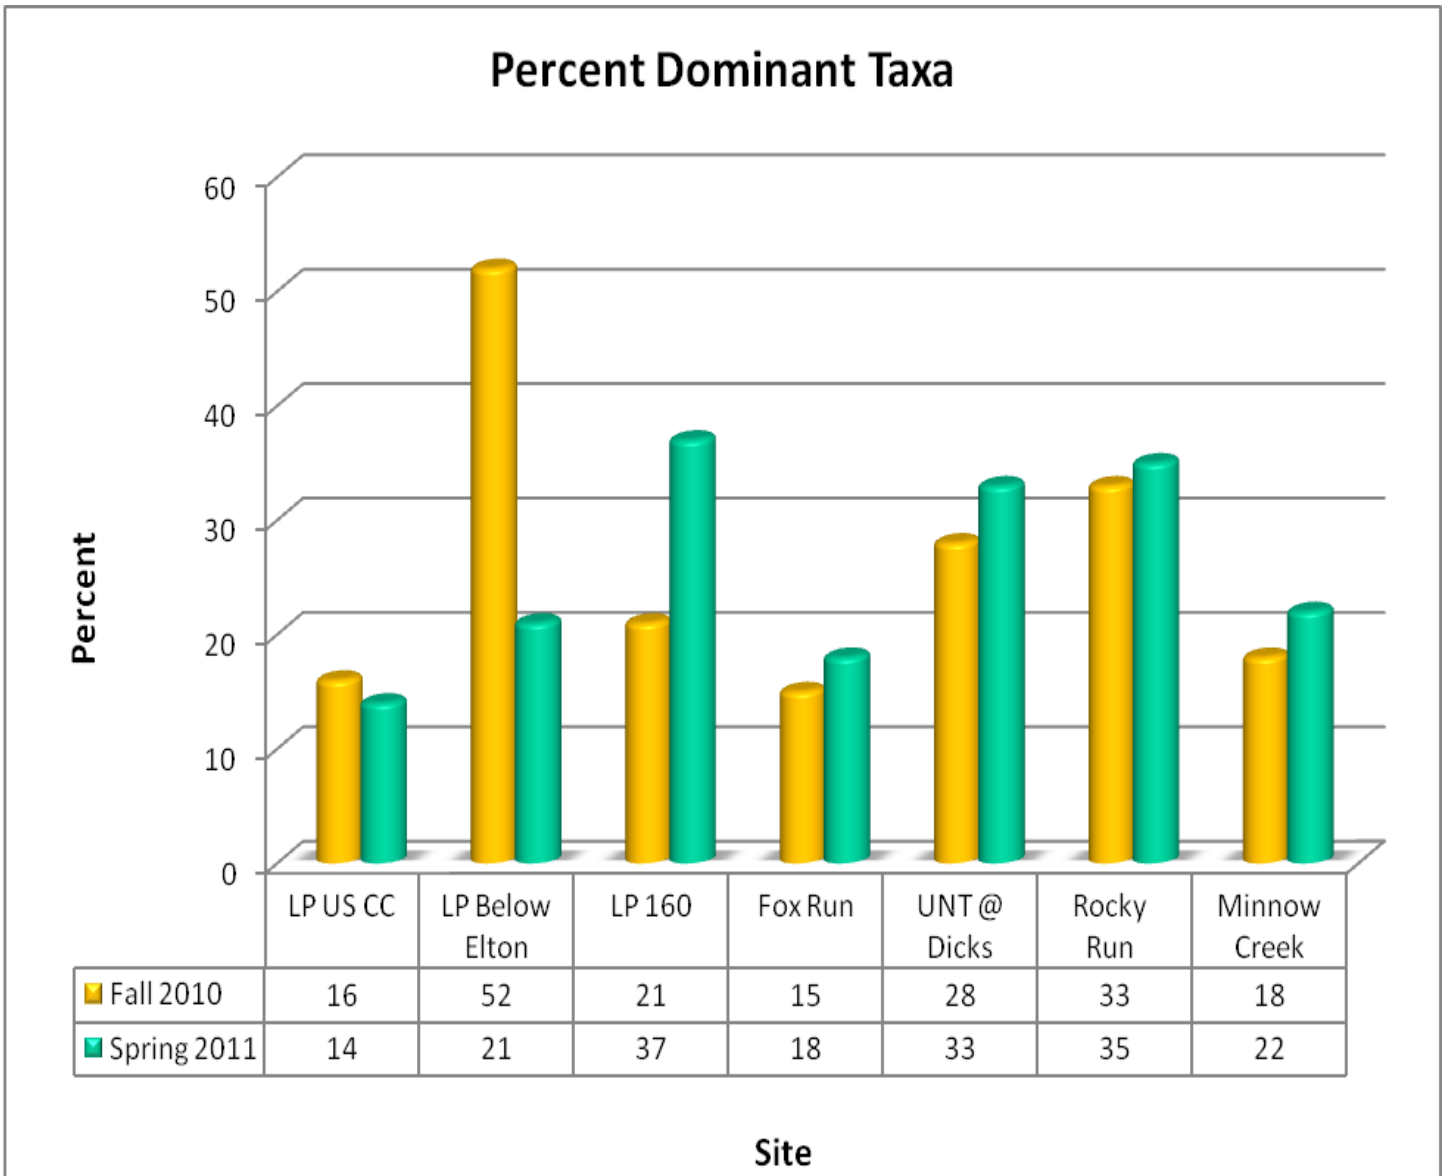
*Figure 33. Percent dominant macroinvertebrate taxa at select sites in the Little Paint Creek watershed ~ Fall 2010 and Spring 2011*

For communities that are not evenly distributed, like those in Rocky Run and the unnamed tributary to Little Paint Creek at Dick’s Auto, metrics like percent dominant taxa measure the composition of the most frequently collected taxa in a site. For example, if one individual composes the majority of the sample, the community at that site will be less diverse, which can indicate a stressor. The results of this metric are located in Figure 33.

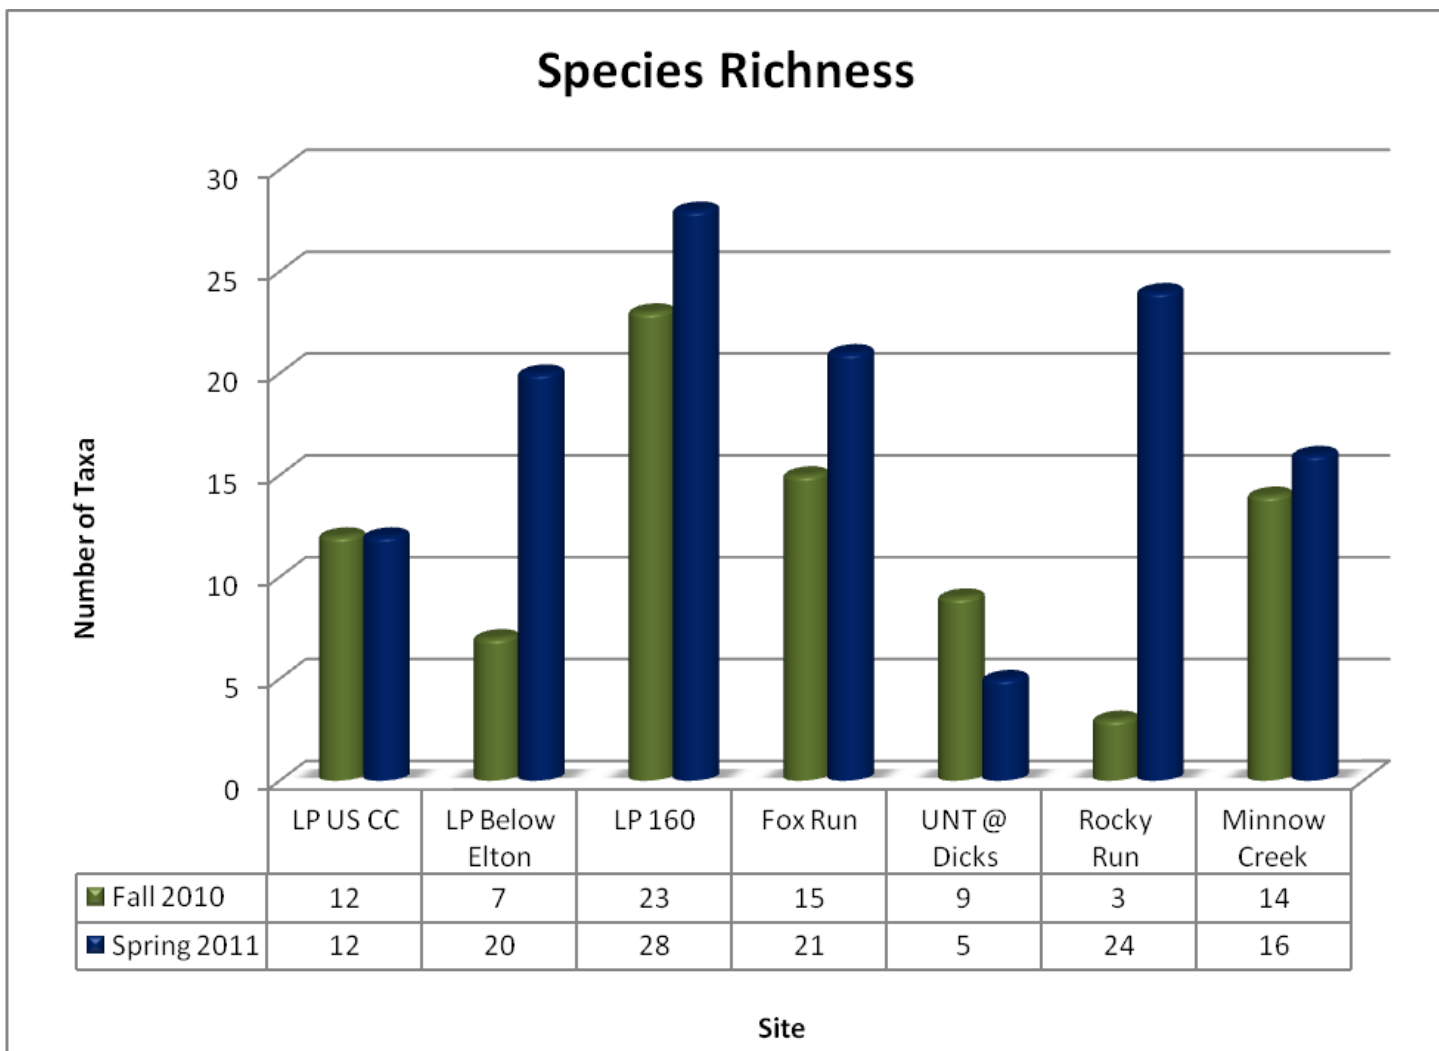
*Figure 34. Species richness of Fall 2010 and Spring 2011 macroinvertebrates from select sites in the Little Paint Creek watershed*

Species richness and total individuals collected are measures of community diversity and robustness. When water quality increases, usually species richness increases. When organic pollutants degrade the water quality, total individuals increase. If a stream is mildly impacted by acid, species richness decreases and total individuals increase. Streams that have severe acid impacts have decreased total individuals and species richness (Barbour et al. 1999). The results for these metrics are located in Figures 34 and 35.

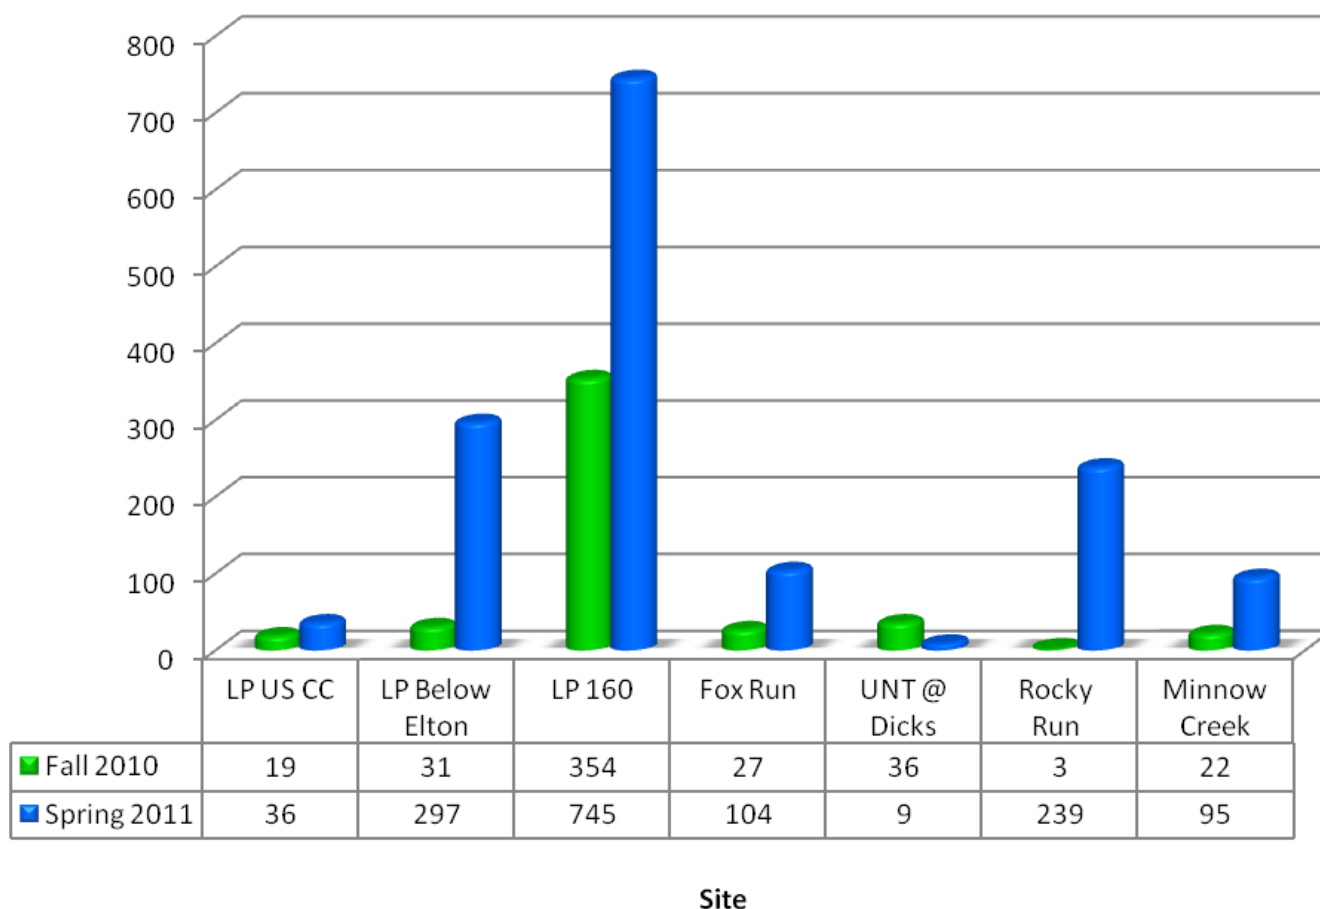
*Figure 35. Total individuals collected from select sites in the Little Paint Creek watershed Fall 2010 and Spring 2011*

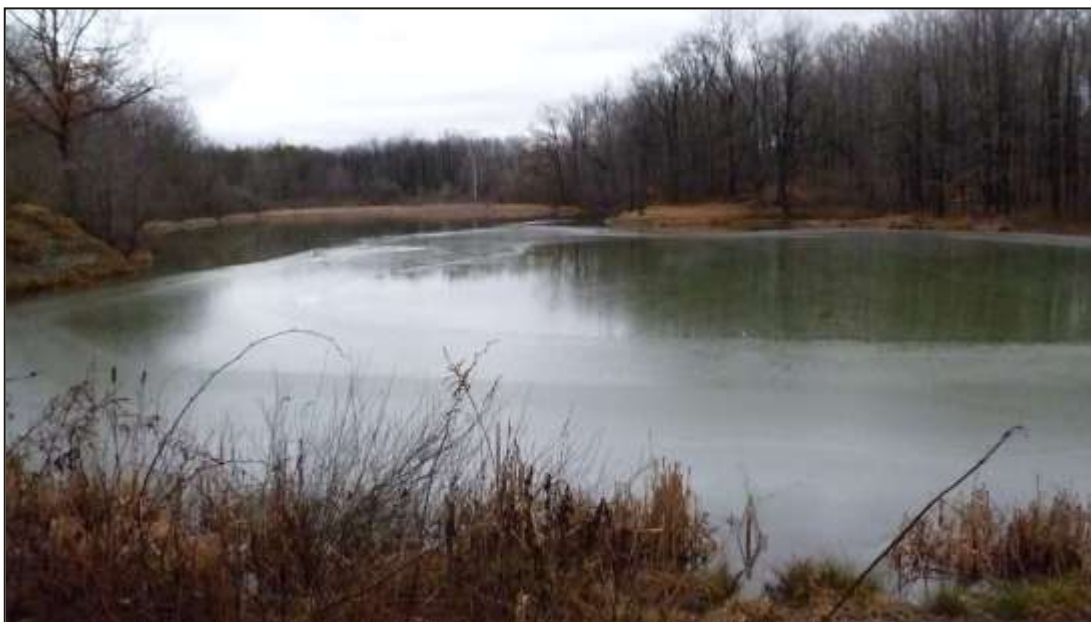
*Figure 37. Elton Sportsmen's Dam  
Photo by Melissa Reckner*

Elton Sportsmen's Dam was first surveyed by PFBC in April 2000 to assess its fish community and update fisheries management strategies for the lake; however, PFBC did complete a chemical profile in April 1993. The PFBC noted that the pH of the dam's water fell from 6.9 in April 1993 to 6.3 in April 2000 and its total alkalinity decreased from 30 mg/L to 9 mg/L causing PFBC to deem the waters infertile in April 2000. The PFBC speculates that, "The low alkalinity and the presence of a coolwater environment may be reasons that Elton Sportsmen's Dam is infertile and slow fish growth occurs. The warmwater and coolwater fish community provides only a low quality fishery at Elton Sportsmen's Dam." They noted, "Little Paint Creek has also shown low alkalinity levels of 12 mg/l and 21 mg/l in past surveys," (Wisniewski et al. 2001).

The *Paint Creek Restoration Plan* and *PFBC Elton Sportsmen's Dam (818E) Management Report* indicate that the Elton Sportsmen's Dam has little warmwater fishing recreation value due to low numbers of fish and the slow growth of fish. Partners and the landowner should discuss the removal of this impoundment, which would reduce thermal pollution and possibly lengthen the wild trout sections of Little Paint Creek. Full restoration and sediment removal at this site would be necessary if the dam were removed. Because of the access, it would make an ideal fishing area for handicapped people and children.

American Rivers, a national non-profit conservation organization working to protect and restore the nation's rivers and streams, has identified the Elton Sportsmen's Dam as a dam removal candidate. American Rivers noted that, in 2006, the Pennsylvania Department of Environmental Protection requested immediate repairs to this earthen dam that was built in 1956. According to American Rivers, design and construction for removal of this dam would cost approximately \$80,000 (Hollingsworth-Segedy 2011).

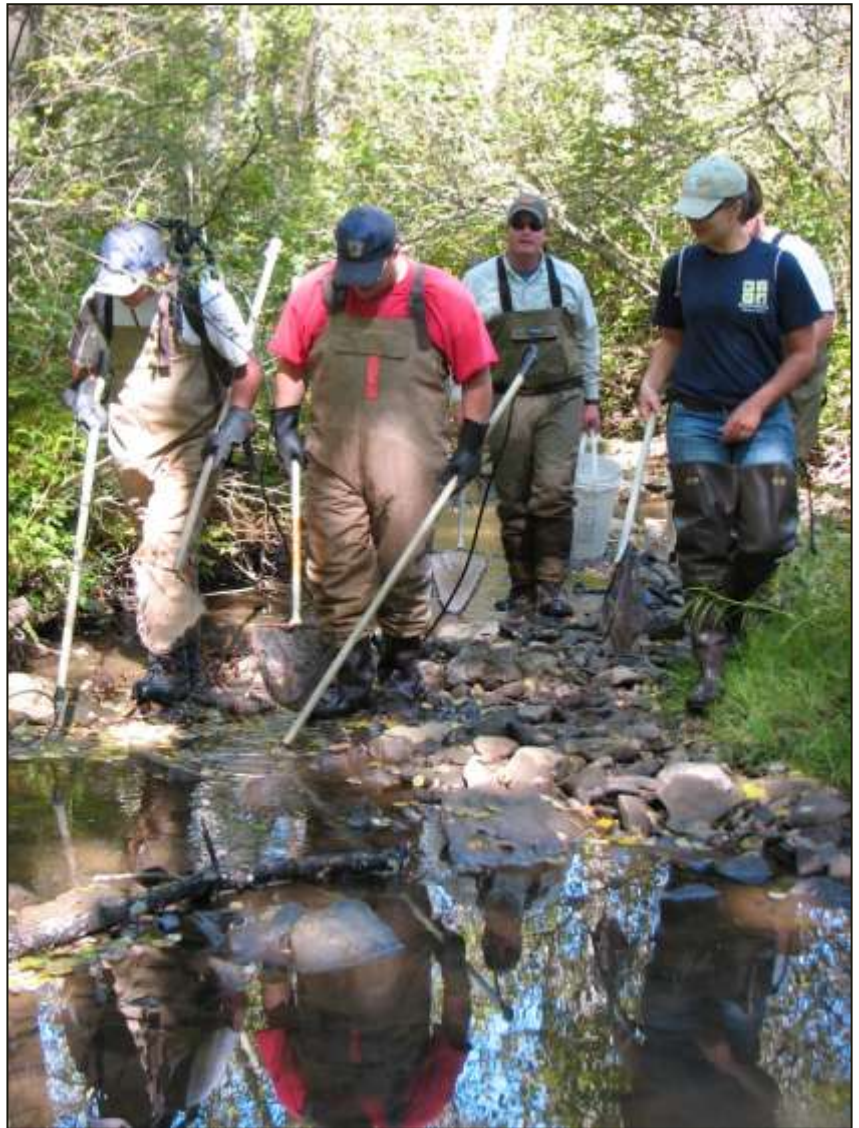
*Figure 38. PFBC, SCD, and KCST staff survey Little Paint Creek in September 2010  
Photo by Len Lichvar*

PFBC collected fish using an AC backpack electrofishing unit set at 450 volts and 125 watts. All fish captured were enumerated and identified to species level. Gamefish were measured to the nearest 25mm. WPC collected fish from Minnow Creek using an AC backpack electrofishing unit set at 300 volts for a total effort of 2,185 seconds. All fish were promptly returned to the streams where they were collected after measurements and identifications were completed. The species found at each survey site are located in Appendix 4. The species composition of the Little Paint Creek watershed is located in Figure 41. The composition of the individual sites is located in Figures 42 to 44 and 46 to 48.

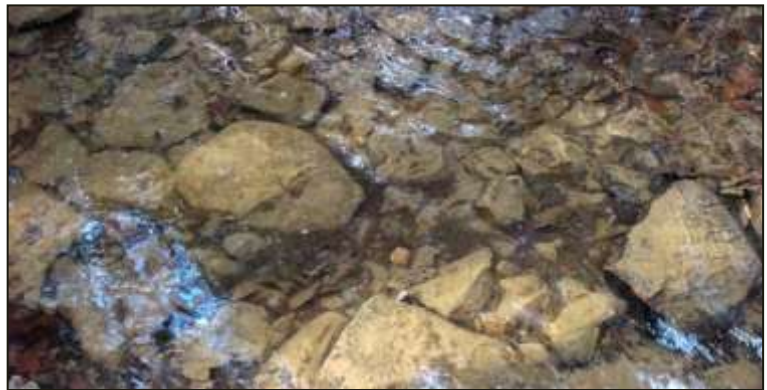
*Figure 50. Sedimentation in the headwaters of Little Paint Creek stifles aquatic life  
Photo by Melissa Reckner*

The headwaters of Little Paint Creek (above the Windber Country Club) contain cold water, but are impacted by sedimentation. Sand and silt fill in most of the interstitial space of the bottom substrate creating an area non-conducive to trout spawning. The sedimentation impacts can be seen in the limited macroinvertebrate community and depressed fish community. The cause of this sedimentation appears to be the historic timbering of the area. While the forest is presently mature, a layer of sand has been exposed through historic timbering of the area. This sand is continuously deposited in the stream after high flow events.
