# Little Paint Creek

## Coldwater Conservation Plan

Paint Creek  
Regional  
Watershed  
Association

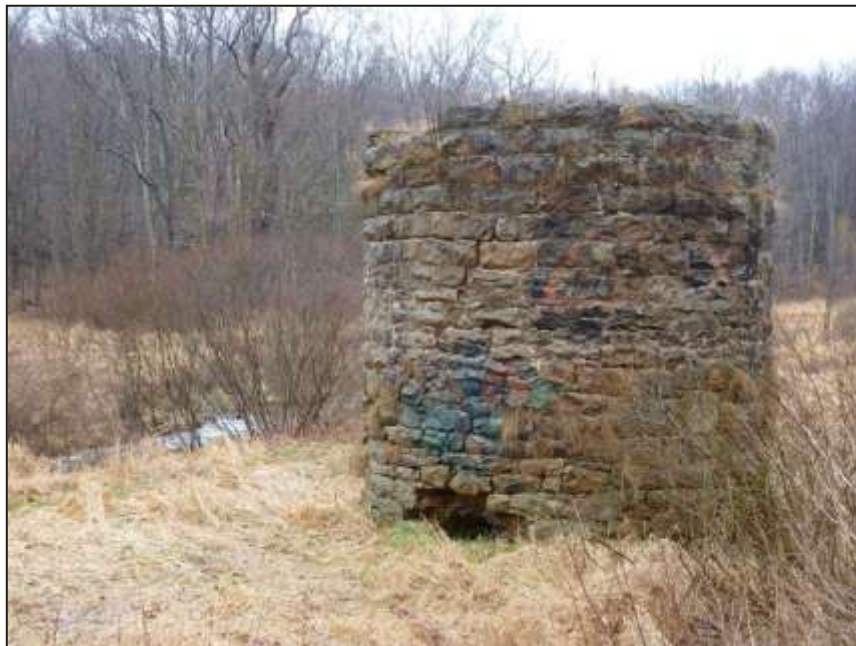
*Figure 53. The remains of a round structure along Little Paint Creek said to float coal and separate it from rock.  
Photo by Melissa Reckner*

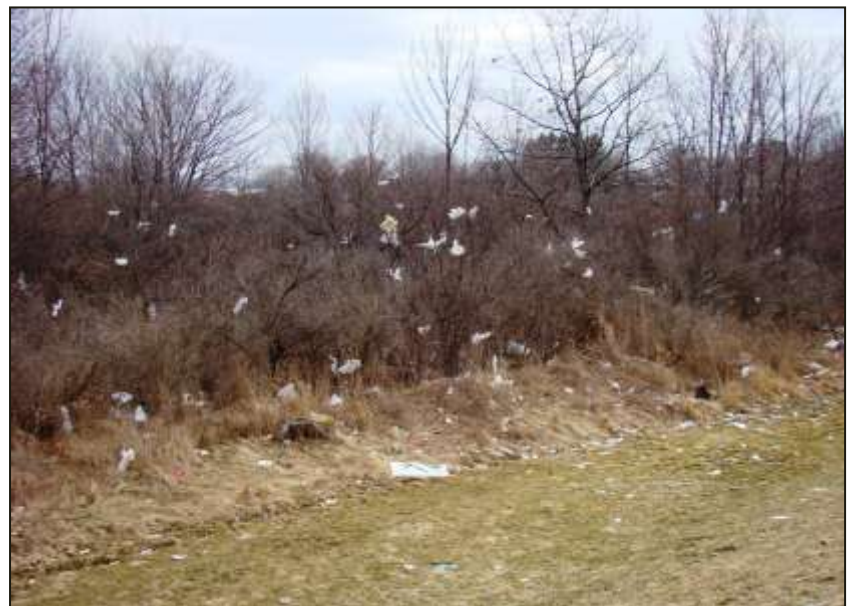
*Figure 55. Plastic shopping bags snag in brush near the Richland Towne Centre shopping complex  
Photo by Melissa Reckner*

Litter along roadways and streams continue to be a problem, especially by the Richland Towne Centre shopping complex.

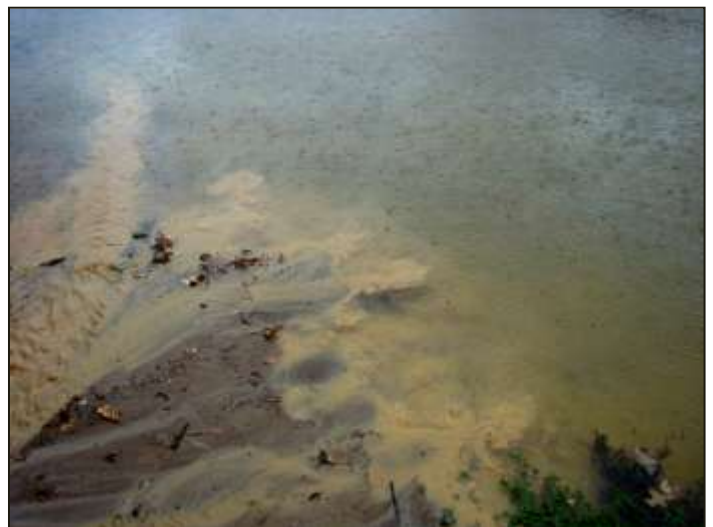
*Figure 59. Sediment flows into Elton Sportsmen's Dam from its parking lot during a rain event  
Photo by Melissa Reckner*

Sedimentation from erosion and runoff is degrading aquatic habitat in Little Paint Creek and its tributaries. PCRWA should work to improve dirt and gravel roads in partnership with Adams and Richland Townships and the Cambria County Conservation District's Dirt and Gravel Road Program. Parties also need to ensure healthy, riparian buffer zones are in place. If necessary, partners should educate farmers on best management practices to reduce soil compaction and loss. Regular inspections at housing developments, like Centennial Woods, are necessary. Stormwater runoff needs to be reduced.
