Middle Fork East Branch
Clarion River
Coldwater Conservation Plan
Elk County, Pennsylvania

FINAL
February, 2020

Western Pennsylvania Conservancy

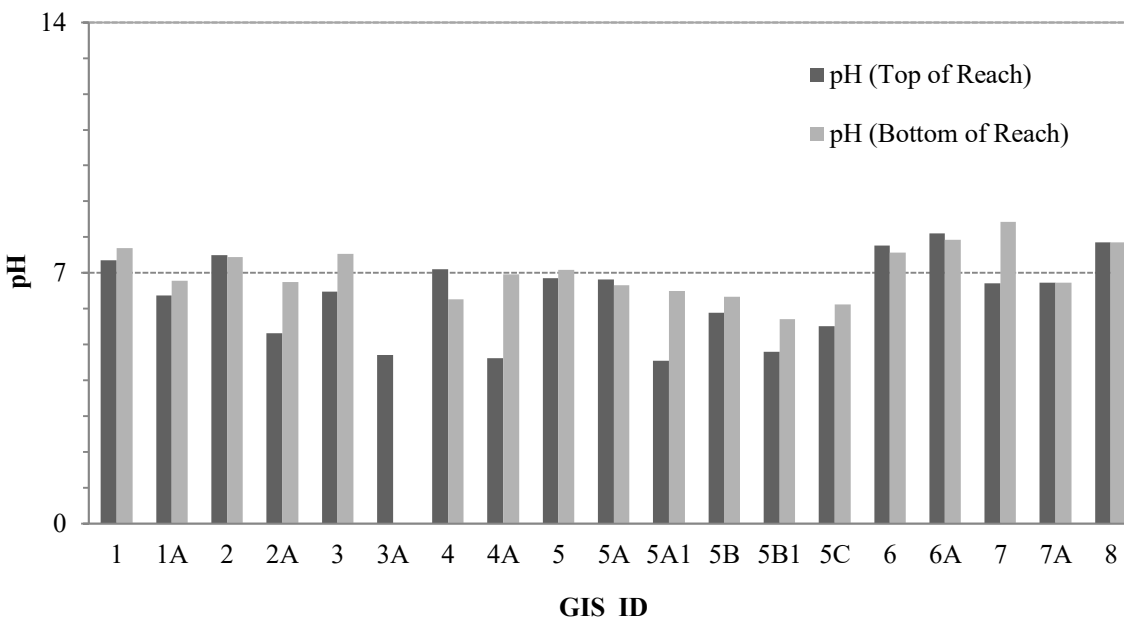
Figure 1. Stream Acidity measured at the top and bottom of each segment within the Middle Fork watershed. pH of 7 is neutral, while less than 7 is acidic and greater than 7 is basic. pH was not measured at the bottom of segment 3A due to technical difficulties with the multi-meter

Acidity (pH) is the measure of free hydrogen ions within solution. pH is measured on a logarithmic scale ranging from 0–14, with a pH of 7.0 representing a neutral midpoint. Solutions become 10 times more acidic with each integral drop in pH value (e.g. a pH of 5 is 10 times more acidic than a pH of 6). Streambed elevation and groundwater interactions with the stream heavily influence stream pH value. Headwater streams on the Allegheny Plateau tend toward a pH of 4.5–6.0 due to acid precipitation and initial reduced groundwater interaction, while downstream pH values in lower elevations often range from 5.5–7.0, with some streams exhibiting pH values as high as 8.0. Systems that are considered to be impacted by acid precipitation typically exhibit pH values lower than 5.5 (PA DEP 2012). Coldwater fish on the Allegheny Plateau can survive through a range of acidic solutions, but thrive in the pH 6.0–7.0 range. Acidity in the assessed watershed was not as low as investigators expected, and largely improved or remained consistent as stream elevation dropped. Eleven segments experienced an increase in pH as water traveled downstream, while six segments remained within 0.2 of the initial upstream measurement and only two segments experienced declines in pH downstream (Figure 1). pH readings at the bottom of each stream segment ranged from 5.7–8.4, with the average of all measurements falling at 7.0 (neutral). As would be expected, at higher elevations in the watershed, pH values exhibited a larger range (4.6–8.1), and a slightly more acidic average of 6.4 (Table 8). Details of recorded pH can be found in the Watershed Acidity map (Appendix 2).

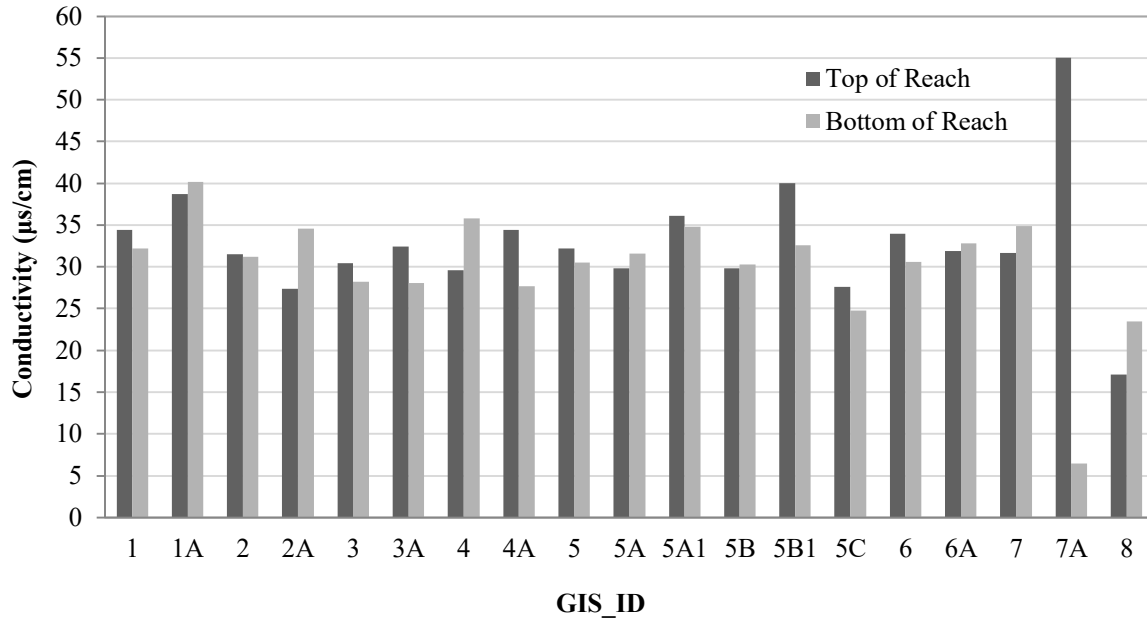
Figure 2. Specific Conductance measurements at the top and bottom of each stream segment

Specific Conductance (or Conductivity) is the ability of water to conduct an electrical current. Pure water is unable to conduct electricity, but as the amount of dissolved ions in solution increases, water is increasingly able to pass electrons through it. On the Allegheny Plateau, conductivity in streams similar to Middle Fork generally ranged from 20–100 $\mu\text{s}/\text{cm}$, but “normal” values for a particular reach can be variable and are specific to an individual stream and its geologic composition. Like pH, conductivity is also influenced by elevation and groundwater interaction. Since it is a measure of dissolved ions (generally salts, metals, and other conductive materials), conductivity is influenced by human activity within a watershed. No “typical” conductivity observation (i.e. measurement taken at the top or bottom of a stream segment) exceeded 55 $\mu\text{s}/\text{cm}$, with the highest measurement occurring in the upstream reaches of an unnamed tributary (UNT) to Middle Fork (GIS_ID 7A). However, this tributary was an outlier, since the average conductivity across upper reaches was 32.8 $\mu\text{s}/\text{cm}$. At the bottom of the segments, average conductivity was 30.0 $\mu\text{s}/\text{cm}$, and the same tributary, 7A, provided the minimum measurement of 6.5 $\mu\text{s}/\text{cm}$. Recorded conductivity measurements can be found in Table 8.

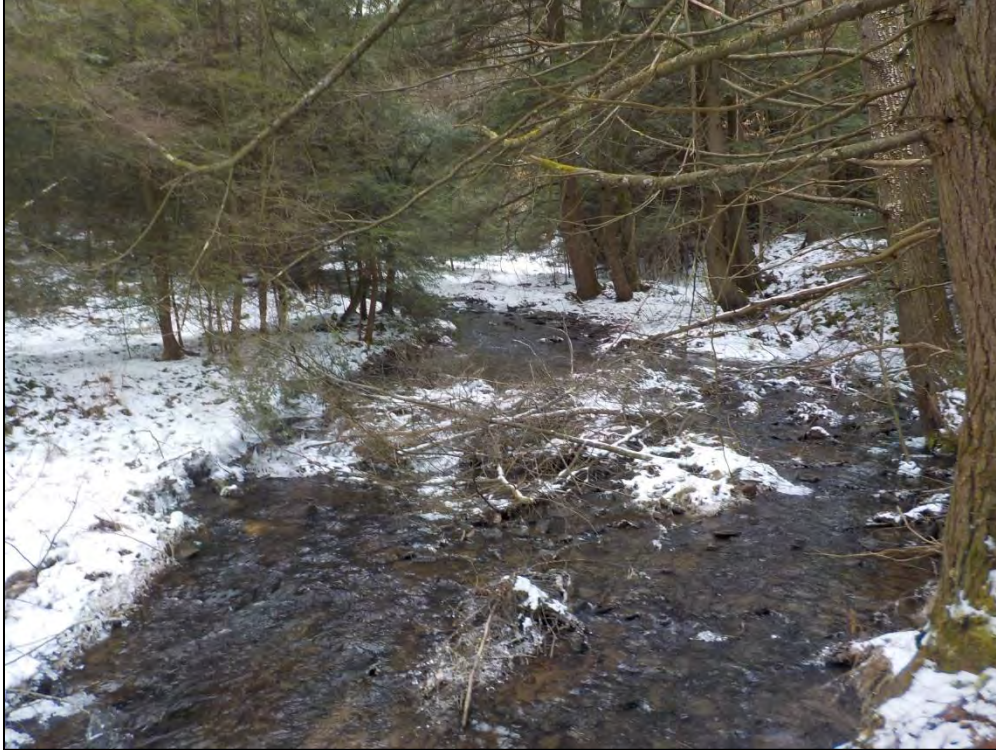
Adding large, stable pieces of LWM to sections like the one depicted above on segment 6 will prevent smaller, mobile woody materials seen in the photo from moving downstream to block culverts. Large wood installations are also anticipated to benefit the wild trout populations in Middle Fork. In monitoring studies conducted by WPC on the Allegheny National Forest, the number of wild trout captured during backpack electrofishing studies increased by 45% from pre- to post installation of LWM structures at other project sites.

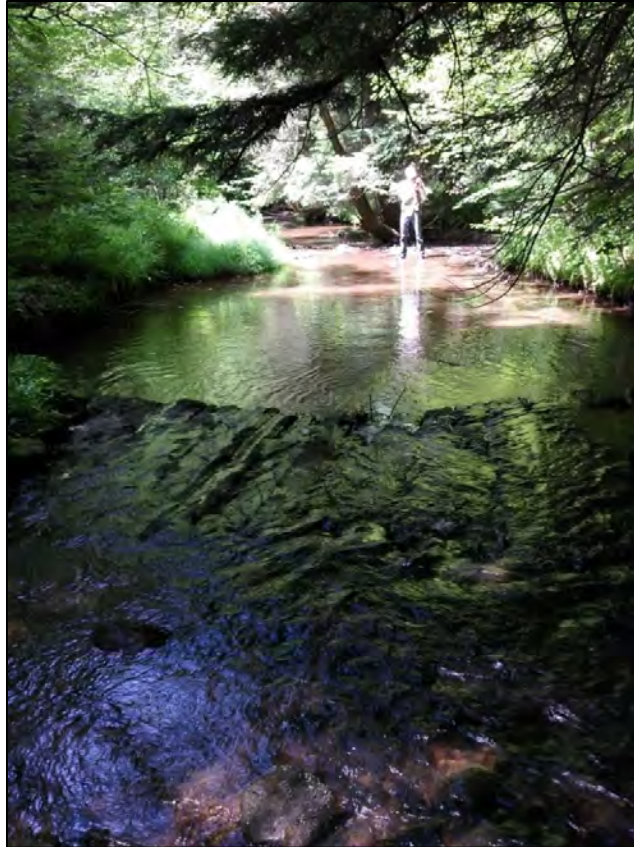
Barrier 1: Brookie Water Jack is elevated and provides a low-water partial passage barrier

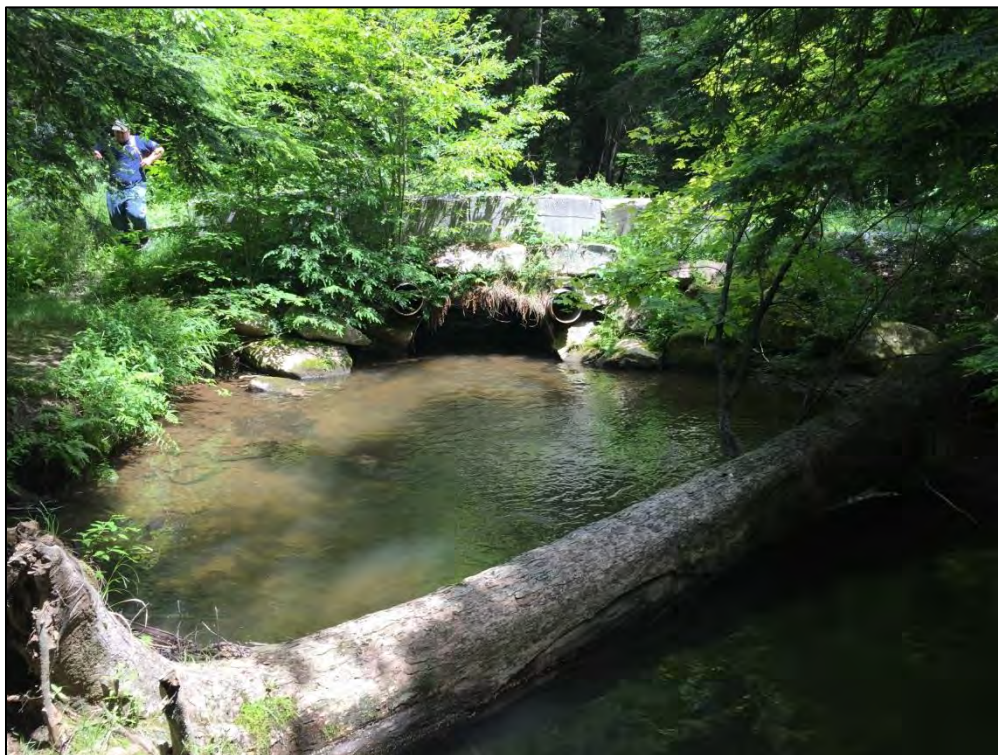
Barrier 2 Outlet: note the size of the scour pool compared to the culvert

| Stream Name | GIS ID | Barrier ID | Barrier Description | Lat. | Long. | Recommendation |
|---|---|---|---|---|---|---|
| Middle Fork | 3 | 2 | undersized culvert | 41.54617 | -78.57233 | Replace with 40' bridge |

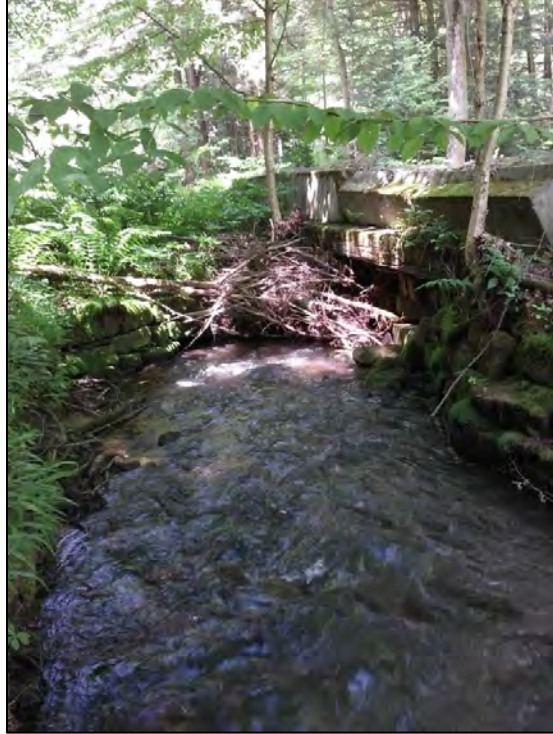
Barrier 3: illustrates how undersized culverts collect flood debris; adequately-sized culverts pass debris of this size, and much larger, more easily

| Stream Name | GIS ID | Barrier ID | Barrier Description | Lat. | Long. | Recommendation |
|---|---|---|---|---|---|---|
| Middle Fork | 3 | 3 | undersized culvert | 41.54665 | -78.56976 | Replace with 50' bridge |

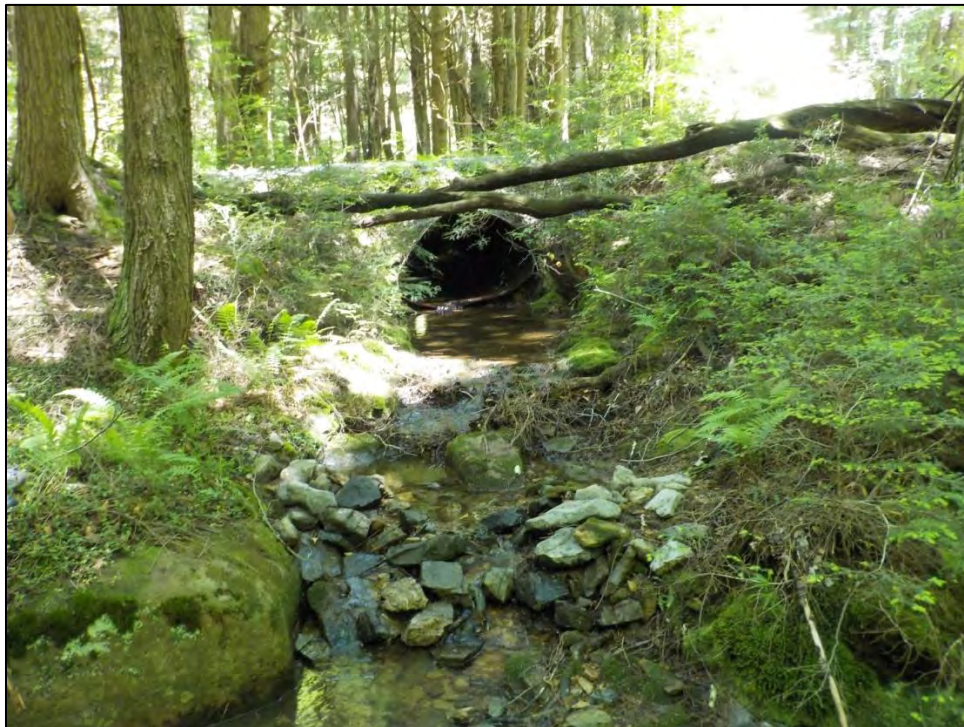
barriers 4 and 5, with barrier 5 on an ephemeral (seasonally dry) channel that serves as an overflow for the upstream Middle Fork culvert (barrier 6), as well as a road cross drain. Replacement of barriers 4 and 6 with bridges will negate the need for establishing aquatic connectivity at barrier 5, thus making its replacement primarily a road management issue.

Barrier 4: conveys one of the anastomosed channels of Birch Hollow

| Stream Name | GIS ID | Barrier ID | Barrier Description | Lat. | Long. | Recommendation |
|---|---|---|---|---|---|---|
| Birch Hollow* | 3A | 4 | undersized culvert | 41.546852 | -78.56761 | Replace with 20' bridge |

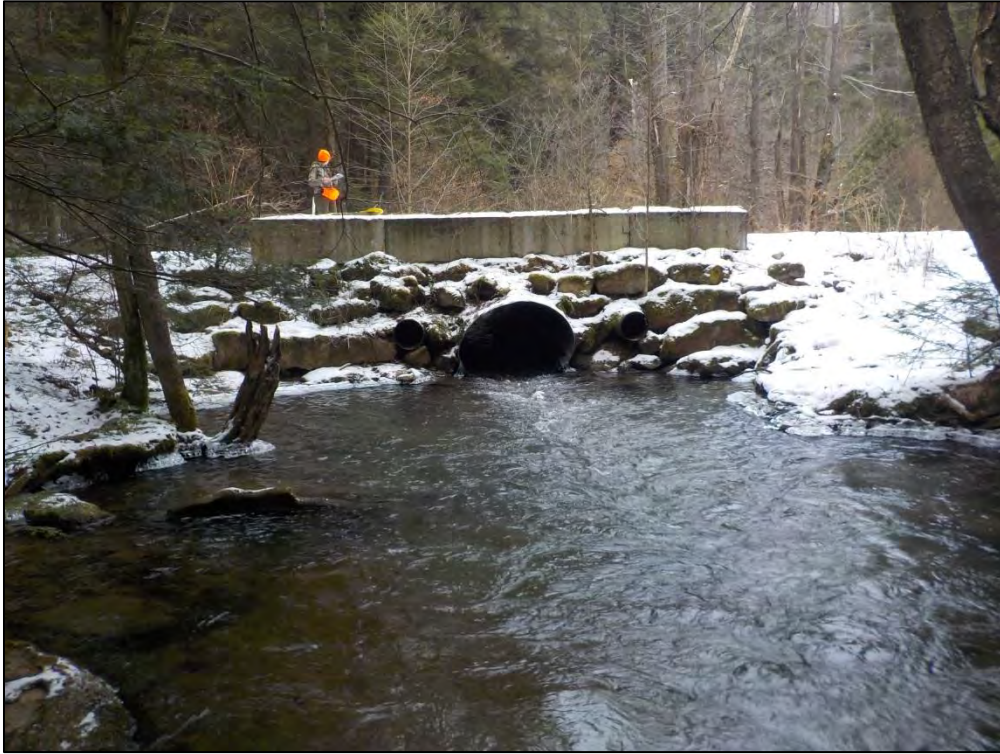
Barrier 6: exhibits “fire hose effect” scour pool at its outlet

| Stream Name | GIS ID | Barrier ID | Barrier Description | Lat. | Long. | Recommendation |
|---|---|---|---|---|---|---|
| Middle Fork | 3 | 6 | undersized culvert | 41.546913 | -78.56752 | Replace with 40' bridge |

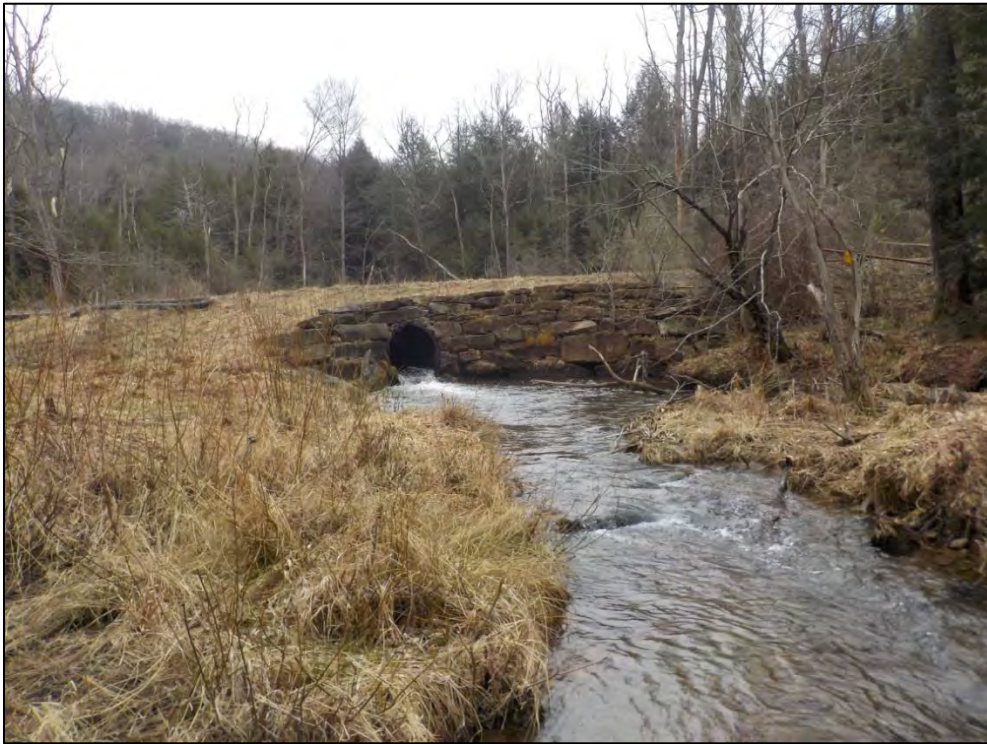
Barrier 7: a perched high-density polyethylene (HDPE) pipe with a smooth bore is a complete passage barrier. Access roads to both sides of the valley are present on the ridges. This passage barrier is recommended to be removed and the stream and floodplain fully restored.

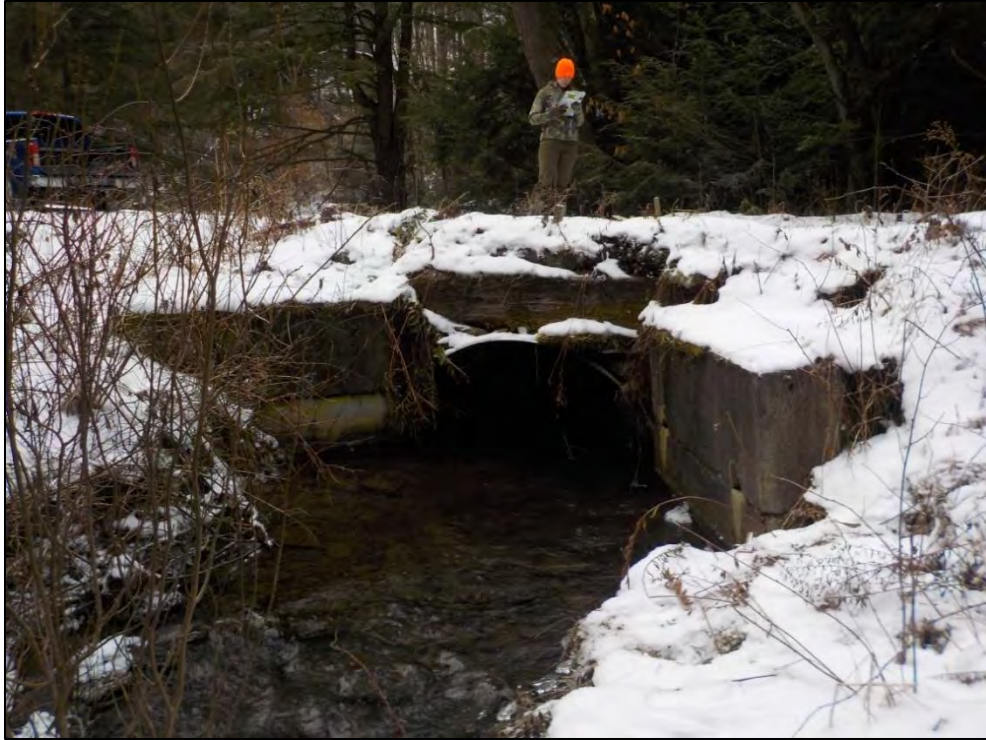
Barrier 8 outlet: some stream substrate is present through the crossing, making this barrier one of the more passable crossings in the watershed

| Stream Name | GIS ID | Barrier ID | Barrier Description | Lat. | Long. | Recommendation |
|---|---|---|---|---|---|---|
| Middle Fork | 6 | 8 | undersized culvert | 41.540732 | -78.552165 | Replace with 30' bridge |

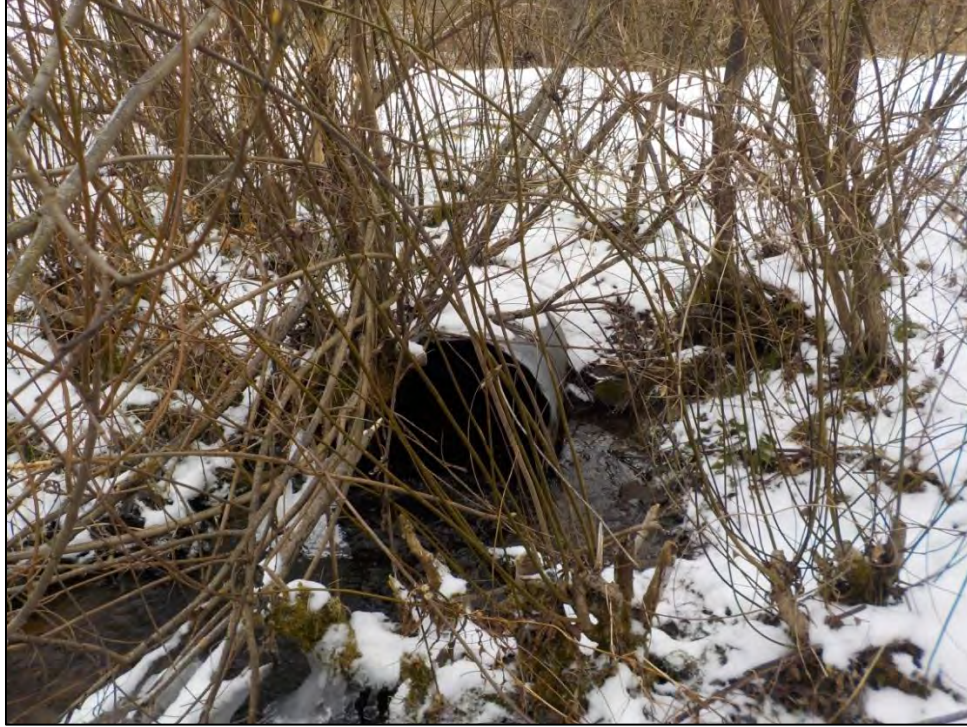
Barrier 10 is located on a vegetated road that provides access for PGC to manage food plots located in this area. Due to the minimal amount of traffic this crossing receives, a stable ford is recommended to replace this undersized culvert.

| Stream Name | GIS ID | Barrier ID | Barrier Description | Lat. | Long. | Recommendation |
|---|---|---|---|---|---|---|
| UNT | 6A | 10 | undersized culvert | 41.53784 | -78.548959 | Replace pipe with stream ford |

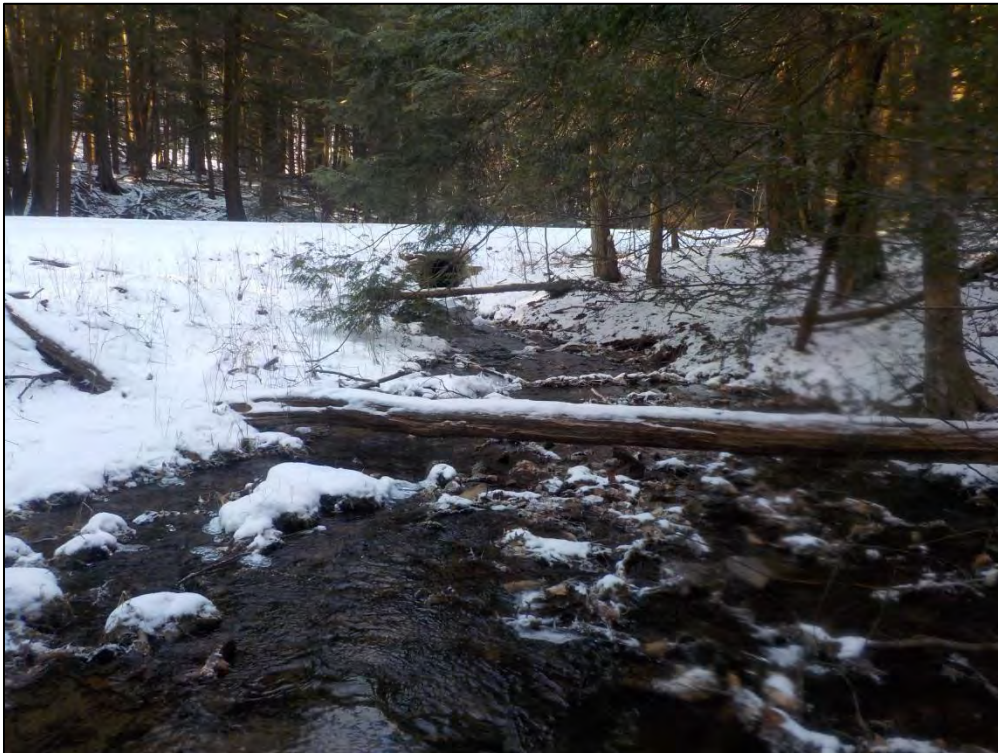
Barrier 11 is located on segment 8. On the map in Appendix 2, it appears to be located on section 7. This is due to the disagreement of stream layers in the GIS mapping system being slightly inaccurate compared with field conditions. In the interest of presenting the most accurate data, the latitude and longitude available in Table 5 are accurate to field conditions, with the barrier being located where segment 8 passes under Middle Fork Road.

Barrier 11 outlet: Located on segment 8, this HDPE pipe has a smooth bore and, due to high velocities in the pipe, prevents aquatic organisms from migrating upstream.

| Stream Name | GIS ID | Barrier ID | Barrier Description | Lat. | Long. | Recommendation |
|---|---|---|---|---|---|---|
| Middle Fork* | 8 | 11 | undersized culvert | 41.533694 | -78.539365 | Replace with 30' bridge |

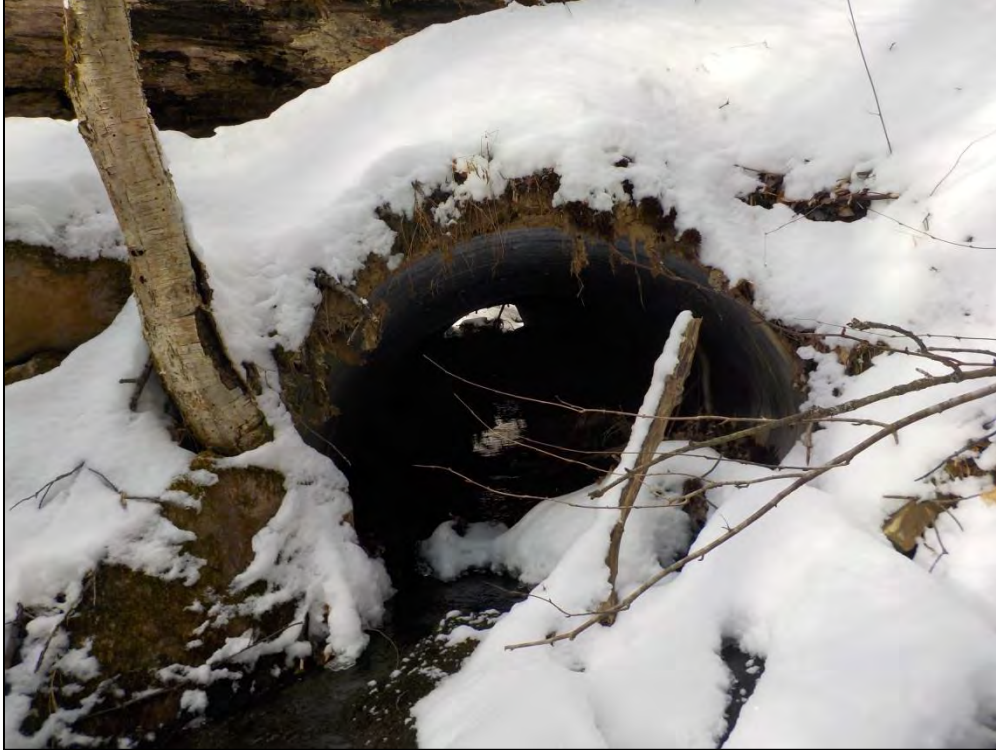
Barrier 12: squash pipe outlet on segment 5A1-Meyers Hollow; this culvert is rusted through portions of the bottom

| Stream Name | GIS ID | Barrier ID | Barrier Description | Lat. | Long. | Recommendation |
|---|---|---|---|---|---|---|
| Myers Hollow | 5A1 | 12 | undersized culvert | 41.54855 | -78.54665 | Replace with 40' bridge |

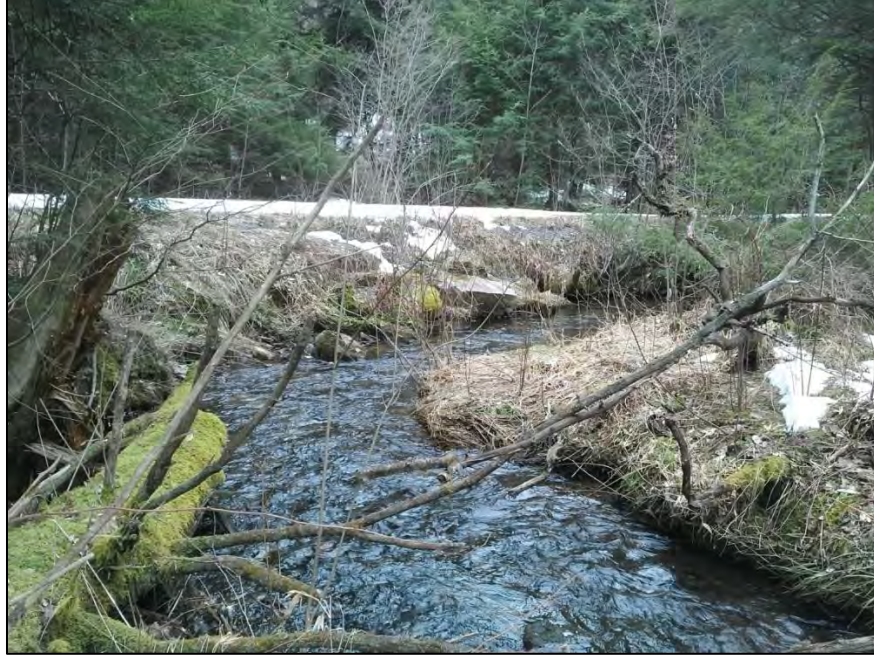
Toe-of-road bank stabilization # 7 on Segment 4: Installing a 2-section modified root wad sill here will deflect flows away from the road and provide overhanging cover for fish

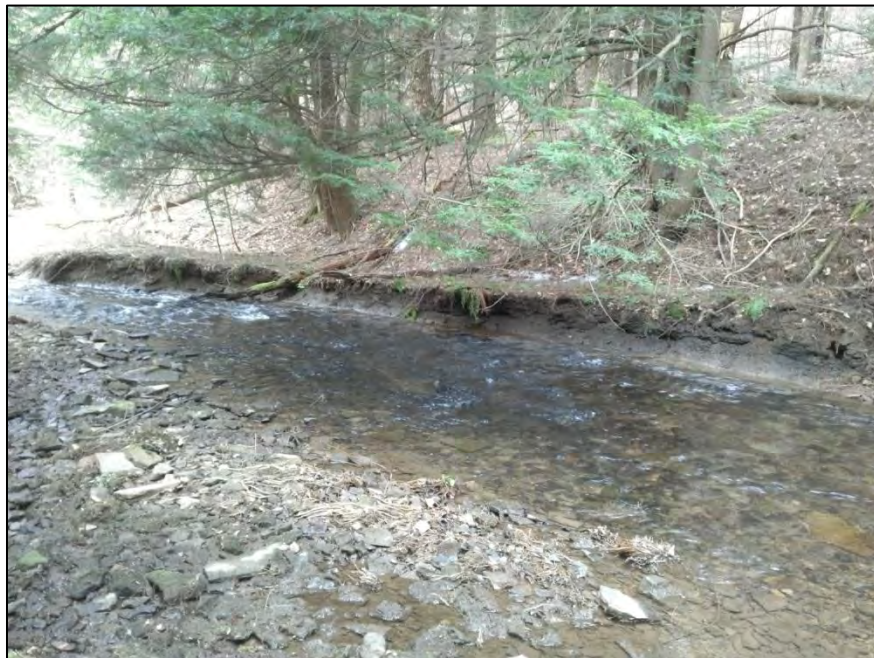
Eroding right descending bank on a less accessible section of Segment 4. This is an ideal location for a manually-installed lateral bar jam to deflect flow and create deep water habitats. Erosion was fairly minimal throughout the watershed, with moderate erosion on segments 2A, 4A, 5A1, and 5C.

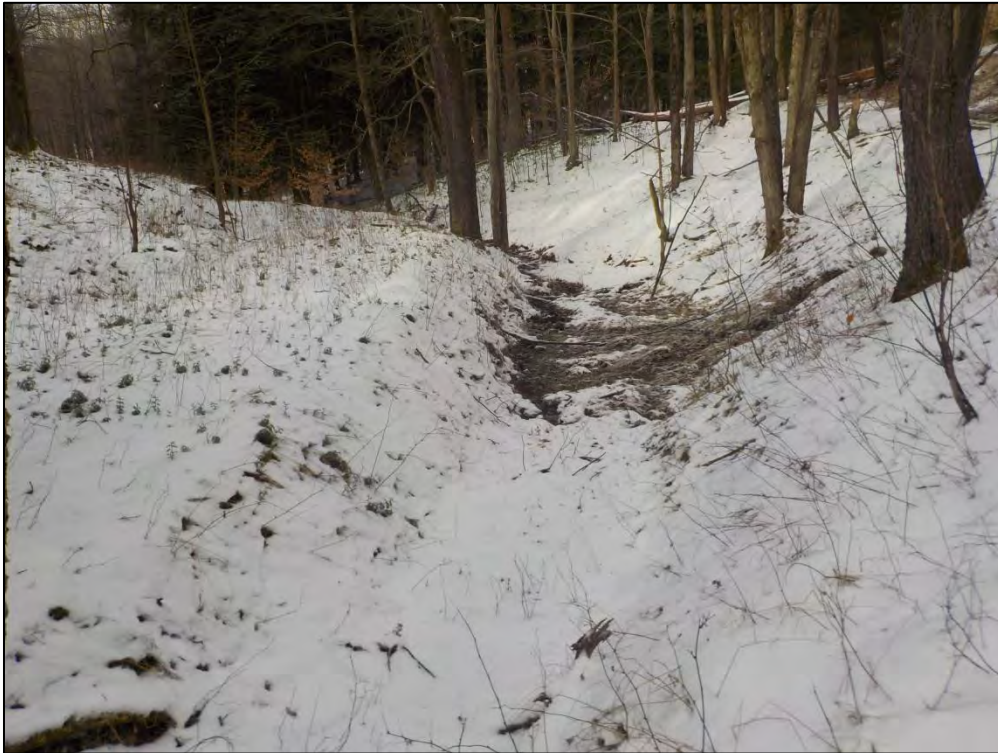
The very top of Segment 8, the headwater spring of Middle Fork emerges from a relict railroad bed on its left descending bank

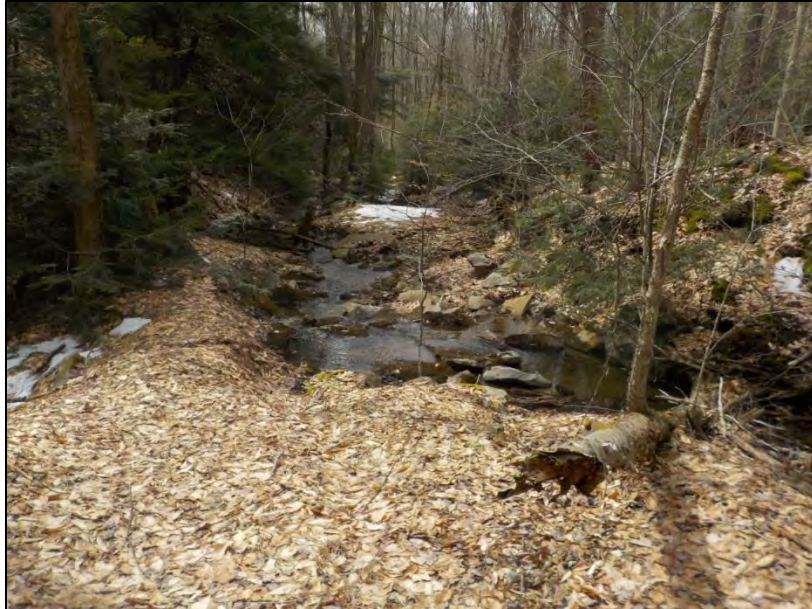
Birch Hollow (segment 5A) exhibited the third lowest overall pH at 4.71. However, due to technical difficulties with the multimeter, an accurate assessment of pH change from the top of the reach to the bottom of the reach was unable to be obtained.

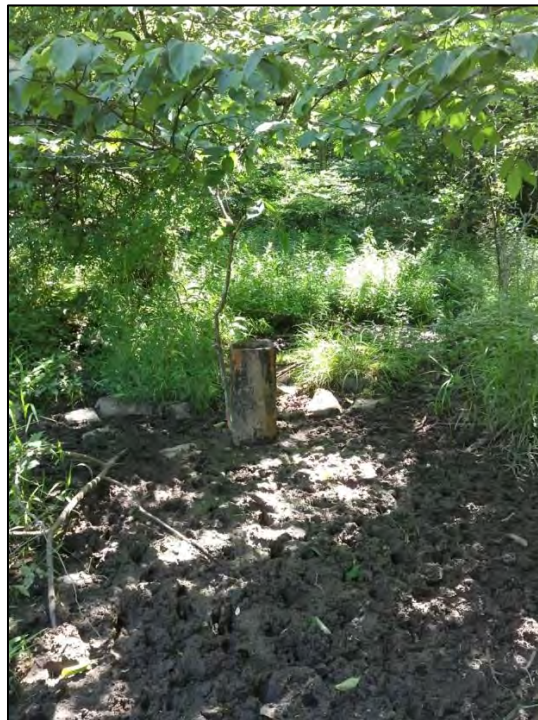
Abandoned well adjacent to segment 1; No water was leaking from the well at the time of the assessment, but drainage patterns indicate flow does come from the well and ends up in Middle Fork.

Measurements of specific conductance (conductivity) were not outside the normal range for headwater streams in this region. The forested, non-developed nature of the watershed should ensure this into the future. Several abandoned oil and gas wells were discovered in the watershed, but were having no measurable impact on water quality. Plugging of these abandoned oil and gas wells in the watershed is recommended as time and resources permit. The most notable instance is a well located on Segment 1, on the east bank of Middle Fork and approximately 150 yards from the parking lot on Middle Fork Road. This well is located at 41.55145, -78.59705. Specific conductance of the water in this pipe was measured at 6.15 $\mu\text{s}/\text{cm}$.

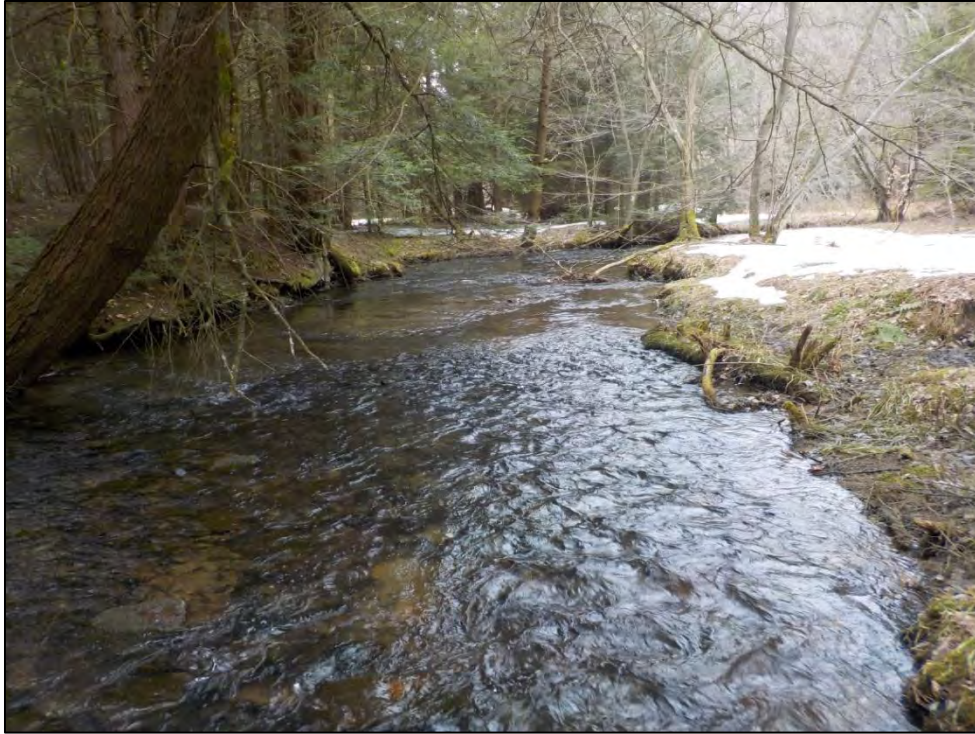
Adding LWM to streams, such as this stretch on segment 5, will increase development of deep-water habitats trout need. Cool, deep places to reside in are especially important in the face of a changing climate.
