# COLDWATER CONSERVATION PLAN

## Miller Run

# Coldwater Heritage Plan for Miller Run

October, 2010

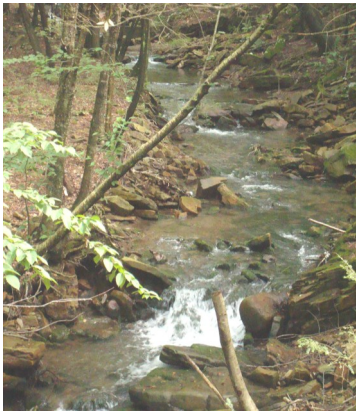
**pH = 3.2**

**This stream contains water that is highly acidic, so metals are dissolved, leaving the water with a clear appearance.**

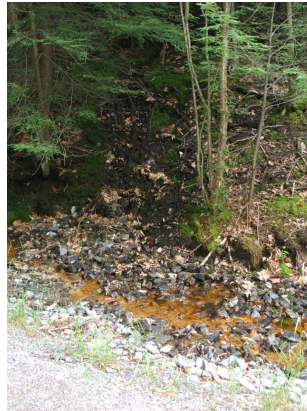
**pH = 4.5**

**In this stream, the water is slightly less acidic, allowing the iron to settle out and create an orange appearance.**

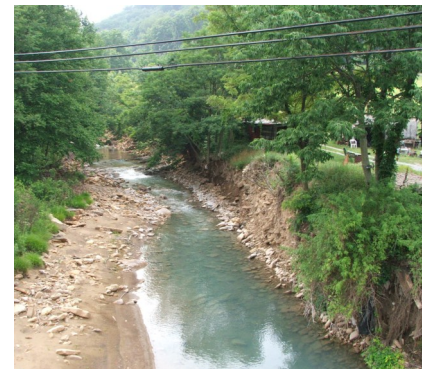
**pH = 5.9**

**This stream is the least acidic of all, however, the aluminum that has settled out of the water creates an unusual bluish white appearance to the stream, often causing the perception that the stream is worst in water quality.**

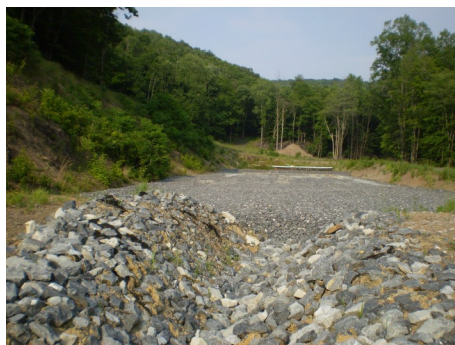
A passive treatment system (right) and a settling pond (far right) are often used to treat AMD.

Limestone rock is the primary component of AMD treatment systems. Limestone is primarily composed of calcium carbonate. When constructing AMD treatment systems, planners often seek high calcium carbonate limestone for optimal system performance. Acidic water from a mine discharge slowly dissolves the limestone, and the calcium carbonate ions are able to absorb the hydrogen ions that cause the acidity. Further, this reaction not only neutralizes acid, but creates ions that are capable of absorbing additional acidity. This alkalinity addition buffers a stream from small acidic discharges that may appear downstream. The goal for each treatment system is to maximize the contact between the acidic water and the limestone.

The treatment systems increase the pH of the mine discharge to neutral or near neutral conditions. Dissolved metals can only remain dissolved under acidic conditions. After the treatment system increases the pH of the mine discharge, the metals settle out of solution. Large ponds or wetlands, known as settling ponds, are used to slow down the water, allow for settling, and capture these metals before they enter the stream.

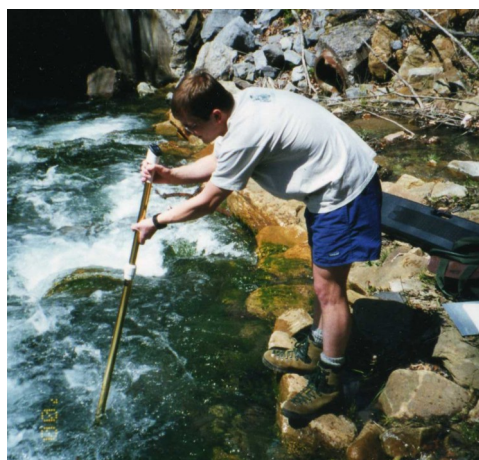
The Shoup's Run Watershed Association tested the water from mine openings for 4 years in order for a treatment system to be built.

SRWA began the process of reclaiming the area by building weirs to measure flow, frequently testing the mine water, and documenting the acidity and metals contained in each mine discharge for four years. This information was used in the design process for the proposed passive treatment system. In 2002, the construction phase of the project began with the removal of the high-walls and dumpsite, sealing the mine openings, and the installation of a large AMD passive treatment system, known as a SAPS system (Successive Alkalinity Production System). The treatment system was designed by Musser Engineering of Central City, PA to treat mine drainage from four mine openings, removing acidity and metals from up to 150 gallons of water each minute. The project was funded by Pennsylvania's Growing Greener program and the U.S. Environmental Protection Agency. SRWA also received funding and assistance from the Pennsylvania State Game Commission, who served as a partner in the project by providing planting crews, seed, and lime to beautify the entire construction area with wildlife plantings.

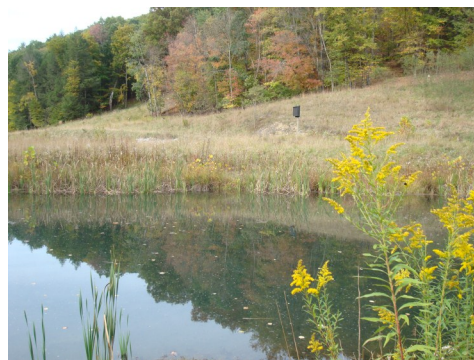
A wetland settling pond, part of the AMD treatment system, surrounded by native plantings provided by the PA Game Commission.

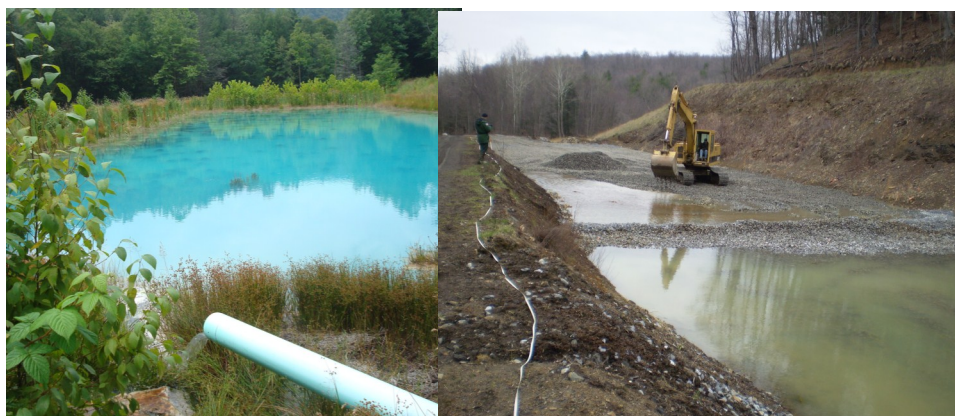
The Minersville AMD treatment system (far right) and aluminum settling pond (right) are the largest in the watershed.

In 2006, the AMD treatment system was upgraded to a newer, more effective passive treatment system called a FeAlMn system. It was the first of its kind in Pennsylvania and is named for its design to remove the three metals commonly associated with mine drainage in the region – Iron (Fe), Aluminum (Al), and Manganese (Mn). The treatment system includes a 50 by 250 foot limestone bed, which ranges in depth from 5 to 10 feet. The bed contains vertical barriers to increase the polluted water’s contact time with limestone, allowing the system to produce far more alkalinity. The system outlet leads to a large settling pond and polishing wetland that remove aluminum from the water before entering Miller Run.

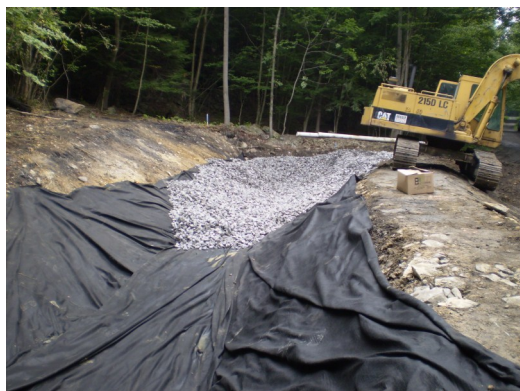
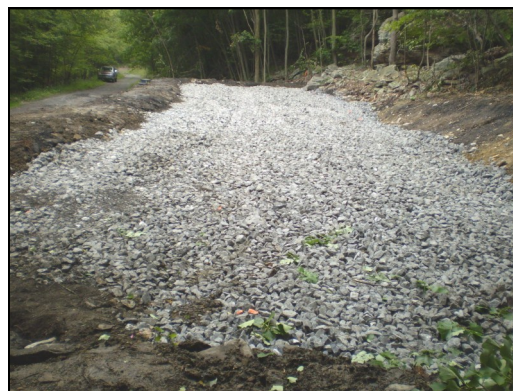
**Miller Run AMD Treatment systems under construction (left) and completed (right).**

This project included the construction of two Open Limestone Beds to treat small, but highly acidic discharges. The treatment systems increase pH of about 15– 60 gallons per minute (gpm) of mine water discharging to the stream but do not include settling ponds for metals because the discharges contain relatively low metal concentrations. The project was completed in 2007 with funding from Pennsylvania’s Growing Greener Program.

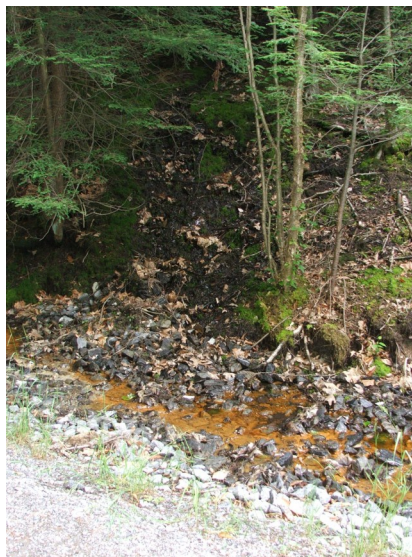
**The polluted runoff caused by the roadway was evident by the orange stained water in roadway ditches after a rain event.**

The access road for State Game Land number 67 runs alongside Miller Run for approximately 2 miles. Prior to the project, the road was constructed with leftover shale from strip mining that was inexpensive and easily accessible. This material produced acidic discharges to the stream after every rain event, adding to the pollution caused by the abandoned mines.

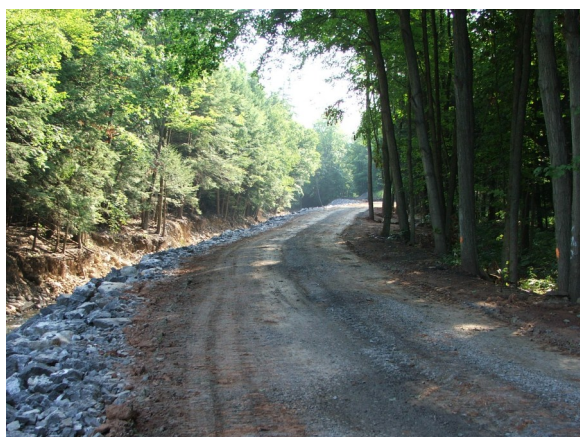
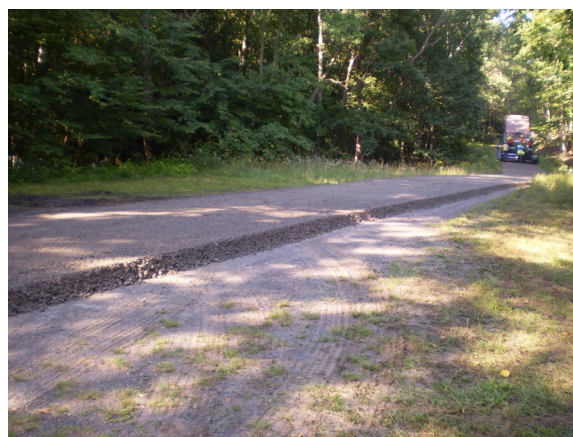
The road improvement project utilized dirt & gravel road Best Management Practices (BMPs), including:

- Removal of mine spoil material
- Lining 600 feet of drainage ditches with limestone
- Stabilizing culvert outlets with large limestone rock
- Constructing 8,000 feet of roadway with limestone driving surface aggregate

The road improvements served to reduce sedimentation and runoff to Miller Run as well as provide long-term passive alkalinity to the watershed. The project was completed in 2008 over a period of three years and included a partnership with the Penn State Center for Dirt and Gravel Road Studies. Funding for the road and ditch improvement projects was provided by the U.S. Environmental Protection Agency 319 Program, the Foundation for Pennsylvania Watersheds, and the Western Pennsylvania Conservancy.

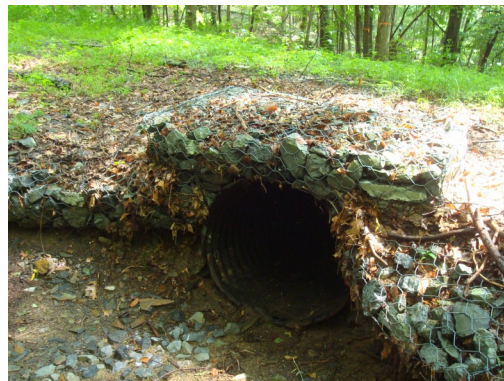
Gabion baskets were used to stabilize a road crossing along Kennedy Run, preventing excess sedimentation to the stream, and adding alkalinity to the watershed.

This project stabilized excessive erosion around a culvert on the headwaters of Kennedy Run by using gabion baskets filled with limestone rock. The project serves to reduce sedimentation to Miller Run, and the use of limestone also contributes some alkalinity to the watershed. The project was constructed in 2005 with funding from the Foundation for Pennsylvania Watersheds.

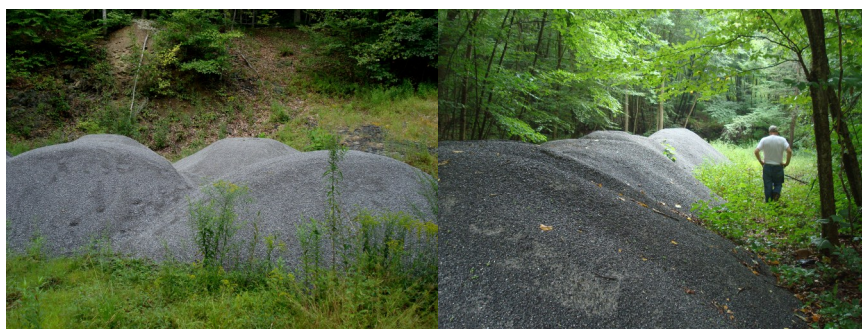
Limestone sand is stockpiled in the Miller Run watershed for future in-stream dosing.

Miller Run has not been dosed since 2004, and the stream has retained good water quality. An additional 260 tons of limestone sand has been stockpiled in case the need arises to dose the stream in the future. Funding for this project was provided by the Foundation for Pennsylvania Watersheds.

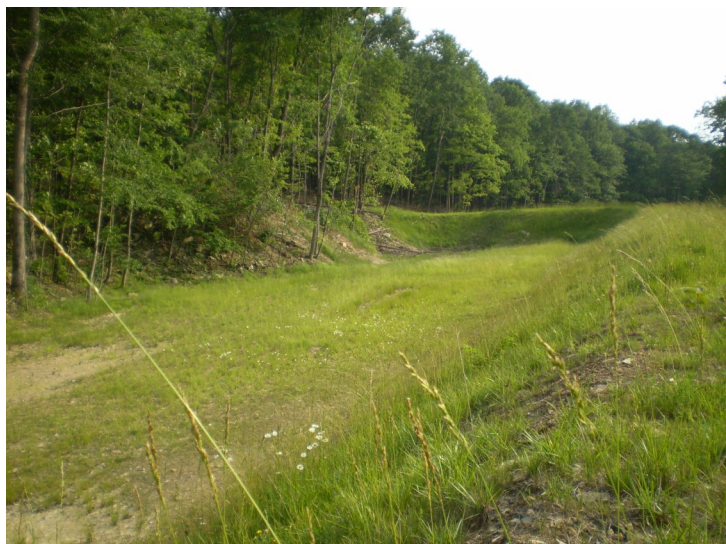
The storm water detention basin detains runoff from heavy rain events. Prior to the project, this site contributed massive amounts of storm water and sediment to Miller Run.

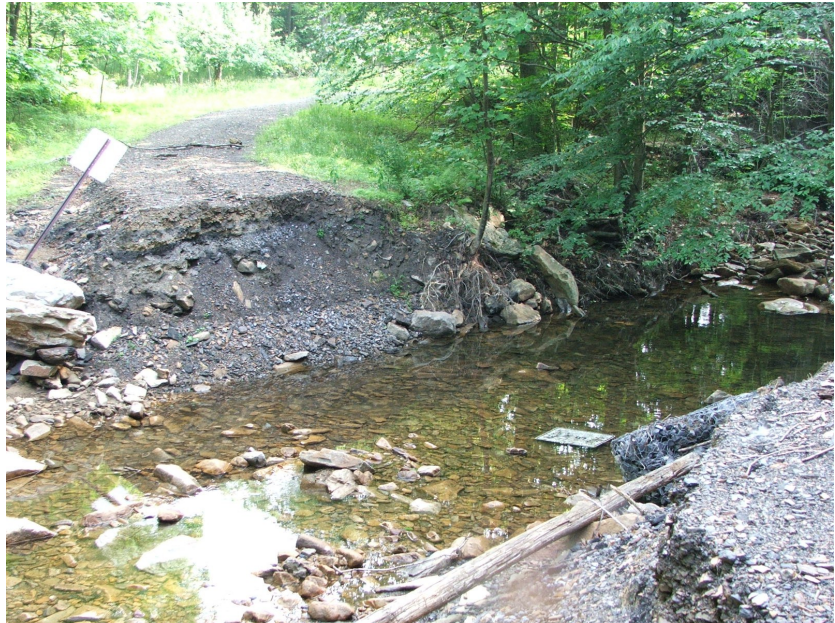
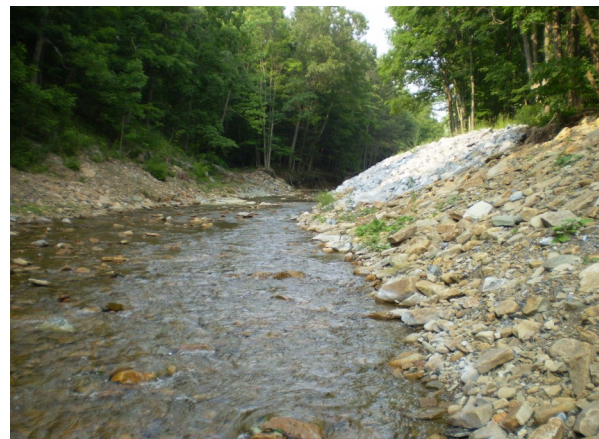
Severe flooding washed away this bridge along Miller Run (right). The banks along Shoup's Run can be extremely steep from previous high water events (below, left). The Shoup's Run Watershed Association has initiated projects to stabilize stream banks when possible (below, right).

Flooding has been a major problem for both the Miller Run and larger Shoup's Run watersheds. Excessive encroachment on the streams has left little natural floodplain left, causing homes and roads to be impacted by floodwaters. The Shoup's Run Watershed Association formed in response to the extreme flooding in the area and engaged in projects to improve conditions when possible. Numerous stream bank stabilization projects were implemented along Shoup's Run to protect properties and restore stream banks, and several along Miller Run, namely to protect or restore the access road to the game lands.

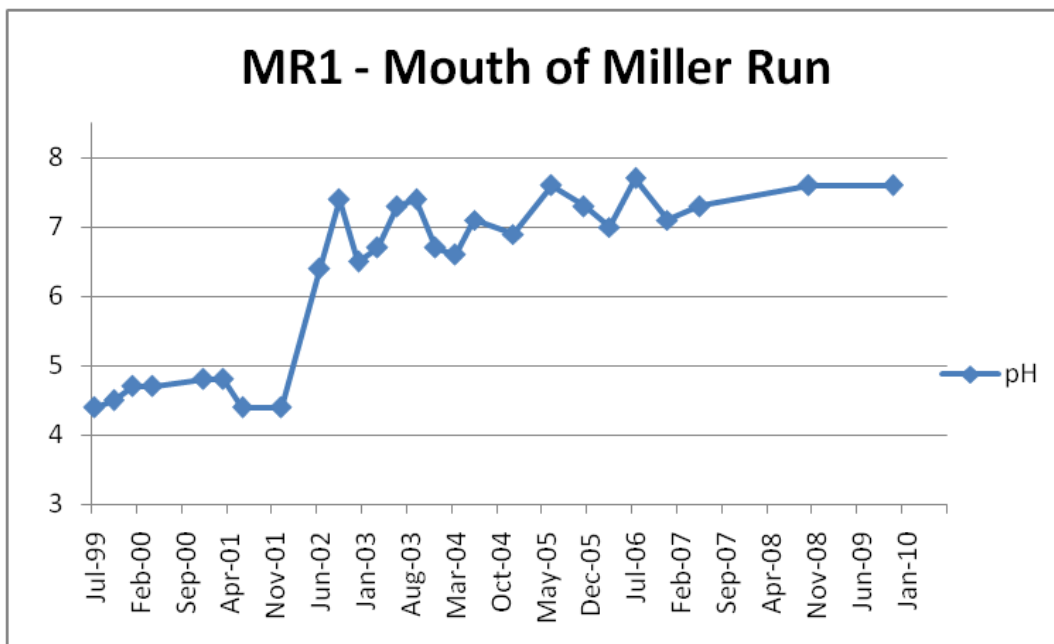
**The pH of Miller Run at the mouth of the stream has increased dramatically and indicates that the water quality in the entire stream has improved enough to support aquatic life.**

Overall, water quality conditions in Miller Run have greatly improved as a result of projects done by SRWA. Prior to 2002, when several major projects were completed, readings at the mouth of the stream were poor. The average pH was 4.6, below the threshold for supporting most forms of aquatic life. Since then, water quality data shows a greatly improved pH of 7.3 and a net alkalinity of 24.7 mg/L. Water quality conditions at the mouth of Miller Run are now a better environment for aquatic life than the headwaters of the stream. In terms of water quality, the entire length of stream should be able to support aquatic life.

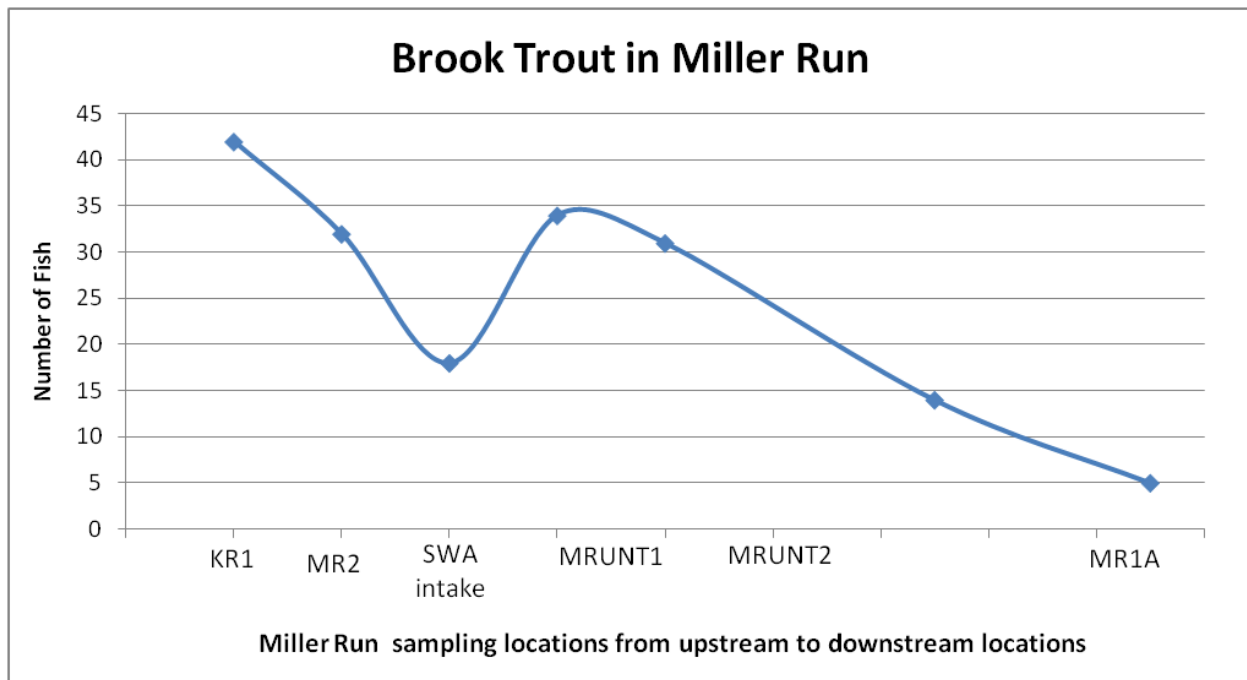
Qualitative bioassessment comparison collected by PA DEP in 2009-2010.

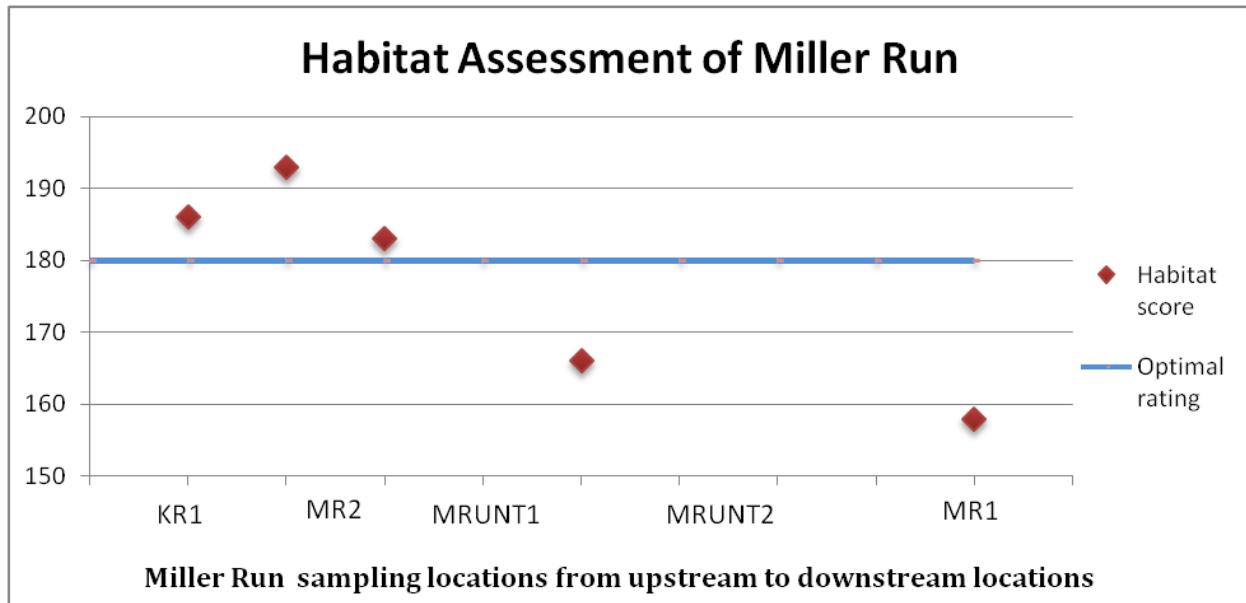
Data collected by the Huntingdon County Conservation District according to the Instream Comprehensive Evaluation (ICE) protocol in 2010.

**Habitat quality was assessed throughout the Miller Run watershed and results corresponded with fish sampling data—the stretches of stream in the upper portions of the watershed contain the most fish and also the highest habitat scores. The lower stretches of Miller Run contained fewer fish and suboptimal habitat ratings.**

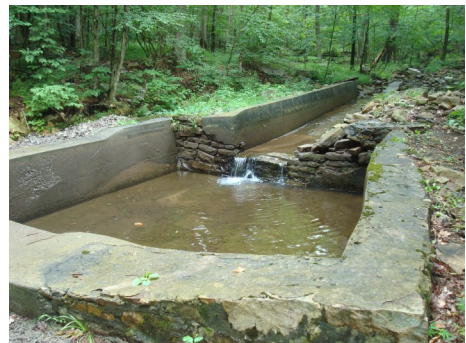
**The Saxton Borough Water Authority intake is located in the headwaters of Miller Run.**

The Shoup's Run Watershed Association will work with HCCD, PA Fish & Boat Commission, and PA Game Commission on the water quantity issue in Miller Run. The primary task is to encourage the Saxton Borough Water Authority and the Department of Environmental Protection to resolve the existing compliance issues relating to Saxton Borough's water intake. The intake structure is located in the headwaters of Miller Run and draws water during dry periods, leaving isolated pools in the stream channel. SRWA will continue to work with DEP to document aquatic life in Miller Run and limitations for the brook trout population caused by lack of water in dry periods and subsequent loss of fish mobility.

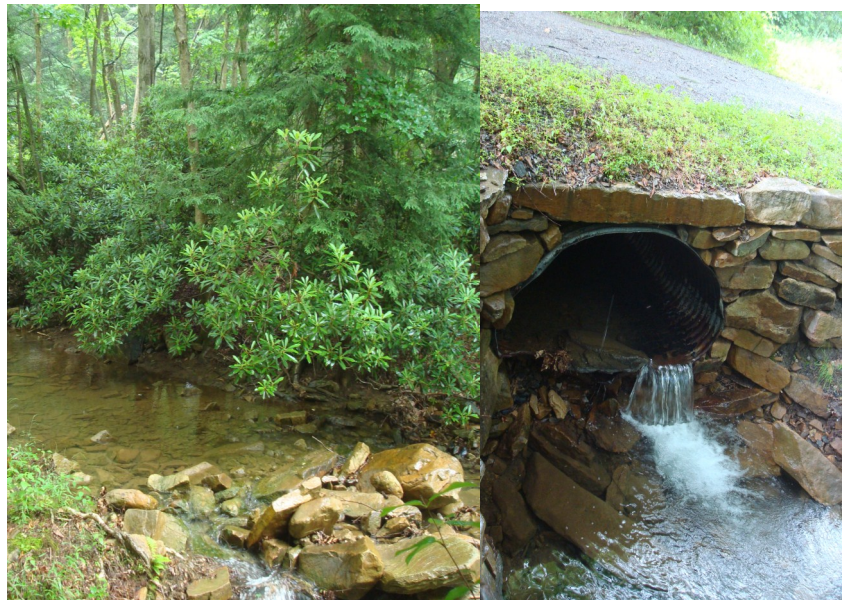
**There are many sites suitable for habitat improvement projects along Miller Run, including a stream blockage caused by flooding (right) and culvert replacement (far right). Both obstacles present barriers to fish movement and limit the success of the recovering brook trout population.**

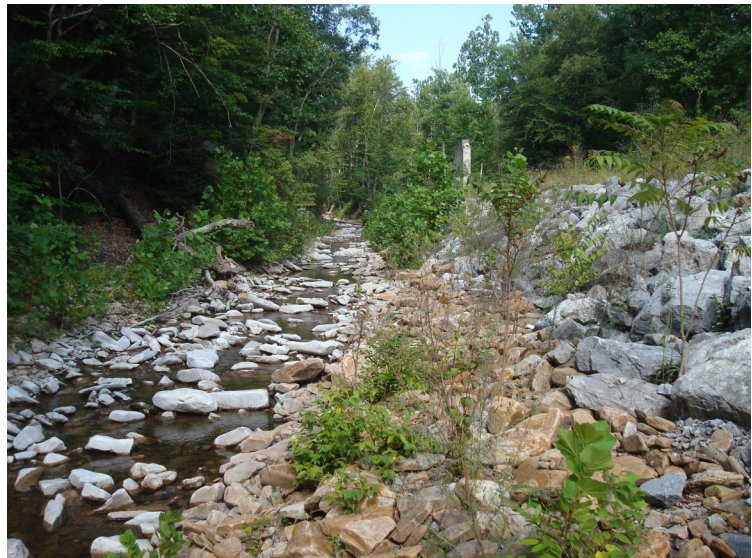
**Segments of Miller Run have been severely channelized and have suboptimal fish habitat. Construction of habitat improvement projects would likely aid in the brook trout population recovery in this stream.**

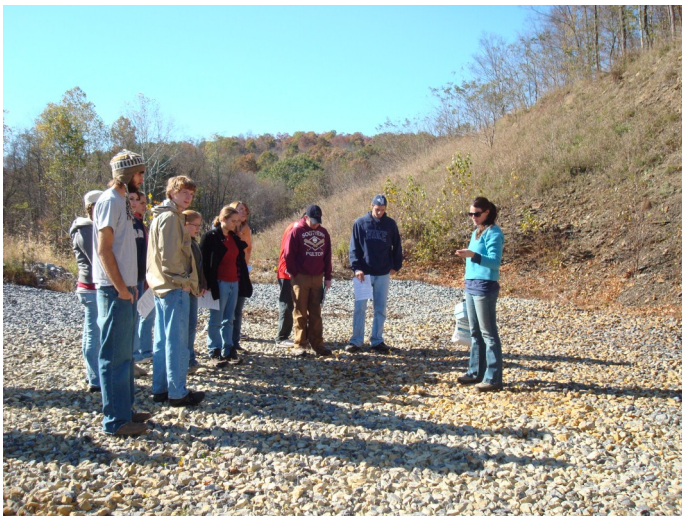
Students from nearby Juniata College stand on an actual limestone bed while learning about how AMD treatment systems work to reduce pollution to nearby streams.
