# Moshannon Creek Headwaters Coldwater Conservation Plan

Prepared by:  
Clearfield County Conservation District

**Conducted under a Coldwater Heritage Partnership (CHP) grant**

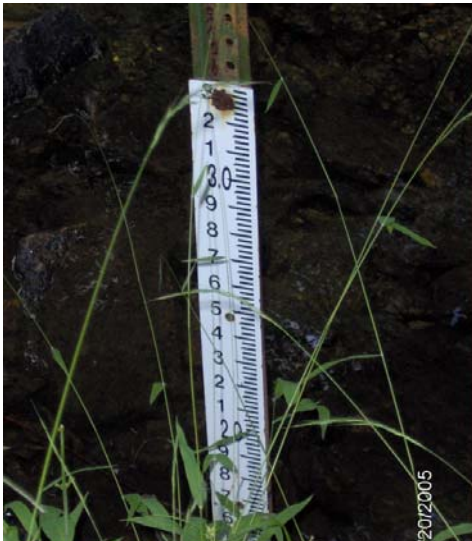
**Measuring Flow on Moshannon Creek**

This situation was highlighted in the Spring 2002 issue of the Pennsylvania Trout (Coulton, 2002). Mountain Branch, a tributary of Moshannon Creek downstream of this particular study area, was the source of water for 8,000 customers in the Houtzdale area. With the building of the Houtzdale State Correctional Institution the usage had to increase to an additional 400,000 gallons per day. Therefore new wells were drilled in the Trim Root Watershed, a tributary to Mountain Branch. Trout Unlimited members were concerned that the excess water being drawn from the wells was taking away baseflow from Trim Root Run. The Pennsylvania Fish and Boat Commission was contacted to complete various studies on the stream. Flows are measured in Trim Root Run. Any pumping from the shallow well

be used to monitor the flow to ensure it doesn't drop below the level that would damage the stream.

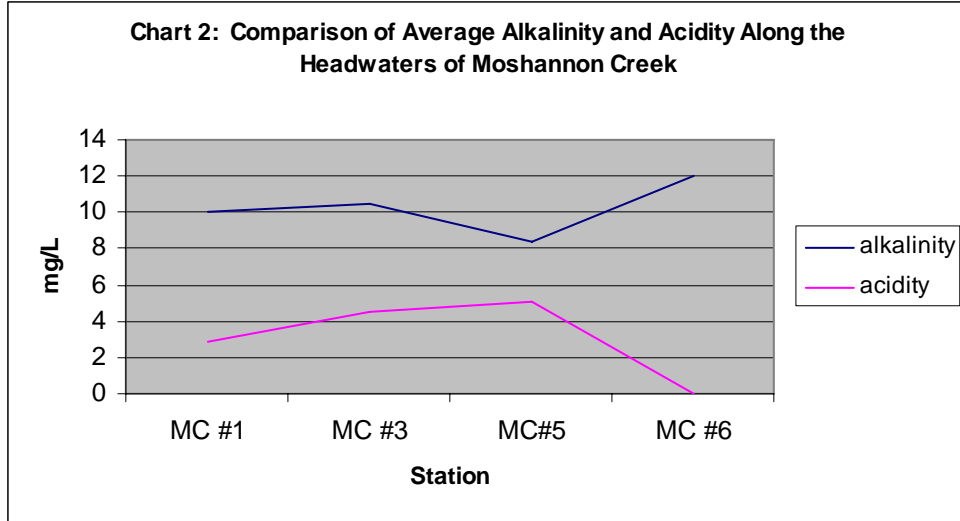
In a watershed it is important that alkalinity is always more than acidity. That way the water body can buffer any changes in pH. On average as shown in Chart 2, all stations show alkalinity is higher than acidity throughout the section studied. Unfortunately there were instances during the spring when acidity was the same or higher than alkalinity at individual stations. This will be elaborated further when each section is discussed in detail separately.

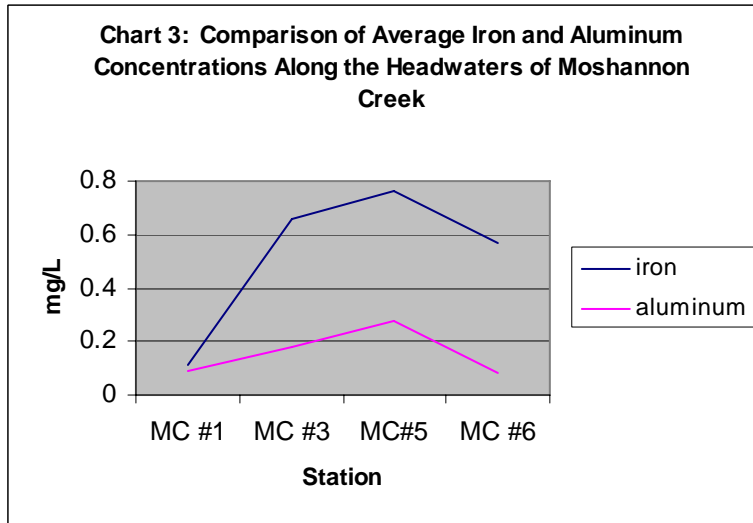
AMD is definitely present within the watershed. As shown in Chart 3, both iron and aluminum show an increase after AMD enters the stream upstream and downstream of MC#3. Iron shows the biggest increase, most likely due to MCFOR, an AMD site that contains a large amount of the metal. Fortunately the average of both iron and aluminum (See Table 1, Appendix A) are below state standards.

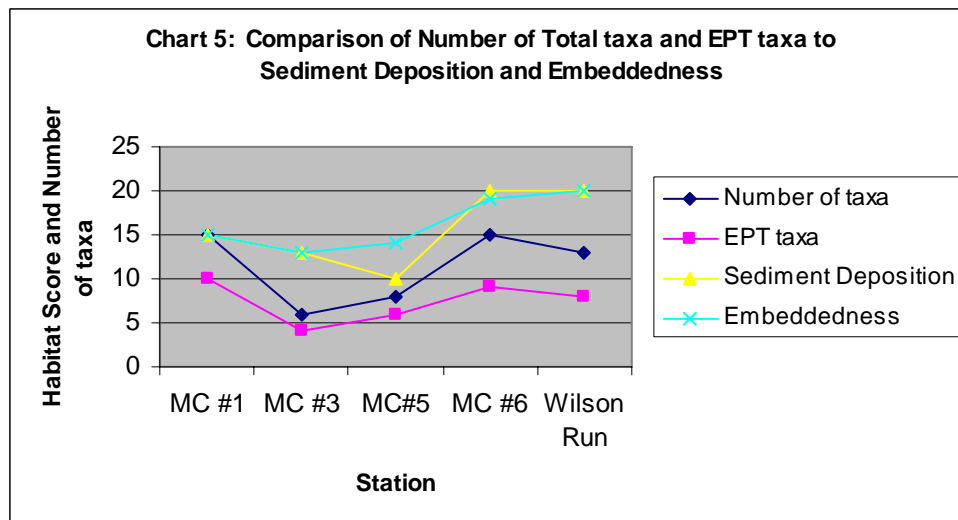
Chart 5 shows the effect of the sediment. The habitat score is from the visual assessment looking specifically at sediment deposition and embeddedness. The closer the score is to 20 the better. The drop in habitat score for deposition and embeddedness indicates there is more sediment present in the stream at these locations. The macroinvertebrate data drops in response to the increase in sediment. It begins to recover at MC #6 due to less sediment deposition and embeddedness. Wilson Run is shown for comparison because it is a relatively undisturbed watershed.

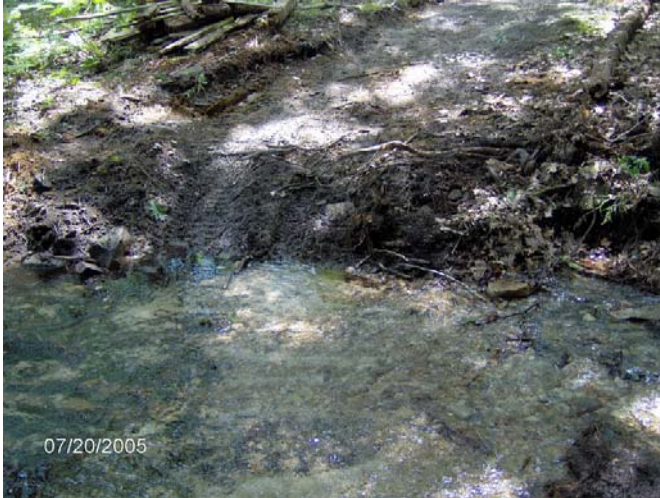
The headwaters of Moshannon Creek are heavily forested. The stream is very intact. There were a couple of disturbances noted. First was an ATV trail that travels down the hill and crosses the stream. There are areas of erosion along the trail that would be an issue during rain events. The stream crossing is actually quite stable. It would appear that the trail is an access for hunters who are not intent on tearing up the stream.

**ATV Trail in headwaters of Moshannon Creek**

7. ATV use was not identified as a huge problem. Even so, MCWC could help educate ATV riders and landowners on environmental damage that can occur to streams with irresponsible riding.

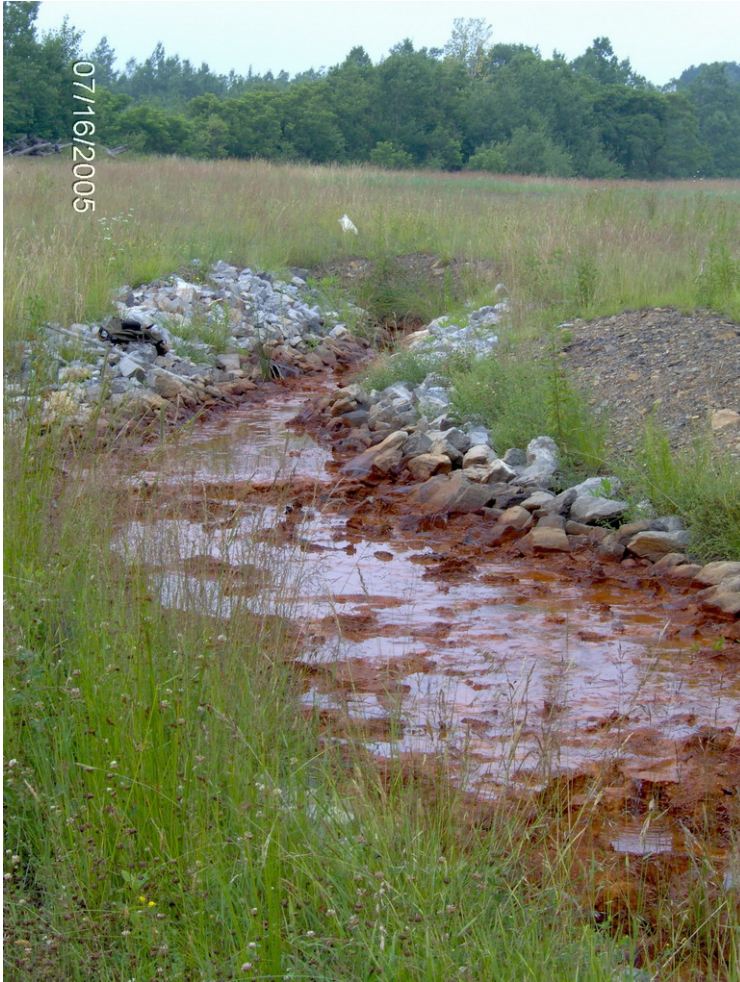
These changes are all due to a few abandoned mine areas entering the watershed between MC#1 and MC#3. The largest contributor is MCFORE, a discharge that originates in an area that was backfilled and reclaimed by the Bureau of Abandoned Mine Reclamation (BAMR). In one sample taken, the pH was 4.7 and conductivity 2480 umhos. This high conductivity would indicate possible metals in the water, which is found to be the case. Iron is at 253 mg/L and manganese at 66.2 mg/L in the MCFORE discharge, which is grossly over the standards for aquatic life to survive. Aluminum is below state standards at .36 mg/L. Sulfates are also above standards at 1211 mg/L in this discharge, which is a prime indicator of AMD. Even though there is some alkalinity found in the water (12 mg/L) at MCFORE, acidity is much higher (508 mg/L).

**MCFORE Discharge**

The effects of mining are beginning to occur. The MCFORE discharge is a pond that had been backfilled about 2 years ago and is located in this section of the watershed. The pond was an AMD discharge that just trickled into the stream, but once backfilled the discharge flowed into the stream at a higher rate. The water from the discharge travels through a limestone channel that is covered with an iron precipitate. The water then enters a beaver pond that slows the flow of the AMD. However during high flow conditions like in the summer of 2004, it could be seen where the water had flowed due to the path of iron and dead trees on its way to the wetland. In speaking with the landowner after the summer of 2004, the backfilled pond had greatly affected the stream quality and rocks downstream now had an orange precipitate.

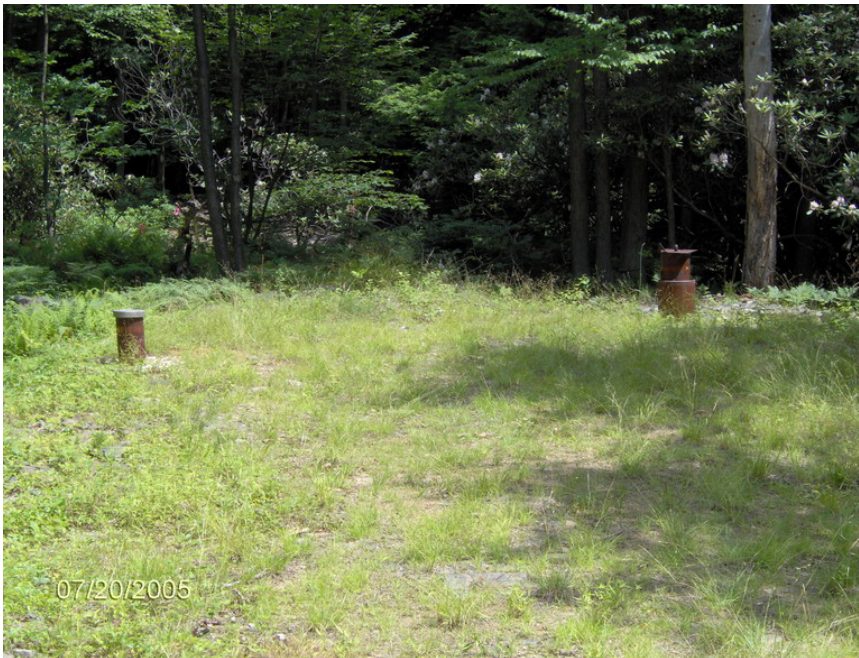
Changes are beginning to occur in the watershed from MC #1 and MC #3. The first noticeable issue is the groundwater wells that were mentioned in the headwaters section. There are three wells located in this section of stream used by Houtzdale Municipal Authority. They are used as a back-up supply only.

**Groundwater wells**

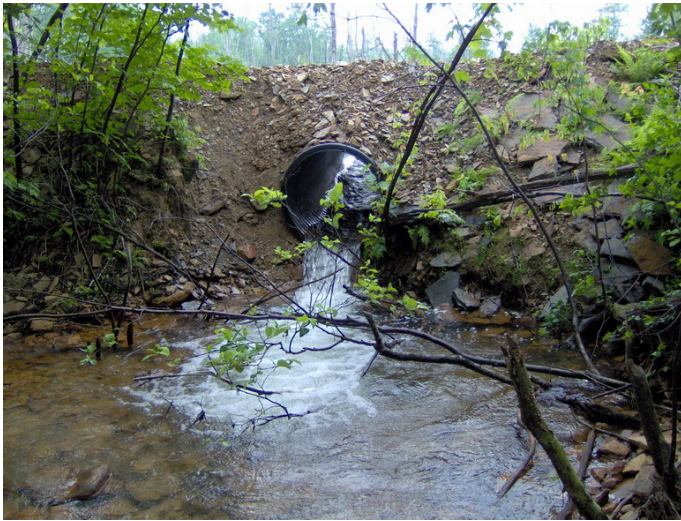
There is also evidence from past mining located throughout this portion of the watershed. There are areas of spoil that have not been revegetated. There are also old dirt roads that cross the stream. Both of these are examples of sources for excess sediment in the stream.

**Culvert from dirt road crossing**

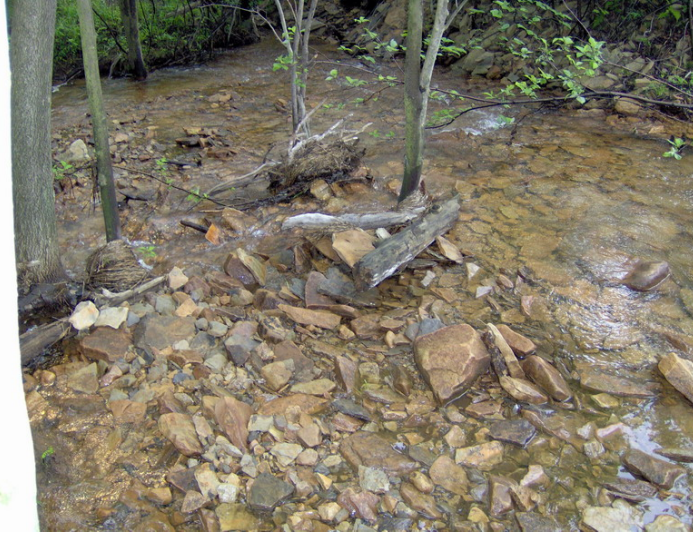
**Cobbles and sediment below culvert shown above.**

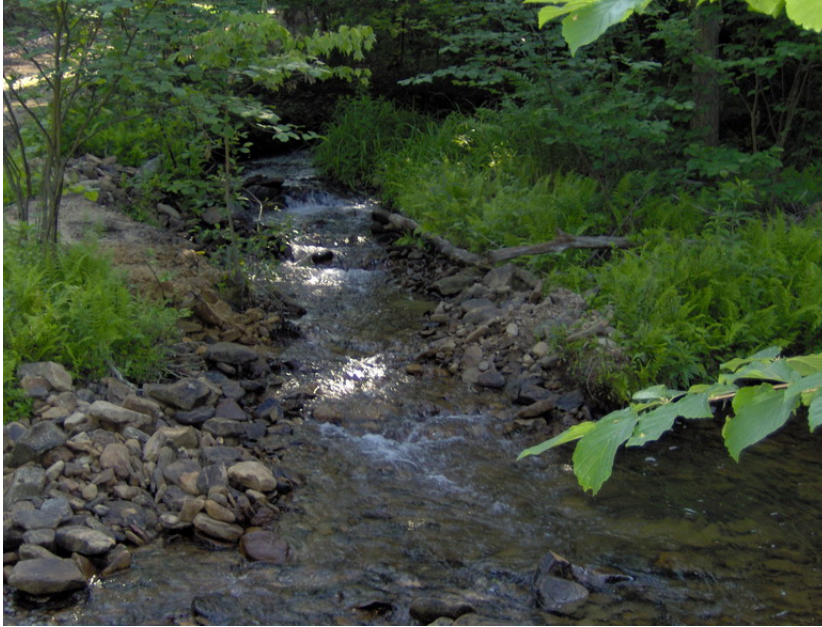
**Wilson Run at mouth. A logging road can be seen on the left**

The Stream Habitat Assessment showed a score of 184 out of a possible 200, the second highest habitat score in this study. All habitat parameters showed optimal conditions except the riparian vegetative zone width. This was due to the logging road that ran along Wilson Run.

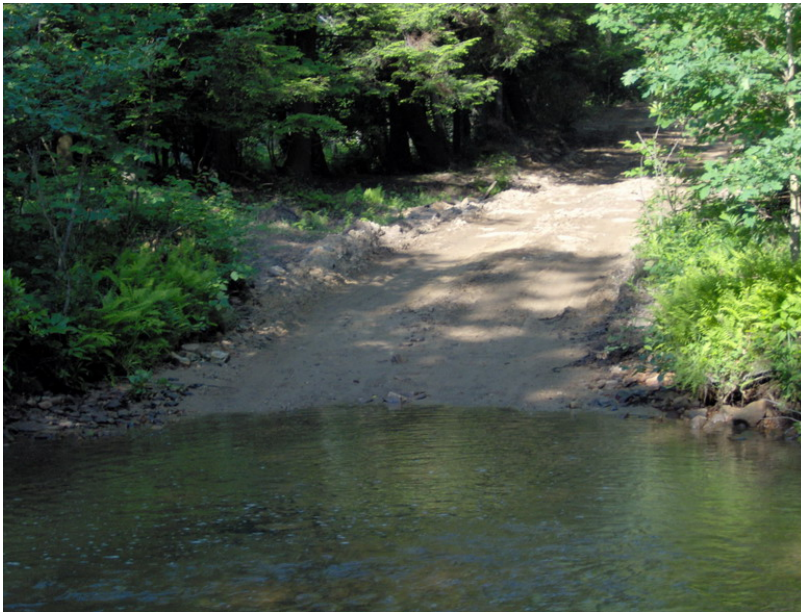
A logging operation was occurring during the time this study was completed. A logging road crossed Moshannon Creek below the mouth of Wilson Run then ran along side of this tributary. Even so there was no evidence of excess sedimentation in Wilson Run due to this road or the logging occurring in the watershed. The riparian zone was narrow due to the road but there were still trees shading the stream.

**Logging road crossing Moshannon Creek below the mouth of Wilson Run**

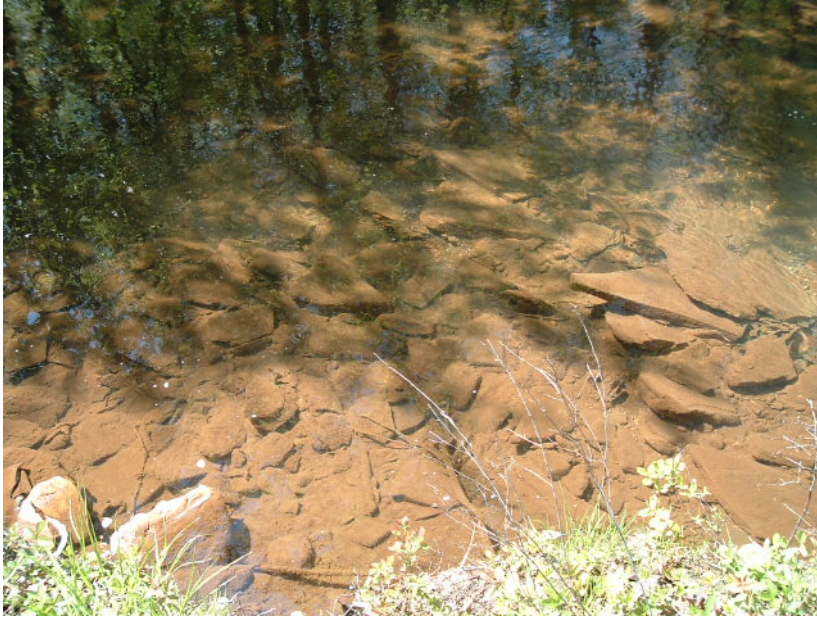
Downstream of Wilson Run at MC #5 the habitat score was 176 out of a possible 200, ranking it fourth out of the five sites. Suboptimal conditions were found for embeddedness and sediment deposition. The parameters for the riparian zone were optimal. This indicates that the banks are very stable with an excellent riparian zone.

**Sediment coating substrate below Wilson Run**

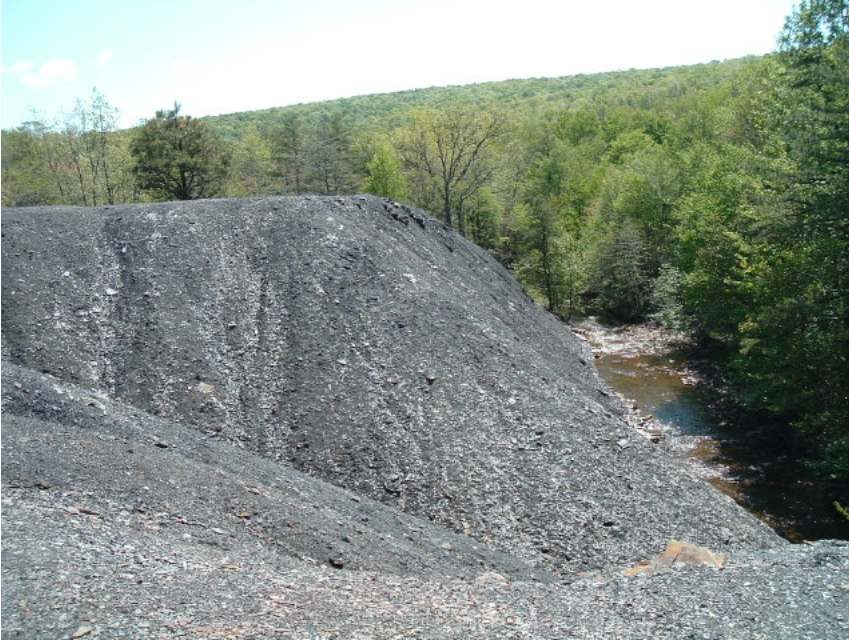
The first problem located in this section of the study was an iron mat that runs into the stream and a large spoil pile adjacent to the streambed. The iron mat is approximately 40 feet long and visibly disturbs the streambed. The spoil pile has deep channels where runoff reacts with the pyrite and enters the stream. There are also two small tributaries that receive runoff from the spoil. The area is approximately 3 acres and forms the left bank of Moshannon Creek.

**Spoil pile forming the left bank (facing downstream) of Moshannon Creek**

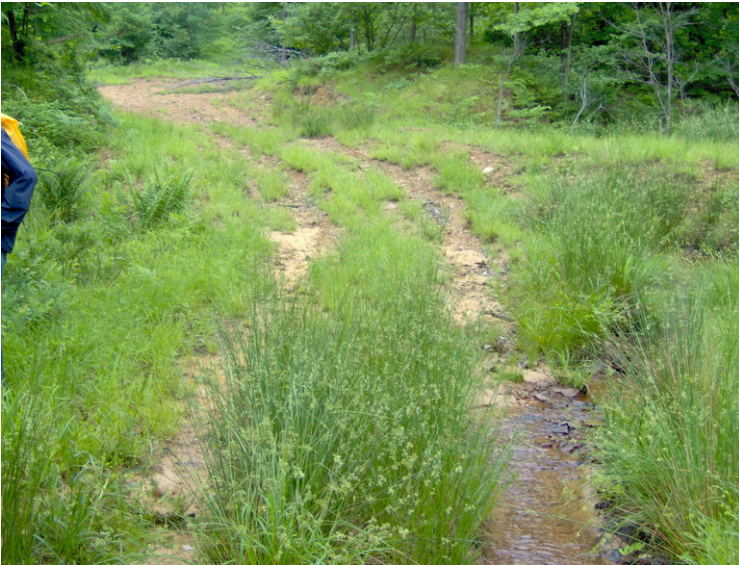
Leftovers from mining are prevalent in this section of stream. All the land on the Clearfield side of the watershed has been affected by mining. There is also one more AMD tributary that enters from the Clearfield County side, which runs across an used road and into a man-made channel adjacent to spoil piles. This could be having a small affect on Moshannon Creek.

**Tributary affected by AMD receiving excess sediment from logging road**

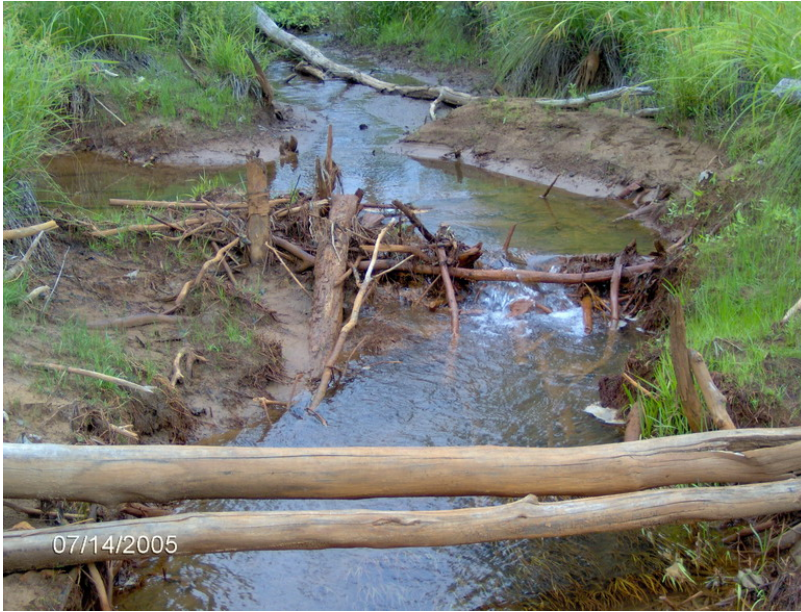
An explanation of this section would not be complete without mentioning Roup Run. This particular study ended at the mouth of this tributary because once it enters, Moshannon Creek is dramatically altered. Roup Run was the first source of water that kills all life downstream on Moshannon Creek. This tributary enters from Centre County. The pollution of this tributary occurs only 100 yards above the mouth of the stream. This discharge comes from a large 2 acre pond which was surrounded by reclaimed mines. Approximately 10% of Roup Run's water comes from this tributary, which has a pH of 2.9 and a conductivity of 2060 umhos. The water has very high levels of acidity, iron,

manganese, aluminum, and sulfates. Above this bad tributary, Roup Run has good water quality.

**Mouth of Roup Run**
