Rogues Harbor Run Coldwater Conservation Plan

Prepared by:
Clearfield County Conservation District
650 Leonard Street
Clearfield, PA 16830

Funded by a grant from the Coldwater Heritage Partnership (CHP)

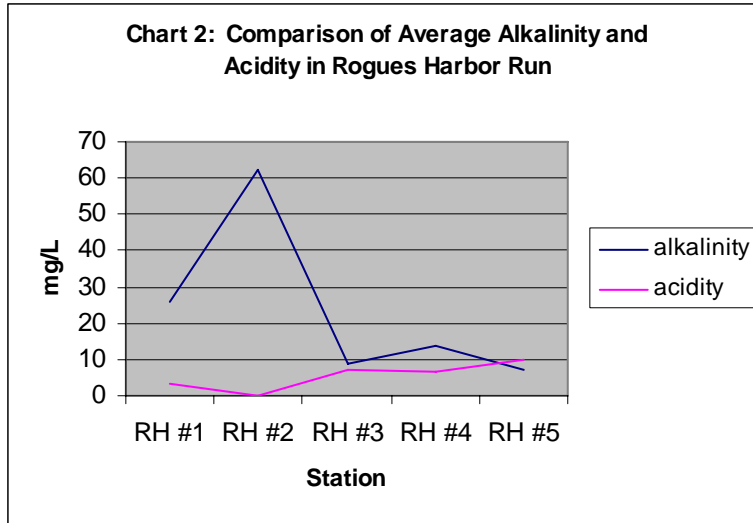
In a watershed it is important that alkalinity is always greater than acidity. That way the water body can buffer any changes in pH. On average as shown in Chart 2 below, all stations show alkalinity is higher than acidity throughout the section studied. Unfortunately, there were instances during the spring when acidity was the same or higher than alkalinity at individual stations. Also, there is an obvious spike of alkalinity in the bad tributary (RH #2) that affects this parameter at the mouth (RH #1). This is due to the highly alkaline AMD discharge that affects this tributary. This will be elaborated further when each section is discussed in detail separately.

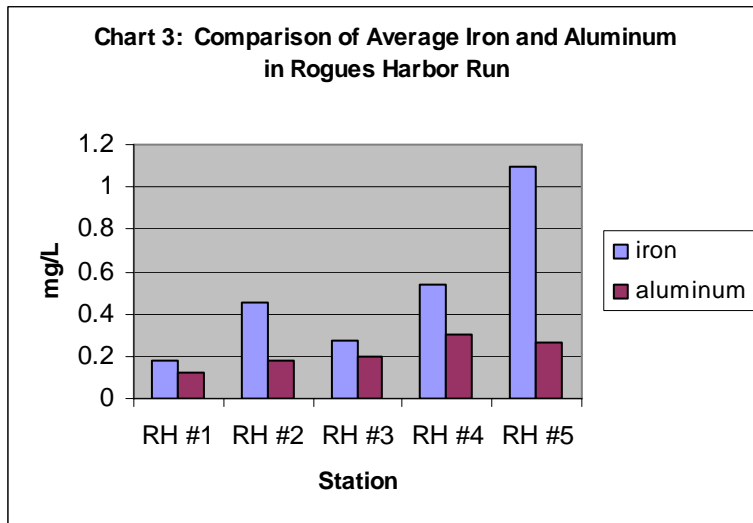
As shown in Chart 3 below, iron and aluminum concentrations at all sampling locations are both below the level that would harm aquatic life. There is an unexplained amount of iron in the upper most station (RH #5). This is elaborated upon in each individual section discussion below.

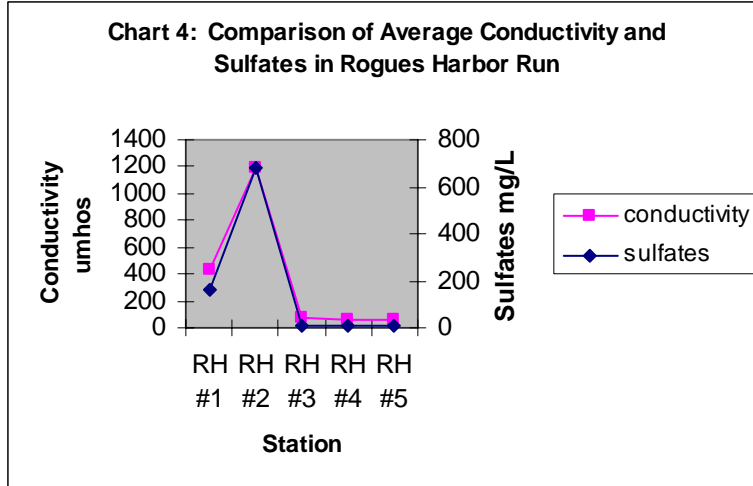
Chart 4 below shows that the bad tributary (RH #2) has a significant influence on the mouth of Rogues Harbor Run. The AMD located in this tributary causes a huge increase in conductivity and sulfates. Until that tributary enters, all readings for sulfates and conductivity are very low, which is a good indication that no mining has occurred in the watershed to that point.

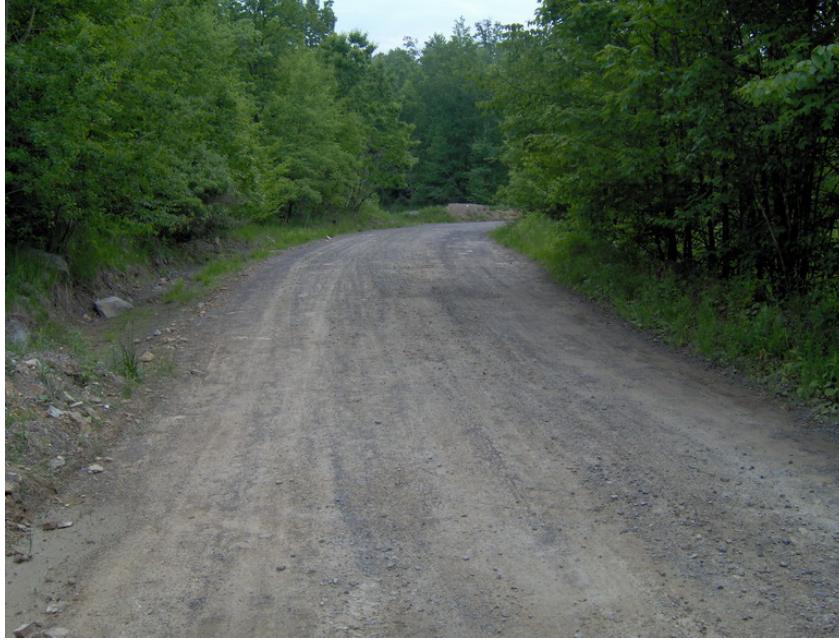
Rock Run Recreational Road

One of the most noticeable problems in this section of stream is the road for Rock Run Recreation Area. The road was originally used to gain access to the mining operations occurring in the Rock Run watershed. There appear to be some signs of erosion from this road that enters Rogues Harbor Run. Excess sediment may also be entering the stream from an area of exposed soil near where the road crosses the stream.

- 2). The watershed group may also want to work with the Rock Run Recreation Area on their access road that crosses Rogues Harbor Run. This road has caused excess sediment in the past and may continue to do so. Proper BMP's to help prevent excess runoff from the road should be installed. The size of the culvert should also be examined to confirm it is large enough for the drainage area.

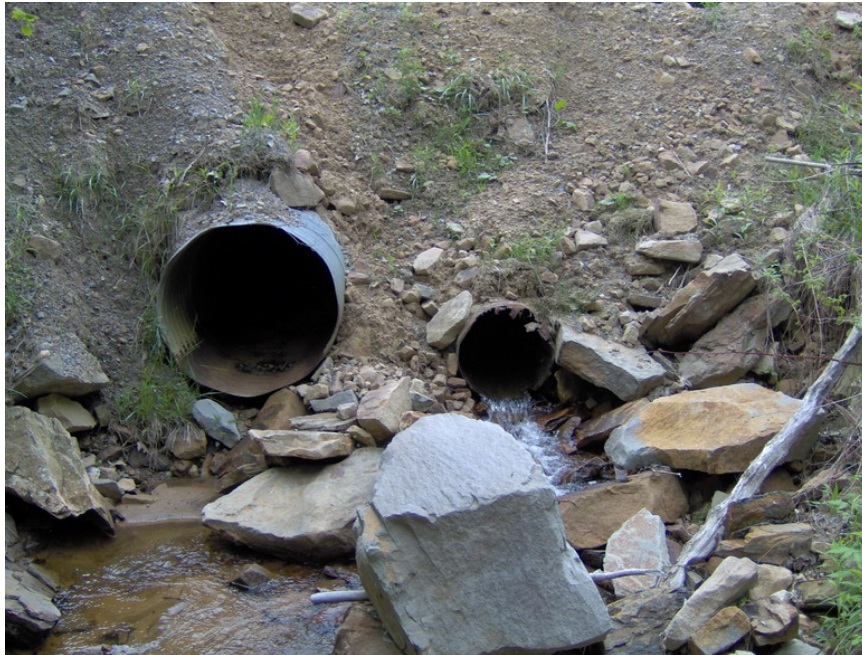
Culvert pipes under Rock Run Road. Note the lack of vegetation to stabilize area.

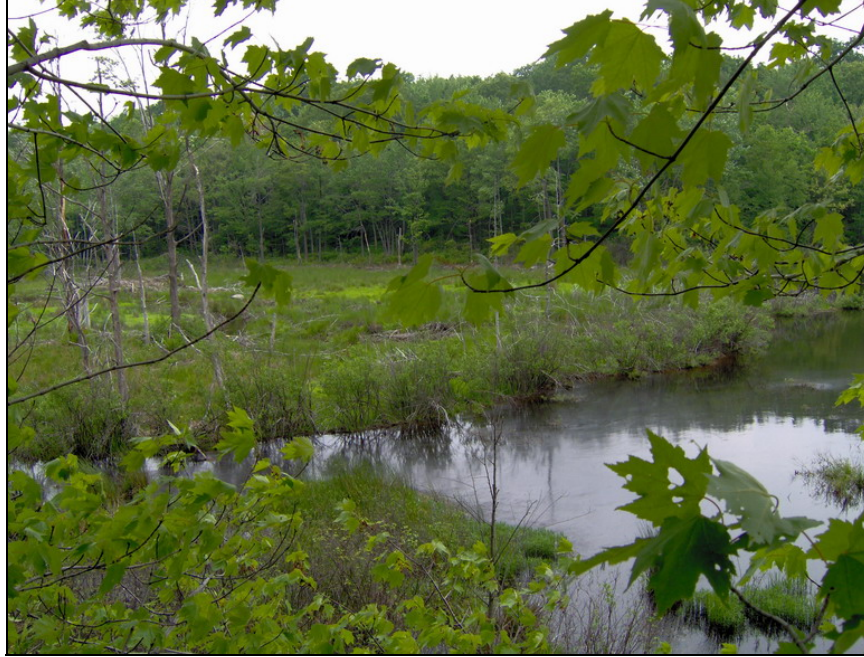
Above this road, there was a long series of wetlands constructed by beavers that covered about 20-30 acres, giving the water a tea color for a small section downstream. These beaver ponds were noted in a 1931 study conducted by a local group.

Beaver Dam in headwaters above Rock Run Road

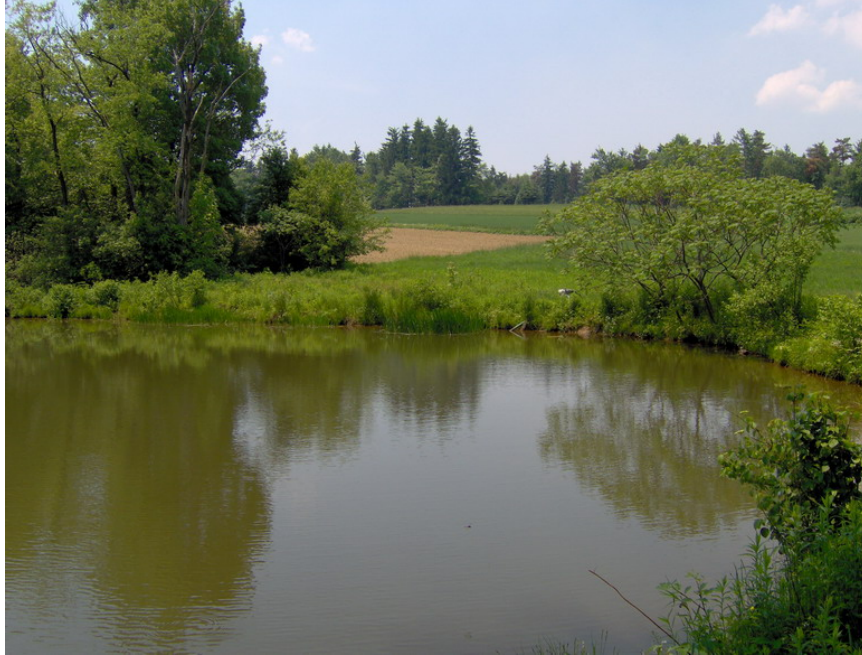
Moving upstream there is another dirt road crossing. The pipe that goes under the road is rusted out but water is still flowing through. The stream bottom is extremely sandy. Further up, there is a large field on the left side (facing downstream) that is uncultivated. There is limestone dumped at an old road crossing. It appears that there is a pipeline that crosses the stream at this point. Further upstream a wetland is encountered. By hiking around the wetland and towards the headwaters, it was discovered Rogues Harbor Run flows through a large farm. The stream seems to originate at some old farm ponds.

Farm pond, Headwaters of Rogues Harbor Run

Another concern in this section of the watershed is the suboptimal conditions due to sediment deposition that were observed during the Stream Habitat Assessment. Many sources of sediment were found in this section of the watershed. Between the two dirt road crossings, one being the road that leads to the Rock Run Recreation Area and another road with a pipeline, there are numerous opportunities for water to flow over the roads and in the ditches, transporting excess sediment into the stream. Finally, the headwaters begin in an agricultural area. Excess sediment can enter from plowed fields and the roads leading to them. Excess nutrients could also be a concern, but they were not tested for during sampling, nor was the possibility the ponds were causing an increase in the temperature of the water in the stream.

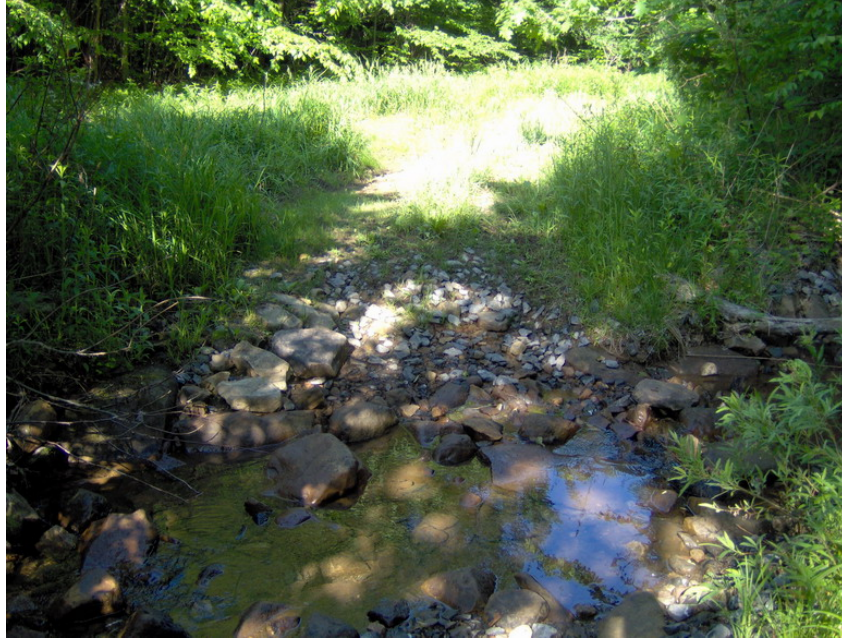
A pipeline crosses upstream from this point. The pipeline is also used as an ATV crossing. There were pieces of limestone on this crossing, but the limestone was washed downstream. This crossing seemed to be a rather well used trail.

Pipeline erosion

- 1). The main concern is working with the Rock Run Recreation Area to help educate ATV riders on environmental damage that can occur to streams with irresponsible riding. There is also a concern that riders will try to enter the Rock Run area through Rogues Harbor Run so they can ride the trails for free.

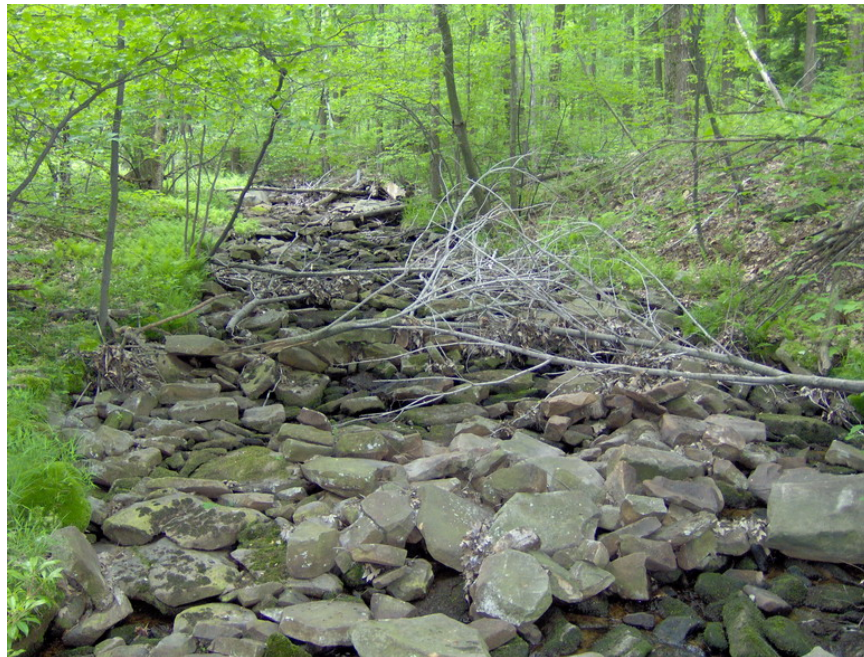
Just upstream from the pipeline crossing, an interesting geological feature occurs. The stream disappears underneath extremely large boulders and rocks for about a quarter of a mile. There were large rocks around the area. The stream could be heard in some areas in the valley but was not observable below the rocks.

Large cobbles in stream channel

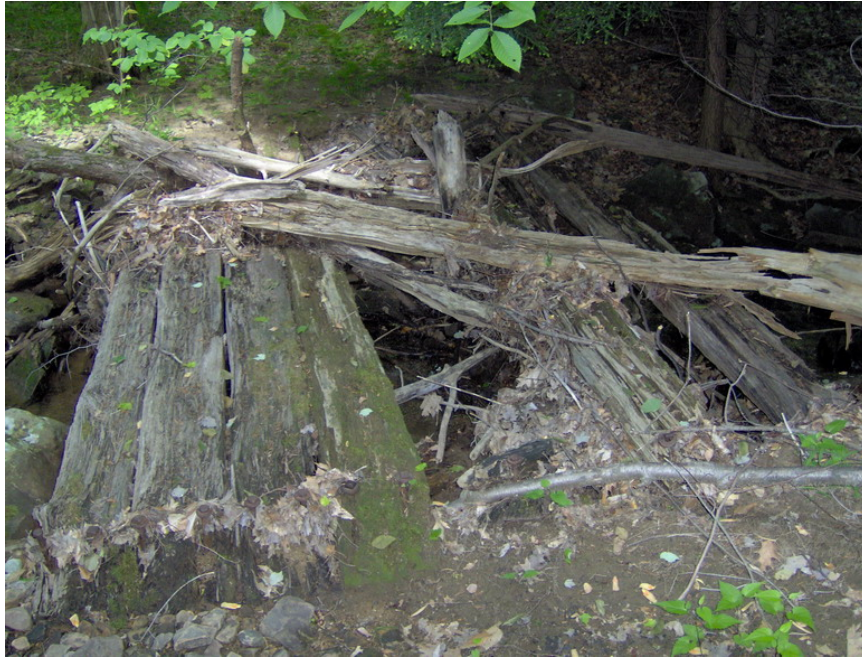
Also the pipeline tributary travels through an old logging area, therefore, some of the little tributaries run down logging roads. Also an old bridge was discovered during stream reconnaissance. It appears that it had been present there for many years.

Old bridge located on the pipeline tributary.

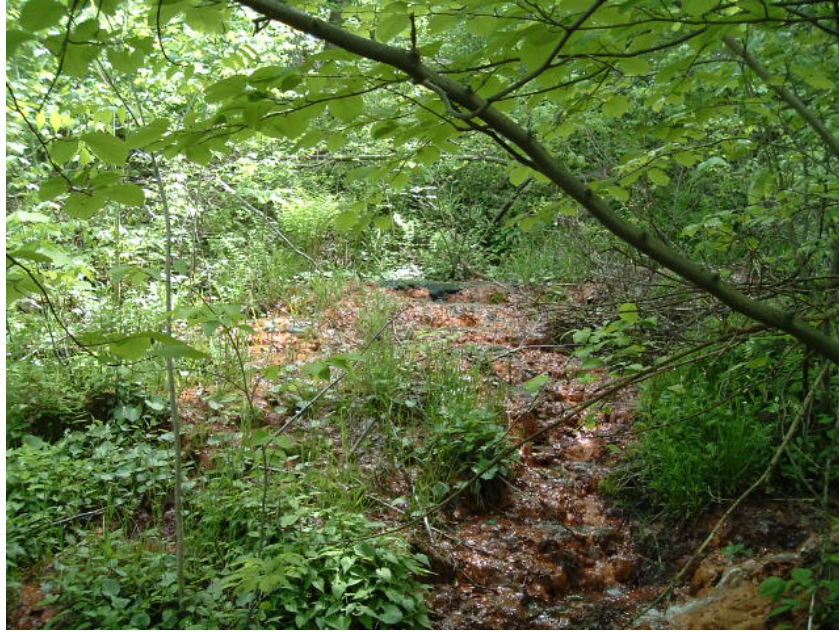
The bad tributary splits about halfway up the watershed. The first problem that was observed hiking up this stream was the high conductivity in the stream that was on the left (facing downstream). The headwaters start on the side of a hill where an iron mat is present as the water exits the hill. This is a great indicator of some type of mining influence in the area.

Abandoned Mine Drainage Site along Bad Tributary

There are several concerns for the watershed health in this tributary. The alkalinity is extremely high for this area due to the mine discharge. It also has a higher pH than all the readings found in Rogues Harbor Run. It is definitely an alkaline discharge. The question is what is causing it. No mining has occurred in the watershed but there was a mining job on the other side of the hill. This could be the cause for the discharge. There is a possibility that this was a small, old deep mine used only to extract coal for a few homes that could have been in the area. Whatever the reason for it, it definitely is affecting water quality in this tributary and also in Rogues Harbor Run. Fortunately, the effect is not large enough to destroy the aquatic life located in the watershed.

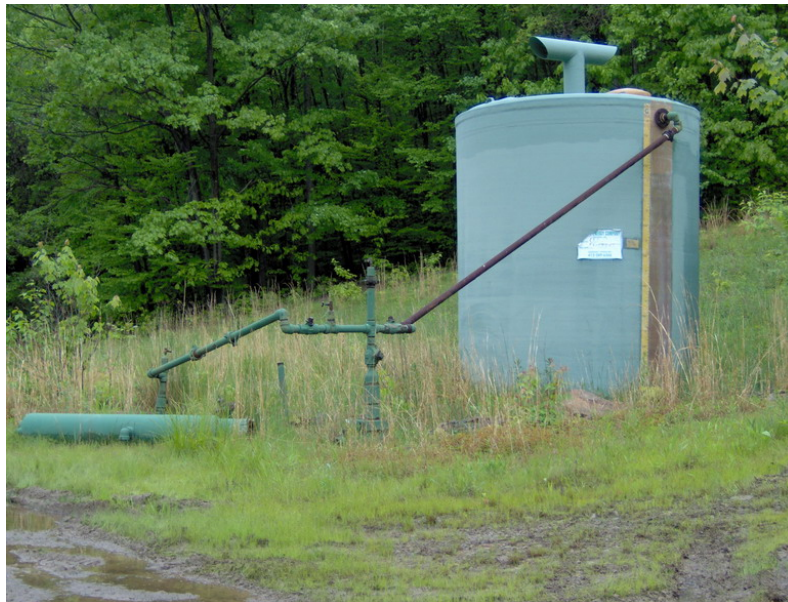
Secondly, gas wells were encountered on the way up the same stream. It was first thought that excess salinity might have been raising the conductivity in the stream. Conductivity was still high above these wells so the culprit seems to be the previous mentioned mine drainage. Along with gas wells there are dirt roads that lead to the wells. The pipeline also crosses the stream. Although excess erosion from these roads was not noted at this time, this could cause a problem in the future.

Gas well located along Bad Tributary

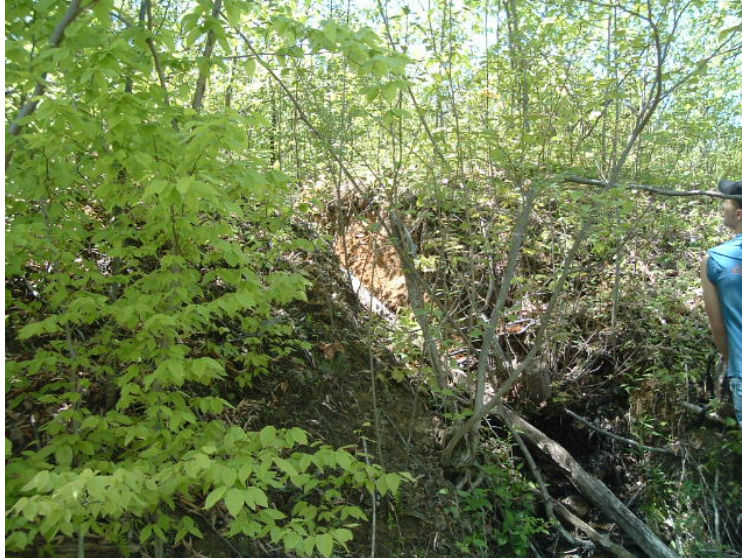
In the headwaters of the tributary on the right side (facing downstream) the logging seems to have a different effect. The stream actually runs down an old logging road. This would definitely be contributing sediment to the stream. Also water running down roads is causing deeply incised channels. This is increasing erosion.

Deeply incised tributary

Erosion is a huge issue. There are so many roads dissecting this tributary from gas wells, pipelines, logging and powerlines that the chances for extra sediment making it to the stream is high. The fact that ATVs are using some of the roads does not help the situation. There were many cases of very incised channels and high eroding banks in this little tributary. Much of the excess sediment that can be found near the mouth of Rogues Harbor Run is most likely from this tributary.

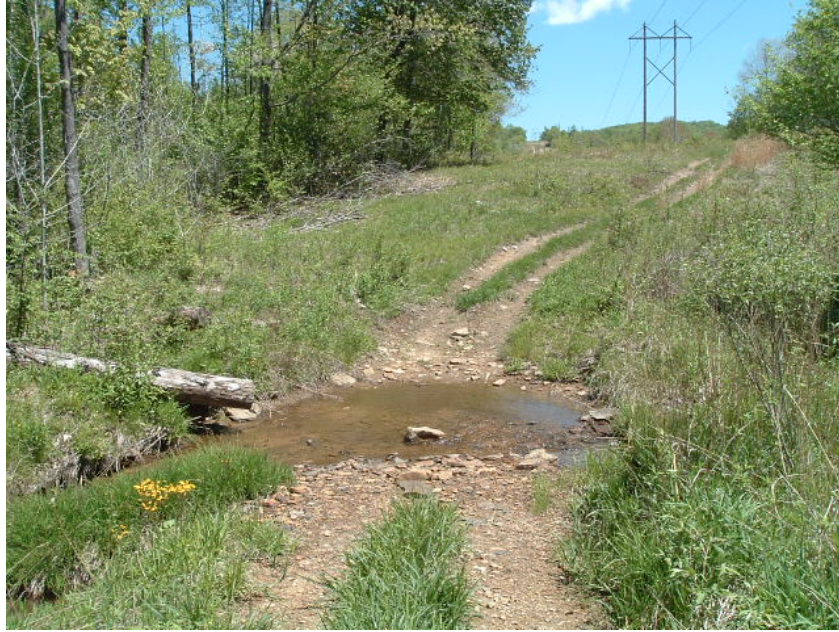
Lastly there is a powerline that crosses the tributary. The access road appears to be used as an ATV trail.

Powerline with road

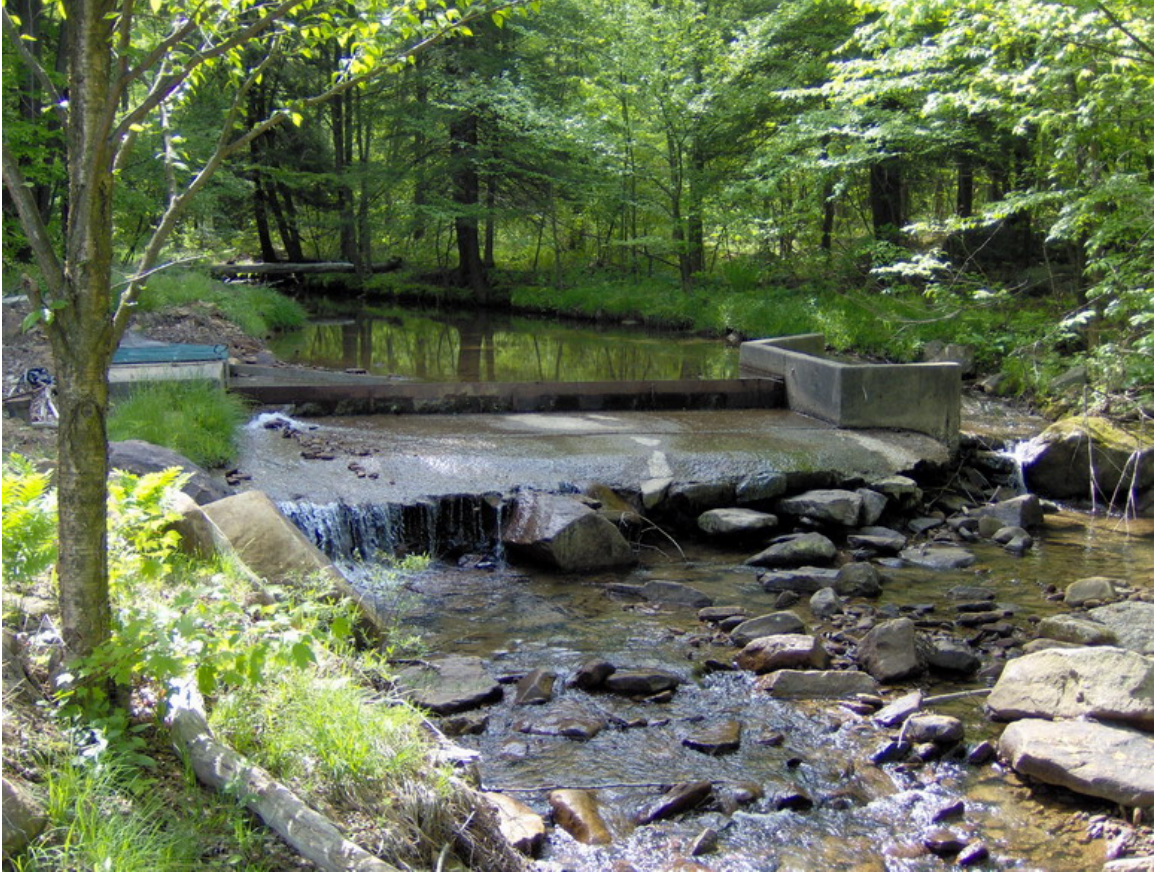
The Westover Municipal Authority draws their water from a dam in this area of Rogues Harbor Run. A new treatment plant was built in 2004. There are also several small springs that enter near the reservoir that have good water quality. There is an ATV path that crosses one of these small tributaries formed from the springs.

Dam in stream for Westover Municipal Authority

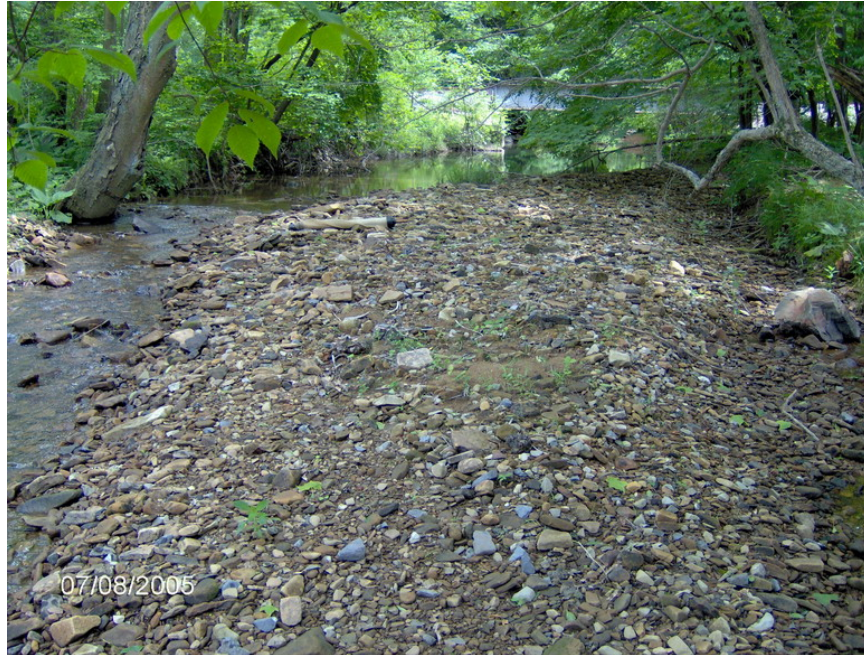
Near the mouth of Rogues Harbor there is a bridge for the railroad. Below the bridge there is large accumulation of substrate. Apparently after crossing under the bridge the stream slows down enough to deposit its sediment load. This excess sediment could be coming from the bad tributary.

Gravel bar below railroad bridge
