Tea Creek

Coldwater Conservation Plan

Prepared by:
Cadie Pruss, Watershed Specialist
Mifflin County Conservation District
20 Windmill Hill #4
Burnham, PA 17009
May 2007

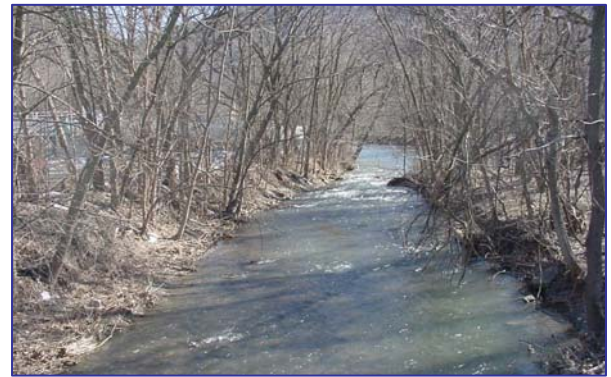
TECR 02 at Confluence of Tea Creek and Kishacoquillas Creek

Creek watershed only sites TECR06, TECR03 and TECR02 were sampled during the full assessment. Sample Location TECR01, immediately downstream of the dam in Reedsville, was sampled one time during our in-depth study and then was sampled again post dam removal (Figure 4). Only one location, TECR 02, was within the stretch classified as Class A Wild Trout and it was below the dam in Reedsville at the confluence with Kishacoquillas

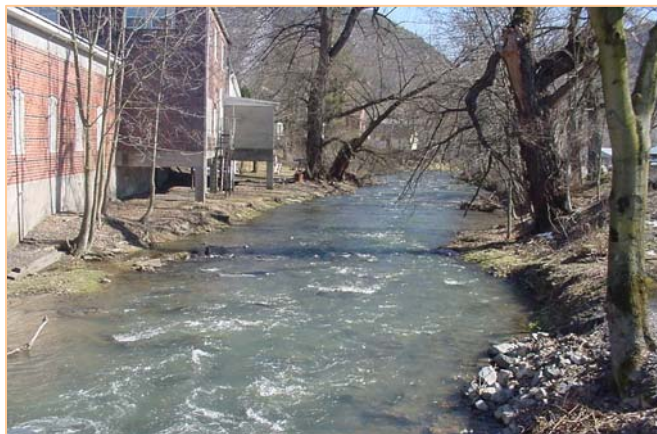
TECR 01 between Reedsville Fire Hall and the Youth Park

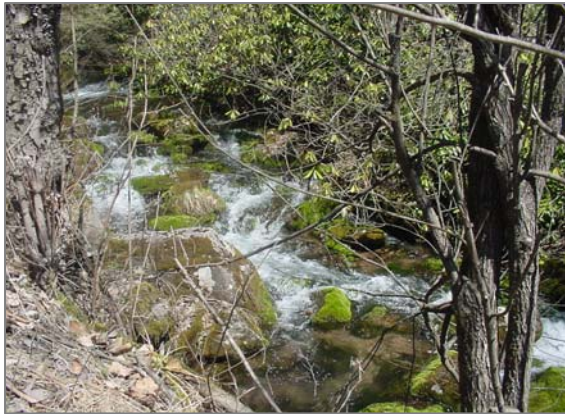
TECR06 in Coopers Gap

Agriculture is not the only source of sediment to Tea Creek. Logging practices that took place in Rothrock State Forest are still evident by the amount of sediment we observed at TECR06. This sample location

was in the State Forest and we were amazed at the level of sedimentation. This excessive soil loss comes from the dirt roads in the Forest, and also by past logging practices that did not have adequate control measures for the silt. Sediment and erosion control practices must be in place during logging and a Sediment and Erosion Control Plan must have been written for the site, but these standards are not always followed and damage does occur. Similar plans must be

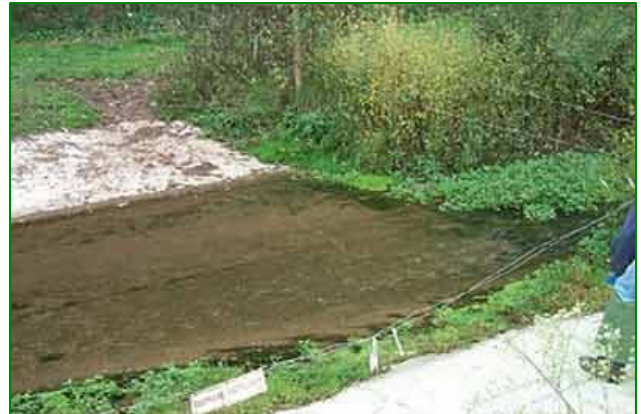
Stabilized crossing at TECR 03

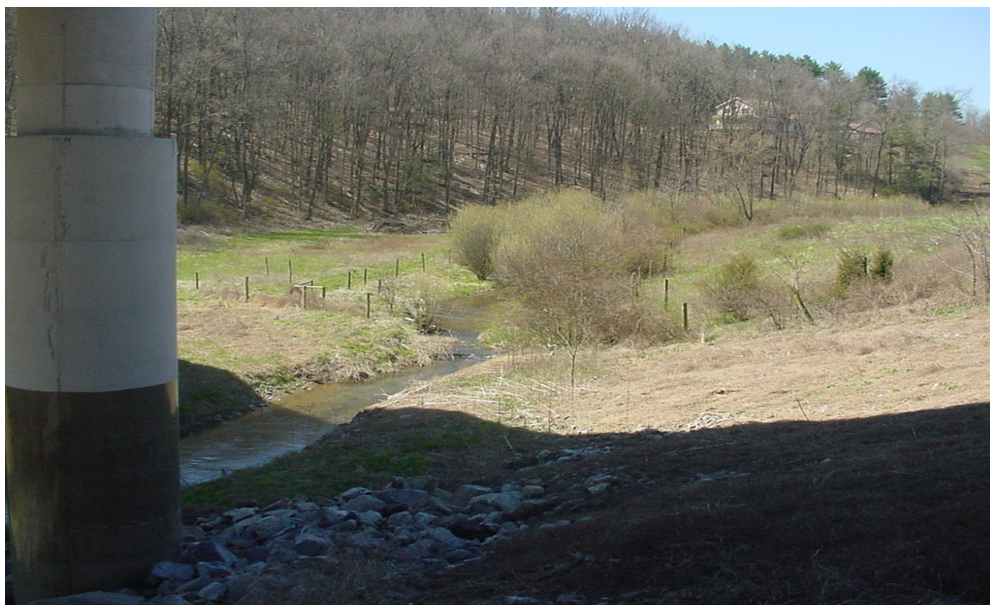
A look at the section of Tea Creek designated “Class A Wild Trout” also shows an area of exceptional habitat. This 1.1 mile stretch has overhanging branches, vegetation right up to the edge of the stream, and a buffer that was un-measured, but has thick mature vegetation. The stream has a few very deep pools, shallow riffles, and the sediment is transported through this section because of the stream flow.

This series of photos shows more than just impressive fish. It shows impressive habitat as well. Notice how deep the water is in places and the healthy fast-flowing riffles. Notice how much vegetation is along the banks in all of the pictures. Also notice also the branches and other natural items in the stream.

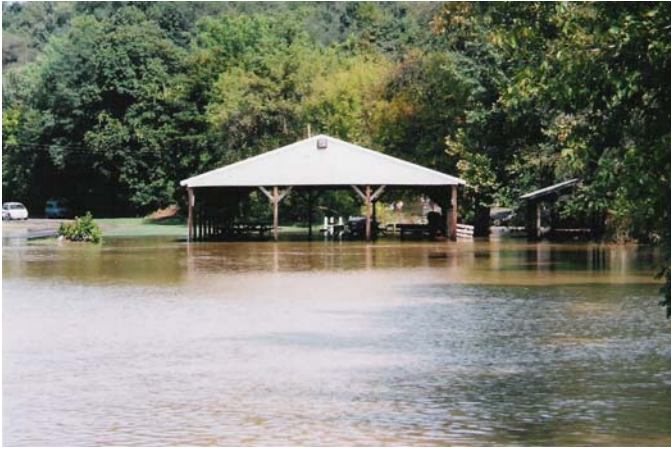
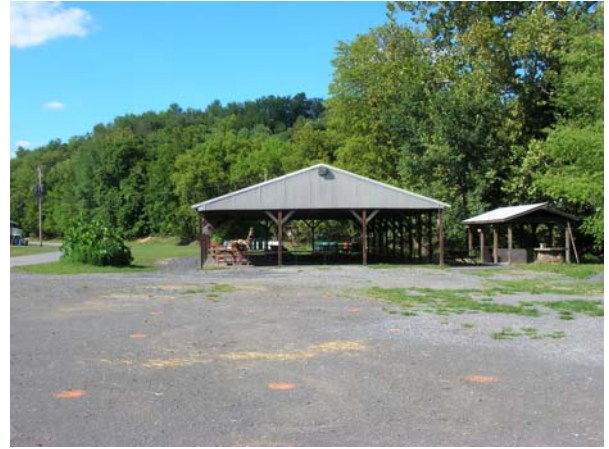
Figure 5. Pavilion in Mifflin County Youth Park, Reedsville, PA following the September 2004 flood (left) and during a dry summer (right).

Interestingly enough, TECR02 did show improvement from “very poor” in October 2001 (Table 8) to a score of “Good” in October 2004 and May 2005 (Table 11). This site has not stabilized yet as it was back to “Fair” in October 2005. On September 17, 2004 Hurricane Ivan flooded the region (Figure 5 and Figure 6.). Large and widescale events such as hurricanes redistribute organisms. When newly deposited organisms meet with favorable habitat conditions they populate the area. If organisms meet with unfavorable habitat conditions they do not establish new populations. One explanation for a classification of “good” at TECR02 in October 2004 following the September flooding may be that macroinvertebrates had been redistributed to this downstream most site at the confluence of Kishacoquillas Creek and Tea Creek and were detected during the sampling one month after the event. A review of Table 11 shows that many of these macroinvertebrates were “intolerant species” and many of them were tolerant mayflies, but by October 2005, these newly deposited macroinvertebrates were no longer detected at this site. As mentioned above, this would indicate that the physical and/or chemical conditions were outside their preferred limits. Despite the “fair” and “poor” macroinvertebrate scores, the fish sampling showed dramatic improvement.

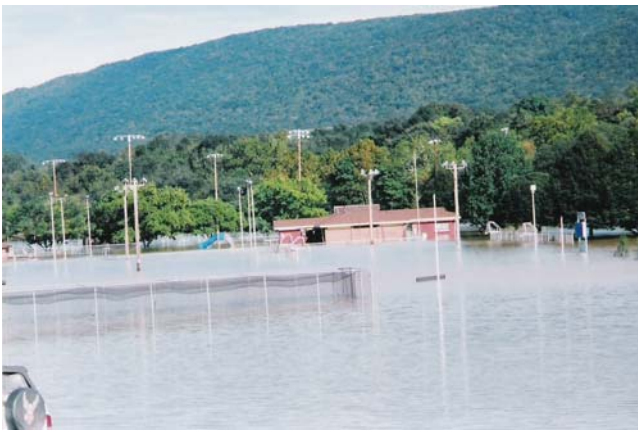
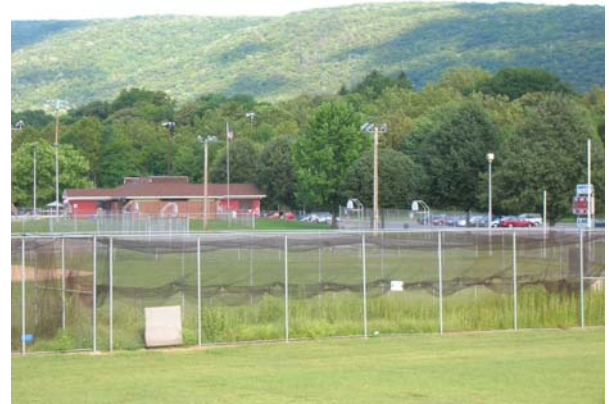
Figure 6. Recreation Park, Lewistown, PA located along Kishacoquillas Creek following the September 2004 flood (left) and during a dry summer (right)

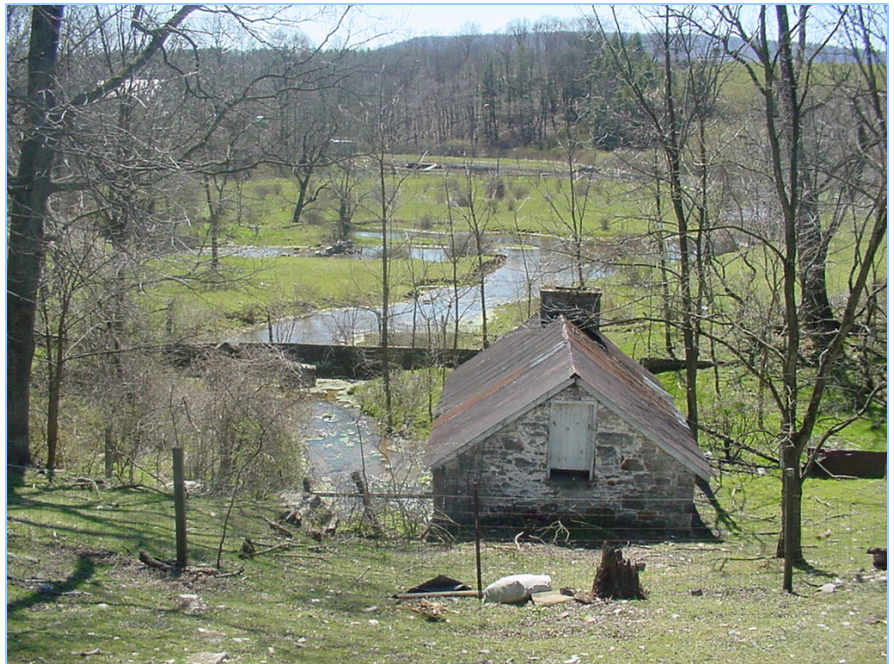
A Spring House on Tea Creek. The landowner reports that this spring stays at a constant flow year round.

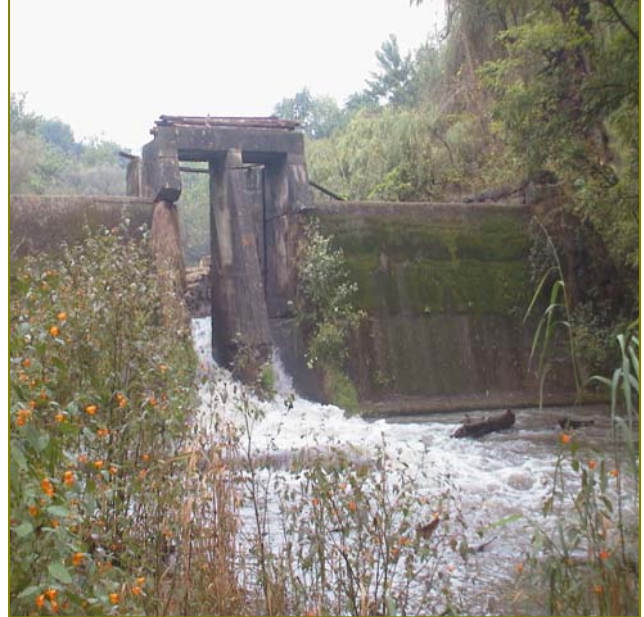
Photo by Mark Embeck- courtesy of PA DEP and located in the report: Aquatic Biological Investigation Reedsville Milling Company Dam Draw-down Tea Creek (Appendix B).

A draw-down permit was obtained by the Reedsville Milling Company from the Pennsylvania Fish & Boat Commission to begin removing the boards and lower the level of the Duck Pond prior to the full removal of the dam. In a report issued by PA DEP (Appendix B) the draw-down resulted in a “catastrophic” release of sediment.

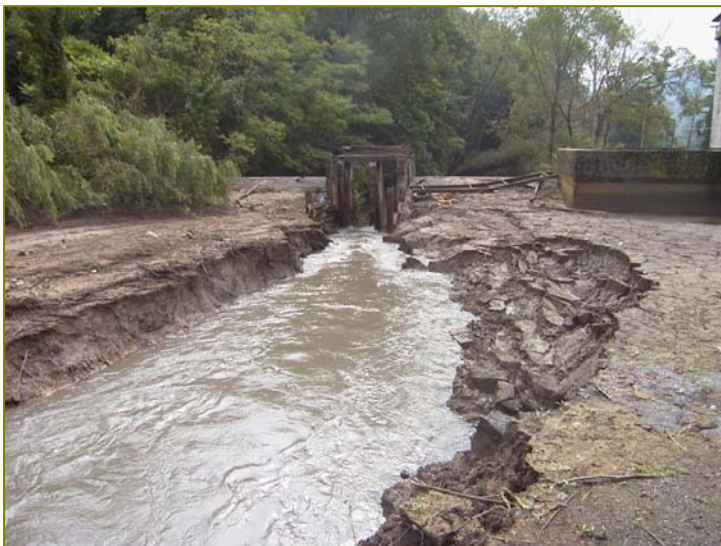
Photo by Mark Embeck - courtesy of PA DEP and located in the report: Aquatic Biological Investigation Reedsville Milling Company Dam Draw-down Tea Creek (Appendix B).

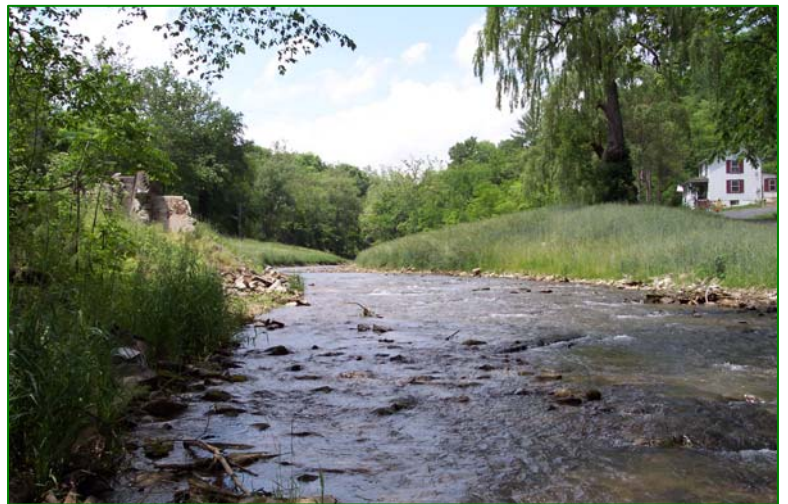
Looking upstream. Tea Creek following restoration efforts. A portion of the concrete dam is still intact and visible on the left hand side of the picture.

Once the dam had been removed, restoration efforts got underway. Under the guidance of the Pennsylvania Fish & Boat Commission, Gleim Environmental Group installed a rock vane, and the Penns Creek chapter of Trout Unlimited installed several multiple log vanes, a rock cross vane and a modified mud sill. These structures help stabilize the stream by channeling the direction of stream flow towards the center

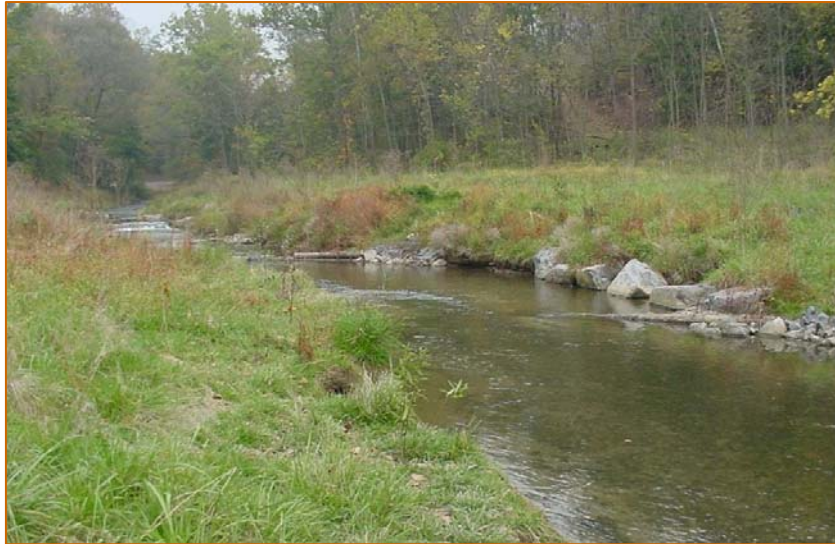
Looking downstream. Tea Creek during the restoration efforts. If you look carefully, you can see a portion of the concrete dam on the right next on the building.

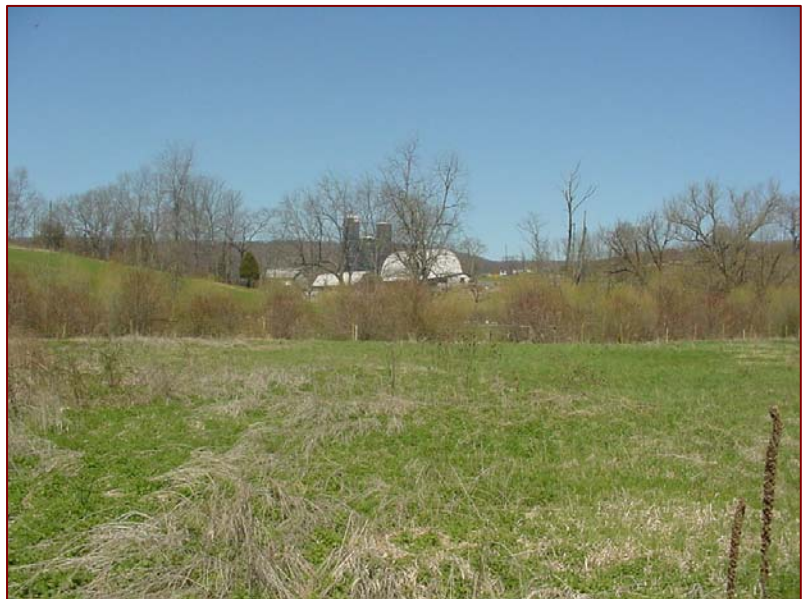
Park's farm showing lightly used pastures and vegetated stream buffers

As mitigation for work on State Route 322, Pennsylvania Department of Transportation relocated a portion of Tea Creek and created a riparian area on Roger Park's farm. This section of the stream is a perfect example of how farmland and natural stream habitat can co-exist. Although Tea Creek runs in the middle of the pasture, there is a livestock crossing to allow the animals both sides of the stream to graze. The picture below shows that the pastures have not been

over utilized, and the pasture grasses also serve as a filter and an additional buffer before soil and nutrients reach the stream.

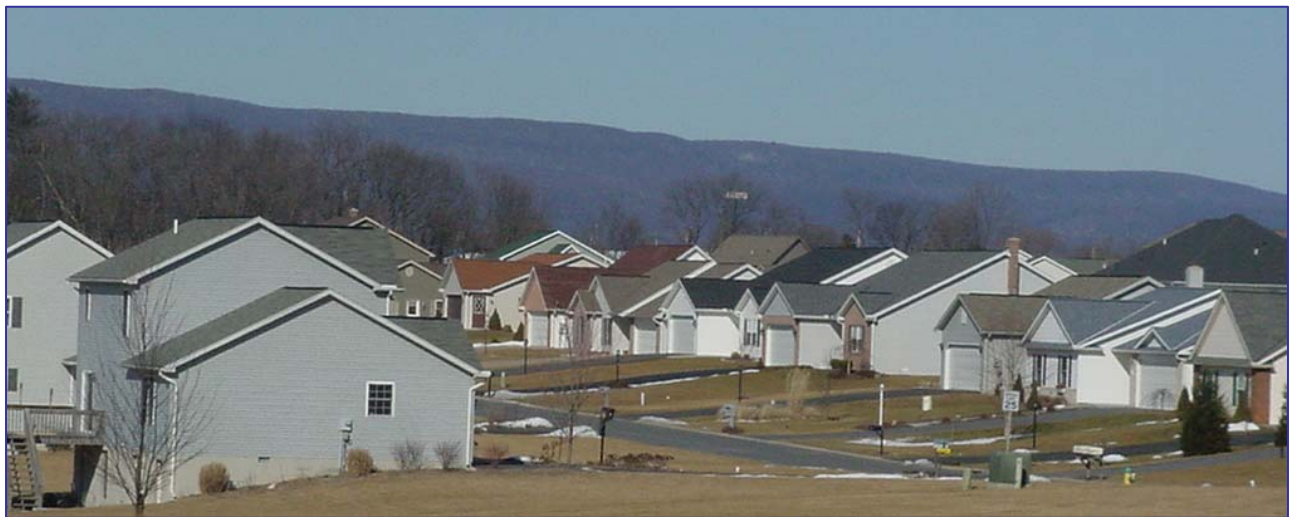
Stream research has shown there is a direct correlation between the amount of impervious cover (cover that prevents water from infiltrating into the ground) in a watershed and water quality in the watershed (See Appendix C). Streams first start to degrade when 10% of the watershed is impacted by impervious surfaces and then a second threshold appears between 25-30% impervious (Figure 8)

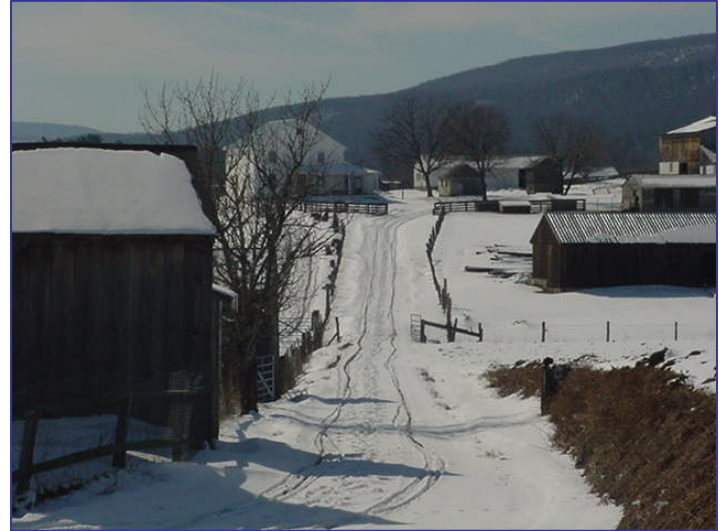
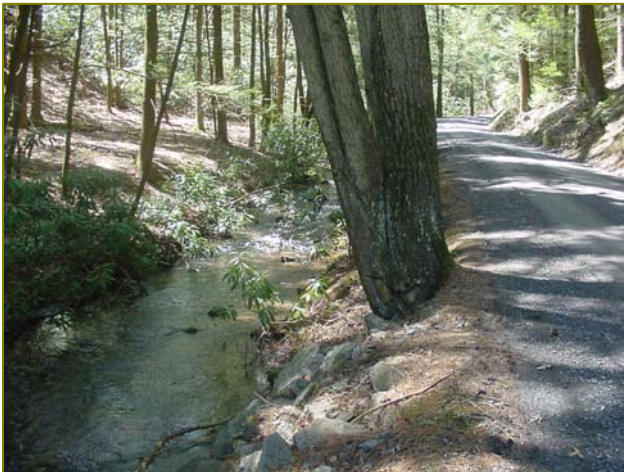
The majority of the unpaved roads found in this watershed occur in Rothrock State Forest. There are a tremendous number of dirt farm lanes in this watershed, and

although they are not public roads, they receive heavy use and are often traveled by horse and buggy.

These travel areas develop ruts and are subject to loosening due to the types of travel that are occurring on them. They are not maintained to the high standards that the Center for Dirt and Gravel Roads at Penn State University suggest and in many cases, are not maintained in a regular and consistent manner at all. Many of these unpaved roads are continual sources of sediment to Tea Creek.

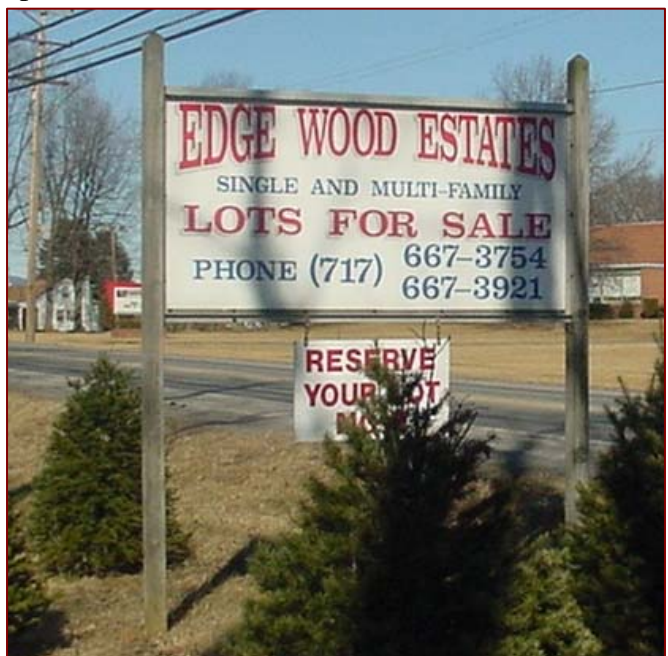
Look carefully at the center of this picture. You will see a fence line, boulders, and shrubs. This is Tea Creek in the middle of a pasture. This farmer is to be commended for fencing the cows out of the stream and for allowing vegetation to grow, however, this is not enough to protect Tea Creek from the sediment and nutrients coming down the hill and across this pasture. More education is needed so that the people who are willing to do the right thing, will truly benefit the stream, and the health of the community.

1. Outreach to discuss the importance of stream buffers and fencing livestock away from streams
2. Outreach to discuss other Farming Best Management Practices that would help reduce soil erosion and nutrients from getting into the streams and groundwater. A Conservation Plan can be obtained at the local NRCS (Natural Resource Conservation Service) office or by contacting the Conservation District. Recommended BMP's include, but are not limited to:

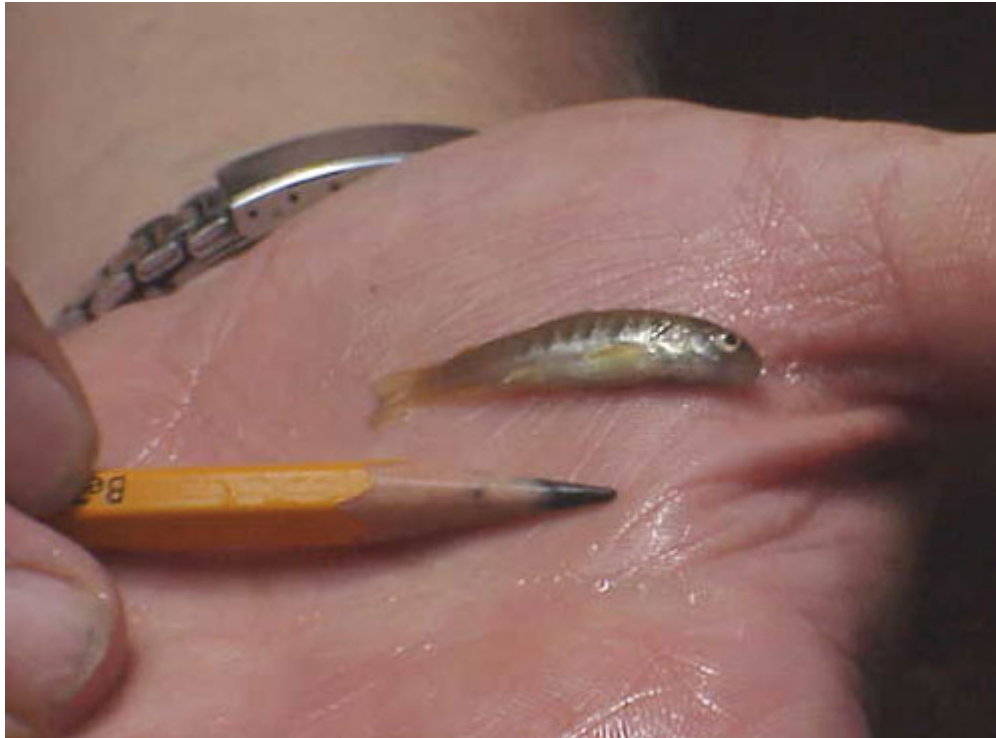
Brown trout were captured in lengths from 2 to 13 in. Tea Creek has continued its recovery from the pollution of August 1997 to Class A status with an August 2000 biomass of 90.91 kg/ha well exceeding the Pennsylvania Fish and Boat Commission's minimum criteria of 40 kg/ha for wild brown trout management. Biomass for brown trout less than 150 mm total length was 15.87 kg/ha, exceeding the 0.1 kg/ha minimum.

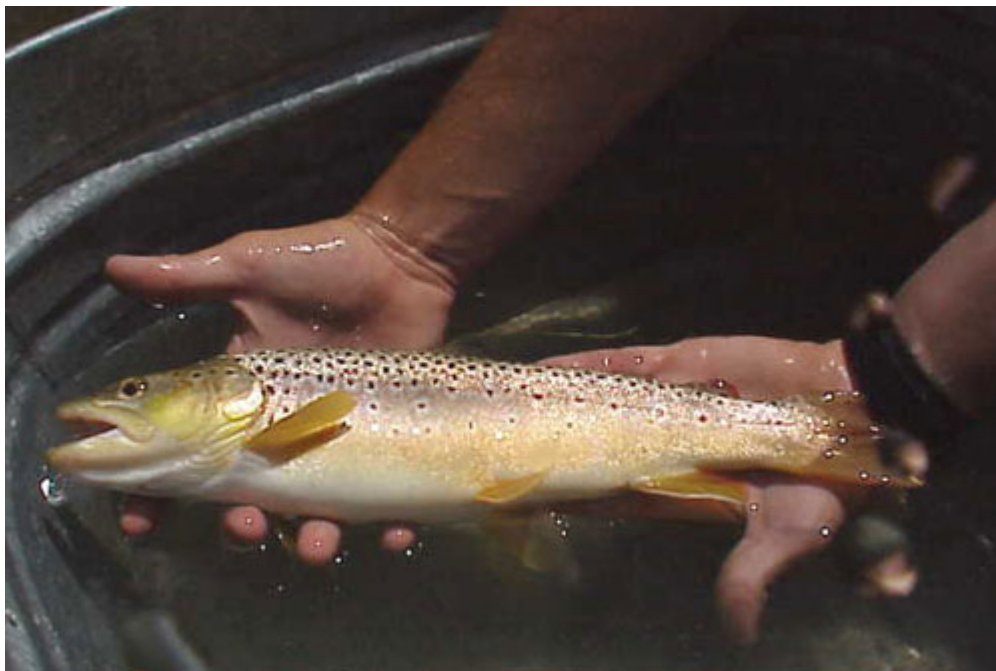
The 2000 survey of this small stream estimated 996 brown trout per mile in size groups from 2 to 13 in. with 24% of that total estimate exceeding the legal harvest length of 7 in. The 1998 survey estimated 812 brown trout per mile ranging in size groups from 2.0 to 10.8 in.; however, only 5.5% of that total brown trout estimate exceeded 7 in. The 1994 survey estimate of 726 brown trout per mile ranging in size groups from 2.0 to 15.7 in reported 43% of the total brown trout estimate exceeded 7 inches. The 1989 survey estimated 731 brown trout per mile ranging in size groups from 2.0 to 14.7 in. and reported 33% of the total brown trout estimate exceeded 7 inches. A mature wild brown trout population made up of more big trout very likely will have fewer trout per stream mile as seen in 1994 with a comparatively low 726 brown trout per mile, but recording a high 43% of that population at 7 inches and longer.

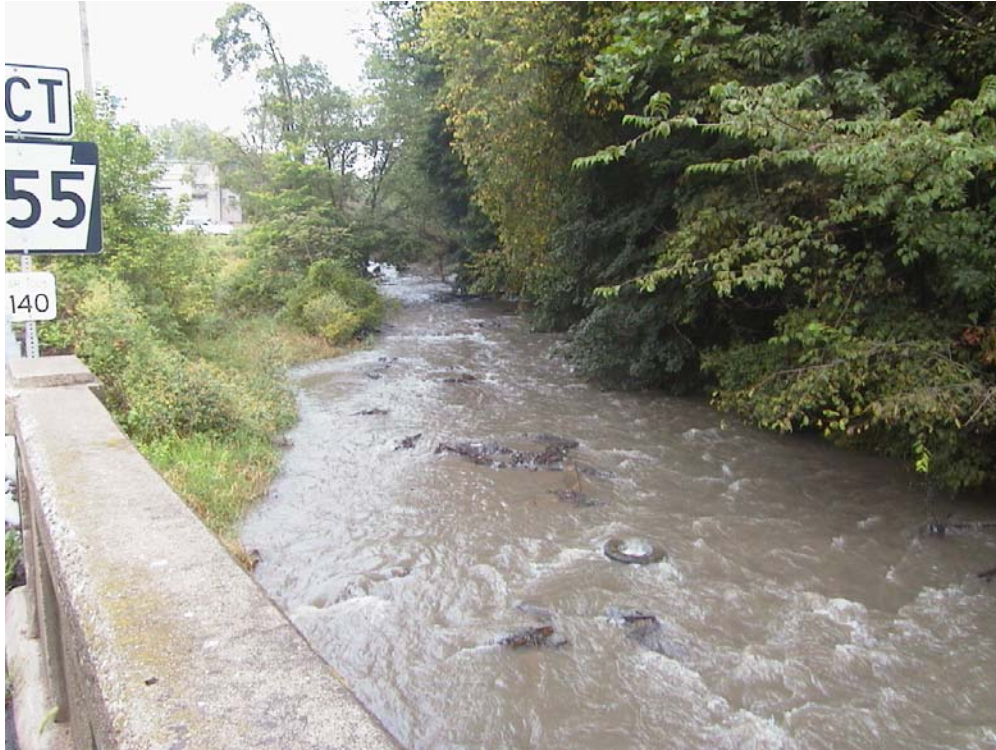
Photo 1: Sediment laden water below Reedsville Milling Company Dam discharge.

Pictures are attached which indicate the volume of sediment released and the condition of the stream following board removal. The effects of the sediment release were nothing short of catastrophic. It was not difficult to find areas containing 38 cm (15 in) or more of accumulated sediment. Sediment laden water continued to discharge from the millpond area. The macroinverte-

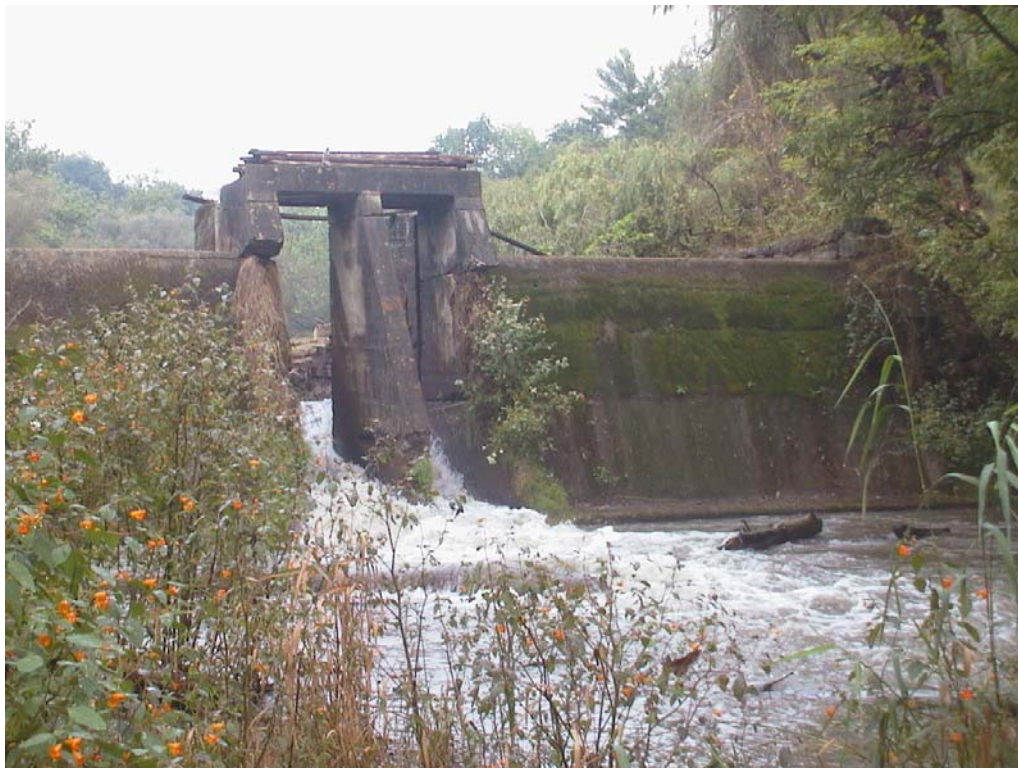
Photo 2: Sediment laden water being released from Reedsville Milling Company Dam with all boards removed

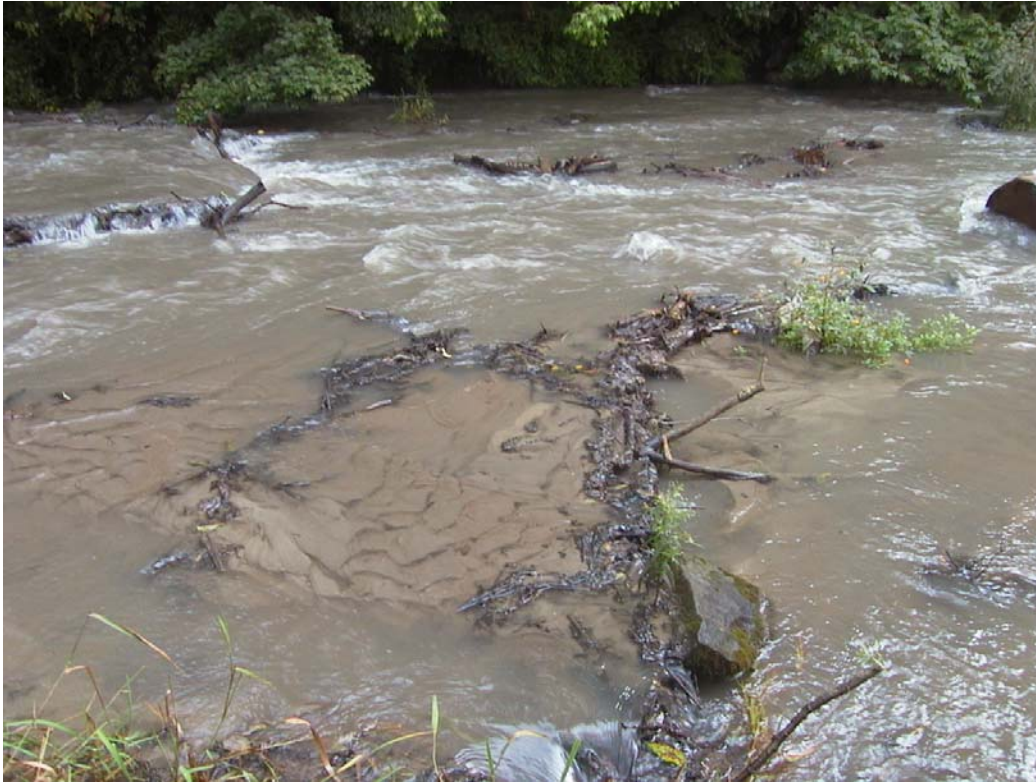
Photo 3: Sediment deposition below Reedsville Milling Company Dam.

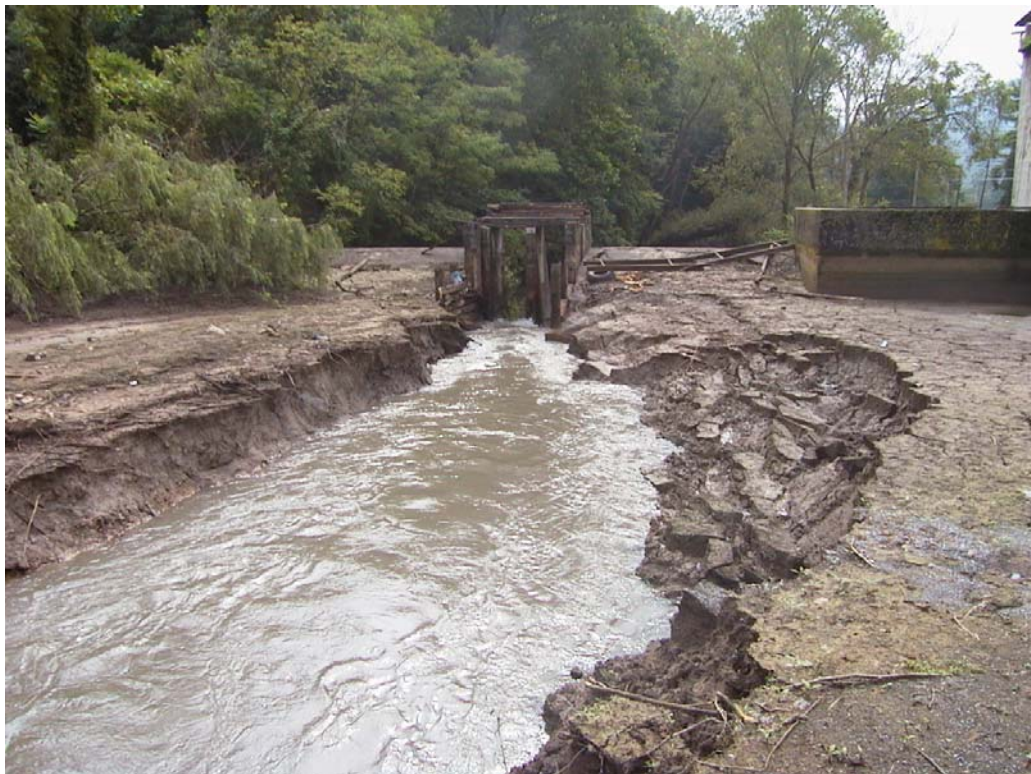
Photo 4: Newly eroded channel upstream of Reedsville Milling Company Dam.

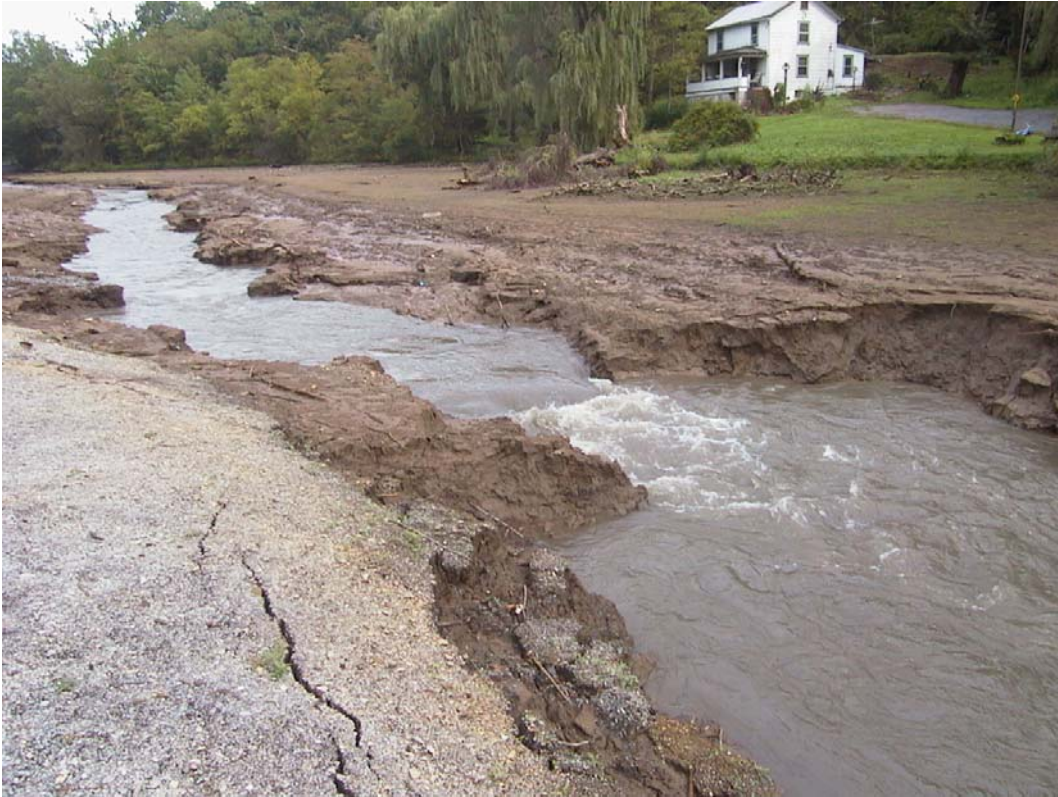
Photo 5: Nickpoint showing continuing upstream erosion above Reedsville Milling Company Dam.
