# Upper Spring Creek Watershed Coldwater Conservation Plan

Centre County, Pennsylvania  
January, 2007

**CLEARWATER CONSERVANCY**  
**SUMMARY OF THE UPPER SPRING CREEK WATERSHED COLDWATER CONSERVATION PLAN**  
**1/31/2007**

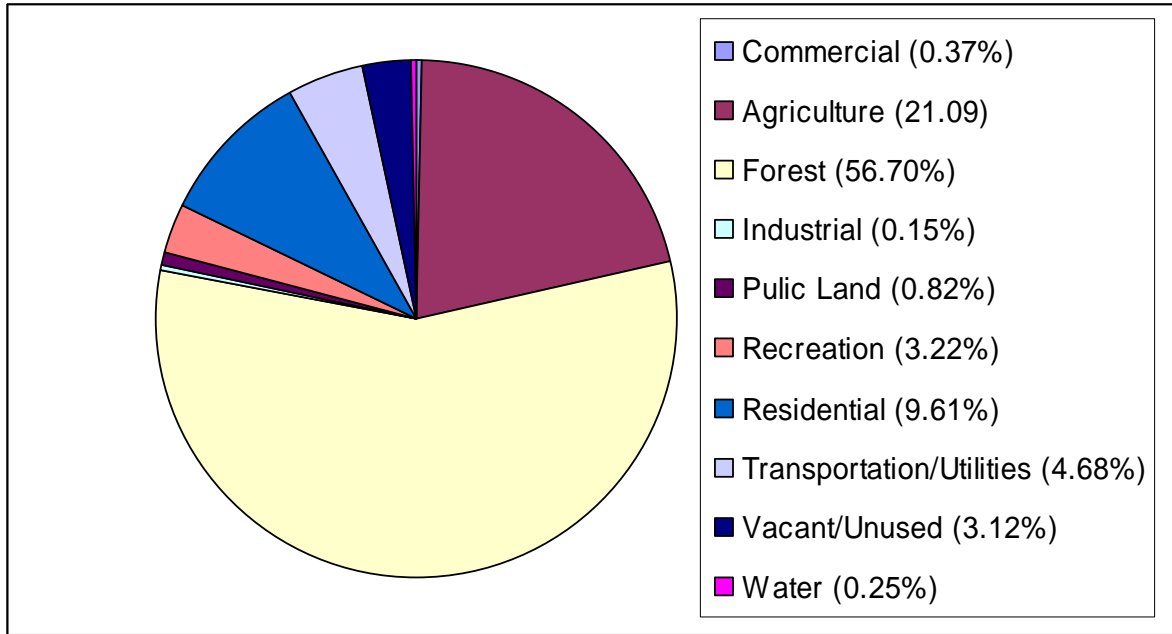
**Figure 2.** Land use in the Upper Spring Creek Watershed (Confessor and Hamlett 2003).

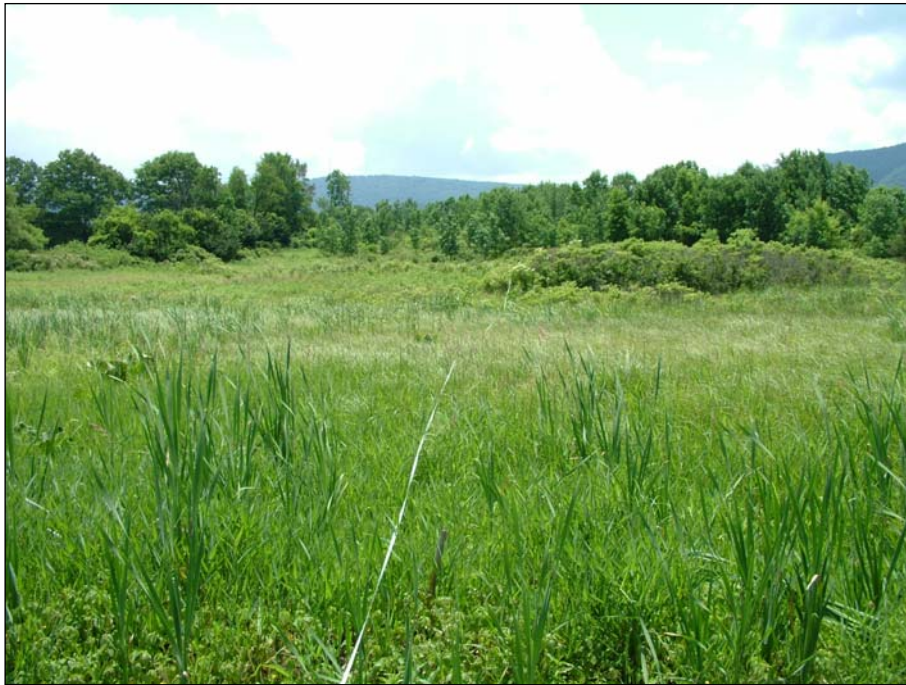
A measuring transect used to assess the plant community at Fasick Park

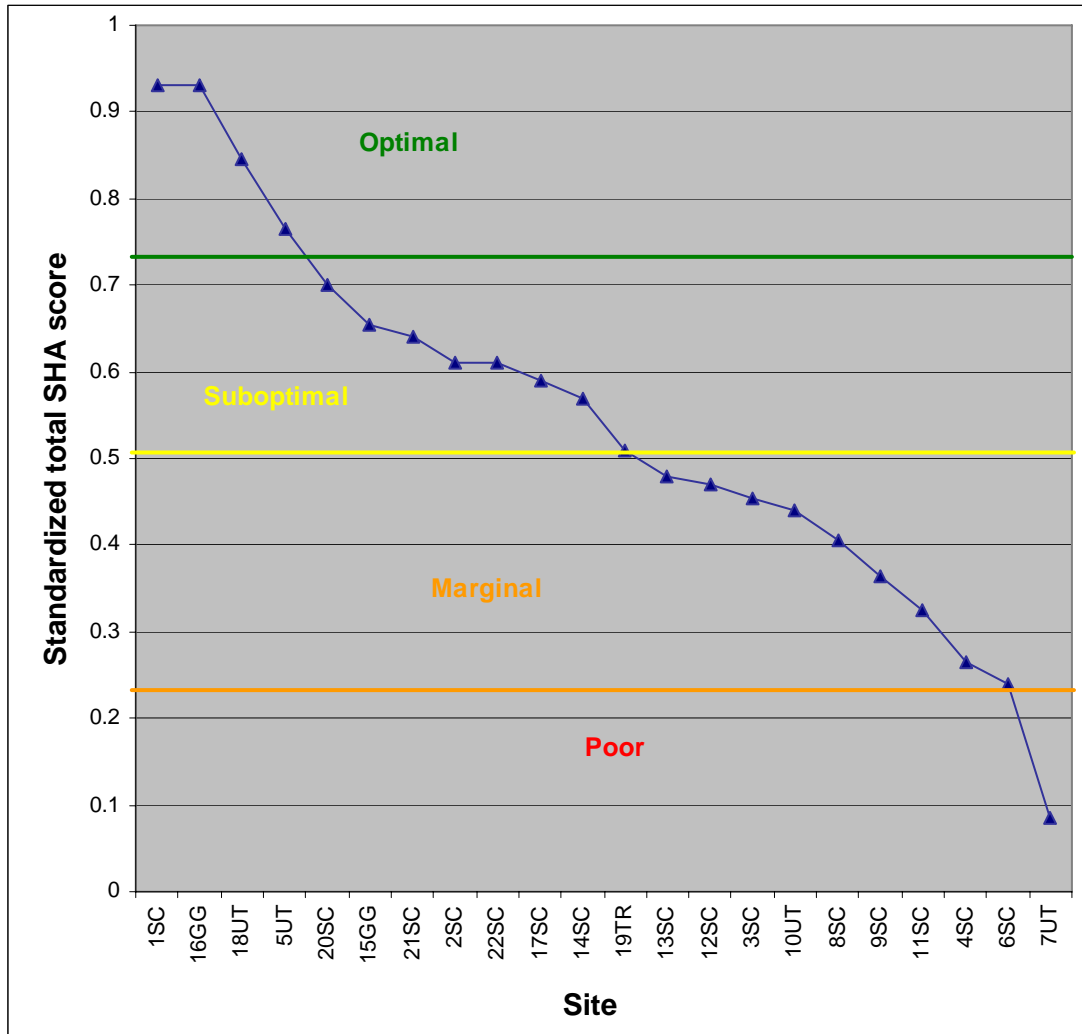
**Figure 4.** Stream condition of each assessment site in the Upper Spring Creek watershed based on standardized total Stream Habitat Assessment (SHA) scores. The break down of scores by general condition (optimal, suboptimal, marginal and poor) is displayed to show the number of sites in each category. Site codes are given in Table 4.

The total SHA scores observed resulted in a consistent distribution of sites along the condition continuum. Sites considered reference (undisturbed) all had higher scores and were distributed in the optimal condition category. The most seriously disturbed sites are clustered in the poor/marginal condition categories.

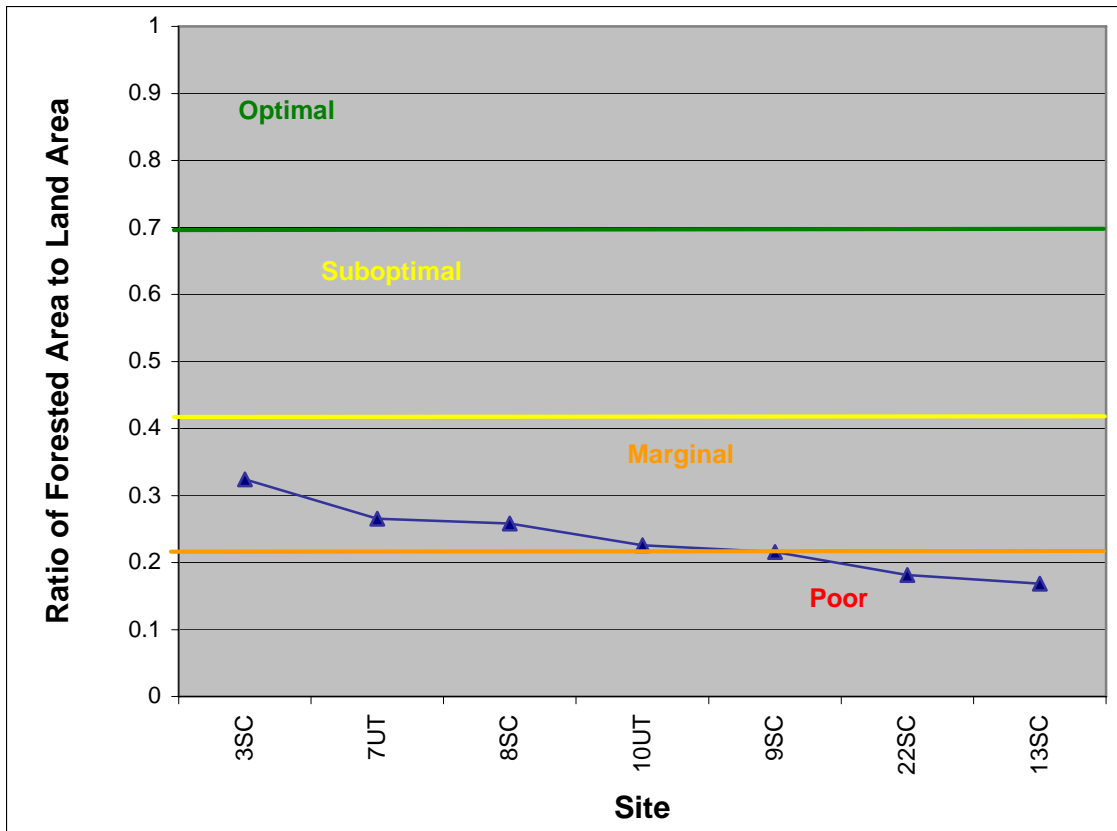
**Figure 5.** Forest cover within a 1-km radius around seven assessment sites in the Upper Spring Creek Watershed. Site codes are given in Table 4.

The Cooperative Wetlands Center uses GIS land cover analyses to consider how the surrounding land cover may impact aquatic resources. Land cover analysis collected from a 1-km circle radius helps quantify the extent to which human activities in the surrounding area of a site have influenced the landscape, potentially impacting the aquatic resource. The landscape circles analyzed provide a point-in-time record of human activity at an exact location intended to be an indicator of a larger area's land cover. Completing the land cover analysis for all SWR sites will be helpful in determining how well percent forest and stream habitat are correlated in this watershed (Figure 5).

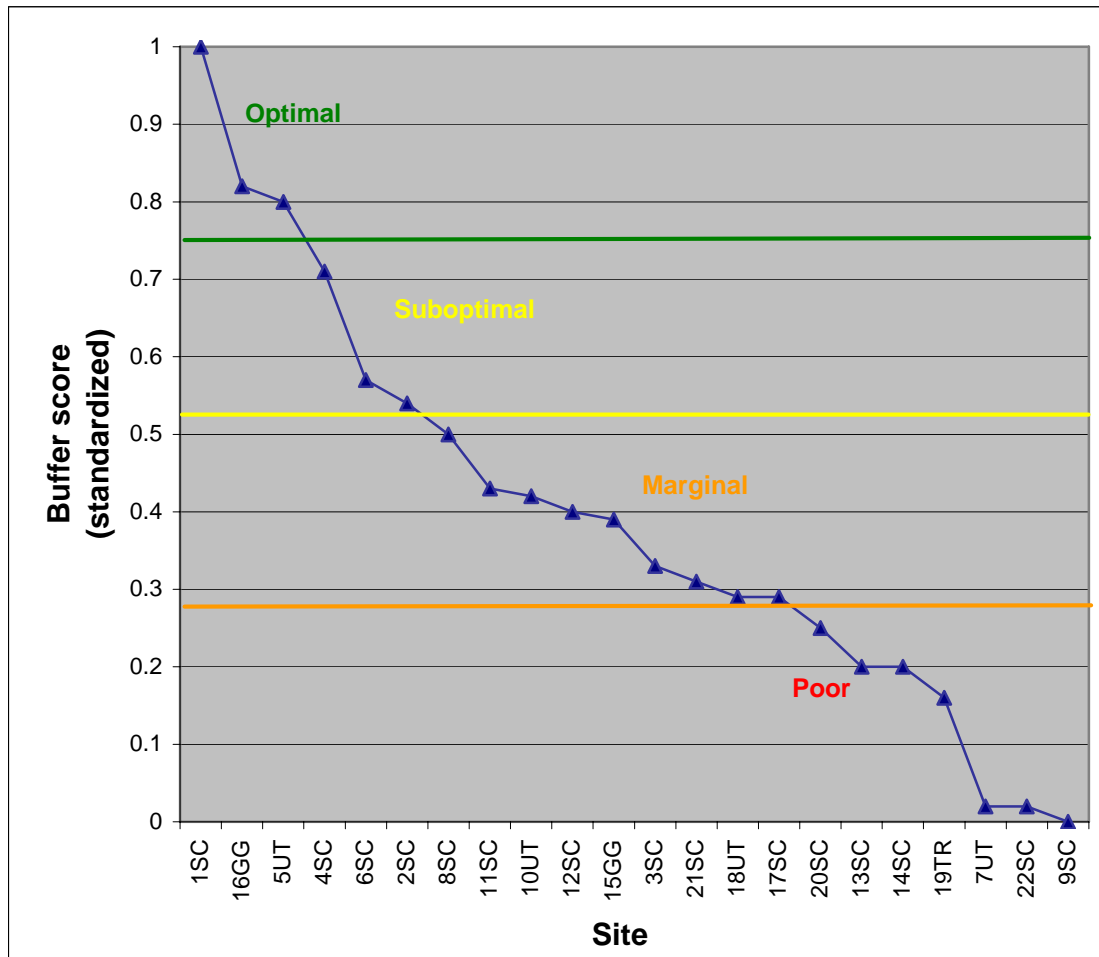
**Figure 6.** Standardized buffer scores of assessed sites in the Upper Spring Creek Watershed. The break down of buffer scores by general condition (optimal, suboptimal, marginal and poor) is displayed to show the number of sites in each category. Site codes are given in Table 4.

The thresholds identified for buffer score and condition are based upon natural breaks in the data distribution and on literature that provides a strong basis for threshold recommendations for buffer condition and width.

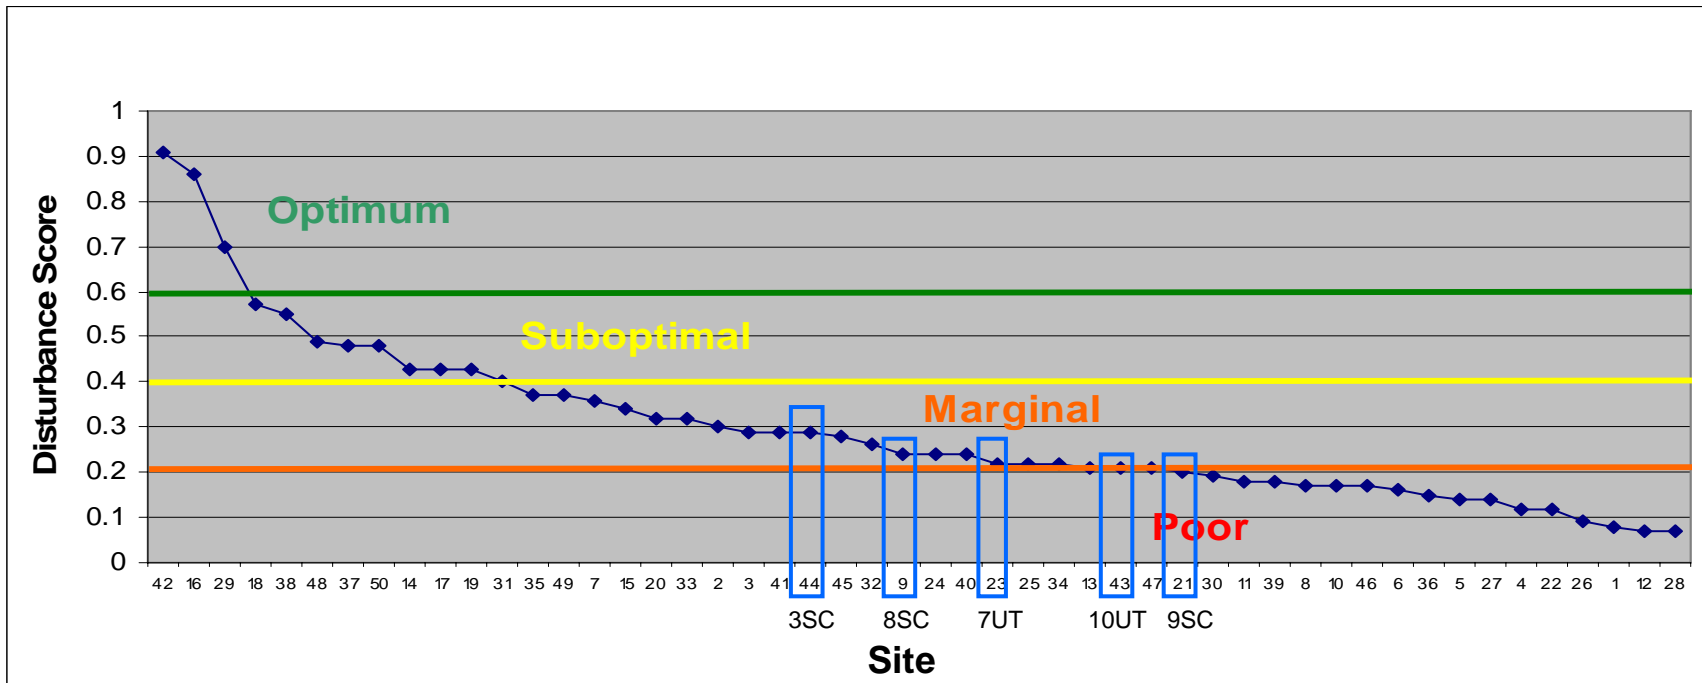
**Figure 8.** Wetland disturbance scores of assessed sites in the entire Spring Creek Watershed (data from Saacke Blunk 2005). The five sites assessed in the Upper Spring Creek Watershed are highlighted by blue boxes and relabeled according to the site codes used in this report (sites 3SC, 8SC, 7UT, 10UT, 9SC; Table 4) for comparison with the condition of wetlands found throughout the Spring Creek Watershed.

Wetland disturbance scores allow for comparison of wetland health among sites within a watershed. The scores and their thresholds used here were derived with methods given in Brooks *et al.* (2002), which document the correlation between watershed health and the condition of a watershed’s wetlands (Figure 8).

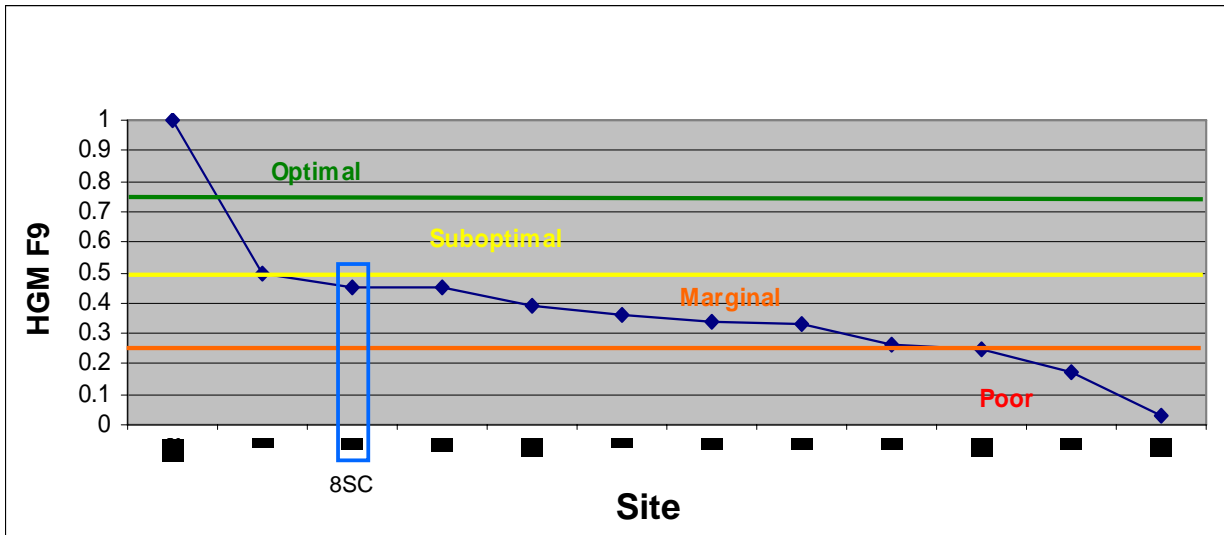
**Figure 9.** Hydrogeomorphic Functional Assessment Model Function 9 (HGM F9) scores of assessed sites in the entire Spring Creek Watershed. The site assessed in the Upper Spring Creek Watershed is highlighted by a blue box (site 8SC; Table 4) for comparison with the rest of the Spring Creek Watershed.

Hydrogeomorphic Functional Assessment Model (HGM) scores were available from the Penn State Cooperative Wetlands Center for one reference wetland in the Upper Spring Creek Watershed, site 8SC (Figure 9). In particular, the HGM F9 assessment variable was of interest because it describes the ability of a site to maintain vegetation characteristic of wetlands. This variable indicates a site's capacity for sustaining wetland vegetation based on hydrogeomorphic features required to support wetland vegetation.

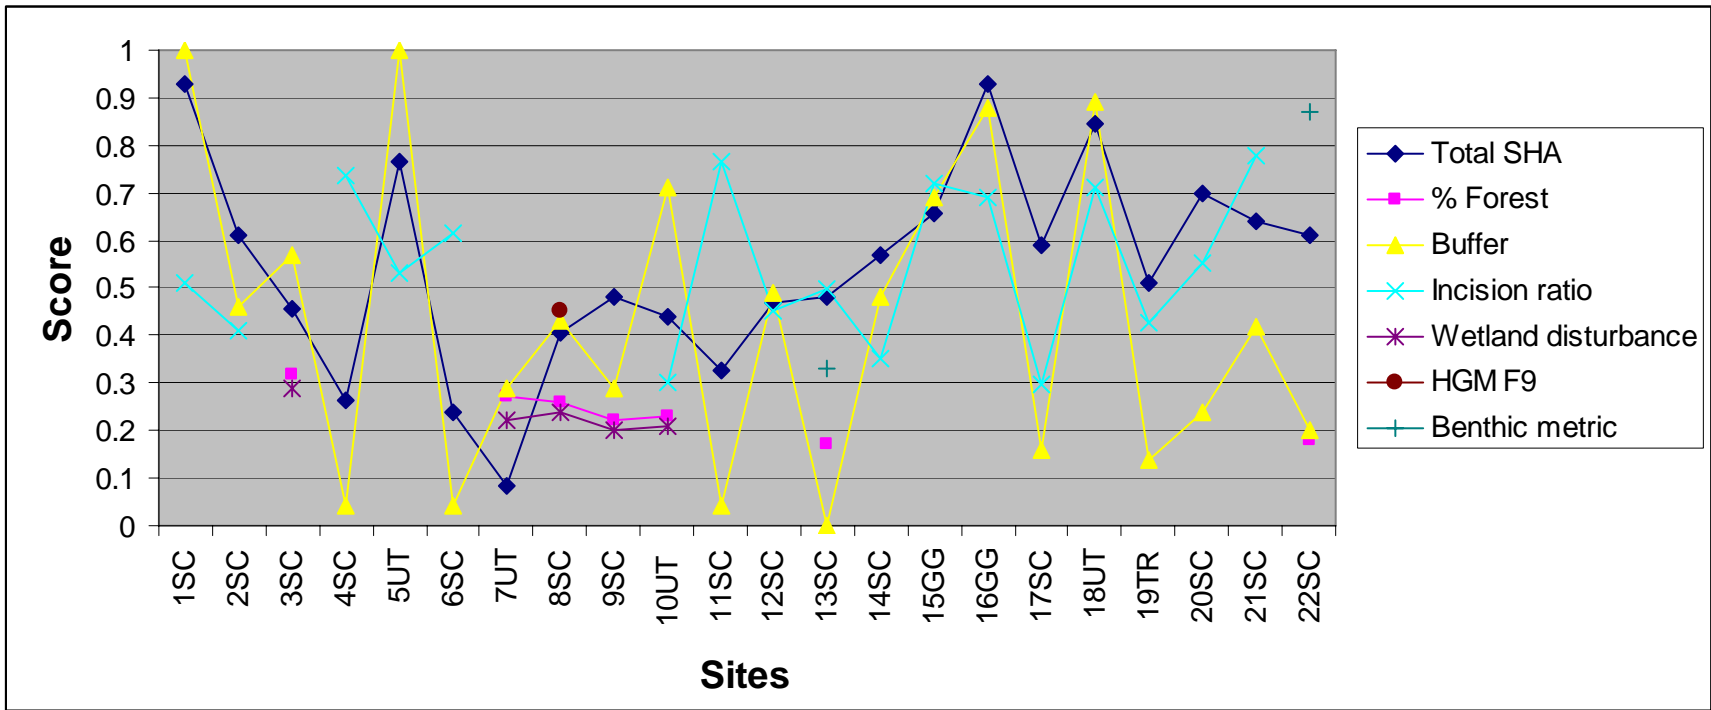
**Figure 11.** Standardized scores of assessment variables compiled for each site. Sites are ordered from upstream (left) to downstream (right). Site codes are given in Table 4.

This section presents standardized assessment variables collectively so that relationships among variables can be more clearly evaluated and changes along the stream can be better observed. Figure 11 shows the sites from left (most upstream) to right (most downstream) along the x-axis. Noticeable spikes in stream condition can be attributed to tributaries at these stream points. For instance, the first four sites beginning upstream are along the headwater Spring Creek flowing from Tussey Mountain into the agricultural valley and the corresponding overall condition of Spring Creek goes from very high (optimal at 1SC) to very low (site 4SC). The spike in condition noted following site 4SC corresponds with the confluence of a headwater tributary between site 4SC and site 6SC on Spring Creek.

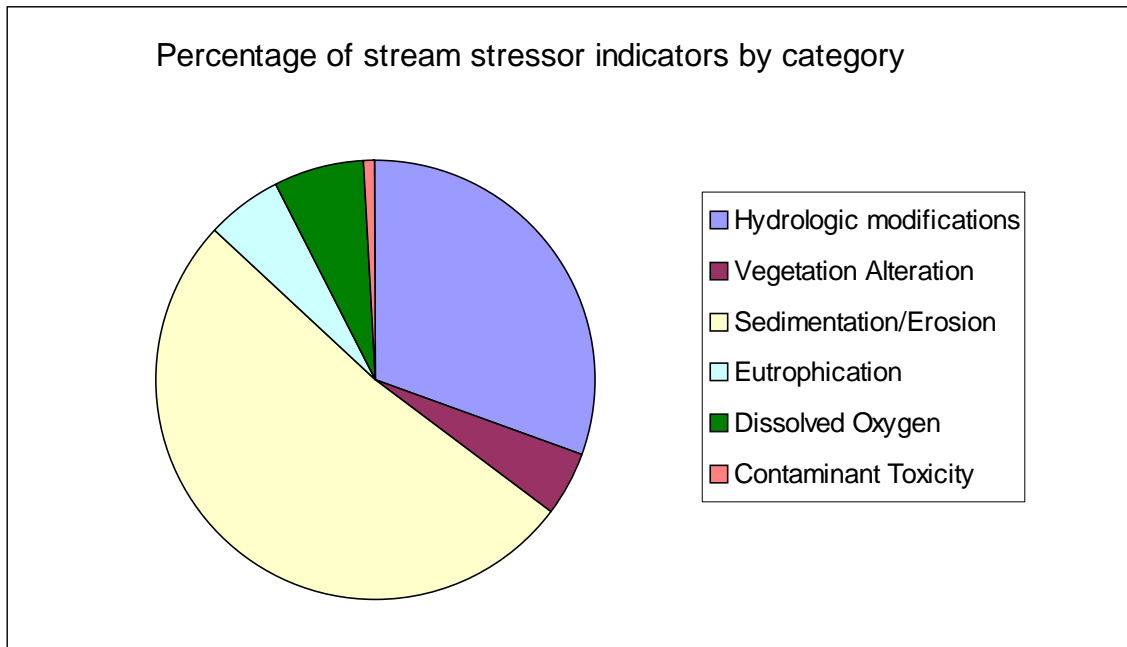
**Figure 12.** Percentage of stressor indicators within each stressor category that were found within stream channels of assessment sites in the Upper Spring Creek Watershed.

Half of all stressor indicators observed within stream channels were sedimentation and erosion stressors (Figure 12). Next, hydrologic modifications represented more than 25% of the stressors observed. The remaining stressors observed were from vegetation alteration, eutrophication, dissolved oxygen, or the contaminant toxicity stressors.

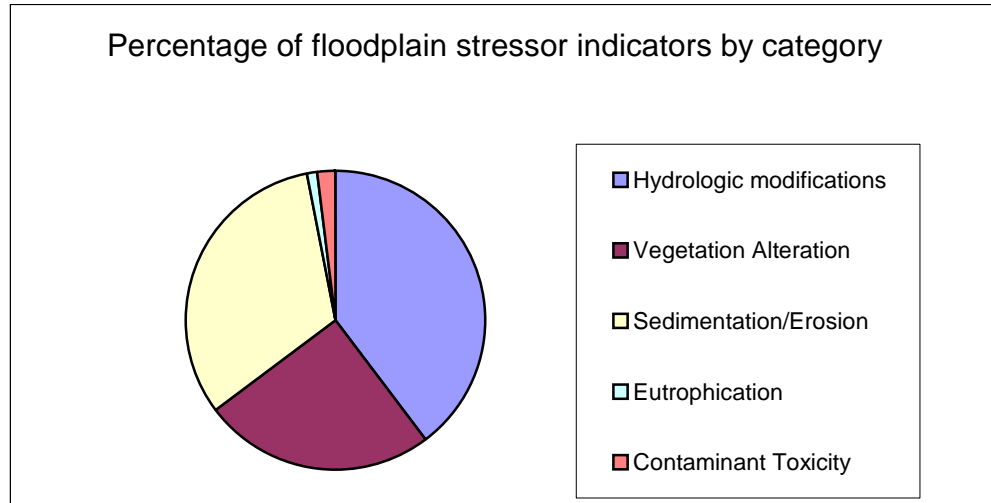
**Figure 13.** Percentage of stressor indicators within each stressor category found within floodplain areas of assessment sites in the Upper Spring Creek Watershed.

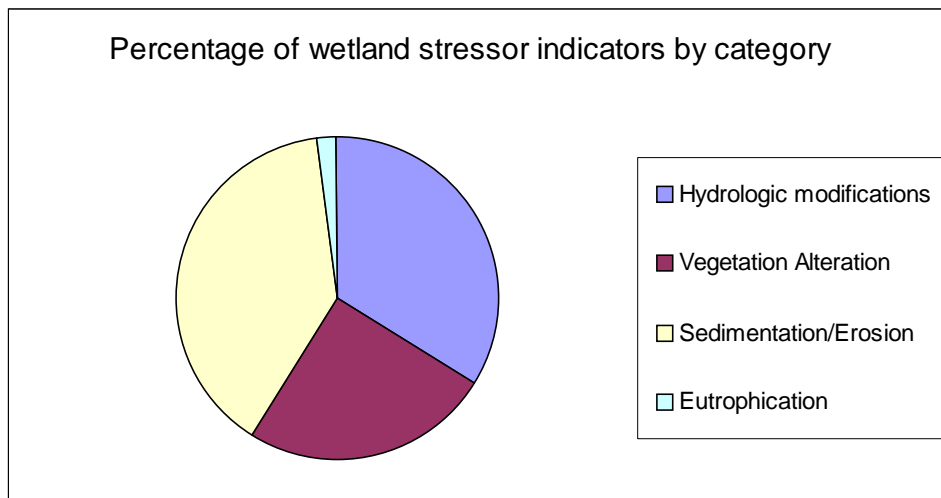
**Figure 14.** Percentage of stressor indicators within each stressor category found within wetland areas of assessment sites in the Upper Spring Creek Watershed.

In wetland areas, the breakdown of stressor indicators were similar to those found in floodplains (Figure 14).

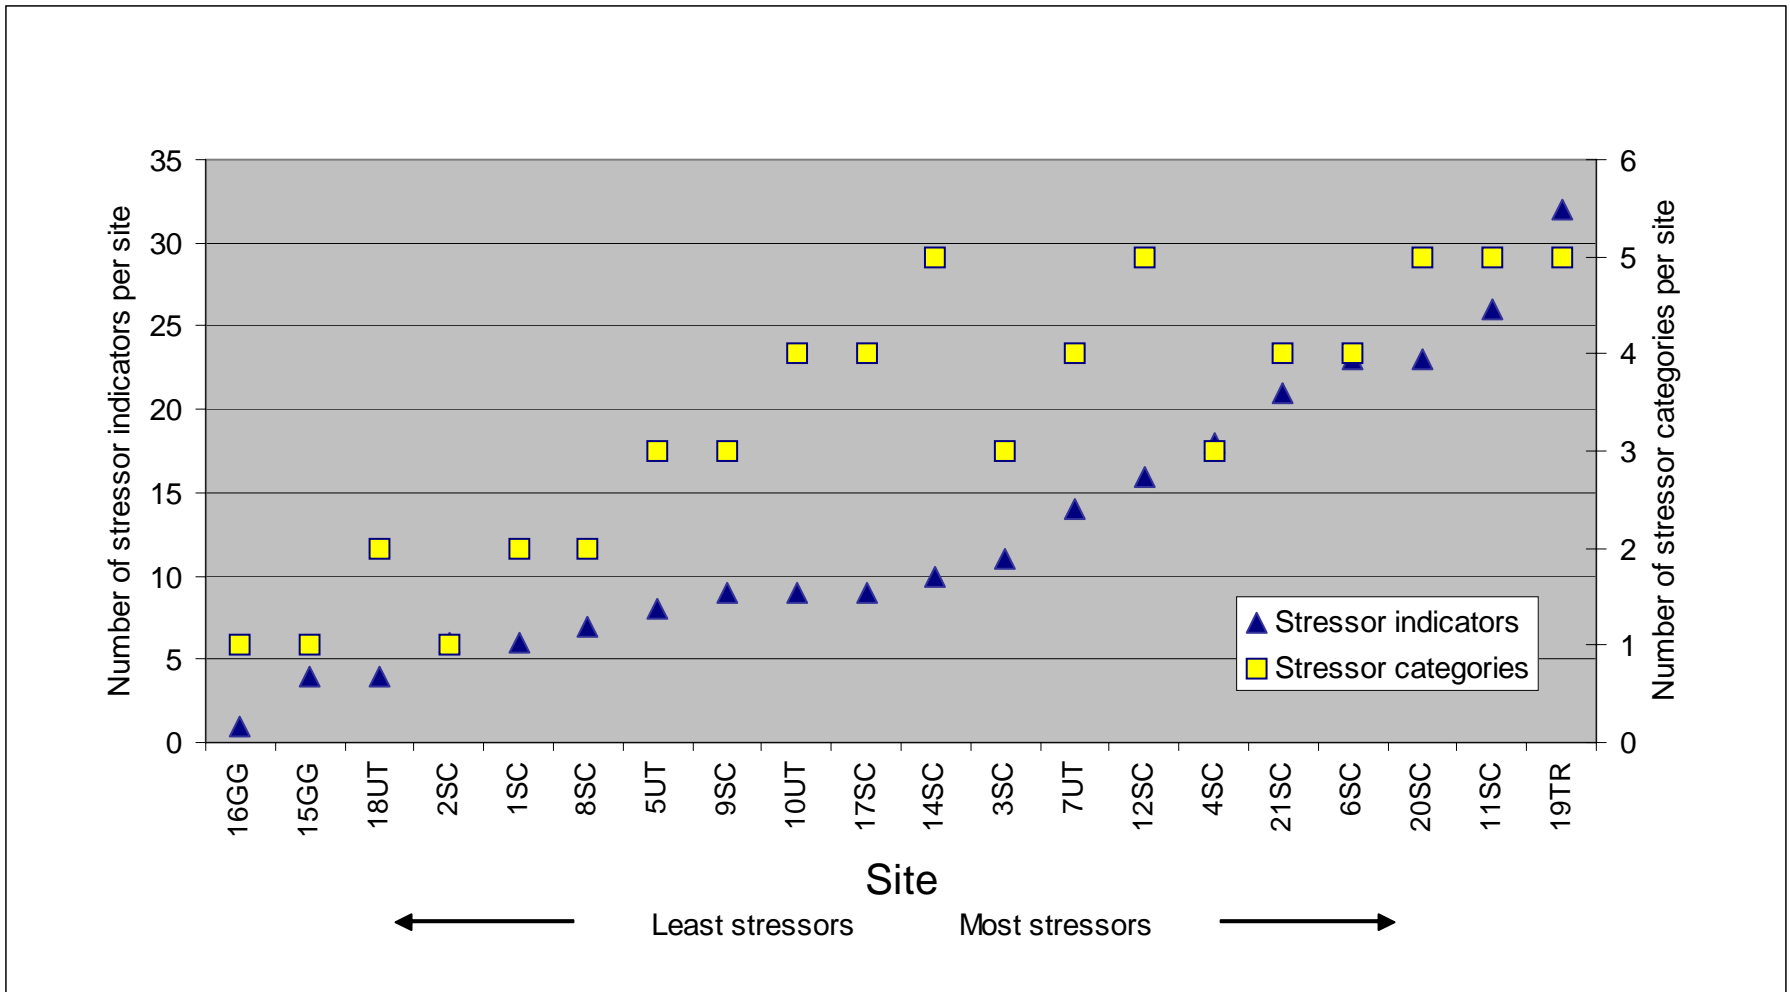
**Figure 15.** Total number of stressor indicators and categories found in each assessment site for the Upper Spring Creek Watershed.

Sites that have been most disturbed by human activities can be identified by examining stressor indicators on a site-by-site basis. Figure 15 summarizes stressors by site, ranking sites from least number of stressor indicators on the left, to the most number of stressor indicators on the right.

From Figure 15, natural breaks in of the number of stressor indicators found among sites can be observed, allowing for generalizations to be made of site conditions based on these stressors. General site conditions were as follows:

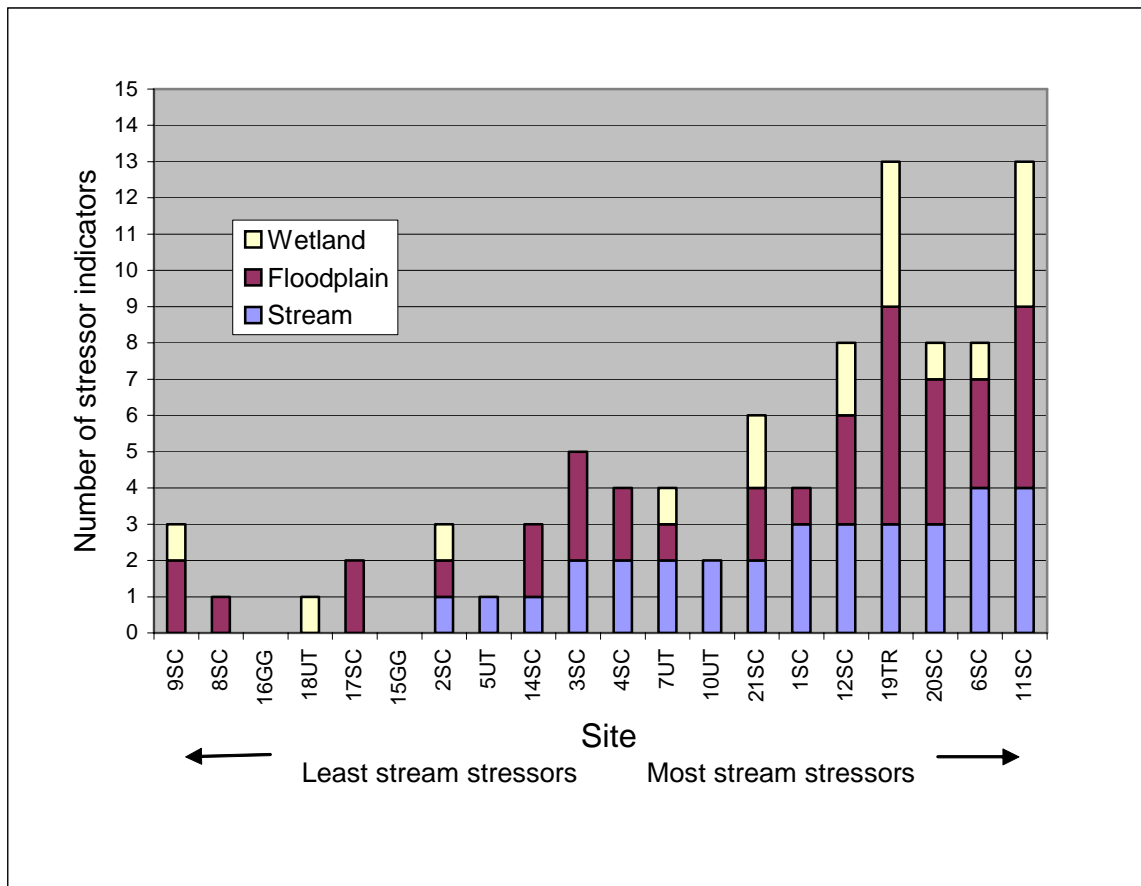
**Figure 16.** Number of hydrologic modification stressors in riparian areas (wetland, floodplain, stream) of each assessment site in the Upper Spring Creek Watershed.

Using the stream as the benchmark, Figure 16 lists the sites from left to right along the x-axis, showing those with the least number of indicators of hydrologic modification to the highest number of stressor indicators. The number of stressors shown within the floodplain and wetland within the hydrologic modifications category are shown for comparative purposes and as an indication for restoration potential.

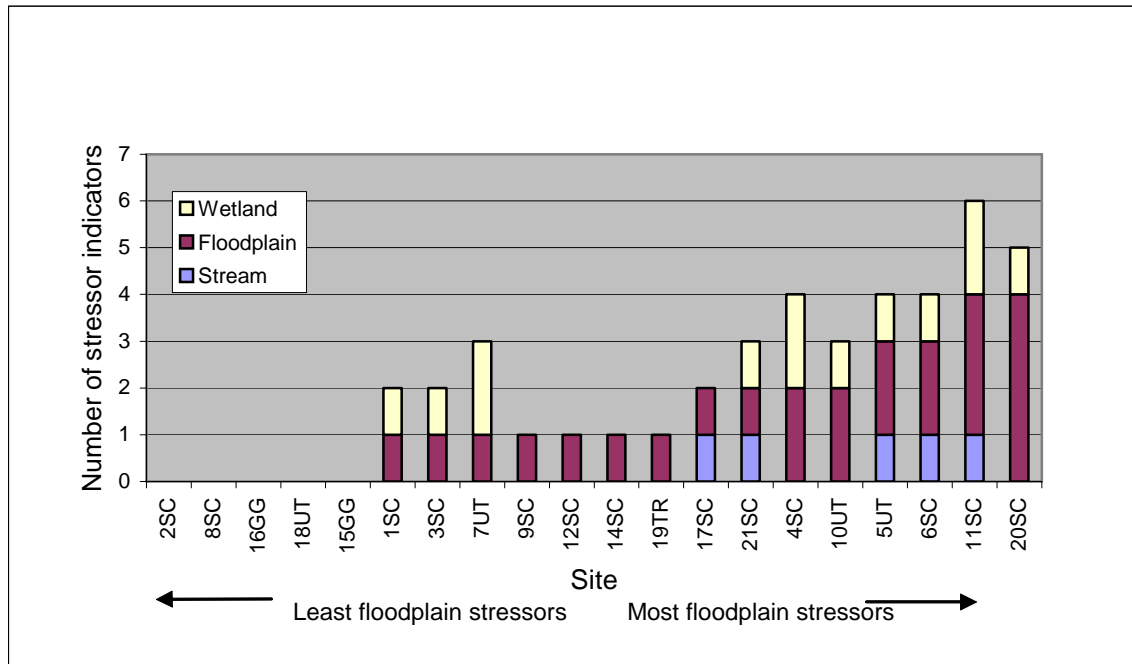
**Figure 17.** Number of vegetation alteration stressors in riparian areas (wetland, floodplain, stream) of each assessment site in the Upper Spring Creek Watershed.

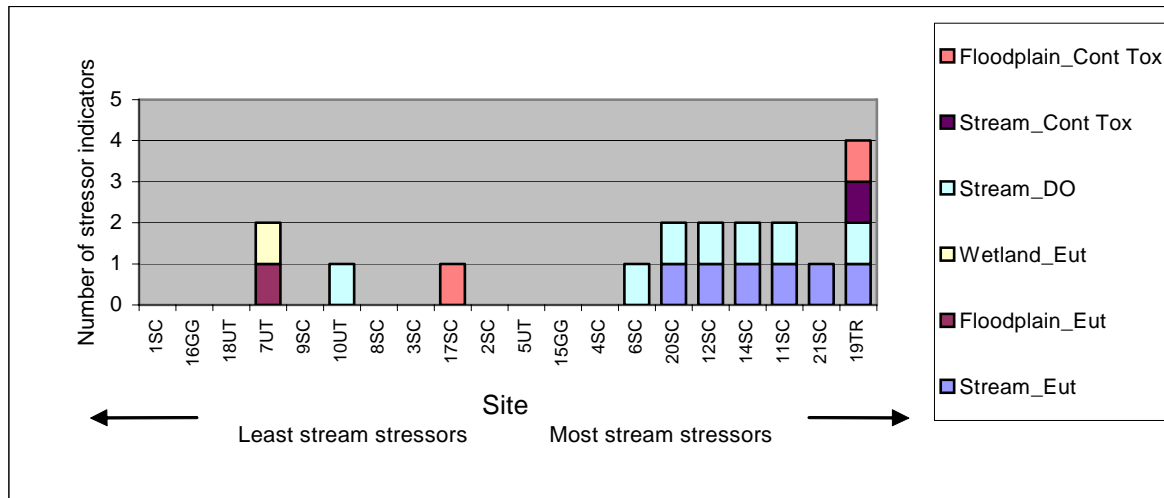
**Figure 19.** Number of eutrophication (Eut), dissolved oxygen (DO), and contaminant toxicity (Cont Tox) stressors in riparian areas (wetland, floodplain, stream) of each assessment site in the Upper Spring Creek Watershed.

Because these stressor categories had the least number of indicators, they are combined here simply to provide a summary of distribution by site. The sites are sorted from least to most eutrophication stressors in the stream.

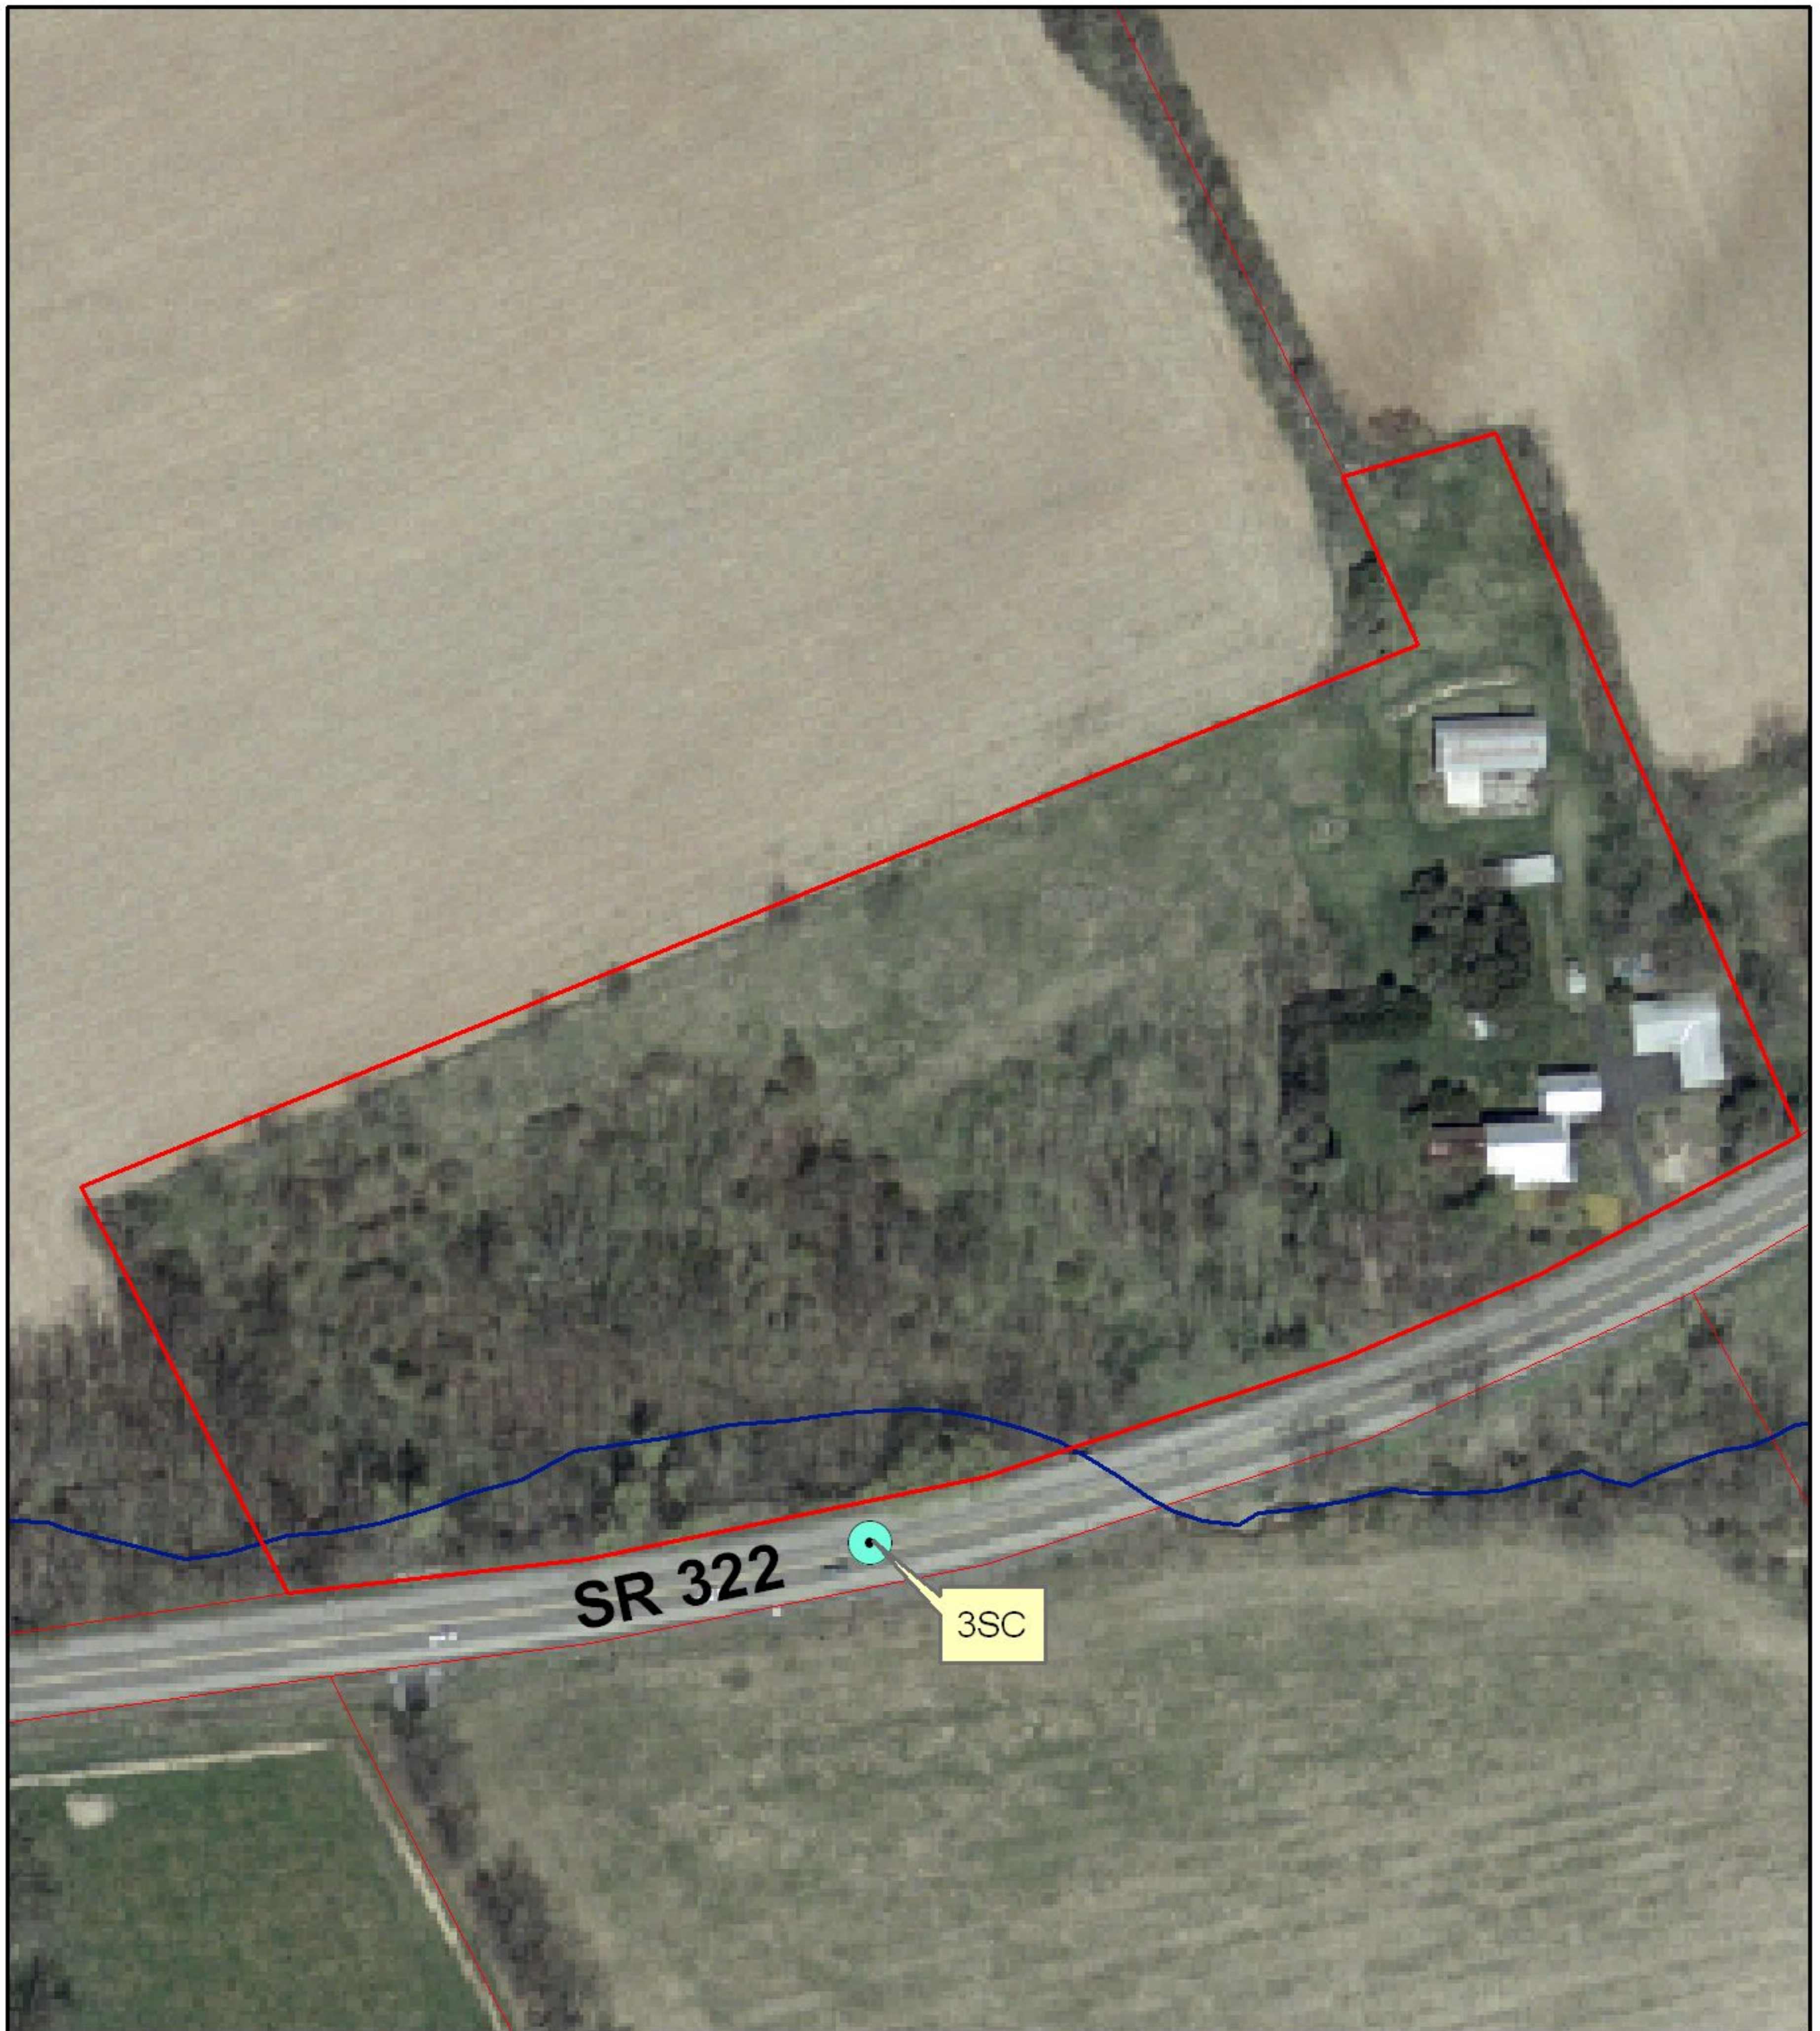
Land Owner= Kathy Confer

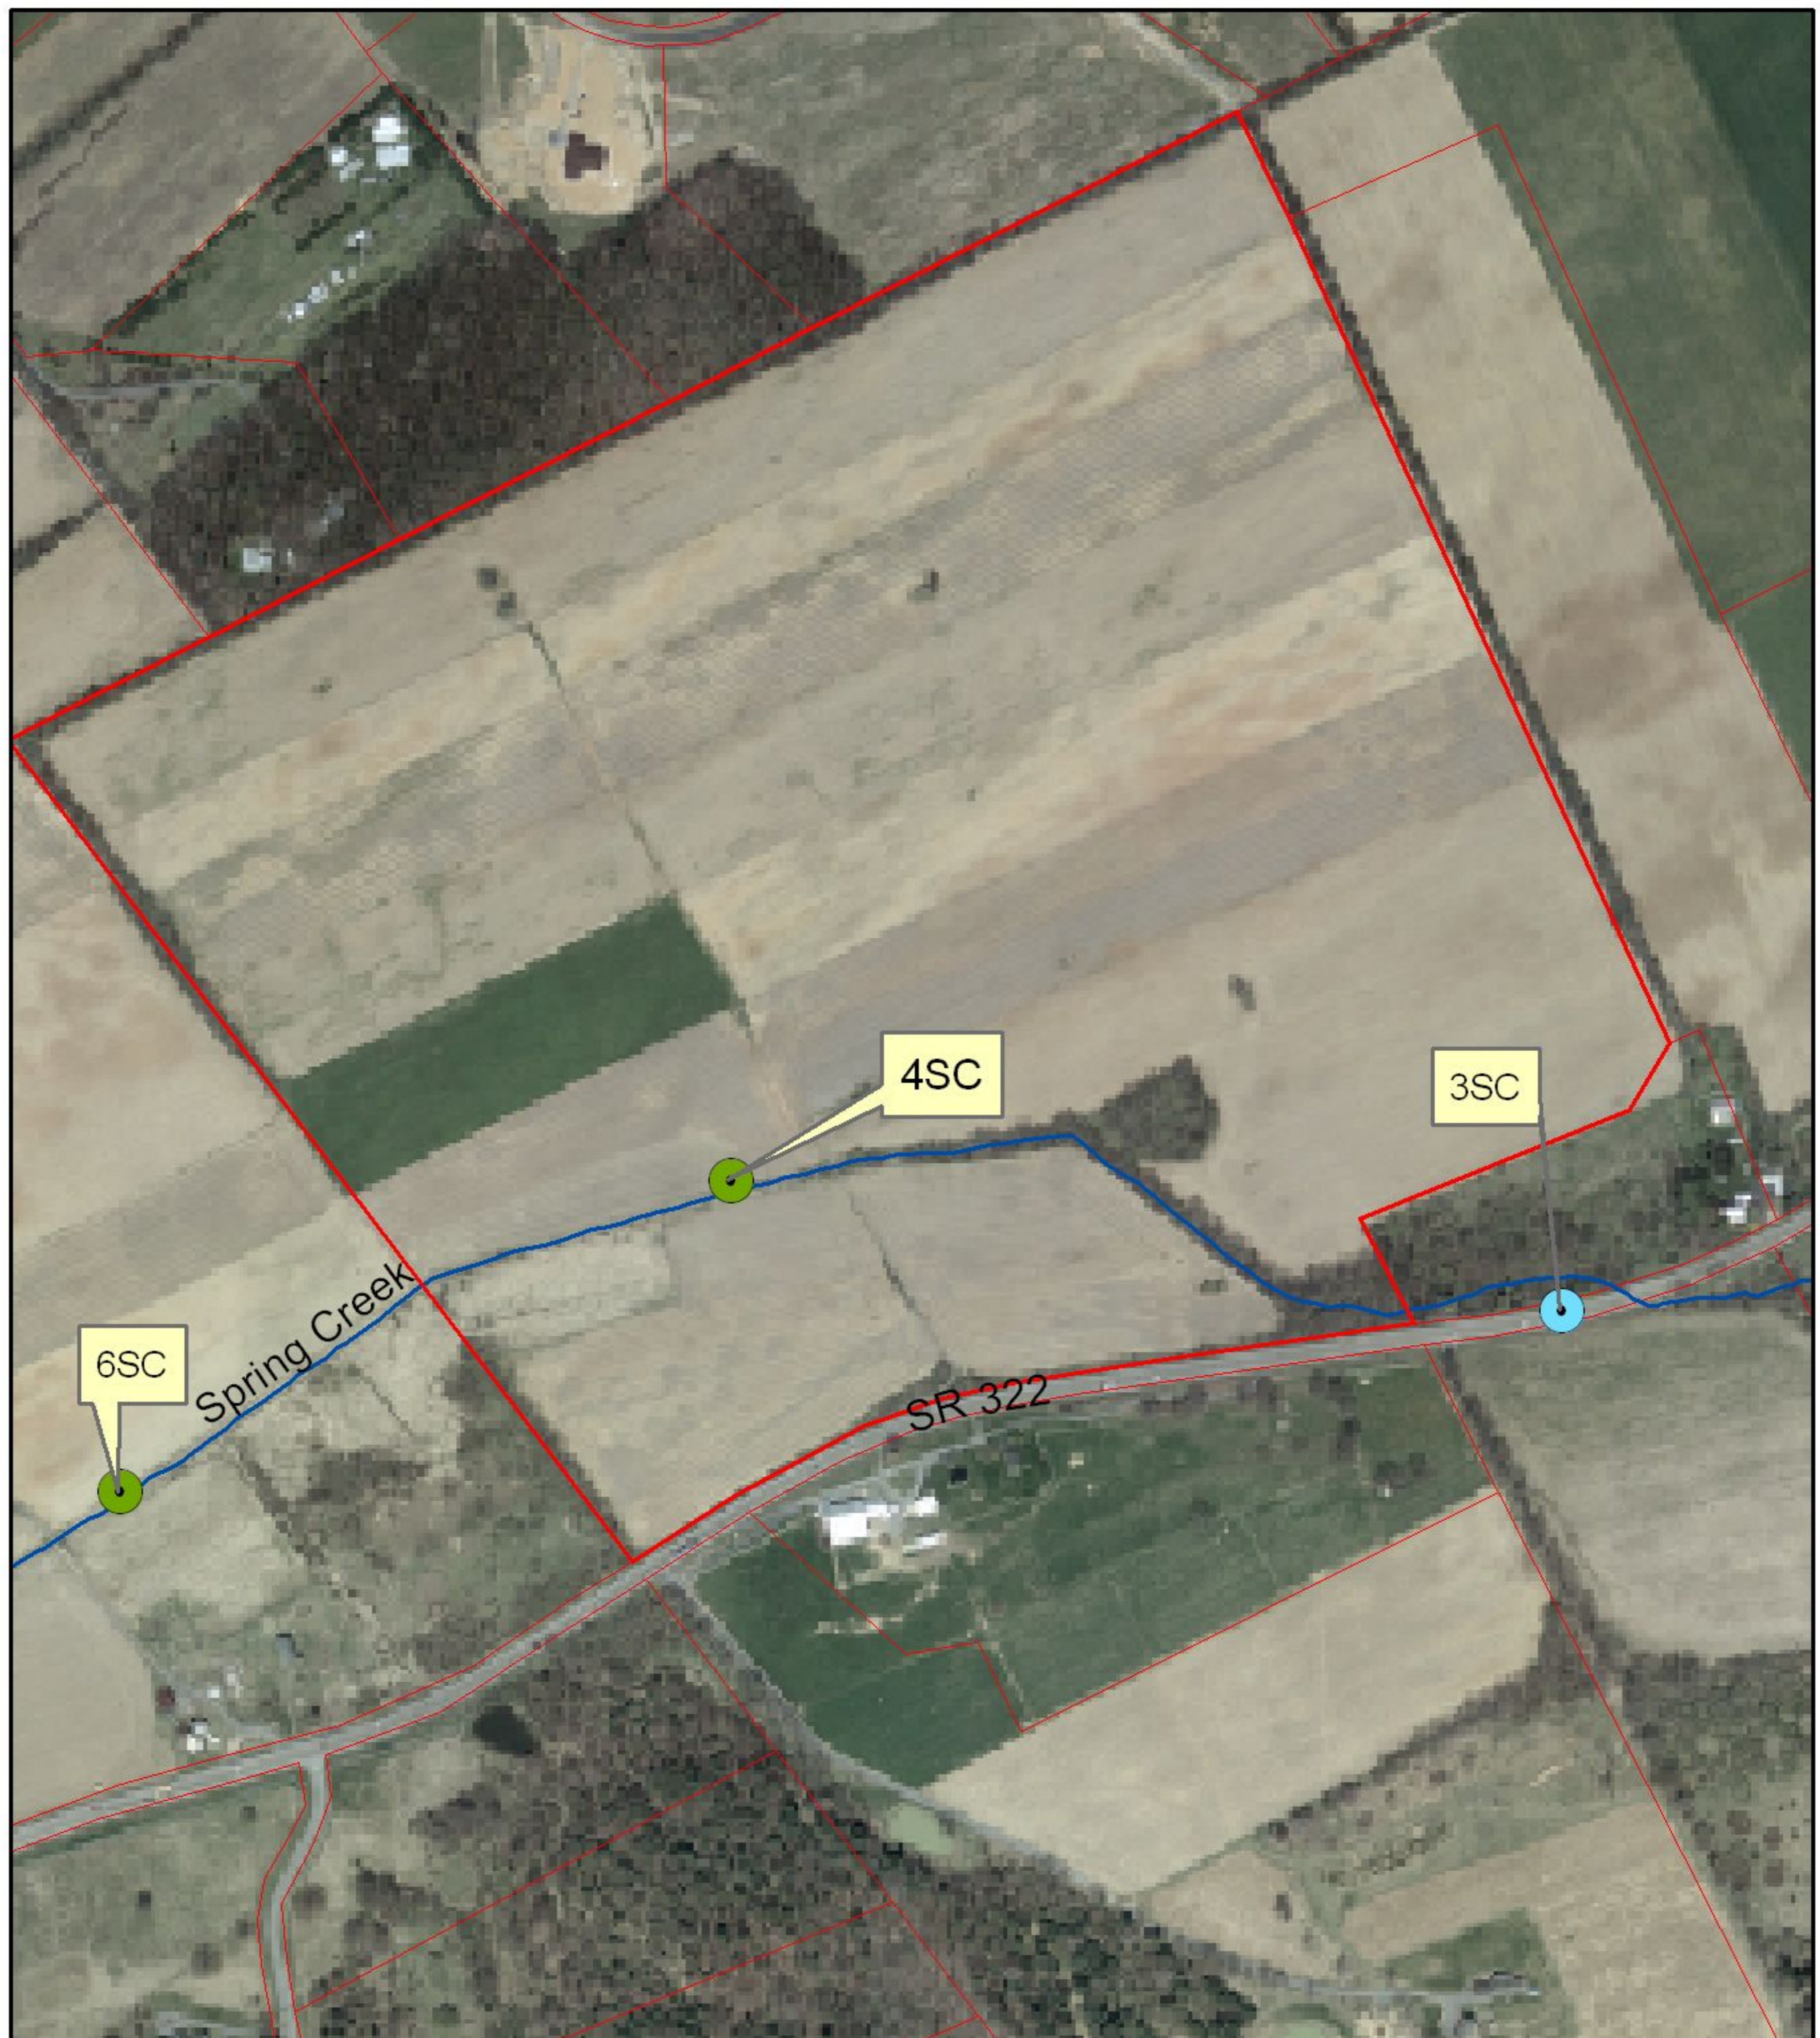
Land Owner = Franklin Chow  
 Tax I.D. # = 20-008-001-0000  
 Number of Acres = 158  
 Approx. linear meters of Stream = 735
