# Upper Spring Creek Watershed Coldwater Conservation Plan

Centre County, Pennsylvania  
January, 2007

**CLEARWATER CONSERVANCY**  
**SUMMARY OF THE UPPER SPRING CREEK WATERSHED COLDWATER CONSERVATION PLAN**  
**1/31/2007**

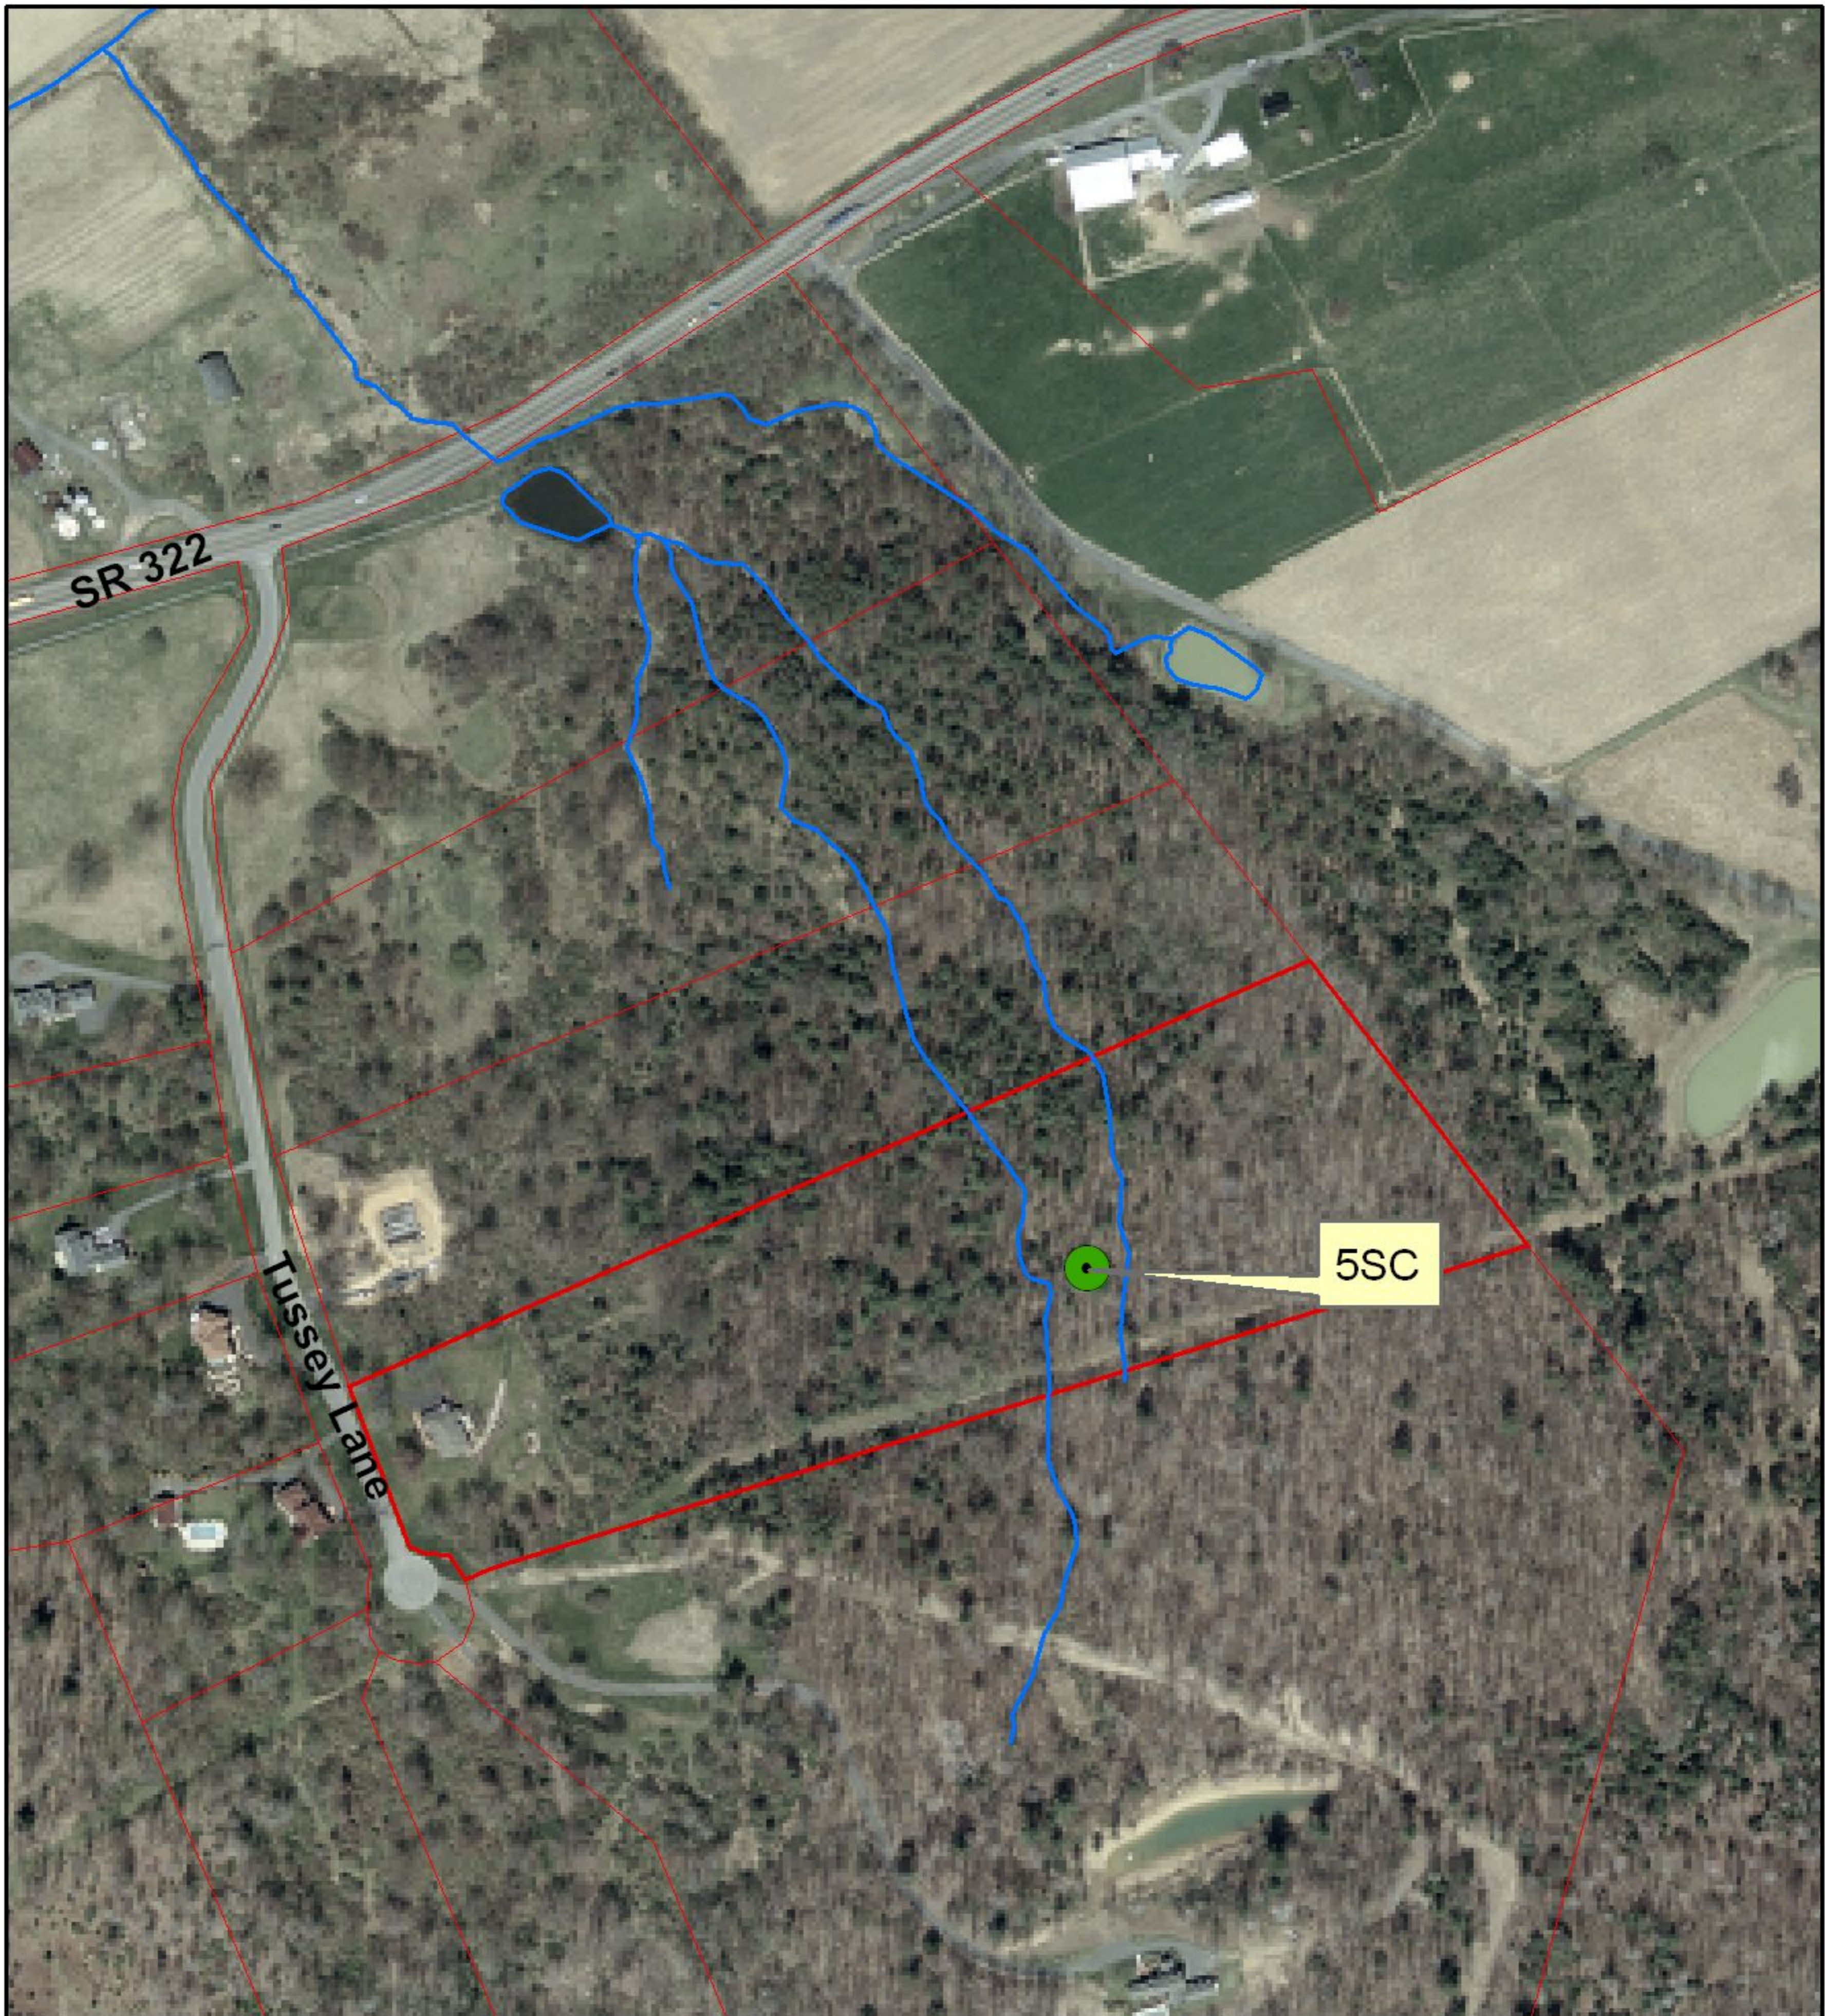
Land Owners = Paul & Mayme Gigl

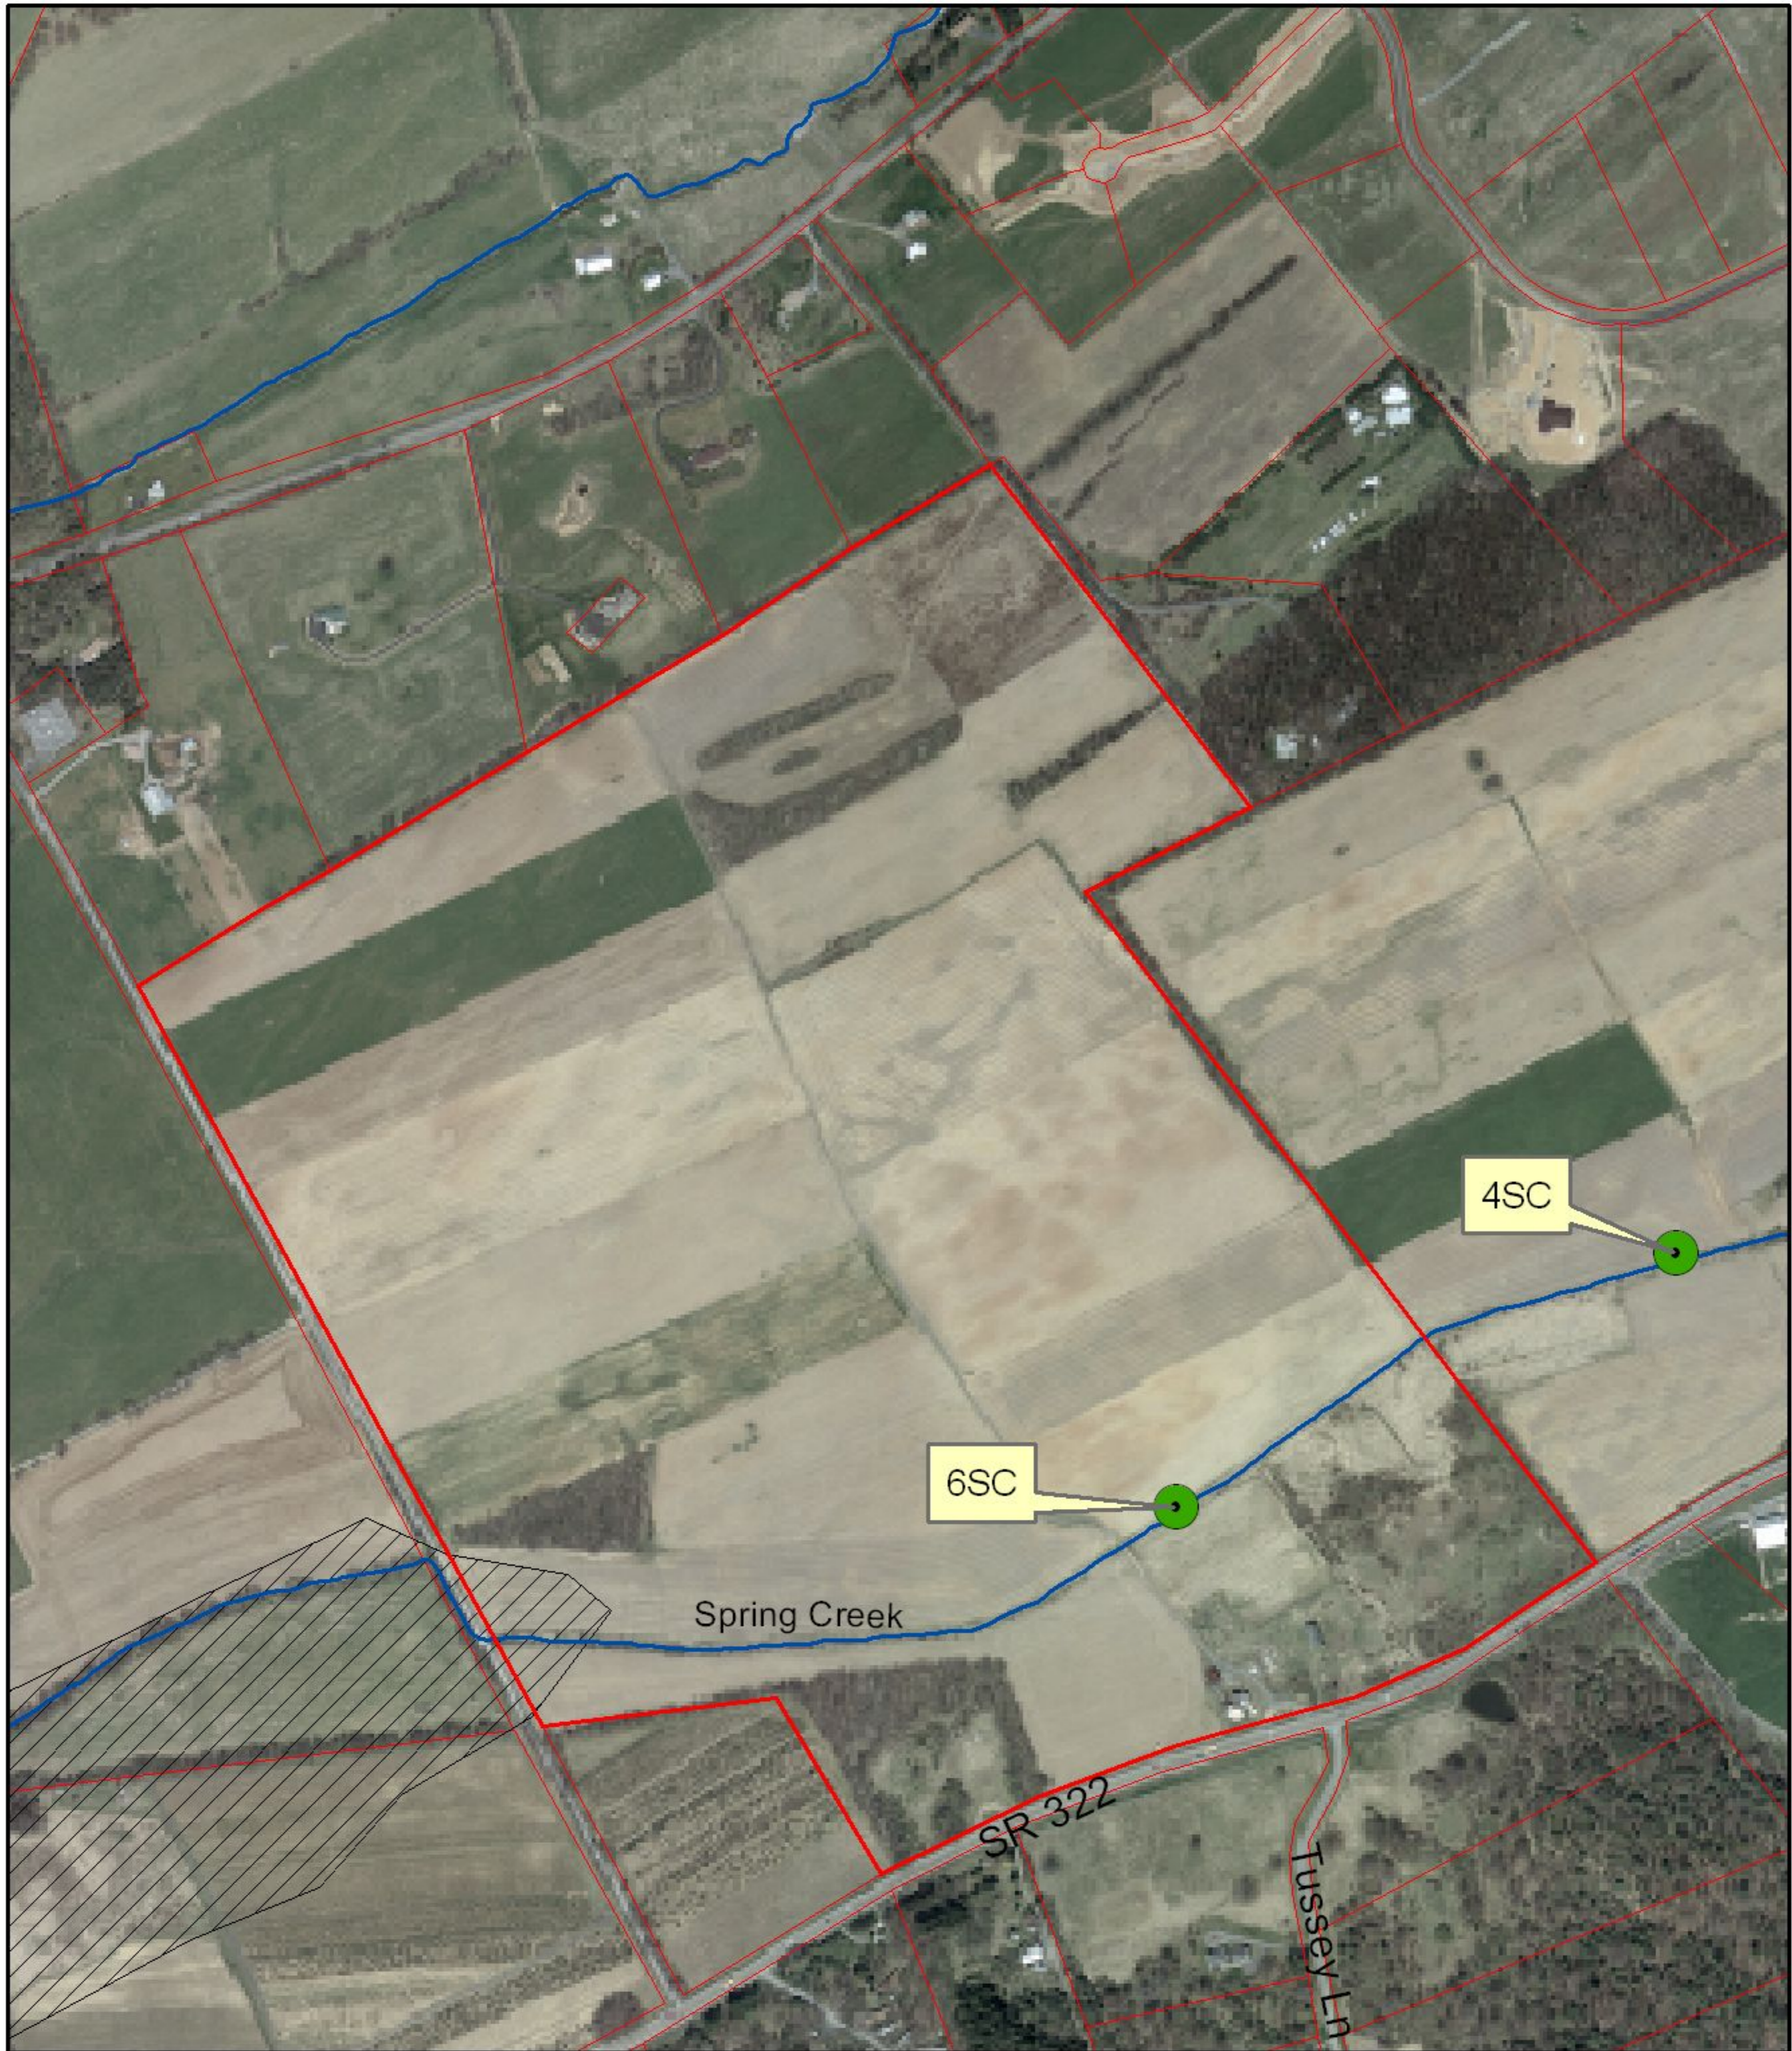
Land Owner = E.J. and Rebecca Oelbermann  
 Tax I.D. # = 25-005-015-0000  
 Number of Acres = 195  
 Approximate linear meters of stream = 1120

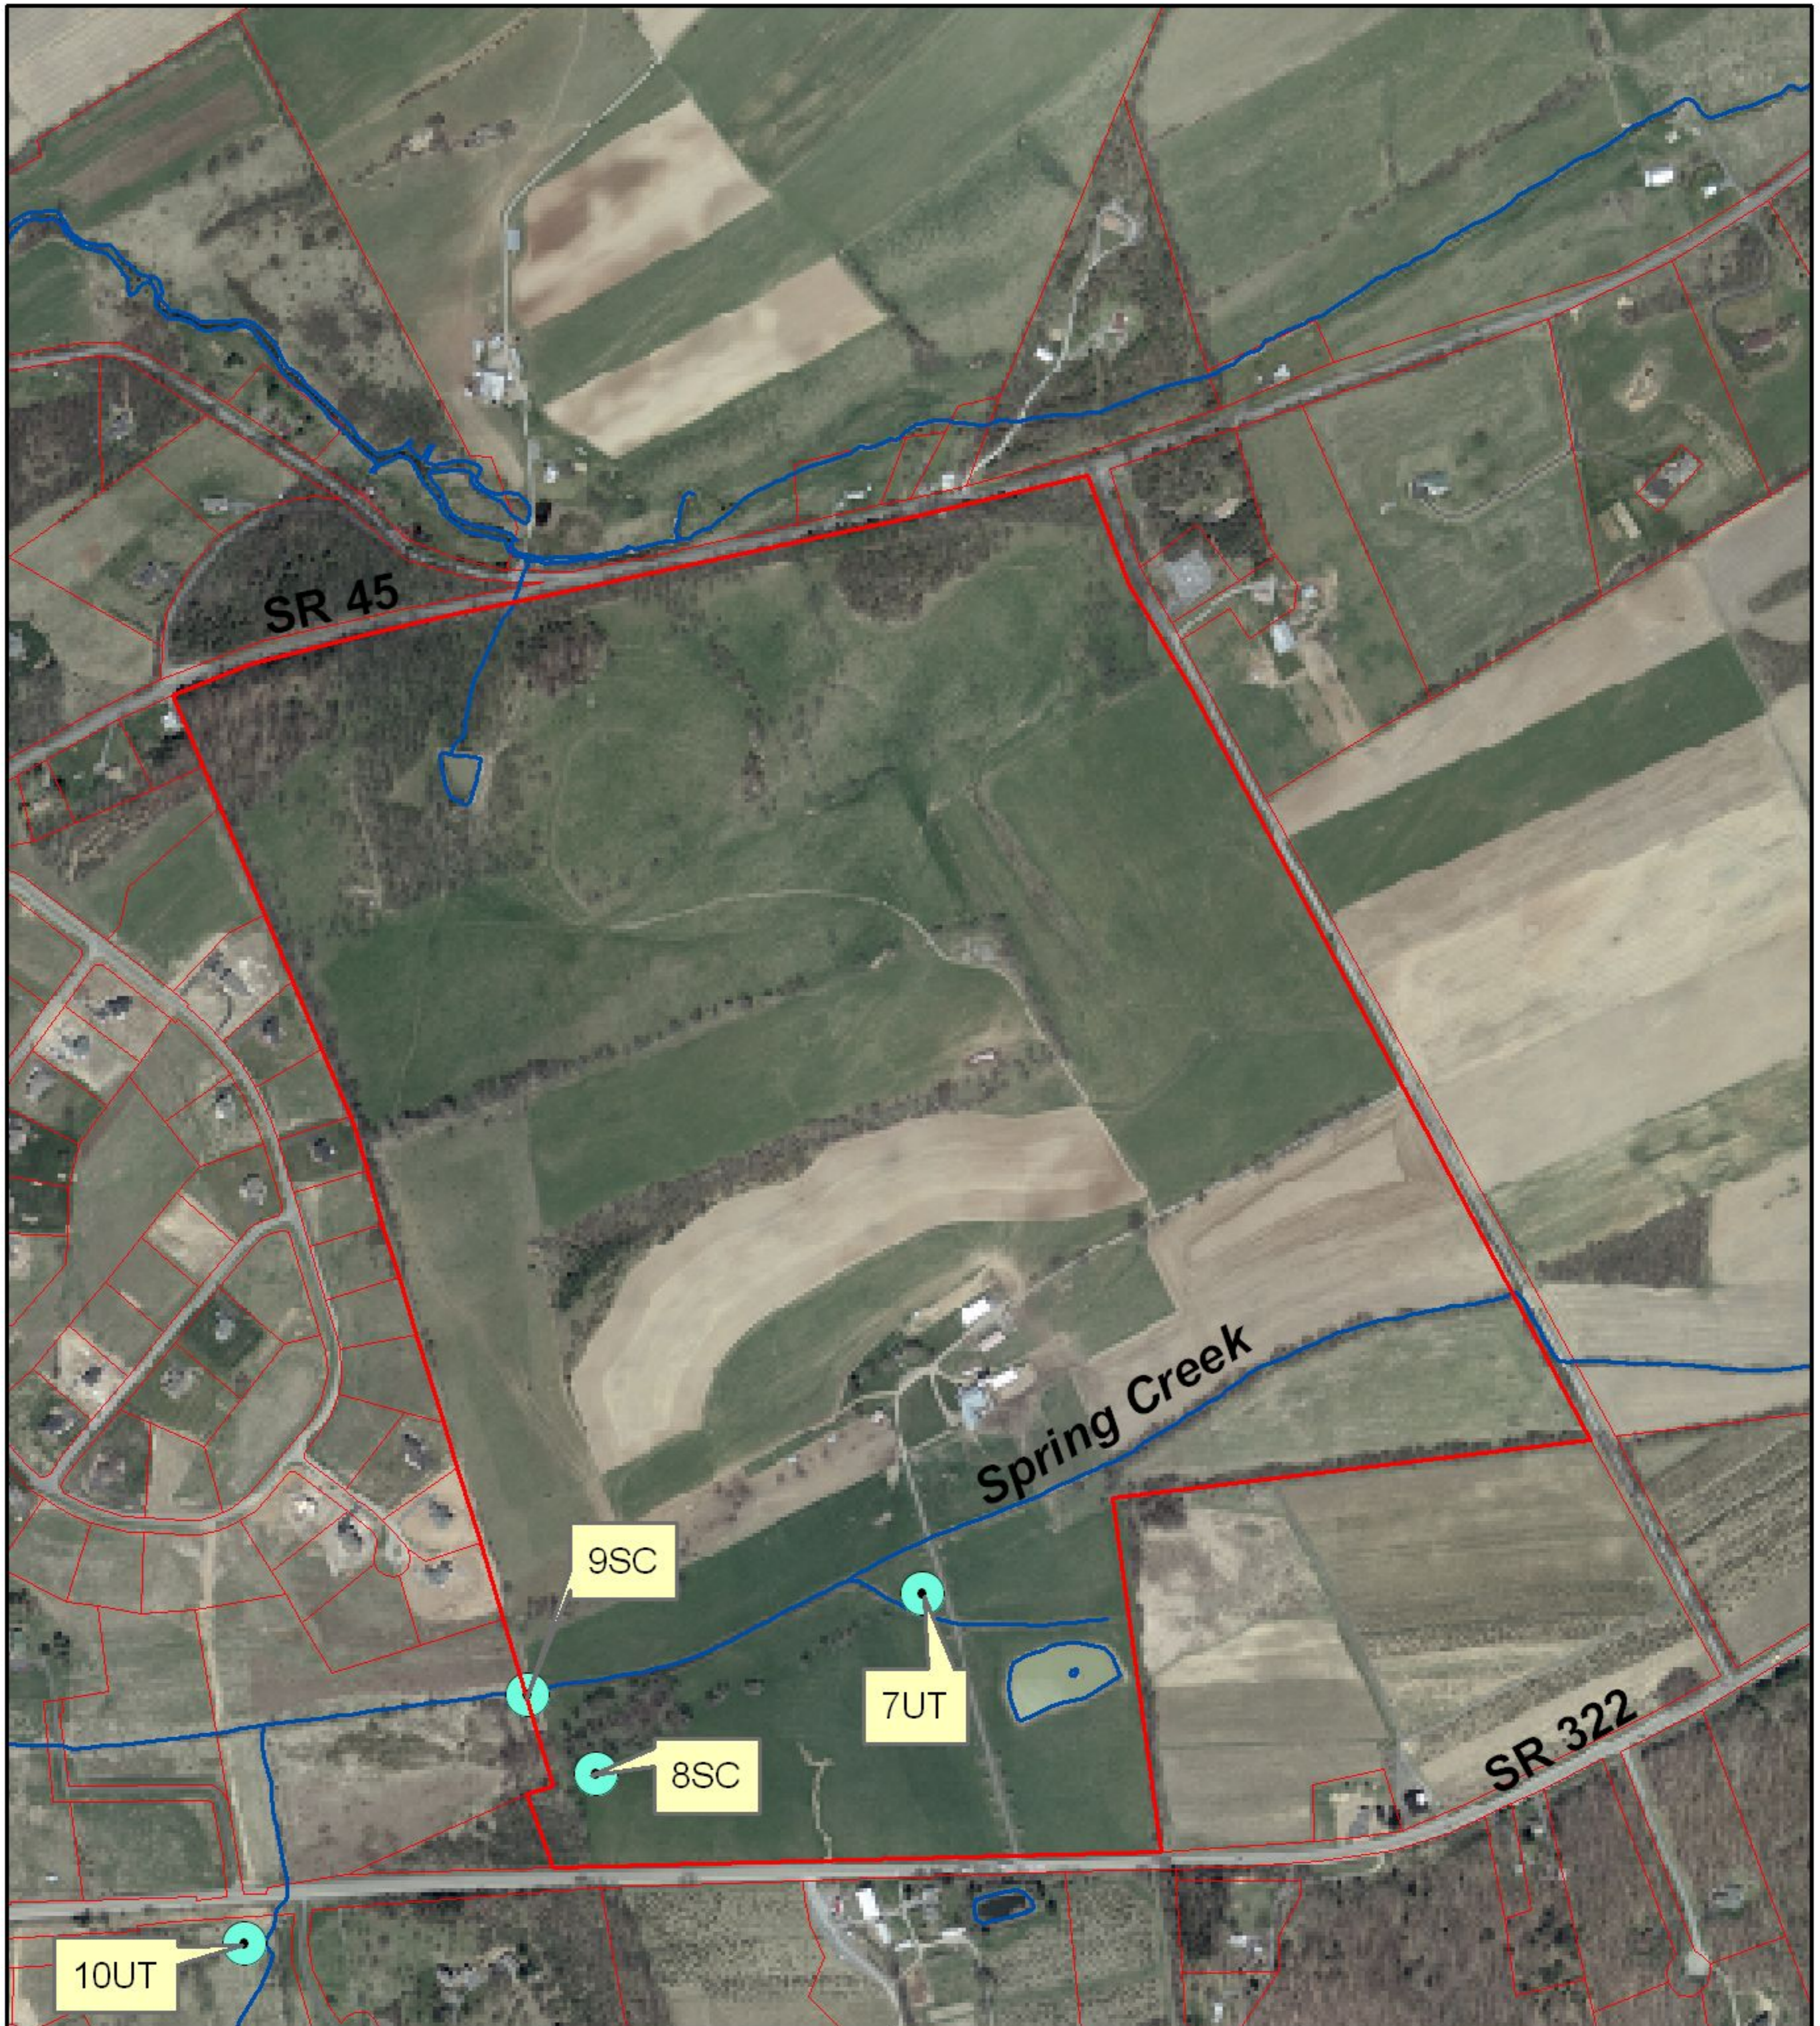
Land Owner - Galen Dreibelbis  
 Tax I.D. # = 25-005-001-0000  
 Number of Acres = 285  
 Approximate Linear meters of stream = 4,100

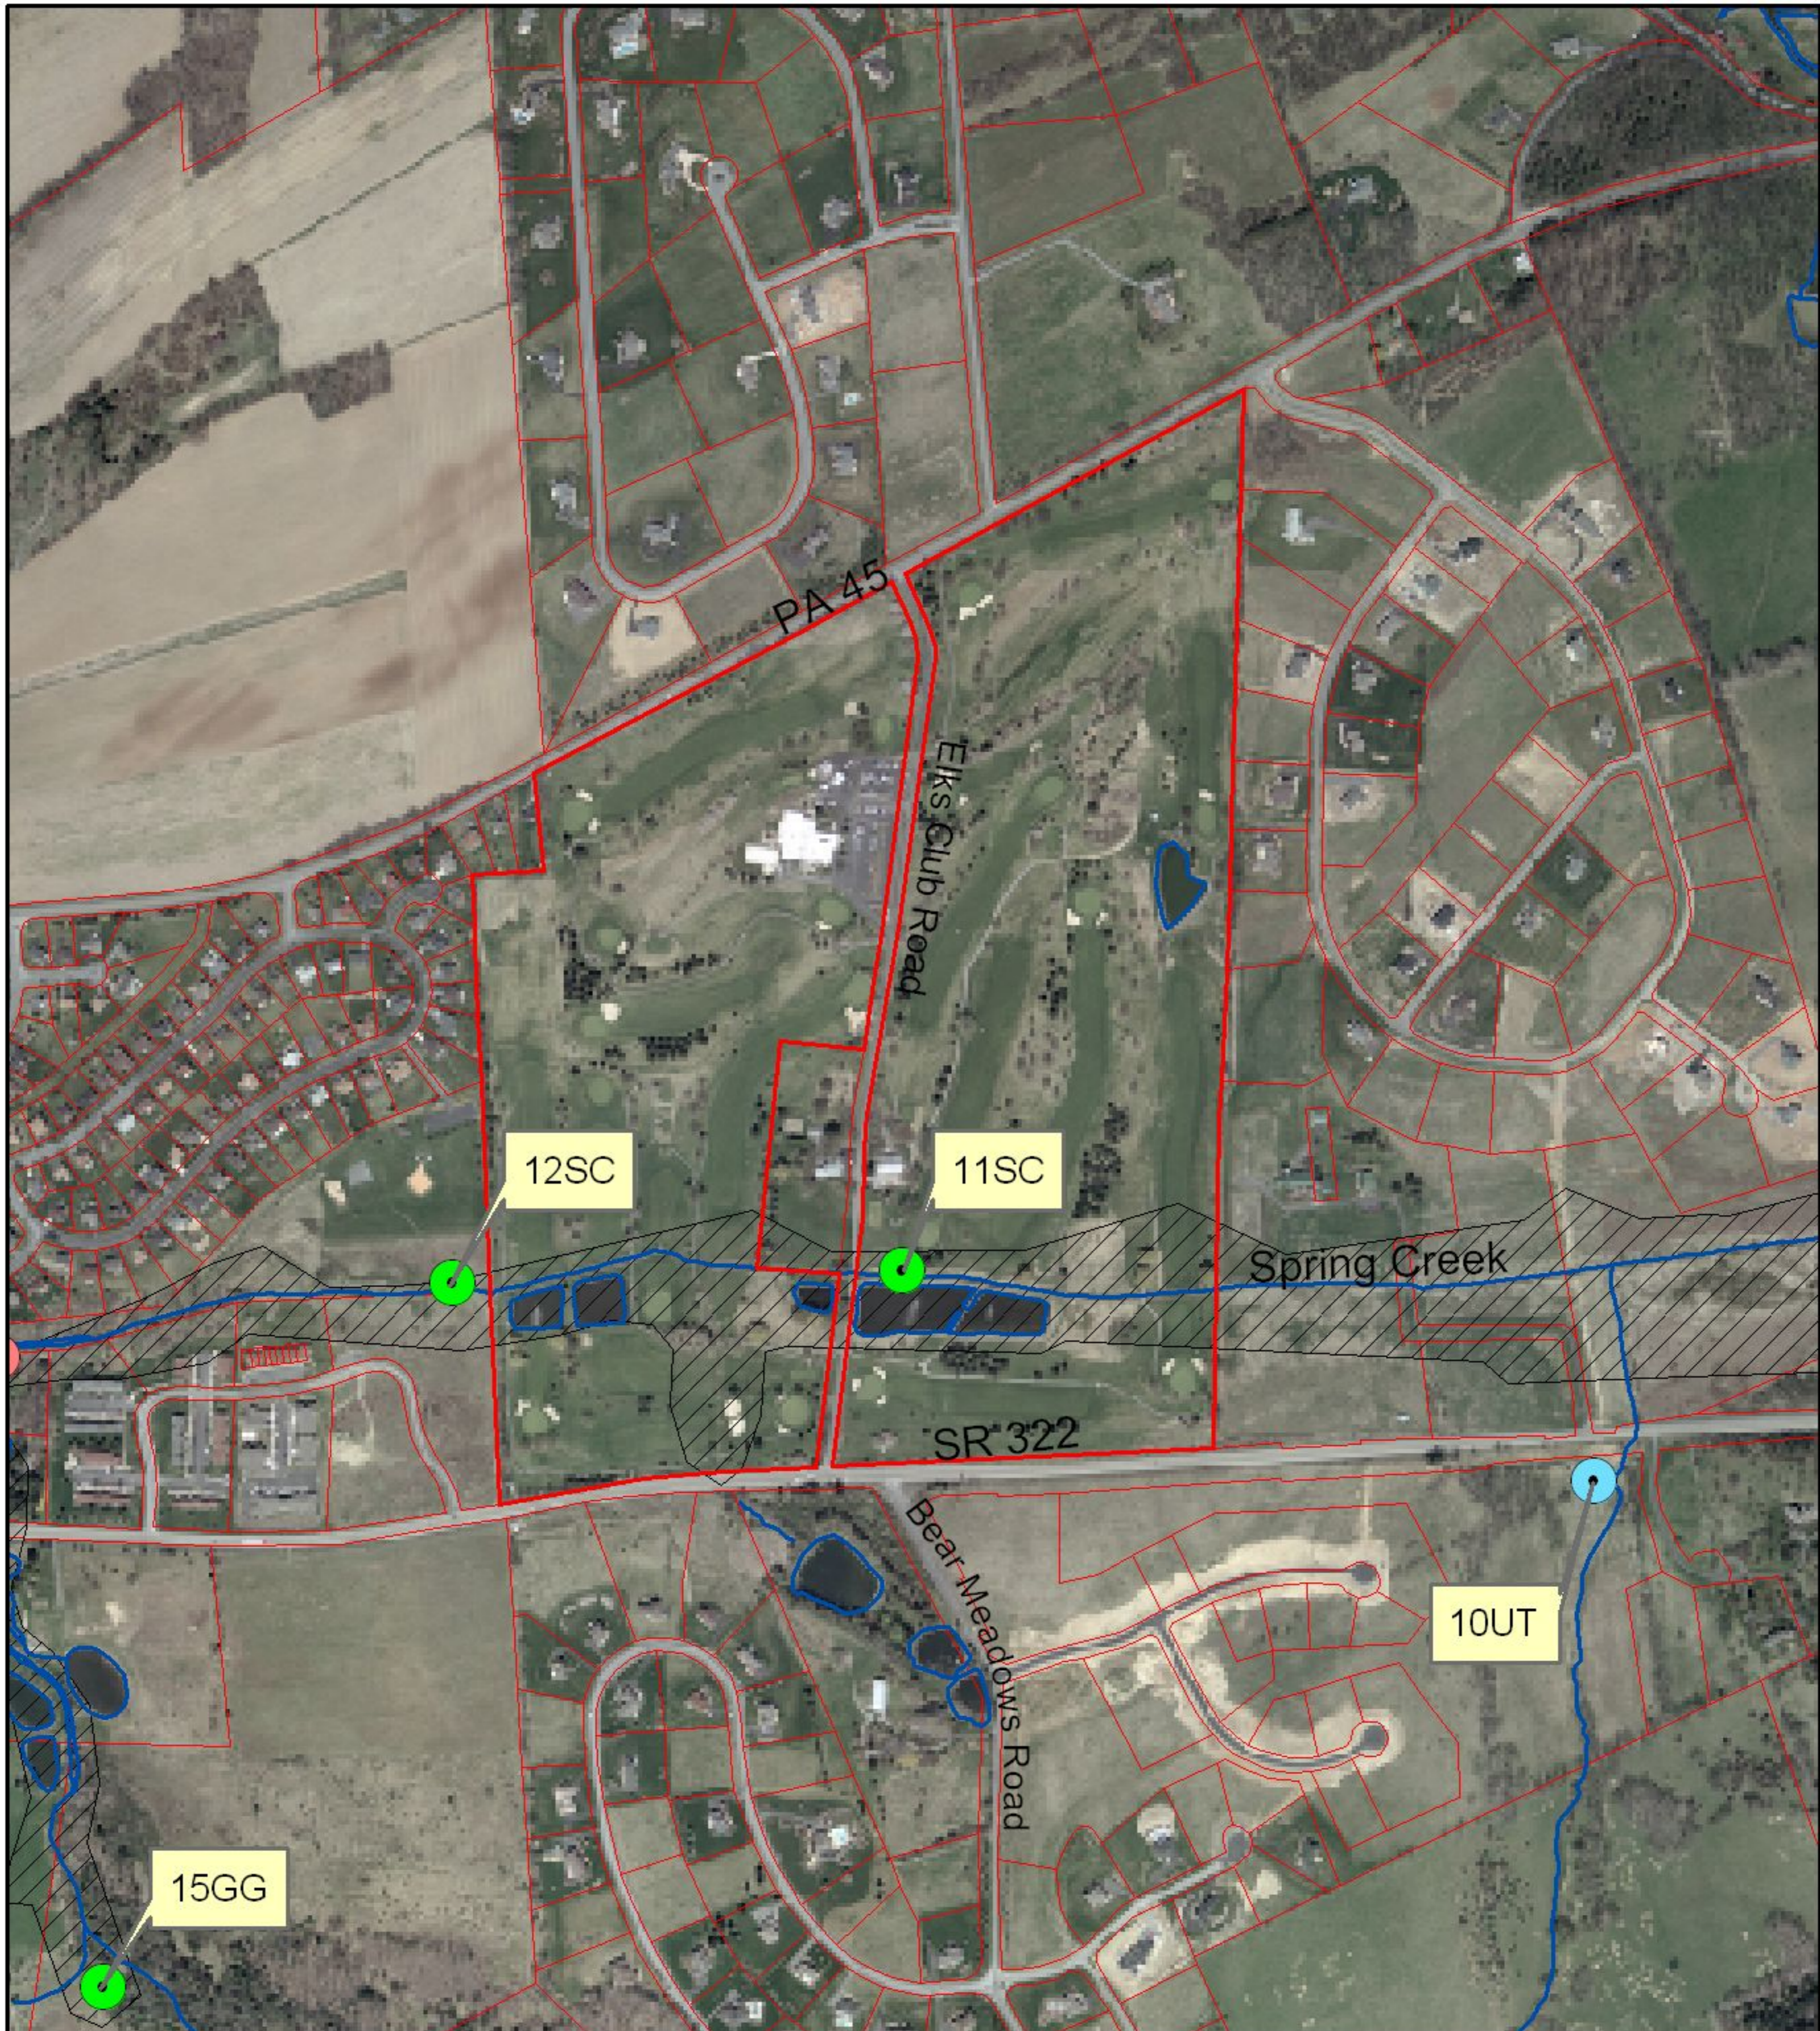
Land Owner = State College Elks Inc.  
 Tax I.D. # = 25-408-035-0000  
 Number of Acres = 146.2  
 Approximate linear meters of stream = 675

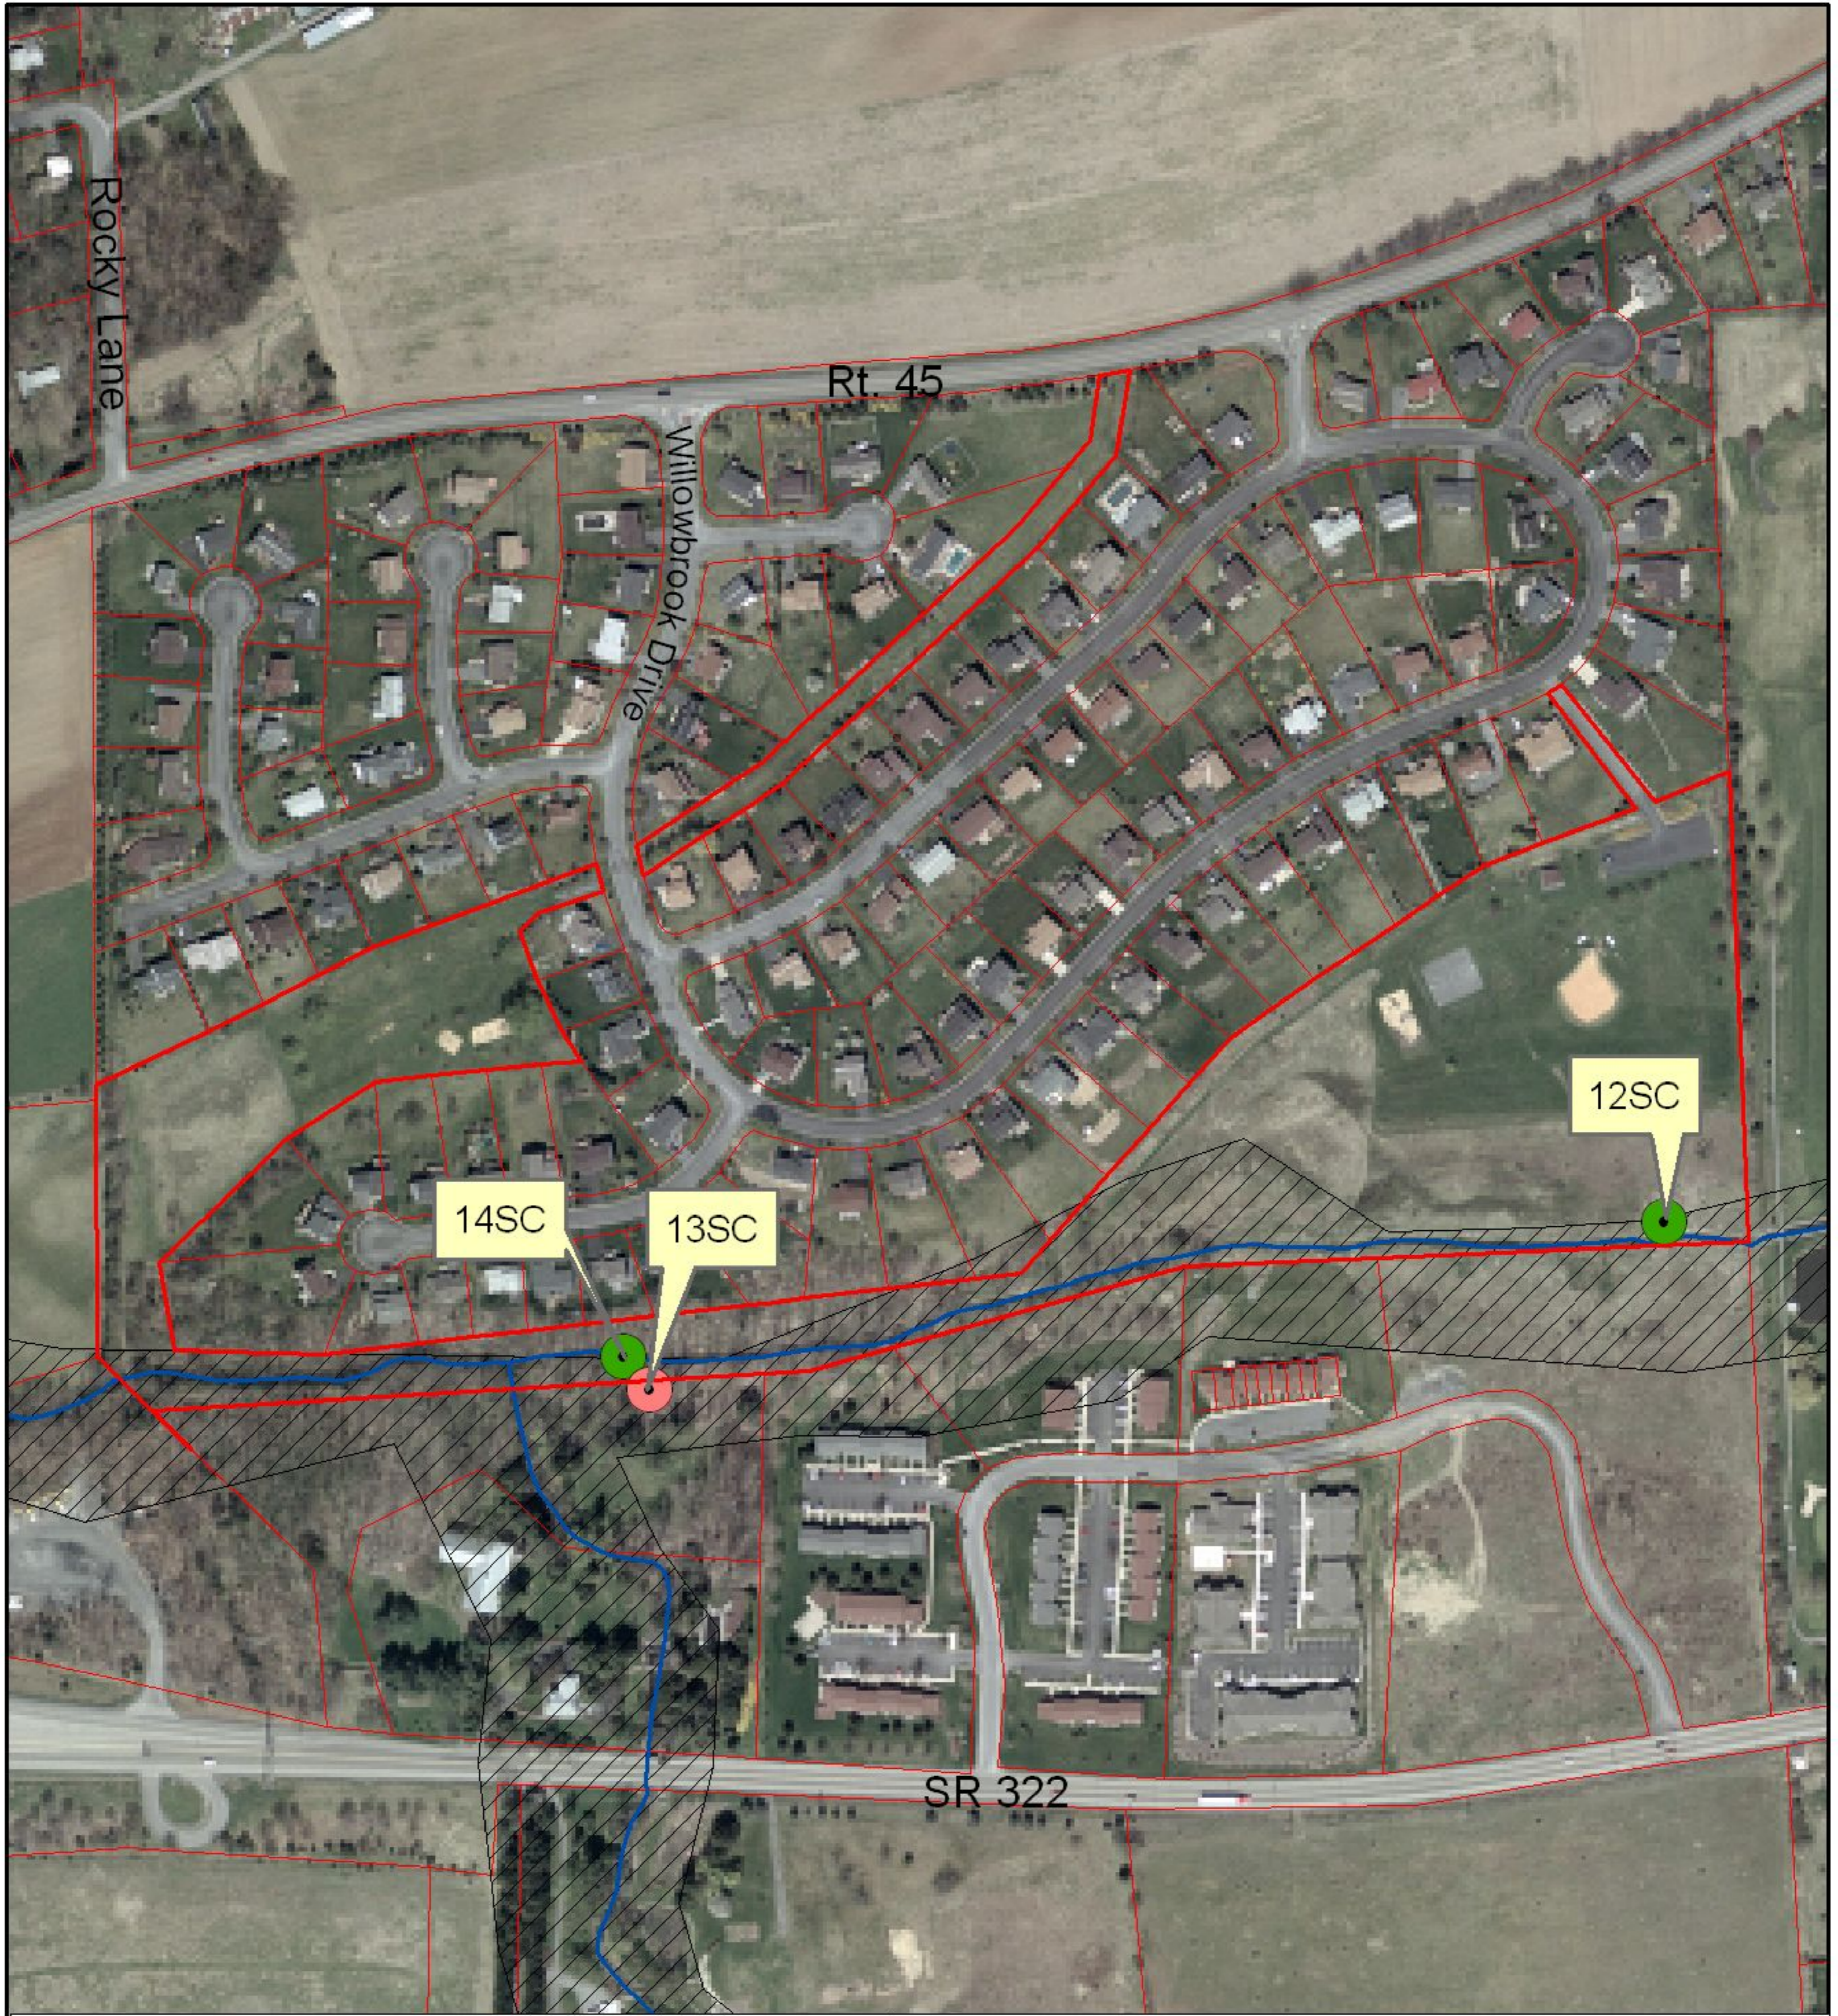
Land Owner = Harris Township  
 Tax I.D. # = 25-004A-200-0000  
 Number of Acres = 17.95  
 Approximate linear meters of stream = 735

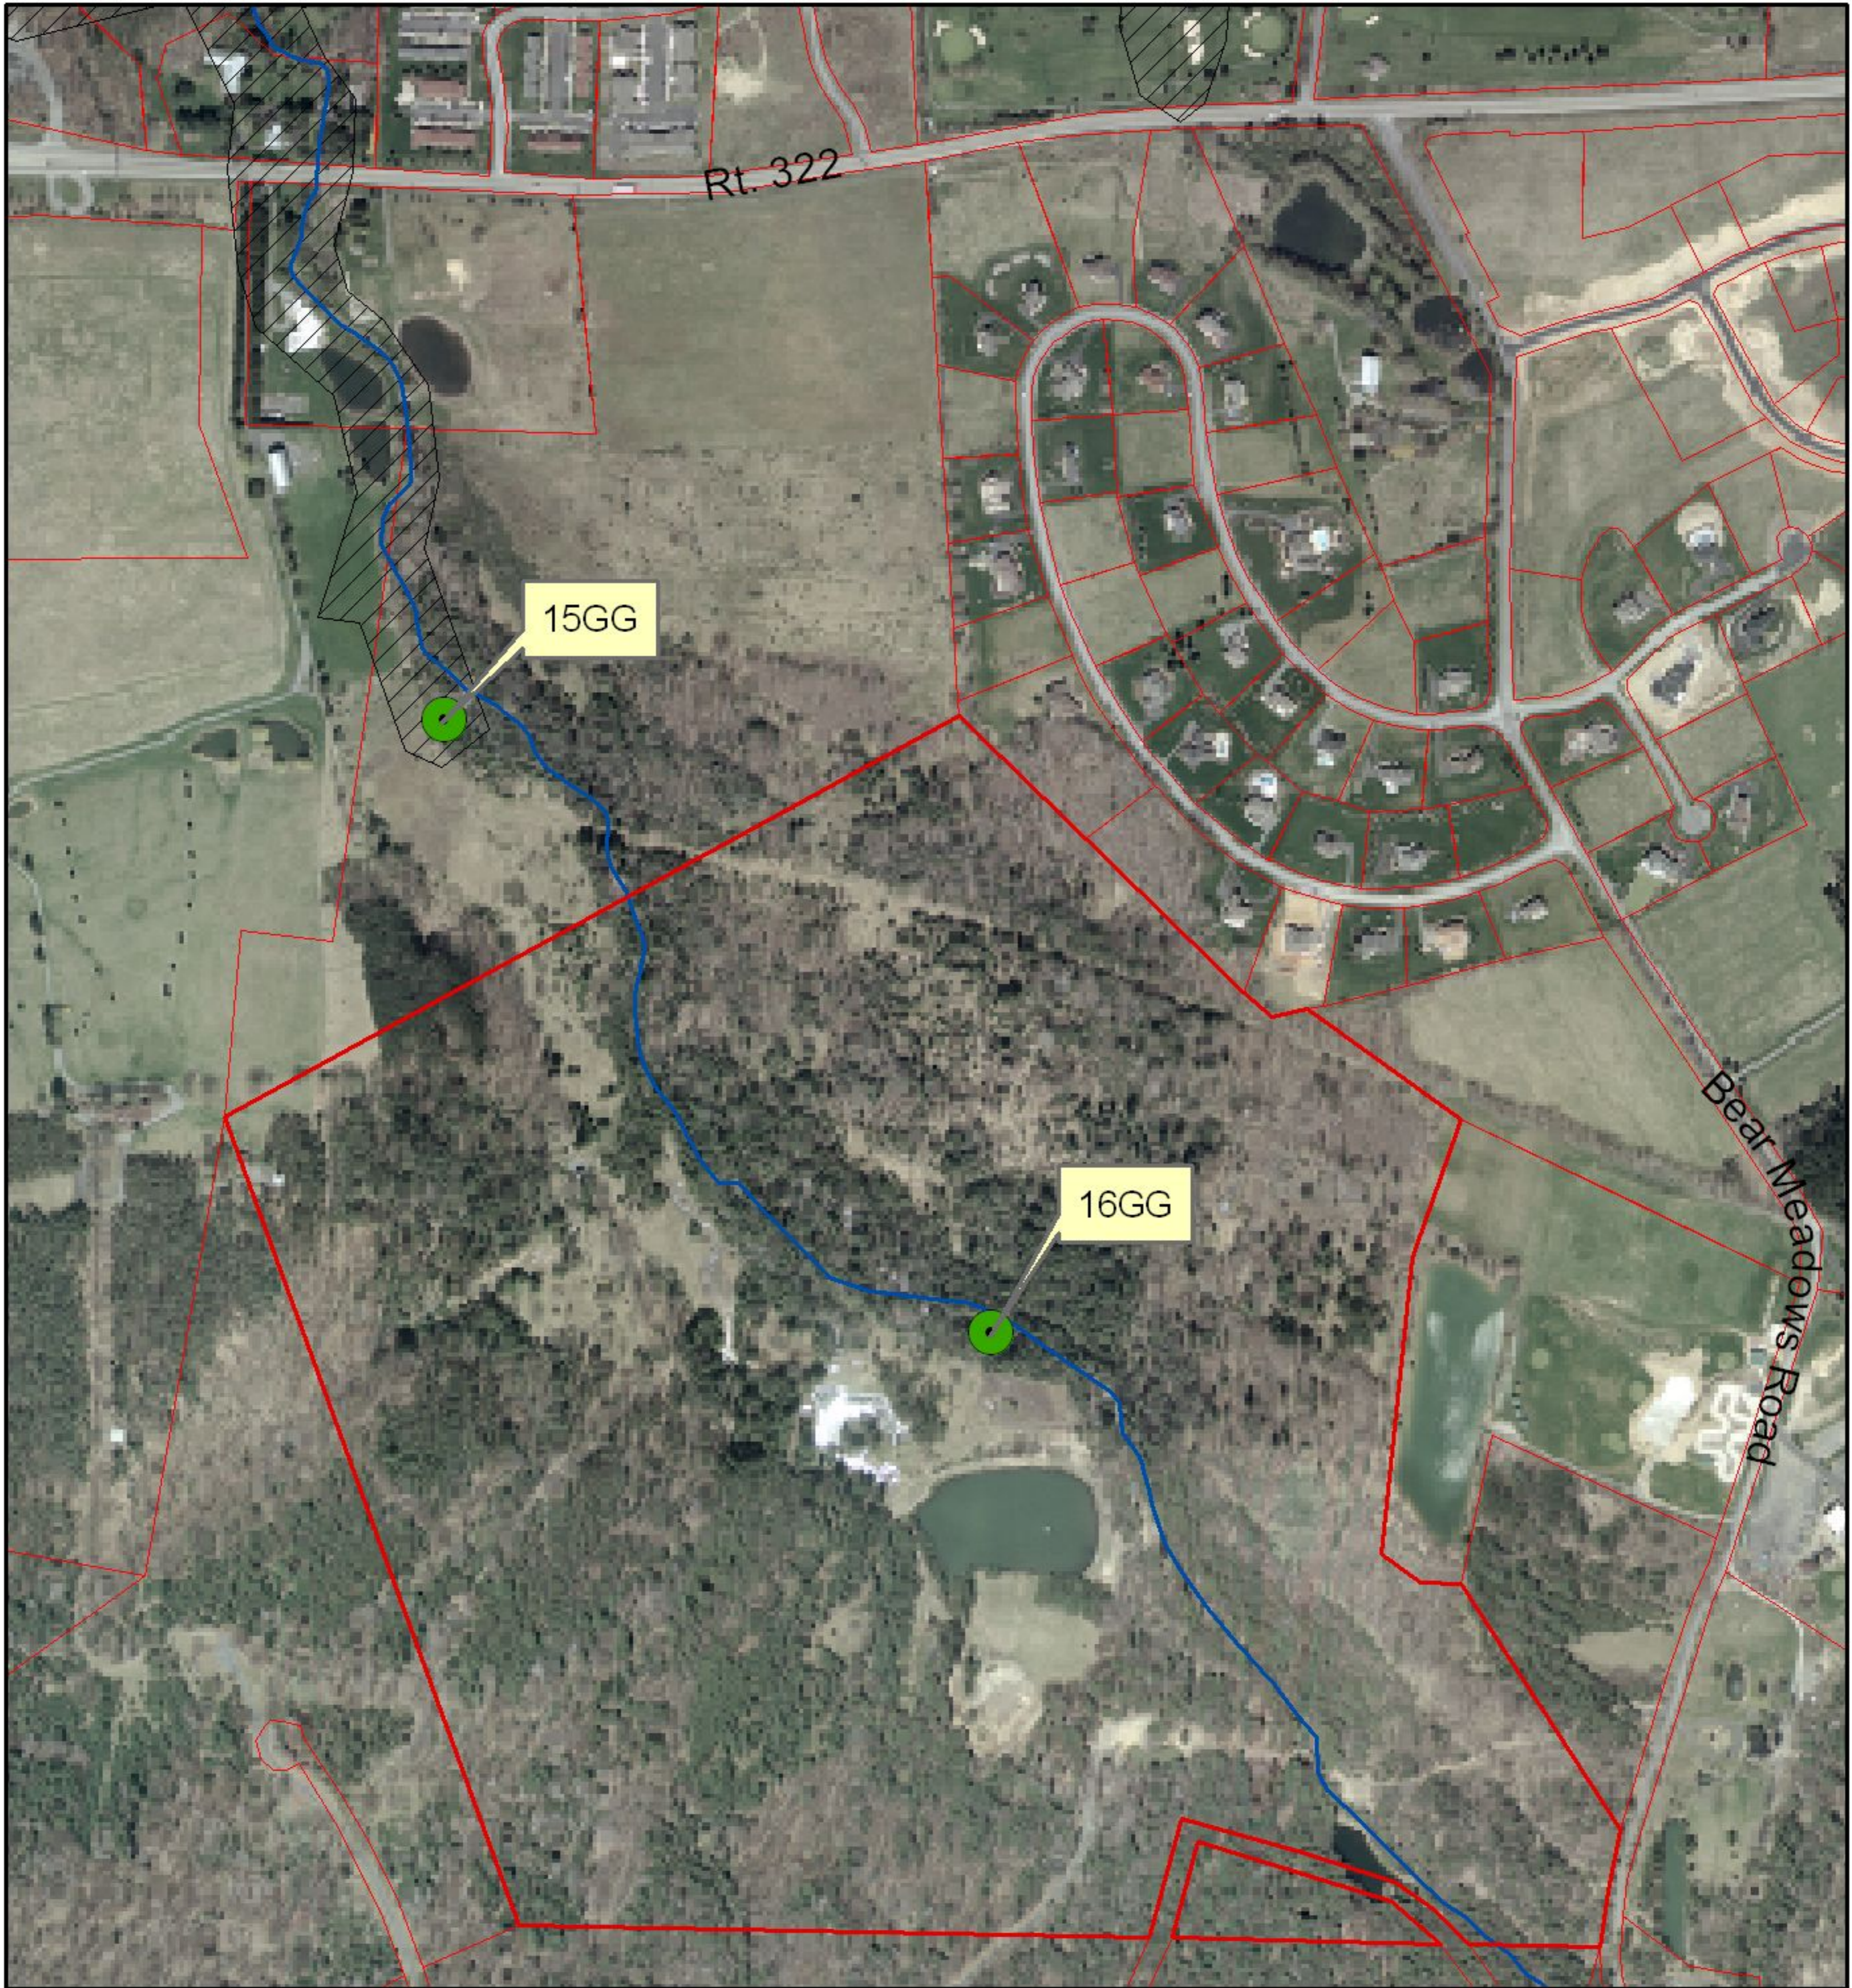
Land Owner = Randolph G. Aikens
