# Upper Spring Creek Watershed Coldwater Conservation Plan

Centre County, Pennsylvania  
January, 2007

**CLEARWATER CONSERVANCY**  
**SUMMARY OF THE UPPER SPRING CREEK WATERSHED COLDWATER CONSERVATION PLAN**  
**1/31/2007**

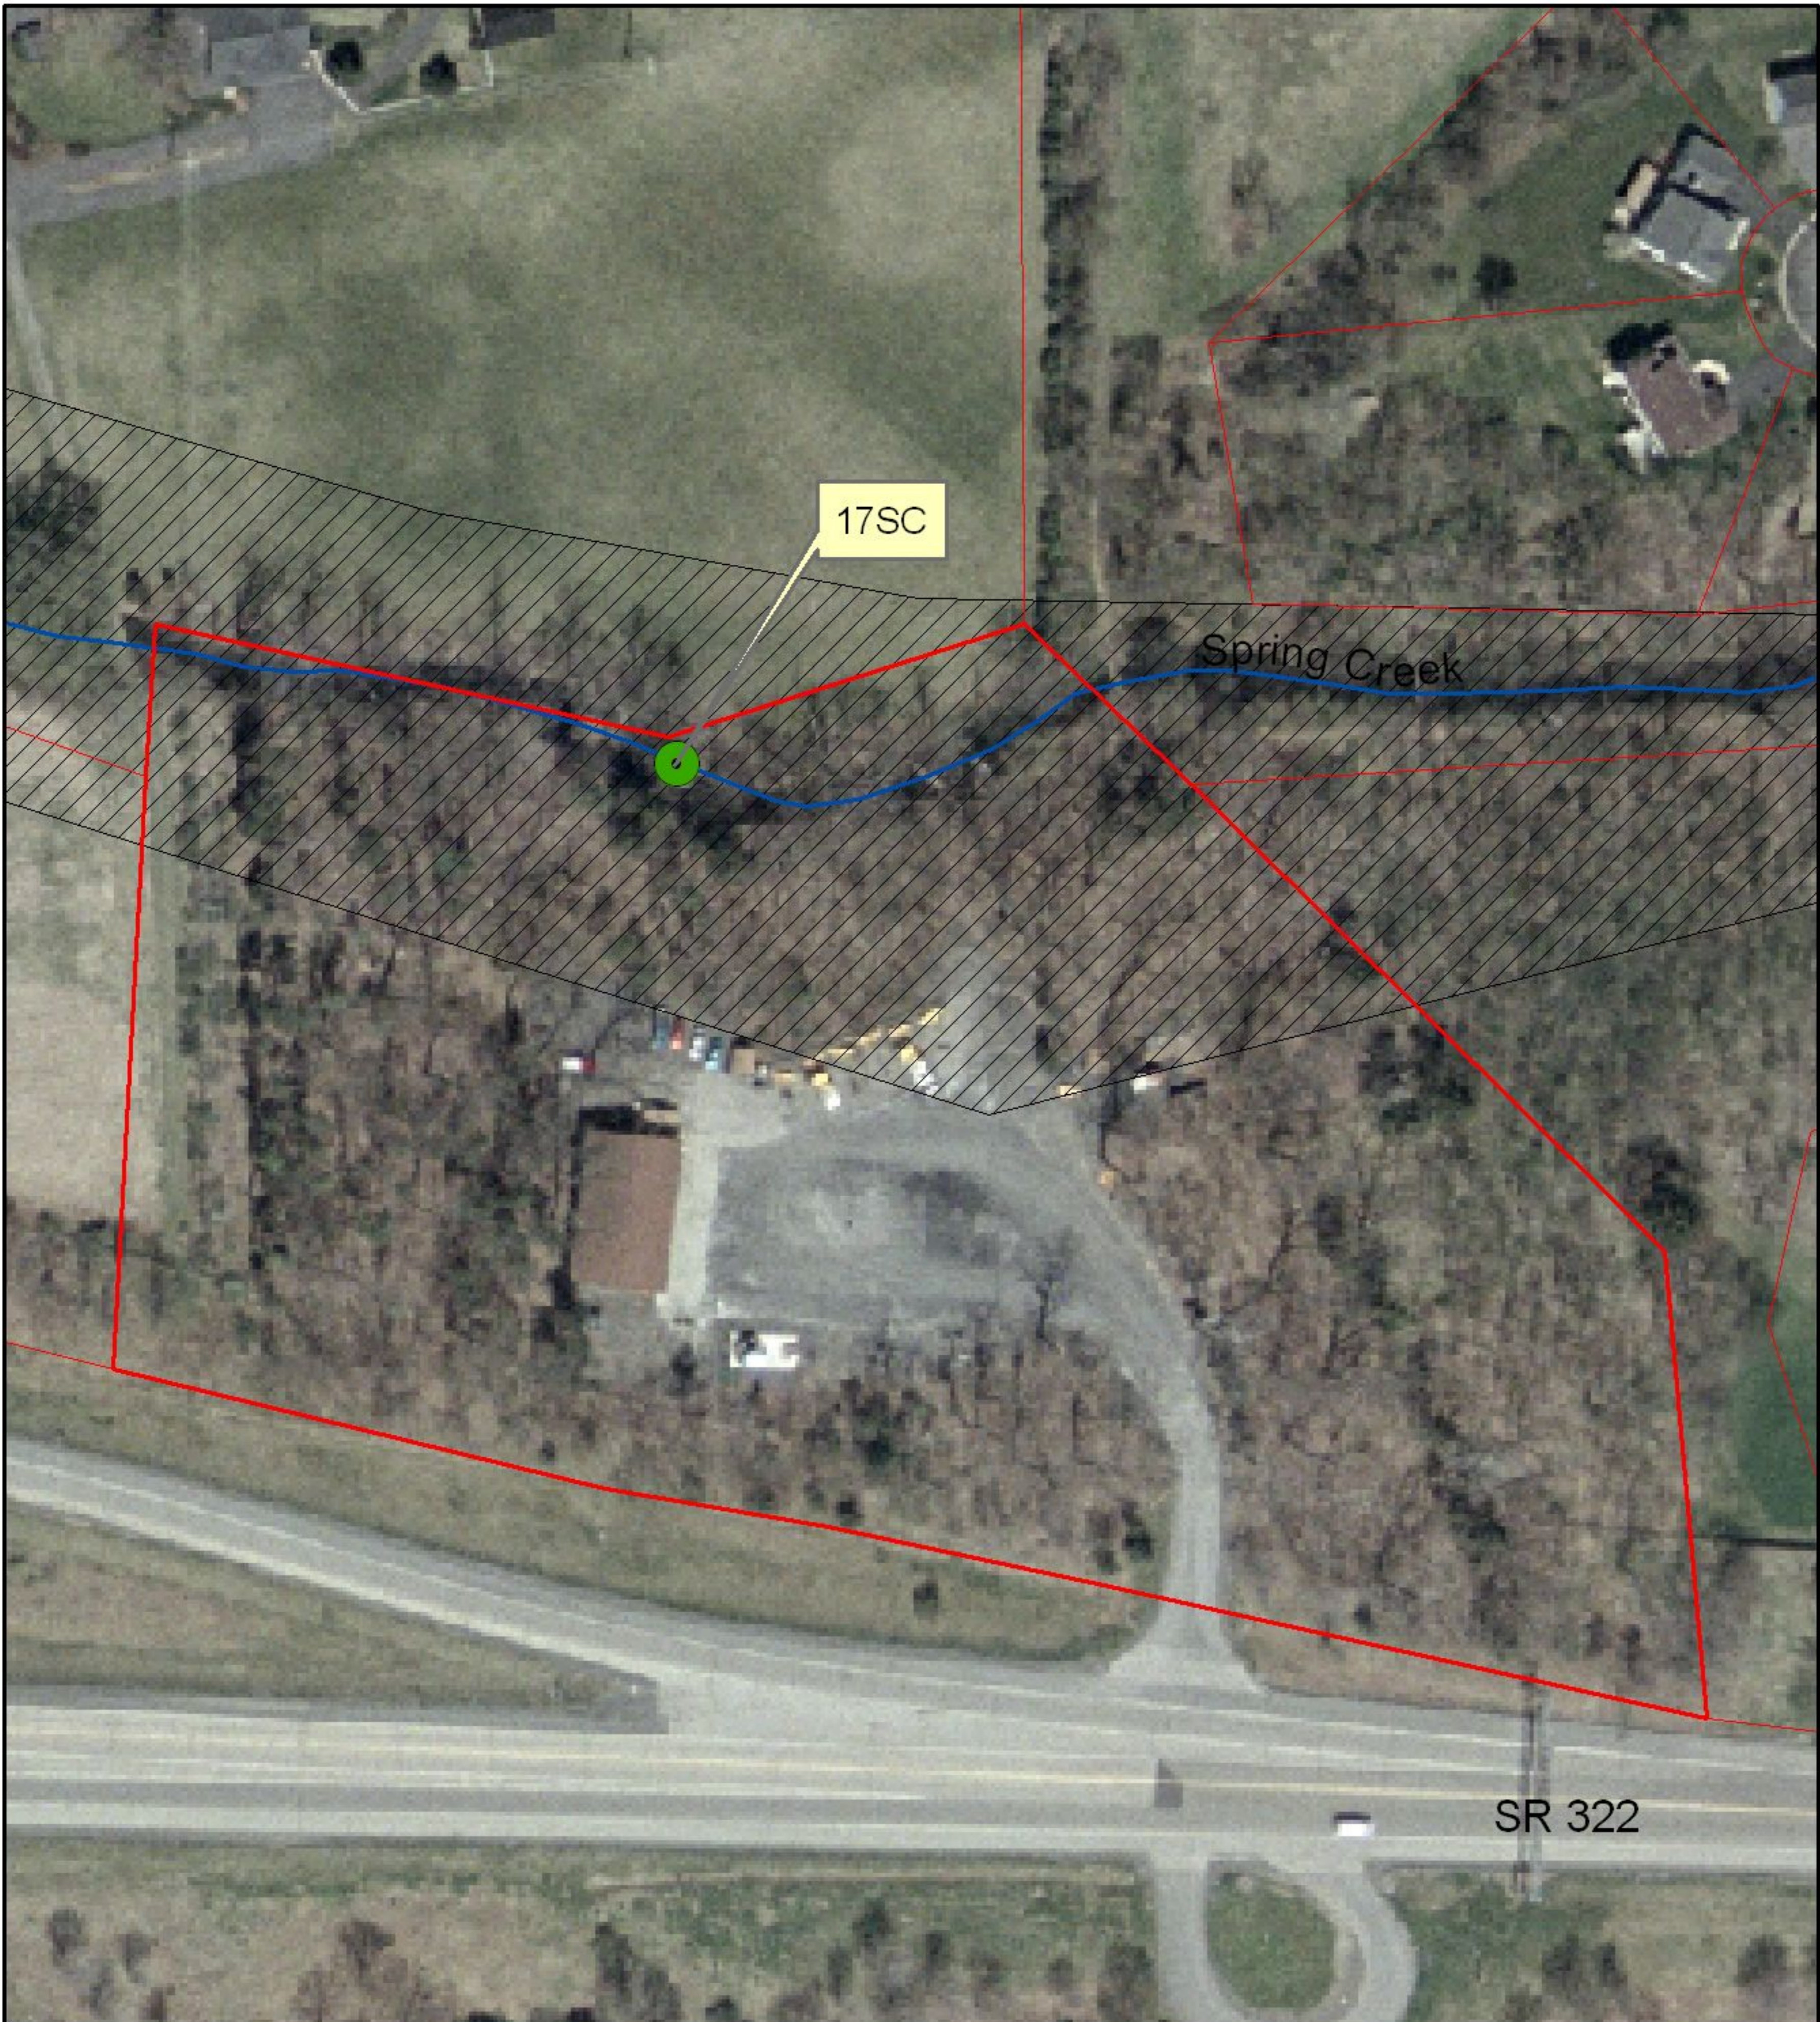
Land Owner = PennDOT  
 Tax I.D. # = 25-004-005C-0000  
 Number of Acres = 6.43  
 Approximate linear meters of stream = 146

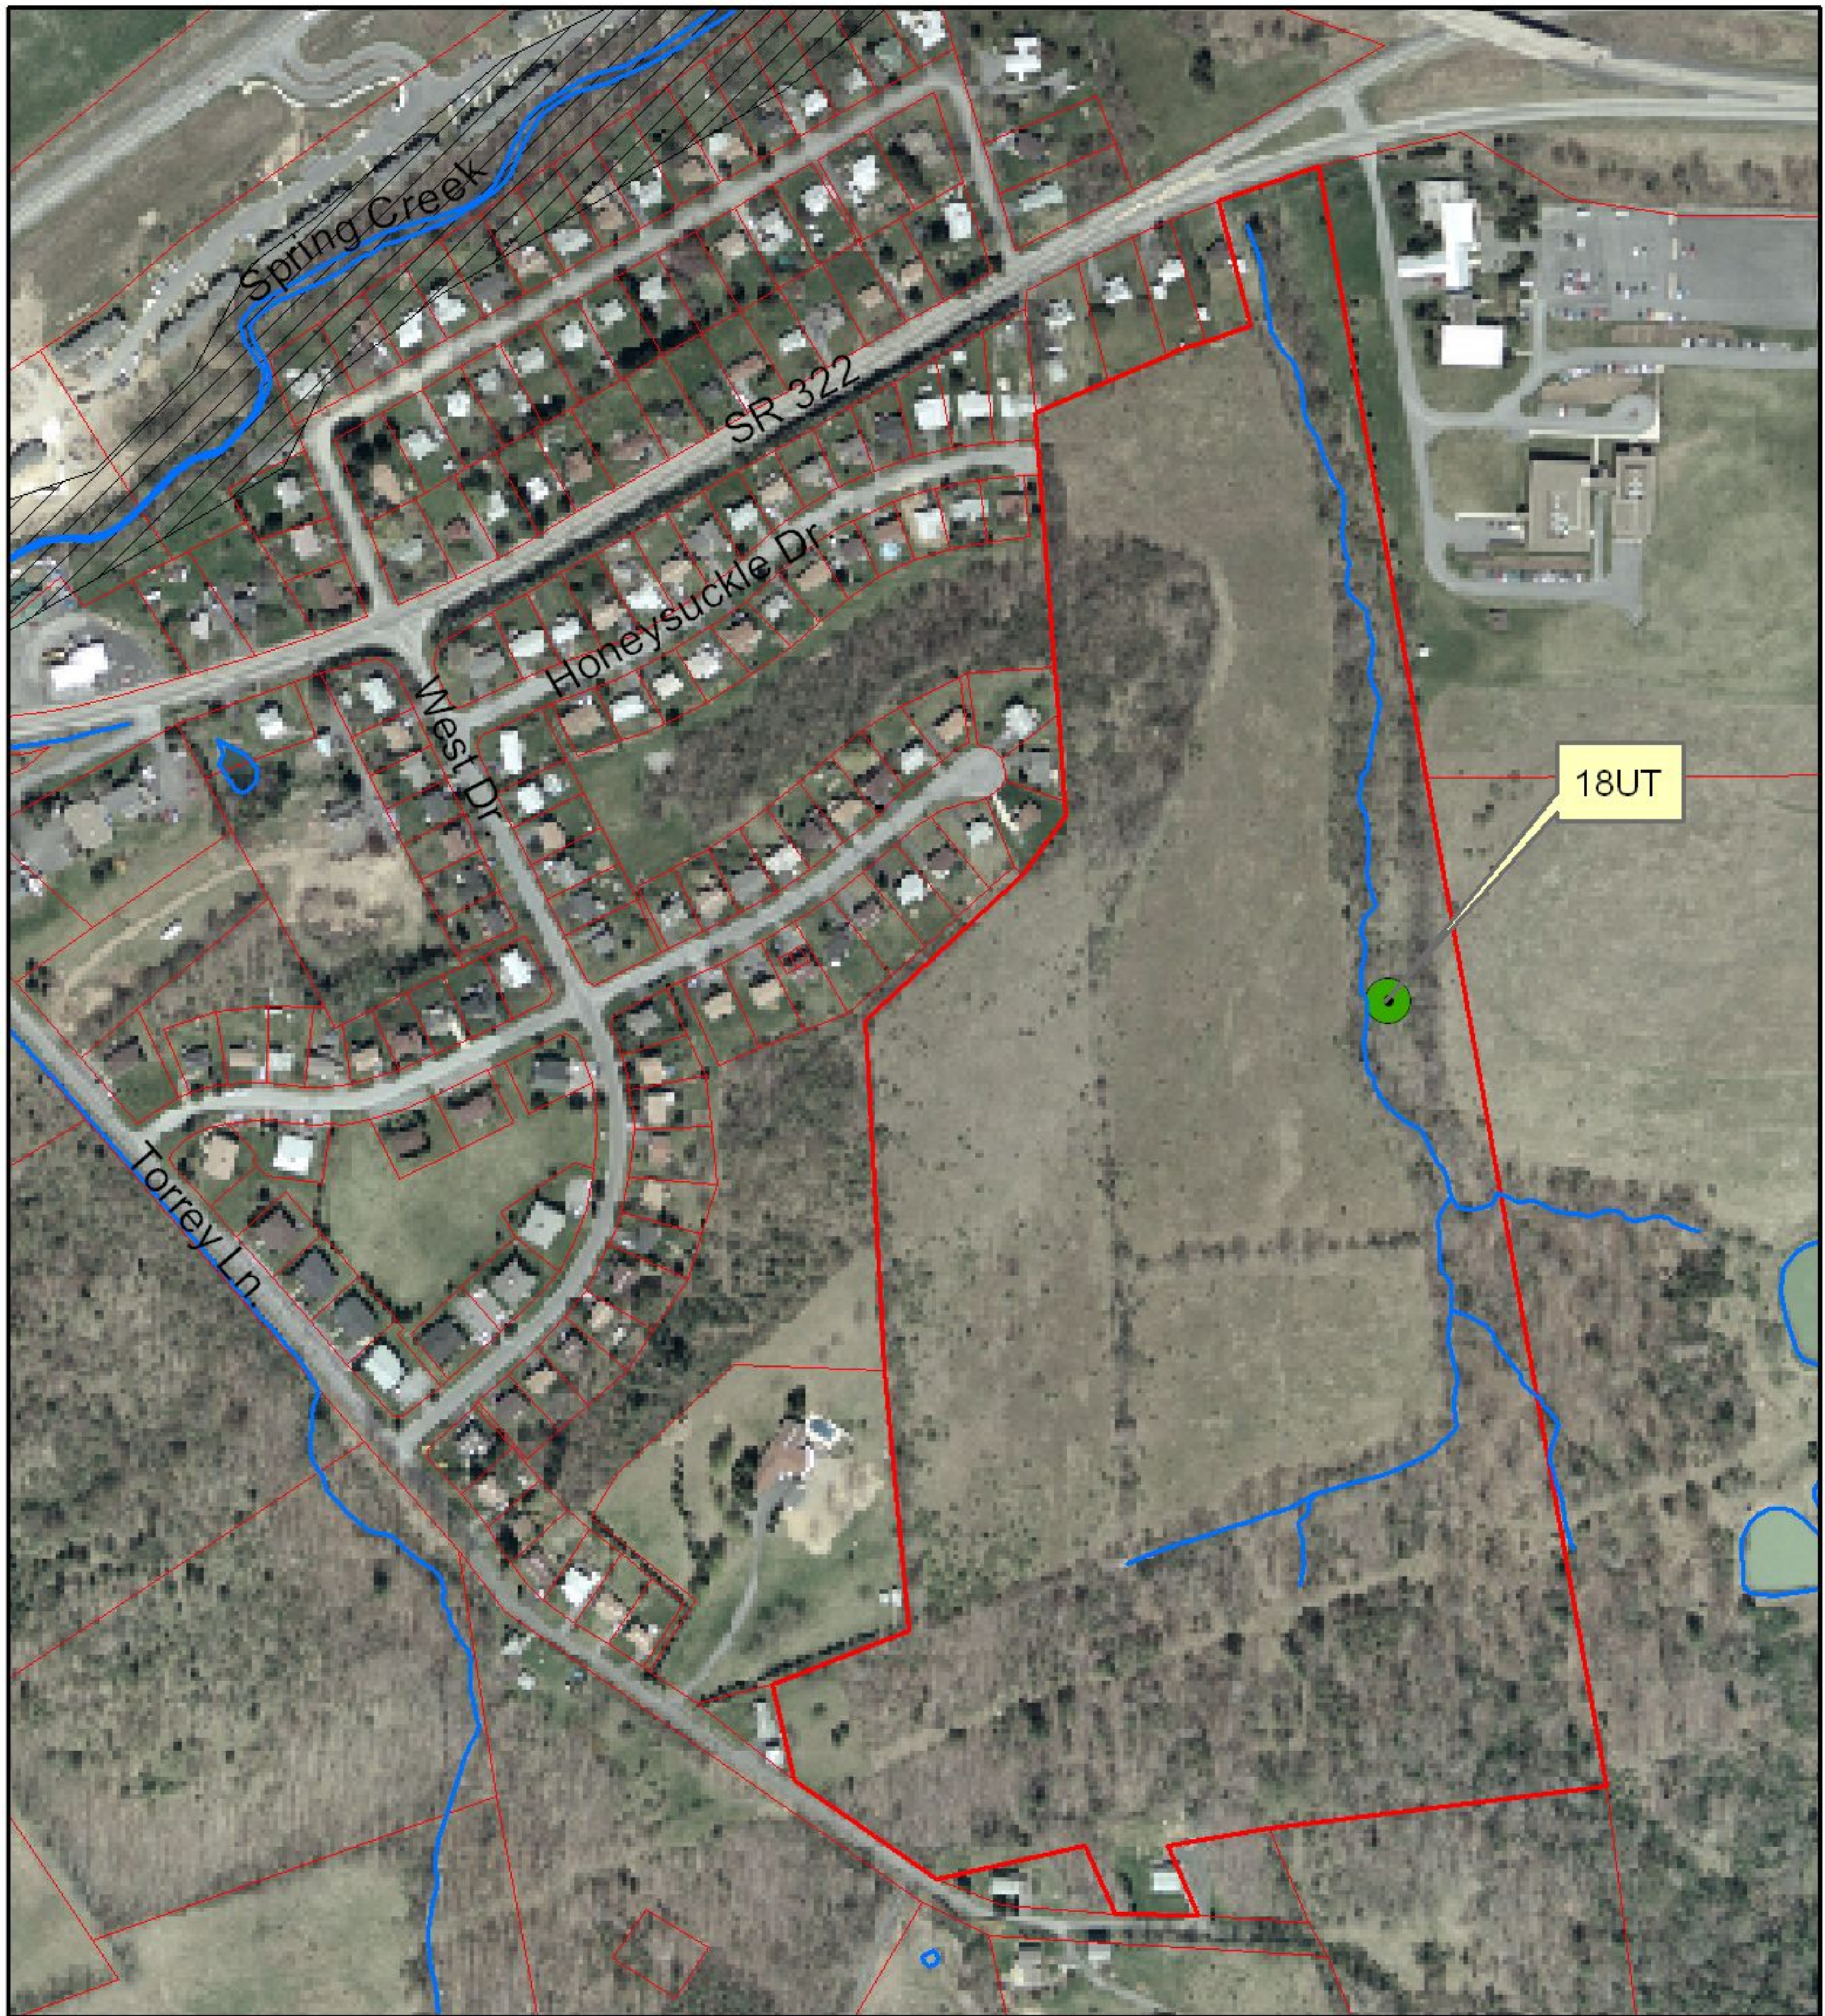
Land Owner = Charles Aikens  
 Tax I.D. # = 25-004-055M-0000  
 Number of Acres = 50.1  
 Approximate linear meters of stream = 1000

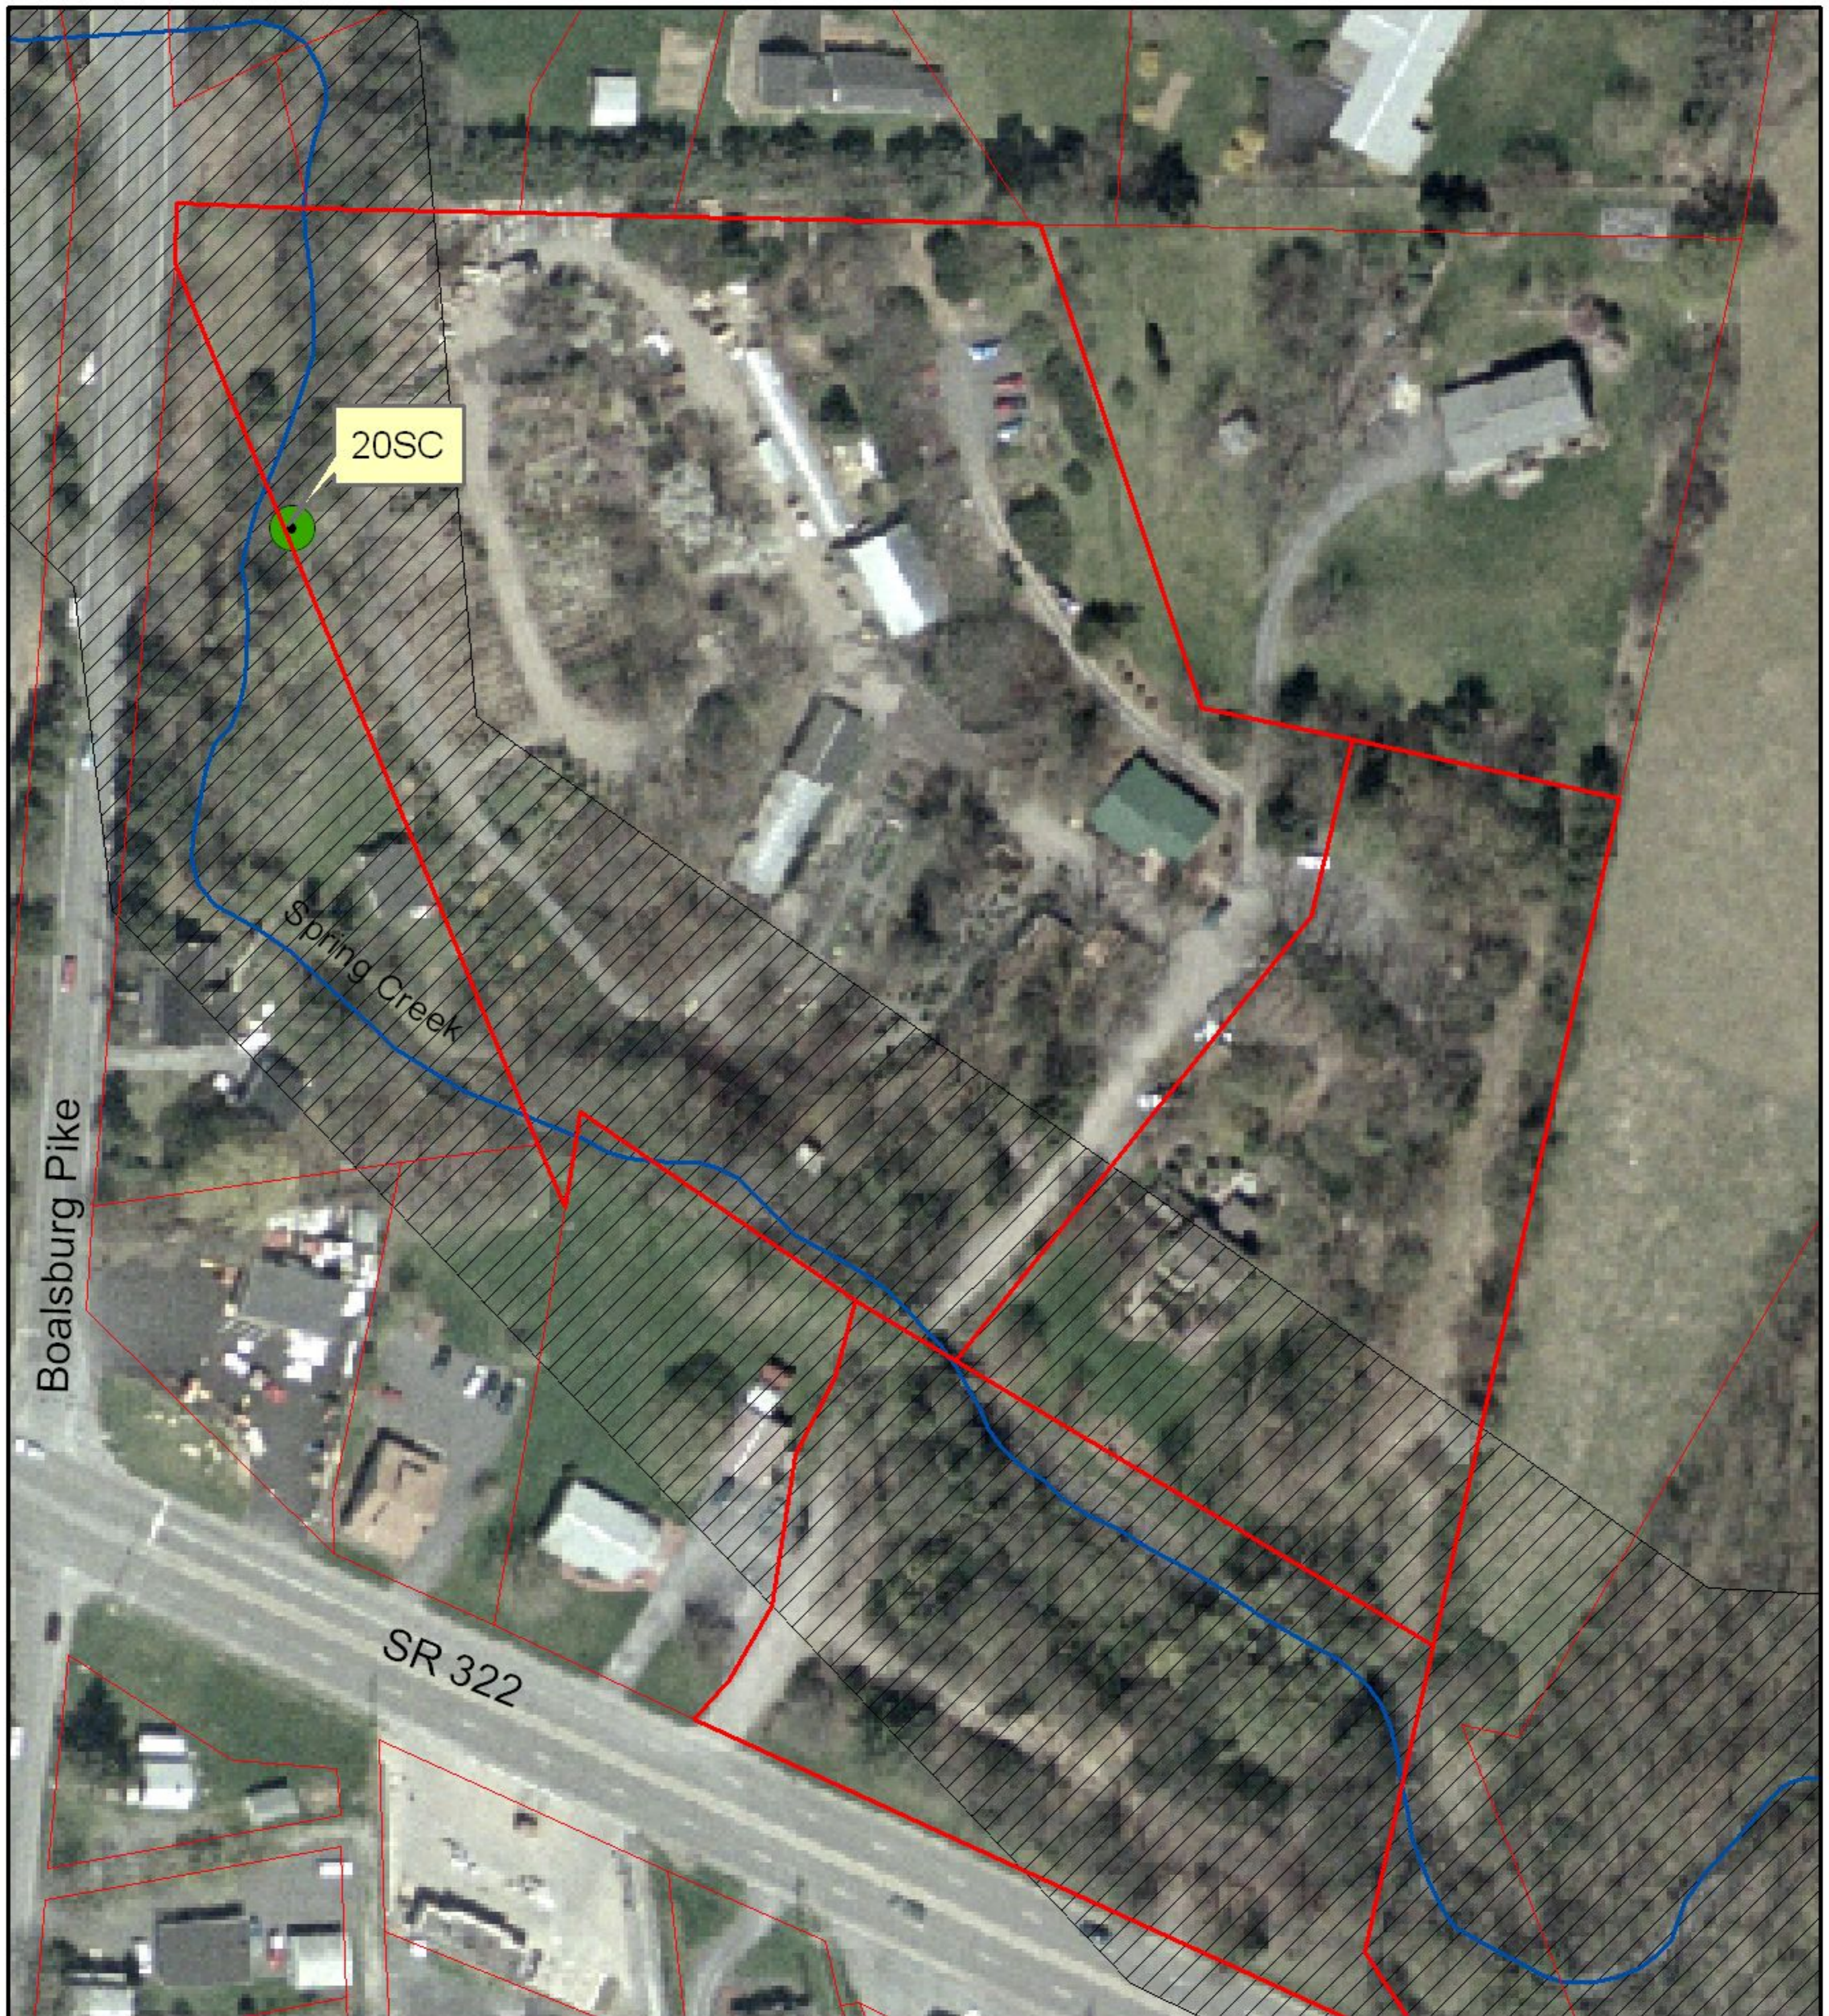
Land Owner = Randy Bachman  
 Tax I.D. # = 25-010-034A-0000  
 Number of Acres = 7.71  
 Approximate linear meters of stream = 290

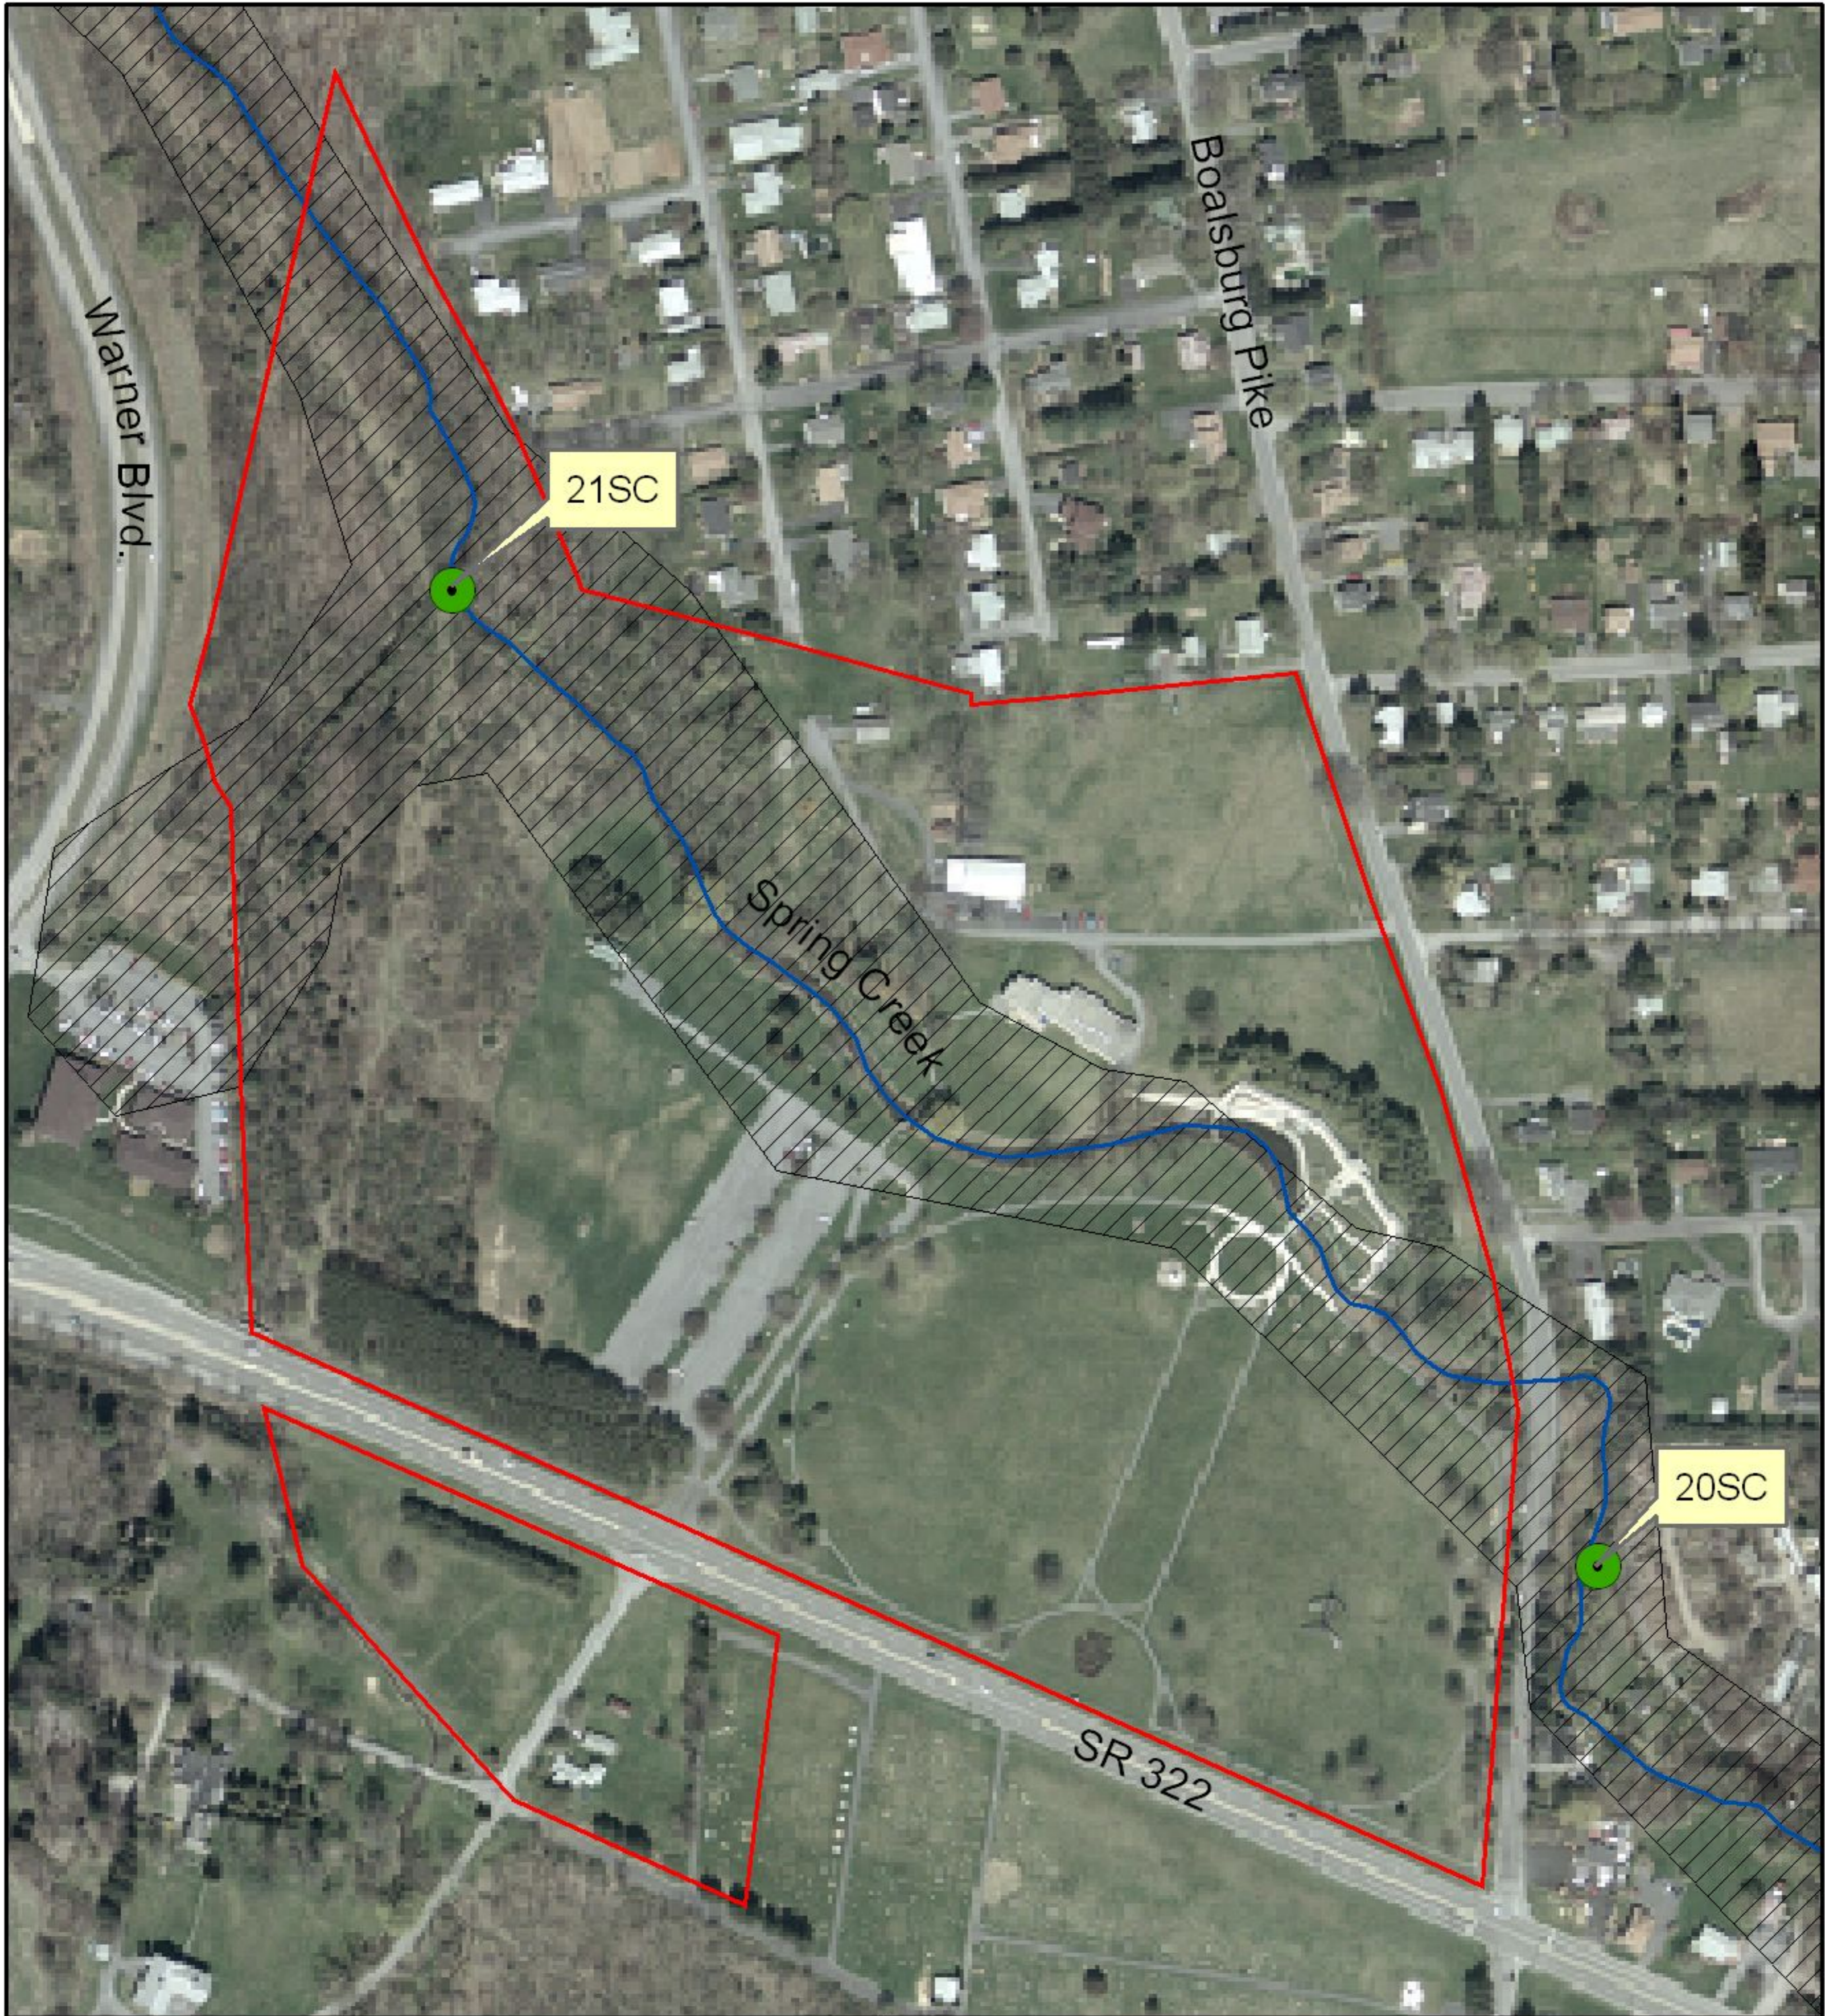
Land Owner = PA Military Museum  
 Tax I.D. # = 25-004-001-0000  
 Number of Acres = 55.05  
 Approximate linear meters of stream = 750

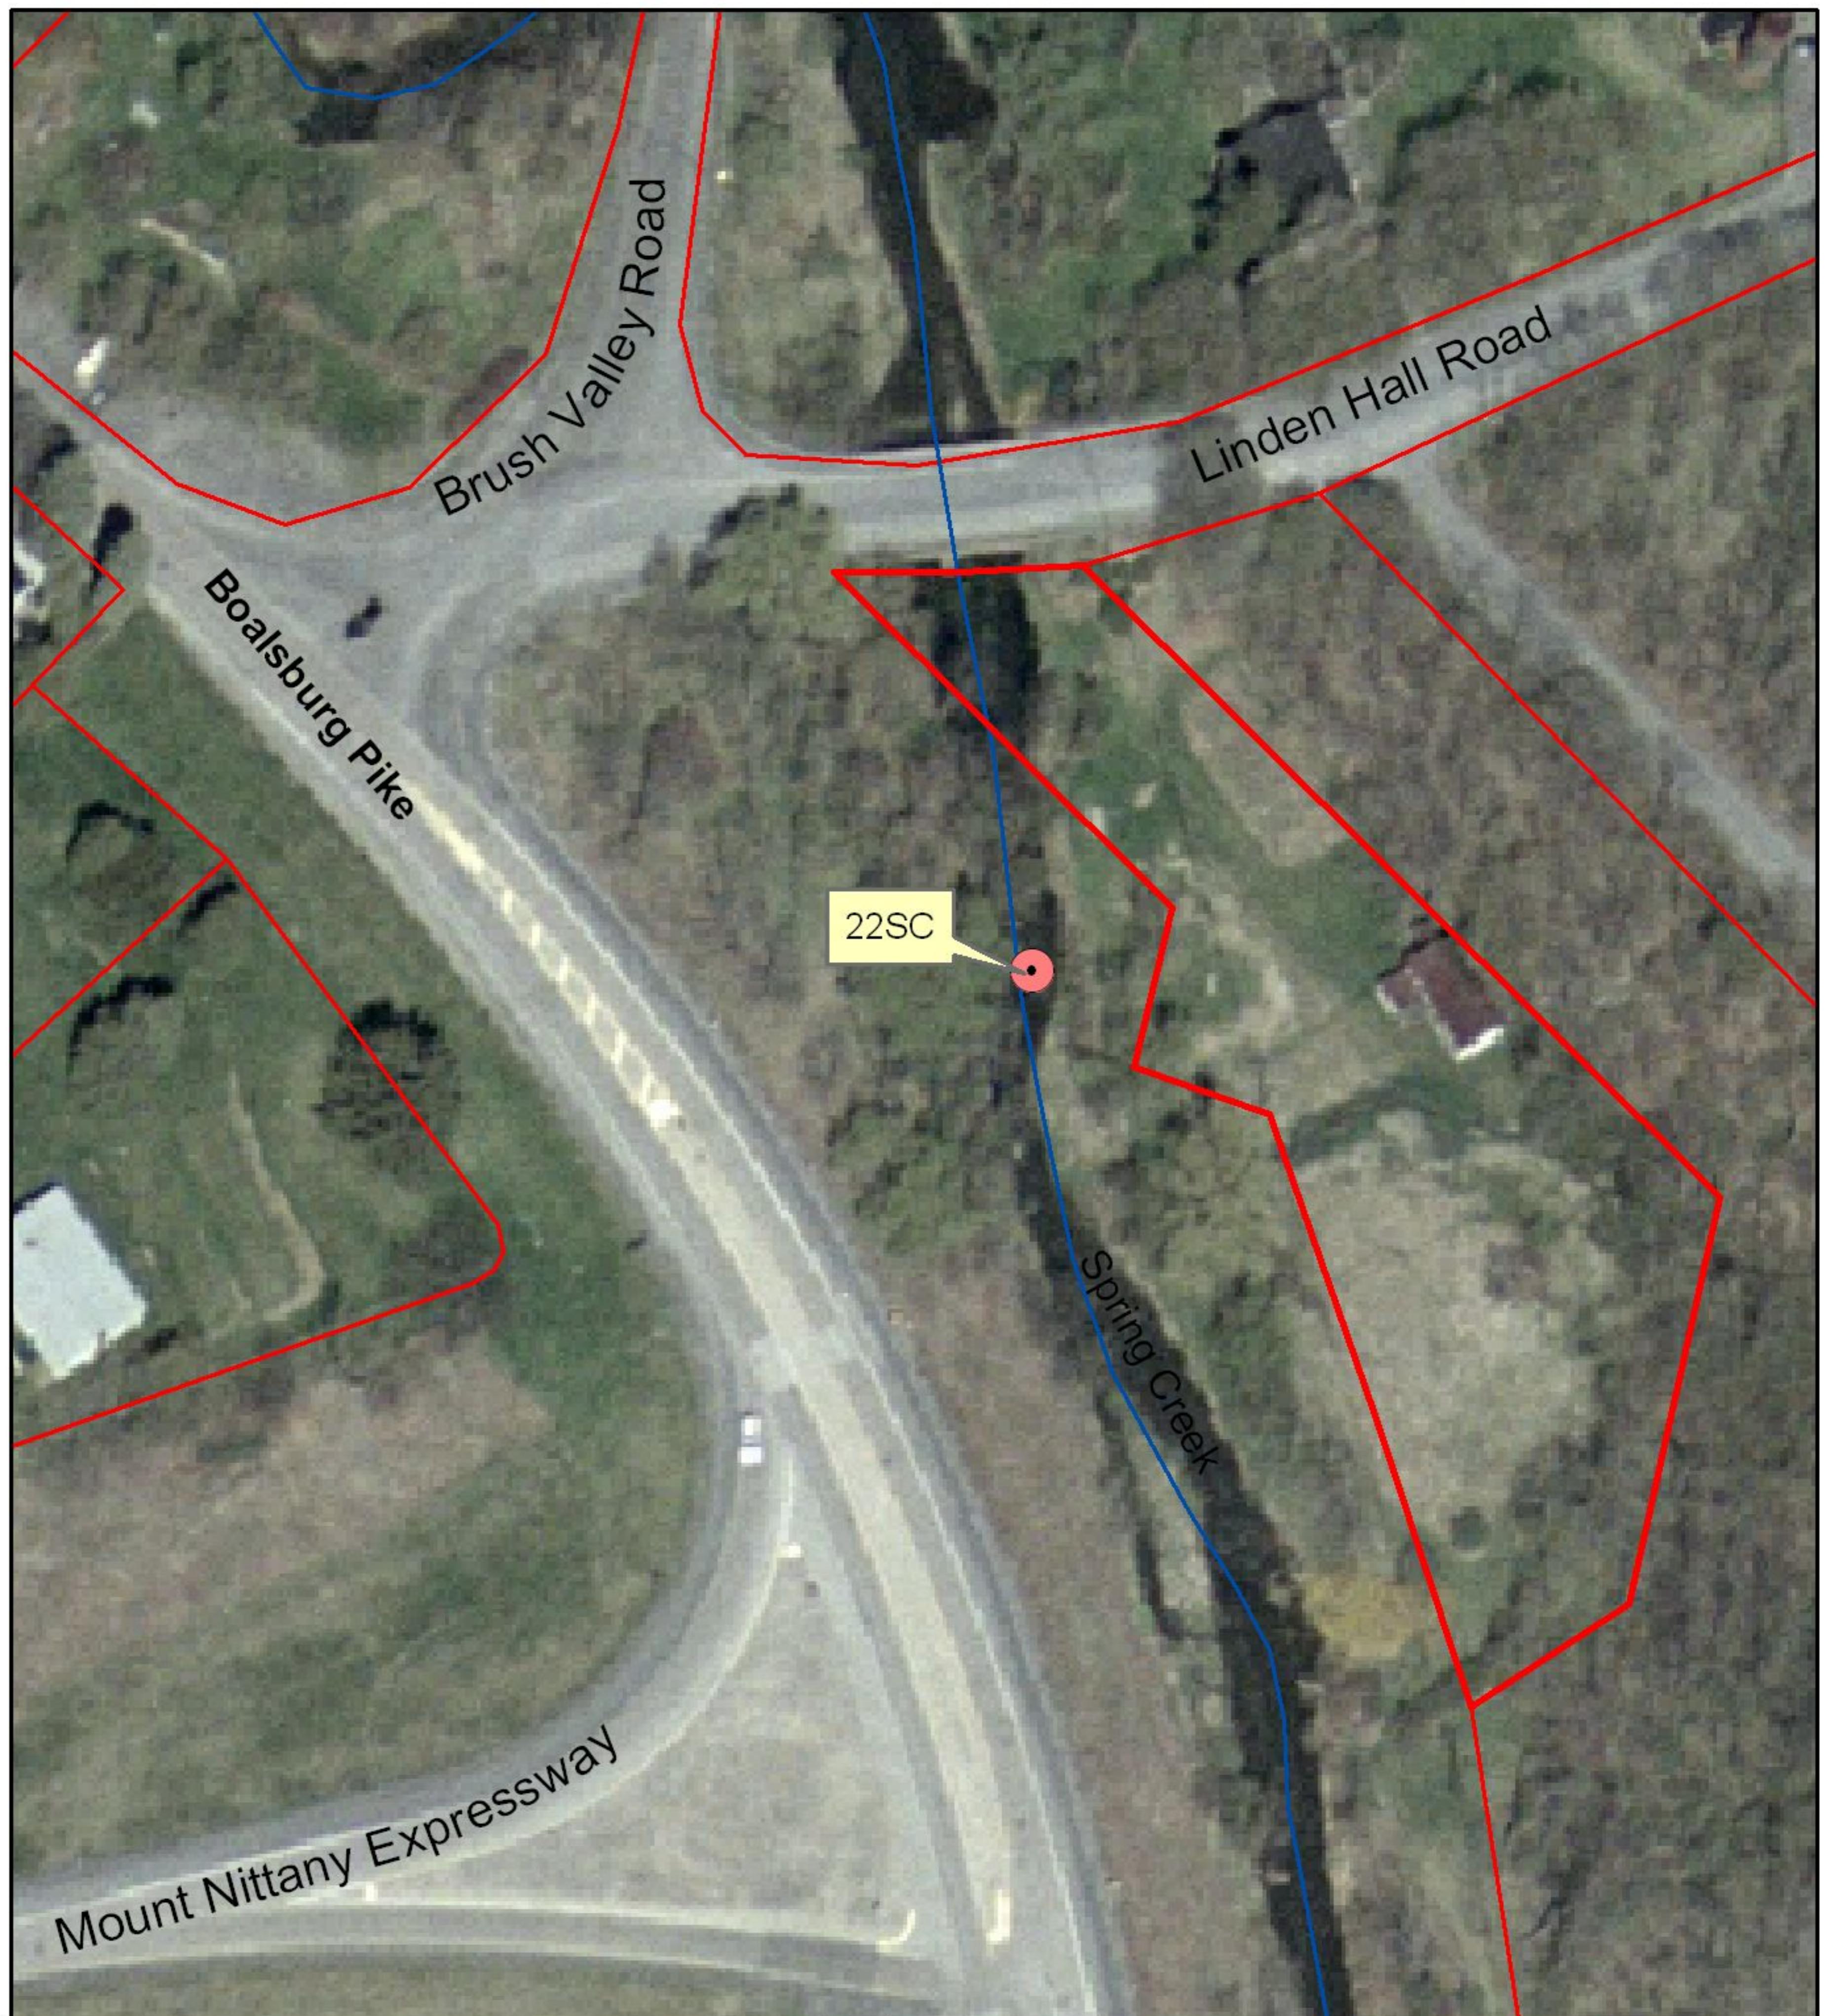
Land Owner - Joseph and Linda Westrick
