WEST BRANCH CRUM CREEK
COLDWATER CONSERVATION PLAN

CHESTER-RIDLEY-CRUM WATERSHEDS ASSOCIATION
DELAWARE RIVERKEEPER NETWORK

July 2009

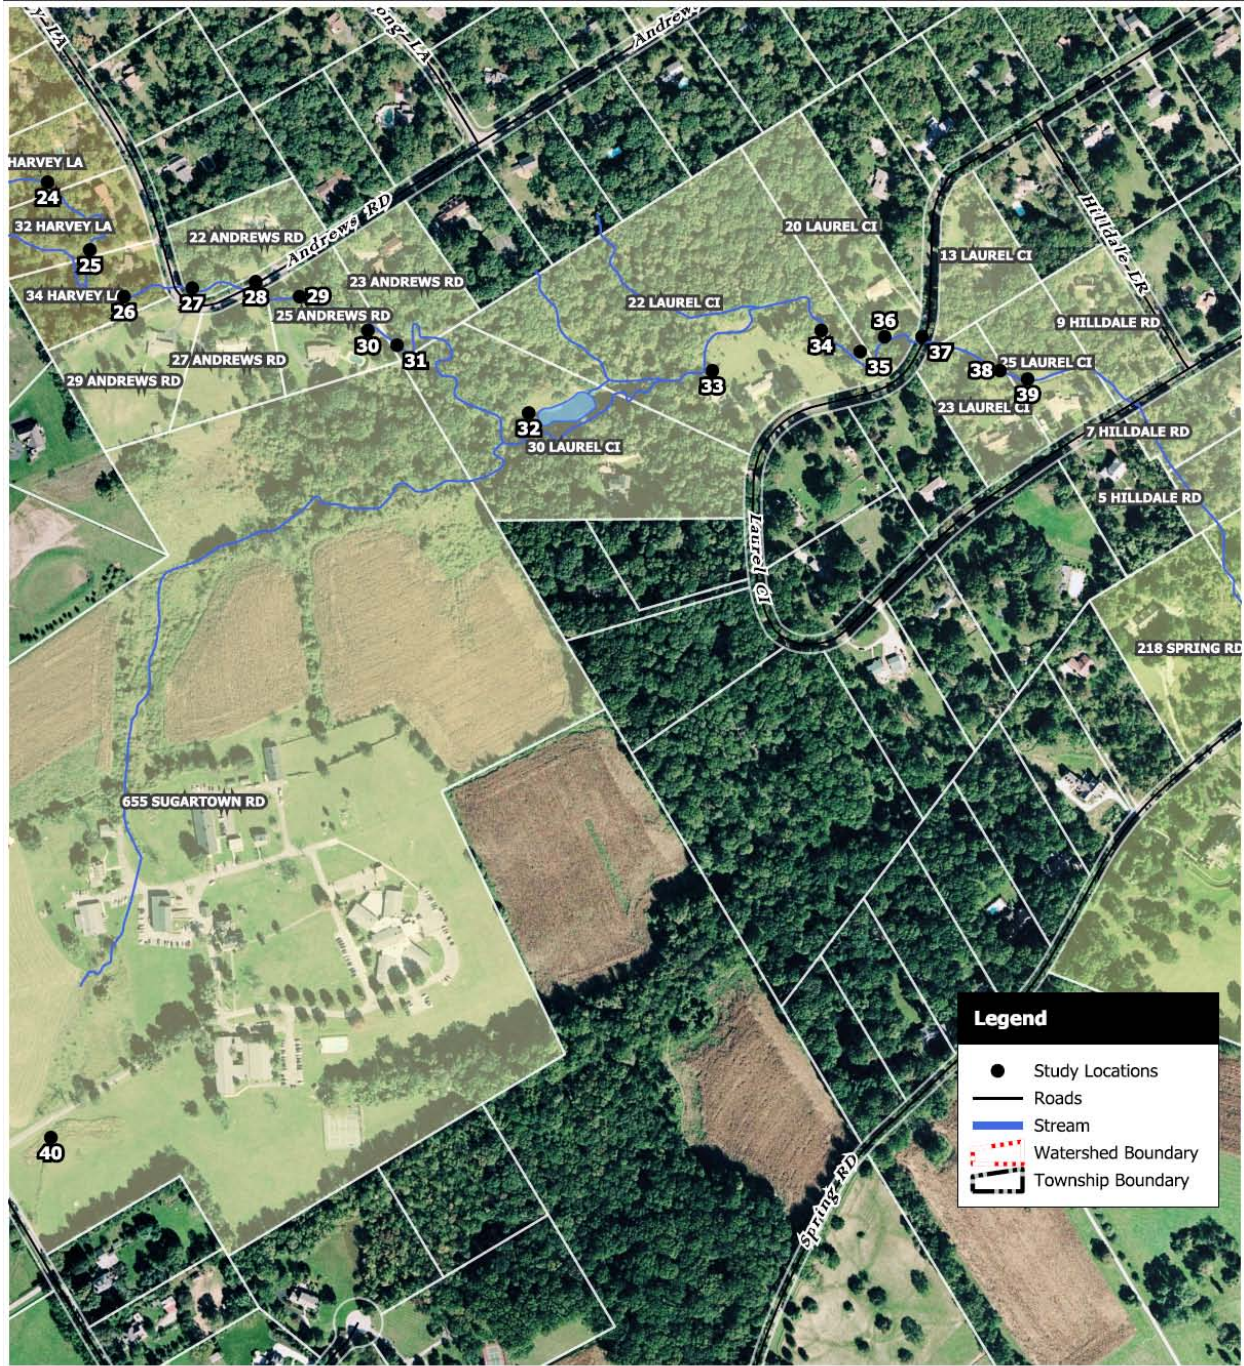
Upper Crum Creek Cold Water Conservation Plan
West Branch Stream Enhancement Opportunities

- Mowing to the top of the stream bank and lack of riparian buffers*
 - *22, 23, 25 Andrews Road*
 - *20, 22, 25, 30 Laurel Circle*
 - *655 Sugartown Road (Devereux Foundation) - tributary*
- Stormwater conveyance from roadways
 - *Andrews Road crossing*
- Dumping of yard waste and trash in the stream corridor
 - *22 Andrews Road - leaf*
 - *22 Laurel Circle - mulch*
 - *30 Laurel Circle - construction*
- Off-line pond receiving lots of sunlight and providing possible habitat for Canadian geese
 - *30 Laurel Circle*
- Instream rock riffle “structure”
 - *23, 25 Laurel Circle*
- Large stand of bamboo
 - *13 Laurel Circle*

- Retrofit stormwater conveyance from Andres Road to encourage infiltration
- Beautify roadside area with native plants
- Mailing or other outreach to homeowners regarding the uniqueness of the West Branch, proper yard waste disposal, need for no-mow zones and riparian buffers, and stream encroachment permits
- Outreach to 13 Laurel Circle about bamboo control/eradication and installation of a native buffer that will provide shade to the stream

- 655 Sugartown Road (Devereux Foundation) – sole streamside property owner for tributary – riparian buffer establishment
- 30 Laurel Circle – property contains lengthy reach of stream and both stream banks – buffer establishment along stream channel and pond margins, streamside cleanup
- 22 Laurel Circle – property contains lengthy reach of stream, both stream banks, and is immediately downstream of 30 Laurel Circle – buffer establishment, streamside cleanup

Site #	Longitude	Latitude	Address	Recommendation
27	-75.5112167	40.013467	22 Andrews Road	Increase no-mow on both banks; beautification project along Andrews to alleviate downslope erosion
28	-75.5105667	40.013517	Andrews Road ROW	Investigate road runoff conveyance method and alter to encourage infiltration
29	-75.5101167	40.0134	25 Andrews Road	Establish no-mow and plant shrubs
30	-75.5094167	40.013133	25 Andrews Road	Live stake lower berm on left bank
31	-75.5091167	40.013017	23 Andrews Road	Establish no-mow and plant
32	-75.5077667	40.012483	30 Laurel Circle	Establish no-mow along pond and stream; live stake along right bank; clean up debris dumped on right bank
33	-75.5058833	40.012817	22 Laurel Circle	Establish no-mow and plant right bank for channel stability and shade; further downstream on this property plant left bank
34	-75.5047667	40.013133	22 Laurel Circle	Remove dumped mulch from right bank

35	-75.5043667	40.012967	20 (LB) and 22 (RB) Laurel Circle	Establish no-mow; live stake upper ~15';
36	-75.5041167	40.013083	20 Laurel Circle	Establish no-mow and plant both banks
37	-75.5037333	40.013083	Road ROW	Control bamboo on left bank to prevent spread; plant with native trees to provide shade
38	-75.5029333	40.012817	23 (US) and 25 (DS) Laurel Circle	Evaluate fish passage of riffle rock structure and modify
39	-75.50265	40.01275	25 Laurel Circle	Establish buffer along right bank
40	-75.512753*	40.006372*	655 Sugartown Road	Outreach to Devereux Foundation on educational demonstration project; no-mow and buffer establishment

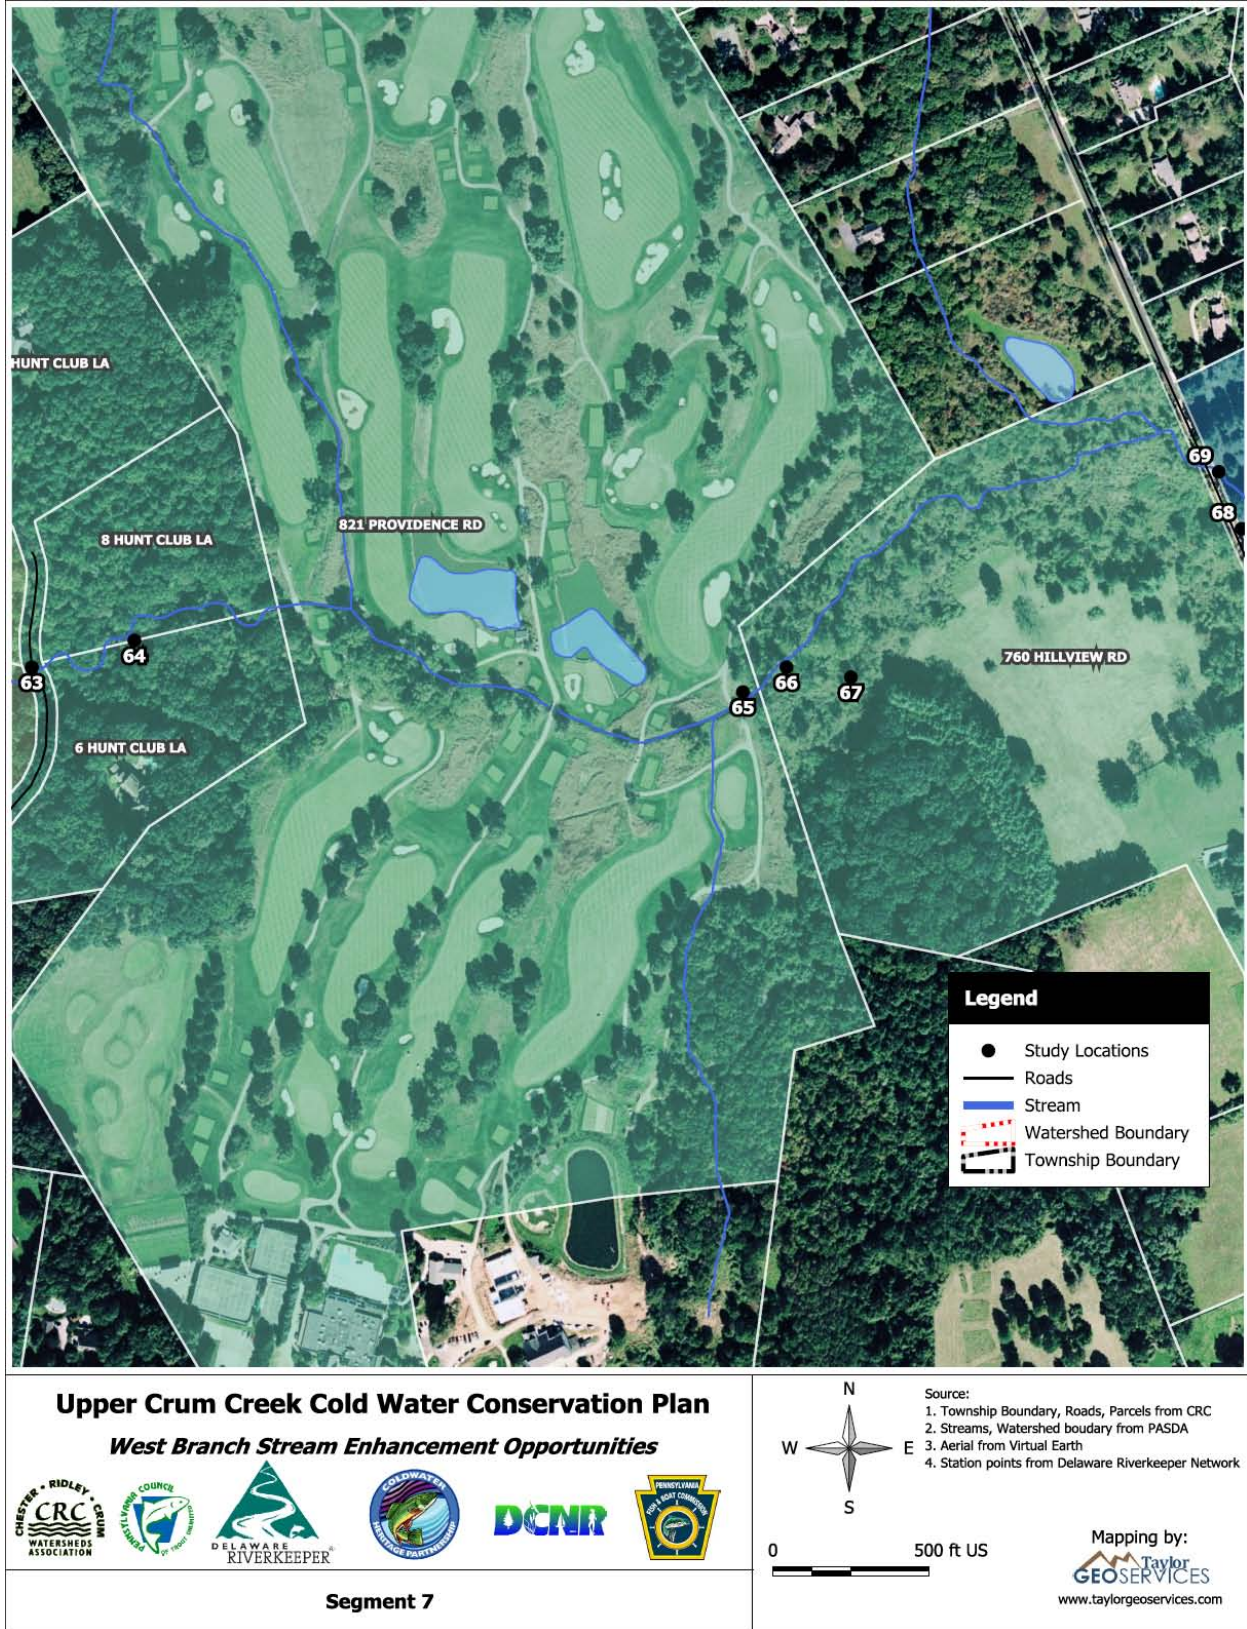
Figure 13. Stream enhancement opportunities for the West Branch in Segment 7.

- Well defined stream channel in upper two thirds of the segment which disappears in the downstream third and becomes a wetland
- Upper and lower thirds are well vegetated
- Riparian buffer largely missing in the middle third
- Only four streamside properties – three residential and one institutional

- Monitor bank erosion at 8 Hunt Club Lane and evaluate need for bank stabilization project
 - Install bank pins to monitor bank retreat rate
 - Access to the site is limited, but possibly tree revetments could be installed to provide surface protection to the bank and reduce near bank stress
- Outreach to 10 Hunt Club Lane about measures that could encourage infiltration of stormwater running off of the Hunt Club Lane bridge and prevent exacerbation of gullies
 - Grade the site to evenly distribute runoff and plant native woody vegetation

Site #	Longitude	Latitude	Address	Recommendation
63	-75.4848	40.002583	10 Hunt Club Lane	Control runoff from Hunt Club Lane
64	-75.483899*	40.002764*	5 (RB) and 8 (LB) Hunt Club Lane	Monitor and stabilize eroding right bank; access is difficult
65	-75.47855	40.002417	821 Providence Road	Plant woody species where possible along West Branch, tributaries, and ponds; retain and increase no-mow zones; continue planting of little blue stem and other native herbaceous species; continued discussion on wetland creation, spillway from pond, and cart path relocation
66	-75.4781667	40.002583	760 Hillview Road	Plant ~350 square foot area on right bank
67	-75.4776	40.002517	760 Hillview Road	Protect wetland
68	-75.4741667	40.003517	741 Hillview Rd	Control runoff from Hillview Road; increase vegetation along formed channel

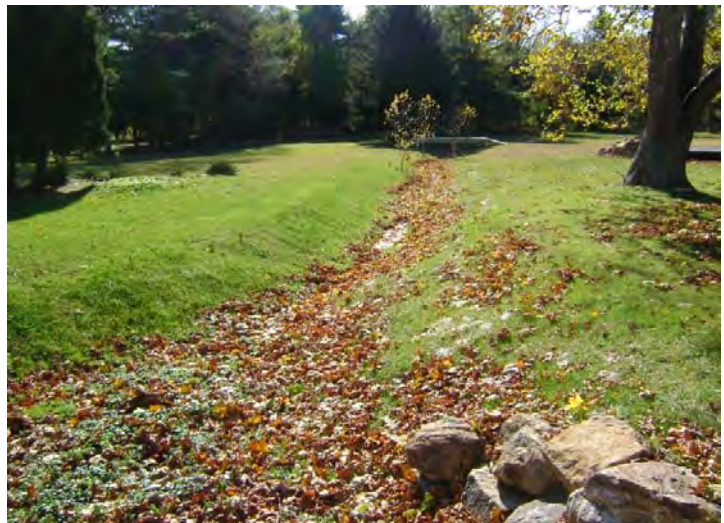
Figure 15. Example location along the West Branch in need of a riparian buffer.

Vegetated buffers protect against stream bank erosion by providing structural stability to the soil and “roughness” to the channel banks. The root masses of native plants, especially woody vegetation, act to hold soil particles together and possess an amazing shear stress. Note that native plants provide greater stability than non-natives due to their rooting depths. Additionally, vegetation creates “roughness” which dissipates stream energy by increasing the friction between the flowing water and the channel banks.

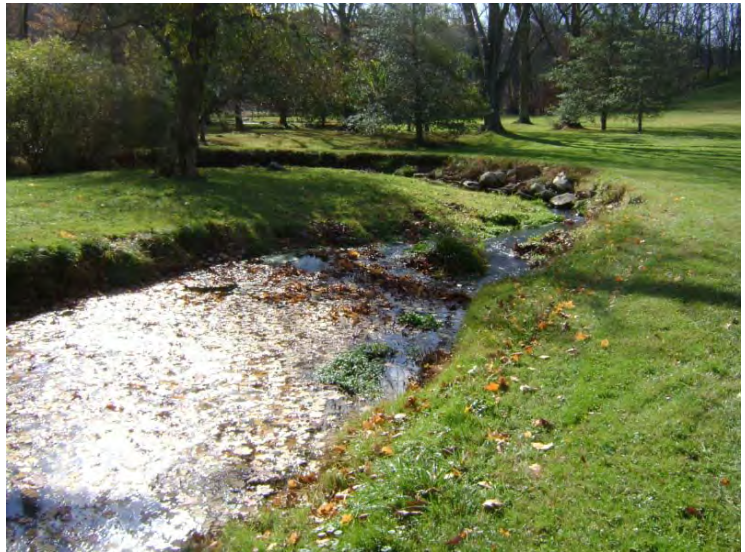
Mowing to the top of a stream bank is one of the most common land management mistakes made by property owners everywhere; streamside residents along the West Branch are no exception. The practice of mowing to the top of the stream bank compacts soil, limits infiltration, stimulates erosion, and deprives the stream of the numerous benefits native vegetation provides a stream. While creating a buffer along the stream with native tree and shrub species is the preferred and recommended action for streamside properties, simply establishing a no-mow zone along the stream will promote plant growth, infiltration, biodiversity, habitat, and stream bank stability. Similar to planted vegetated buffers, the wider the no-mow zone along the stream the more benefits it provides. This is an easy and inexpensive way to improve the West Branch.

Figure 16. Example of mowing to the top bank along the West Branch.

The no-mow zone and buffer will also slow stormwater heading towards the stream. This prevents the formation of rills and erosion while increasing the amount of water that absorbs into the soil to become groundwater. This alleviates flooding during storm events.

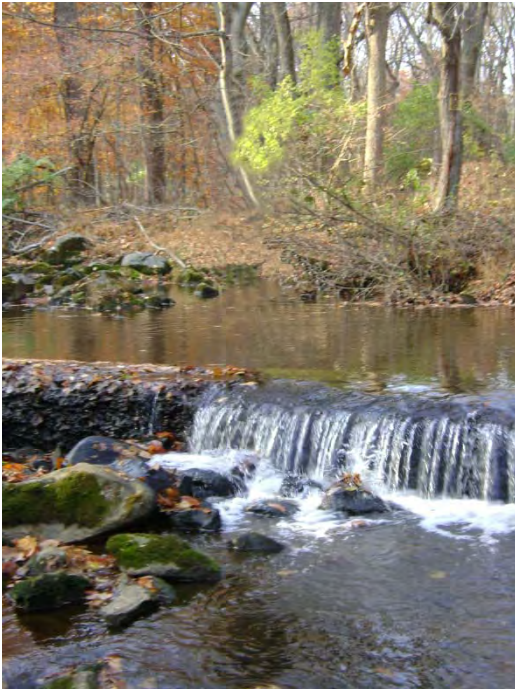
Jump heights on the two West Branch dams range from one to nearly four feet. While both dams are categorized as small (<15 feet), they have a large impact on the physical, chemical, and biological qualities

Figure 17. Looking upstream at upper dam on West Branch Crum Creek.

of the stream. Dams isolate segments of stream. They act as grade control features which may overly flatten or steepen channel slope and thus effect distribution of energy, water, and sediment, as well as aquatic life and fish. The dam structure itself acts as an impediment to stream flow. As flow slows at the obstruction the water's sediment load drops out. This results in the accumulation of fine sediments behind the impoundment. These fines smother channel substrate and take away habitat for benthic macroinvertebrates, an integral component of the aquatic food chain. The water that passes over the dam is devoid of sediment and is referred to as hungry water. Without sediment "hungry" water has more energy, is more erosive, and can attack channel banks and bottom in an attempt to pick up sediment resulting in downcutting of the channel bottom and excessive bank erosion.

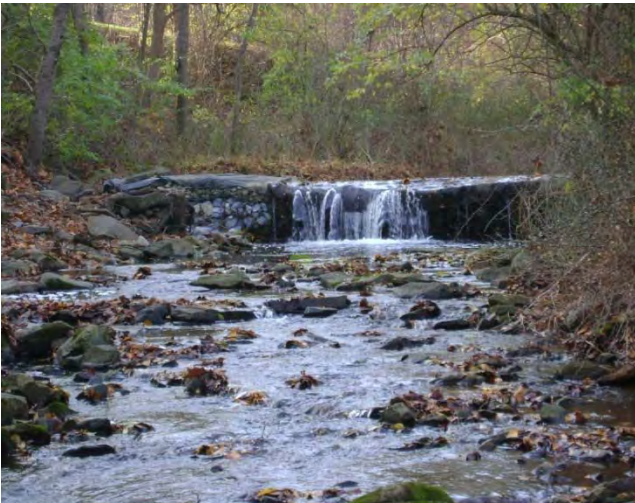
from the dam is not neutralized as it flows downstream but instead water temperatures remain artificially elevated for up to two miles downstream. Therefore, the dams on the West Branch are not only elevating local water temperatures around the dam but are also contributing to warmer water in the main stem of Crum Creek where the highest density and biomass of trout were found in the 1999 Pennsylvania Fish and Boat Commission survey. Like other trout species, brown trout thrive in cold, clear water streams and lakes. The preferred or optimal temperature range for brown trout is 53 to 66 degrees Fahrenheit. Various temperatures have been reported as the upper lethal limit for brown trout, ranging from 78 to 81 degrees Fahrenheit (Piper et al, 1982) (Raleigh et al, 1986). Elevated stream temperatures result in shifts of macroinvertebrate and fish assemblages, densities, and richness.

Figure 18. Looking upstream at lower dam on West Branch Crum Creek.

Dams also pose migration barriers to fish. Brown trout, like rainbow trout, are considered strong swimmers and leapers. Brown trout are stated to have a maximum jump height of 2.6 feet (Reiser & Peacock, 1985). However, jump height is dependent upon other situational variables including water velocity and the depth of the plunge pool from where they jump. Though this report cannot state conclusively, these dams likely are at least partial barriers to fish migration along the West Branch, meaning they act as barriers to certain trout life stages under certain flows.

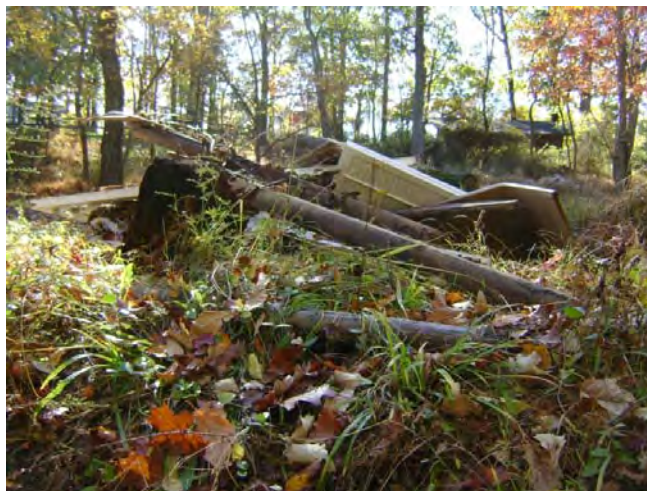
Figure 19. Trash dumped next to the West Branch.

However, leaves and twigs naturally generated by streamside vegetation should be left alone and not removed from the stream corridor as this material provides food and habitat for fish and aquatic insects.

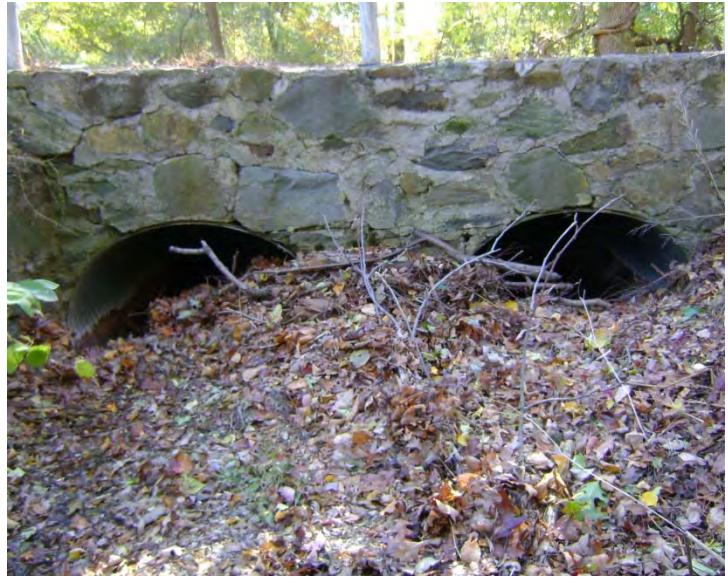
Undersized culverts result in bulbous scouring of the stream channel and banks at both the culvert intake and outfall. Debris which accumulates near culverts exacerbates this occurrence and can result in excessive, unnecessary erosion. Property owners adjacent to road crossings, bridges, and culverts should visually inspect these areas for debris which may block or hinder stream flow following storm events. After storm waters have receded this material should be broken up and/or removed from the channel.

Figure 20. Debris blocking Forest Lane culvert intake.

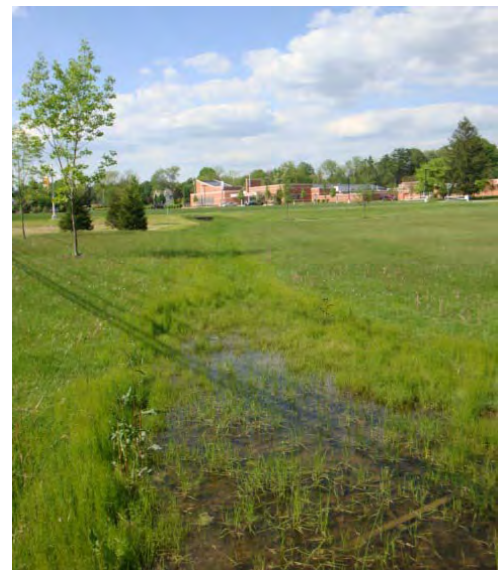
Figure 21. Opportunity for stormwater BMP along the West Branch.

★ *Utilize BMPs to spread stormwater out and encourage infiltration.*

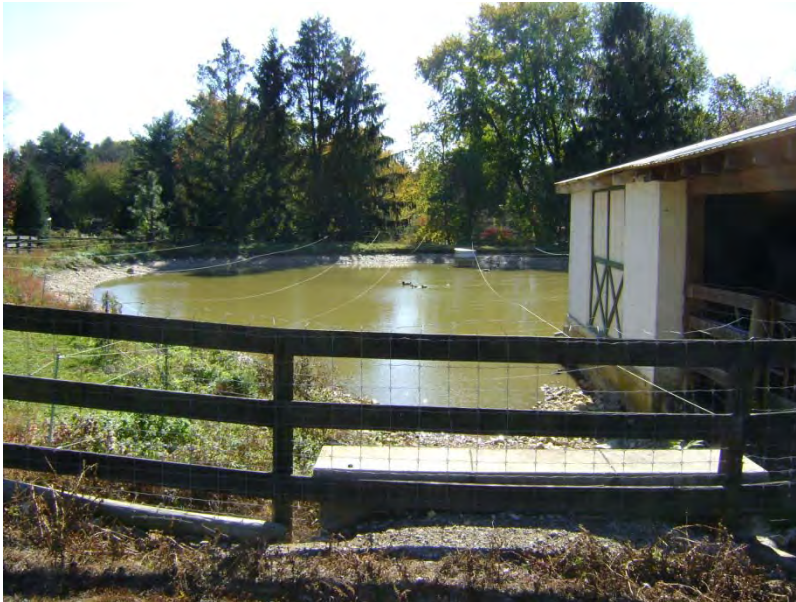
In terms of this Coldwater Conservation Plan, ponds pose three concerns to the West Branch. Ponds by their

Figure 22. In-line pond at the headwaters of West Branch Crum Creek.

nature are heat sources and can artificially elevate stream water temperatures which can be detrimental to the West Branch's brown trout population and the insects on which they feed. Secondly, aging ponds in particular lose their depths and accumulate nutrients. This fuels algae growth and increase temperatures, both of which reduce dissolved oxygen levels. Lastly, ponds often provide habitat for Canadian geese, a recognized nuisance to water quality and other wildlife.

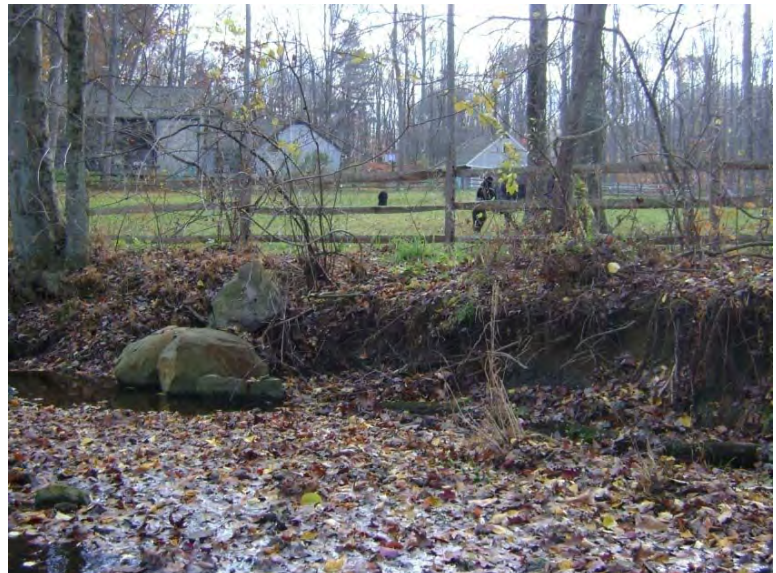
Grazing of animals within 100 feet of the West Branch is not a permitted use under the township's Riparian Buffer Area Conservation District ordinance (§73-62, B) (Willistown Township, 2000). Two sites along the West Branch were noted where horses pasture in close proximity to the stream with little or no riparian buffer. Downstream of one location, algal blooms were observed which may be due to excess nutrients from the pasture. Previous water quality studies of the West Branch documented elevated fecal coliform levels (Mesa Environmental Sciences, 2004). Outreach directed at these and other horse owners on how to properly pasture horses near streams will help to improve West Branch water quality.

Figure 23. Horse pasture within 10 feet of the West Branch.

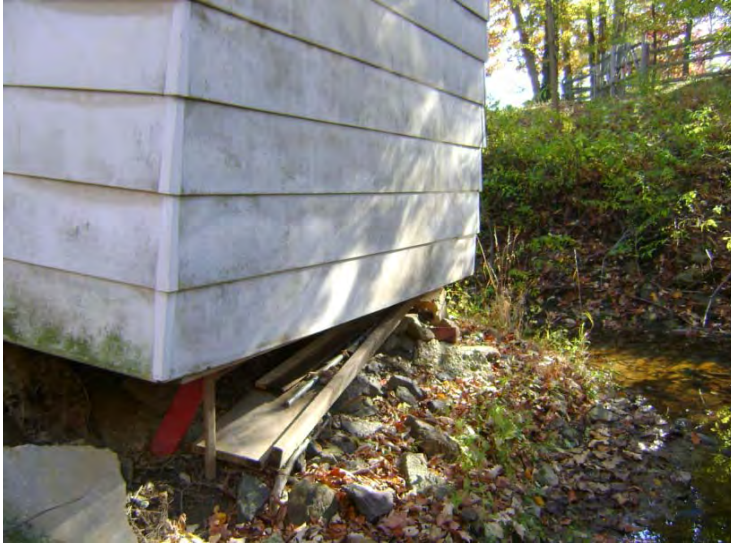
Figure 24. Shed adjacent to West Branch Crum Creek.

Because of the floodplain's critical function, it is important that encroachment of the floodplain is avoided to the greatest degree possible. Along the West Branch there are several garages and sheds adjacent to the stream and within the floodplain. These buildings should be relocated if possible so as to protect the building from damage sustained in a flood and to limit pollution to the West Branch during storm events. For example, a shed within the floodplain containing various containers of gasoline, oil, and other common
