Dam Removal Feasibility Study for Mensch Mill Dam and Impoundment

November 2004

Prepared by:
F. X. Browne, Inc.

Prepared for:
Perkiomen Valley Chapter of
Trout Unlimited

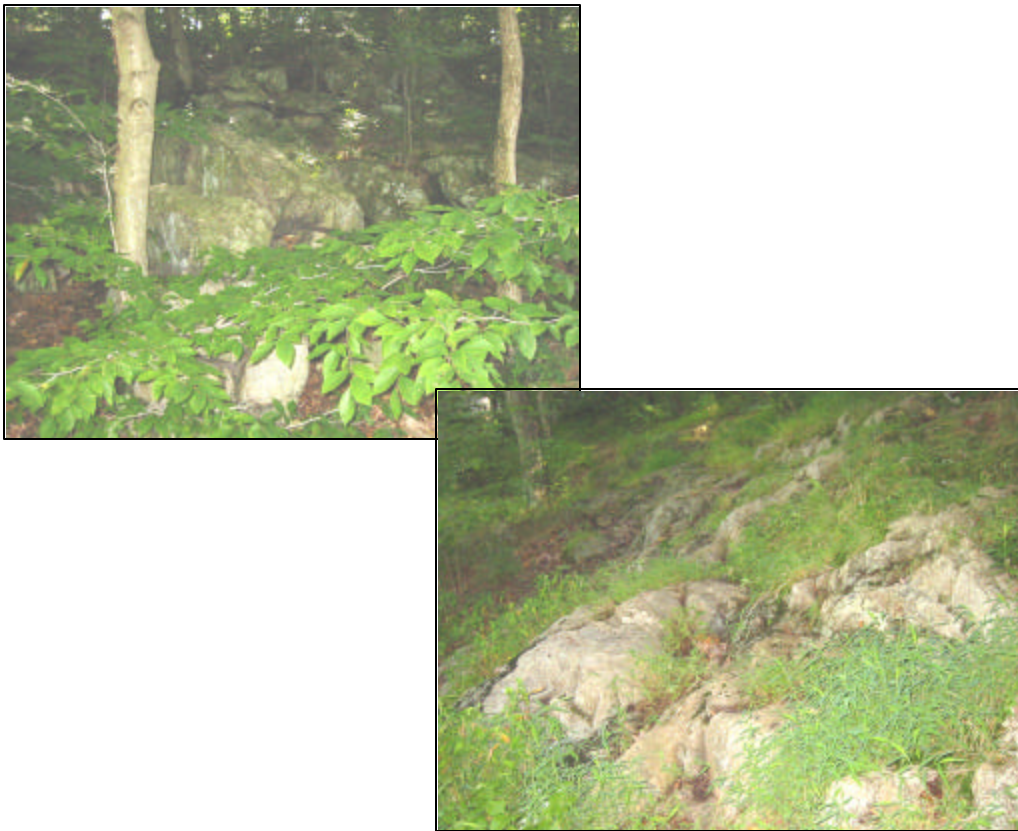
Figure 4. Rock outcroppings adjacent to pond

Like much of the Reading Prong region, Camp Mensch Mill is situated on erosion resistant, igneous and metamorphic rock called granitic gneiss. Weathering of the gneiss materials has produced the well-drained Chester soils that characterize most of camp property. However, most of the impoundment area with the exception the far downstream area is underlain by Atkins soils. These are primary poorly drained alluvial soils deposited in floodplains and differ markedly from the well-drained Chester Soils found in upland regions. Depth to bedrock in Atkins soils is generally 4-6 feet. Atkins soils give way to Chester Soils in the downstream reaches of the impoundment.

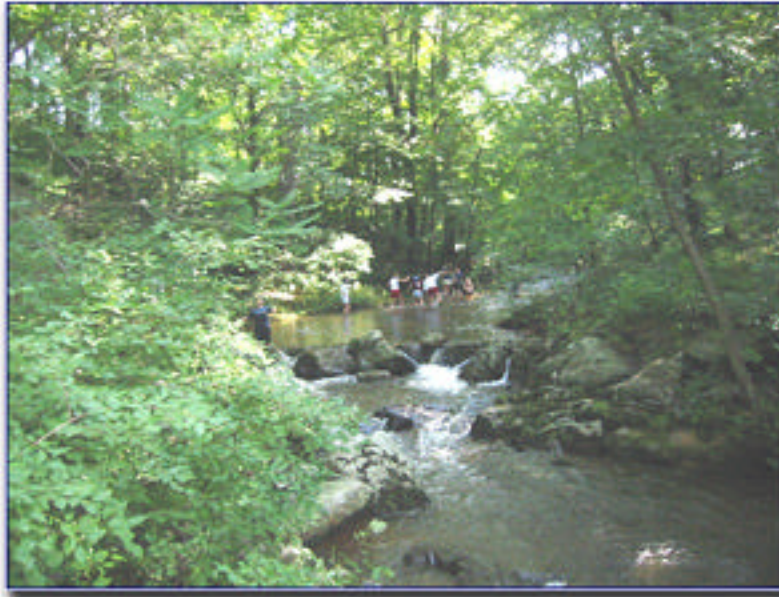
**Figure 5. West Branch Perkiomen Creek
upstream of Mensch Mill Dam**

Within the study area the creek is a 3rd order stream with an approximate slope of 3% and is strongly confined by steep hills on both sides of the stream channel. The strong confinement of the channel suggests that channel geomorphology within this area (e.g., channel location, sinuosity) is largely dictated by the shape and location of the valley walls, rather than by floodplain processes. Upstream and downstream of the study area, the stream valley widens considerably. Groundwater often moves from the shallow hyporeic zones surrounding the active stream channel into the active stream channel itself during transitions from unconfined to confined valleys. This suggests that groundwater maybe flowing into the stream channel within or immediately upstream of the study area. The drainage area to the study site is approximately 4.5 square miles.

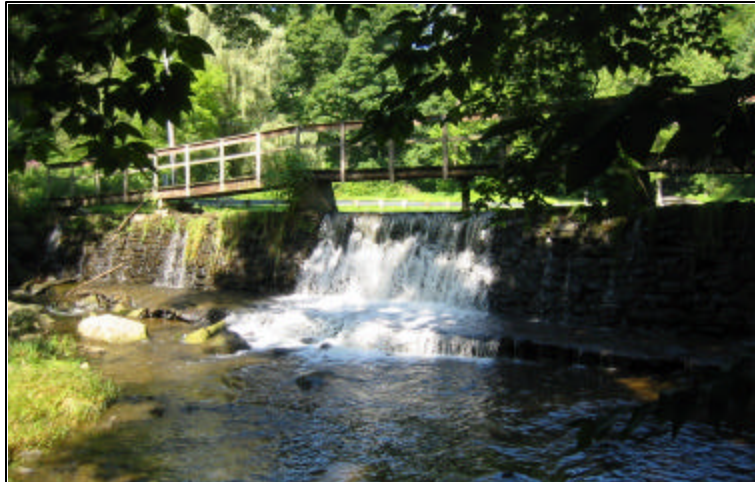
Figure 6. Looking upstream at Mensch Mill Dam

The Mensch Mill dam is rated by PA-DEP as a Hazard Class C-3 dam. The dam is composed of a stone masonry superstructure and a concrete slab foundation. The length of the dam breast is 96 feet. The height of the dam is approximately 7 feet. An elevated wooden footbridge runs across the dam crest leading to a footpath that circumnavigates the pond and leads to boat docks on the far side of the pond. Although the original dam is believed to have been constructed in 1822, the dam currently on site was reconstructed in 1941. The dam breast was again restored in 1987 in conjunction with a dredging project.

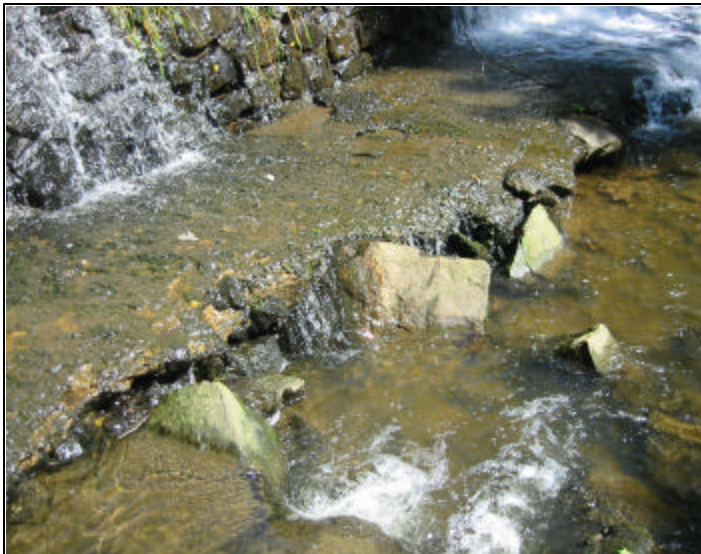
Figure 7. Scour downstream of the concrete footing.

The concrete foundation was in poor to fair condition. The foundation did not show any signs of settling or movement; however portions of the foundation were cracked. Pieces of the foundation were broken off and lying in the stream channel. Erosion was occurring within the stream channel at the base of the foundation and resulted in the stream channel downcutting by 2-3 feet in the

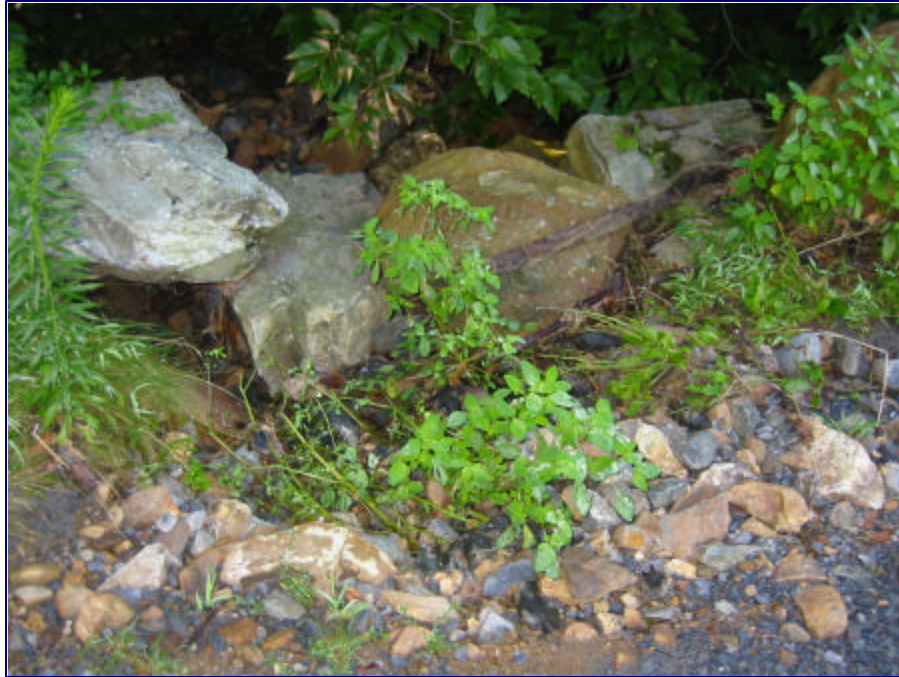
Figure 8. Recent scour and gully formation along the eastern flank of the dam structure

area immediately downstream of the dam. The concrete outlet pipe, which is located on the left side of the dam, appeared to be badly damaged. Extensive erosion and gully formation was observed along the left flank, when looking downstream, endangering the footpath on that side of the dam.

According to Mr. Gary Halstead, Camp Mensch Mill Director, the damage sustained to the flank of the dam occurred after a heavy storm in fall, 2003. The camp plans to install a temporary repair of this area in the fall with a concrete barrier of some kind.

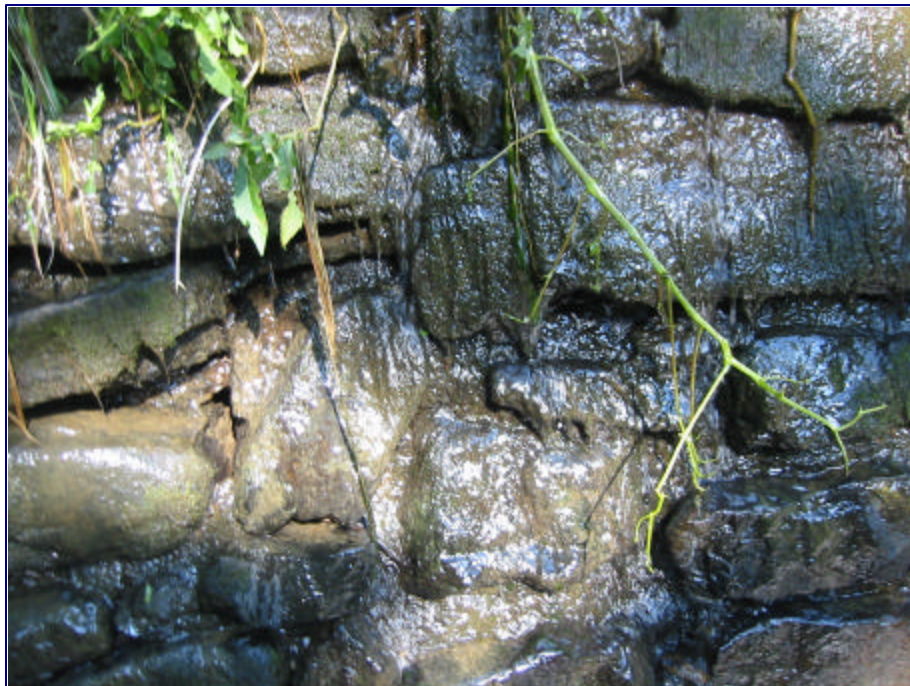
Figure 9. Close-up of downstream masonry face

F. X. Browne, Inc. conducted an informal visual assessment of Mensch Mill Dam on July 30, 2004. The downstream masonry face was in average condition. No major cracks or damage to the masonry were observed. The rock fill behind the dam and the upstream face was in good condition. There was extensive leakage through the dam, mostly in the center and right sections when looking upstream.

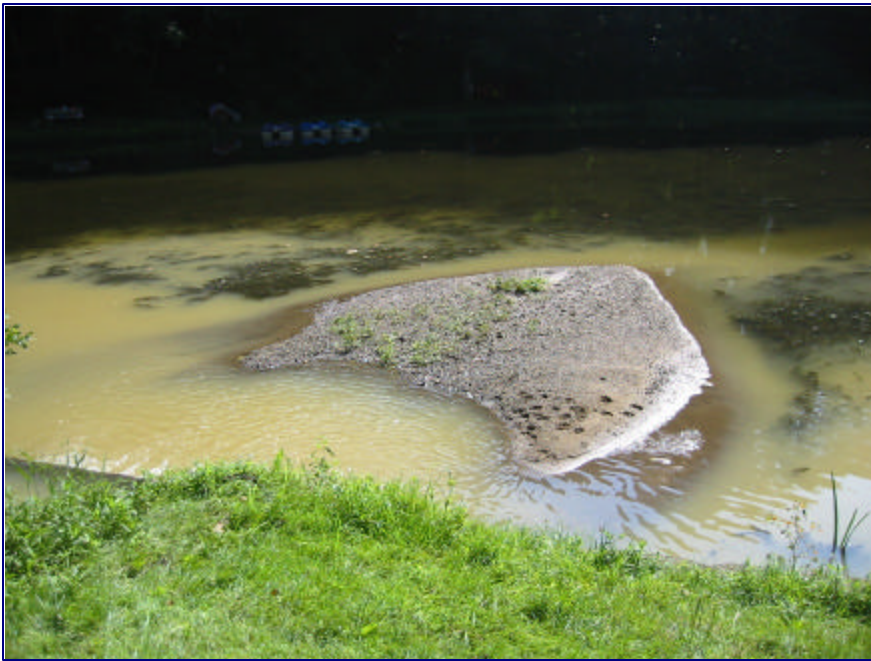
Figure 14. Sediment loading to Mensch Mill Pond

The rapid sedimentation in the pond not only creates a perpetual economic burden for the Camp, but also undermines the uses for which the pond is intended. Accumulated sediments are rich in nutrients, which in turn stimulate growth of nuisance and invasive aquatic plants, such as Eurasian Water Milfoil. Sedimentation also decreases water depth, which increases light transmission throughout the water column. Increased light levels, in turn further stimulate plant growth. Excessive plant growth throughout the pond was observed during our site visit on June 30, 2004. Nuisance plant growth undermines the aesthetic qualities of the pond and renders the pond unusable for activities such as boating. Further, the decomposition of plant material within the pond during the fall and winter can reduce the dissolved oxygen concentrations to levels that are harmful to other forms of aquatic life including fish.

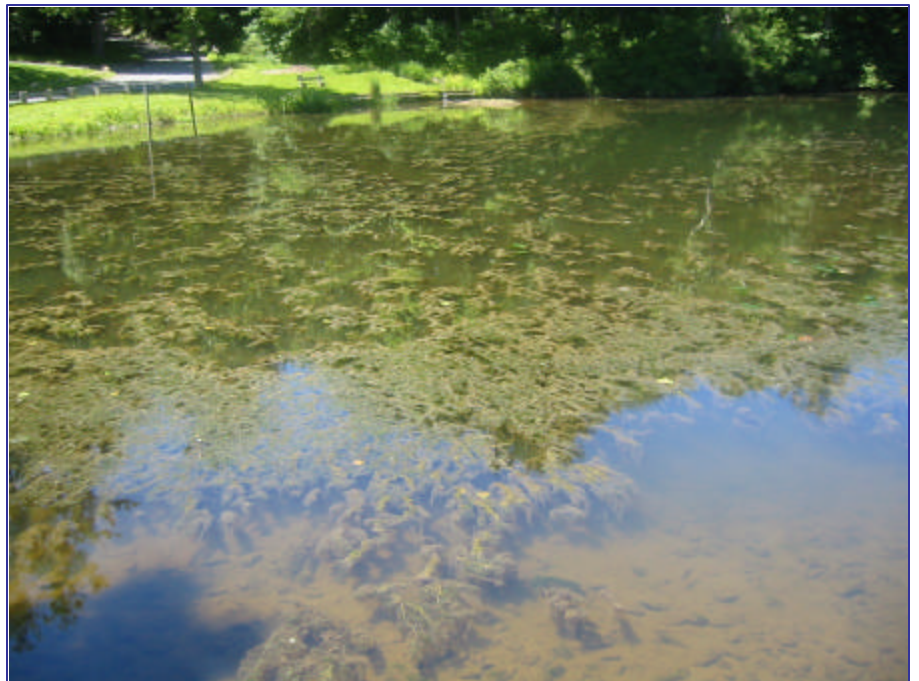
Figure 15. Nuisance aquatic weed growth in Mensch Mill Pond

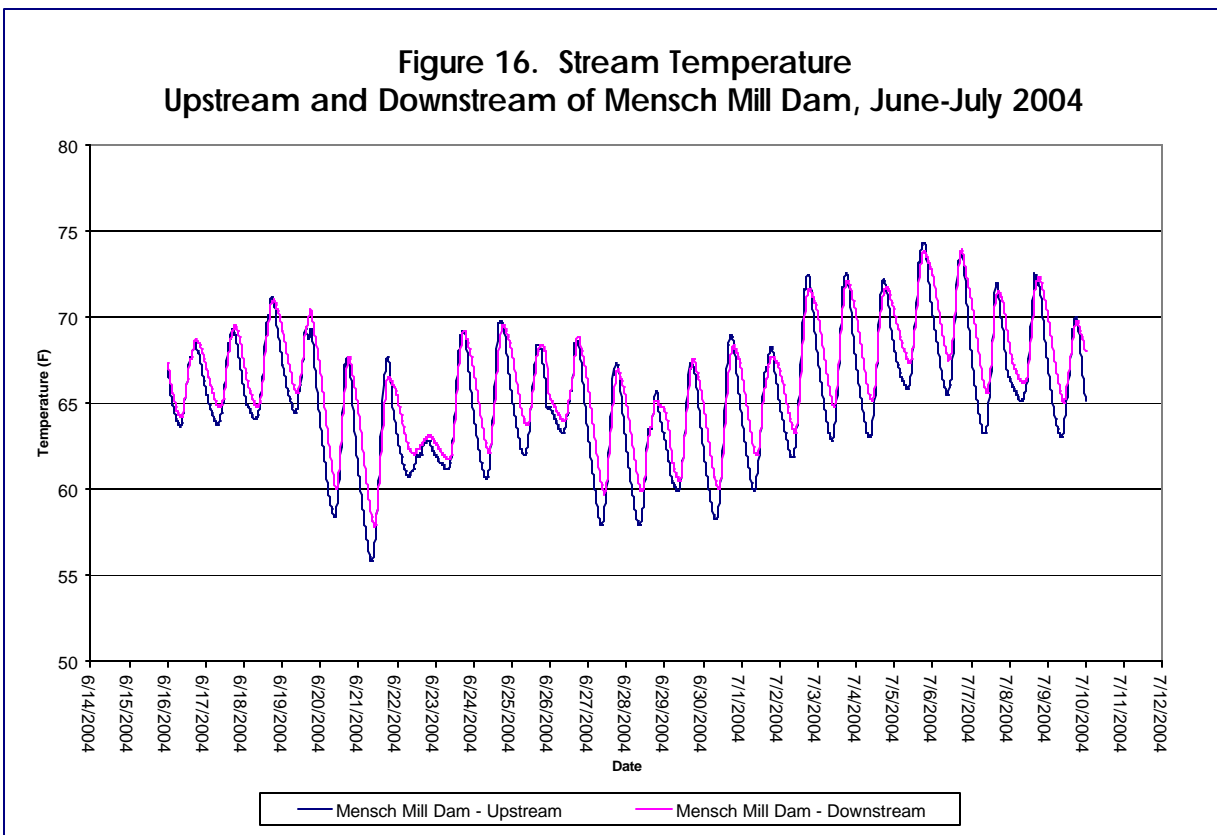
Temperature. The effect of Mensch Mill Dam on stream temperature was studied by placing HOBO® Water Temp Pro automated temperature sensors upstream and downstream of the impoundment. Temperature data was recorded in 15-minute intervals, from July 5 to August 9, 2004. Our results show that average daily temperature were higher at the downstream site (65.27 ° F) than at the upstream site (66.34° F) by 1.06° F. However, average daily maximum temperature was virtually identical at upstream and downstream stations (Upstream = 69.58° F; Downstream =69.49° F). Several site characteristics help

explain the absence of large temperature variations. First, the size of the impoundment is small compared with the volume of water entering the impoundment. Thus, water does not remain in the impoundment for extended periods of time, limiting the amount of time during which direct warming can occur. Secondly, the impoundment is narrow and, for the most part, surrounded by dense forested vegetation. Therefore, it is likely that the impoundment does not receive ample sunlight to permit substantial heating of the stream water. Finally, and perhaps most importantly, a small tributary that enters the northwest corner of the impoundment provides a source of cool spring water that may help to offset any heating that does occur within the impoundment.

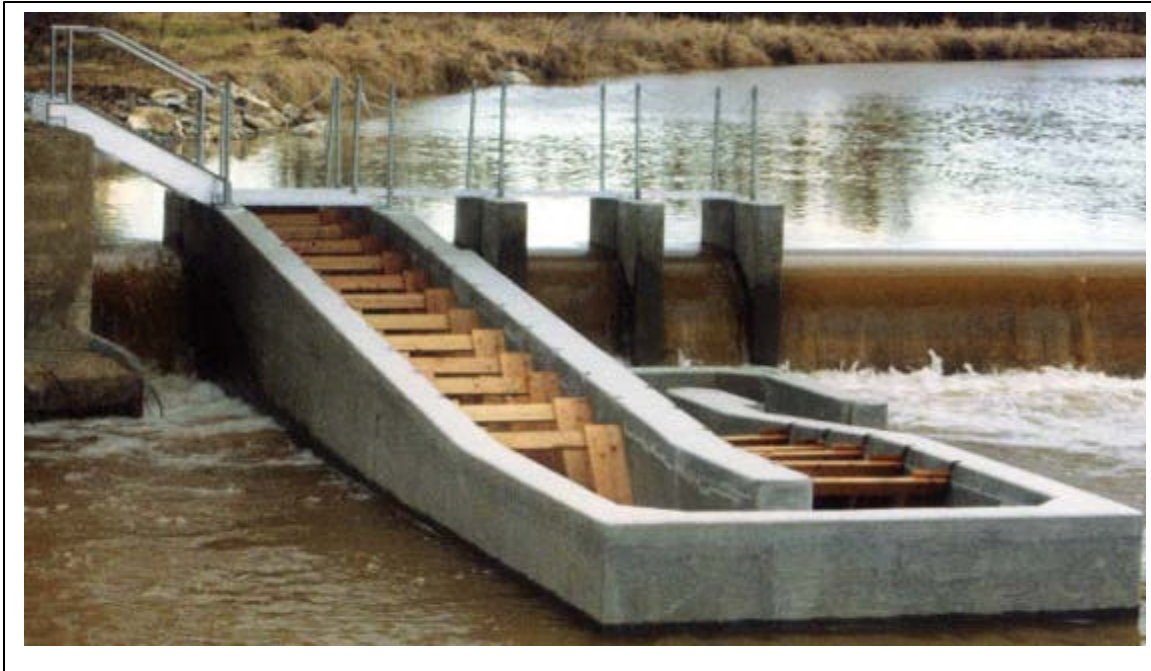
Figure 24. Picture of a typical fish ladder

Alternative No. 5 consists of installing a fish passage device, such as a fish ladder, that would allow fish to bypass the existing dam. The current dam and impoundment configuration would remain essentially unchanged. Under Alternative No. 5, the current benefits and costs of the current configuration would be retained (see Alternative No. 1), with the exception of impacts to fish passage, which would be eliminated. Fish could circumvent the dam by entering and climbing the fish passage structure. The installation of the fish passage structure would require a plan review by PA-DEP Dam Safety.
