Wallacks Branch Coldwater Conservation Plan

Prepared by the
Bobs Creek Stream Guardians
May 2011
for

Coldwater Heritage Partnership

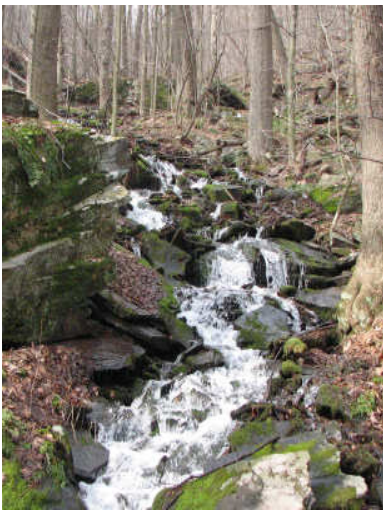
The next reach covers the canyon section of Big Break Hollow, about 4000 feet to 6270 feet above the mouth. This section is very steep with numerous small waterfalls passing over and between enormous boulders, a Rosgen A2a+ reach. The gradient of the stream here would likely present a natural barrier to fish passage. The sidewalls in this canyon area are steeper yet than the gradient of the water path and the terrain is difficult to traverse

Big Break Hollow Run Reach 2
Canyon section
Land use: 100% forest
Length of reach: 2270 feet
Substrate: Cobble (25%), boulder (75%)
Active channel width: 4 feet
Total score: 88

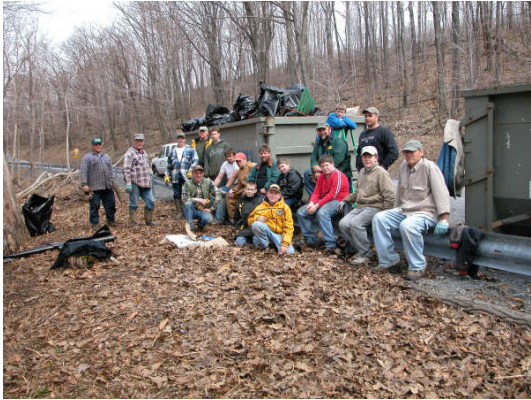
Among the earliest projects undertaken by the Bobs Creek Stream Guardians were illegal dump cleanups. Two of the larger dumps removed by Stream Guardian projects, largely funded by grants from the SRBC in 2003 and 2004, were located in the upper reaches of the Wallacks Branch watershed. The dumpsite referred to as the SR 869 dump in grant correspondence was a roadside dump at a pull-off along SR 869 near the Cambria County line. Many of the volunteers for this cleanup were Boy Scouts who worked tirelessly to cleanup 3.95 tons of trash and collect 3.08 tons of discarded tires for recycling (photo, top right). Repeat dumping at this site has been occasional and trash is removed during annual cleanups or through ad hoc efforts. The other dump was a “homestead” on private property, the former Corle tract, a short distance down the stream from the SR 869 site. This was a long-established, substantial dump with mounds of trash adjacent to the stream bank. Junk cars and a boat, along with 30.55 tons of household trash and nearly one ton of tires were removed from this site. There has not been repeat dumping since it is not a roadside location and the property has been sold (before and after photos, middle and bottom right).

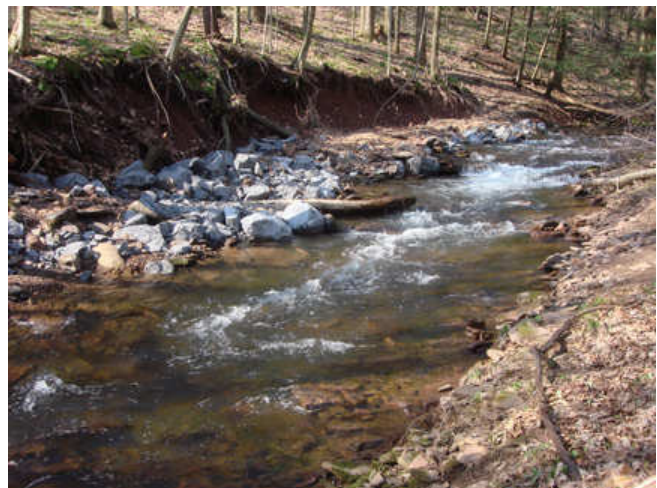
Saw-tooth structure nine months after construction ►

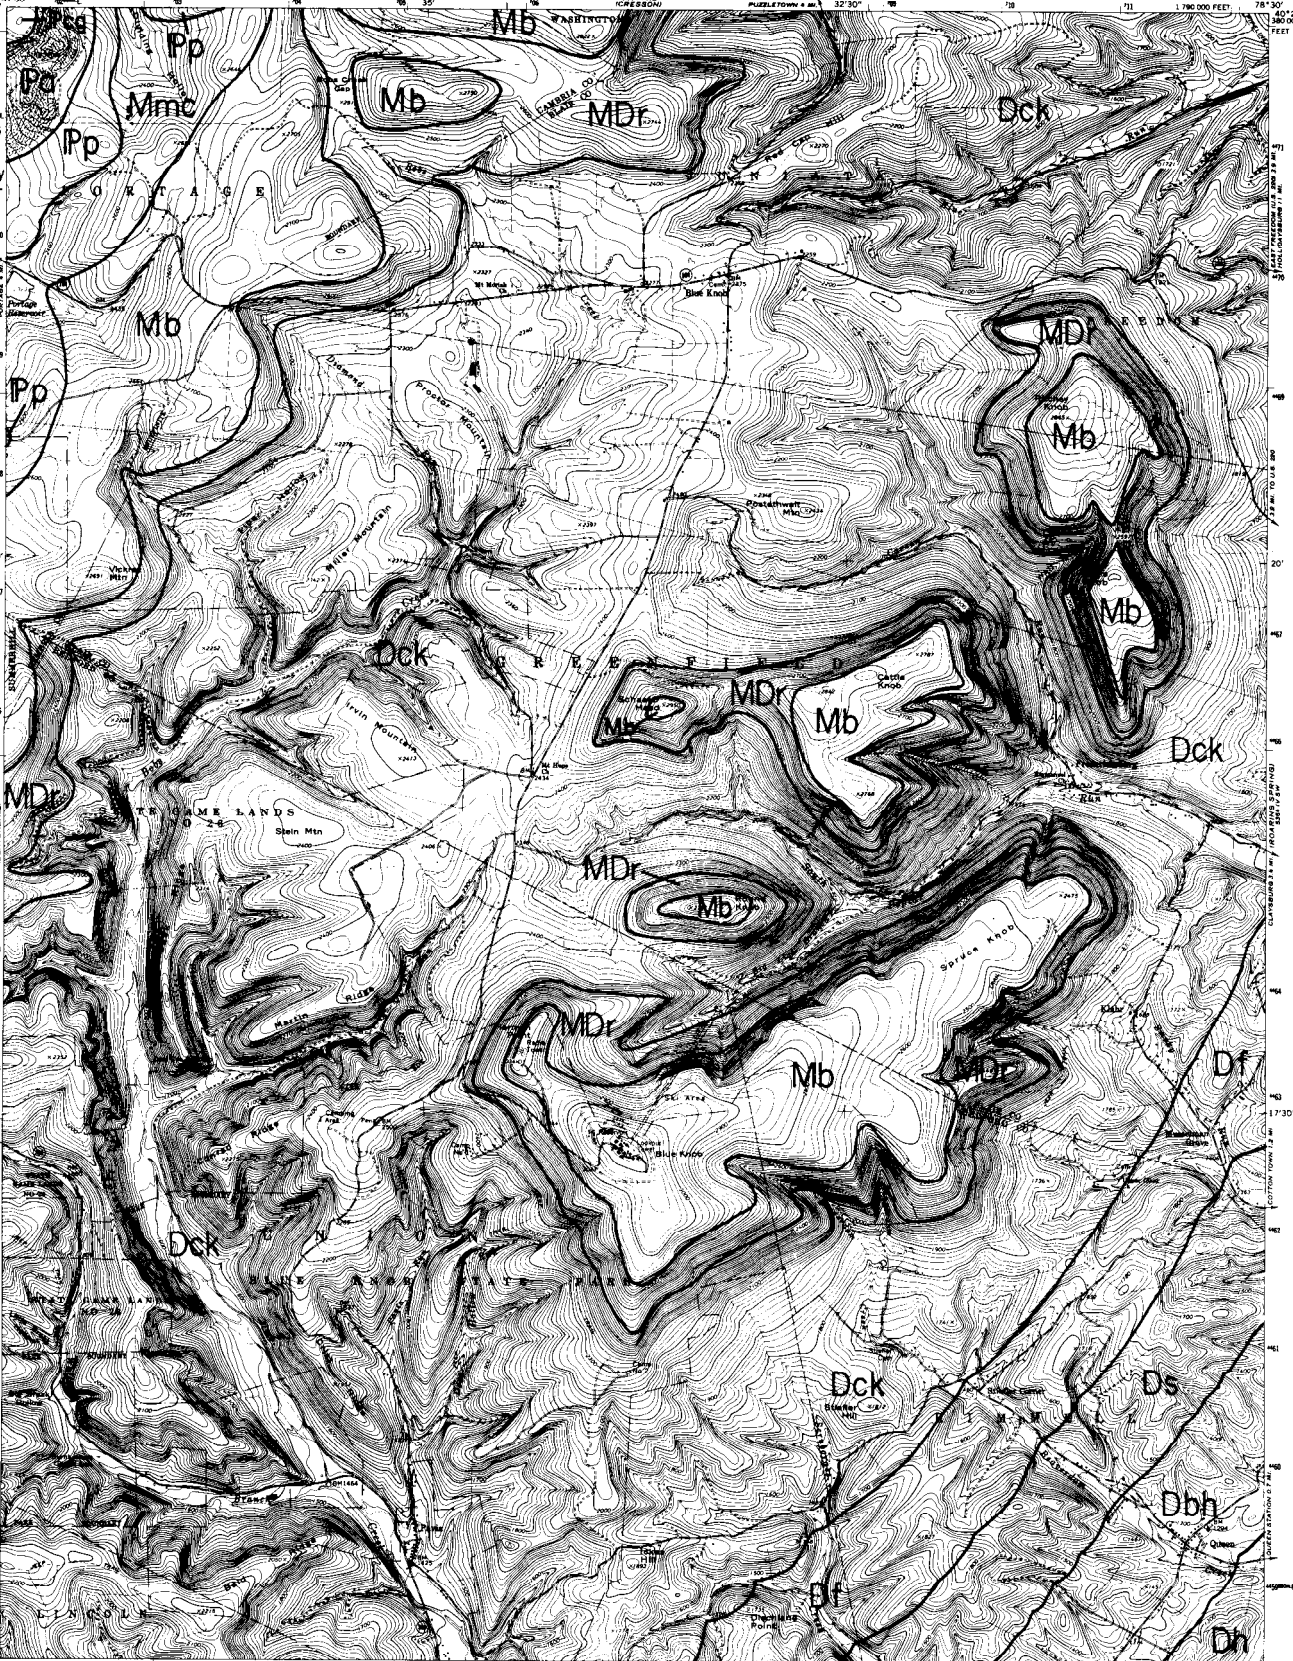
- Pcg
Glenshaw Fm.
- Pa
Allegheny Gp.
- Pp
Pottsville Gp.
- Mmc
Mauch Chunk Fm.
- Mb
Burgoon Ss.
- MDr
Rockwell Fm.
- Dck
Catskill Fm.
- Df
Foreknobs Fm.
- Ds
Scherr Fm.
- Dbh
Brallier and Harrell Fms., undiv.
- Dh
Hamilton Gp.
