Greenwalk Creek Coldwater Conservation Plan

Aquatic Life Use Attainability Evaluation Water Quality Standards Review

BENTHIC MACROINVERTEBRATES OF GREENWALK AND JACOBY CREEKS

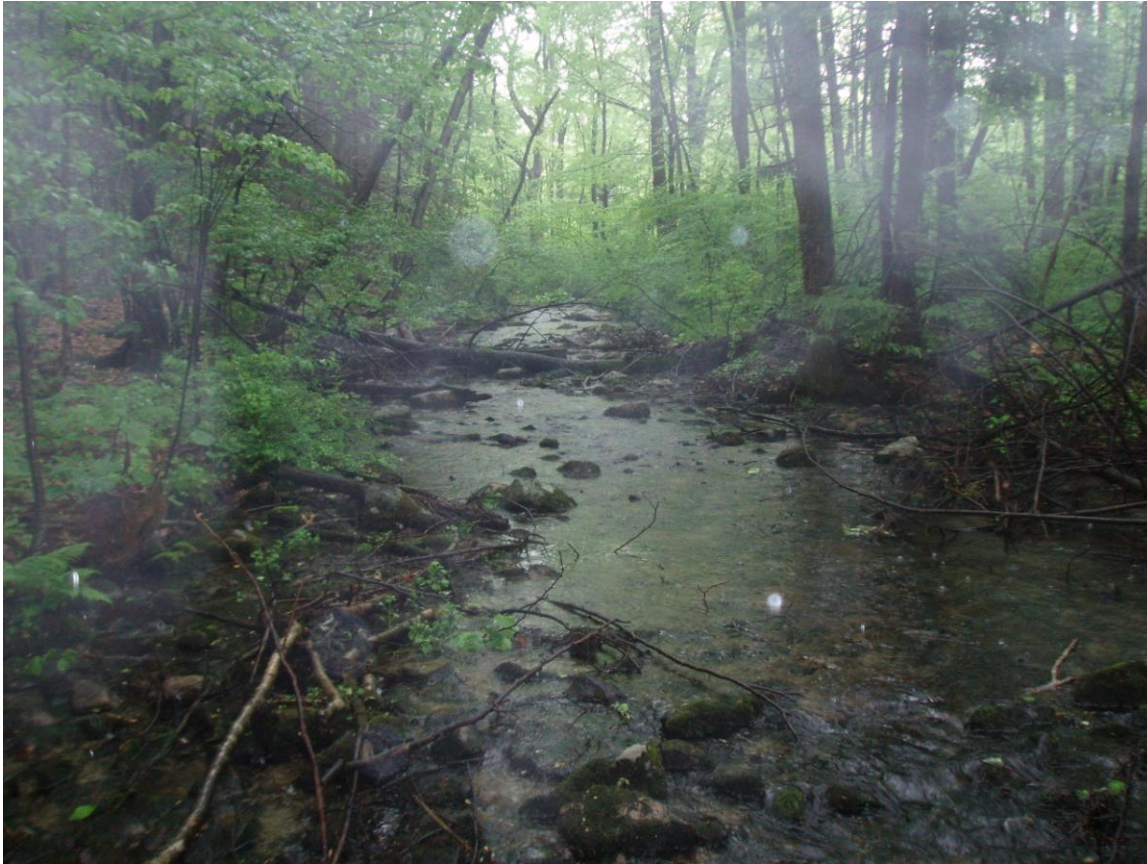
Figure 3. Benthic macroinvertebrate Station 1 on Greenwalk Creek above the trout hatchery sampled on May 20, 2008.

All three stations scored in the low optimal range for habitat quality (Table 3). Each station had minimal erosion, with a good riparian vegetative zone. Disruptive pressure was caused only by the hatchery above Station 2 and a road crossing above Station 3. However, each station was in a relatively shallow stream section lacking the full diversity of velocity and depth regimes (Figures 3-5). Although Station 2 on Greenwalk Creek had good diversity of substrate, including a variety of cobble and boulder, the stream immediately below Station 2 had substrate consisting mainly of sand and fine gravel.

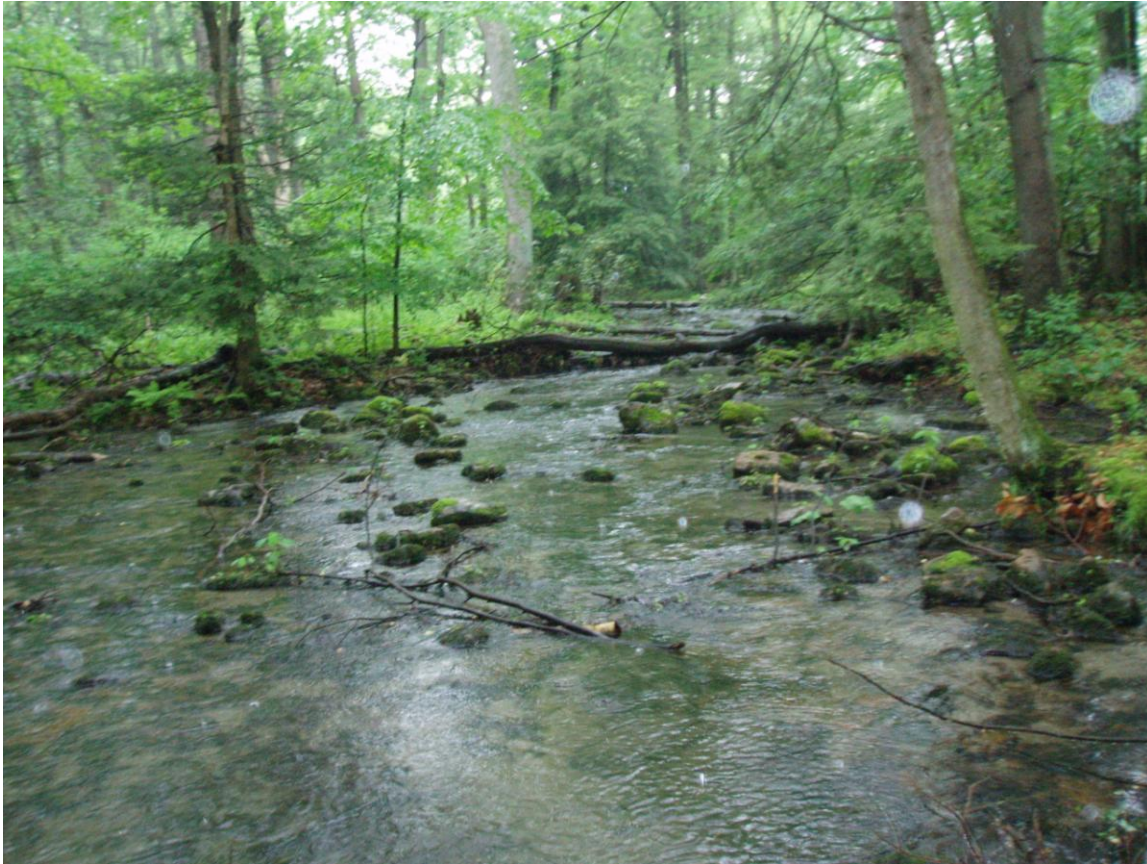
Figure 4. Benthic macroinvertebrate Station 2 on Greenwalk Creek below the trout hatchery sampled on May 20, 2008.

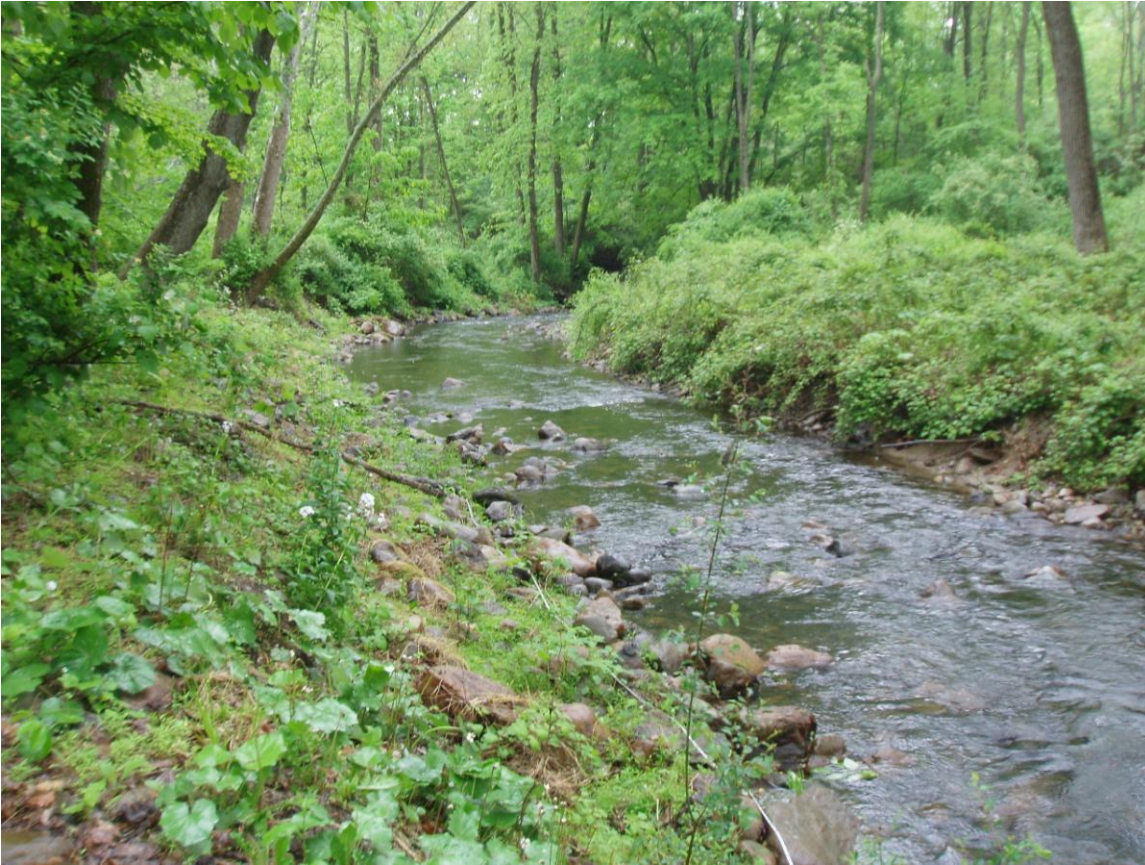
Figure 5. Benthic macroinvertebrate Station 3 on Jacoby Creek sampled on May 20, 2008.
