**East Branch Saucon Creek Stream Restoration**  
**Wildlands Conservancy Inc.**  
**Coldwater Heritage Partnership Grant 2016**  
**Northampton County**

## 1. Photos of Project Area

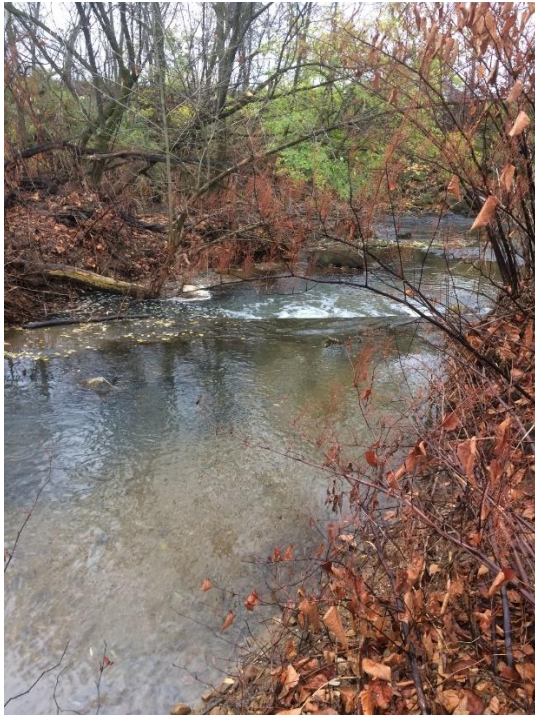
Image 1: Looking downstream at the dam

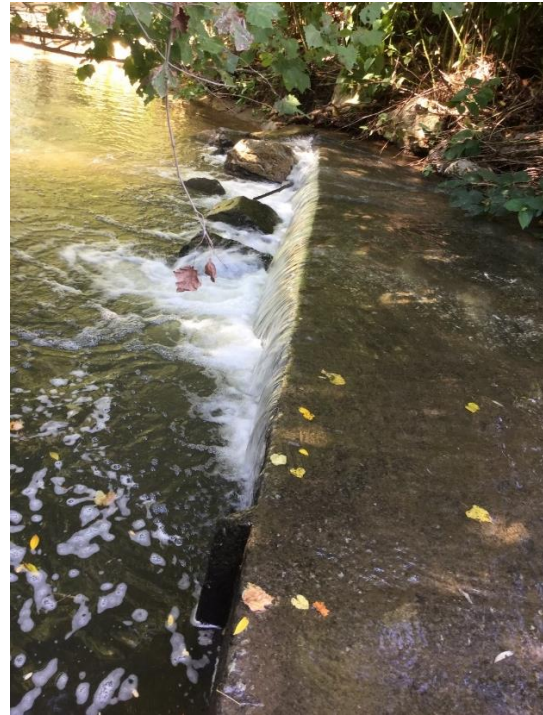
Image 2: Looking across dam, left to right

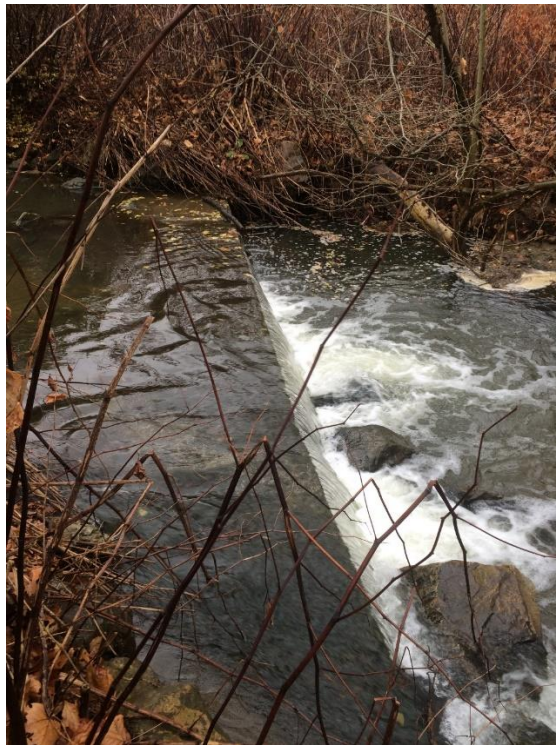
Image 3: Looking across dam, right to left

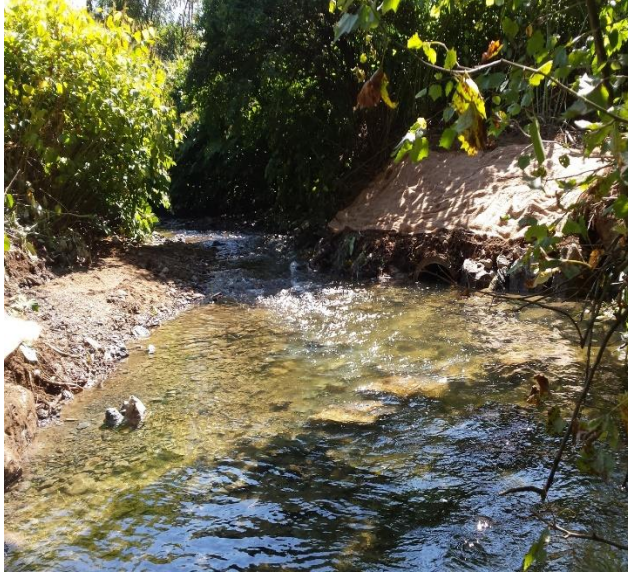
Image 2: Looking upstream from below where the dam was located

Immediately after the dam was removed, the East Branch of Saucon Creek began to look more like a healthy, free flowing, natural stream. The stream at the project site began to narrow and carve a deeper channel. The stabilization and grading of the streambanks will prevent erosion during high flow events and will allow the water to spread naturally into its floodplain.

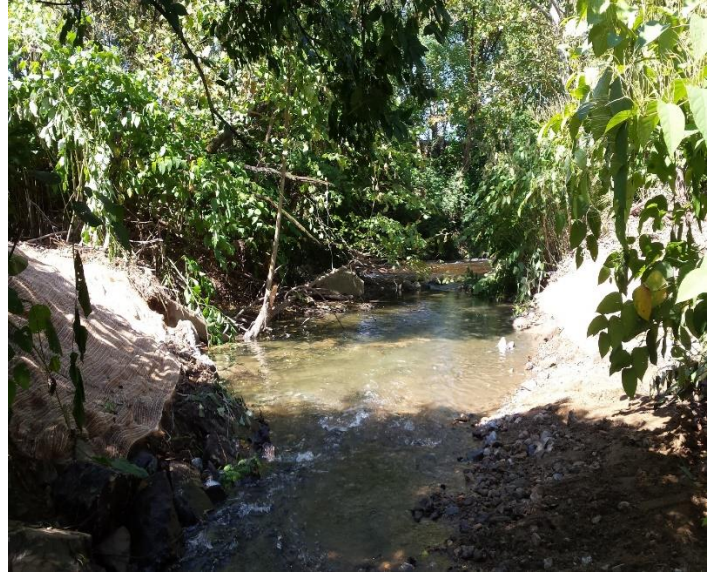
Image 3: Looking downstream from above where dam was located

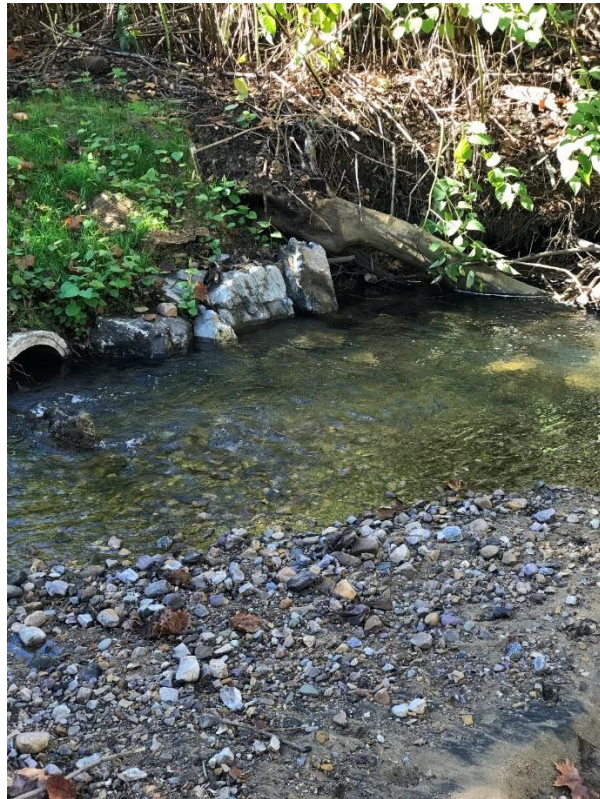
Image 1: Looking across the stream where the dam was located, right to left
