East Branch Spring Creek Habitat Improvement Project
Western Pennsylvania Conservancy
Final Report

East Branch Spring Creek Habitat Restoration Project

This photo compilation captures the site of Structure 9 in the East Branch Spring Creek Habitat Restoration Project before, during, and after construction.

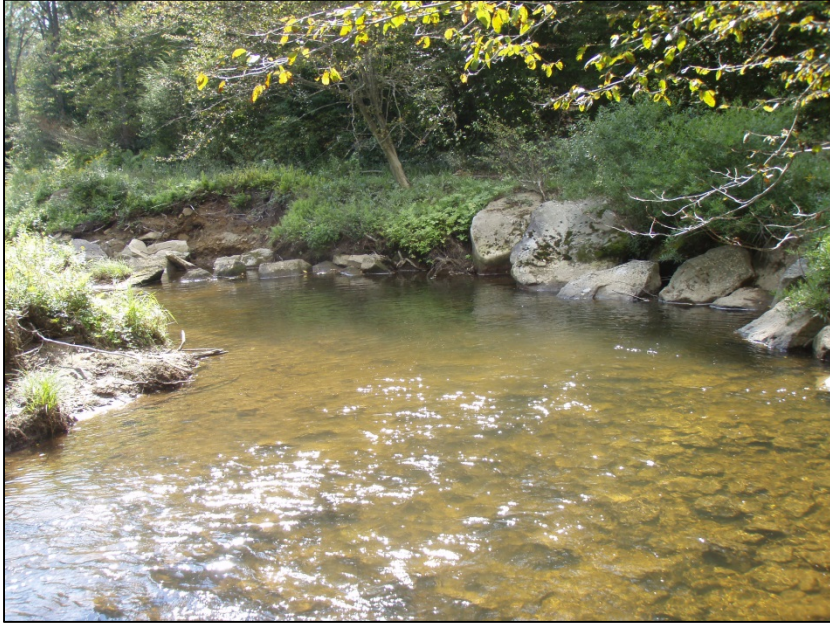
Photo 1: ATV Trail Bend on East Branch Spring Creek: Erosion, rock armoring present. Habitat lacking. May, 2014.

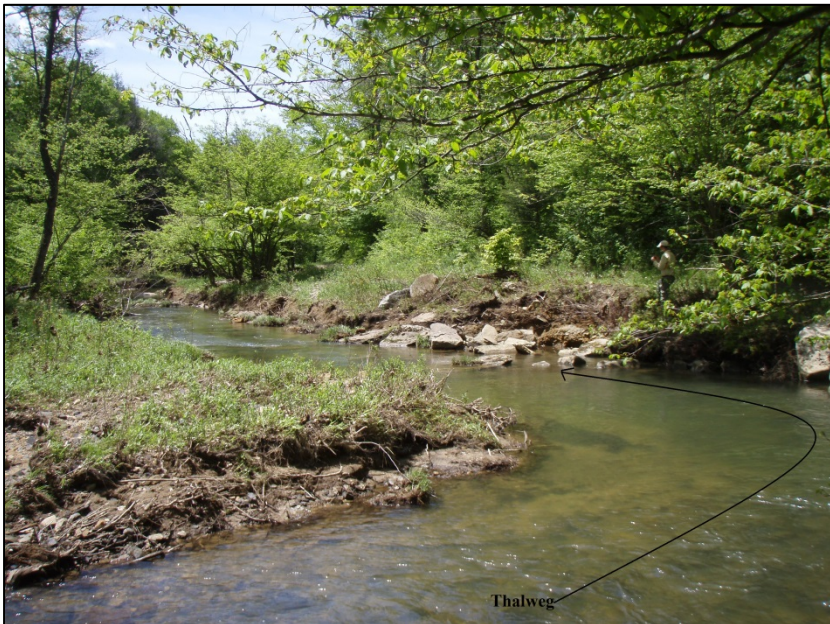
Photo 2. Bend and downstream area: Additional erosion. May, 2014

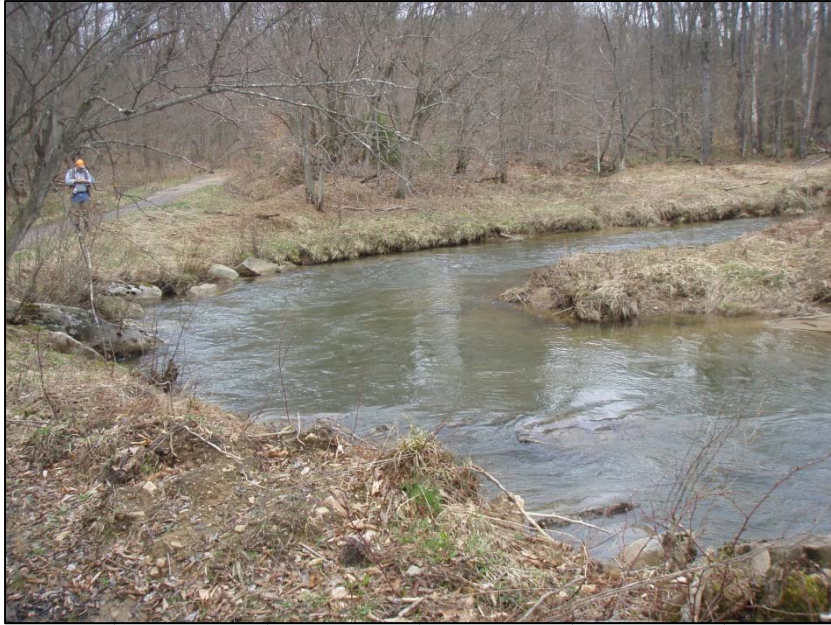
Photo 3. Bank from downstream, during higher flow. April, 2015.

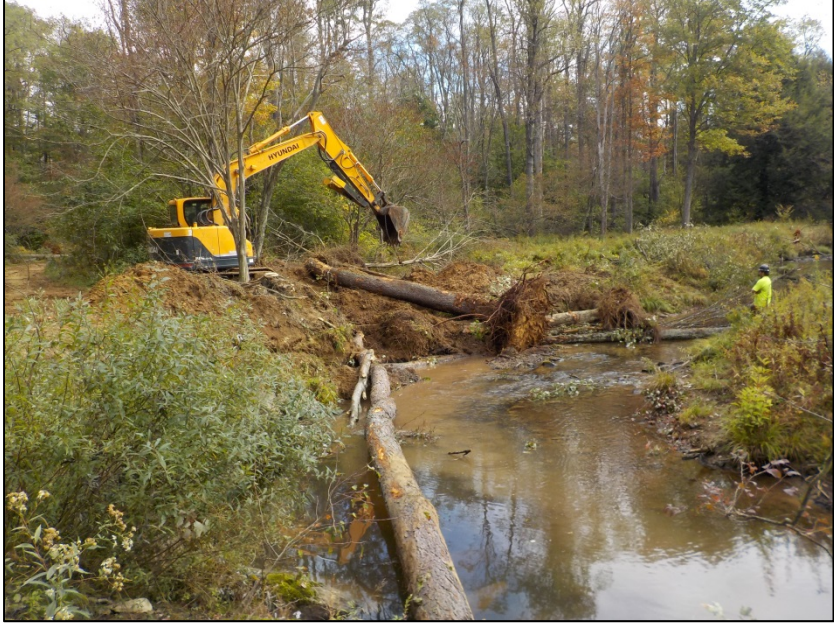
Photo 4. Rootwad installation. September, 2017.

During implementation of this project, 25 LWM structures were added to East Branch Spring Creek and its adjacent floodplains throughout a one-mile-long project reach. These structures were comprised of 77 cut logs and 60 intact root wad logs, which were harvested on site and strategically placed to stabilize 1,955 feet of stream banks. These structures stabilized eroding stream banks, trapped sediment and debris during flood events, and created scour pools in the stream. The creation of a greater quantity and diversity of sizes and depths of pools provides habitat for a wide range of aquatic organisms and different species and age classes of trout. The smaller stems and debris that are trapped in the large wood structures partition the habitat within the pool of that structure, improving the overall holding capacity of the creek within the project reach. A comparison of pre- and post-restoration fish surveys documented an increase in species

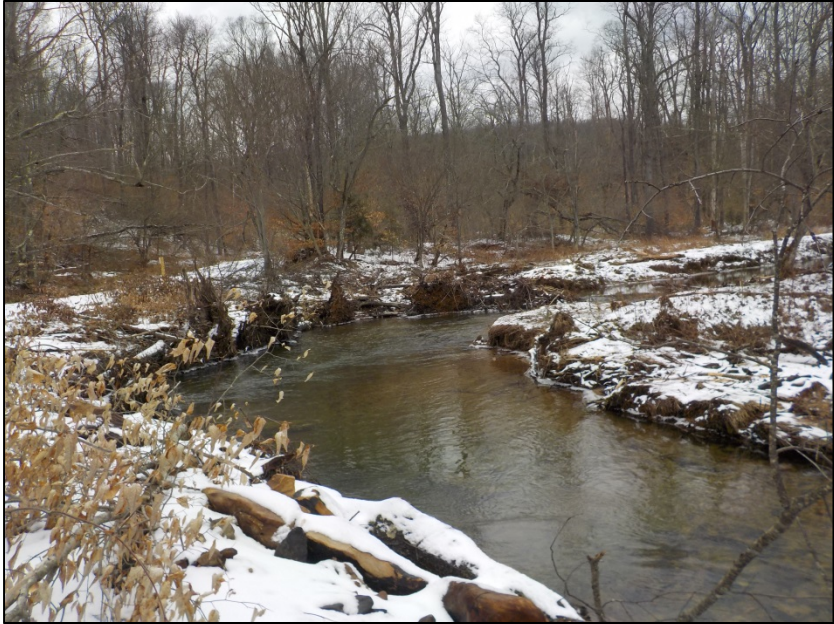
Photo 5. Structure 9 from downstream. February, 2018.

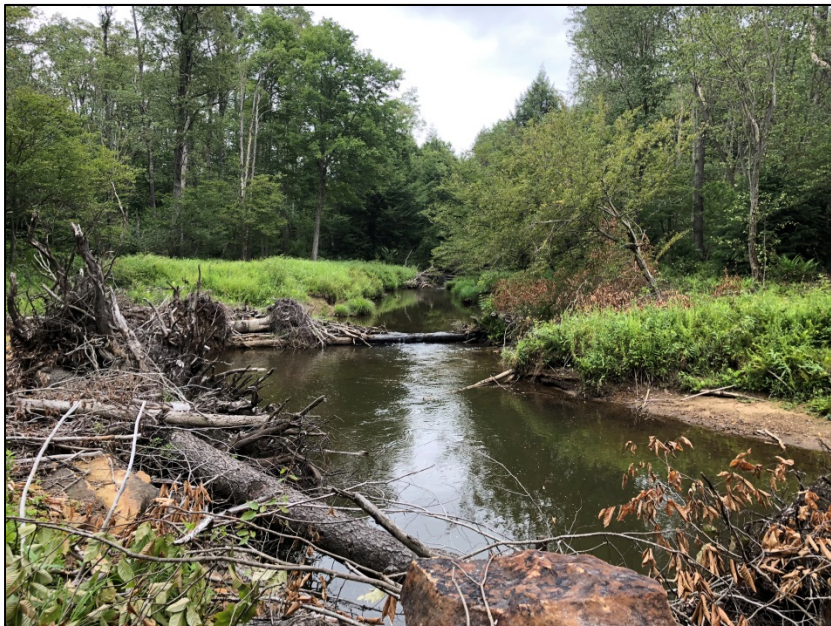
Photo 7. Structure 9, looking upstream from bend. July 2018.
