# Brubaker Run Assessment and Coldwater Conservation Plan

February 2018

Prepared by  
Trout Unlimited  
18 East Main Street, Suite 3  
Lock Haven, PA 17745

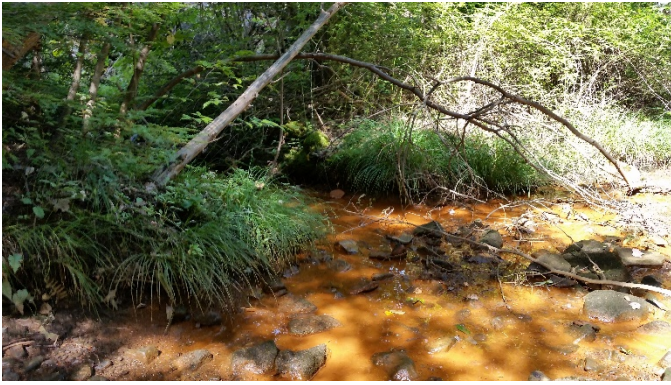
Abandoned Mine Drainage at Site BRT 60

**Strategy 2: AMD/AML Restoration and Monitoring** – Efforts should be made to address the remaining AMD and AML issues throughout the watershed through reclamation, re-mining, water treatment, and reforestation. Water quality and biological monitoring should continue to gage the success of restoration projects and provide data aimed at removing streams from the DEP impaired waters list and upgrading stream status where possible. Along those lines, research should be conducted to determine if sulfate and/or other pollutants are thwarting biological recovery in the watershed, and if so, what is the appropriate way to measure stream recovery on a biological level post mining and reclamation. Additionally, there are un-reclaimed priority AML areas throughout the watershed (Figure 4, above) that should be remediated not only because they pose human health and safety hazards, but also because they would help reduce AMD and sediment pollution. In addition, there are efforts underway in the mining reclamation community to convert sites that were previously restored as grasslands/meadows to productive forestlands. There are several sites in the watershed that could benefit from this approach.

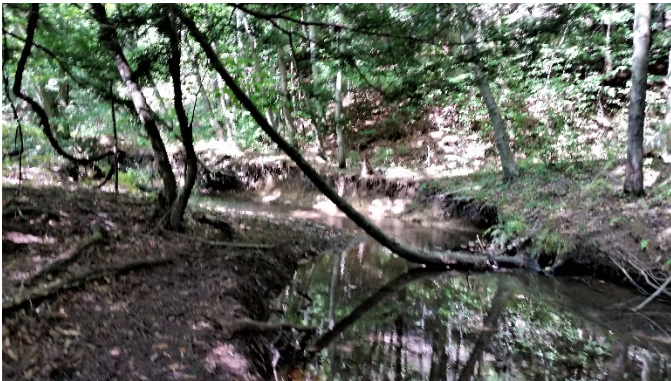
Bank erosion along Little Brubaker Run

**Strategy 3: Habitat and Bank Stabilization Projects** – Efforts should continue to identify areas in need of bank stabilization and/or instream habitat projects that would reduce sediment pollution and provide habitat for fish and other aquatic species. There are many areas in Hastings Borough that are eroding and in need of stabilization. Brubaker Run near Site BR2 has some areas of bank erosion that should be addressed as well. Regarding streamside habitat, there are several areas of the watershed that could benefit from riparian buffer plantings and reforestation, mainly in Hastings (residential) and Driscoll Hollow (AML reclamation). The project partners should work with municipalities and private landowners along Brubaker Run to encourage implementation of riparian buffers.

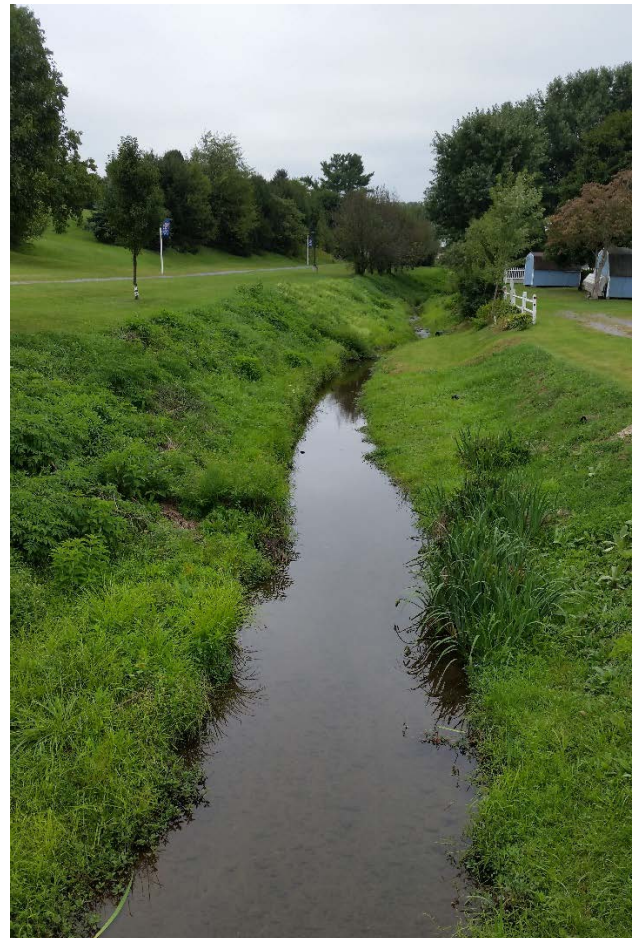
Channelization, sedimentation, and lack of buffers in Hastings Borough

**Strategy 5: Stormwater Management Activities** – Polluted runoff is an issue in the Brubaker Run watershed due to the numerous impermeable surfaces (roads, driveways, parking lots, etc.) that are present in the watershed and the lack of stormwater runoff controls. Efforts should be made to work with municipal officials, business owners, residents, and the PA Department of Transportation to put stormwater control measures in place for new development, retrofit older structures, and assist landowners with stormwater management. These measures will help reduce flash flooding and prevent streambank erosion.
