1. Before and After Photos of the Project Site

2. Location of the Project

5. Information About the Work Completed Through the Grant

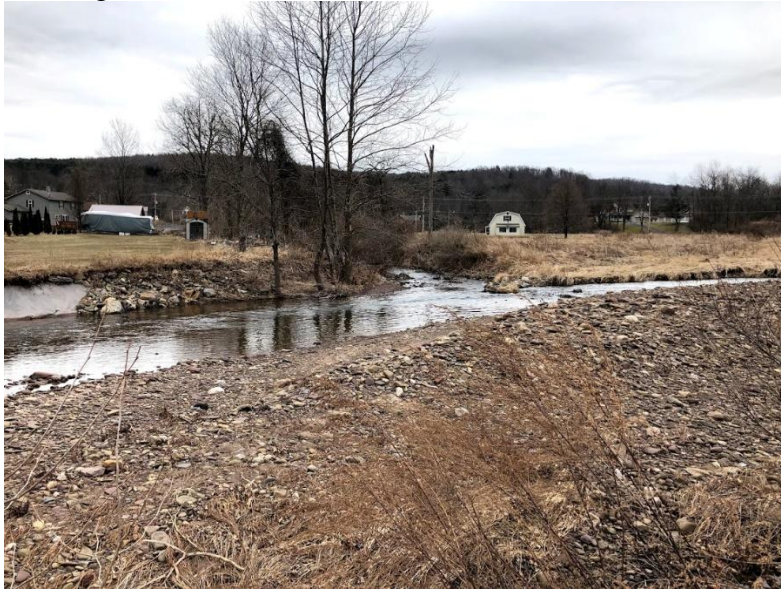
February 25, 2020

Additional photos can be provided. These two “match up” the best since the “big” trees and buildings can be seen.

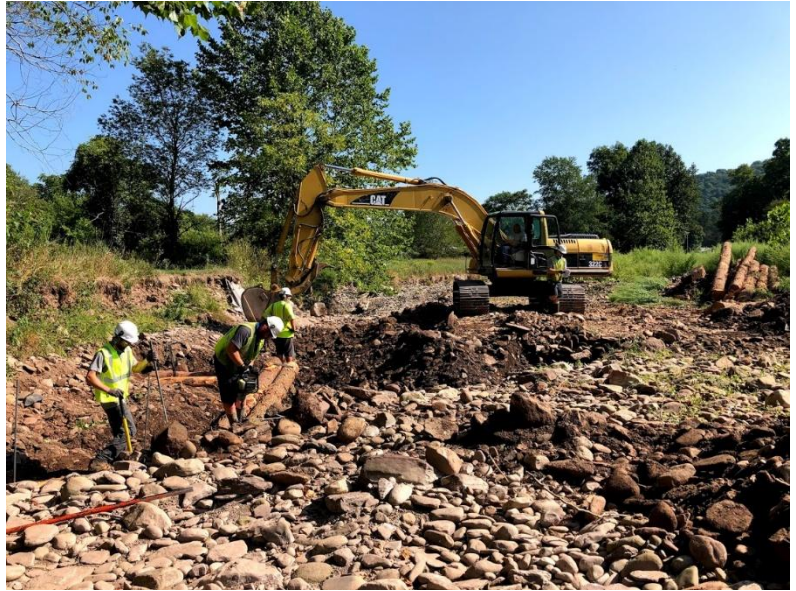
A total of 10 devices were installed. They were all log framed deflectors. They ranged in size from a single section to 4 sections for a total of 20 sections. The original plans called for 7 random boulders to be placed, however the stream substrate contained numerous rocks as large if not larger than the random boulders. All the purchased boulders were placed in the channel, but not necessarily where originally planned.

Hopefully this photo gives you an idea of the size of streambed material we were working in:

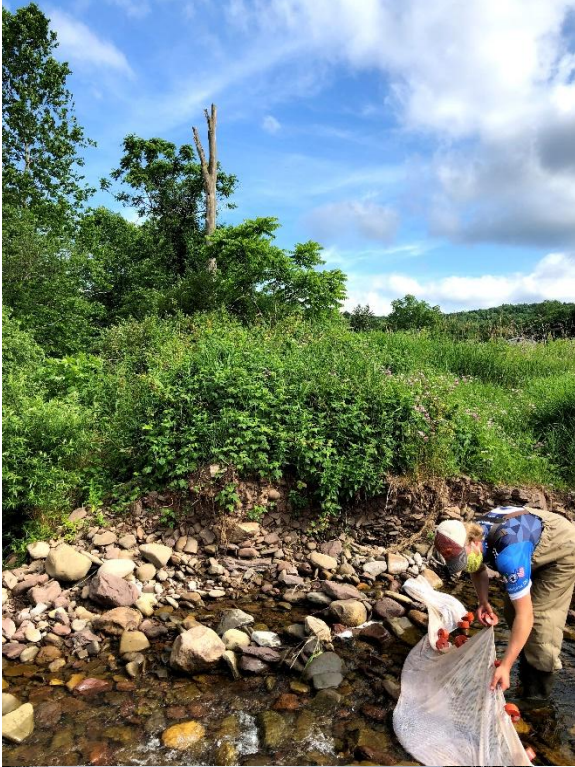
The photo to the left was taken on June 30, 2020 during a fish survey conducted by Susquehanna University's FRI. The vegetation makes it a bit challenging, but you can kind of see the eroded banks

The dead tree is the reference point.

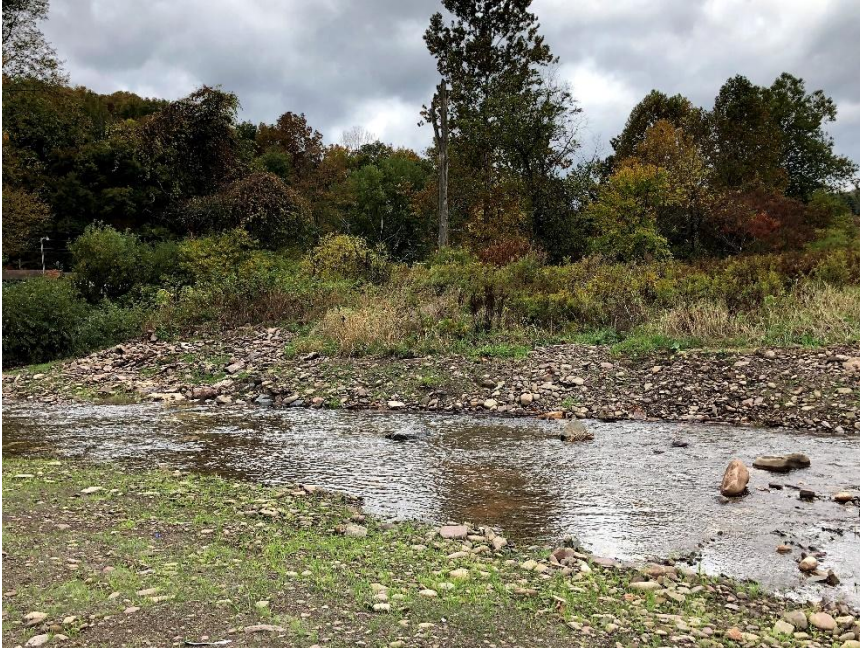
The photo below was taken on September 30, 2020 from a different angle, but includes the dead tree. You can see the sill logs of the structure and the banks sloping back further.

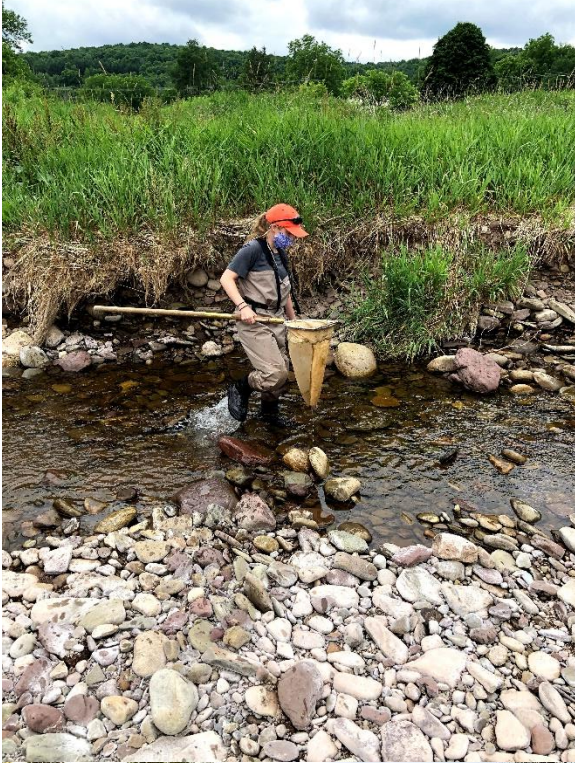
The photo to the left was taken on June 30, 2020 during a fish survey conducted by Susquehanna University's FRI. We are upstream from the dead tree. It's a little easier to see the cut bank (look below the handle of the kicknet).

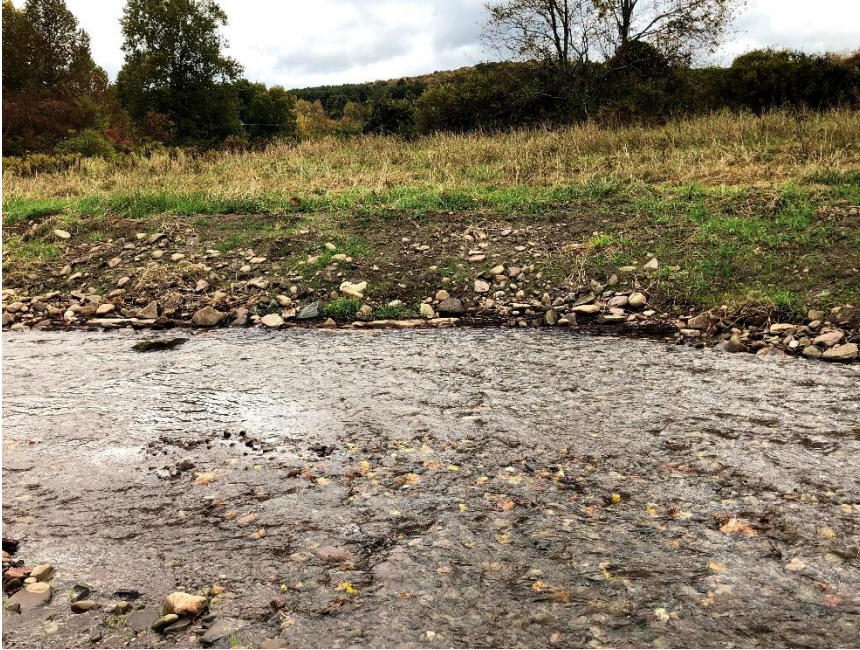
The photo below was taken on September 30, 2020 from a different angle, but includes several of the same trees. You can see the sill logs of the structure and the banks sloping back further.
