PITHOLE CREEK WATERSHED ASSESSMENT REPORT and COLDWATER CONSERVATION PLAN

Venango and Forest Counties

October 28, 2020

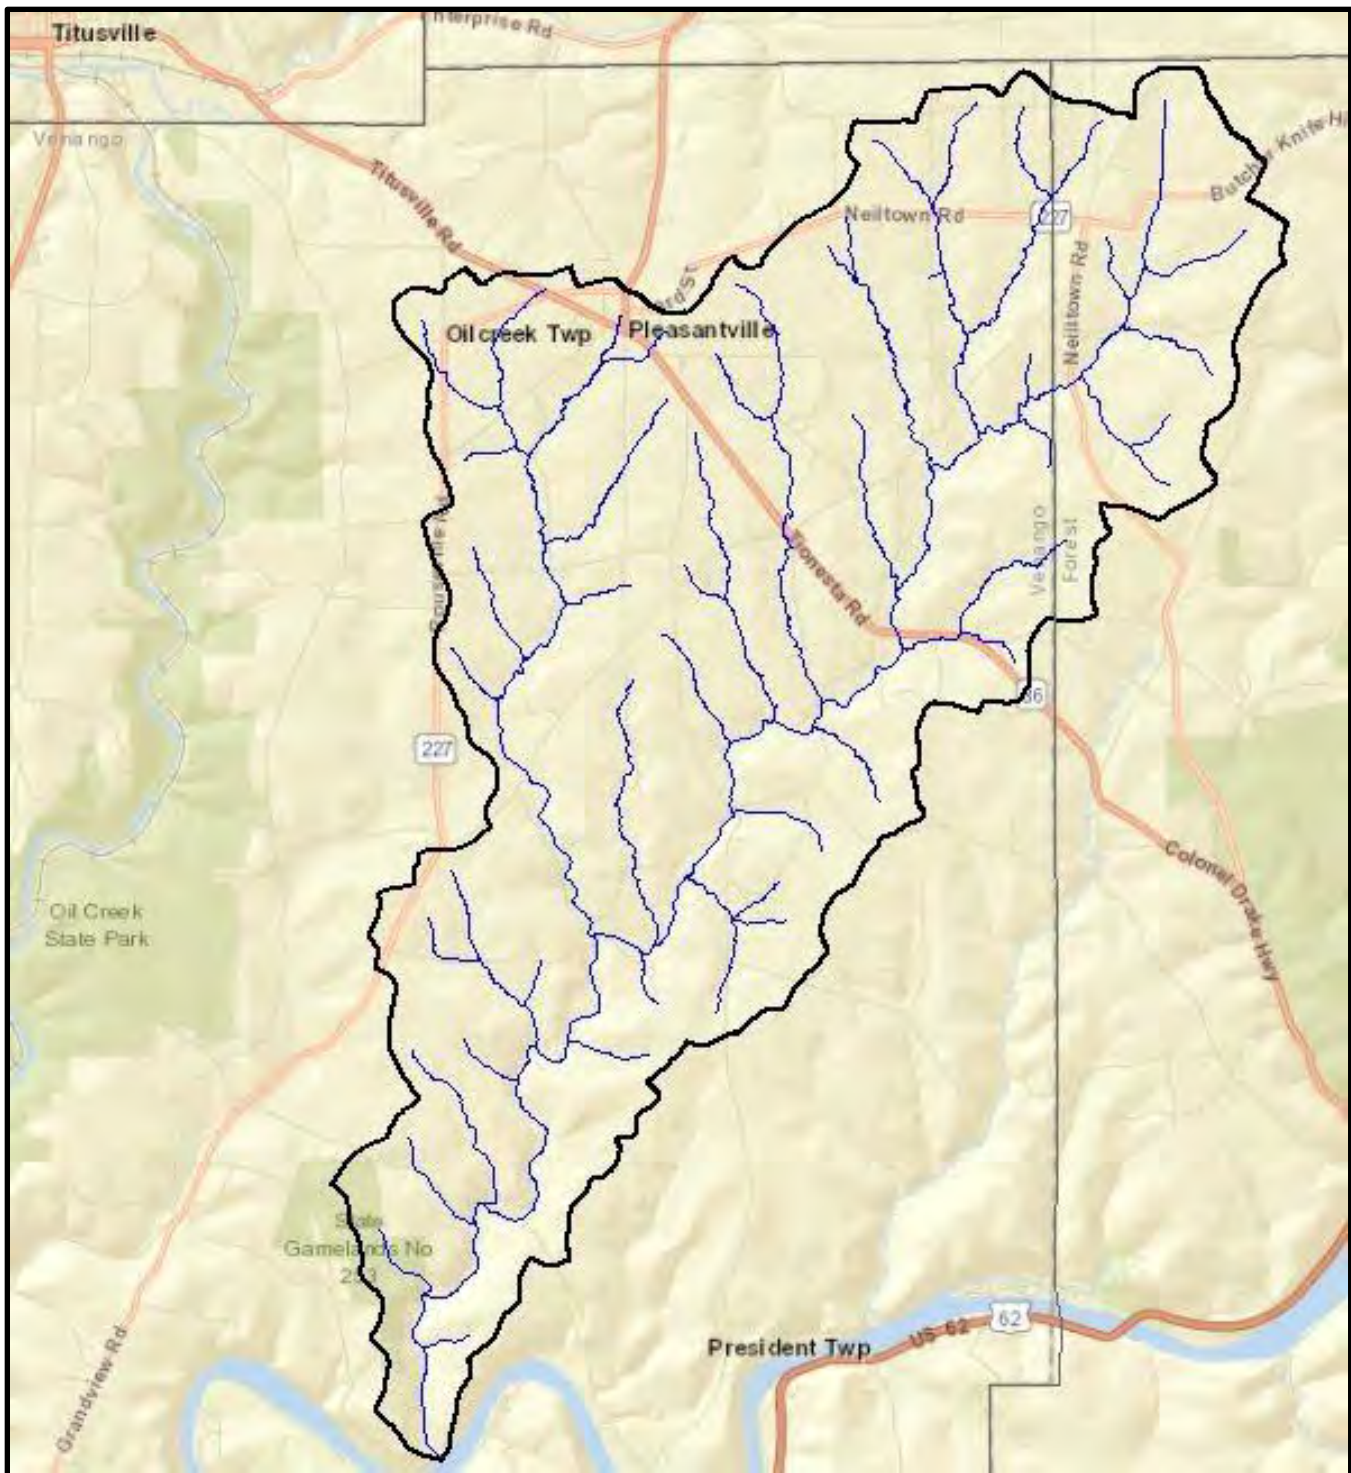
Figure 5. Pithole Creek watershed with 77 mile stream network, Venango and Forest Counties, PA.

Stream density in the watershed is 1.83 miles/sq. mi. and there is a total of 77 miles of mapped streams in the watershed base on 1:24,000 scale mapping (see graphic on next page). Many of the streams are coldwater fisheries supporting native populations of Brook Trout. The PA Fish and Boat Commission regularly stocks Pithole Creek with trout prior to the opening of the annual spring fishing season. The Pithole Creek mainstem has been, and remains, a popular trout fishing destination.

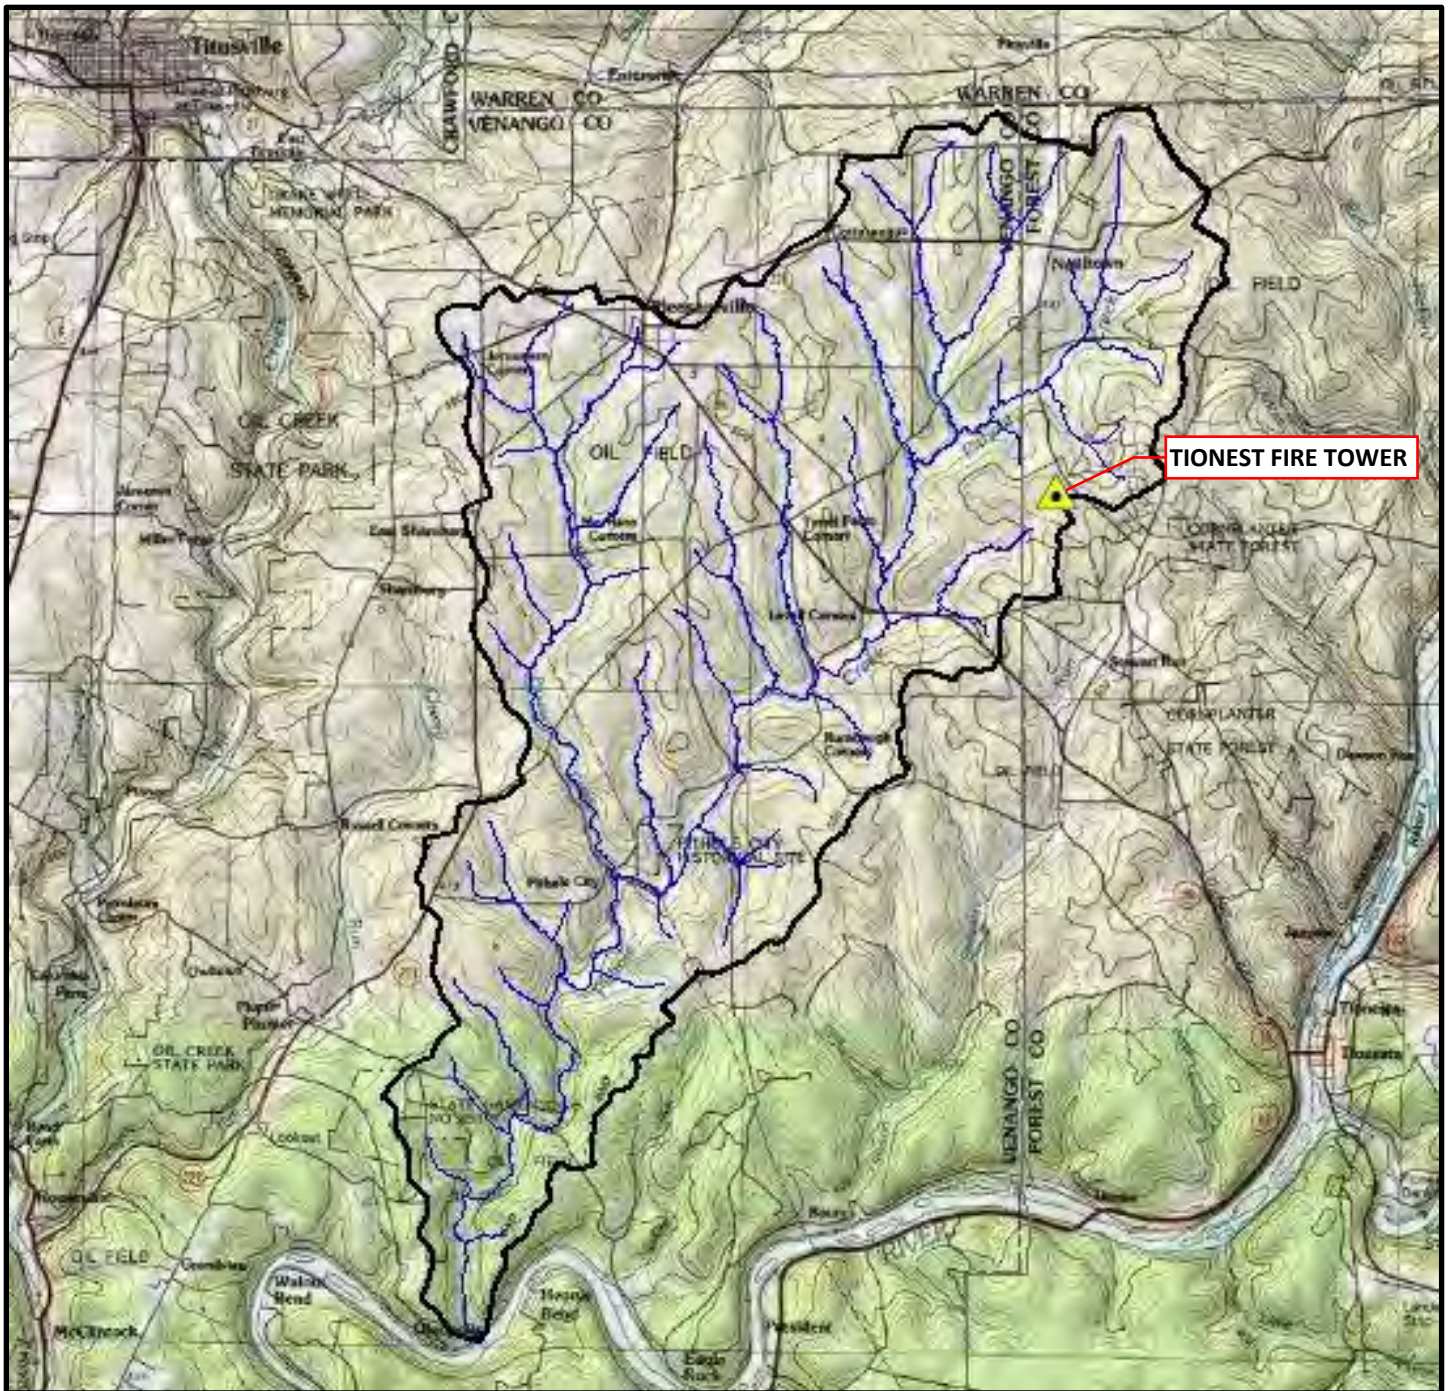
Figure 6. Pithole Creek watershed stream network with topographic map, Venango and Forest Counties, PA.

The Pithole Creek watershed has a mean elevation of 155' above MSL with a mean basin slope of 4.6 degrees. The highest elevation in the watershed is at the Tionesta Fire Tower southeast of Pleasantville at 1744' above MSL. The lowest elevation is at the confluence of the Allegheny River near Oleopolis at approximately 1020' above MSL.

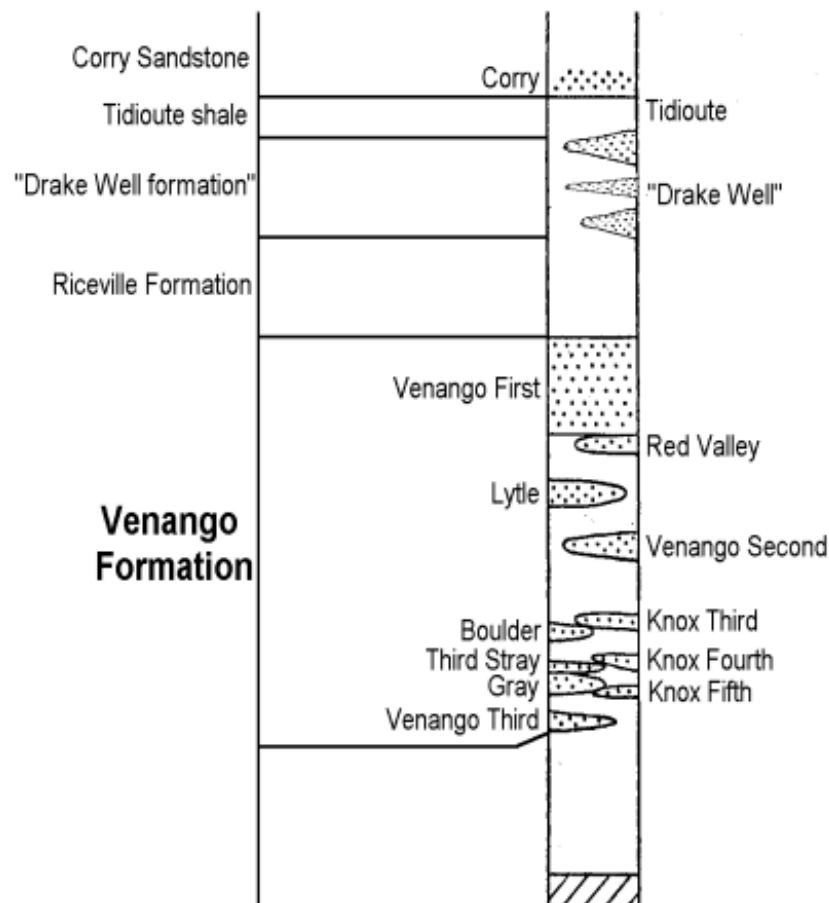
These sedimentary formations are associated with the early development of the oil industry in Venango County. In particular, the Venango Formation contains reservoir rocks of thick sequences of interbedded sandstones, siltstones, and shales. The origin of these rocks is thought to be oceanic nearshore conditions that were associated with beaches, barrier bars, and tidal channels.

Figure 7. Stratigraphy of the Venango Formation with formal and local driller nomenclature.

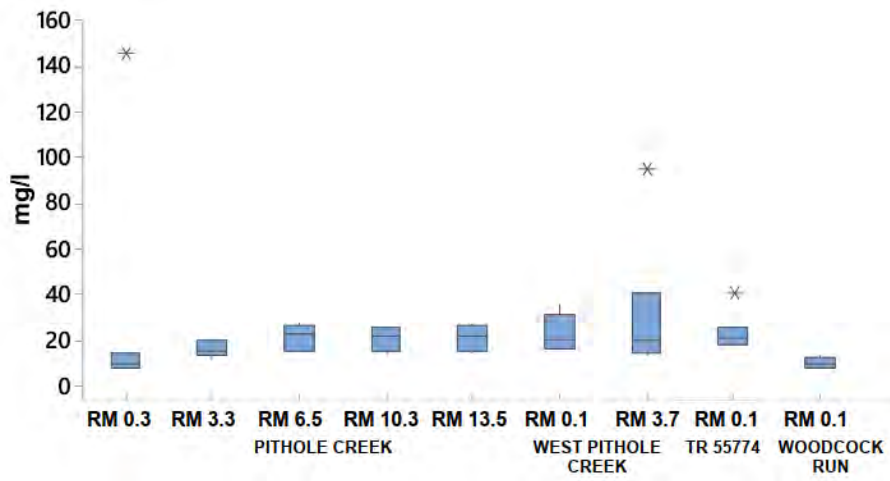
Chloride, sodium, and bromide showed somewhat elevated concentrations and variability throughout the watershed. It is reasonable to expect this result in that produced water (brine) from conventional oil wells escapes to local streams from currently producing wells, numerous abandoned and inactive wells, and from previous road applications throughout the watershed. It should be noted that there are no unconventional wells located in the Pithole Creek watershed as of August 2020.

Figure 16. Box plot of chloride at Pithole Creek, West Pithole Creek, Trib 55774, and Woodcock Run stations collected from 2018 -2020. N= 7.

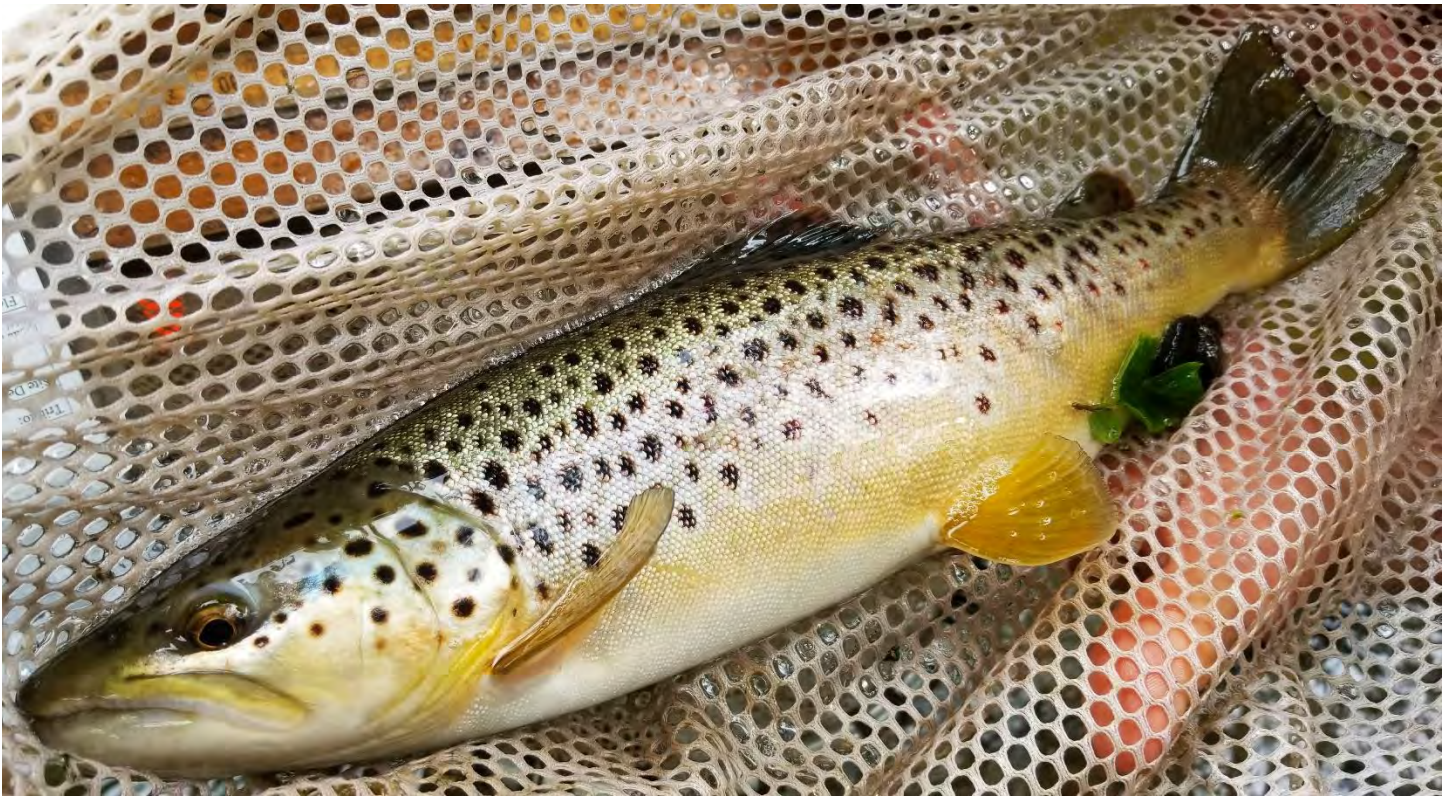
Figure 27. Large brown trout (*Salmo trutta*) captured during PAFBC electrofishing sampling in the middle portion to the Pithole Creek watershed July 3, 2019.

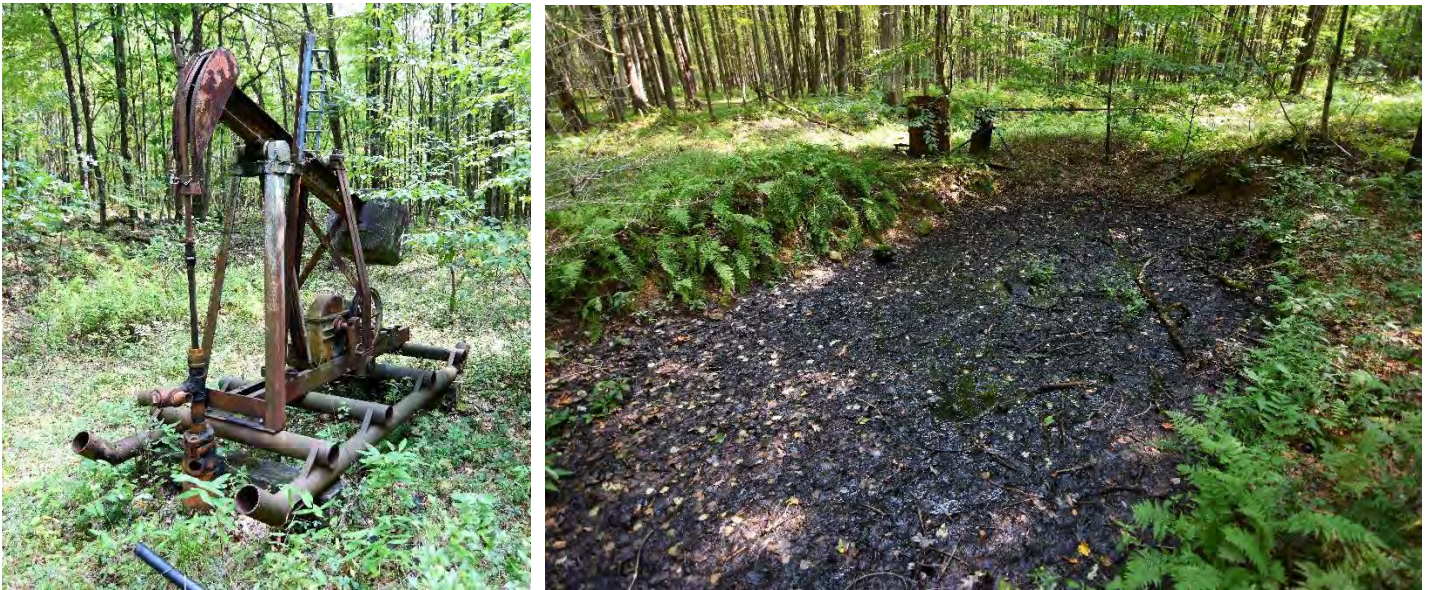
The pathways these chemicals follow to reach surface waters in the watershed is linked to groundwater and surface runoff. Subsurface connectivity of oil producing formations and freshwater aquifers from drilling activity beginning 155 years ago is well known throughout the watershed. Many of the producing formations are “flooded” with freshwater as wells have been abandoned over the years and well casings have subsequently failed. This allows formations that were previously isolated from one another geologically to interact with this mixed groundwater subsequently reaching streams. Numerous abandoned and inactive wells are spread across the watershed potentially contributing to groundwater contamination with brine.

Figure 28. Inactive well site with pump jack (photo left) and old separator with overflow pit (photo right) in the Pithole Creek watershed.

There is room for improving water quality and in-stream habitat conditions throughout the watershed. Water quality improvements can focus on finding and eliminating brine from reaching Pithole Creek and its tributaries. This has the potential to reduce the concentration of chloride, sodium, and bromide in stream water. Targeting abandoned and inactive wells for plugging and proper brine management could achieve this goal.

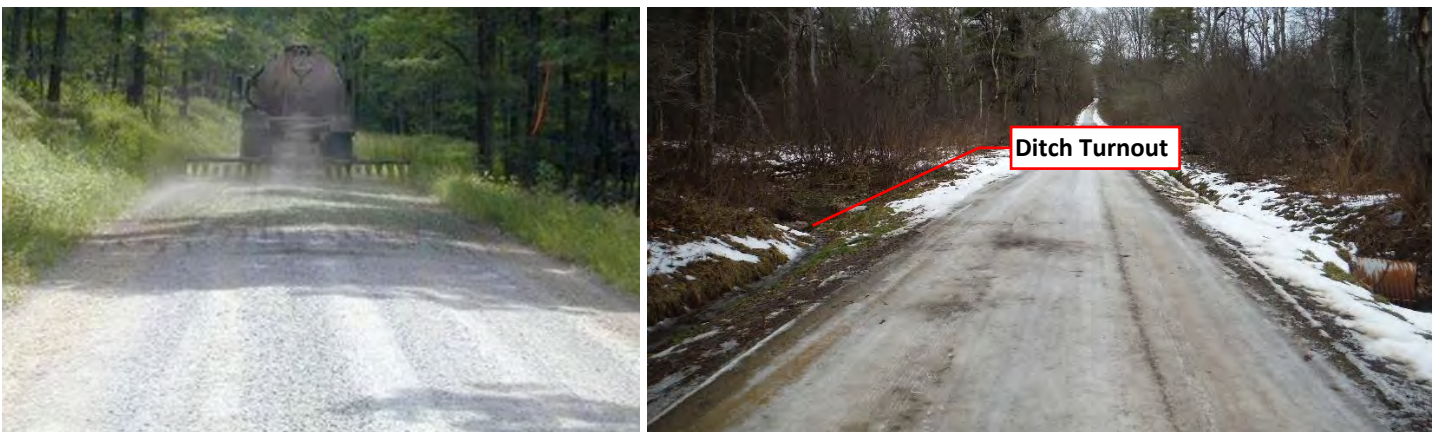
Brine spreading for dust control on dirt and gravel roads has historically been a common practice in Pennsylvania that was loosely overseen by PADEP. Brine spreading was terminated in late 2017 following a court case in Warren County that contended that produced water from conventional wells was hazardous waste and should be regulated just like produced/flowback water emanating from unconventional wells that cannot be spread on roads. Locally produced brine is typically spread by private contractors on dirt roads maintained by townships predominantly in northwest Pennsylvania.

Figure 29. Typical application of brine on dirt and gravel roads as practiced prior to 2018 (photo left) and ditch turnout on Dean Road aiding brine and sediment runoff into Otto Run (photo right).

Habitat improvement in the upper portion of the watershed will require improving dirt and gravel road management. This has the potential to reduce road generated sediment from reaching the stream and causing the widespread embeddedness encountered in many stream reaches. Reducing the degree of embeddedness in riffles may help restore trout reproduction in those areas where 2019 surveys failed to find native populations.

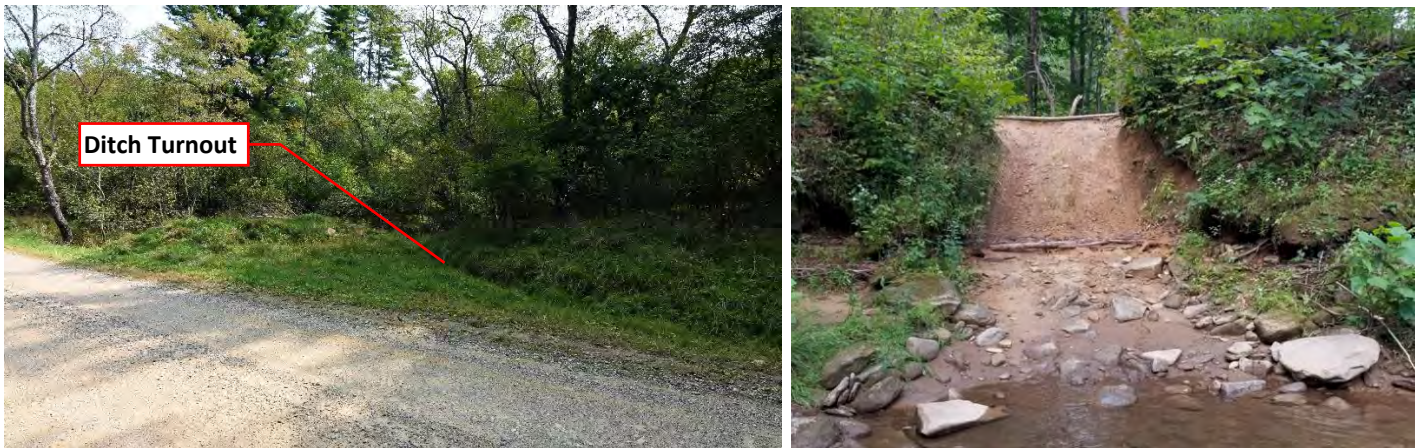
Sediment loading related to channel widening and dirt and gravel roads is driving increasing embeddedness primarily in the upper portion of the watershed. Sedimentation in lower gradient reaches nearer to the mouth of Pithole Creek is also associated with heavy ATV use in riparian areas adjacent to the stream channel.

Figure 31. Ditch turnout into Woodcock Run on Pike Road (photo left) and ATV crossing on Pithole Creek mainstem near mouth at Oleopolis (photo right).

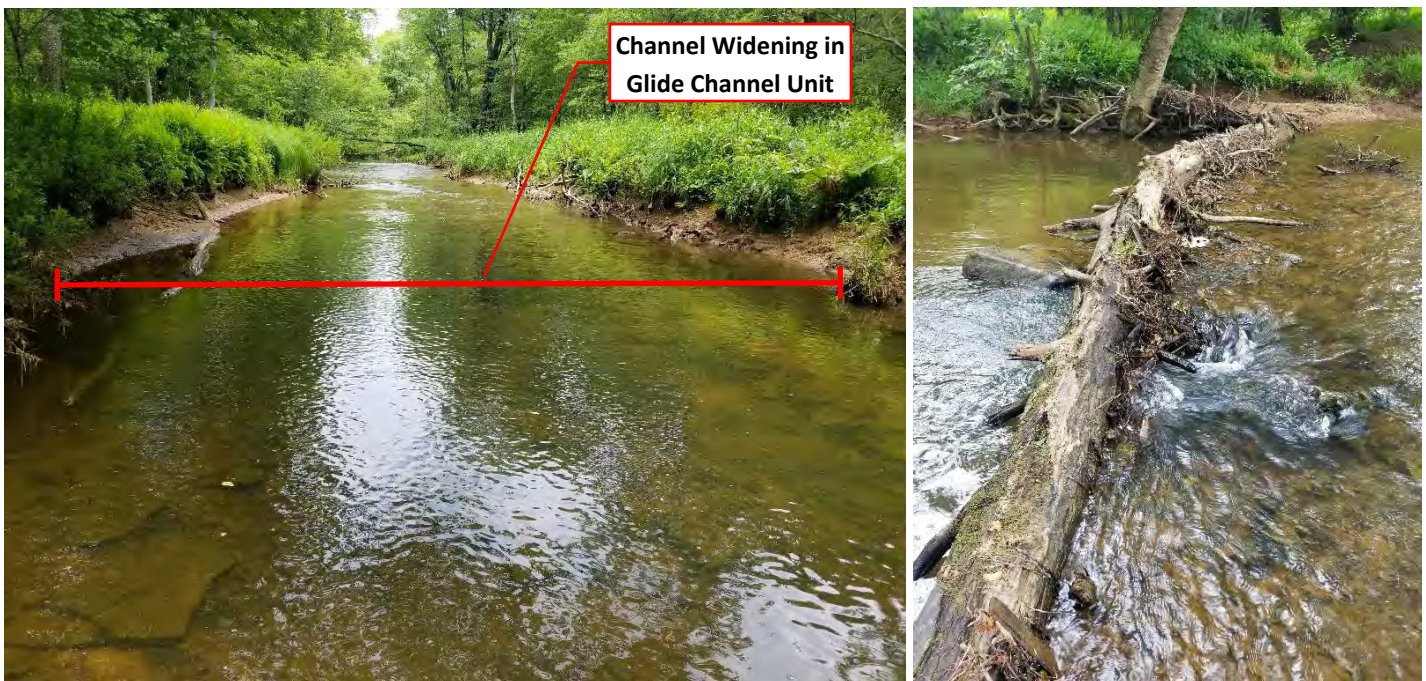
Channel widening has been documented in the reaches historically sampled by the PAFBC. The result of channel widening in the stream channel is a modification in channel units (creation of glides), reduction in water depth and hydraulic cover, reductions of in-stream cover (overhanging vegetation) and loss of large woody debris (log jams and log deflectors). Lateral widening is also contributing sediment as bank full discharge events increase in frequency.

Figure 32. Channel widening in PAFBC sampling section in the middle portion of Pithole Creek. Note lack of instream habitat, overhanging vegetation, hydraulic cover, and woody debris (photo left) compared to in-stream log with downstream scour pools (photo right).

Habitat in the center section of the mainstem of Pithole Creek above the Stone Arch Bridge often lacks channel structure and habitat diversity. Sections of the channel have failing banks from long term widening and lack large woody debris. Reintroducing large wood into the channel and stabilizing bank and riparian areas would create locations that would support a more diverse and robust fishery.

- Conduct a habitat assessment of the middle and upper sections of Pithole Creek where channel widening has been observed and channel units are dominated by glides. Survey results can identify locations where improvement projects could be implemented by local interests that could stabilize failing banks where appropriate, add large woody debris and boulders, and diversify in-channel habitat.

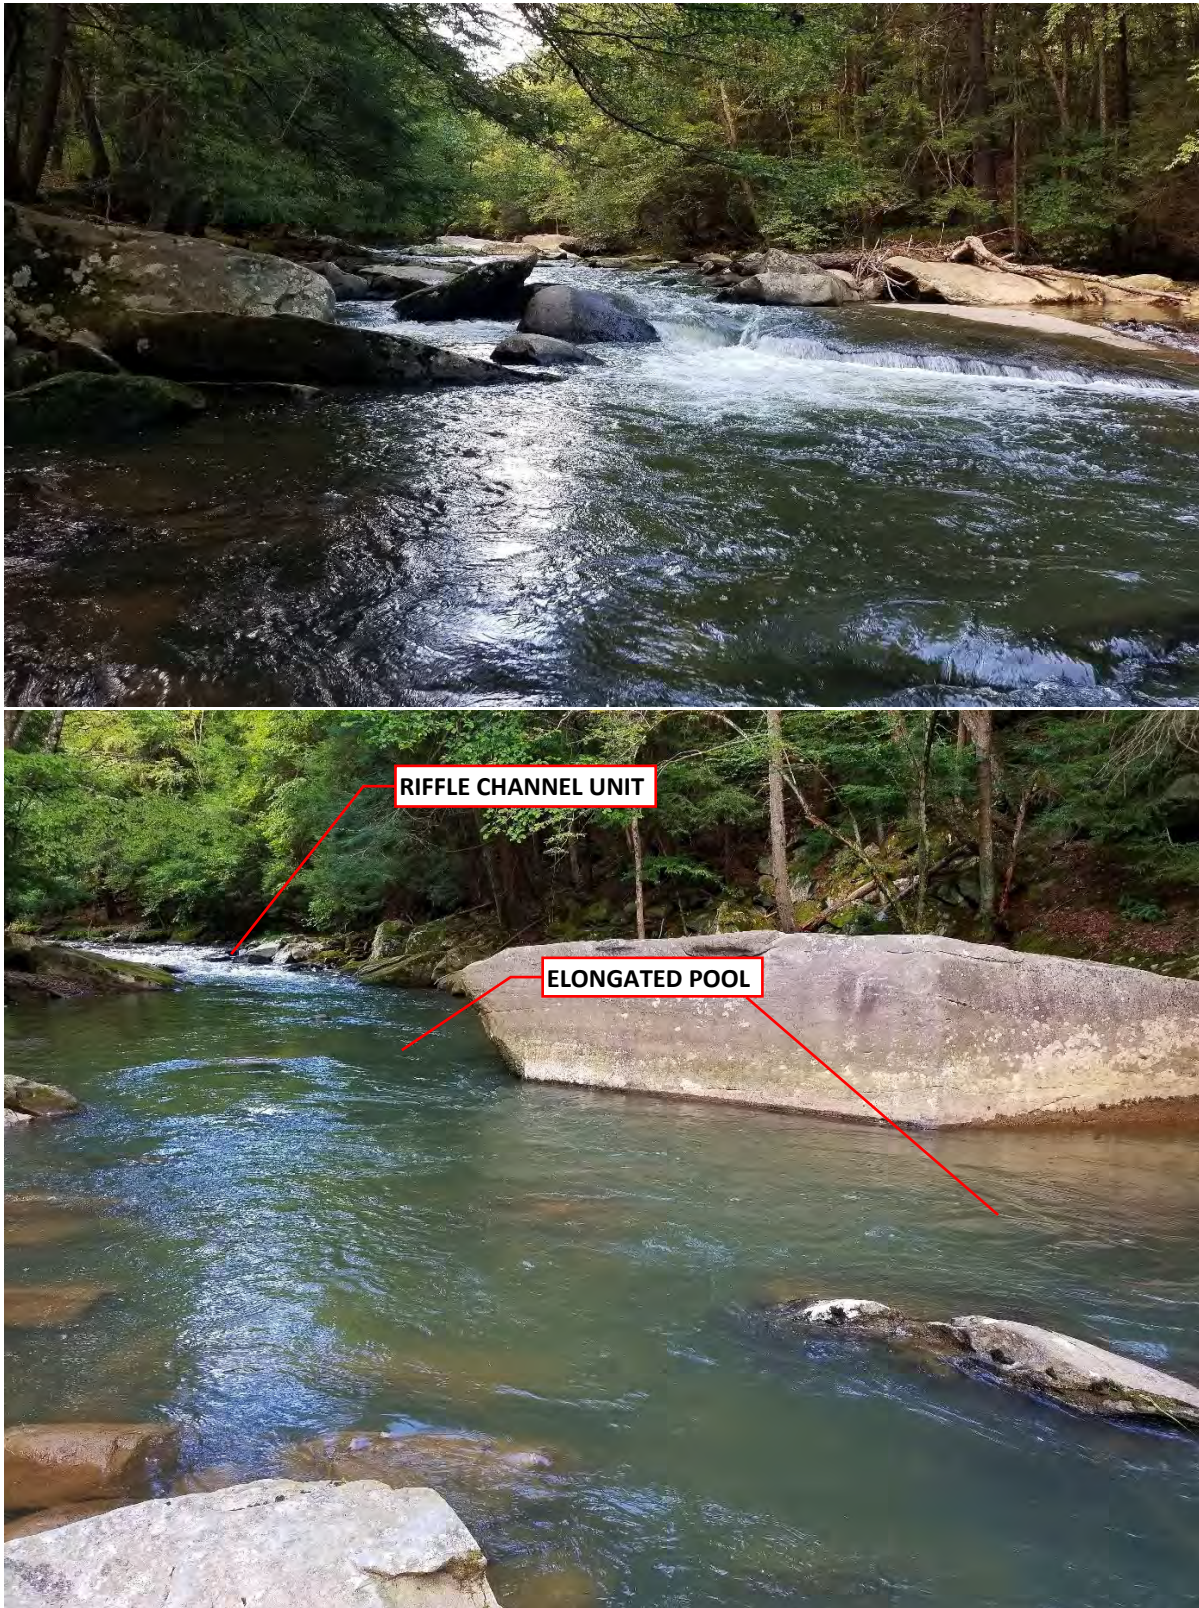
Bridge on Eagle Rock road and extends to about 3/4 mile above the confluence of Pithole Creek with the Allegheny River. This section contains gradient breaks, boulder fields, chutes, flow deflectors, and large pools that are favored by trout and other fish species.

Figure 33. Quality fish habitat found in higher gradient portions of Pithole Creek. Upper photo shows a boulder field and lower photo an elongated pool below a high gradient riffle.
