Coldwater Conservation Plan

Upper Starrucca Creek Watershed

SUSQUEHANNA COUNTY, PENNSYLVANIA
MAY 2023

Prepared by the Susquehanna County Conservation District

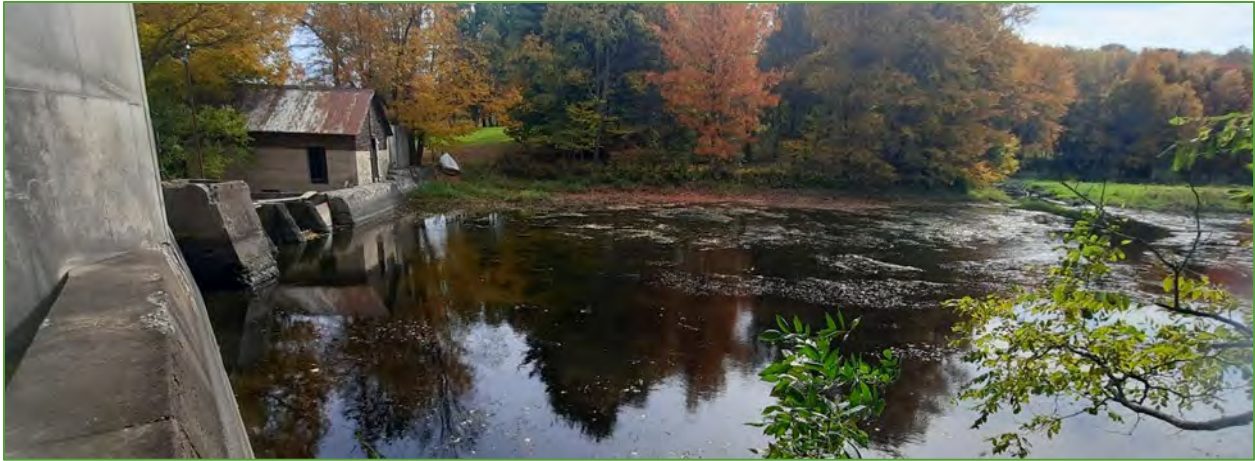
Figure 6 Spencer Mill Dam Pond on Starrucca Creek in Thompson Borough

The Borough of Thompson has been a witness to Starrucca Creek's wonder since its founding in 1876 but the stream's potential to generate power was developed years prior. The Spencer Milling Company gristmill was constructed on Starrucca Creek in what would later become the Thompson Borough. Over the years the building has had multiple businesses run out of it and recently had been used as an Agway. The mill dam it's self is made of concrete and the streambanks from the outflow have been also been lined with concrete and stone for over 280ft downstream. The impoundment created by the mill dam has filled in with sediment over the decades creating a shallow pond that fluctuates in size with rain.

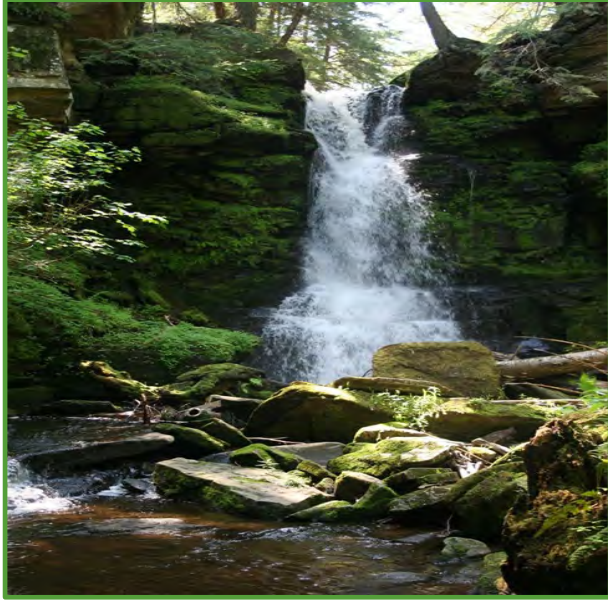
Figure 8 Buck Run Falls

Native trout were found in the reach of stream between the bottom of the falls and the confluence with Starrucca Creek. Buck Falls and the hemlock dominated riparian forests around it are situated along a section of the Delaware & Hudson (D&H) Rail Trail. This striking natural feature brings in recreational notoriety for trail users and out of town visitors alike. The D&H Rail Trail offers 19 miles of recreational trails between the trailhead in Ararat Township and the New York state line. Much of the trail intersects and provides creek access throughout the entire Starrucca Creek Watershed.

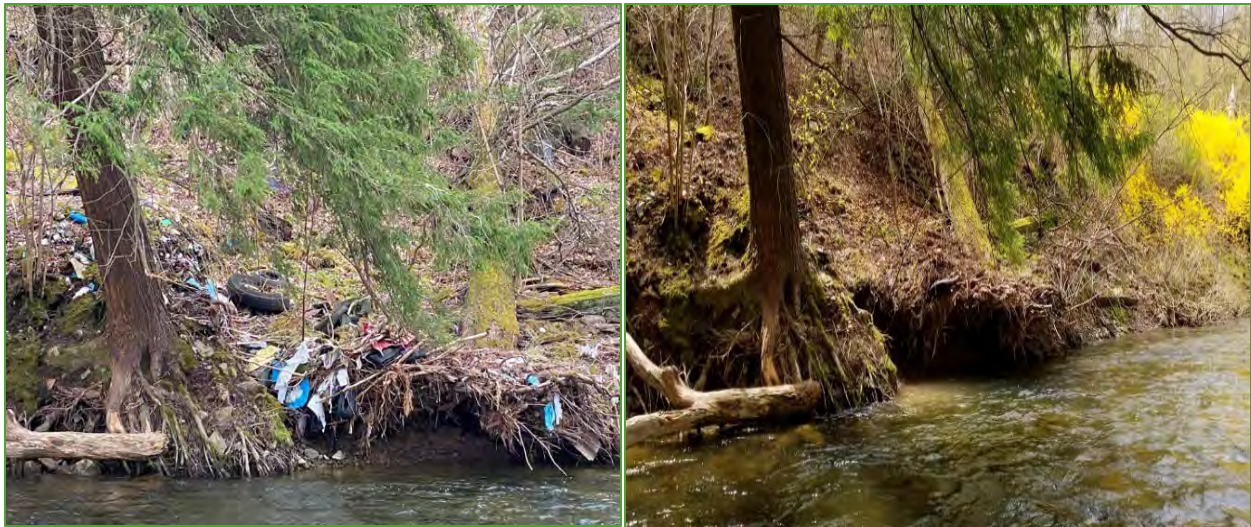
The Friends of Starrucca Creek is a local watershed group that have annually worked within the watershed to help remove rubbish to beautify and prevent potential pollution. Partnering with the Pennsylvania Environmental Council to host the annual clean up, the group have removed massive amounts of trash and debris from not only upland areas within the watershed but even within the creek itself. Below is a before and after picture showing the results of the hard work that they have dedicated to improving the waterways.

Figure 9 Before and after pictures of massive trash and rubbish site on Starrucca Creek

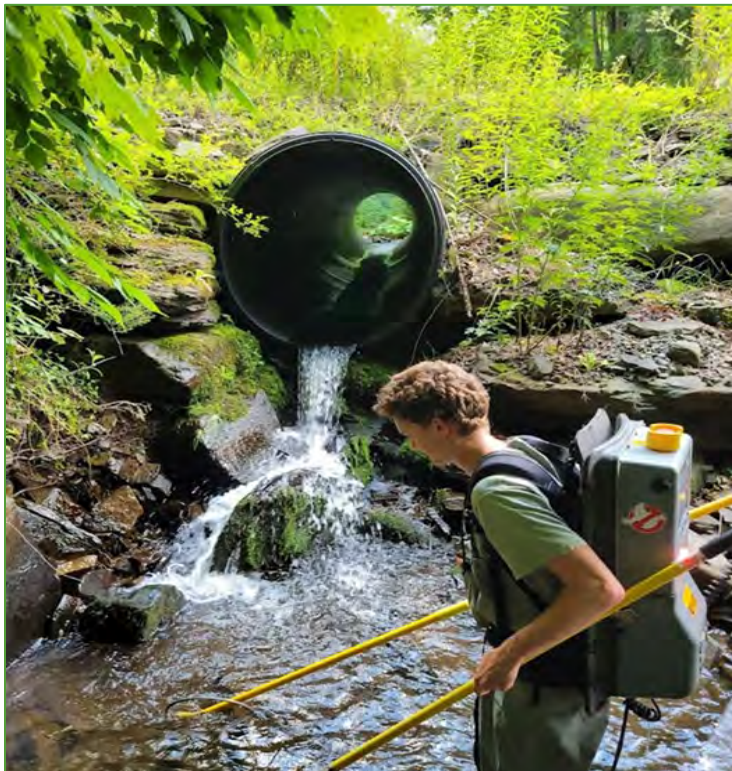
Figure 11 Trout Unlimited intern Willie Cosner conducting electroshock fish survey at crossing 89619 on unnamed tributary. Brook trout were documented here.

Crossing 89619 on Lamb Road was found to have No AOP and a passability score of 0. This is a round culvert pipe with a large outlet drop. This crossing is on unnamed tributary 32296 which was found to have naturally reproducing populations of brook trout during surveys for this project.

Unnamed Tributary 32296 to Starrucca Creek was surveyed downstream of the Lamb Creek Road crossing (Crossing ID 89619). Ten brook trout (*Salvelinus fontinalis*) were documented throughout the survey and it was noted some trout were missed (Table 2). Brown bullhead and pumpkinseed sunfish were also documented in this reach. In-stream habitat was noted to be good for trout but also steep. The culvert at the top of this reach was documented to have No AOP and is discussed in detail in the Culvert Assessment section.

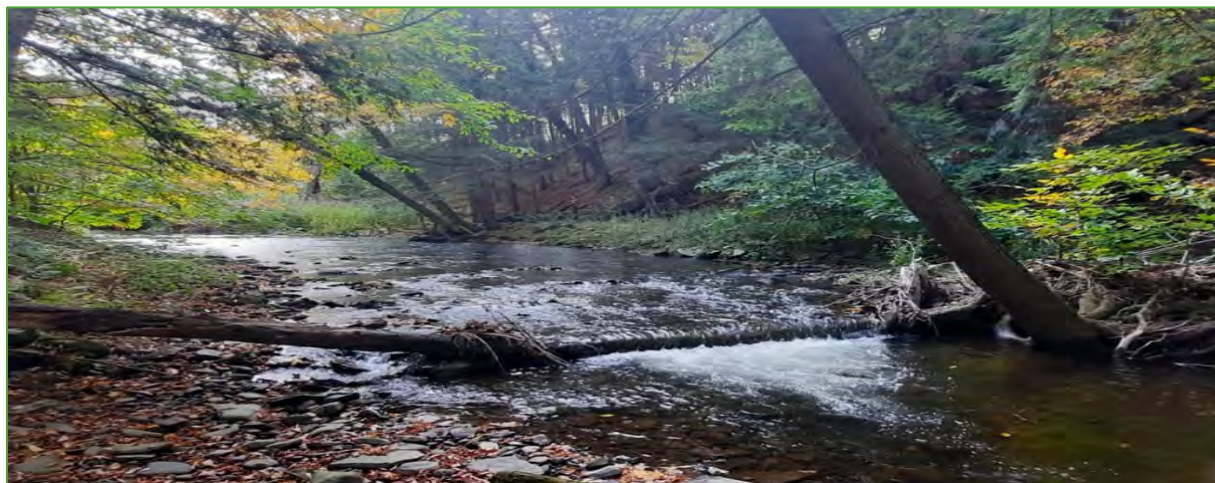
Figure 12 Natural plunge pool habitat and forested riparian area observed during habitat assessment

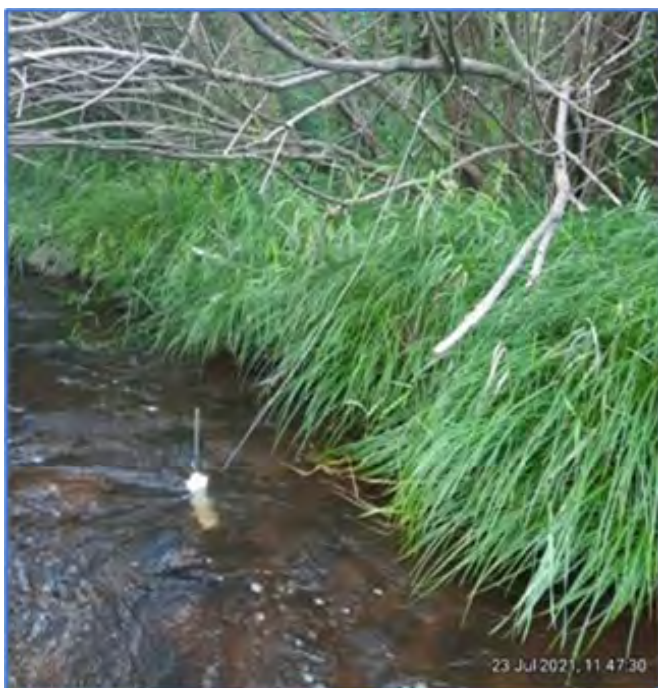
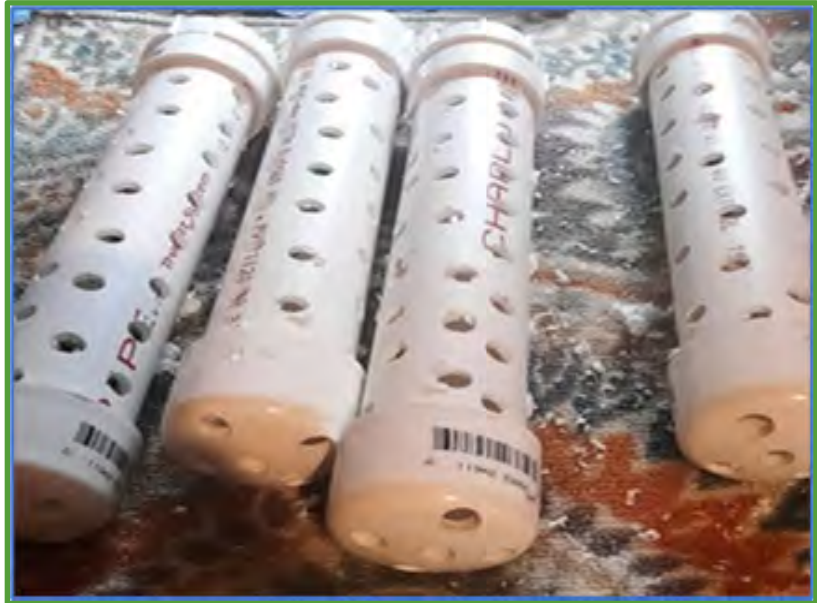
Figure 13 Temperature logger housing deployed on tributary 32264

Data collected related to thermal fluctuations throughout the watershed can help with planning future conservation efforts and provide insight into how current conditions are impacting native trout populations. SCCD staff utilized the protocols provided in the *Stream Temperature Monitor Handbook for Trout Unlimited Chapters (2018)* to develop its program for this project. Temperatures were recorded using HOBO Pendant Data loggers. Before deployment these loggers were calibrated according to the manufacturer’s instructions. None of the loggers displayed any variances of more than .5°F. Protective housings were constructed using PVC piping and caps drilled with holes to allow water to flow through freely. The loggers were secured

within the housing with wire and anchored at desired sites. Each logger was set to capture a temperature data record every hour. A picture of the housing and logger can be seen below. At the time of deployment, the logger serial number; depth; surrounding habitat; canopy cover; time of day; and temp of water was recorded Table 1 (Appendix F).

Figure 14 PVC housings for temperature loggers

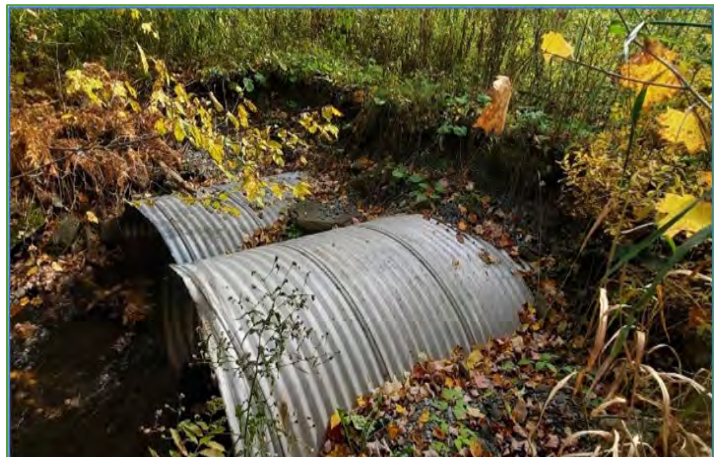
Figure 15 Crossing 92241 Culvert pipe with eroded surrounding crossing base

Crossing 92241 located on PA-1001 was found to have reduced AOP, however the passability score was 0.712. This crossing consists of two elliptical culverts and was noted to be in poor condition. One of the culverts was blocked and caving in, leaving only one culvert to pass water. Erosion was evident at the inlet and outlet. The unnamed tributary (32299) was found to have naturally reproducing populations of brook trout during surveys for this project.

- Recommend and follow up on the prompt redesignation of the USCW as naturally reproducing trout waters with the Pa Fish and Boat commission.
- Replace the culverts that scored poor or reduced AOP on the main stem of Starrucca Creek above the mill dam and those on tributaries 32299 and 32296.

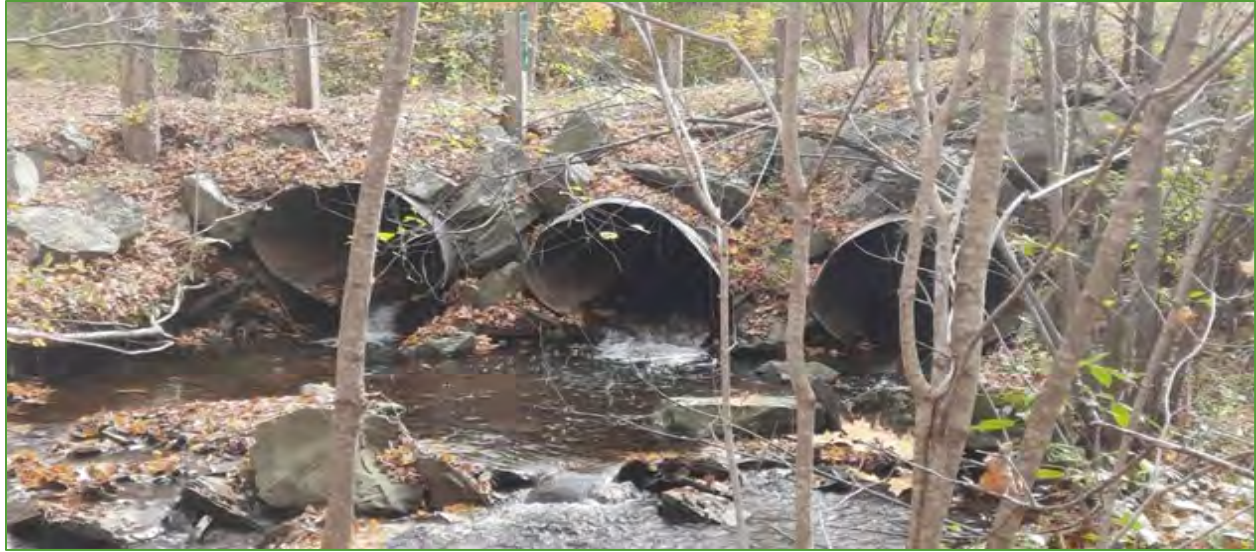
Figure 17 Crossing 92244 consisting of three elliptical pipes

Crossing 92244 was located on the main stem of Starrucca Creek and was an old driveway and received an AOP rating of no AOP and a passability score of 0.477. This crossing consisted of three elliptical pipes with varying heights under a trail/driveway. During lower or higher flows passability could be even more reduced. Eroded bank material on either side of this crossing was observed during assessment.

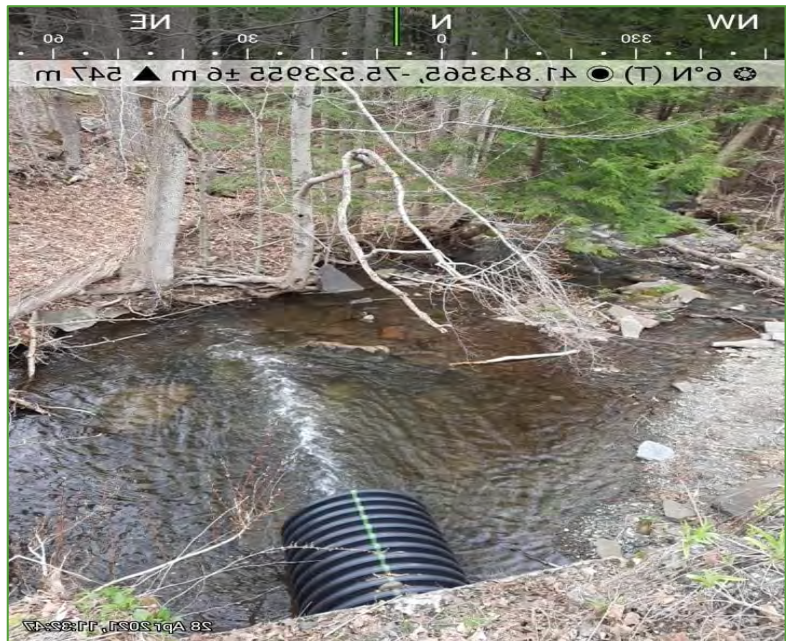
Figure 18 Crossing 89679 at Ogden Road with scour pool

Crossing 89679 on Ogden Road received a Reduced AOP rating with a passability score of 0.482. This crossing was noted to be in poor condition in relation to the roadway. A large sediment wedge has formed at the inlet of this crossing causing erosion and water to flow into the crossing at many angles (Figure 28 section 4.3). There is evidence of the water over topping the road. Flows were moderate at the time of this survey and the outlet could pose a greater obstacle to fish passage at lower or higher flows.

- Utilize the County's Dirt, Gravel & Low Volume Roads program to address deteriorated culverts and roadways contributing sediments to surface waterways that have been identified in this study.

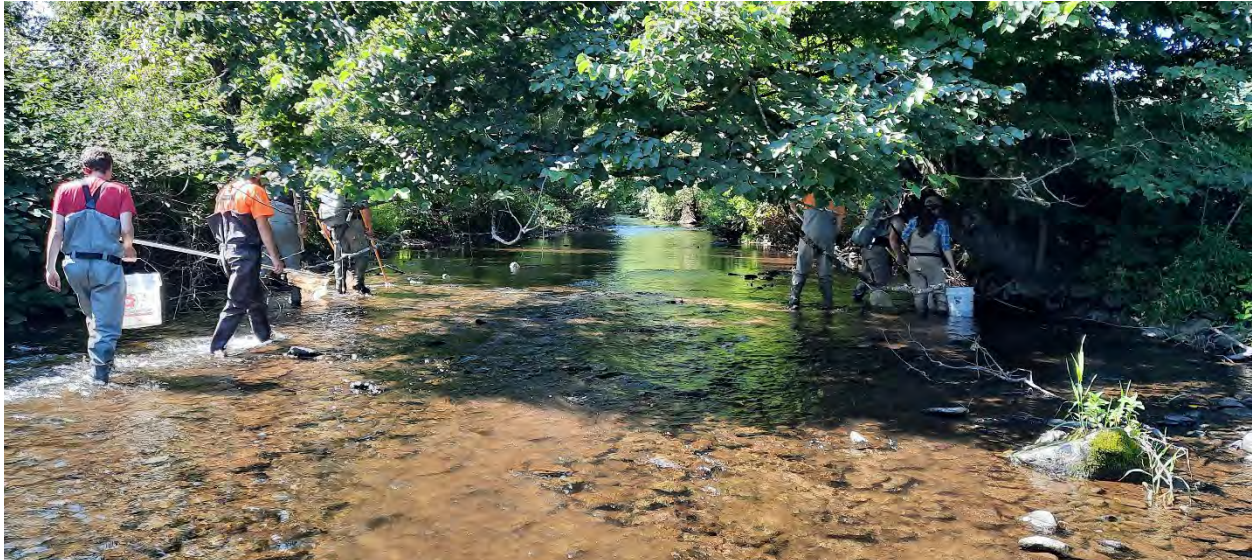
Buck Run (Tributary 32264 to Starrucca Creek) was surveyed in four locations. Brook trout and brown trout (*Salmo trutta*) were documented at Buck Run Site 4 which is downstream of a large waterfall, Buck Run Falls (Figure 20). Trout documented here will warrant a Naturally Reproducing Trout listing from PFBC. In addition to the trout species, blacknose dace, sculpin spp, (*Cottoidea*) and creek chub were found to be common. Brown bullhead and longnose dace (*Rhinichthys cataractae*) were found to be present and one yellow perch (*Perca flavescens*) was documented (Table 1).

Figure 20 Trout Unlimited Team conducting Fish Survey around Buck Run and Starrucca Creek confluence

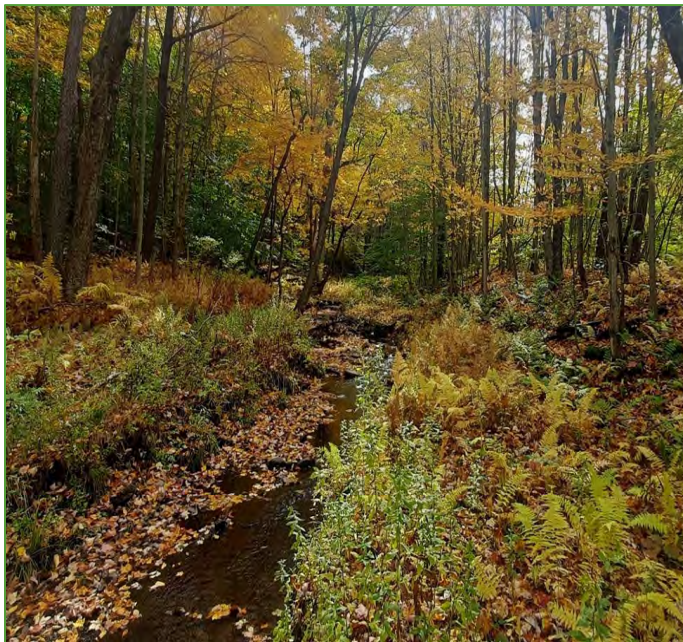
Figure 23 Sub optimal habitat assessment location at the top of Starrucca Creek Watershed

Rail Trail documented optimal riparian habitat but sub-optimal overall scores due to siltation of stream substrate. Figure 23.

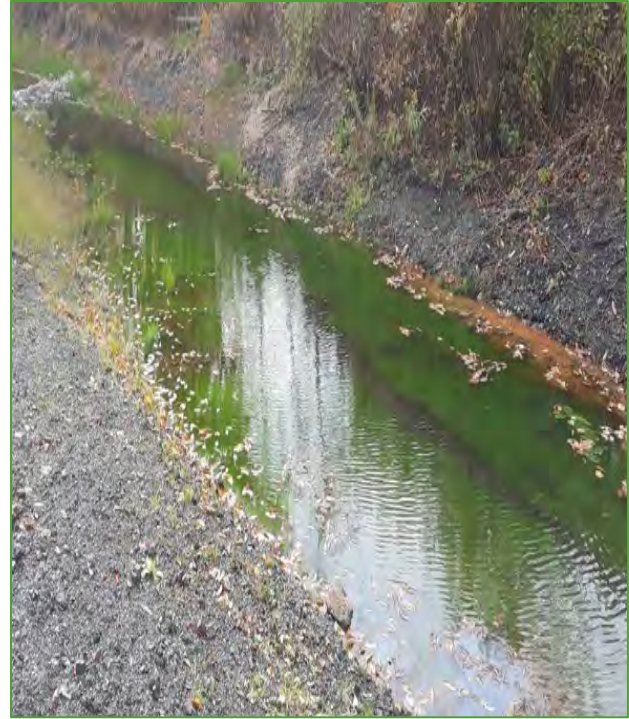
Figure 24 Nutrient rich ground flow along trail maintenance location

sediment loading, and channel alteration assessment scores reflect recent trail maintenance activities that have potential for long term negative impacts to instream habitat and overall water quality. Habitat was assessed at points along the rail trail where Starrucca Creek parallels and crosses the rail trail via culverts. Some of the lowest habitat assessment scores were recorded in this section. Disruptive pressures, vegetated riparian habitat, sediment loading, and channel alteration assessment scores reflect recent trail maintenance activities that have potential for long term negative impacts to instream habitat and overall water quality. At the site of trail maintenance adjacent to the first beaver dam impoundment below Roberts Pond, an area where trail comb material was excavated to build up the trail base seemed to have constant standing water with an increased concentration of nutrients leading to an algal growth Figure 24.

- Promote the conservation of forested and riparian habitat in the upper reaches of the watershed. Where trail maintenance activities come in contact with Starrucca Creek, minimal disturbance of rail trail bed comb material and wetland habitat is recommended. Installation of flow control structures such as Clemson levelers could be installed in areas where there has been historical trail deterioration from high water events. This would mitigate the risk of trail damage, reduce the need for expensive maintenance, and allow for wildlife to thrive in wetland habitats created by beavers.

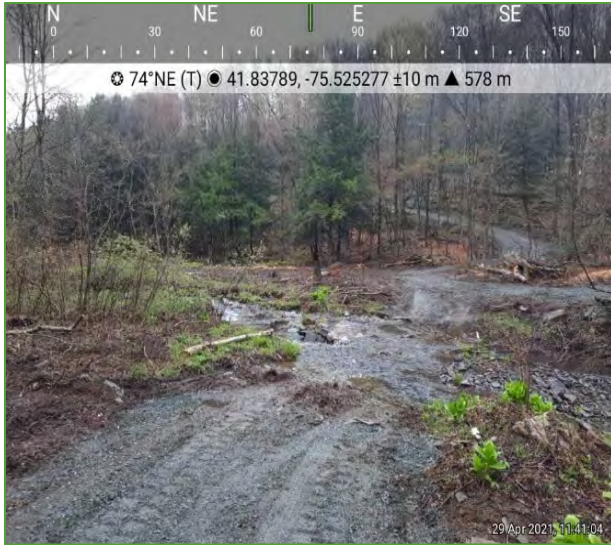
Figure 27 Forested riparian habitat loss to development

Disruptive pressures observed included losses of shrubby and forested riparian habitat in residential areas of the Thompson Borough, channel constriction due to armored banks Figures 5&6 (Appendix E) , loss of riparian habitat due to development (Figure 27), and improper placement of stream debris from culvert maintenance.

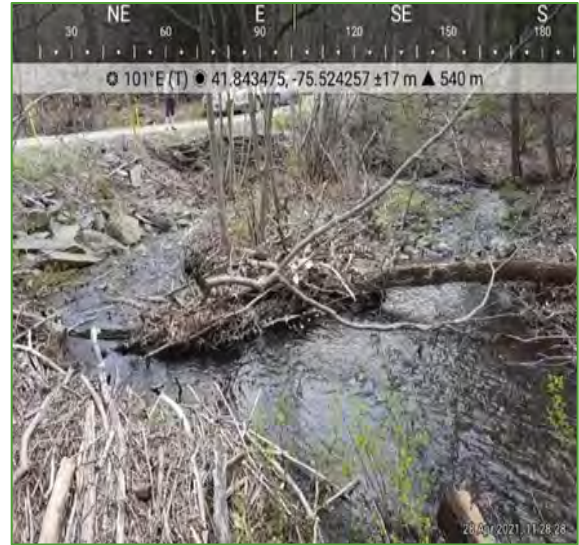
Figure 28 Ogden Road culvert causing stream to back up and erode new channel

downstream Figure 3 (Appendix E). At one culvert crossing on Ogden Road, the stream channel had split into two after a high-water event and subsequent debris jams (Figure 28). Sedimentation of stream substrate was observed around this location.

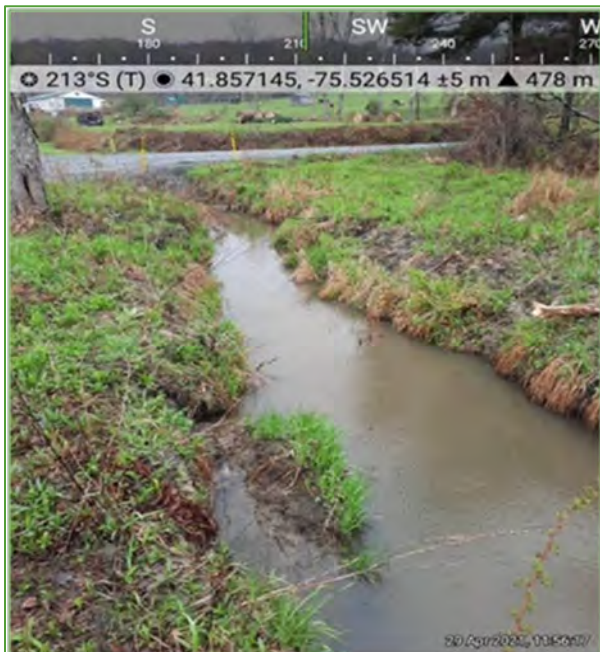
Figure 29 Ararat Road ditch

Assessments further down the watershed revealed improved overall habitat scores; however, potential threats and causes for lower habitat scores were observed and documented. Sediment sources observed while assessing habitat included sites with storm water conveyance ditches (Figures 29 & 30), unstable banks around the 171-bridge Figure 3 (Appendix E), and eroding banks due to under sized or failing culverts. Large amounts of sediments have been deposited in the channel behind the Spencer Mill Dam that have the potential to migrate during high water events and cause sedimentation of substrate

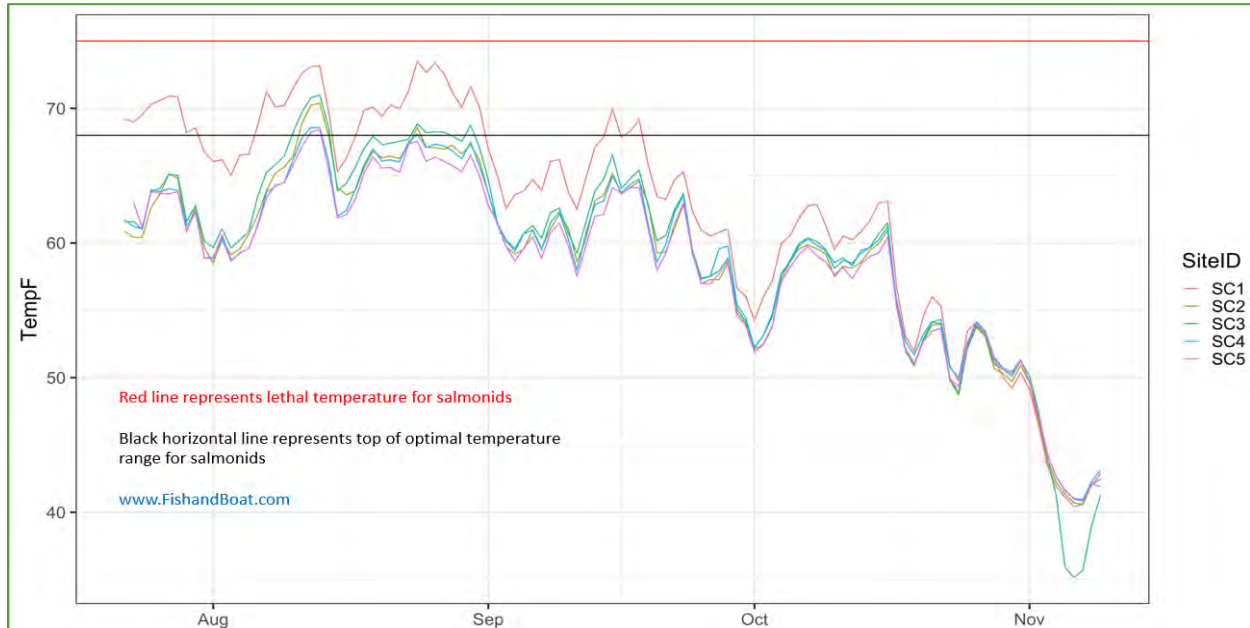
Figure 32 Temperature profiles at points along Starrucca Creek main stem

Figure 32 displays the temperature profiles recorded on points along the main stem of Starrucca Creek. This graph shows that during the summer of 2021, water temperatures in the main stem of Starrucca Creek were capable of supporting trout. While every point along the creek did at some point reach a temperature that could put stress on trout, SC1, SC2 and SC3 were the only points where warmer water temperatures were sustained longer than a day.

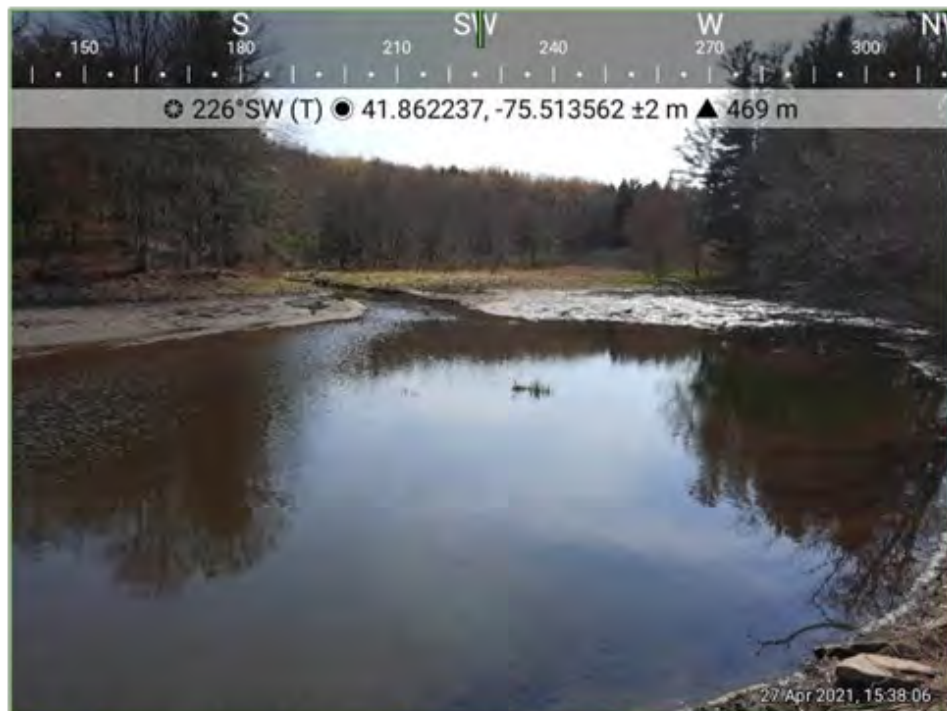
Figure 1 Impoundment from the Spencer Mill Dam in Thompson Borough

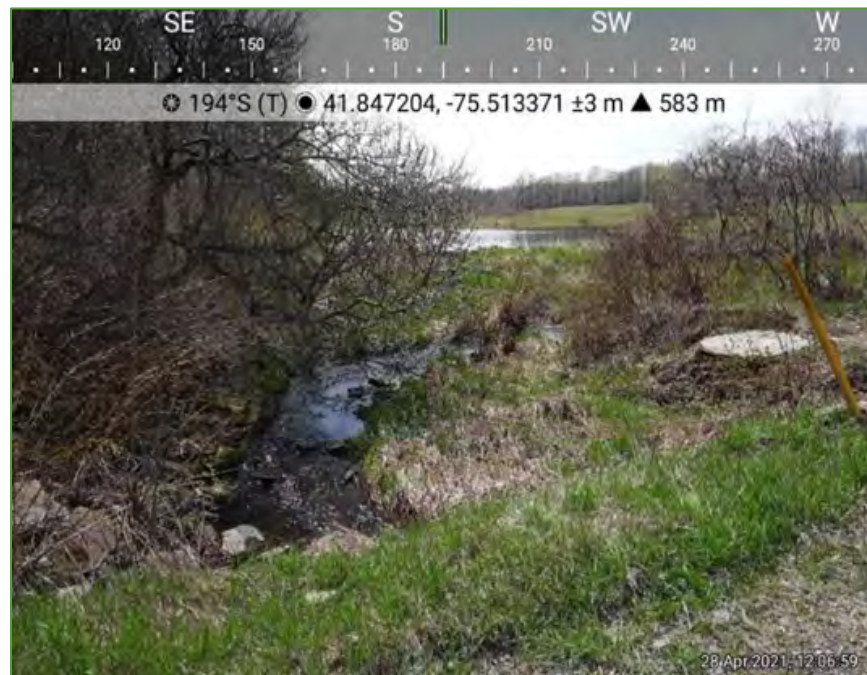
Figure 1 Impoundment from beaver dam upstream from logger on UNT 32298

Water temperatures recorded downstream from the wetlands on Starrucca Creek and unnamed tributary 32298 were on average higher than temperatures lower in the watershed. Table 1 (Appendix F) lists the location and habitat of the area just upstream from the temperature logger at crossing ID 89678. The shallow beaver dam and lack of forested or shrub habitat in the resulting beaver dam could be contributing to the cause of high temperatures being recorded.
