UPPER KETTLE CREEK FISH HABITAT CONSERVATION PLAN TRIBUTARIES ADDENDUM

For: Kettle Creek Watershed Association and Trout Unlimited
March 2005

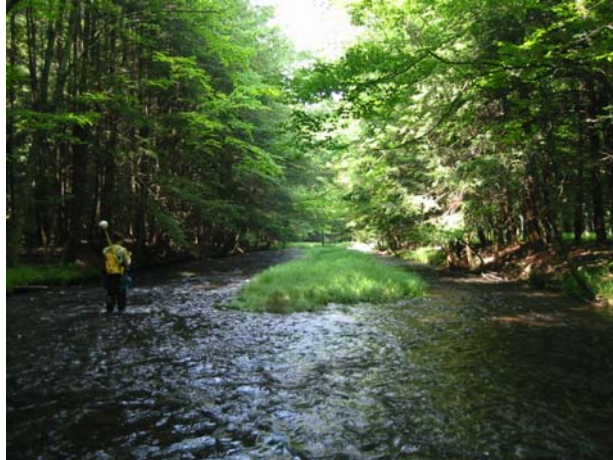
FIGURE 2. High width-depth ratio channel in Upper Kettle Creek

Upper Kettle Creek flows southwest where it joins with Little Kettle Creek forming Kettle Creek. Starting upstream of the bridge on Butternut Hollow Road the channel has few pools but has a significant amount of spawning gravel throughout the channel. At this location the stream can be classified as a Rosgen B stream type. The dominant bed sedi-

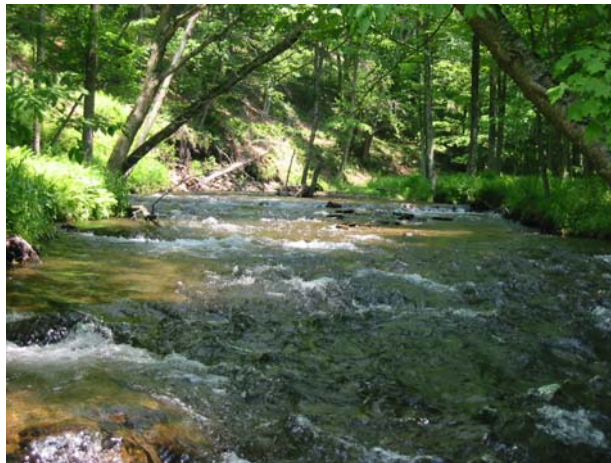
FIGURE 3. Typical stream form on Upper Kettle Creek Reach UK2

The upstream portion of the reach is stable with few mid-channel bars and limited bank erosion. The stream has good access to the floodplain and exhibits a Rosgen C stream type. Embeddedness values are low and the dominant bed sediment is cobble. Pools are limited in this reach. The east bank has a rock wall along part of its length and several locations with

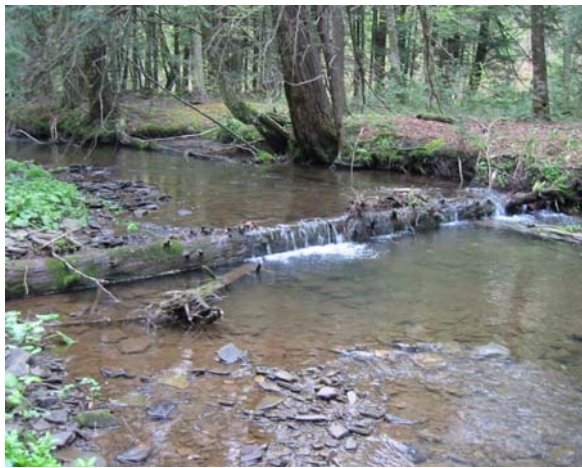
FIGURE 7. Woody debris controls the stream bed elevation

type. There are numerous headcuts in the first 1.75 miles of the reach ranging from 0.3 meters high to 1.5 meters high. Bank erosion is found throughout the reach. The worst area of erosion is in the second half-mile of the assessment reach where the stream is entrenched. Because of the lower entrenchment ratio found in this area, more water is forced through a smaller cross-sectional area, causing increased bank erosion. The erosion in this area is 1 to 3 meters high with vegetated banks. There is also one section of extreme erosion with a 5 meter high, 20 meter long bank with a few trees present. As the stream flows downstream it widens and becomes a braided channel with numerous mid-channel bars. Meandering along the eastern hillside it encounters bedrock outcroppings, however the dominant bed sediment is gravel and small cobble.

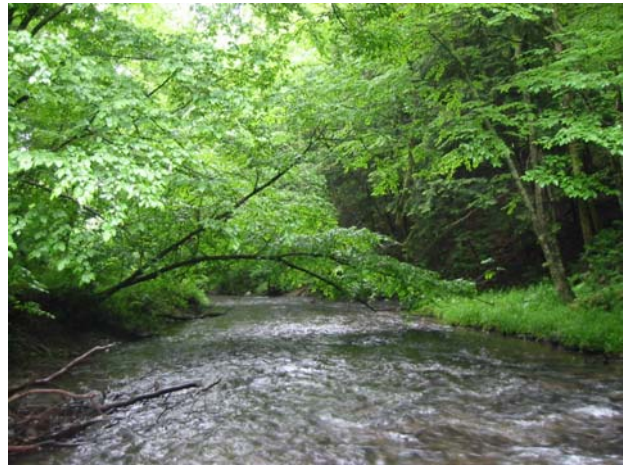
FIGURE 8. Excellent canopy cover and riparian vegetation on Little Kettle Creek

The willow covered east bank has a small floodplain. Most of the willows in this reach have been eaten by beetle larva. The channel flows across the valley in some locations but tends to be along the west bank hillside for most of the length. There is a large (200 meters long) meadow, about 0.2 miles upstream of the Hungry Hollow Bridge. It is located near an old beaver dam that is no longer active. There is also evidence of past beaver activity at the upper end of the reach as well. Fine sediment is captured in the slow moving water behind the beaver dams. Roadside drainage has introduced fine sediment into the channel about 0.3 miles upstream of the bridge.

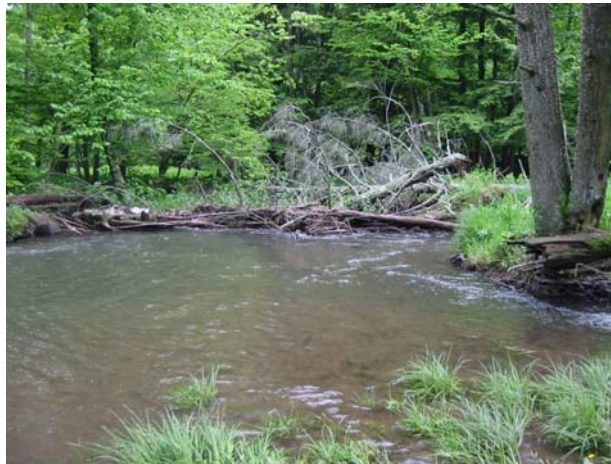
FIGURE 9. Coarse woody debris provides high quality habitat.

Route 44 and Little Kettle Creek occupy the same narrow valley in this section. The stream abuts the road at three locations. This reach has good access to the floodplain and can be classified as a Rosgen C stream type. Undercut banks stabilized by thick vegetation are located throughout the reach. In most of the reach there is limited bank erosion, however, there are

Riparian plantings in this reach will improve canopy cover and bank stability. Recommended tree species are green ash, sycamore, and white pine.

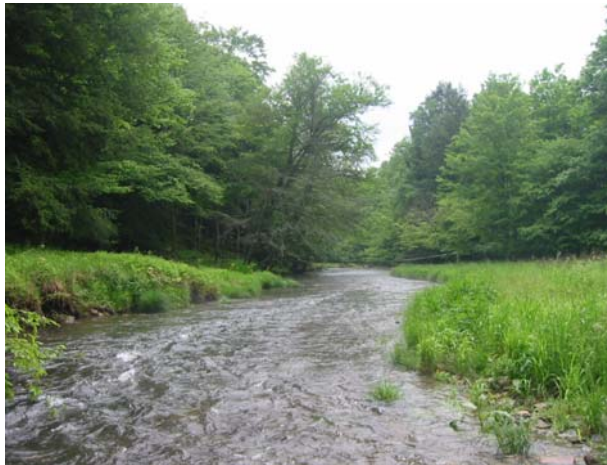
FIGURE 12. Cross Fork reach with good stream channel geometry.

In this section of stream, the floodplain is very wide. The stream flows along the west side of the valley for the entire length of the reach. The channel form and function vary widely through this section while maintaining a Rosgen C stream type. The channel ranges from overwide and sediment laden to a narrowing channel with newly developed lateral bars, to an appropriate width and

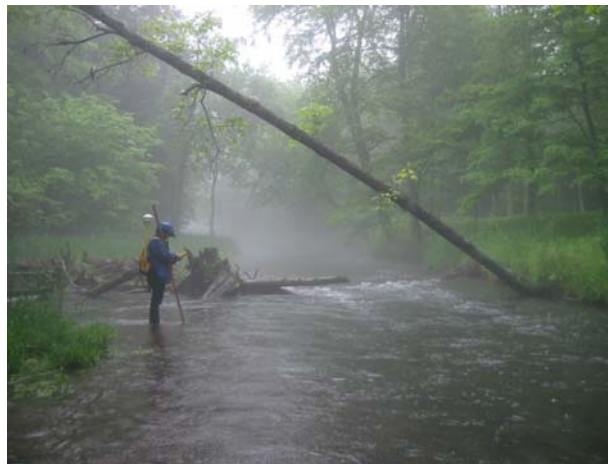
FIGURE 13. Coarse woody debris provides the majority of habitat in reach CF3.

In this reach, the stream is located along the east side of the valley and close to the hillside. There are long, older, thickly vegetated lateral bars throughout the reach. The channel is narrower with higher velocities and numerous 0.5 meter deep runs. Several rock dams are located in the lower part of the reach. There are long pools behind the dams but habitat was limited

While habitat enhancement in this reach can improve the existing conditions, the limitations posed by the high number of camps in the riparian area downstream from Windfall Run would make work difficult. Constructed woody debris jams in key locations can be used for moderate habitat improvement.

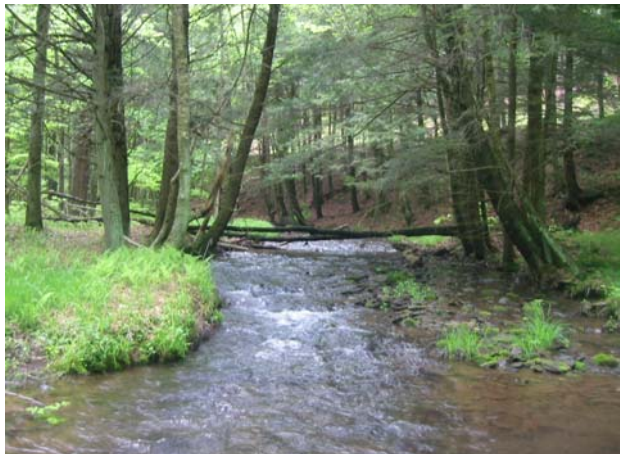
Little Lyman Run is located in the northern part of the watershed and drains into Cross Fork from the west. The valley bottom is narrow and the stream meanders across the valley. The channel is a Rosgen D stream type in most areas and has smaller split channels than upper Cross Fork. The dominant bed sediment found in this reach is small cobble

FIGURE 14. Split channel on Little Lyman Run

The surveyed reach does not contain many large pools. Habitat is created by over hanging banks and small pools formed around course woody debris. Habitat can be enhanced by properly locating and constructing limited woody debris jams or log habitat structures. Due to the small stream size and excellent riparian buffer, no extensive channel modifications are recommended in this tributary. This stream should be permitted to evolve naturally with only limited intervention to improve habitat.

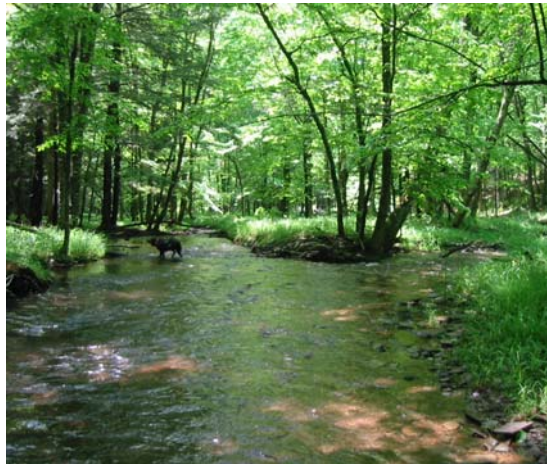
FIGURE 15. Split channel on Yochum Run

Yochum Run drains into Cross Fork Creek from the east and is south of the Little Lyman Run drainage. This tributary has a wide (80-100 meters) floodplain throughout the reach. It is a Rosgen C stream type with cobble as the dominant bed sediment. The upper end of the reach is in an open meadow area for approximately 250 meters. As the stream flows down the valley there are numerous split channels and dry, high

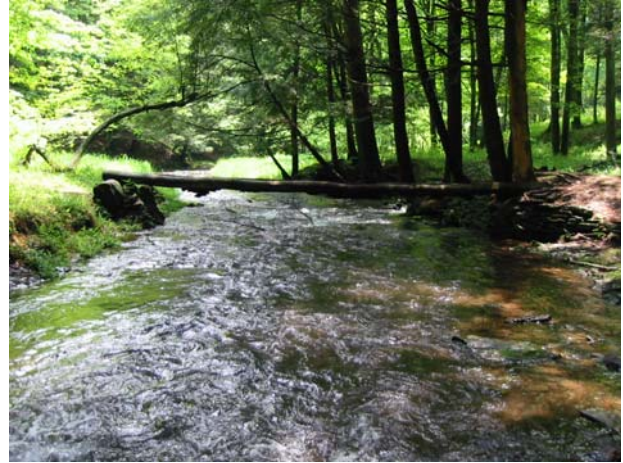
FIGURE 16. Typical channel form on Windfall Run.

along a steep hillside to the northeast. There are bedrock outcrops throughout the stream that help stabilize the stream bed. The stream appears to be over wide in the forested areas, although there are good entrenchment ratios in most of the channel. Bank erosion is common in the channel, with most areas rated mild or moderate erosion. There are several areas of severe erosion sites located near the top of the reach. These erosion areas have sandy substrate and all but one are greater than 19m in length. All of the erosion areas have cumulative inputs to the fine sediments in the system. Rocks on the channel bottom are flat and vary from small to large cobble. There are no willows in the open areas and little human impact in the upper mile of this reach. The channel straightens downstream of the Windfall Run Road Bridge. The bridge is skewed and a bar is forming under the bridge. Upstream of the bridge, the far right bank near the road has been rip-rapped to minimize bank erosion and protect the elevated road. Between the Windfall Run Road bridge and the Cross Fork Road bridge, the stream meanders and has two 180 degree turns with large pools. Sediment enters the channel below Windfall Run Road Bridge and appears to be coming from the road. The channel is a Rosgen G stream type by the Cross Fork Road Bridge. The downstream portion of this reach is an area of numerous headcuts, log jams, and deposition.

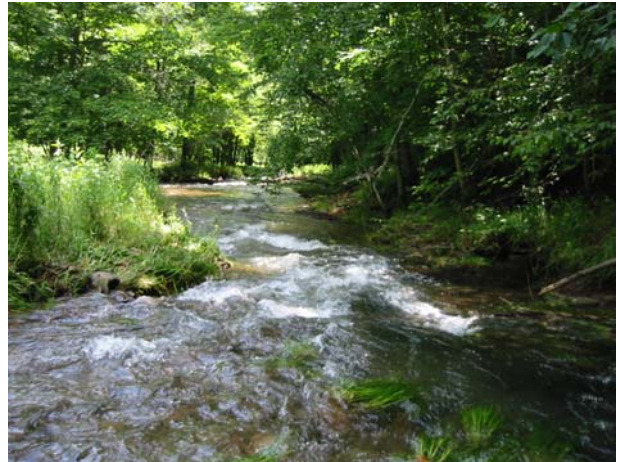
The upper half of this reach is a Rosgen F stream type and the lower half is a Rosgen C stream type. The small sections of erosion were rated as mild and only three mid-channel bars are located in this reach. These mid-channel bars are aggrading on one side and trending toward a stable, single thread channel. There are some bars that are still bare or only sparsely vegetated. Excellent floodplain access allows overbank flow to be conveyed efficiently. Bank erosion and channel stability are not concerns in this reach as it appears to be well on its way to recovery.

FIGURE 17. Lateral bar on Hammersley Fork

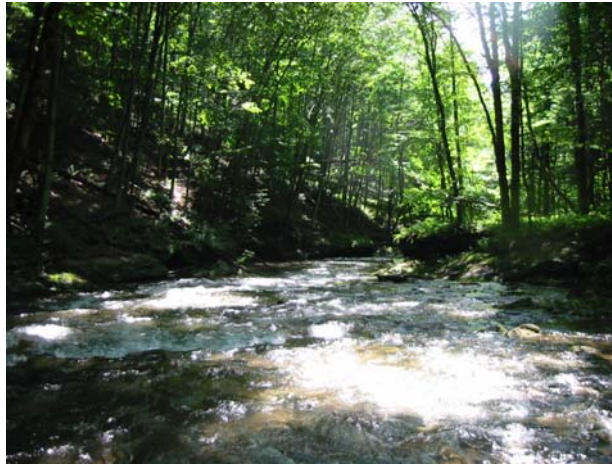
FIGURE 18. Typical channel form on Hammersley Fork.

Dry Hollow joins Hammersley Fork from the west. Beginning 150 meters downstream of Dry Hollow, bedrock is the dominate bed sediment for the next mile. In areas where there is no bedrock exposed, the bed sediment is primarily large cobble. Numerous deep bedrock pools were found in this mile section of stream. A large bedrock pool has formed 175

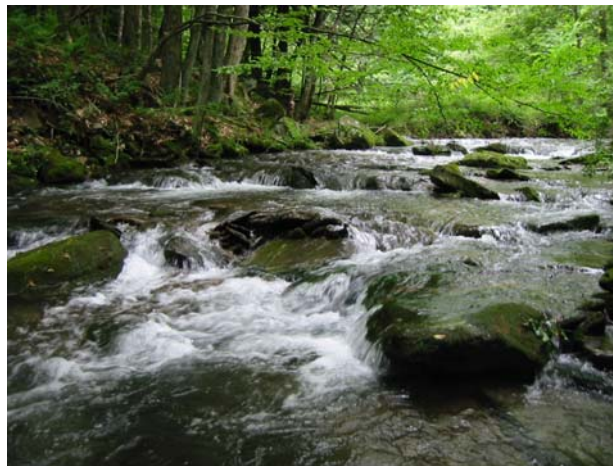
FIGURE 20. Step-pool formation on Bell Branch.

The beginning of this reach is approximately 0.75 miles upstream from the confluence with Nelson Branch. The stream is relatively steep and flows on the left side of the valley. The upper section has bedrock substrate and a few deep bedrock pools. The overall dominant bed sediment size is large cobble. Although not

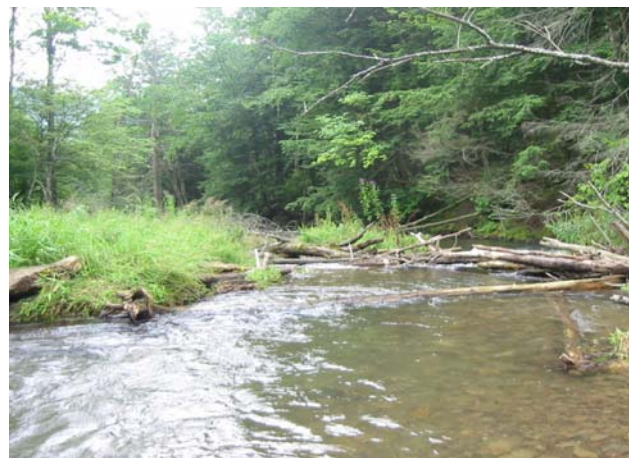
FIGURE 21. End of meadow area on Bell Branch.

right bank has a section of severe erosion that is 18 meters long by 8 meters high. The lower half of the reach has numerous split channels with good habitat. The stream is a Rosgen D stream type in this area. The dominant bed sediment is small cobble. Approximately 300 meters above the confluence with Hammersley Fork, there is a split channel that flows along the western hillside. This channel enters Hammersley Fork at a different location approximately 350 meters downstream of the main confluence. The stream channel function on this reach of Bell Branch is consistent with that of a steep mountain stream entering a wide floodplain complicated by the area of the old beaver dam. Continued channel evolution in this reach will likely produce additional off channel wetlands as the channel trends toward a single channel.

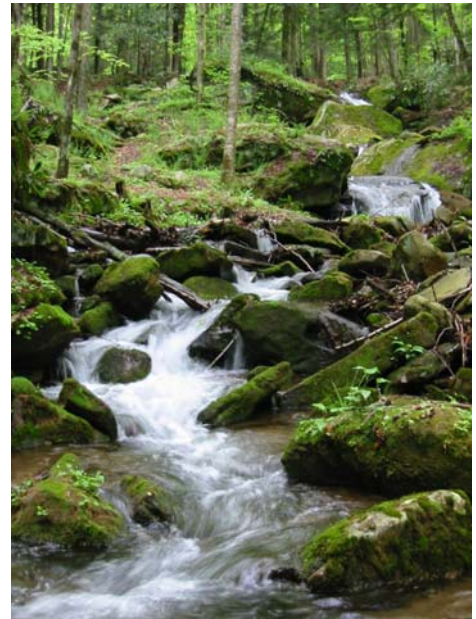
This is a smaller mountain stream that flows in a narrow valley bottom. Wykoff Branch is a Rosgen B stream type with a continuous sequence of step pools. The bed sediment consists primarily of large boulders with some gravel and small cobble. There is limited floodplain area and little evidence of bank erosion. A road parallels the stream but is located on the hillside away from the channel. A gas pipeline crosses the channel 0.15 miles upstream of the Trout Run Road Bridge.

FIGURE 22. Step pool channel on Wykoff Branch.

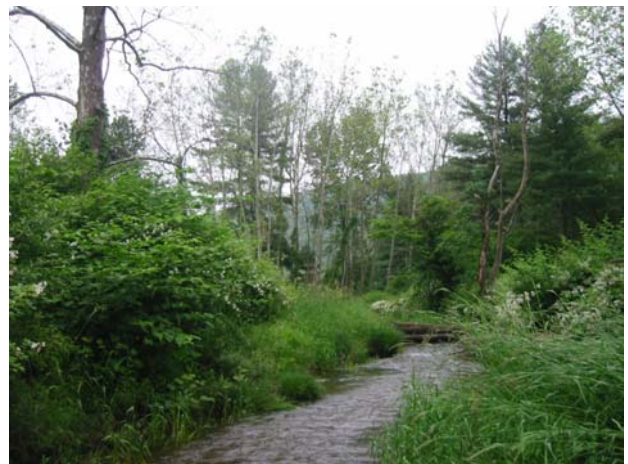
This tributary flows into Kettle Creek at the northern end of Kettle Creek State Park. This is a small stream (<8 meters wetted width) flowing through hemlock forest. There is a state park road in poor condition on the west bank hillside, that may introduce fine sediment to the stream during high runoff events. The channel is entrenched in most

FIGURE 23. Beaverdam Run near the confluence with Kettle Creek.

areas with 1.5 meter high banks. However, the entrenchment ratio improves downstream as the floodplain widens. There are several pipeline crossings and well heads throughout the reach. The channel ranges between Rosgen F and B stream types. There are relatively few areas of bank erosion and mid-channel bars. There is one area of severe erosion located 0.65 miles upstream of the bridge on Kettle Creek Road/Route 144. This site is 7 meters high and 20 meters long with no vegetative cover. There are two headcuts and two bedrock outcrops in this reach which affect the grade of the channel. Bed sediment is primarily large cobble or gravel. Near the picnic area the valley bottom widens. The channel downstream of the bridge flows through a meadow area with willows and multiflora rose next to the stream. The stream is much narrower with several long pool sections.
