# East Branch Tionesta Creek

## COLDWATER CONSERVATION PLAN

McKean, Warren, and Elk Counties

May 2017

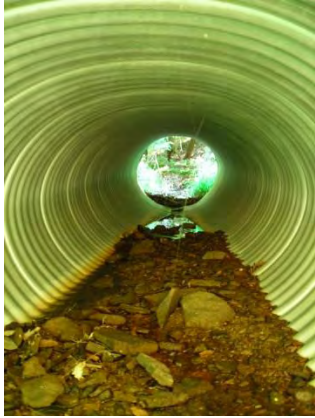
*5853: Culvert lacking substrate the entire length of pipe. Note blockage at visible end.*

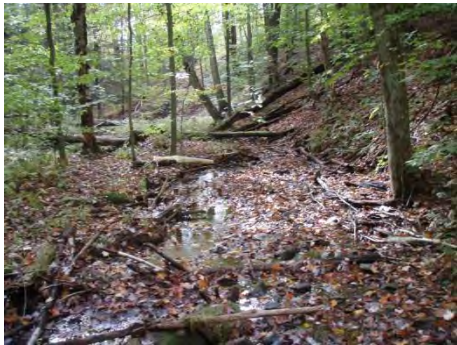
*5905: Patchy flow near top of stream isolates populations of juveniles. Potential natural AOP barrier.*

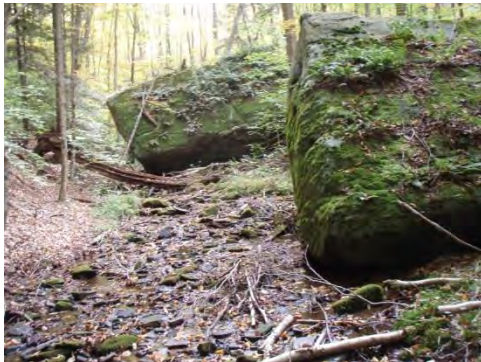
*6006: Free flowing segment downstream of relic log RR boiler-fill pond.*
