# **SANDY LICK CREEK HEADWATERS COLDWATER CONSERVATION PLAN**

**Allegheny Mountain Chapter of Trout Unlimited  
P.O. Box 541  
DuBois, PA 15801**

**Clearfield County Conservation District  
511 Spruce Street, Suite 6  
Clearfield, PA 16830**

**Spring 2015**

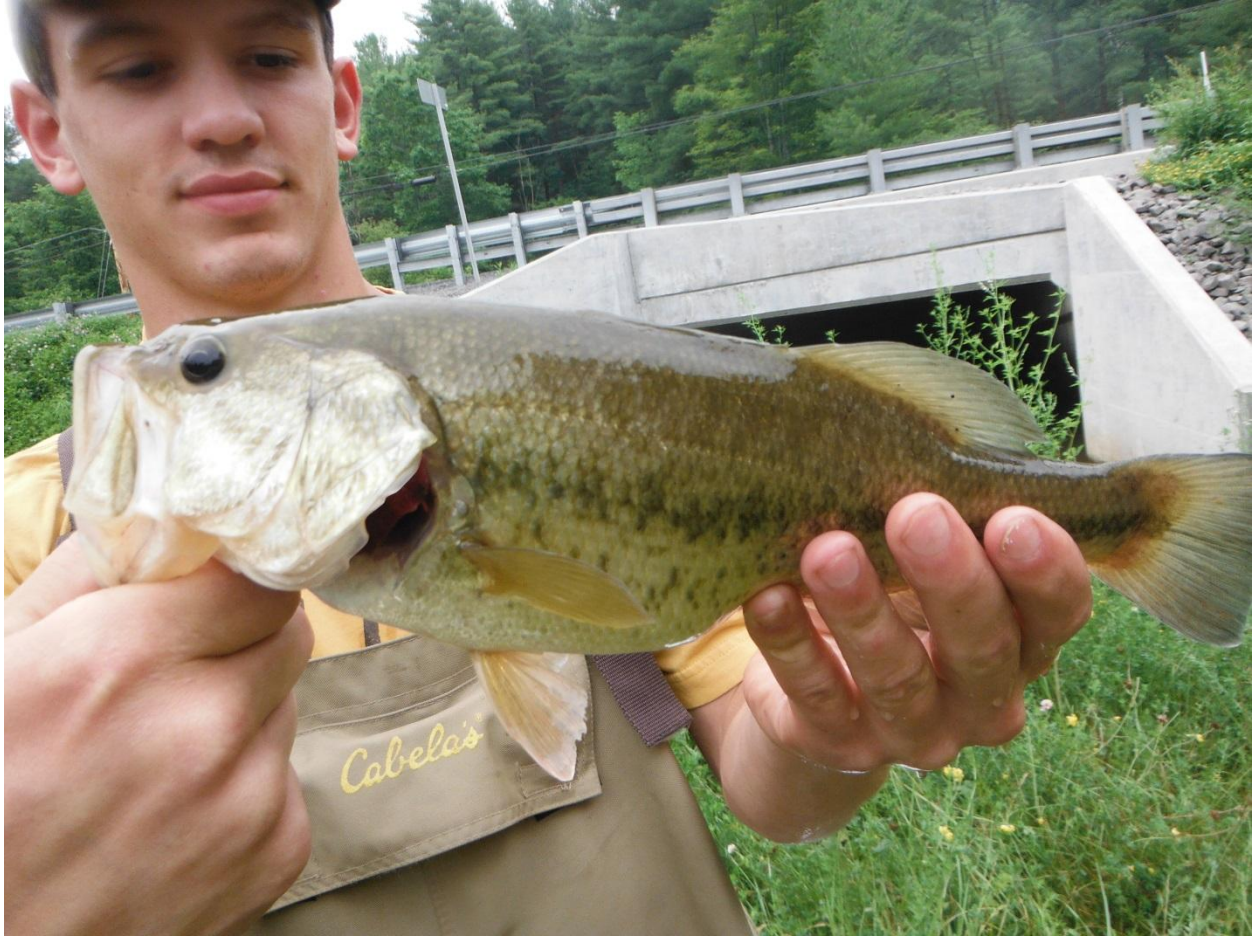
Largemouth bass caught at site SL1.

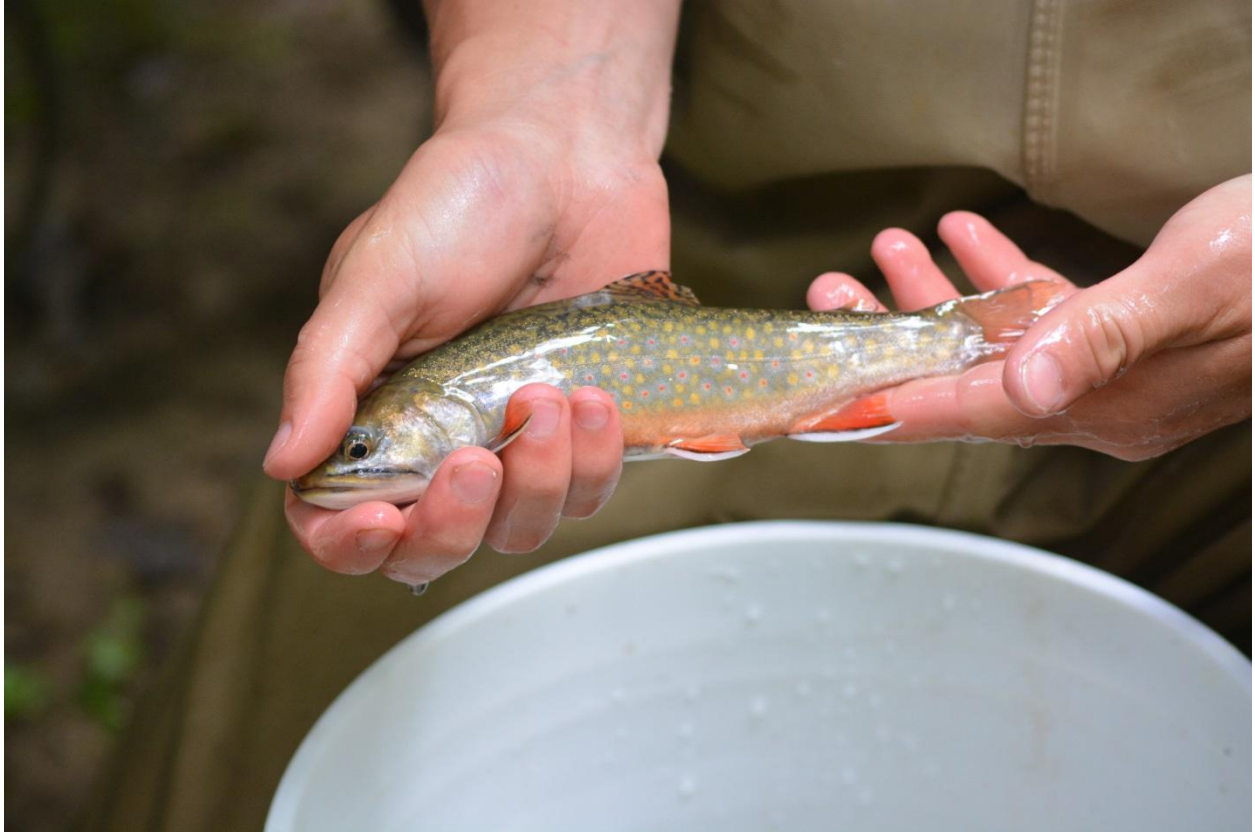
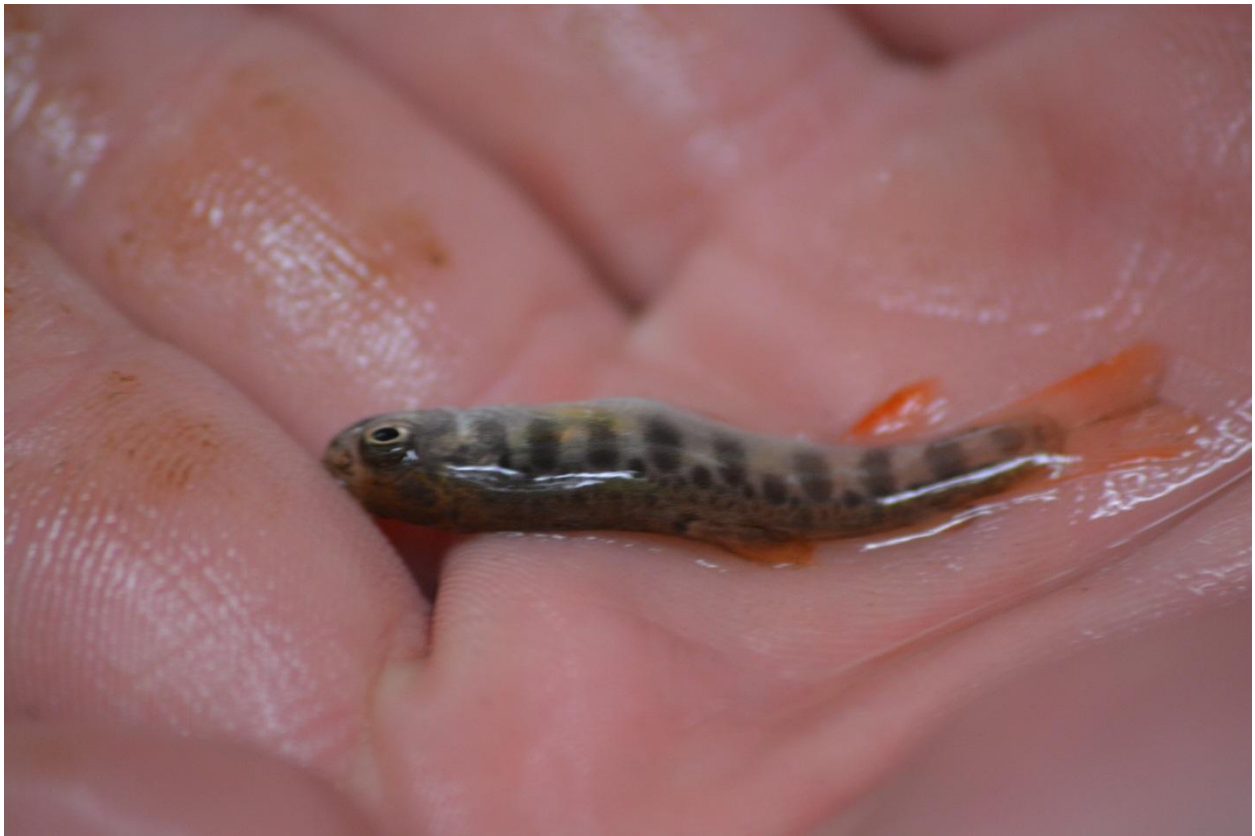
2 brook trout caught at site SL2

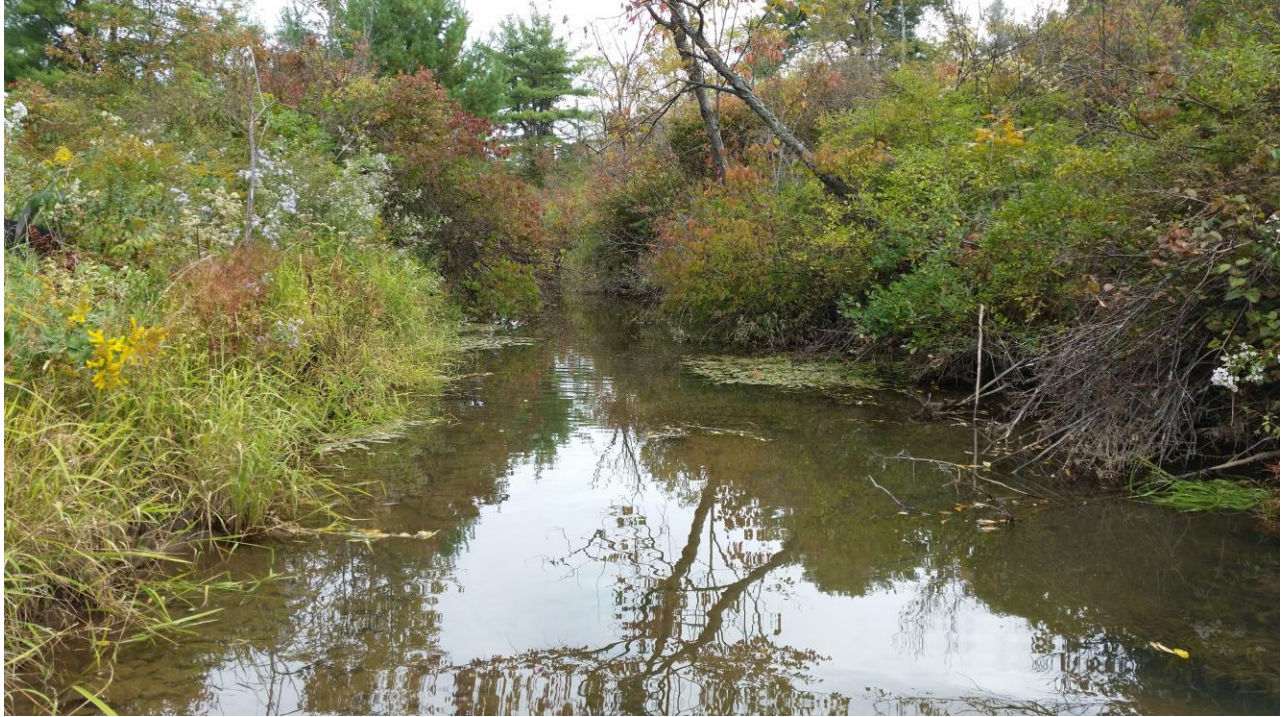
Sample site SL1 is upstream of the SR 255 Bridge which is upstream of Sabula Lake. This site was influenced by the impounded water at Sabula Lake during each sampling event. Flow was almost always very slow and the water was deeper than one would expect for the size of stream. This site was specifically chosen for its location just upstream of the lake to determine how much of an influence the impoundment has on the Sandy Lick Creek headwaters.

Figure D-1: SL1 looking upstream from SR 255 Bridge

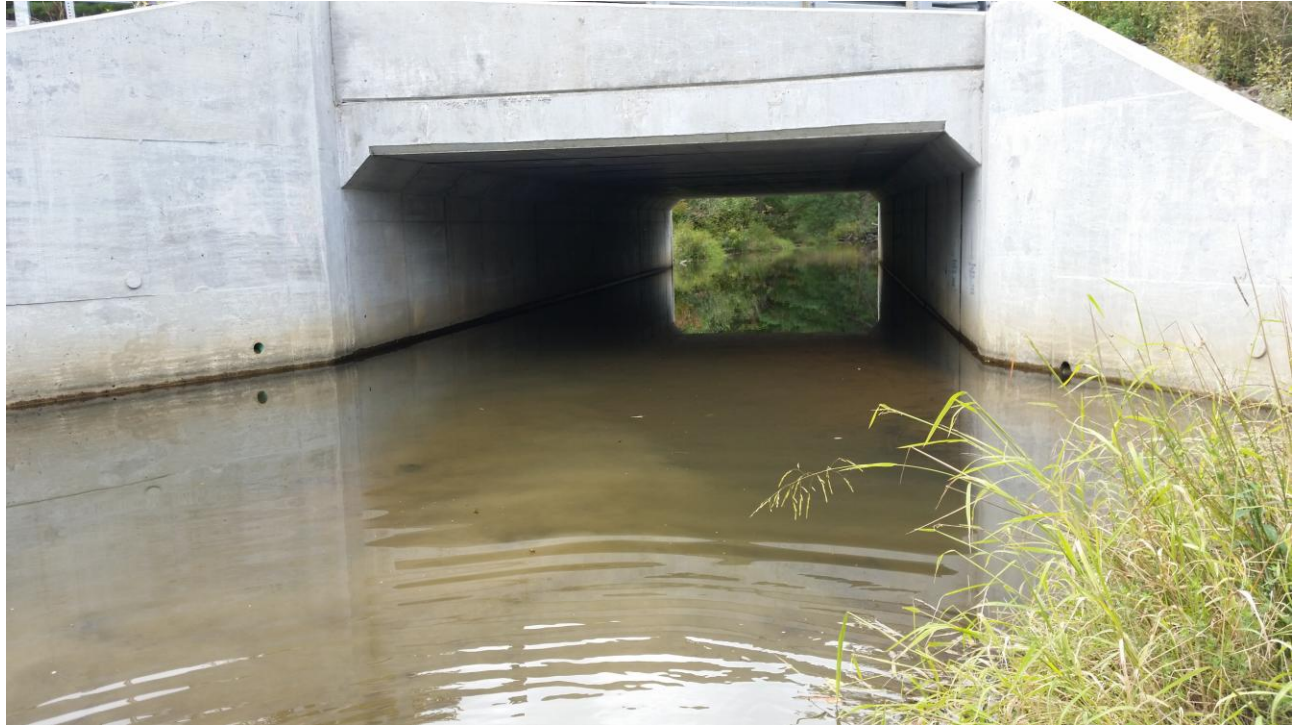
Figure D-2: SL1 looking downstream at SR 255 Bridge

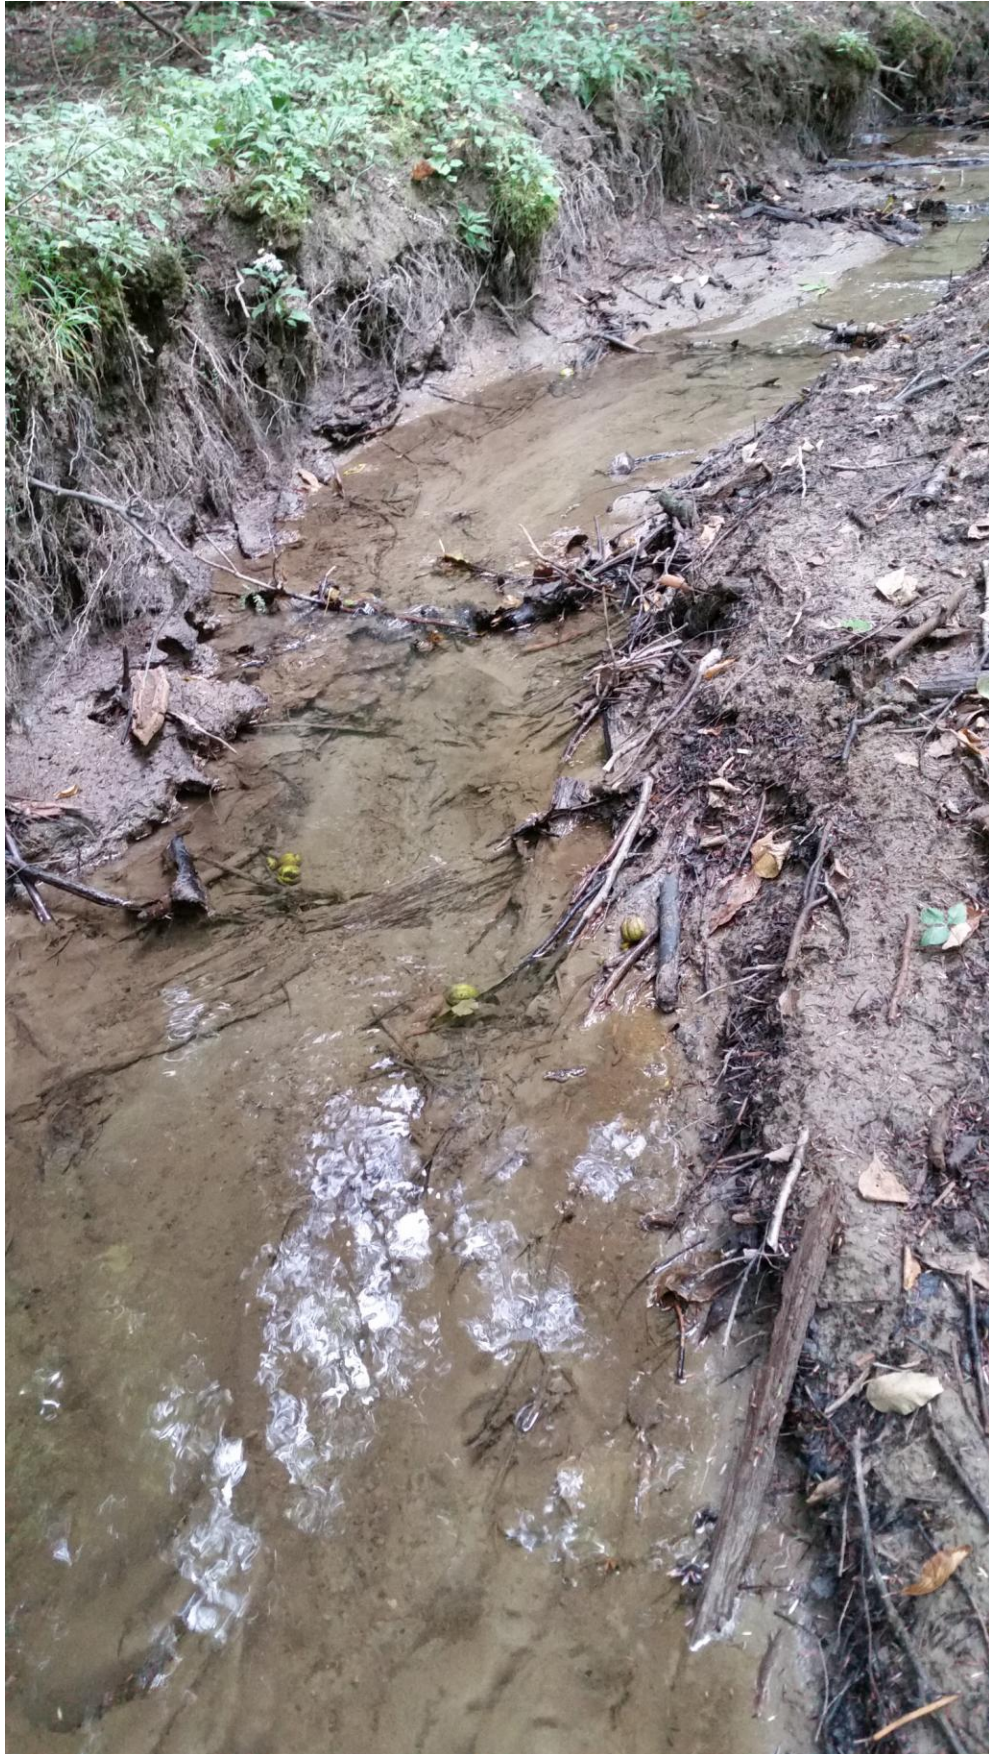
Figure D-3: Site SL2

Site SL2 is at the mouth of tributary #2 to the Sandy Lick Creek headwaters. The entirety of this tributary flows through forested land and there are no road crossings. The only way to access this site was through a backyard and by crossing the main stem of the Sandy Lick Creek.

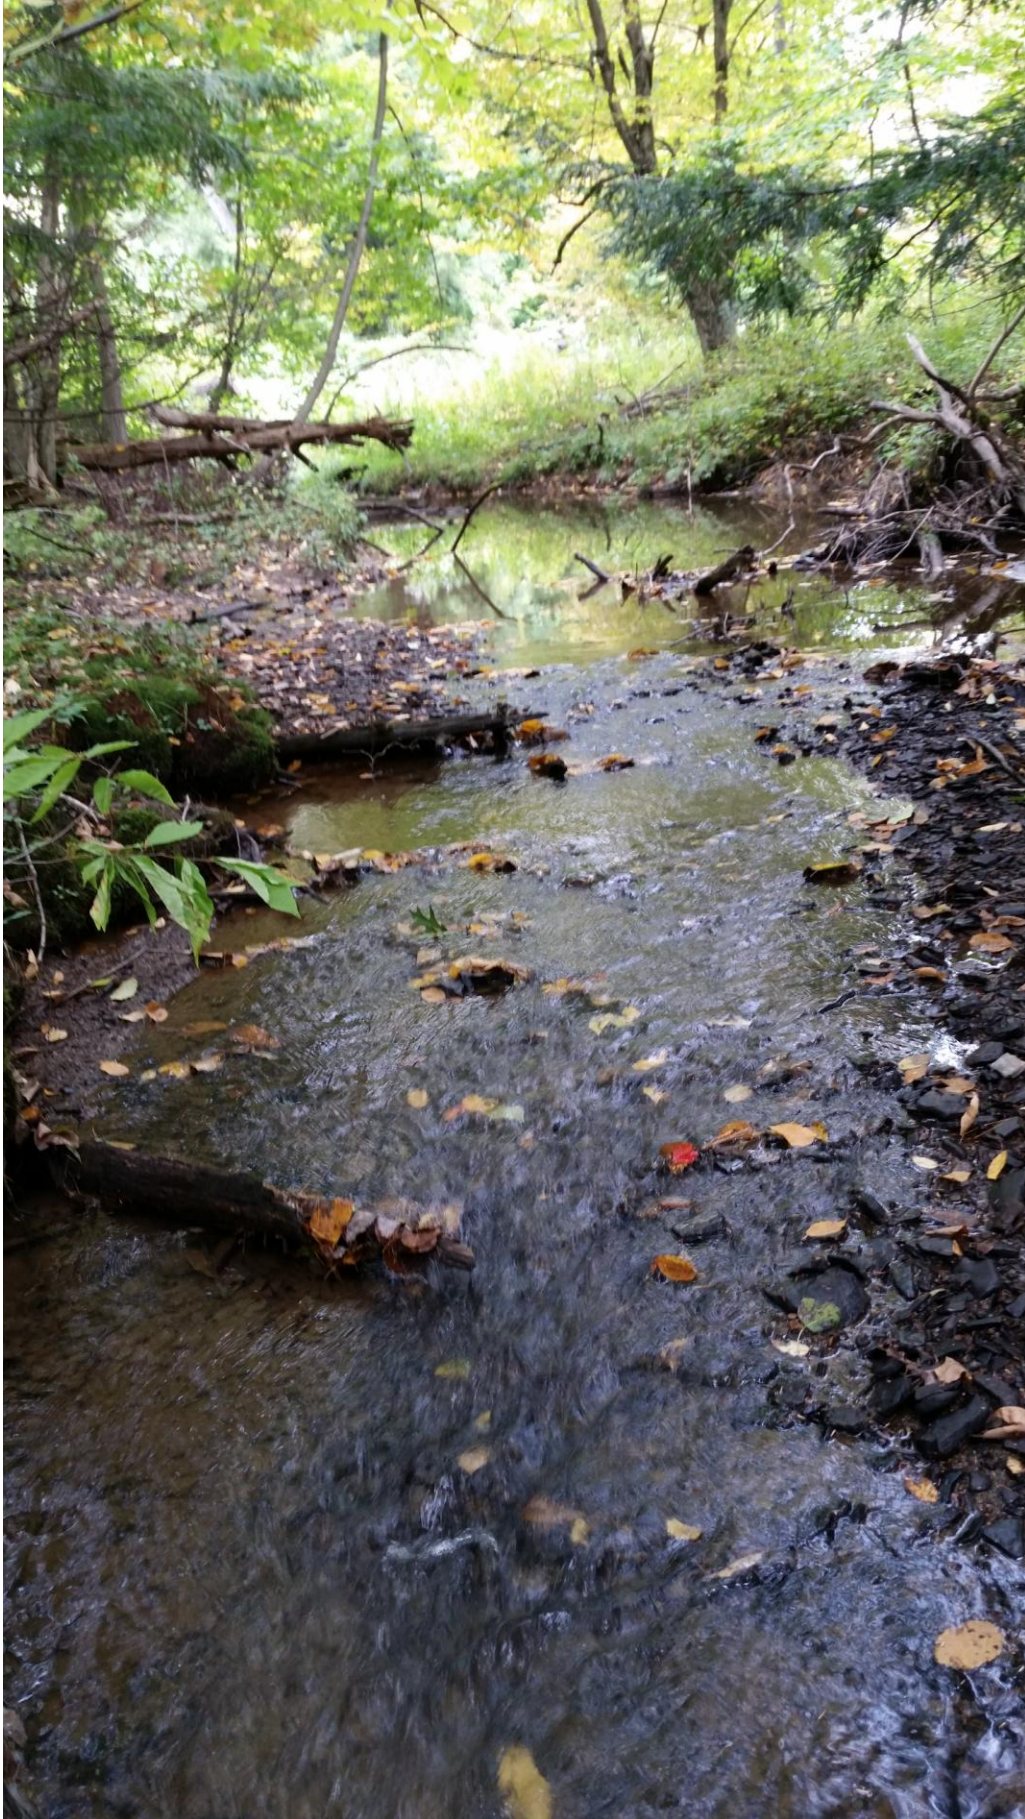
Figure D-4: Site SL3

Sample site SL3 is on the main stem of the Sandy Lick Creek downstream of the unnamed tributary #2 adjacent to Paul Short Road. This site was chosen to determine the extent of the thermal pollution on the main stem of the Sandy Lick Creek due to the ponds found on the unnamed tributary.

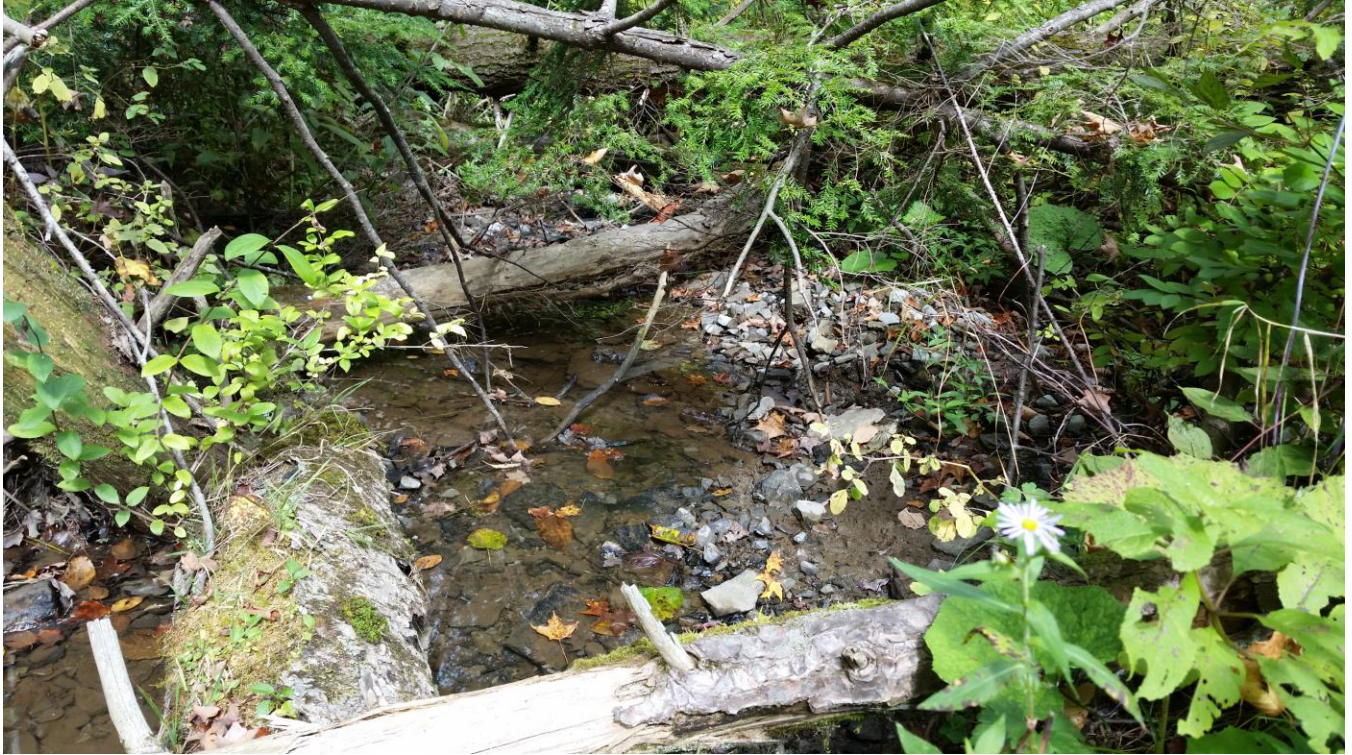
Sample site SL5 was located on the main branch of the Sandy Lick Creek in the very headwaters of the study area. The branch of the headwaters flows through forestland as well as some agricultural land. There are also some ponds that influence it as well.

Figure D-7: SL5
