**Fort Bedford
Trout Unlimited**

Shobers Run Coldwater Conservation Plan

Prepared by Fort Bedford Trout Unlimited Volunteers
August 2006

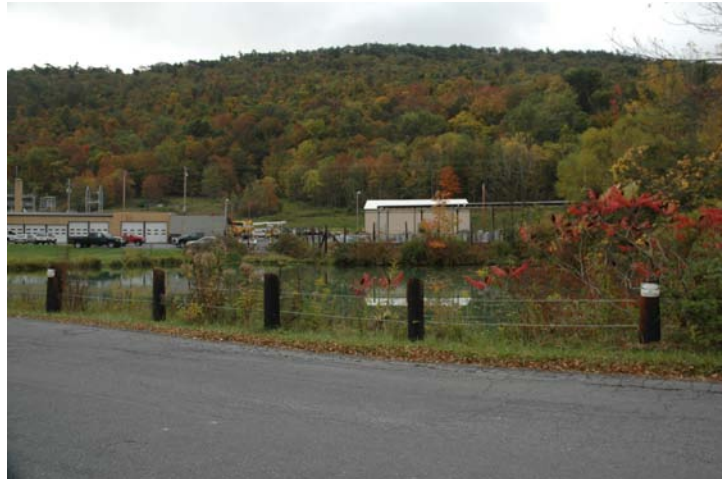
prominently posted against trespassing. Upslope from the pond, there is a fenced but unroofed area where transformers have been stored for many years. There is some concern that contaminants may have entered this pond, and surrounding soil, from this unprotected storage though there is no evidence of such contamination.

Figure 5 Pond at REC facility near junction of Shobers Run and Ravstown Branch

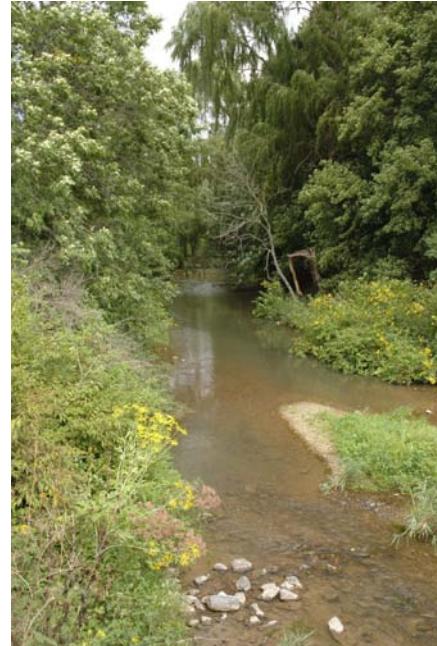
Figure 8 View downstream from Watson Street bridge

across Shobers Run from Meadowbrook Terrace. This was removed during sewer line replacement work in 2002, with a new buried line crossing downstream nearer the treatment plant. A mid-channel, longitudinal gravel bar has developed where this dam crossed, partially seen in above photograph. Upstream from the bridge, a similar mid-channel bar has developed over a long time and now is large enough to support small trees. These

bars have forced bank-full, channel-forming flows to move laterally and, with inadequate bank stabilization have caused the stream to widen, becoming shallower and slower. Shobers Run in this section is nearly twice as wide as it was 30 to 40 years ago. The former dam and the bridge design are probably responsible for the establishment of the gravel bar grown into a vegetated island. Replacement of the bridge (a wooden deck, single lane span) is planned soon and it is anticipated that restoration of a stable, midstream channel can be accomplished at that time. FBTU has been granted permission by the school district to establish a minimal buffer along the west bank; this work awaits completion of the bridge project.

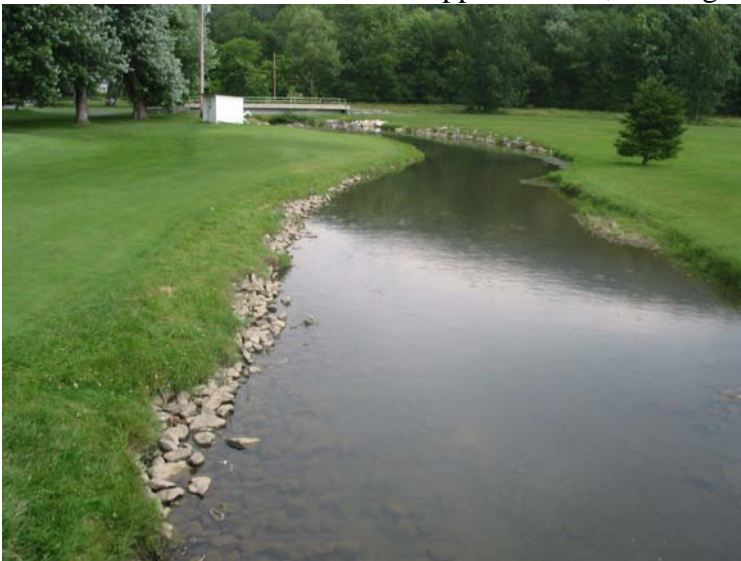
Figure 9 View looking east from Bedford Elks parking lot

places modified by landowners. In this stretch also is found a broader area of buffer into which some of the stormwater runoff from the southern part of Meadowbrook Terrace is diverted. Though shading is fair through this stream segment, habitat for fish and benthic organisms is better than downstream, and the bottom has a greater proportion of larger cobble. A footbridge crosses the stream in this section. Midway through the golf course, there is a vehicular

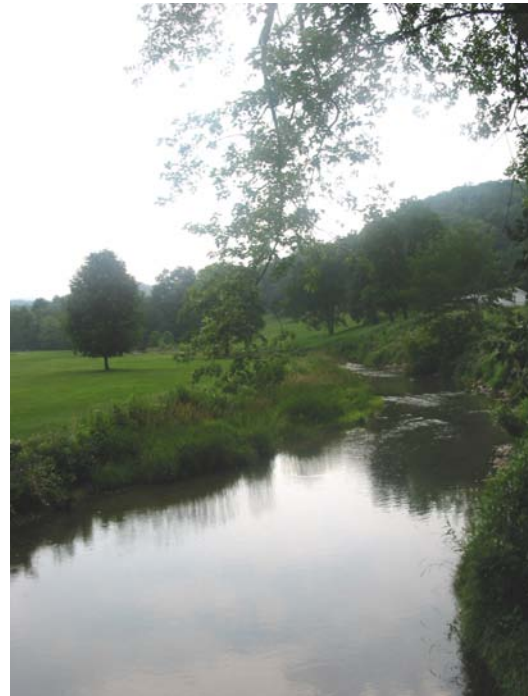
The upstream portion of the stream on the golf course lies at the base of a steep slope to the west, paralleling Business Route 220. There are some minor riffle areas and few deep pools; channel straightening and dredging have produced a 'ditch' with little habitat diversity. Stream banks exhibit signs of severe erosion and slumping in the past, resulting in a too-wide stream channel. This section has some midstream boulders and some bedrock bottom.

Figure 10 View upstream (south) from Bedford Elks parking lot

FBTU has been encouraged in recent years with the Bedford Elks golf course management decisions to leave a larger unmown section along the stream edge and to allow volunteer groups to plant riparian trees and shrubs. While these riparian enhancements cannot be implemented everywhere on the golf course without affecting play, additional stabilization and shading of any degree is welcome.

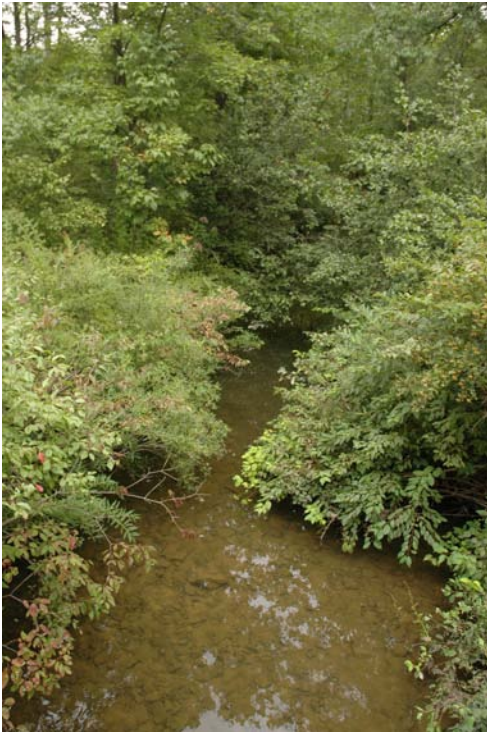
Figure 13 View upstream from Sweet Root Road bridge

houses close to the stream flowing through yards. Even farther south, residences are all on the east side of the road. Throughout these 'developed' parts of the watershed, yard management adjacent to the tributaries as well as Shobers Run typically includes lawns mowed to the stream bank; and runoff, where managed at all, is directed into natural stream channels. There are also pipes emptying into stream channels that might carry runoff or 'gray' water from washers and sumps. On-lot seepage systems are a potential source of non-point source pollution of nutrients and fecal bacteria but no definitive evidence of failing or inadequate systems was detected during the survey. In these limited residential areas, stream shading is poor and bank erosion evident. Embeddedness of bottom gravel and cobble is significant and instream habitat is poor to fair. Throughout the greater wooded portion of this section, habitat diversity is good for benthic organisms and fish, shading is good to excellent, and stream bank stability is fair to good, with some channel migration and anastomosing

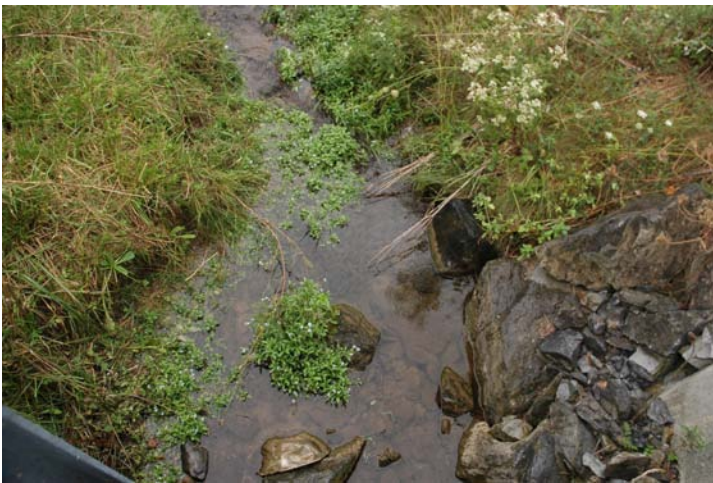
Figure 14 Clear cold water and macrophytes (watercress) in northern tributary at Teaberry Road

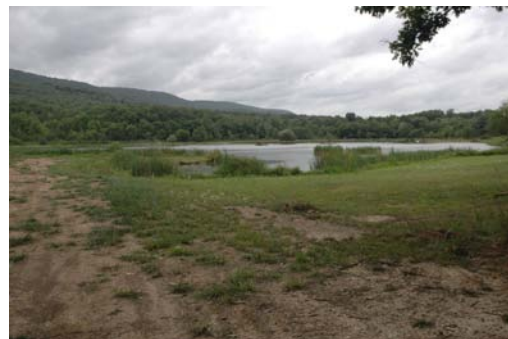
The area around Shobers Run Lane and Flying Dutchman Road (both private) has some residential development and a large, constructed wetland pond. Formerly a harness racing track (still drawn as such on USGS topographic maps and others), the pond was an USDA-NRCS designed project. Water levels in this pond are maintained by a naturally high water table in the Brinkerton soils of the area, by spring seep at the base of the low rise to the west, and by storm water runoff. A diversion from Shobers Run, a six-inch pipe, is sited to only divert water

Figure 16 Constructed wetland pond near Shobers Run Lane
