Wallace Run

***Wallace Run Assessment  
October 2008***

The Wallace Run Assessment was funded by the Coldwater Heritage Partnership and was a collaborative effort between the Bald Eagle Watershed Association and the Centre County Conservation District. The assessment was conducted by Ed Perry, retired USFWS biologist, assisted by Ann Donovan, Centre County Watershed Specialist. Special thanks to Beth Rider from the Centre County Office of Planning and Community Development for her assistance with mapping for this project. Thanks to Joy Teeter from the Centre County Conservation District for her help with formatting the document. Thank-you to Genie Robine of the Centre County chapter of the Senior Environment Corps for monitoring and to the Centre County Government for providing PSU in kind services for printing. For more information about this assessment contact the Centre County Conservation District at 355-6817.

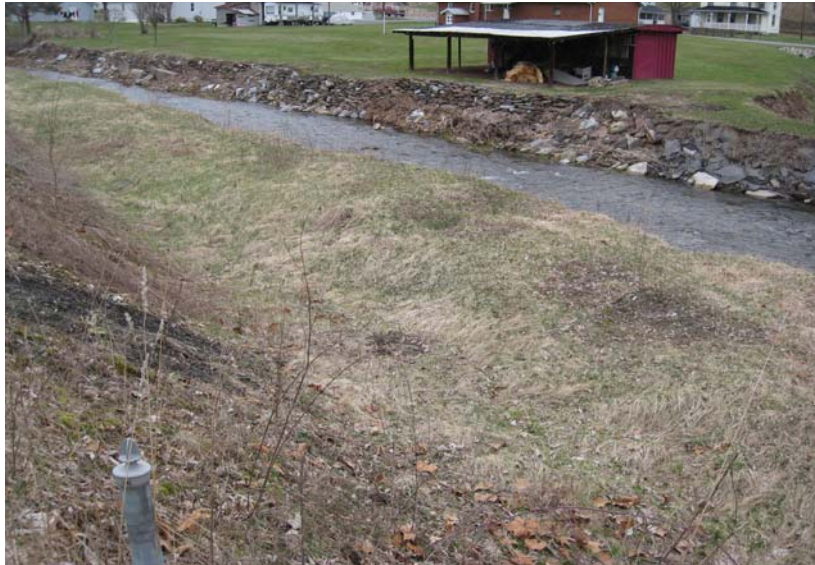
Figure 2. Homes and businesses dominate the landscape along the lower four miles of Wallace Run.

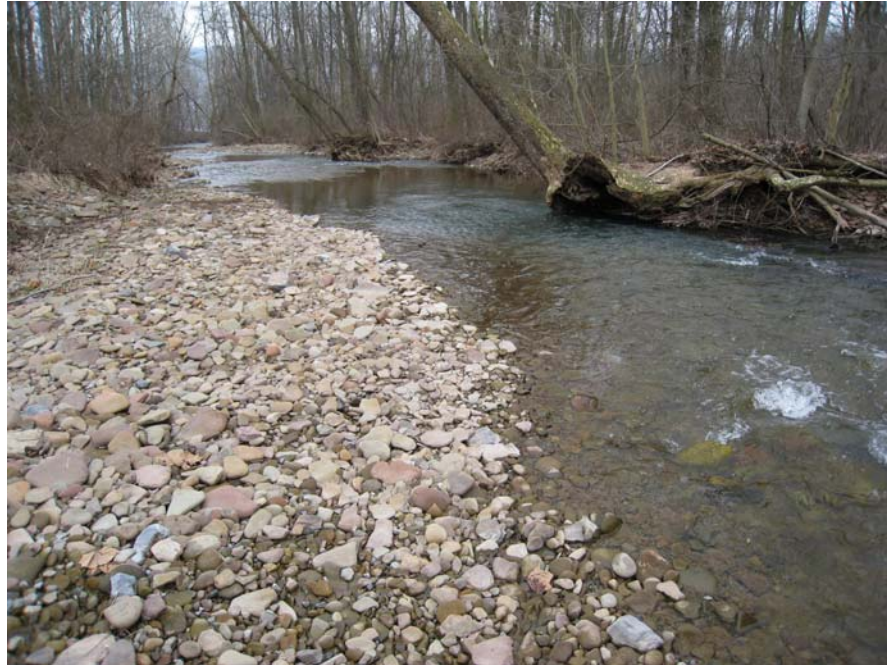
Figure 3. The only high quality habitat in the lower four miles is a series of four deep pools formed underneath tree roots at river mile 1.14.

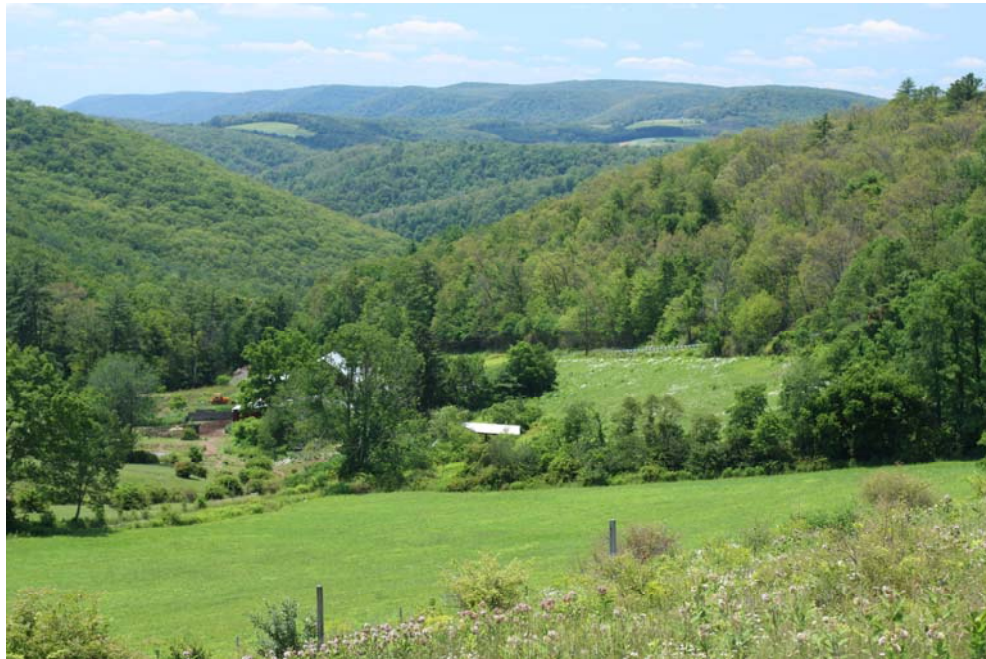
Figure 8. Looking west from the headwaters of an unnamed tributary to Wallace Run along Lost Creek Road Section 2 of Wallace Run is the forested valley in the background.

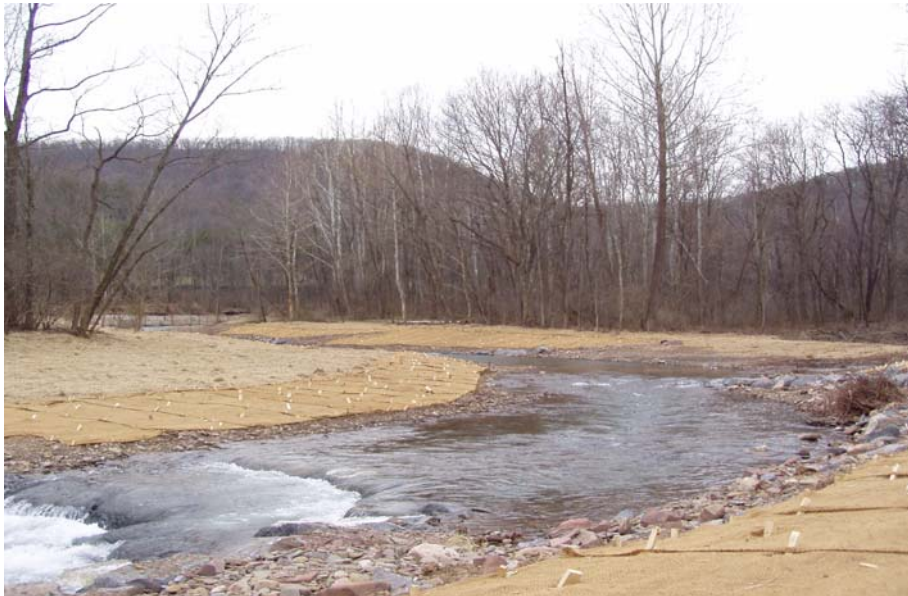
Figure 12. Stream improvement devices stabilize the stream, preventing severe bank erosion behind the Brown home.

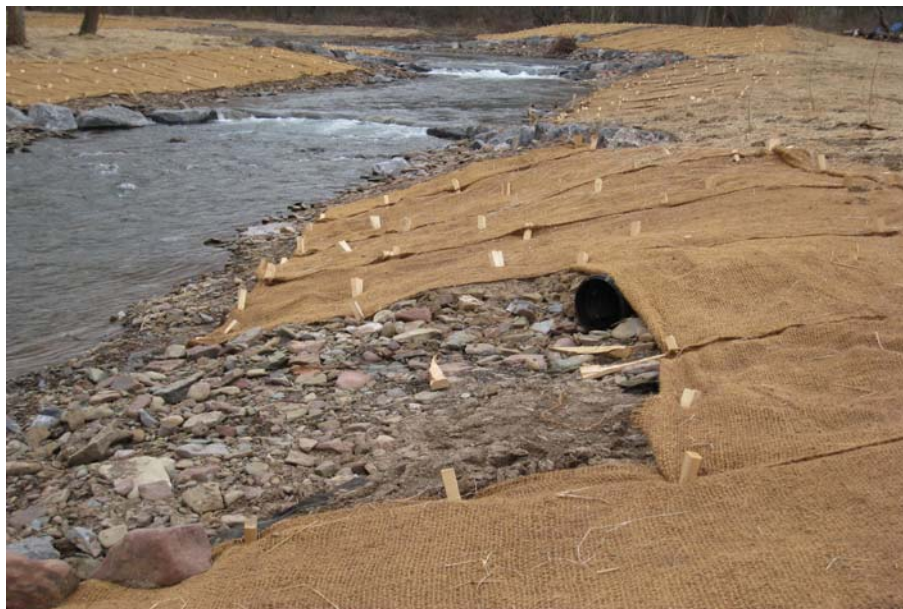
Figure 13. Jute matting stabilizes the bank until shrub plantings develop, and cross veins scour deep pools to provide habitat for trout.

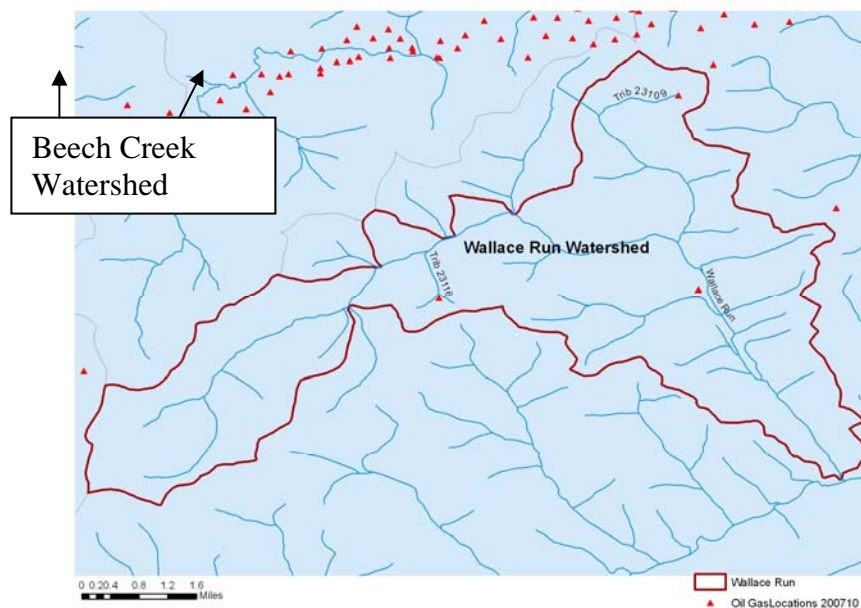
At present, there are three wells in the watershed, and two of those are plugged (Figure 13). However, there is substantial gas well drilling just north of Wallace Run, in the Beech Creek watershed.

Figure 15. Three gas wells are located in the Wallace Run Watershed; two of these are plugged. Note the number of wells north of the watershed.
