BENS CREEK COLDWATER CONSERVATION PLAN

Western Pennsylvania Conservancy

This Coldwater Conservation Plan (CCP) for the Bens Creek Watershed reports on watershed assessment activities completed by WPC in 2021 & 2022. The objective of this plan is to summarize the methods and results of the assessment as well as identify and prioritize potential actions which may be taken to further conservation of the coldwater resources within the drainage.

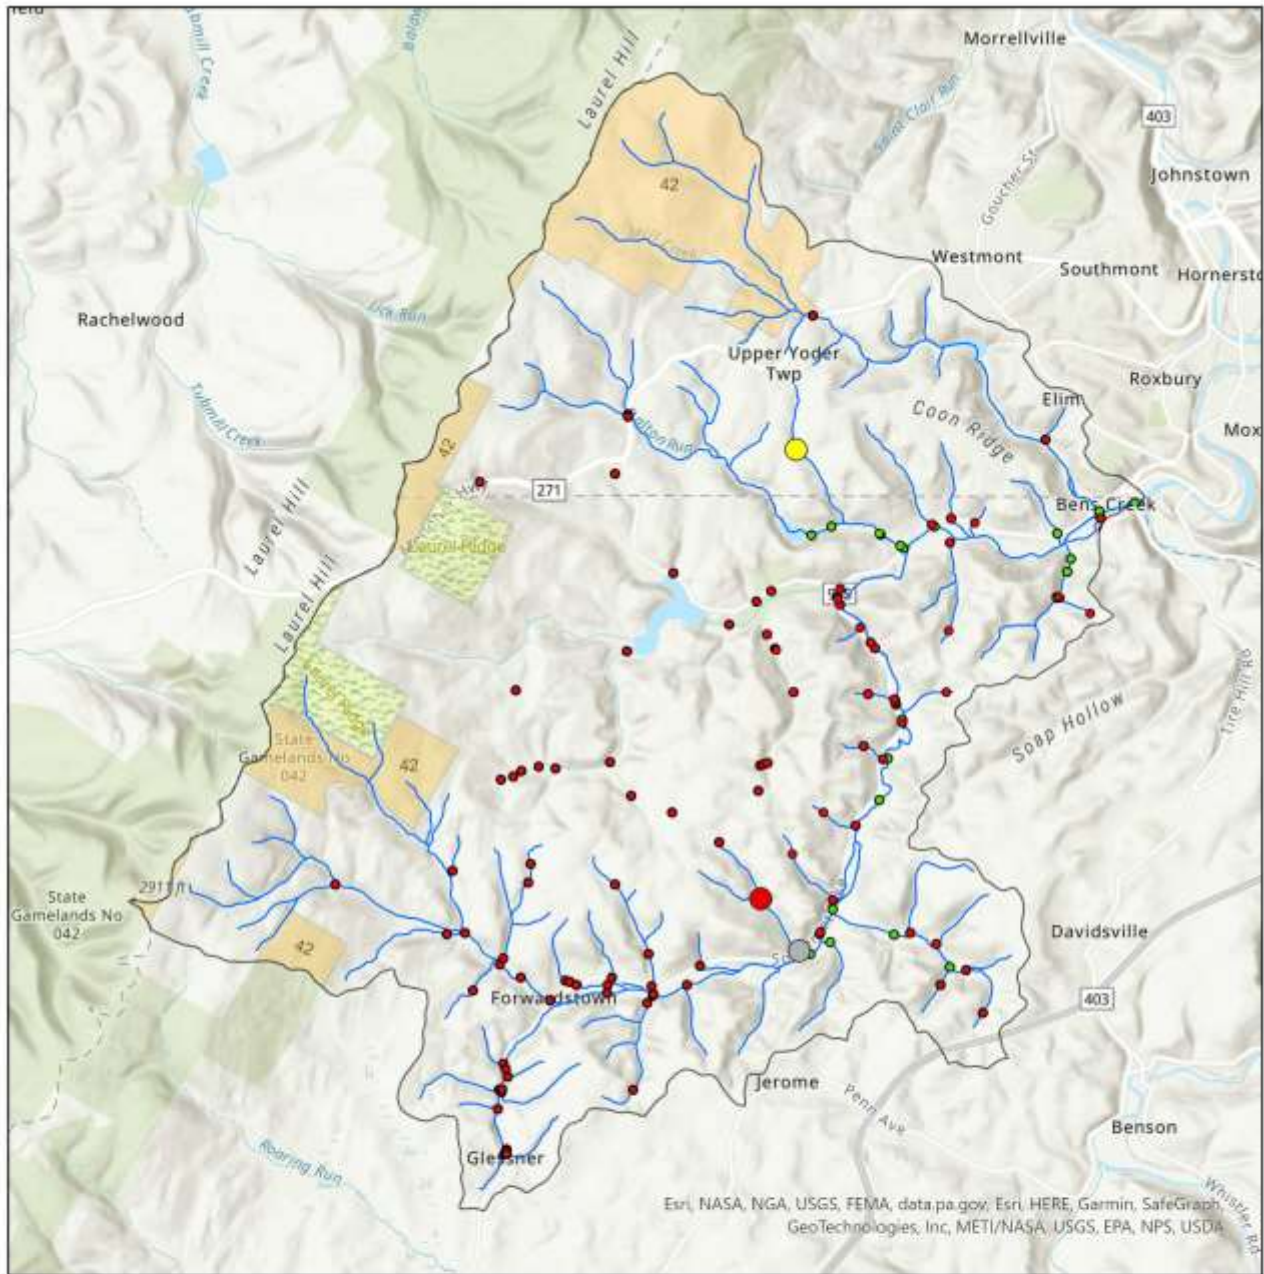
FIGURE 8 – AOP EVALUATION

The results of the limited culvert assessments show that the majority of the Bens Creek watershed is well connected, other than its large drinking water reservoirs. Figure 8 shows that only one of the assessed crossing was found to be a complete AOP barrier during the assessment. Most of the road-stream intersections on significant waterways in the watershed are bridges with full AOP passage, but additional NAACC surveys should be prioritized to look for AOP barriers in smaller tributaries and headwater locations.

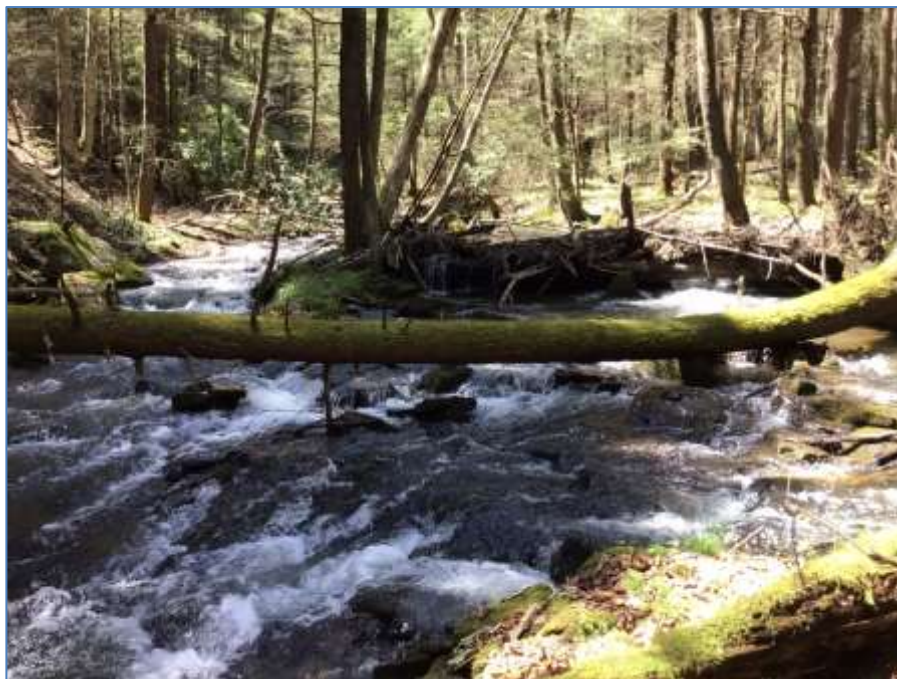
FIGURE 22 – FAVORABLE BROOK TROUT HABITAT ON DALTON RUN

confluences with O’Conner Run, a small Class A brook trout fishery. As Dalton Run descends off of the Laurel Ridge, it enters a deep hollow, mostly owned by GJWA. At this point, Dalton Run is impounded as a drinking-water supply reservoir for GLWA. The Dalton Run Reservoir is an AOP barrier that disconnects this tributary from the rest of the Bens Creek watershed, but the barrier also protects Dalton Run’s brook trout from being invaded by the wild brown trout fishery that is expanding throughout the rest of the Bens Creek watershed. Since Dalton Run is mostly forested and largely undeveloped, the watershed should be prioritized for LWM additions to improve instream habitat for brook trout. This practice would also help reduce sedimentation and improve groundwater recharge upstream to help maintain water levels of the reservoir.

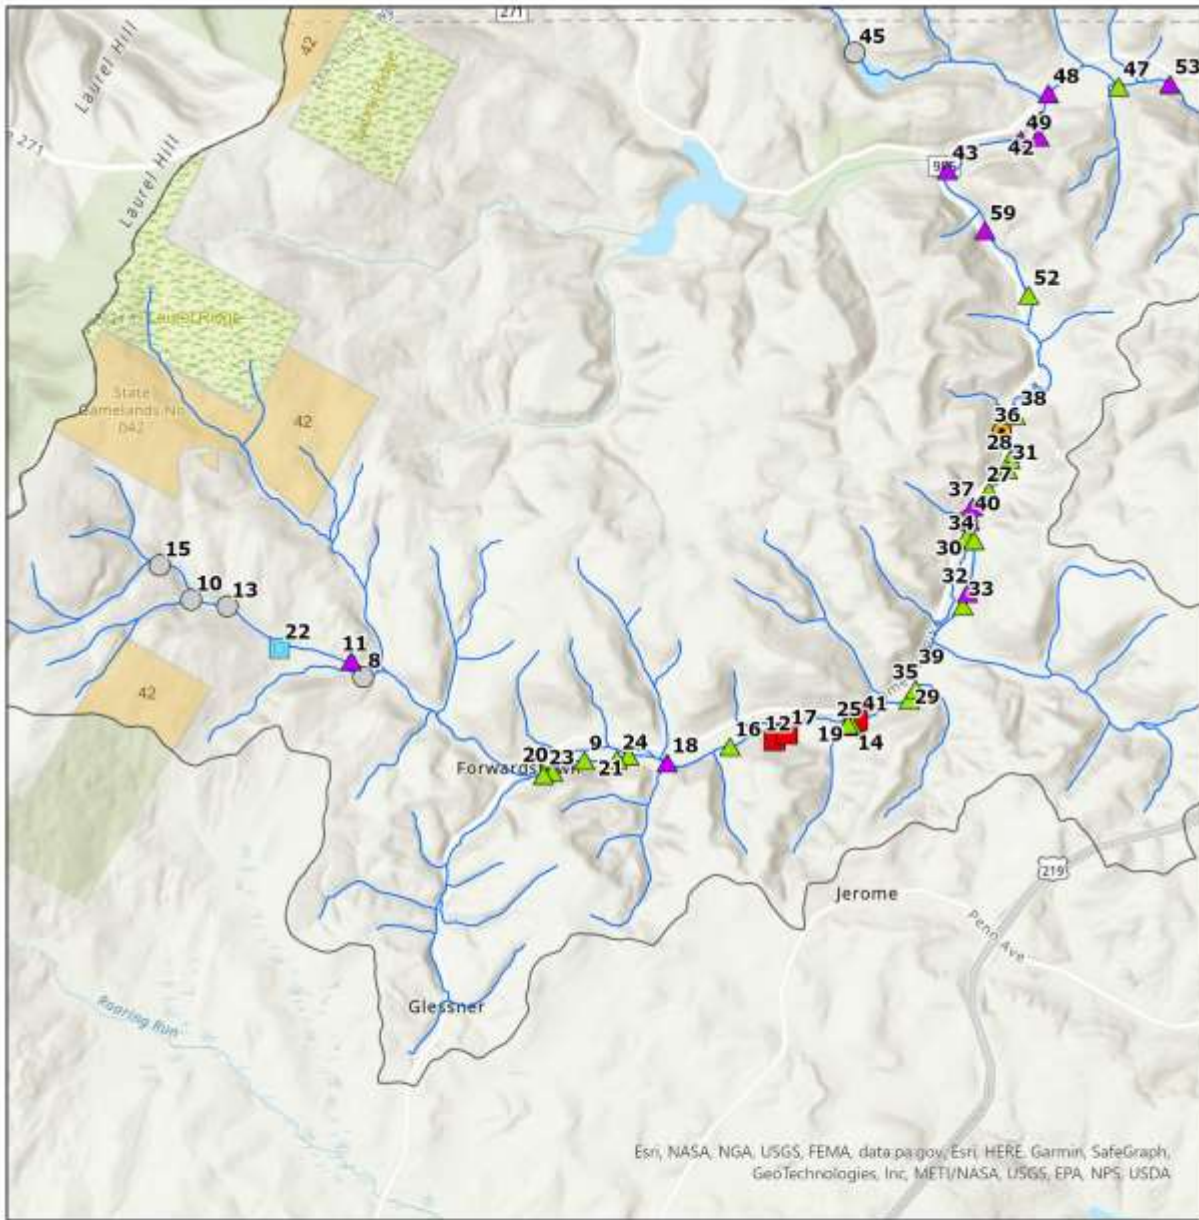
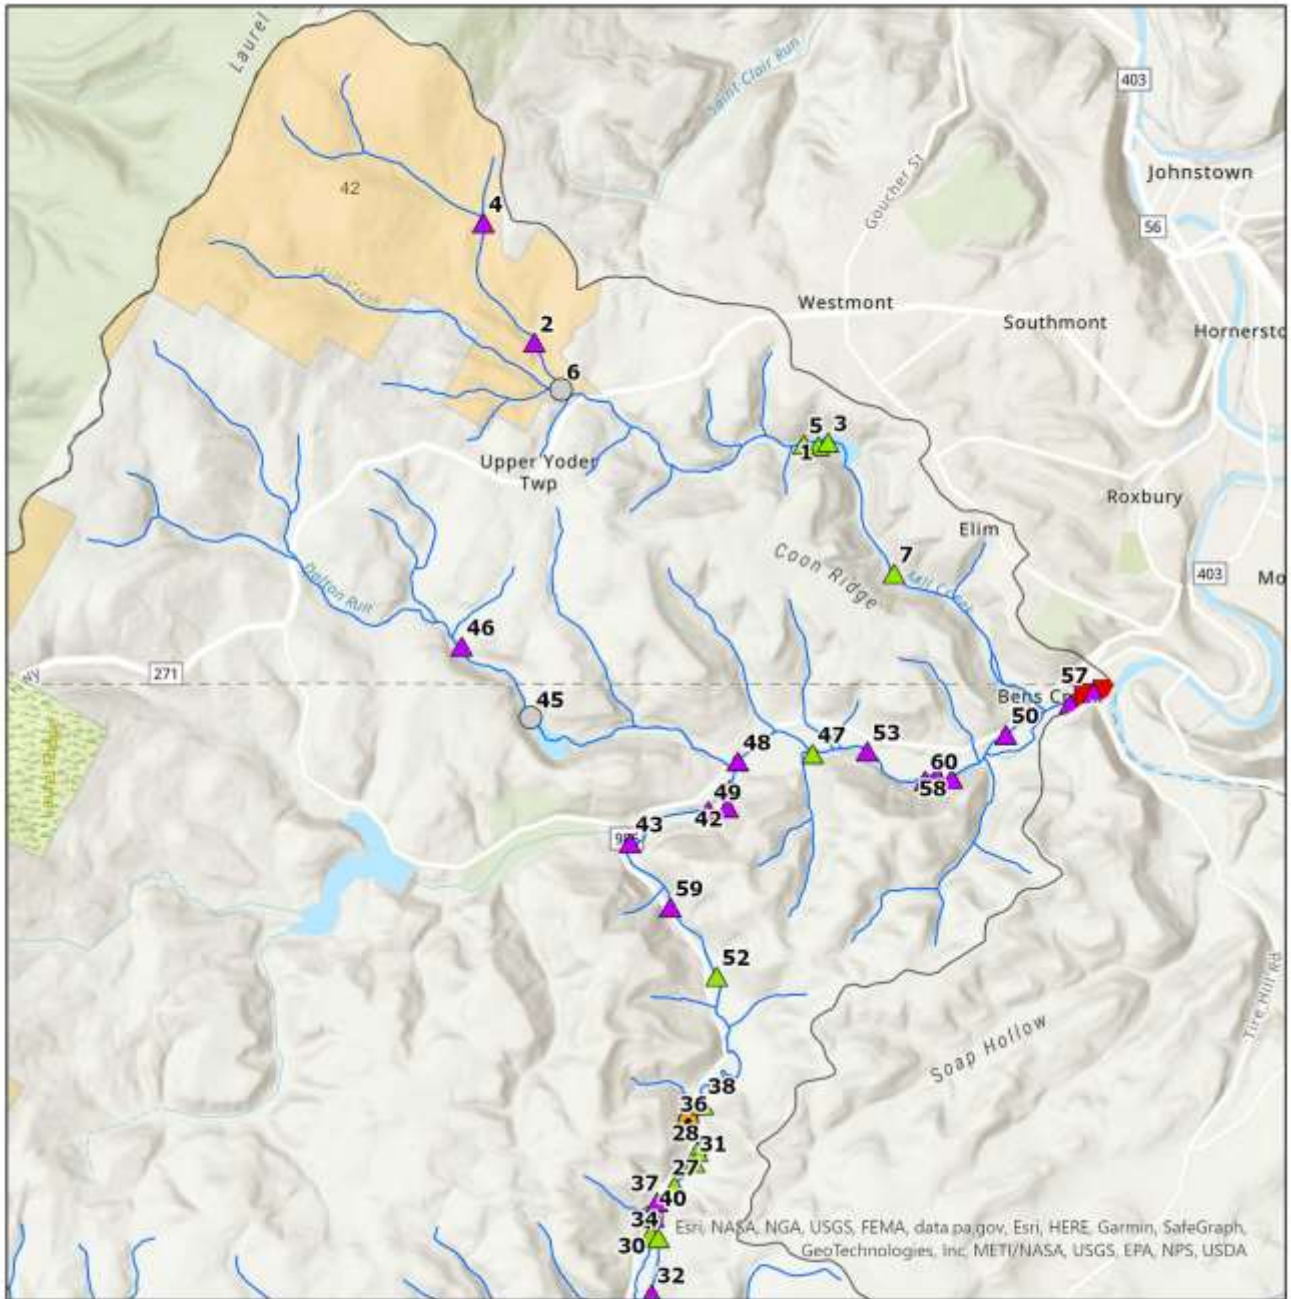
APPENDIX 2: BMP RECOMMENDATIONS FROM VISUAL ASSESSMENT

40	HI	9644	Minor erosion. Shallow and wide. Needs habitat
41	AMD	9722	Rock tunnel system discharge and untreated discharge just above
42	HI	9514	Old failing habitat structures
43	HI	9535	Habitat improvement potential. Small AMD seep
44	HI	9514	Could use habitat structures
45	DR	9479	Dalton run dam
46	HI	9479	Good area for LWM
47	BS	9485	Eroding bank at residence
48	HI	9494	Stream bends into road. Could use long mudsill
49	HI	9514	Old failing habitat structures could be replaced
50	HI	9489	Entrenched and eroding. Old exposed pipeline
51	HI	9499	Great mudsill location
52	BS	10843	Minor erosion
53	HI	9499	Small habitat improvement project potential at camp
54	HI	9466	Needs habitat improvement. Wide and shallow
55	AMD	9466	Iron seeps
56	AMD	9466	St Andrew's AMD discharge. Alkaline iron
57	HI	9466	Habitat improvement project at toll gate
58	HI	9499	Wide flat section
59	HI	10843	Minor erosion. Good section for improvement

60	HI	9499	Long flat section
